Kambala School  
c/- Carmichael Tompkins Property Group  
Remedial Action Plan

Kambala School Sports Precinct

794 New South Head Road,  
Rose Bay, NSW  
25 September 2020

58081/130541 (Rev 0)  
JBS&G

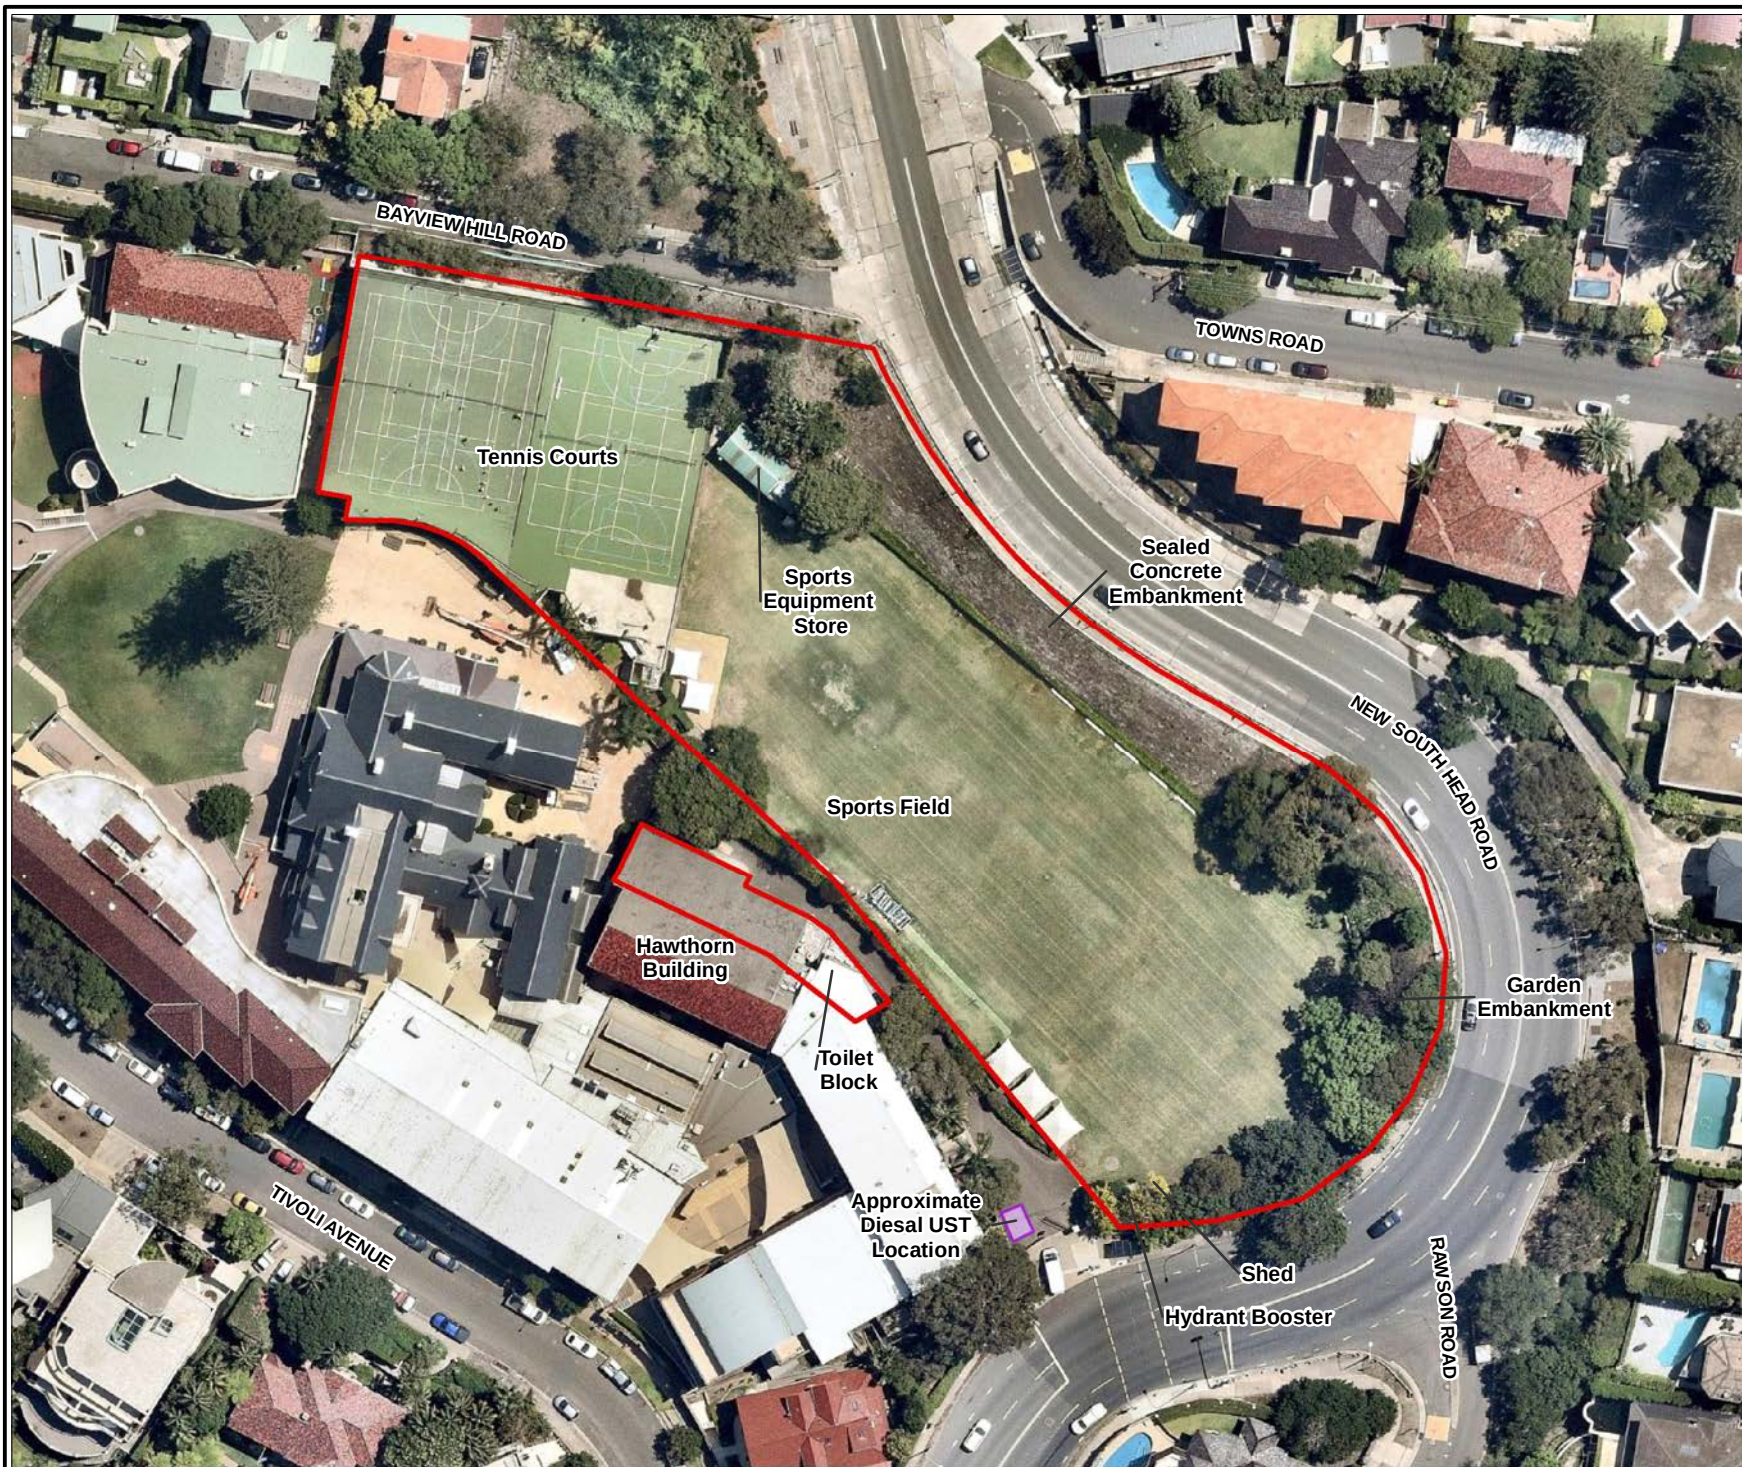
**FIGURE 2**

- Approximate Site Boundary
- Approximate Diesel UST Location

**SITE LAYOUT**

A detailed site inspection was undertaken on 7<sup>th</sup>, 20<sup>th</sup> and 21<sup>st</sup> April 2020 by an experienced JBS&G environmental. The layout of the site was observed to be consistent with that described in the PSI (JBS&G 2020a). Site features observed during site inspections are shown on **Figure 2**.

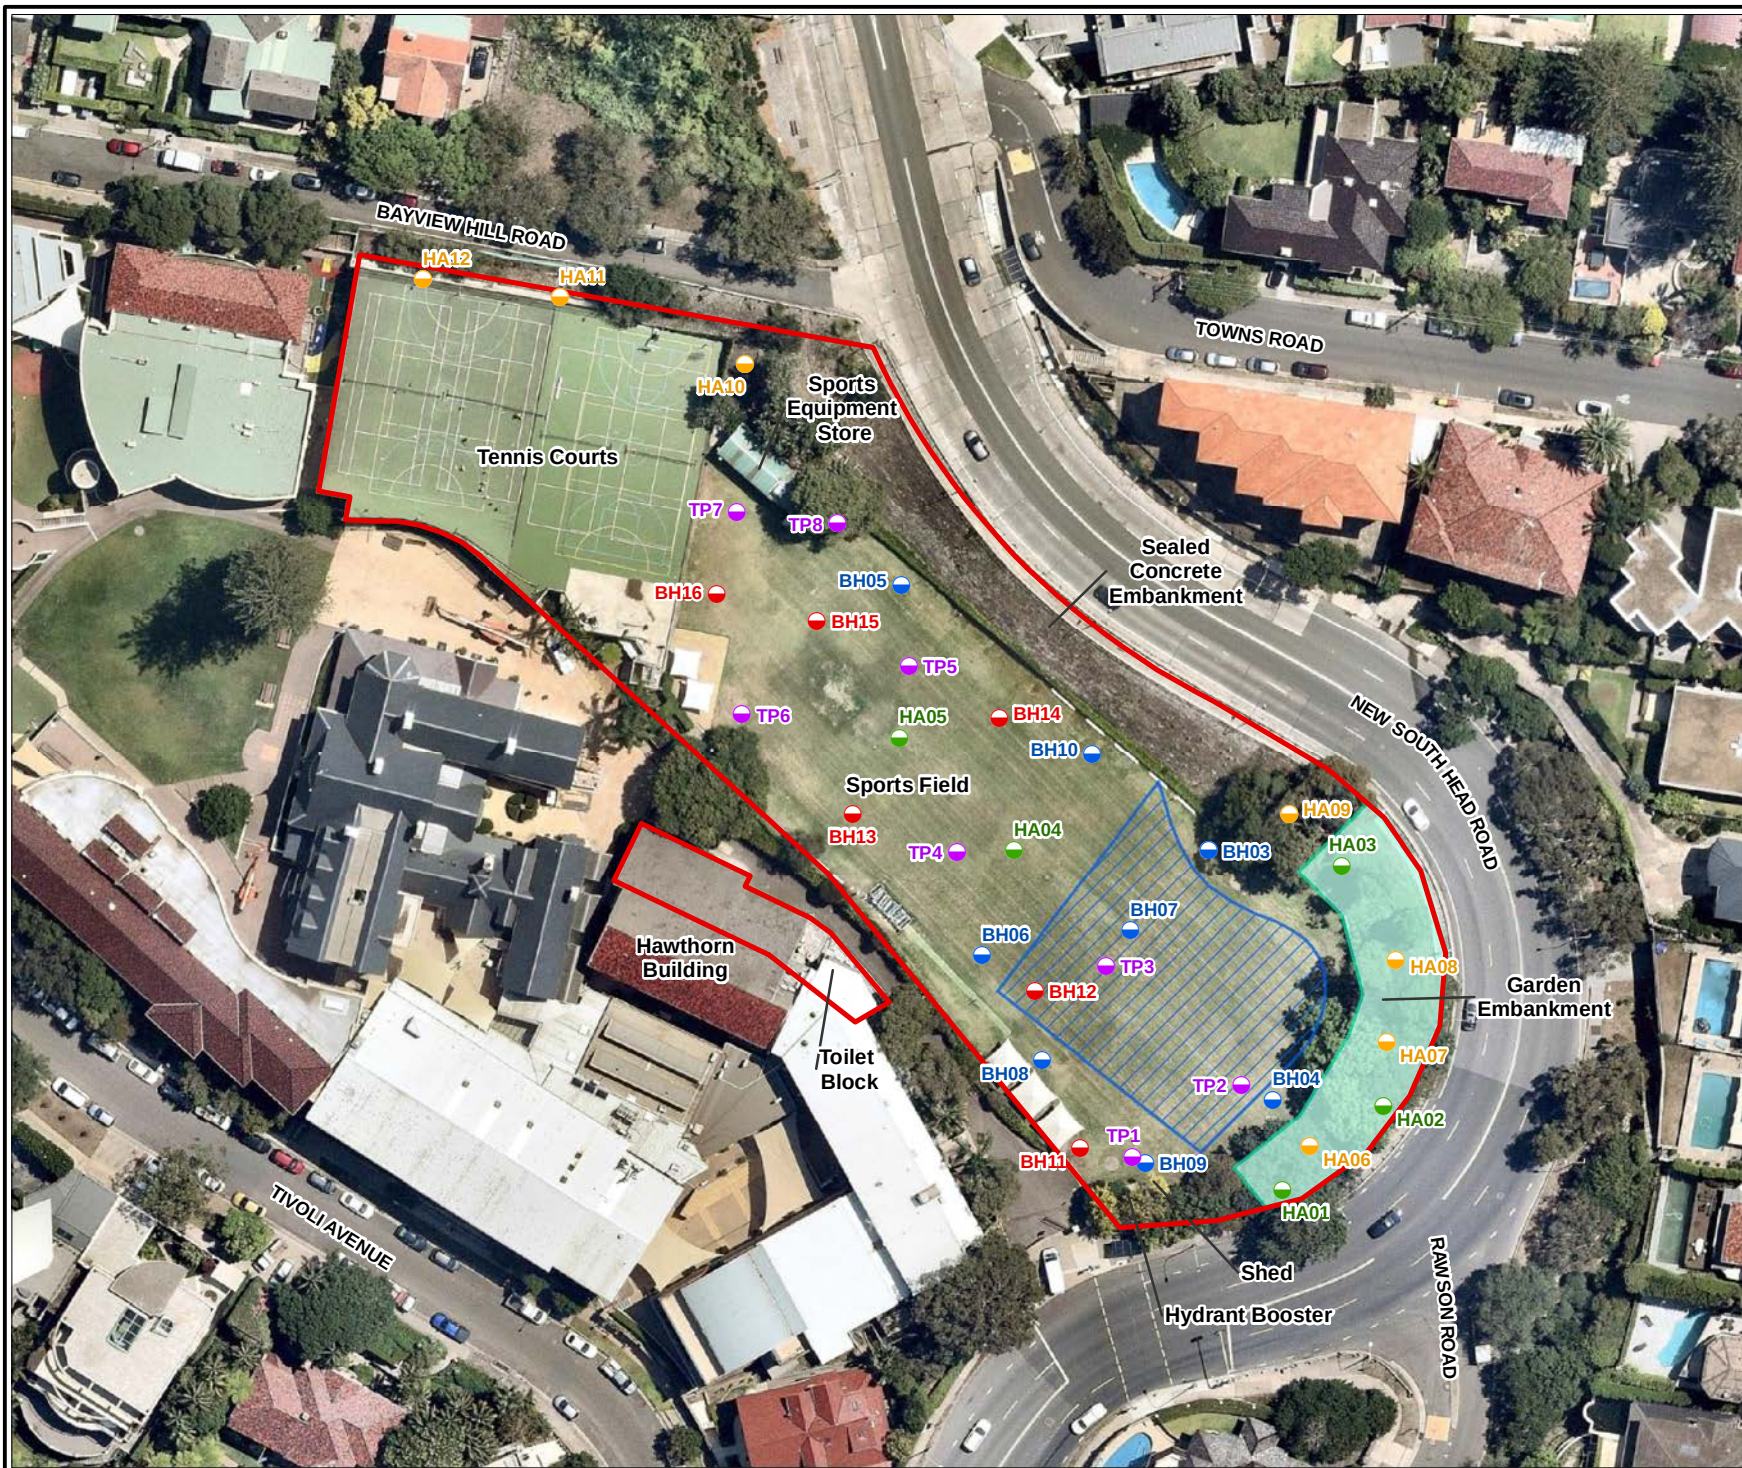
**FIGURE 3**

- Approximate Site Boundary
- Potential Remedial Area within the Sportsfield at a depth of 1m or more
- Remedial Area within Embankment
