# Arboricultural Impact Assessment

PREPARED FOR WOOLWORTHS LTD. 11-13 PERCY STREET,  
AUBURN 15.12.2020

Prepared by Lee Hancock Consulting Arborist AQF LEVEL 5  
LEE@LEEHANCOCKARBORIST.COM.AU | MOBILE 0408 582871

Woolworths Ltd seeks approval to demolish existing warehouse and construct a Woolworths Warehouse & Distribution Centre Auburn SSD - 10470

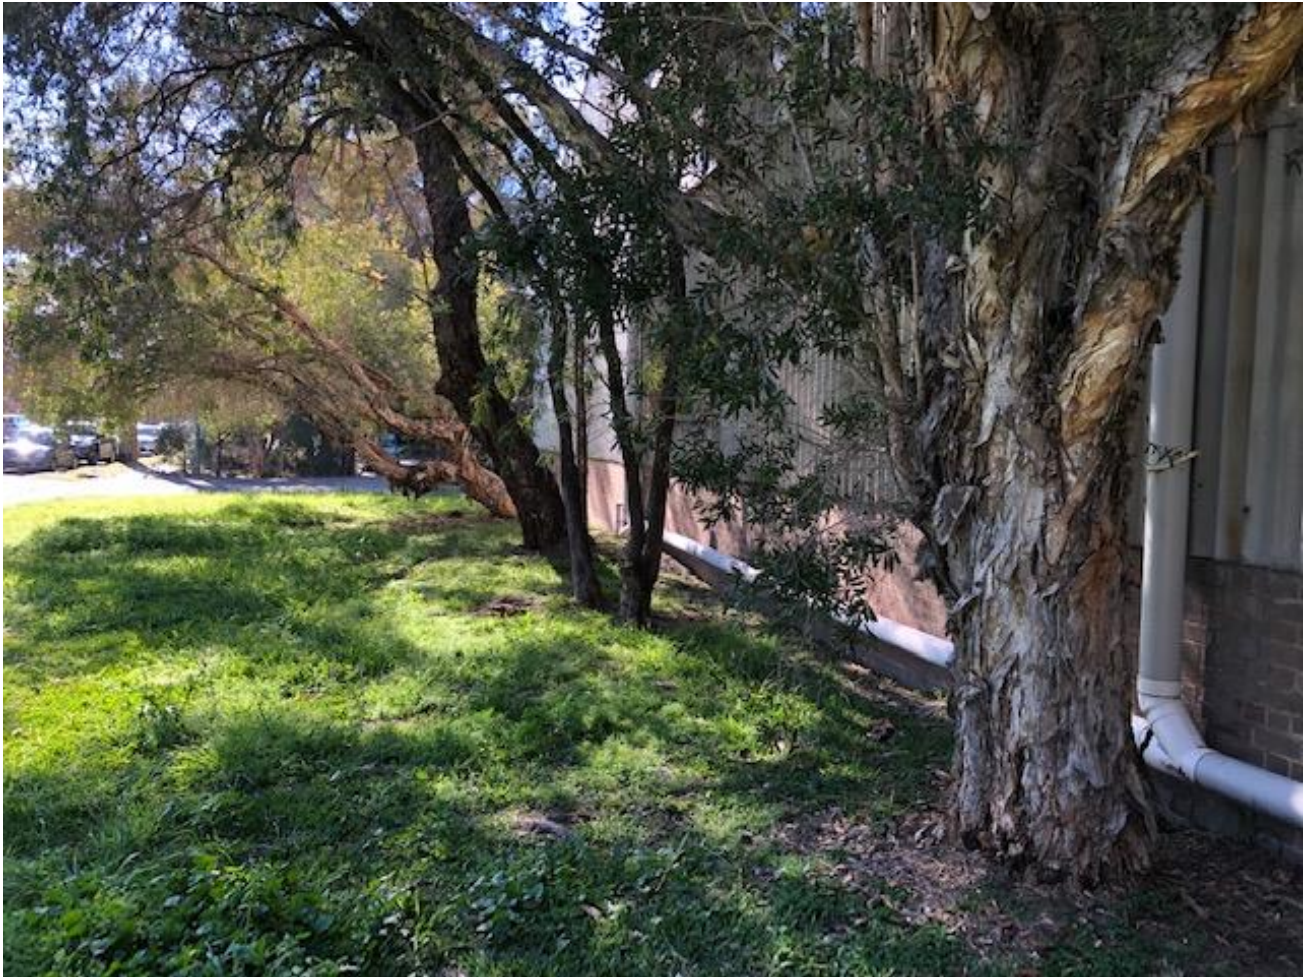
**Plate 2.**

Mature tree positioned 900mm off existing warehouse wall, in fair form and vigour, 40% deadwood in canopy, tree qualifies for Councils 2m rule it is 900mm off the existing warehouse wall. Rated as moderate landscape significance, amenity, and ecological value. Low retention value.

Young tree in fair form and vigour, rated as moderate landscape significance, amenity and ecological value. Low retention value.

Young tree in fair form and vigour, rated as moderate landscape significance amenity and ecological value. Low retention value.

Mature tree in good form and vigour, positioned 400mm off existing warehouse wall, it does not seem feasible to retain tree, it will be adversely impacted upon by the demolition of the building and it qualifies for Councils 2m rule. Rated as high landscape significance amenity and ecological value. Low retention value.

Trees 1 *Melaleuca quinquenervia* (Paperbark), 2 *Eucalyptus nicholli* 3 *Melaleuca citrina* 4 *Melaleuca citrina* and 5 *Melaleuca quinquenervia* (Paperbark),

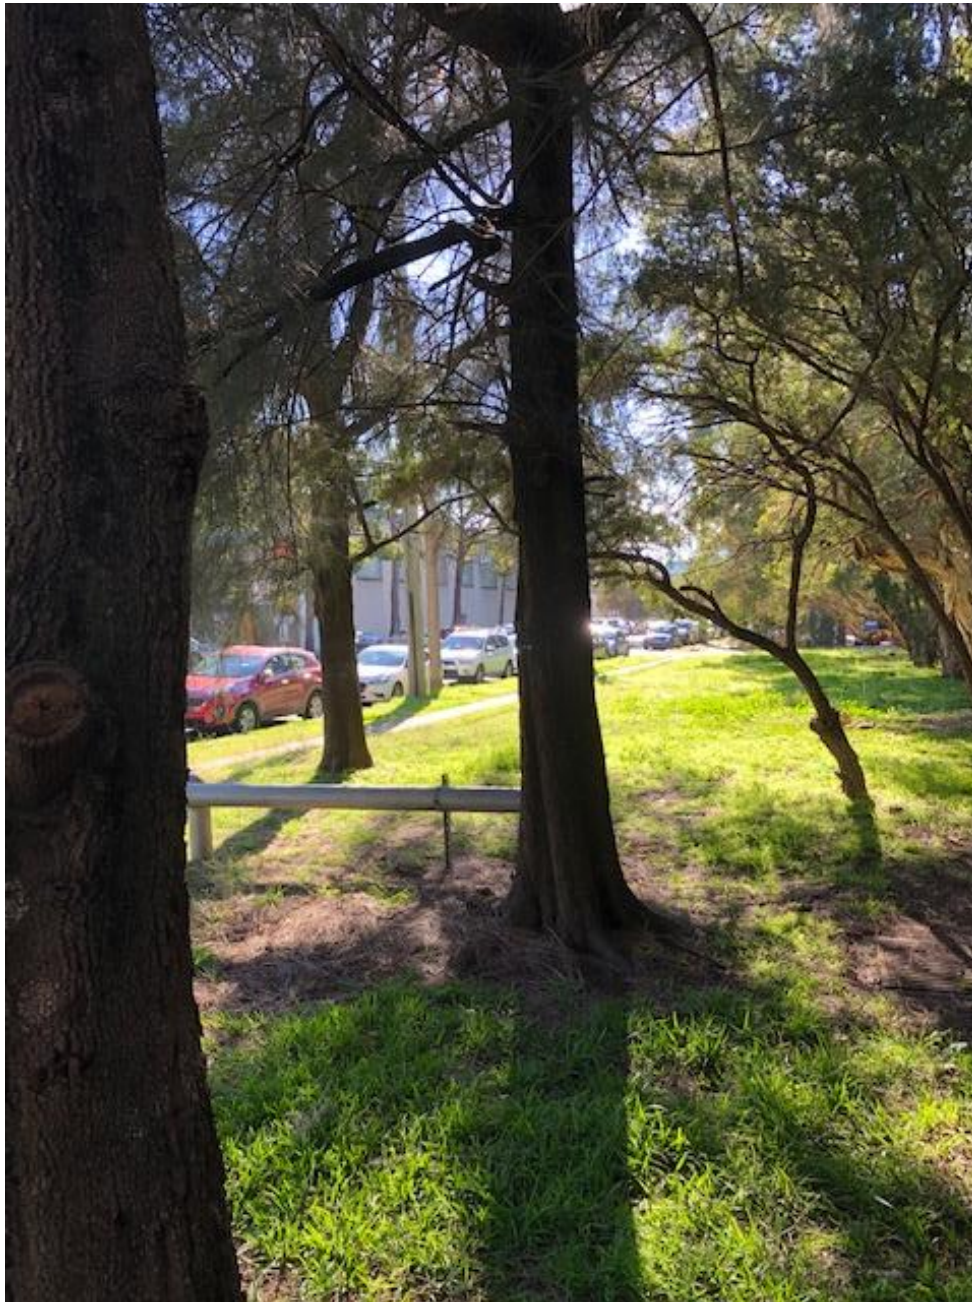
**Plate 4.**

Semi mature multi – stem tree, assessed as in fair form and vigour, appears structurally stable, tree is positioned 1.7m off existing wall and qualifies for Councils 2m rule. Removal is recommended.

Young tree in fair form and vigour, appears structurally stable, not considered worthy of any special measures to retain tree. Rated moderate landscape significance, amenity, and ecological value. Low

Trees 7. *Melaleuca citrina* 8. *Melaleuca citrina*

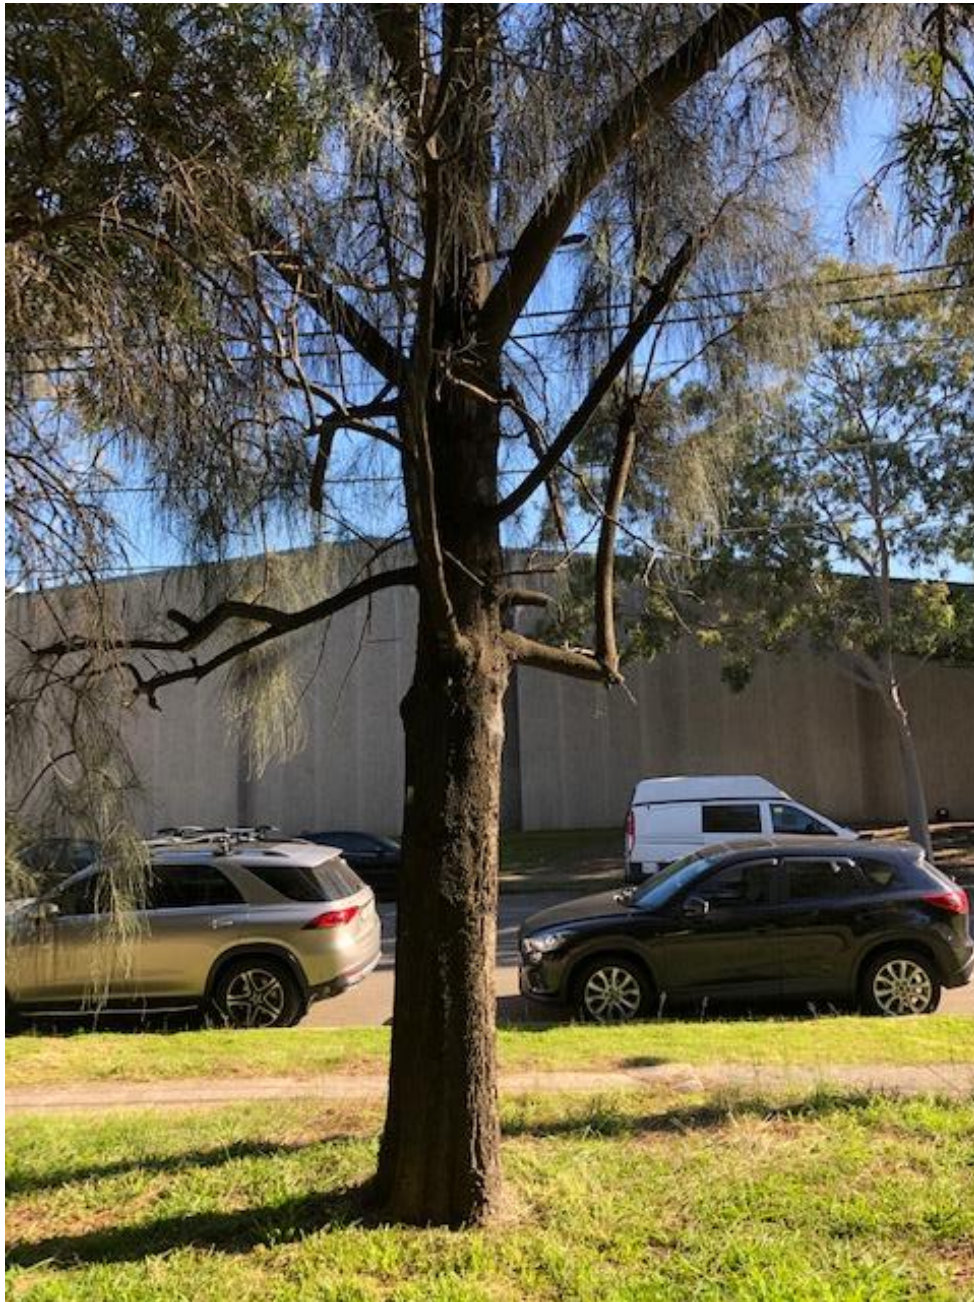
**Plate 5.**

Mature tree positioned 2m from existing footpath, in good form and vigour, appears structurally stable, the supplied plans show tree will spatially conflict with the proposed development. Rated as moderate landscape significance, amenity and ecological value.

Tree 9. *Allocasuarina littoralis*

| Tree | Genus Species | SRZ | TPZ | Recommendation |
|---|---|---|---|---|
| 9 | <i>Allocasuarina littoralis</i><br>(River She-Oak) | 2.5 mR | 5.2 mR | Removal is recommended<br>spatially conflicts with<br>proposed development. |

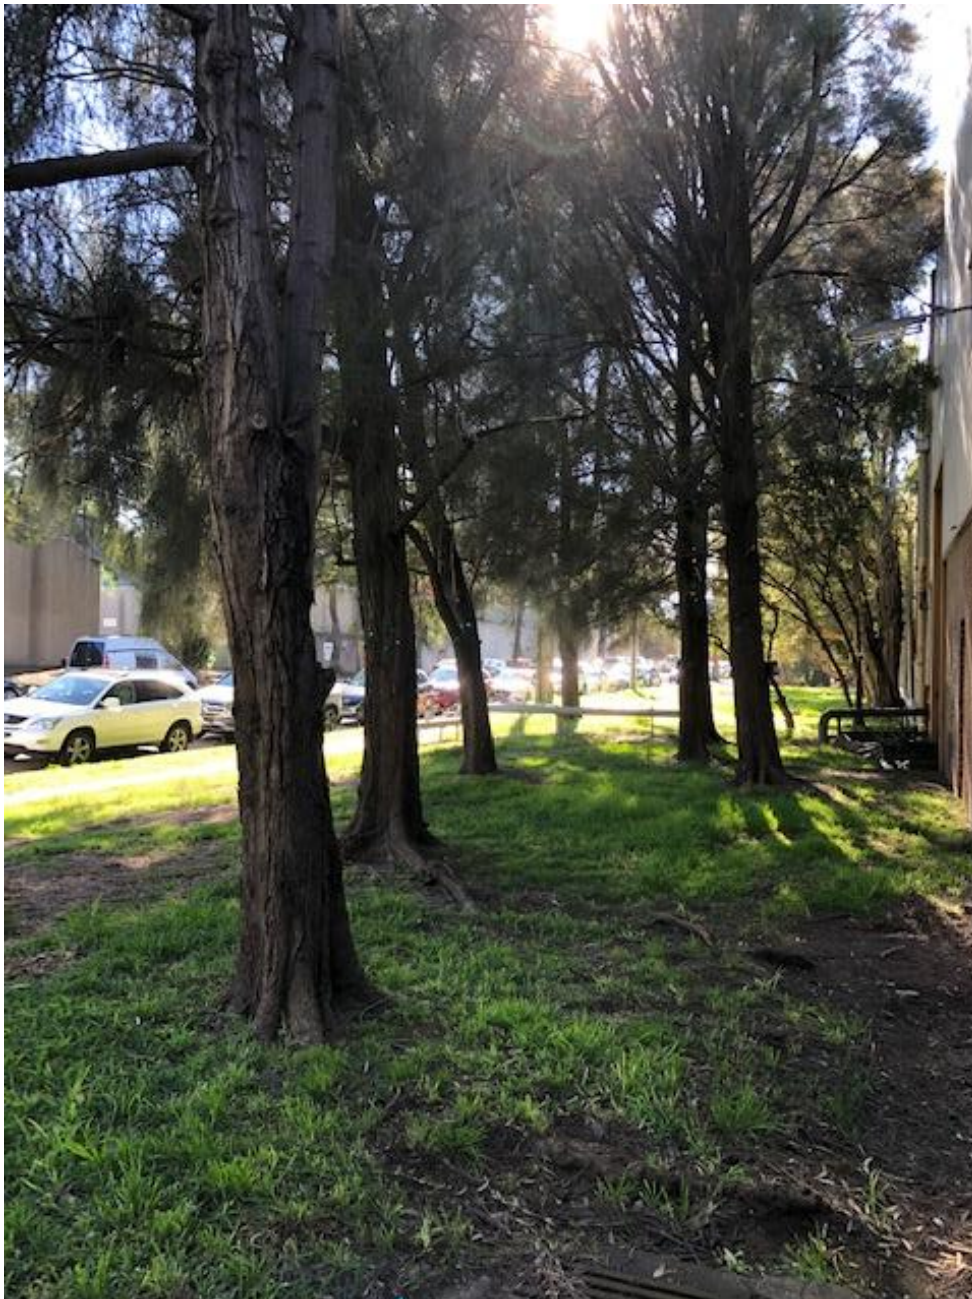
**Plate 6.**

Mature tree positioned 4m off existing wall, forming part of a stand of trees A **stand of trees** *is a contiguous community of trees sufficiently uniform in composition, structure, age, size, class, distribution, spatial arrangement, site quality, condition, or location to distinguish it from adjacent communities*. Tree rated as moderate landscape significance, amenity, and ecological value. Low retention value.

Mature tree positioned 4.5m from existing wall, the proposed demolition will adversely impact upon the tree, rated as moderate landscape significance, amenity, and ecological value. Low retention value.

Mature tree positioned 2m from existing wall, the proposed demolition will adversely impact upon the tree, rated as moderate landscape significance, amenity, and ecological value. Low retention value.

Mature tree positioned 5.5m off existing warehouse wall, in fair form and vigour, appears structurally stable, rated as moderate landscape significance, amenity and ecological value. Rated as low retention value.

Mature tree in good form and vigour, positioned 5m off wall, appears structurally stable, rated as moderate retention value, landscape significance, amenity, and ecological value. Low retention value.

Mature tree in good from and vigour, positioned 3m off existing building, appears structurally stable, rated as moderate retention value, landscape significance, amenity, and ecological value. Low retention value.

Tree 10 *Allocasuarina* spp. 11. *Allocasuarina* spp. 12. *Allocasuarina* spp. 13. *Allocasuarina* spp.

14. *Casuarina cunninghamiana* 15. *Casuarina cunninghamiana*

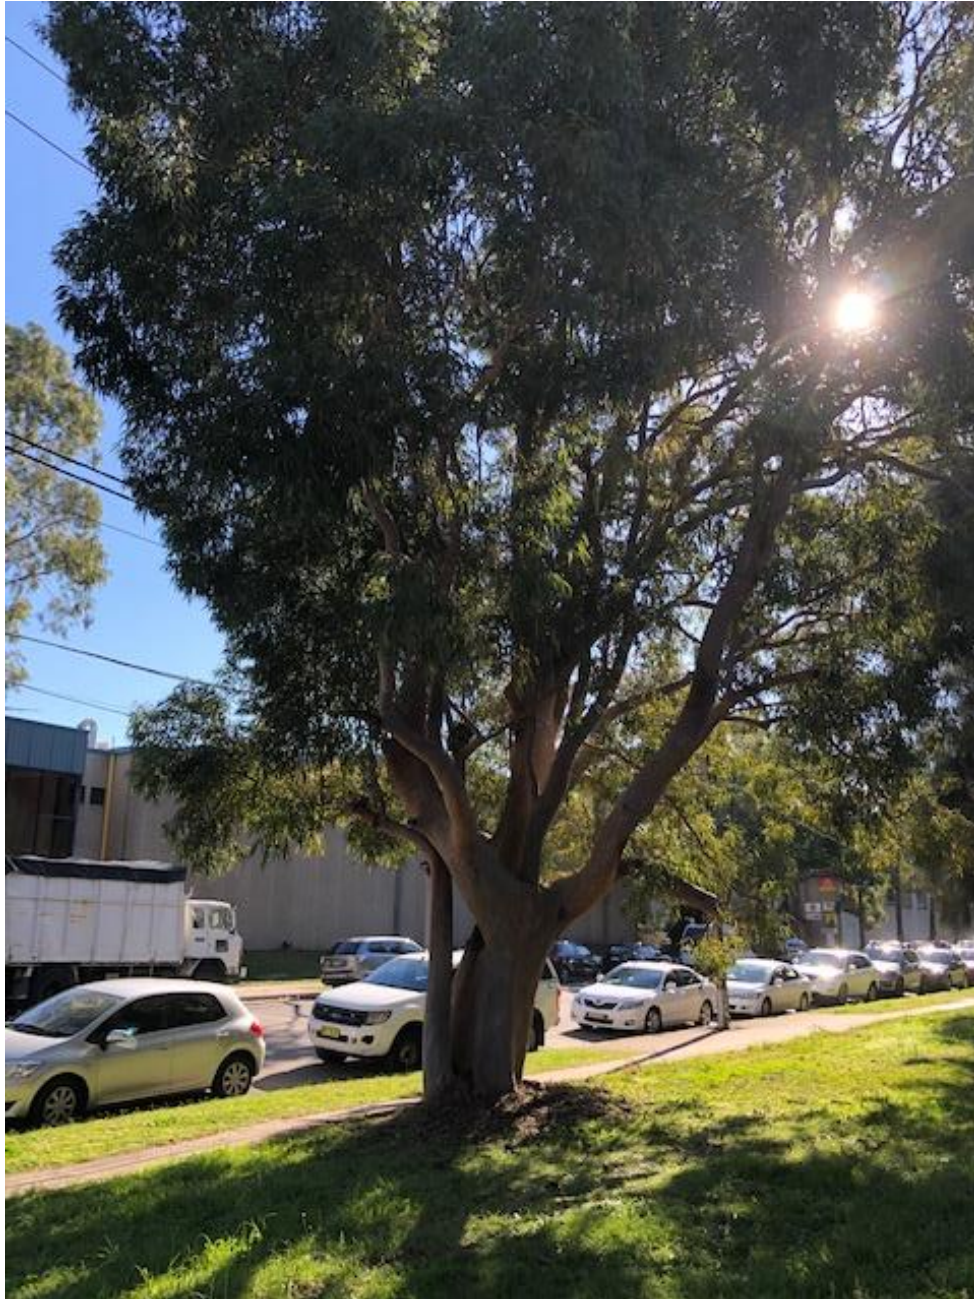
**Plate 7.** Tree 16. *Angophora costata* (Sydney Red Gum) (Not shown on Survey)

Mature tree in good form and vigour, heavily modified pruning to allow clearance overhead powerlines. Tree appears structurally stable. The supplied plans show tree will spatially conflict with the proposed development. Rated as moderate landscape significance amenity and ecological value.

| Tree | Genus Species | SRZ | TPZ | Recommendation |
|---|---|---|---|---|
| 16 | <i>Angophora costata</i><br>(Sydney Red Gum) | 3.4 mR | 12.2 mR | Tree spatially conflicts with proposed development removal is recommended. |

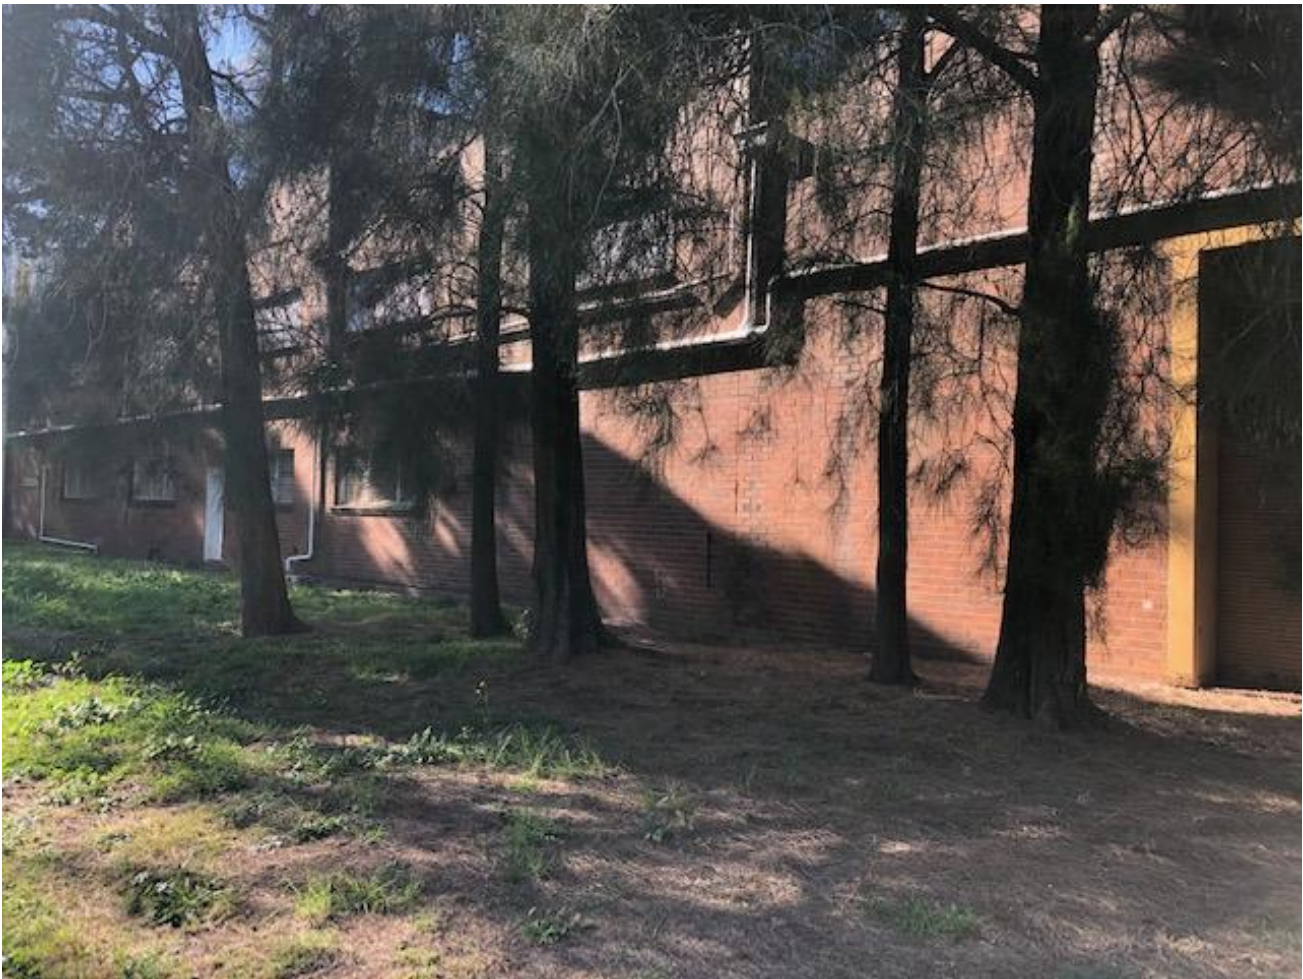
**Plate 8.**

Forming part of a Stand of Trees. Mature tree in fair form and vigour, positioned 5m off existing wall, appears structurally stable, rated as moderate landscape significance, amenity, and ecological value. Low retention value.

Forming part of a Stand of trees. Young tree in fair form and vigour, positioned 3m off existing wall, appears structurally stable, rated as moderate landscape significance, amenity, and ecological value. Low retention value.

Part of a Stand of trees Semi mature tree in good form and vigour, positioned 2m off wall tree qualifies for Councils 2m rule. Removal is recommended.

Trees 17 *Casuarina cunninghamiana*, 18 *Casuarina cunninghamiana*, 19 *Allocasuarina* spp. 20 *Allocasuarina* spp. 21 *Allocasuarina* spp.

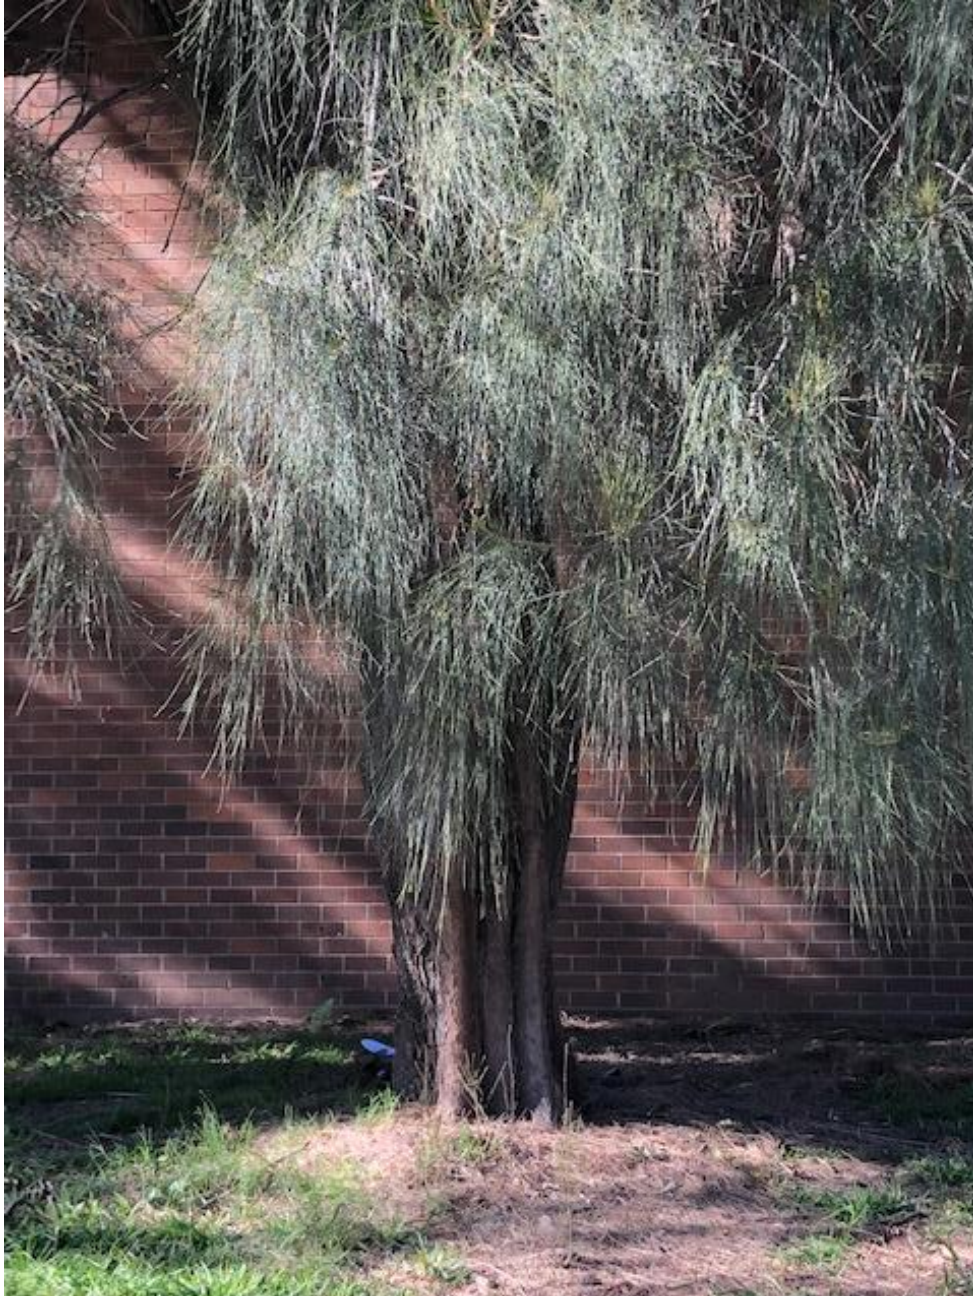
**Plate 9.**

Tree 22. *Allocasuarina* spp.

| Tree | Genus Species | SRZ | TPZ | Recommendation |
|---|---|---|---|---|
| 22 | <i>Allocasuarina</i> Spp. | 2.6 mR | 5.7 mR | Adverse impact Removal is recommended |

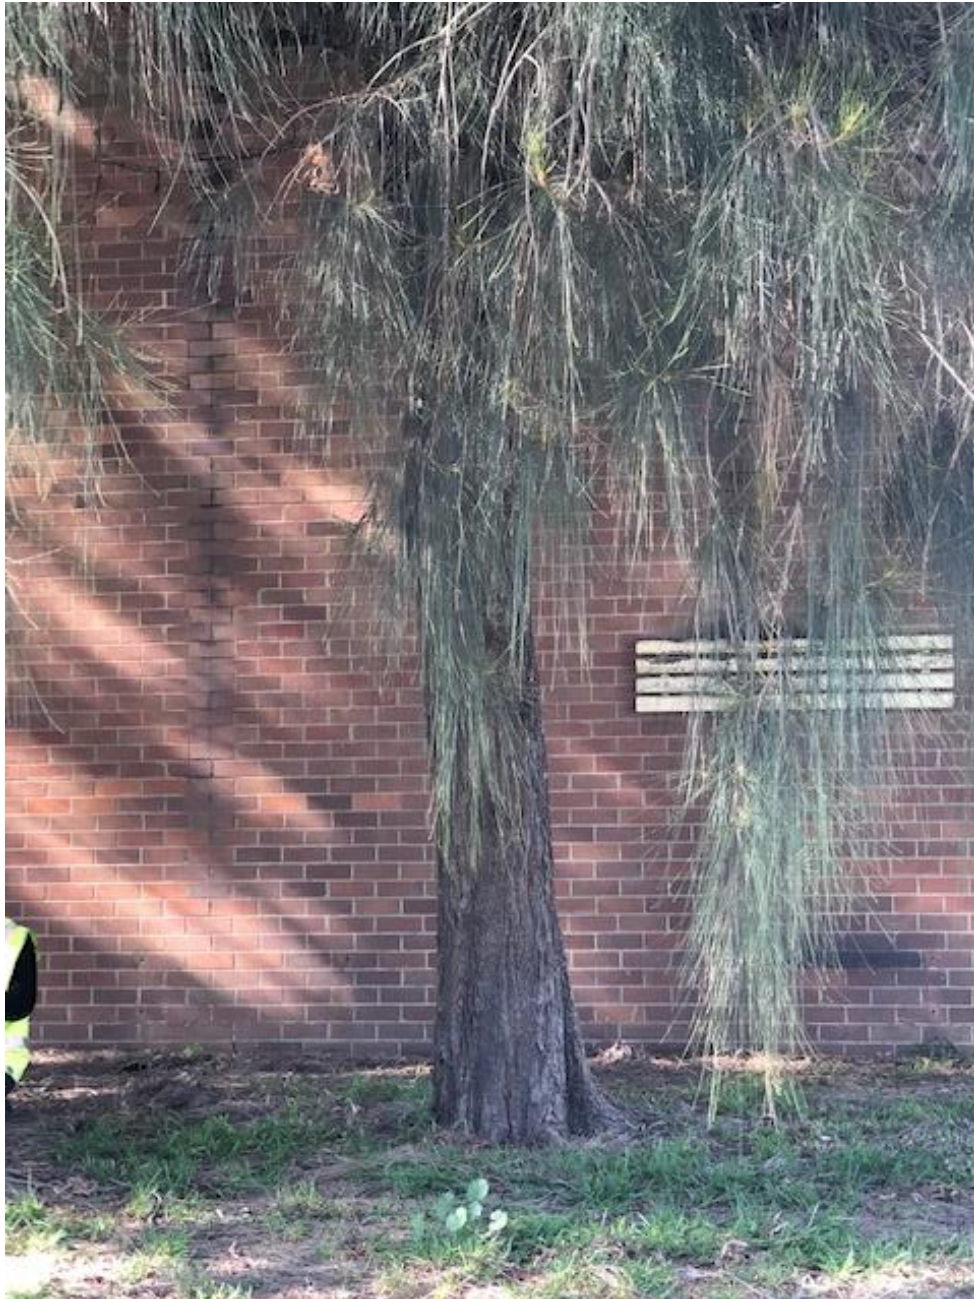
**Plate 10.**

Tree 23. *Allocasuarina* spp.

| Tree | Genus Species | SRZ | TPZ | Recommendation |
|---|---|---|---|---|
| 23 | <i>Allocasuarina</i> Spp. | 2.4 mR | 4.8 mR | Adverse impact Removal is recommended |

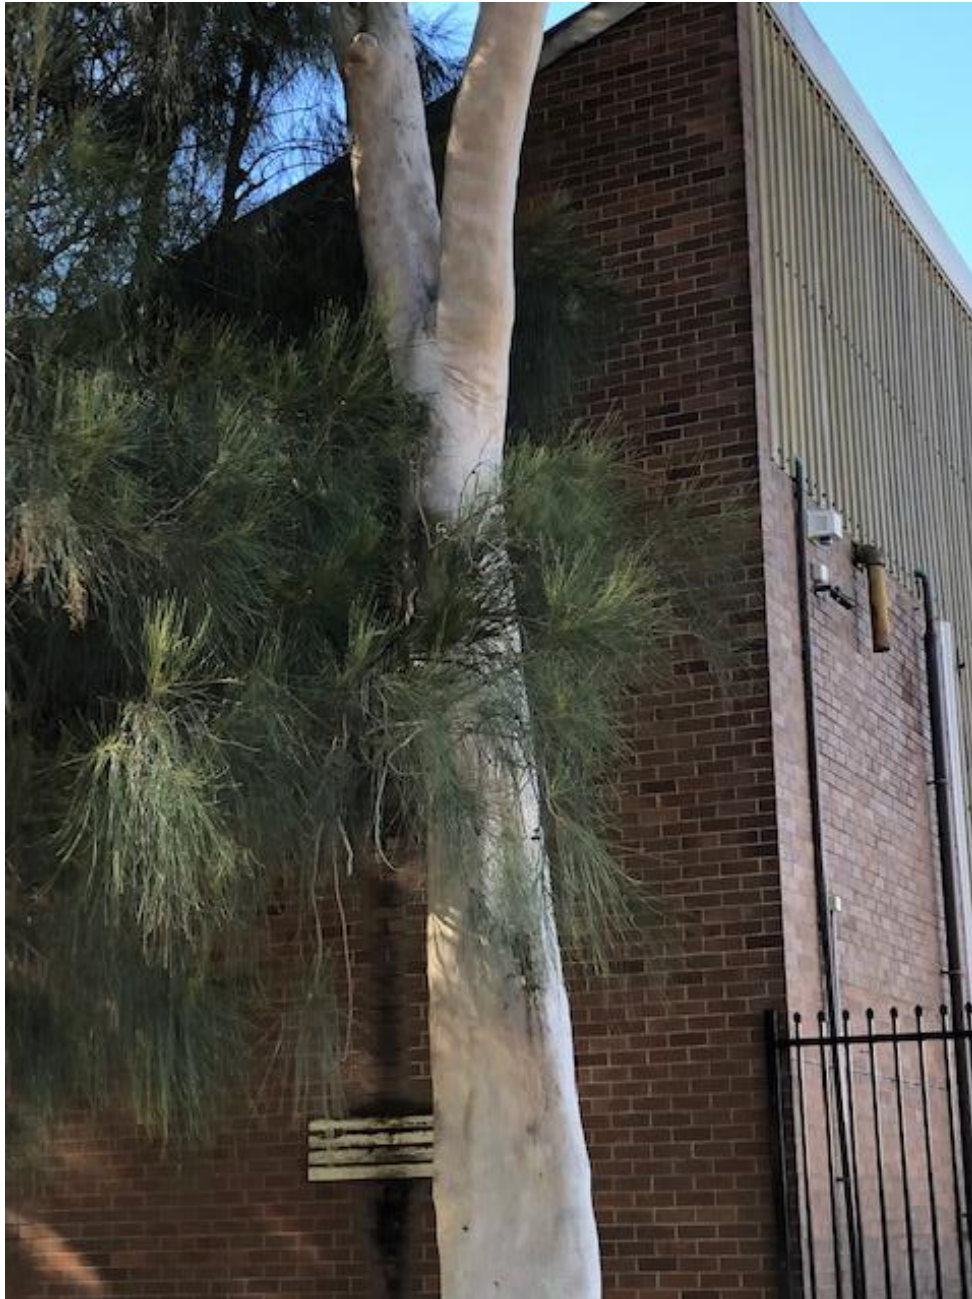
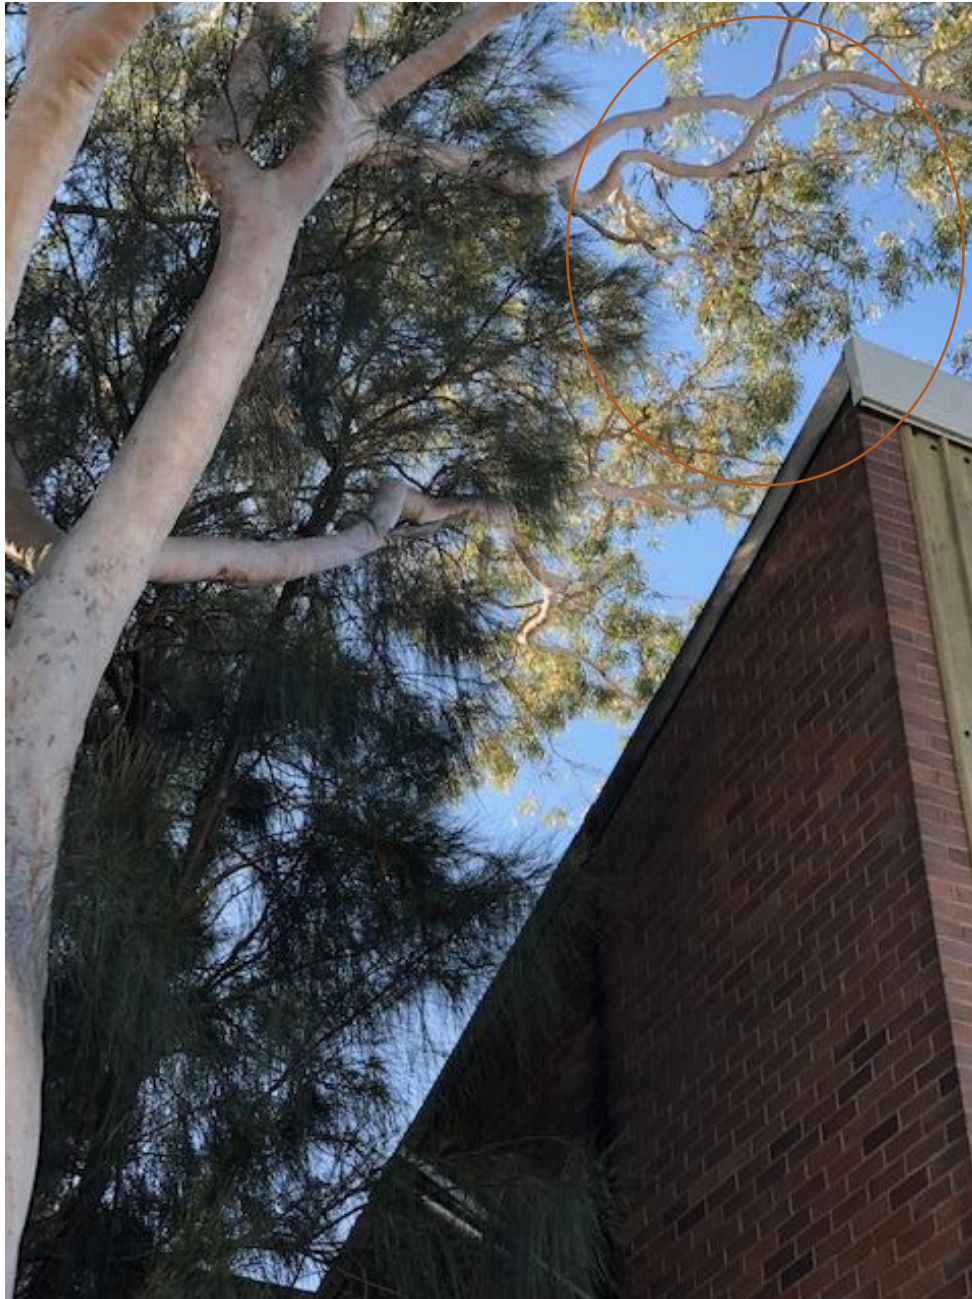
**Plate 11.**

Tree 24 *Corymbia citriodora* (Lemon Scented Gum)

Tree 24. *Corymbia citriodora* (Lemon Scented Gum)

| Tree | Genus Species | SRZ | TPZ | Recommendation |
|---|---|---|---|---|
| 24 | <i>Corymbia citriodora</i><br>(Lemon Scented Gum) | 2.9 mR | 7.6 mR | Adverse impact Removal is recommended |

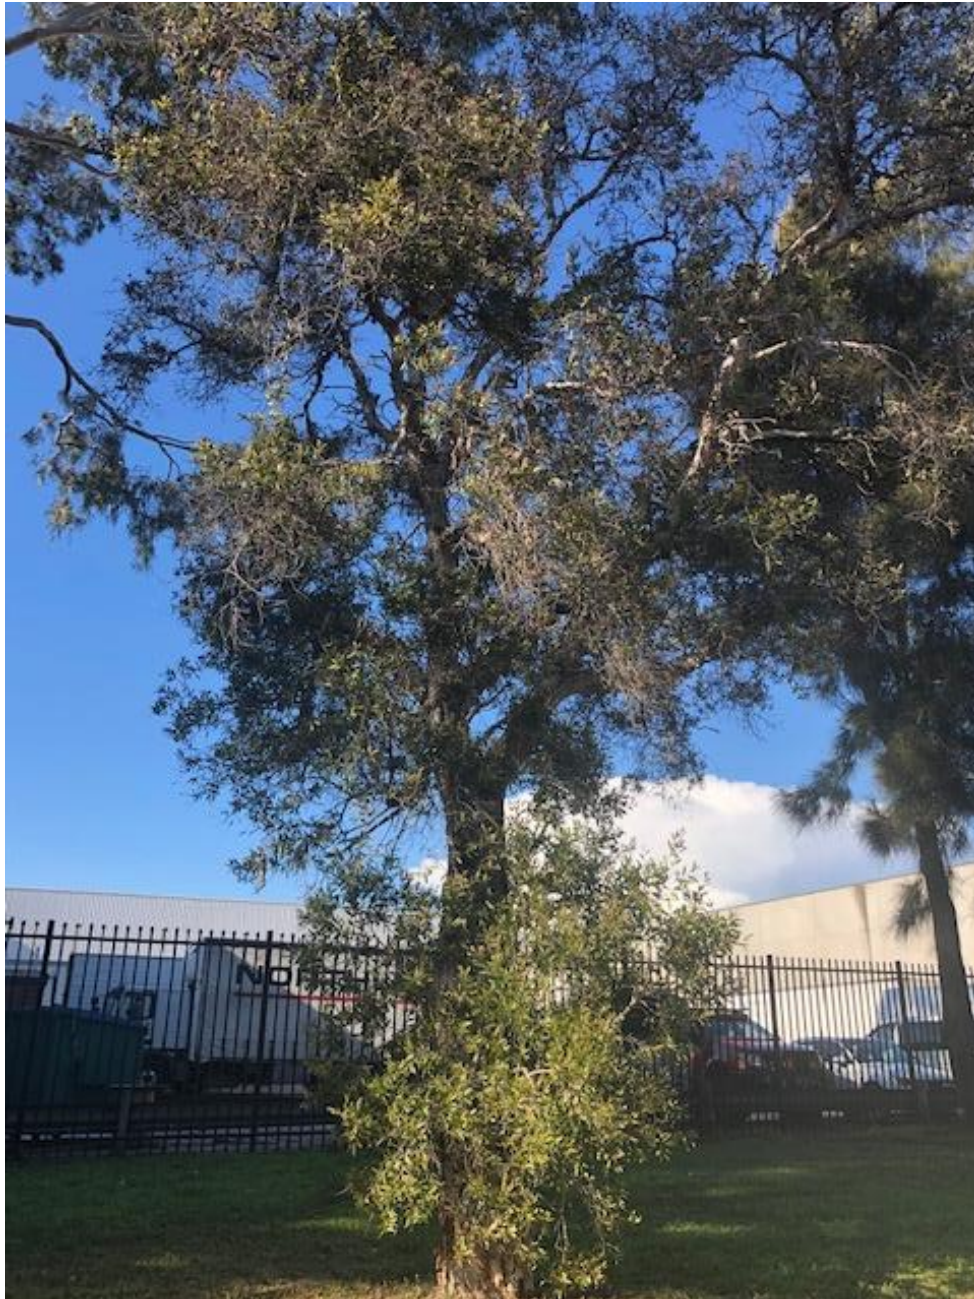
**Plate 13**

Tree 25. *Melaleuca quinquenervia* (Paperbark)

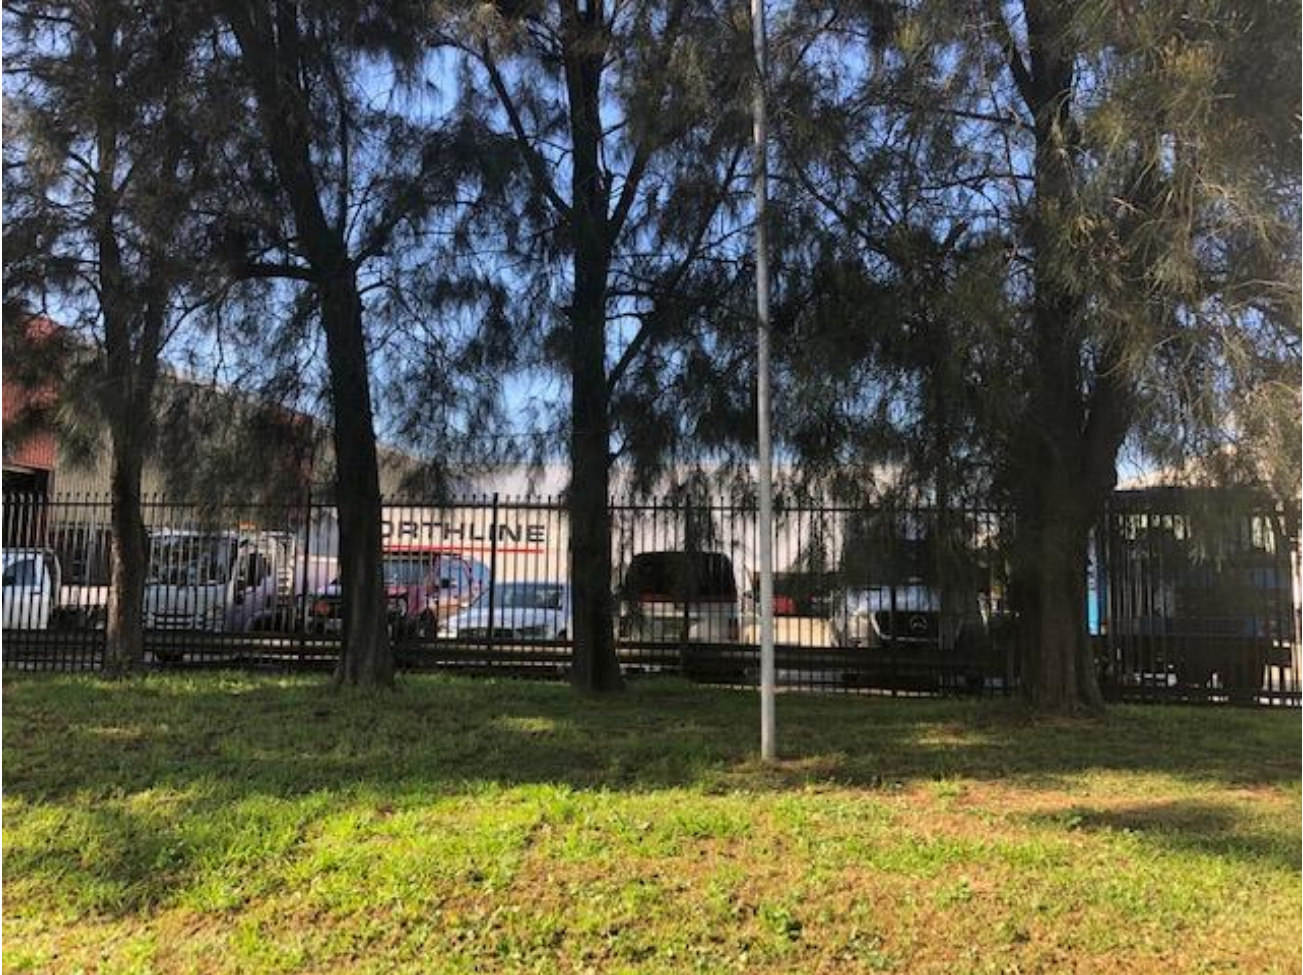
**Plate 14**

Trees 26,27,28 and 29 *Allocasuarina* spp.

| Tree | Genus Species | SRZ | TPZ | Recommendation |
|---|---|---|---|---|
| 26 | <i>Allocasuarina</i> Spp. | 2.3mR | 4.6mR | Adverse impact Removal is recommended |
| 27 | <i>Allocasuarina</i> Spp. | 2.5mR | 5.2mR | Adverse impact Removal is recommended |
| 28 | <i>Allocasuarina</i> Spp. | 2.6mR | 5.6mR | Adverse impact Removal is recommended |
| 29 | <i>Allocasuarina</i> Spp. | 2.8mR | 6.7mR | Adverse impact Removal is recommended |

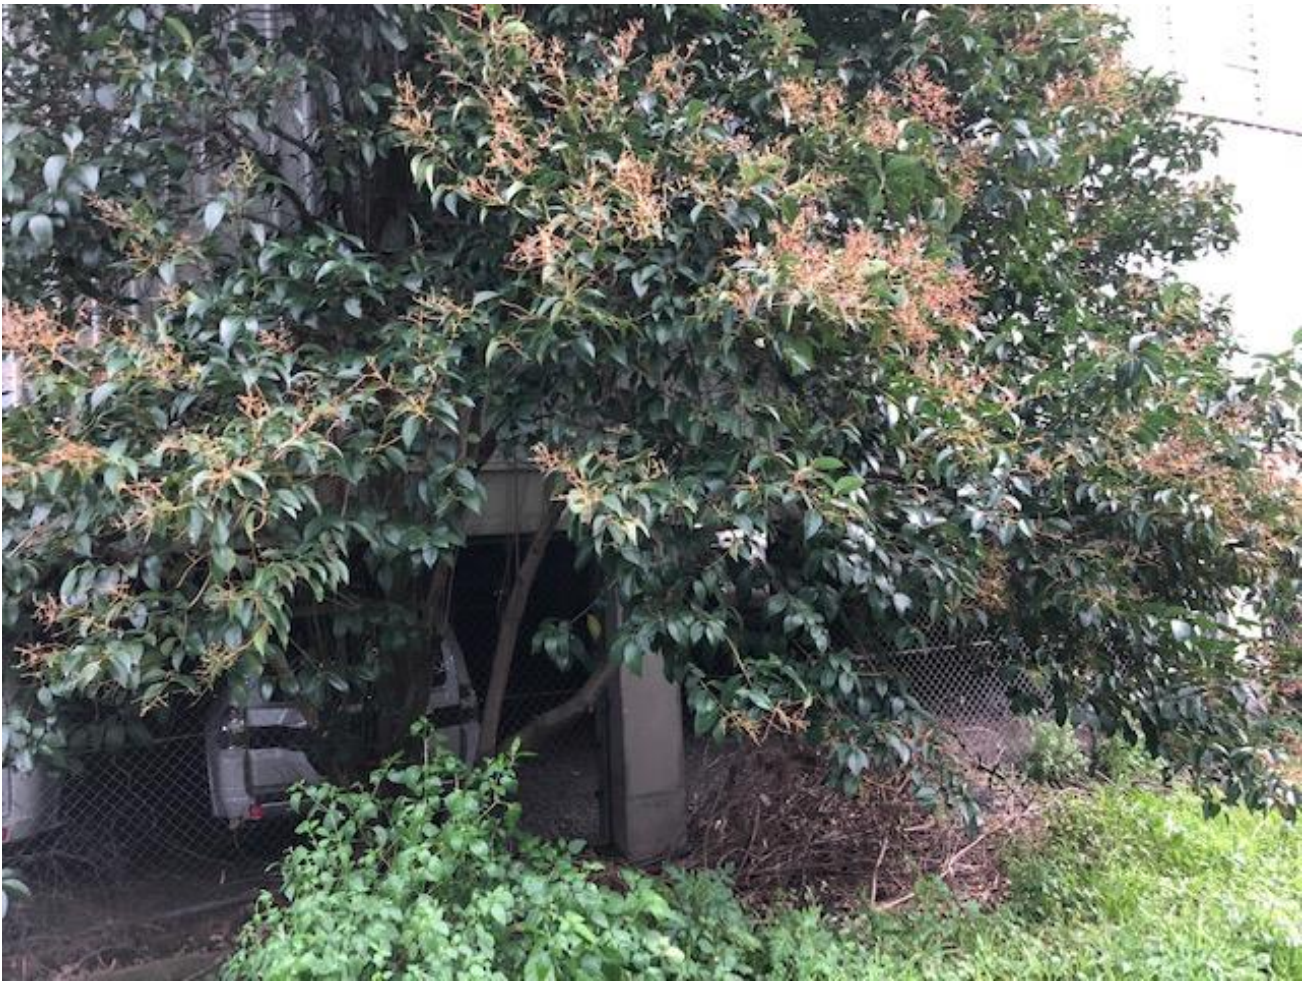
Positioned rear of site adjacent to Haslam Creek, tree is a nominated weed in the Biosecurity Act 2015, removal is recommended.

**Plate 19** Tree 35 *Ligustrum lucidum* (Large Leaf Privet) onsite Haslam's Creek

| Tree | Genus Species | SRZ | TPZ | Recommendation |
|---|---|---|---|---|
| 35 | <i>Ligustrum lucidum</i><br>(Large Leaf Privet) | _____ | _____ | Biosecurity Weed removal is recommended. |

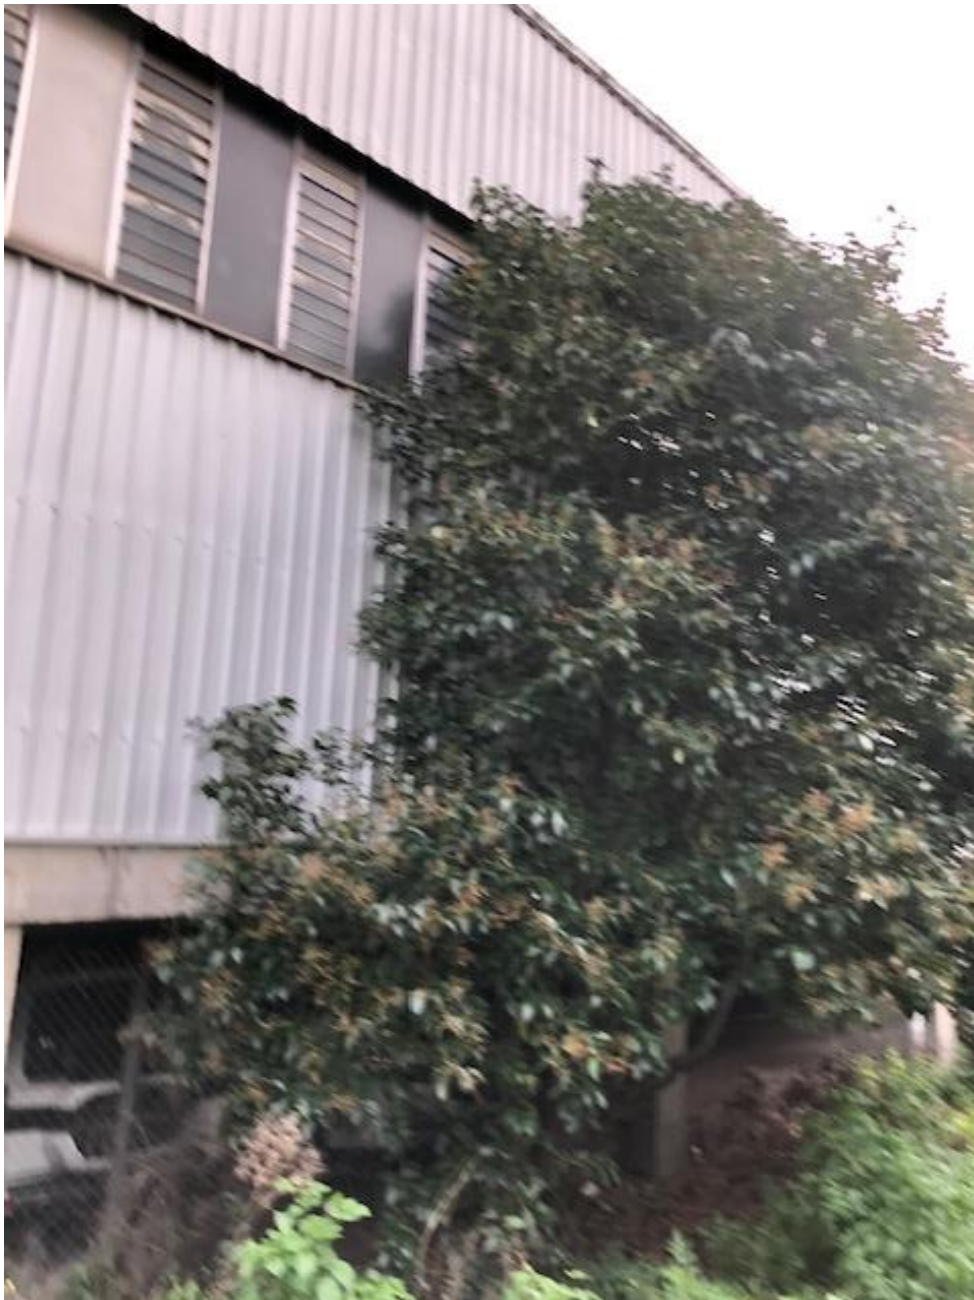
Positioned rear of site adjacent to Haslam Creek, tree is a nominated weed Biosecurity Act 2015, removal is recommended.

**Plate 20** Tree 36 *Ligustrum lucidum* (Large Leaf Privet) onsite Haslam's Creek

| Tree | Genus Species | SRZ | TPZ | Recommendation |
|---|---|---|---|---|
| 36 | <i>Ligustrum lucidum</i><br>(Large Leaf Privet) | _____ | _____ | Biosecurity Weed removal is recommended. |

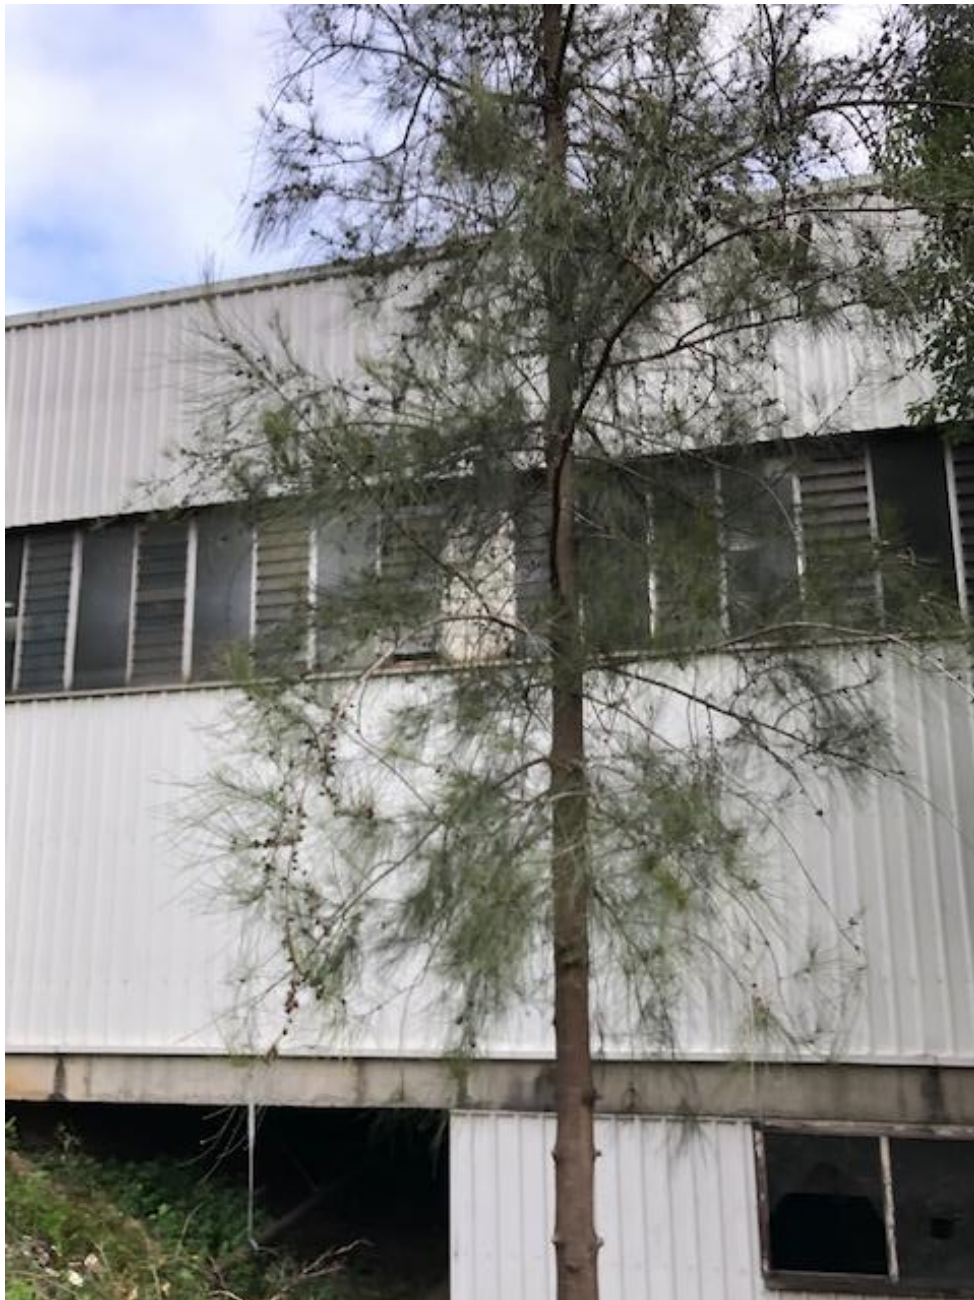
**Plate 21** Tree 36A *Casuarina cunninghamiana* (River Oak) onsite

| Tree | Genus Species | SRZ | TPZ | Recommendation |
|---|---|---|---|---|
| 36A | <i>Casuarina cunninghamiana</i><br>(River Oak) | 2.1mR | 3.0mR | Removal is recommended |

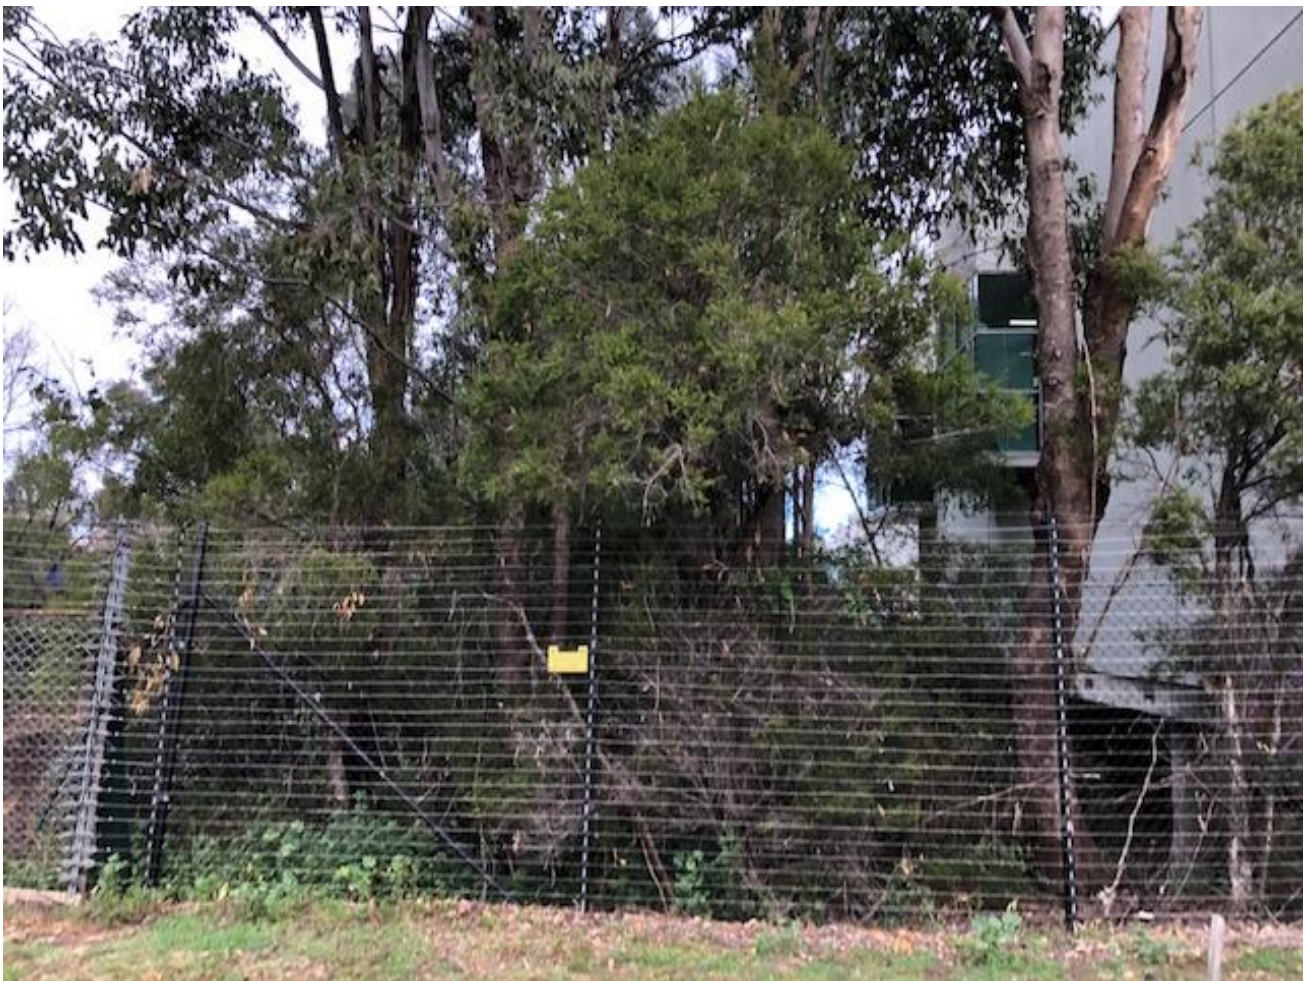
**Plate 23** Stand of *Eucalyptus molucanna* (Grey Gum) offsite 15 Percy Street.

6.2 The stand of *Eucalyptus molucanna* offsite southern boundary 15 Percy Street. The proposed OSD tank is to be excavated in close proximity to the stand of trees. Prior to the installation of the OSD tank. It is recommended that root investigation by Non -Destructive Excavation (NDE) such as hydro-vacuum excavation (Sucker Truck), air spade and manual excavation (Hand Tools). Root mapping will reveal the location and distribution of any woody roots. If any woody roots less than 40 mm in diameter are encountered, they shall be cut cleanly with a sharp instrument. Any woody roots greater than 40mm shall be retained and Project Arborist to provide recommendations.
