# Arboricultural Impact Assessment

PREPARED FOR WOOLWORTHS LTD. 11-13 PERCY STREET,  
AUBURN 15.12.2020

Prepared by Lee Hancock Consulting Arborist AQF LEVEL 5  
LEE@LEEHANCOCKARBORIST.COM.AU | MOBILE 0408 582871

Woolworths Ltd seeks approval to demolish existing warehouse and construct a Woolworths Warehouse & Distribution Centre Auburn SSD - 10470

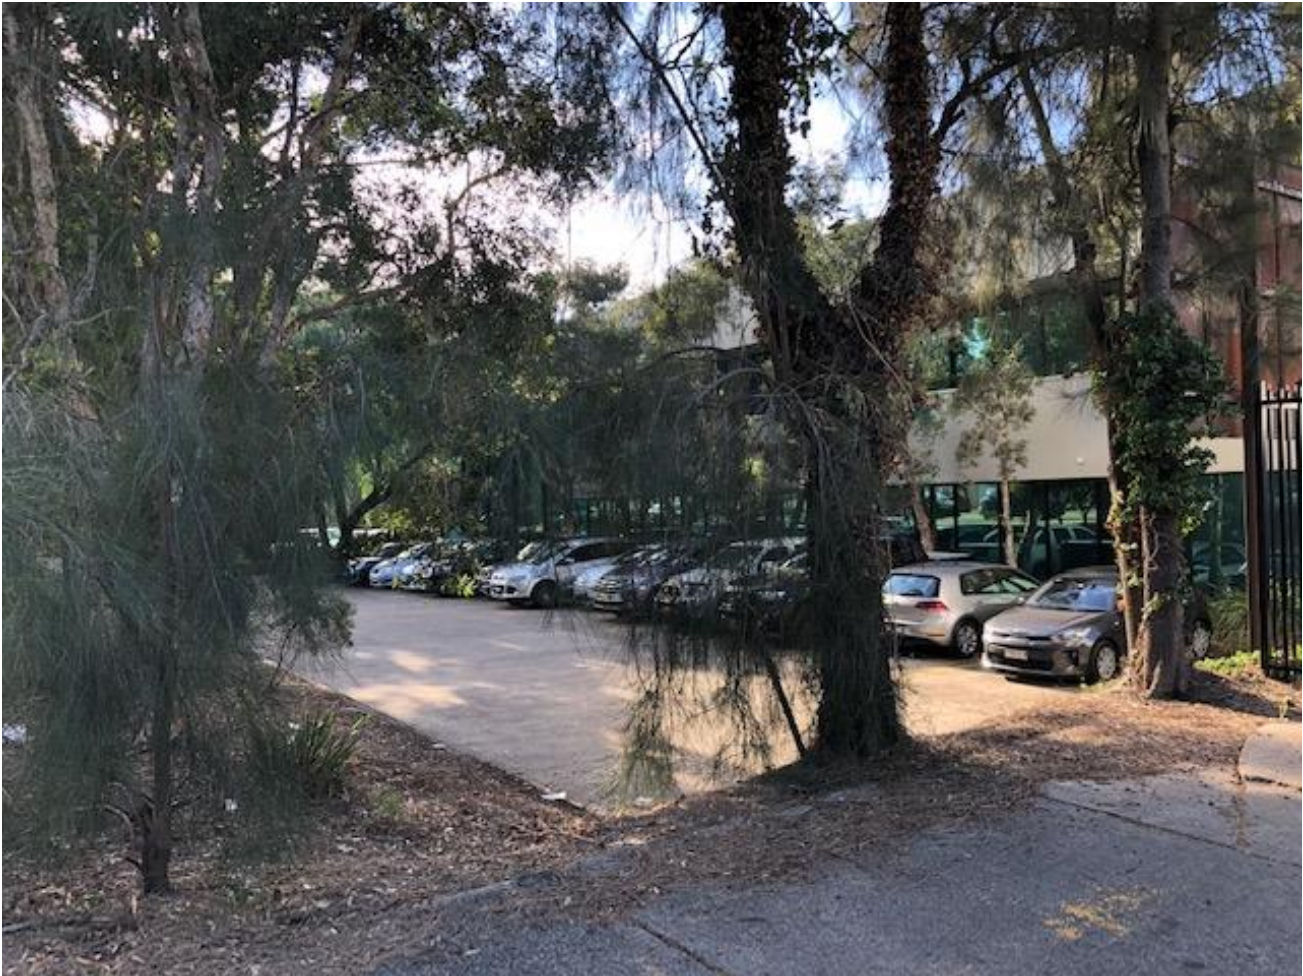
**Plate 24**

Trees offsite Trees 1A,2A.3A *Casuarina cunninghamiana* (River Oak) 9 Percy Street.

Demolition of existing cross over within the tree protection zones of Trees 1A,2A,3A, shall be undertaken under the supervision of the Site Arborist. The crossover surface and sub-base within the TPZ shall be gradually removed in layers of no greater than 50mm thick using a small rubber tracked excavator to avoid damage to underlying roots and minimise disturbance and compaction of the underlying soil profile. The machine shall work within the footprint of the concrete surfaces to avoid compaction of the underlying soil profile. The final layer of sub-base material shall be removed using hand tools where required to avoid compaction and damage to woody roots.

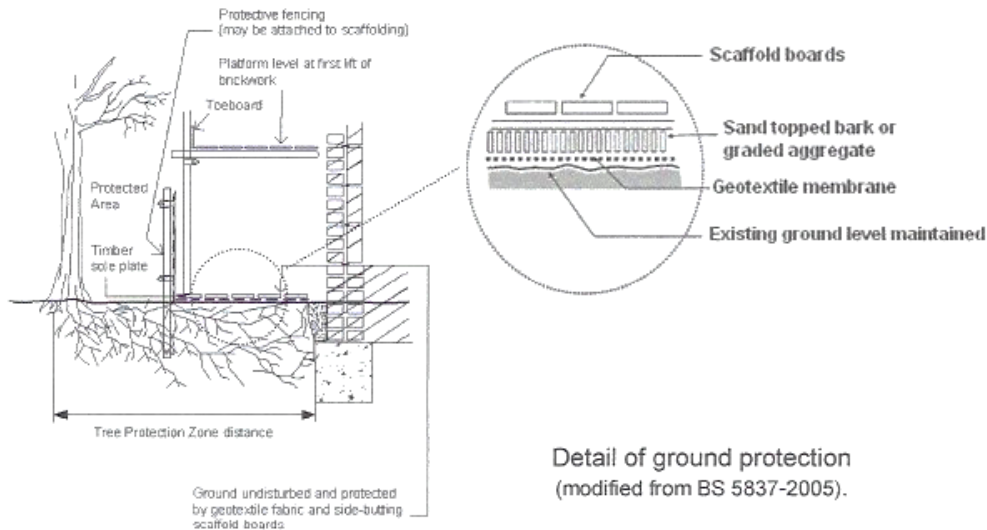
**Root zone protection:** Where necessary, access through the TPZ can be achieved by laying aggregate and timber boards (or similar) over the root zone to protect roots. The ground beneath the boarding should be left undisturbed and should be protected with a porous geo-textile fabric covered with sand or mulch.

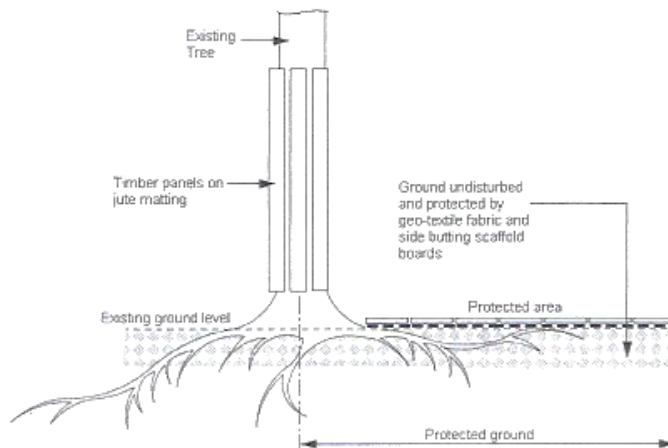
**Detail of trunk protection.**

**Trunk protection:** Where fencing cannot be installed, the vertical trunk of exposed trees shall be protected by the placement of 3.6m lengths of 50 x 100mm hardwood timbers, spaced vertically, at 150mm centres and secured by 2mm wire at 300mm wide spacing over suitable protective padding material e.g. Jute Matting. The trunk protection shall be maintained intact until the completion of all work on site.

Trunk Protection by way of Timber planks (50mmx 100mm or similar) with a geotextile fabric shall be placed around Street tree. The timber planks shall be spaced at 100mm intervals, and must be fixed against the trunk secured together with 2mm galvanised wire. These shall be strapped around the trunk (not fixed in anyway) to avoid mechanical injury or damage. Trunk protection should be installed prior to any site works and maintained in good
