EnergyConnect (NSW – Western Section)

Non-Aboriginal & Aboriginal Cultural Heritage Assessment Report

April 2021

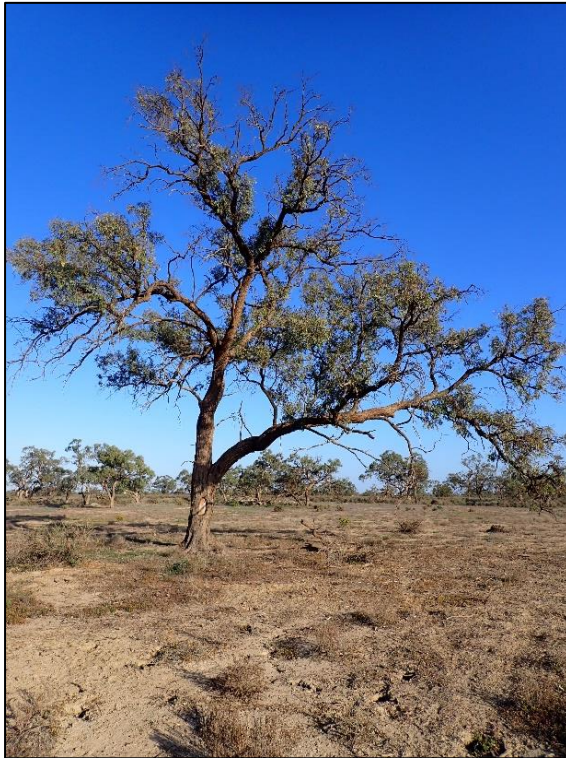
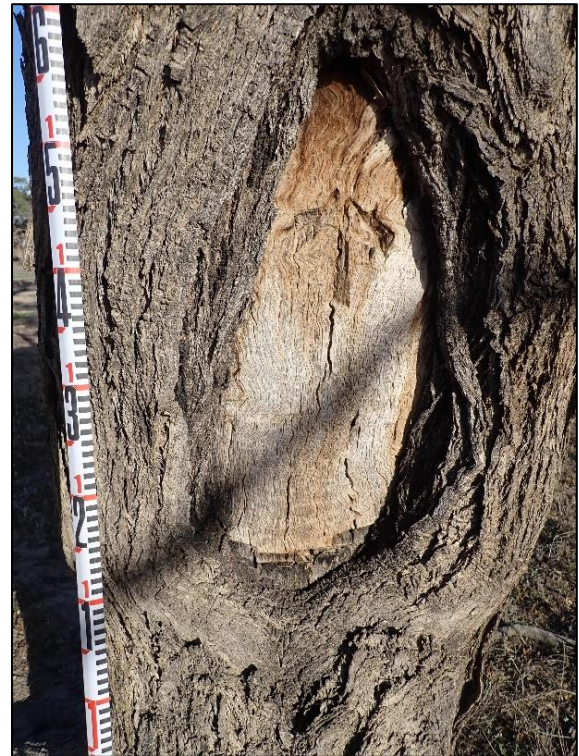
Regrowth:	Maximum width 15 centimetres, maximum depth 6 centimetres
Height of scar above ground:	Internal base of scar 1 metre
Endemic:	Yes
Tree >150 years:	Unsure
Regrowth >100 years:	No

Photo 8.6 Far view of tree

Photo 8.7 Close-up of scar and blaze
