Report on
Preliminary Geotechnical Investigation of Ivanhoe
Estate

Proposed Residential Development
Ivanhoe Estate, Macquarie Park

Prepared for
Frasers Property Ivanhoe Pty Ltd

Project 86043.01
July 2018

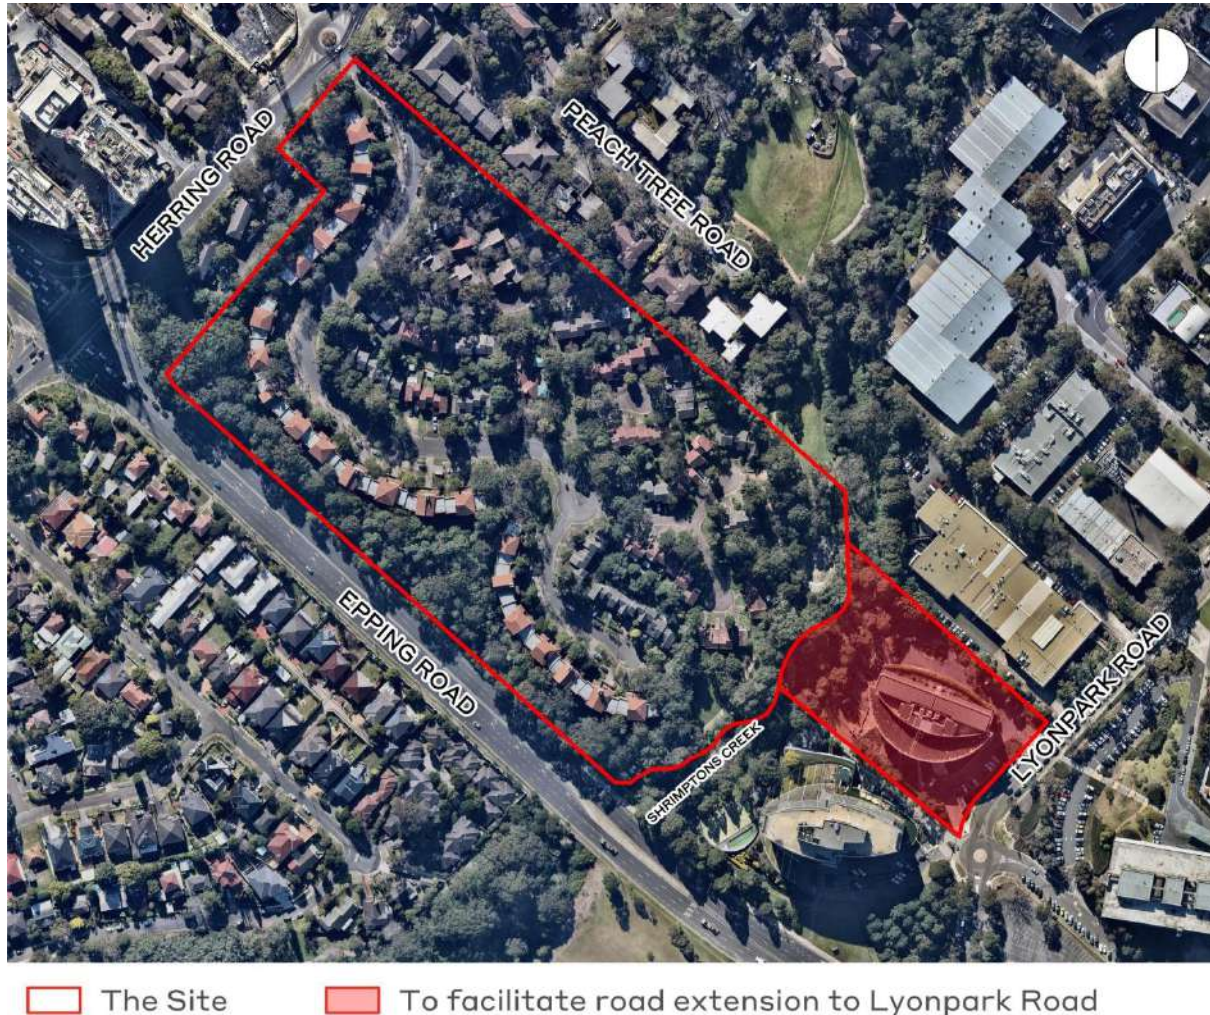
Figure 1: Ivanhoe Estate site

The Ivanhoe Estate site is located in Macquarie Park near the corner of Epping Road and Herring Road within the Ryde Local Government Area (LGA). The site is approximately 8.2 hectares and currently accommodates 259 social housing dwellings, comprising a mix of townhouse and four storey apartment buildings set around a cul-de-sac street layout. An aerial photo of the site is provided in Figure 1.

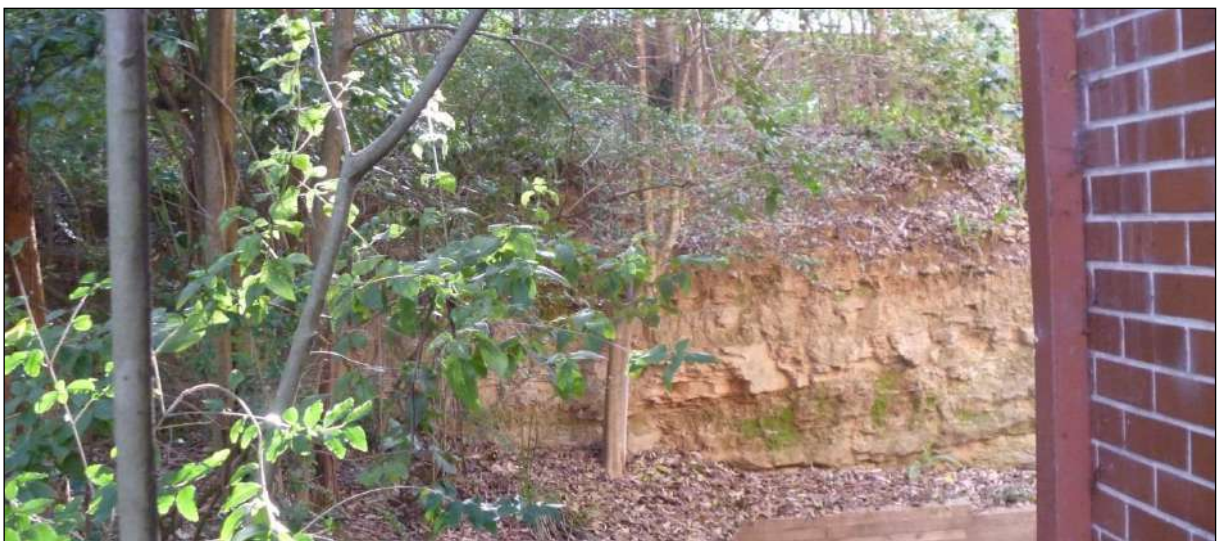
Figure 2: Exposed rock face at rear of 10 Ivanhoe Place.

- o A medium strength sandstone outcrop at the southern corner of the site, near Shrimptons Creek.
 - o Exposed rock cuttings were visible in several locations at the rear of residences west of Ivanhoe Place. The rock faces were generally not accessible for close inspection, but appeared to generally comprise sandstone, sometimes thinly bedded. Shale and siltstone were also considered to be present, particularly towards the upper (north-western) end of the site, based on the apparent bedding thickness and weathering of the rock, although this may also be due to the presence of weaker sandstone. A photograph of a cut rock face exposed at the rear of 10 Ivanhoe Place is included in Figure 2, below.

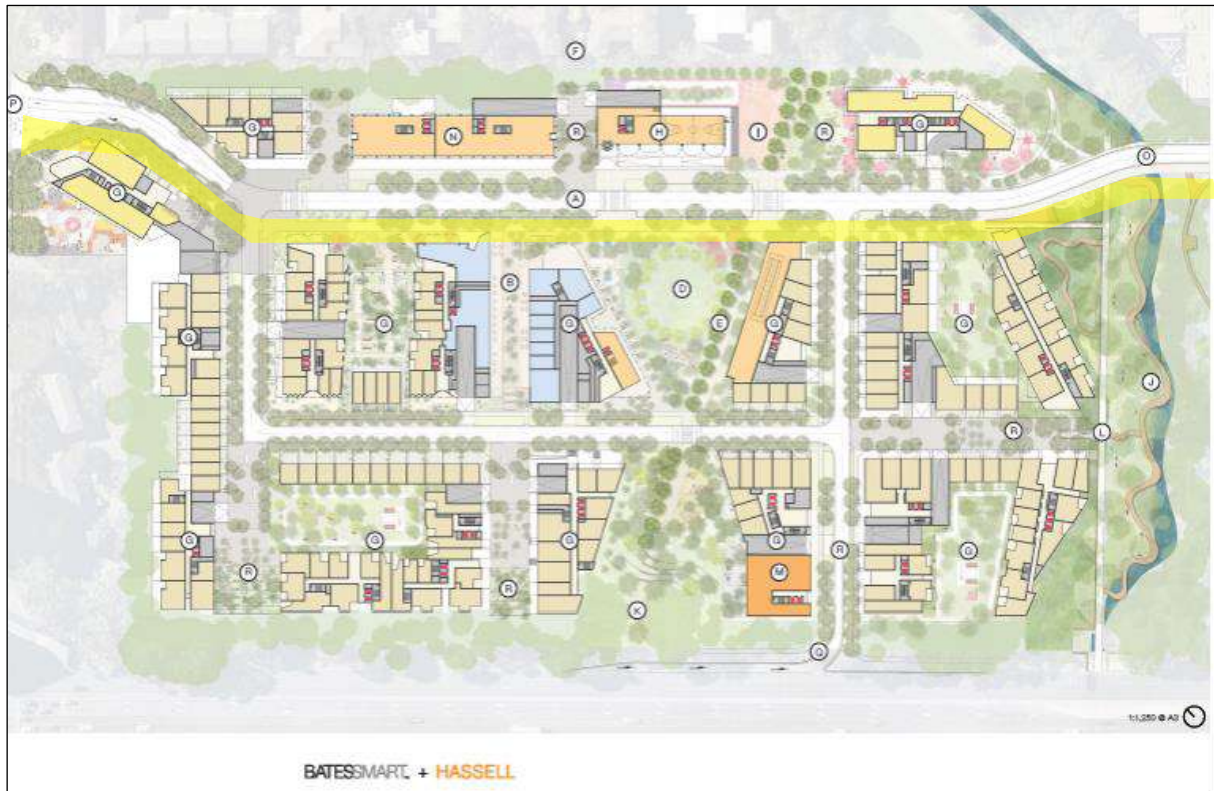
Figure 6: Ivanhoe Estate Masterplan, with Main Road highlighted in yellow

An image of the Masterplan DA is provided at Figure 6 below.

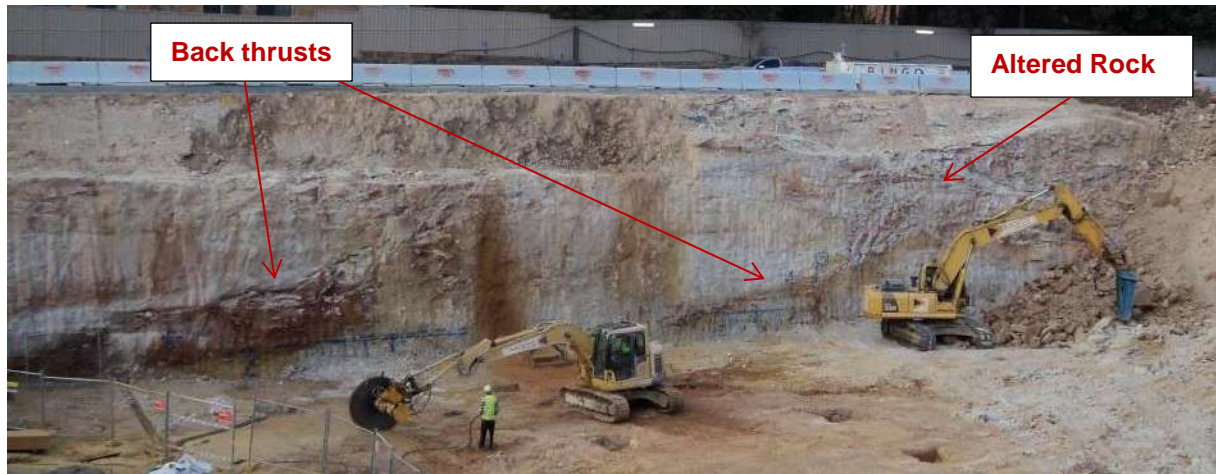
Figure 7: Back thrusts in an excavation wall at a nearby site

Thrust faults may pass along bedding planes before stepping up through a rock bed, potentially presenting as an extremely weathered band, and so can be challenging to identify from widely spaced boreholes such as those at this site. Based on the boreholes, thrust faults are considered most likely to be present within the upper variable strength bedrock (Units 3a, 3b, 3c, 4a, 4b), although the presence of ironstaining, weathered bedrock and weaker sandstone bands at depth may also be indicative of thrust faulting.

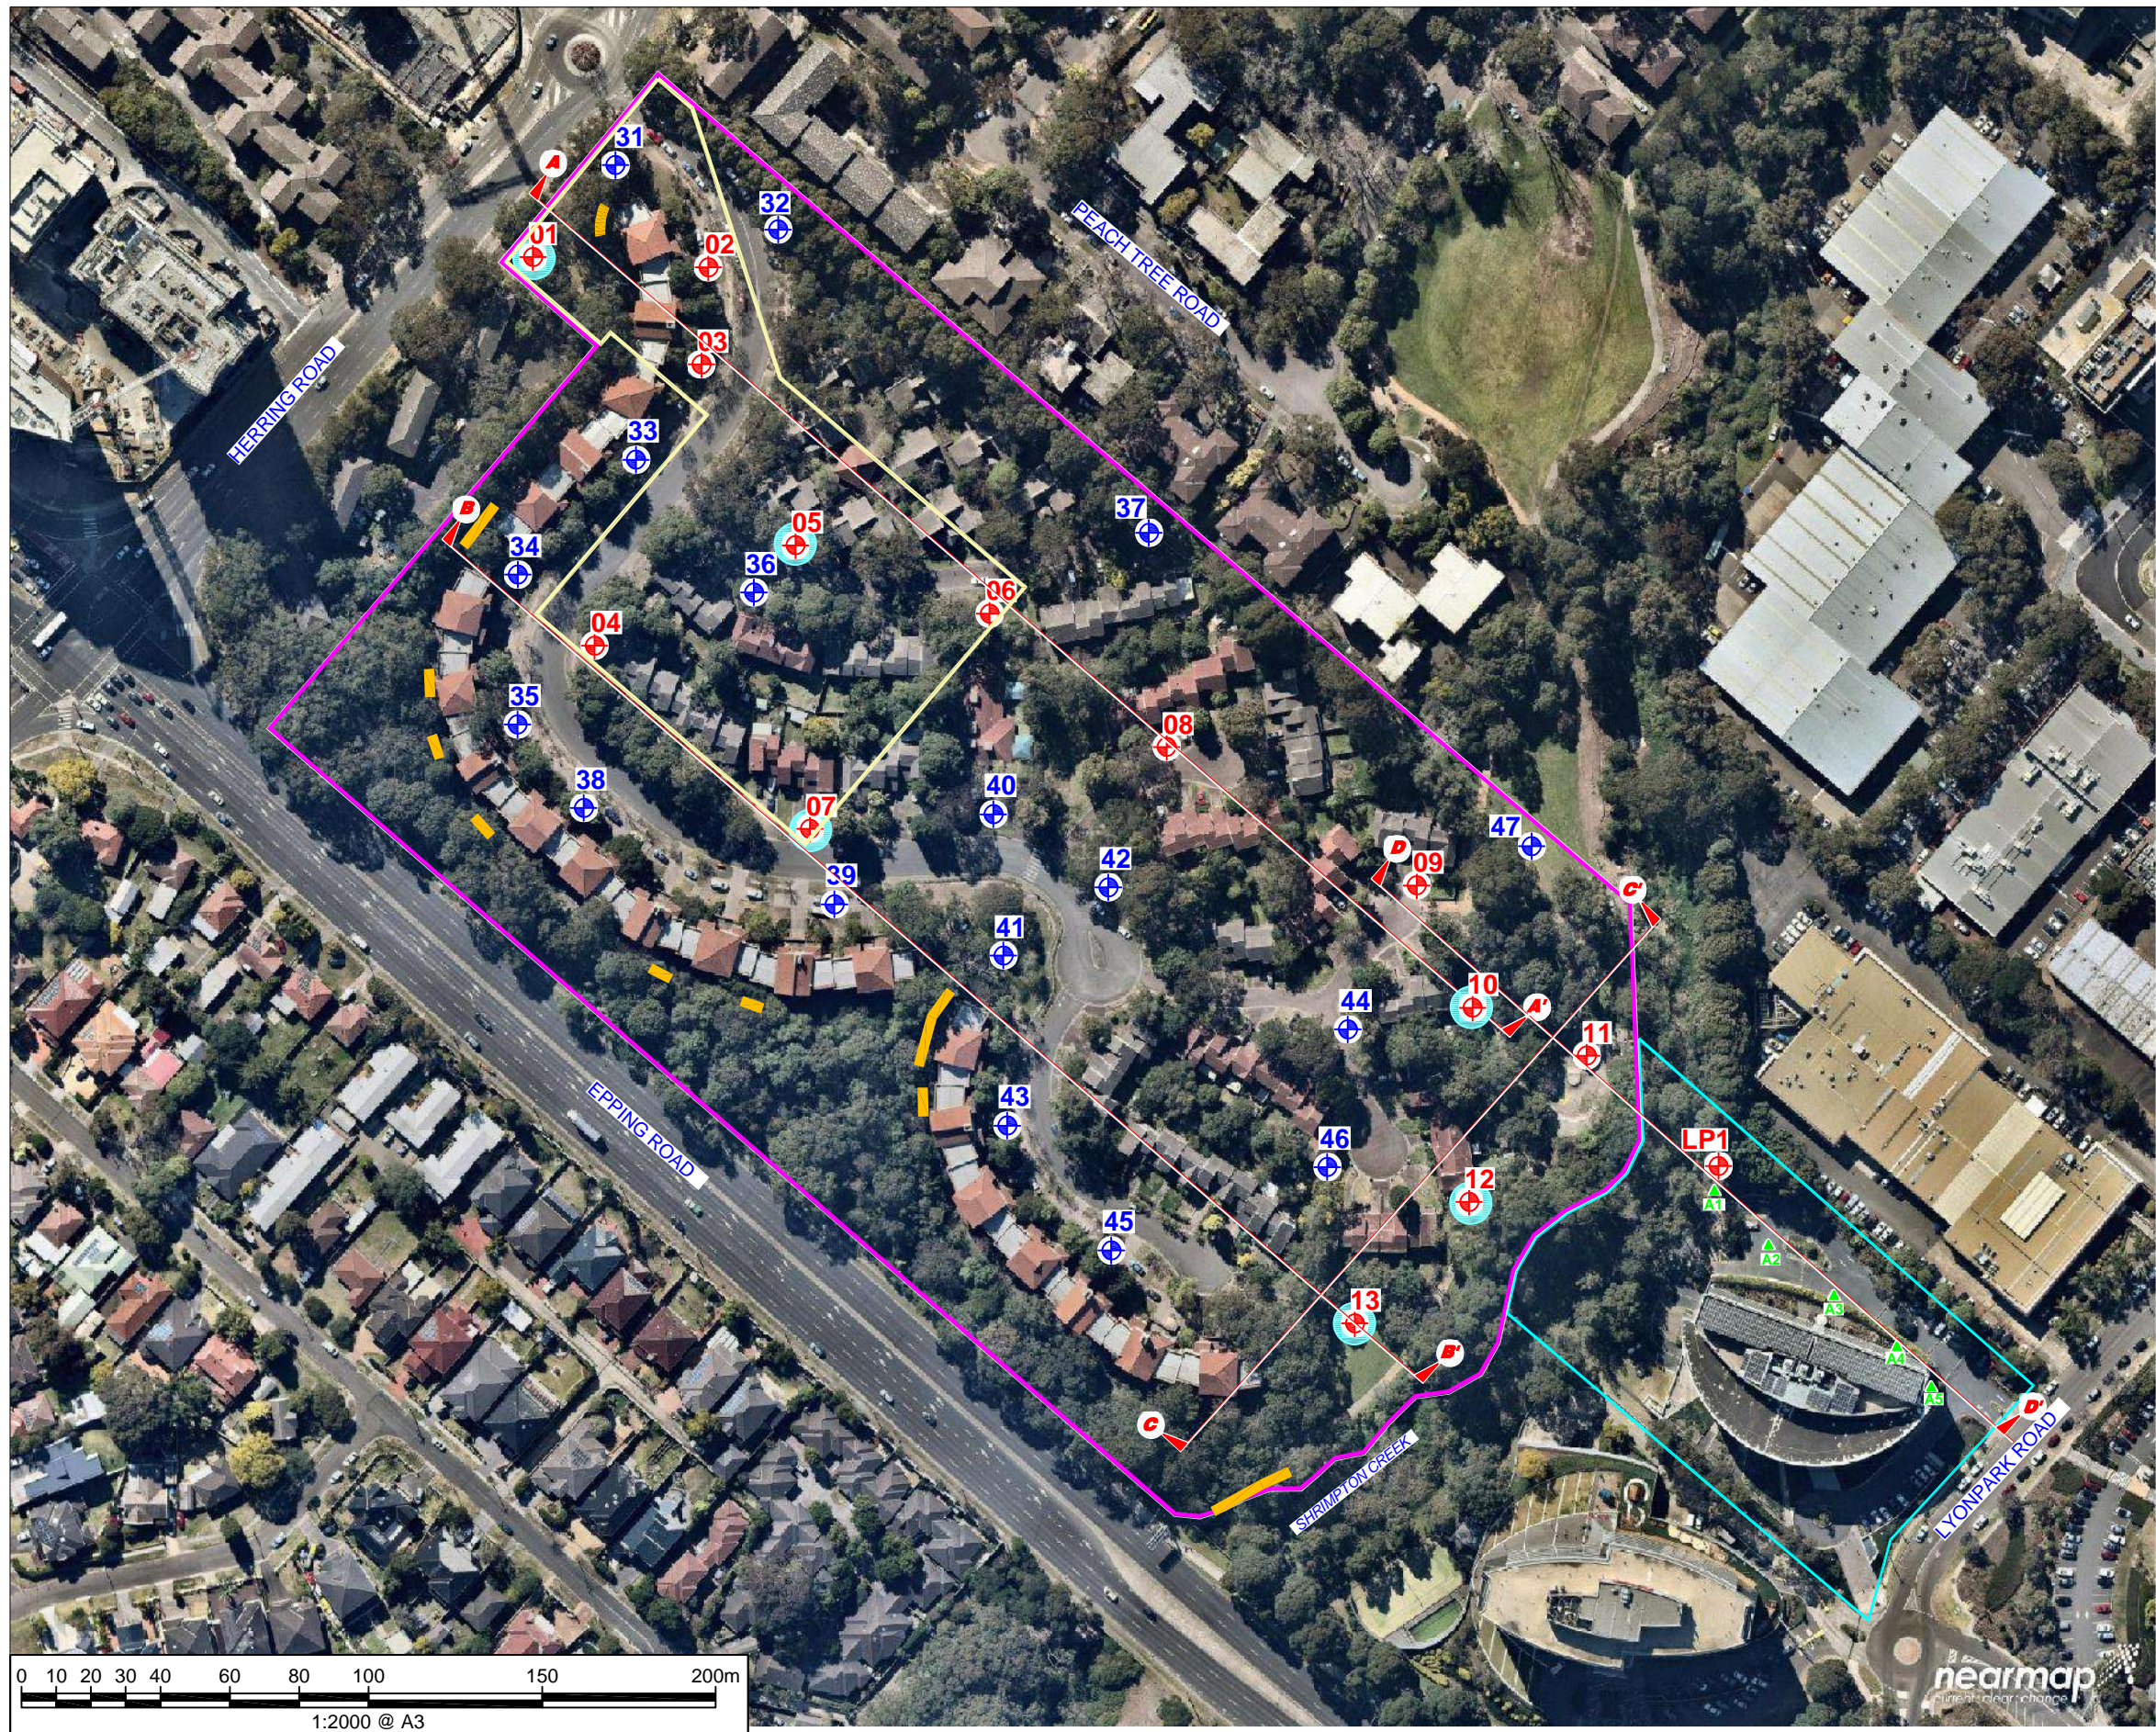
Drawings – Test Location Plan

NOTE:
 1: Base image from Nearmap.com
 (Dated 19.10.2017)
 2: Test locations are approximate only and are shown with reference to existing features.

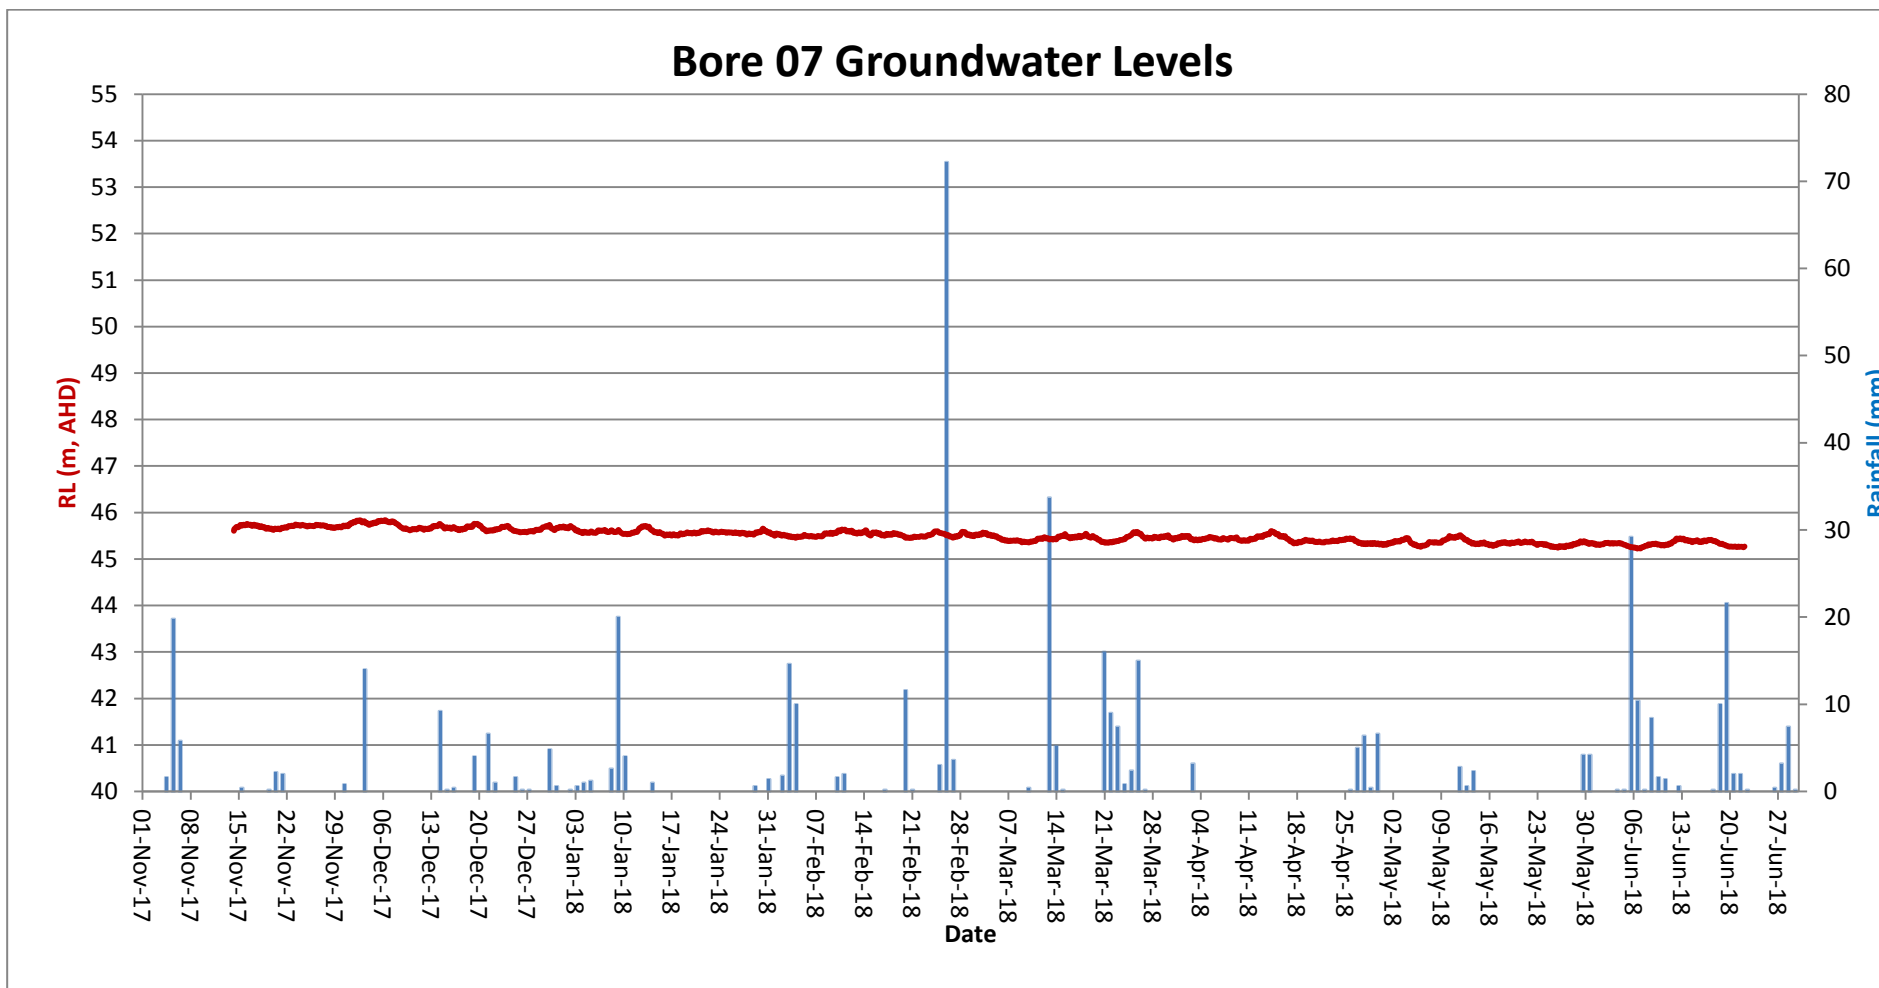
Figure 3: Groundwater Monitoring Results at Bore 07

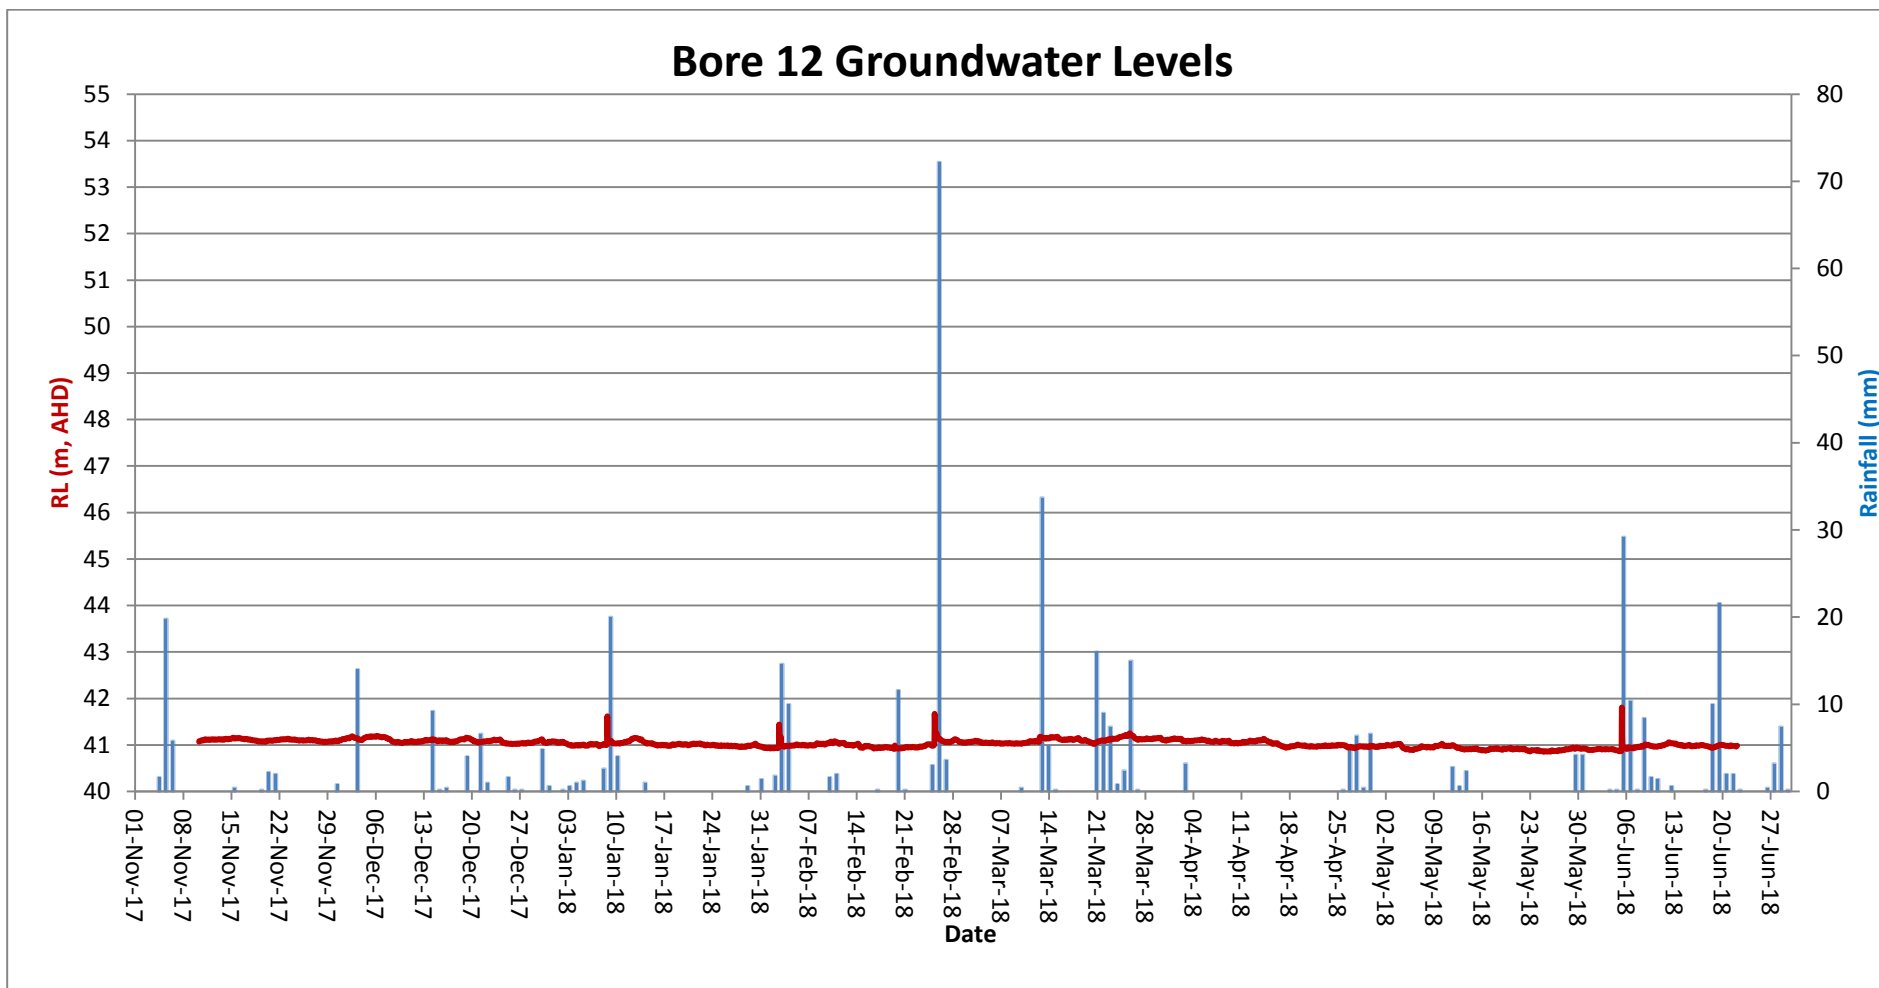
Figure 5: Groundwater Monitoring Results at Bore 12

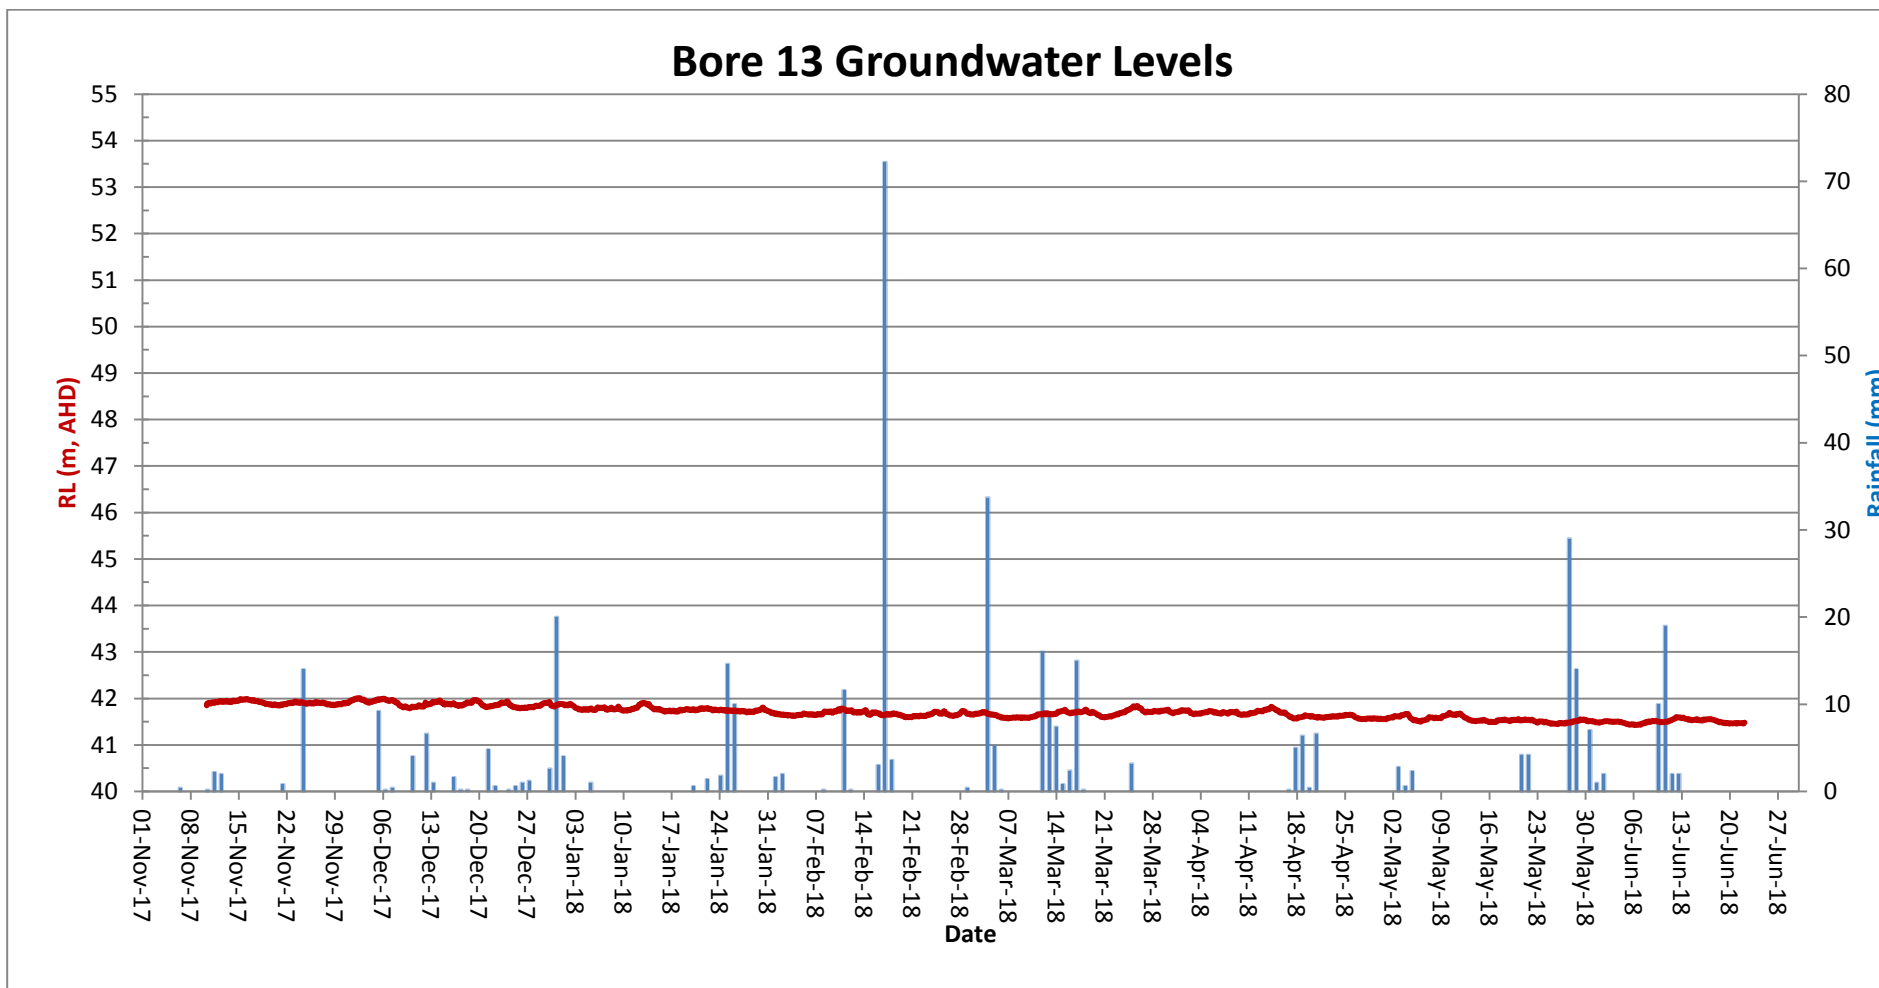
Figure 6: Groundwater Monitoring Results at Bore 13
