Wilkinson House

Structural Options

Retention of Existing Facade

Prepared for SCEGGS Darlinghurst / 26 SEPTEMBER 2019 / Rev D

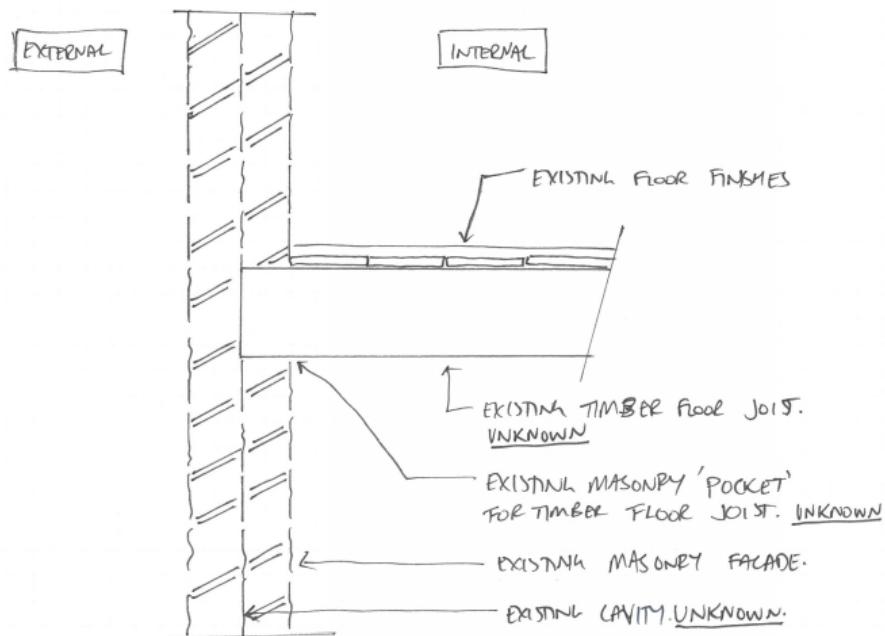
Figure 1: Typical Masonry Façade Junction

The existing façade is a double brick masonry structure that is supporting the internal floor joists. The existing façade is provided with lateral restraint with the floor joists pocketed into the brick wall. This era of construction would have typically relied on friction between the timber joist and the masonry wall to prevent the wall from buckling outwards, rather than any mechanical fixings. Any removal of the internal bracing walls removes lateral restraint to the façade, and increases the potential for the façade to move independently of the existing timber floors.

The figures below illustrate a typical floor junction into existing masonry walls

Without documentation of this structure, we are unable to determine the level of connection between the floor and the external walls. The timber joists could be subject to rot and decay from water egress through the masonry façade, placing more risk on the longevity and stability of this masonry façade.

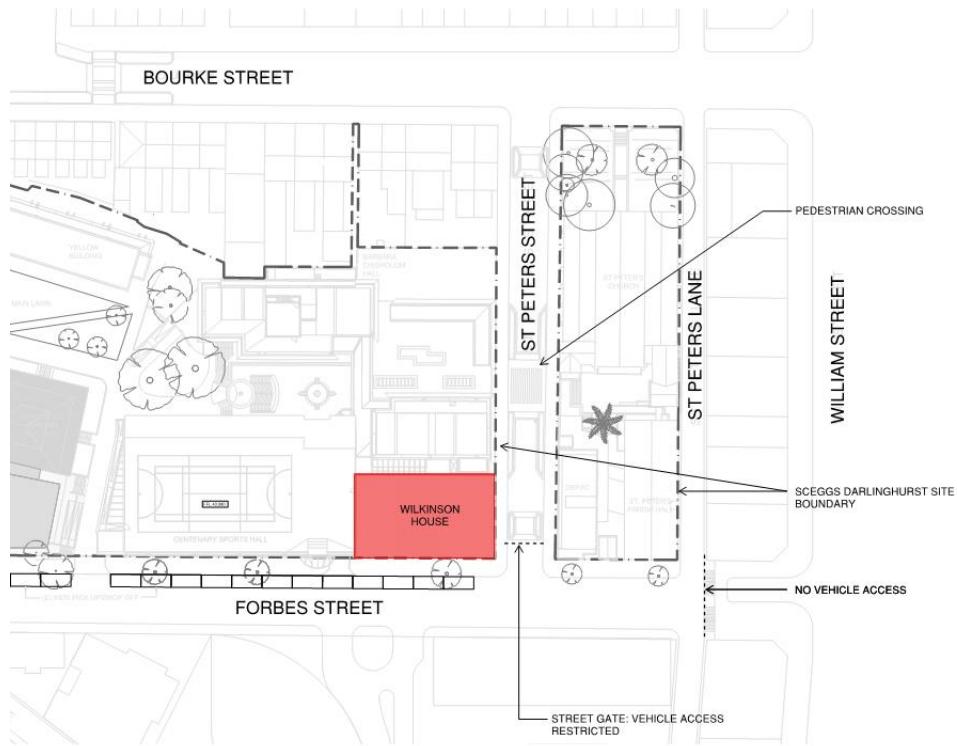
Figure 3: Wilkinson House Site Plan (Image courtesy of TKDA Architects)

Wilkinson House is located on the corner of St Peters Street and Forbes Street in Darlinghurst. The SCEGGS Darlinghurst Campus is located in the site adjacent to Forbes Street and St Peters Street. The site plan below indicates the key elements surrounding Wilkinson House.

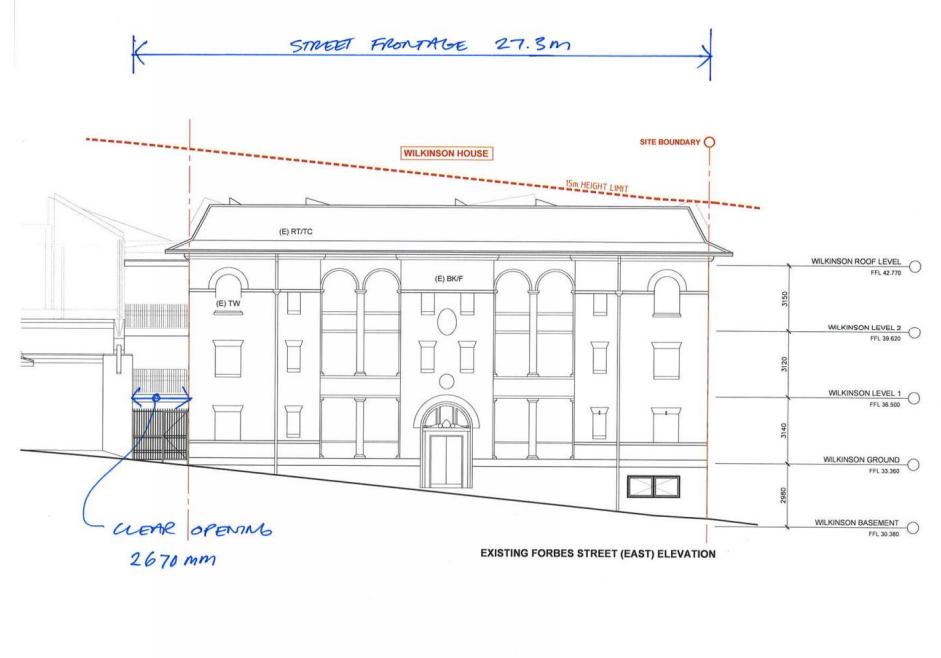
Figure 4: Wilkinson House, Forbes Street Elevation, Clear Opening Offset from Adjacent Sports Hall

If retention of the two existing street facades to Wilkinson House is considered, there are minimal existing openings that will facilitate truck access into the site. The offset of the existing façade on Forbes Street to the adjacent Sports hall is 2670mm clear, refer to Figure below. This dimension will not provide adequate truck access into the site. A larger portion of the façade must be demolished in order to gain adequate construction access into the site.

In order to comply with typical Council conditions of loading and unloading truck inside the site boundaries, significant demolition of the existing façade is required.

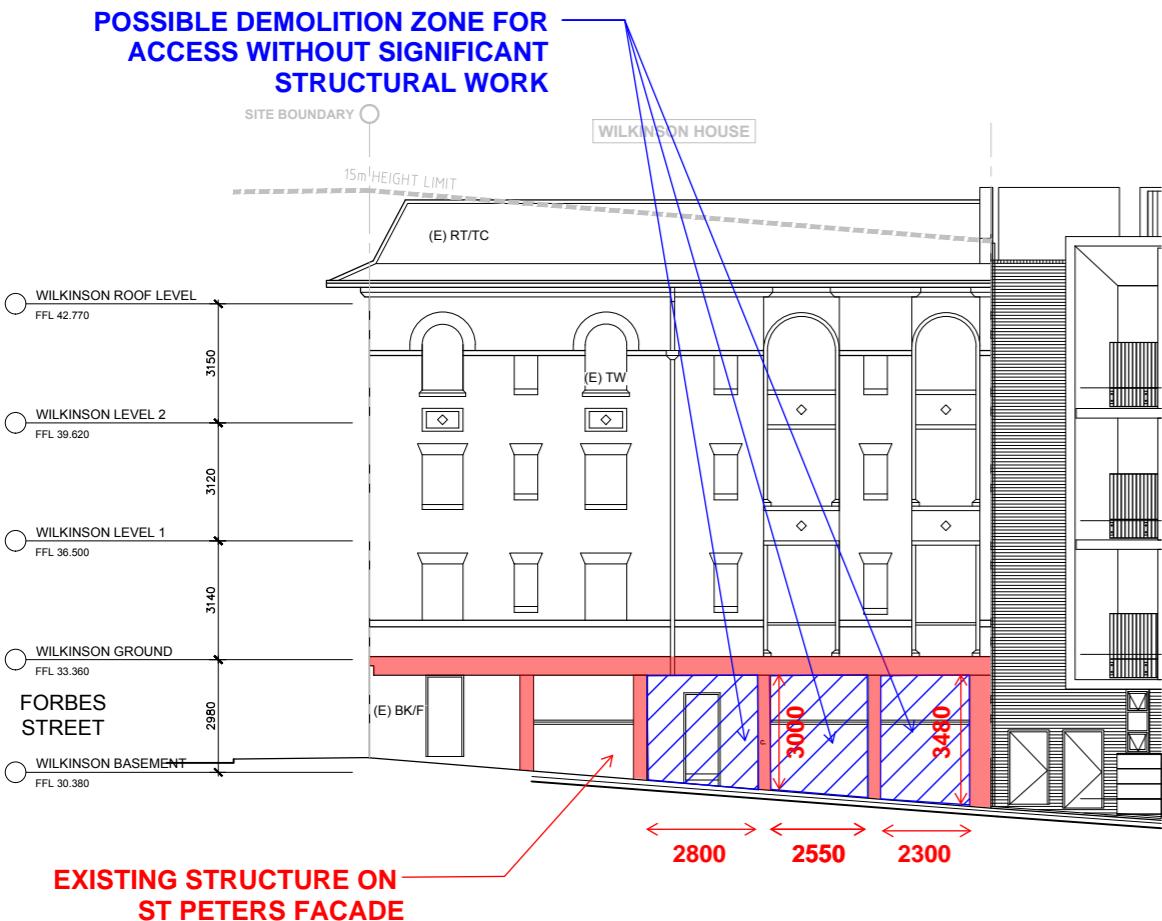
EXISTING WILKINSON HOUSE ELEVATION A-A

THE DEMOLITION ZONES BELOW DO NOT PROVIDE ENOUGH
ROOM TO FIT

ALL DIMENSIONS LABELLED ARE APPROXIMATE,
AND HAVE BEEN MEASURED ON SITE

- Establish construction zone on St Peters Street
- Removal of existing brick infill panels, refer to zones below, without significant structural work to re-support the facade
- Provide access into the site for trucks to remove demolition spoil and excavation material

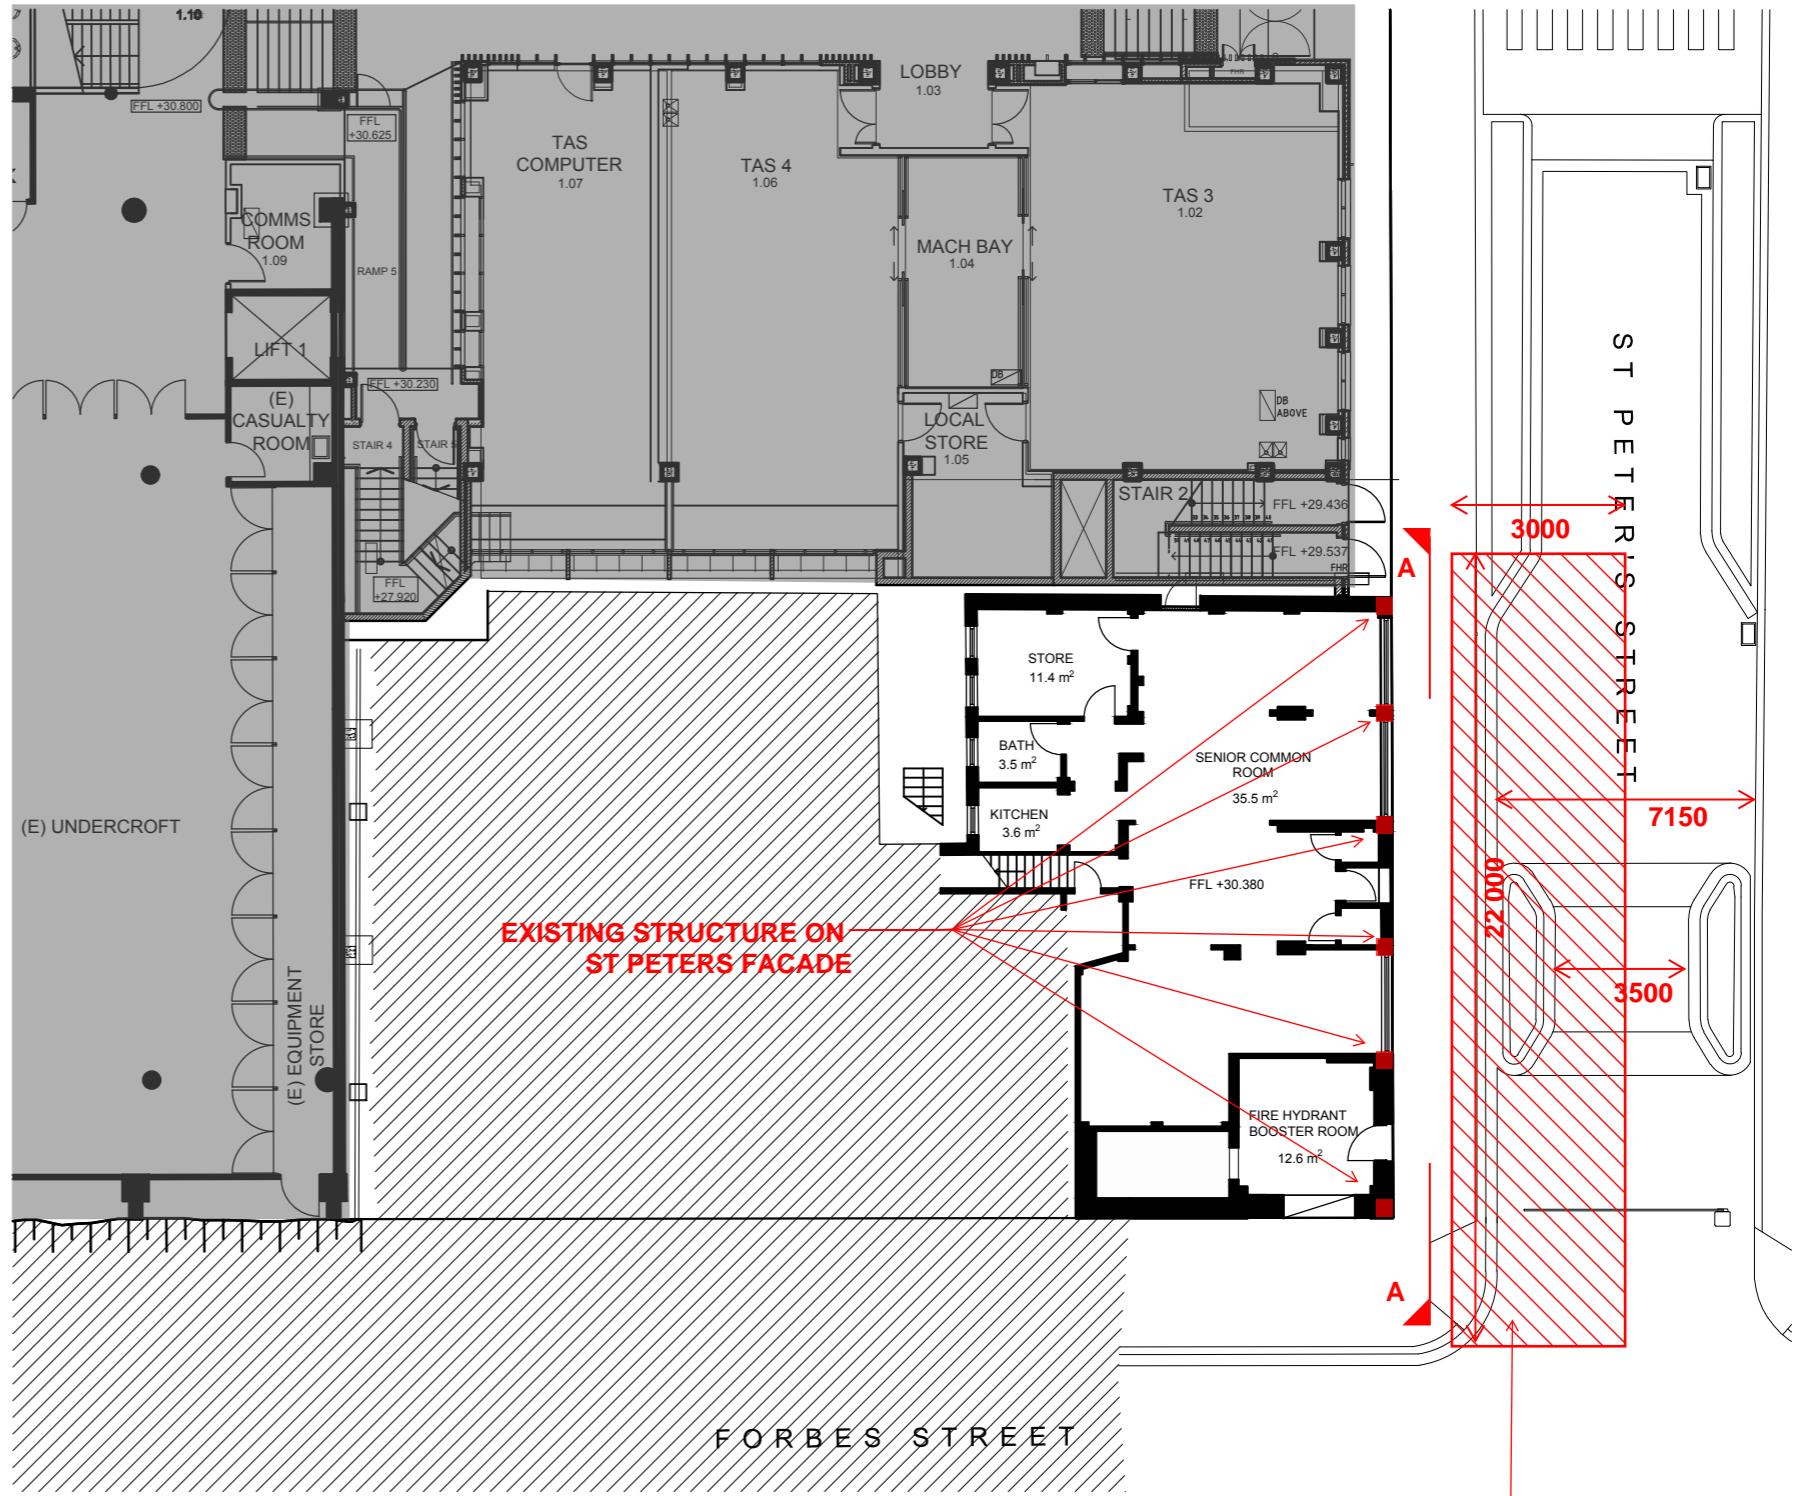
EXISTING BASEMENT FLOOR PLAN

ALL DIMENSIONS LABELLED ARE APPROXIMATE, AND HAVE BEEN MEASURED ON SITE

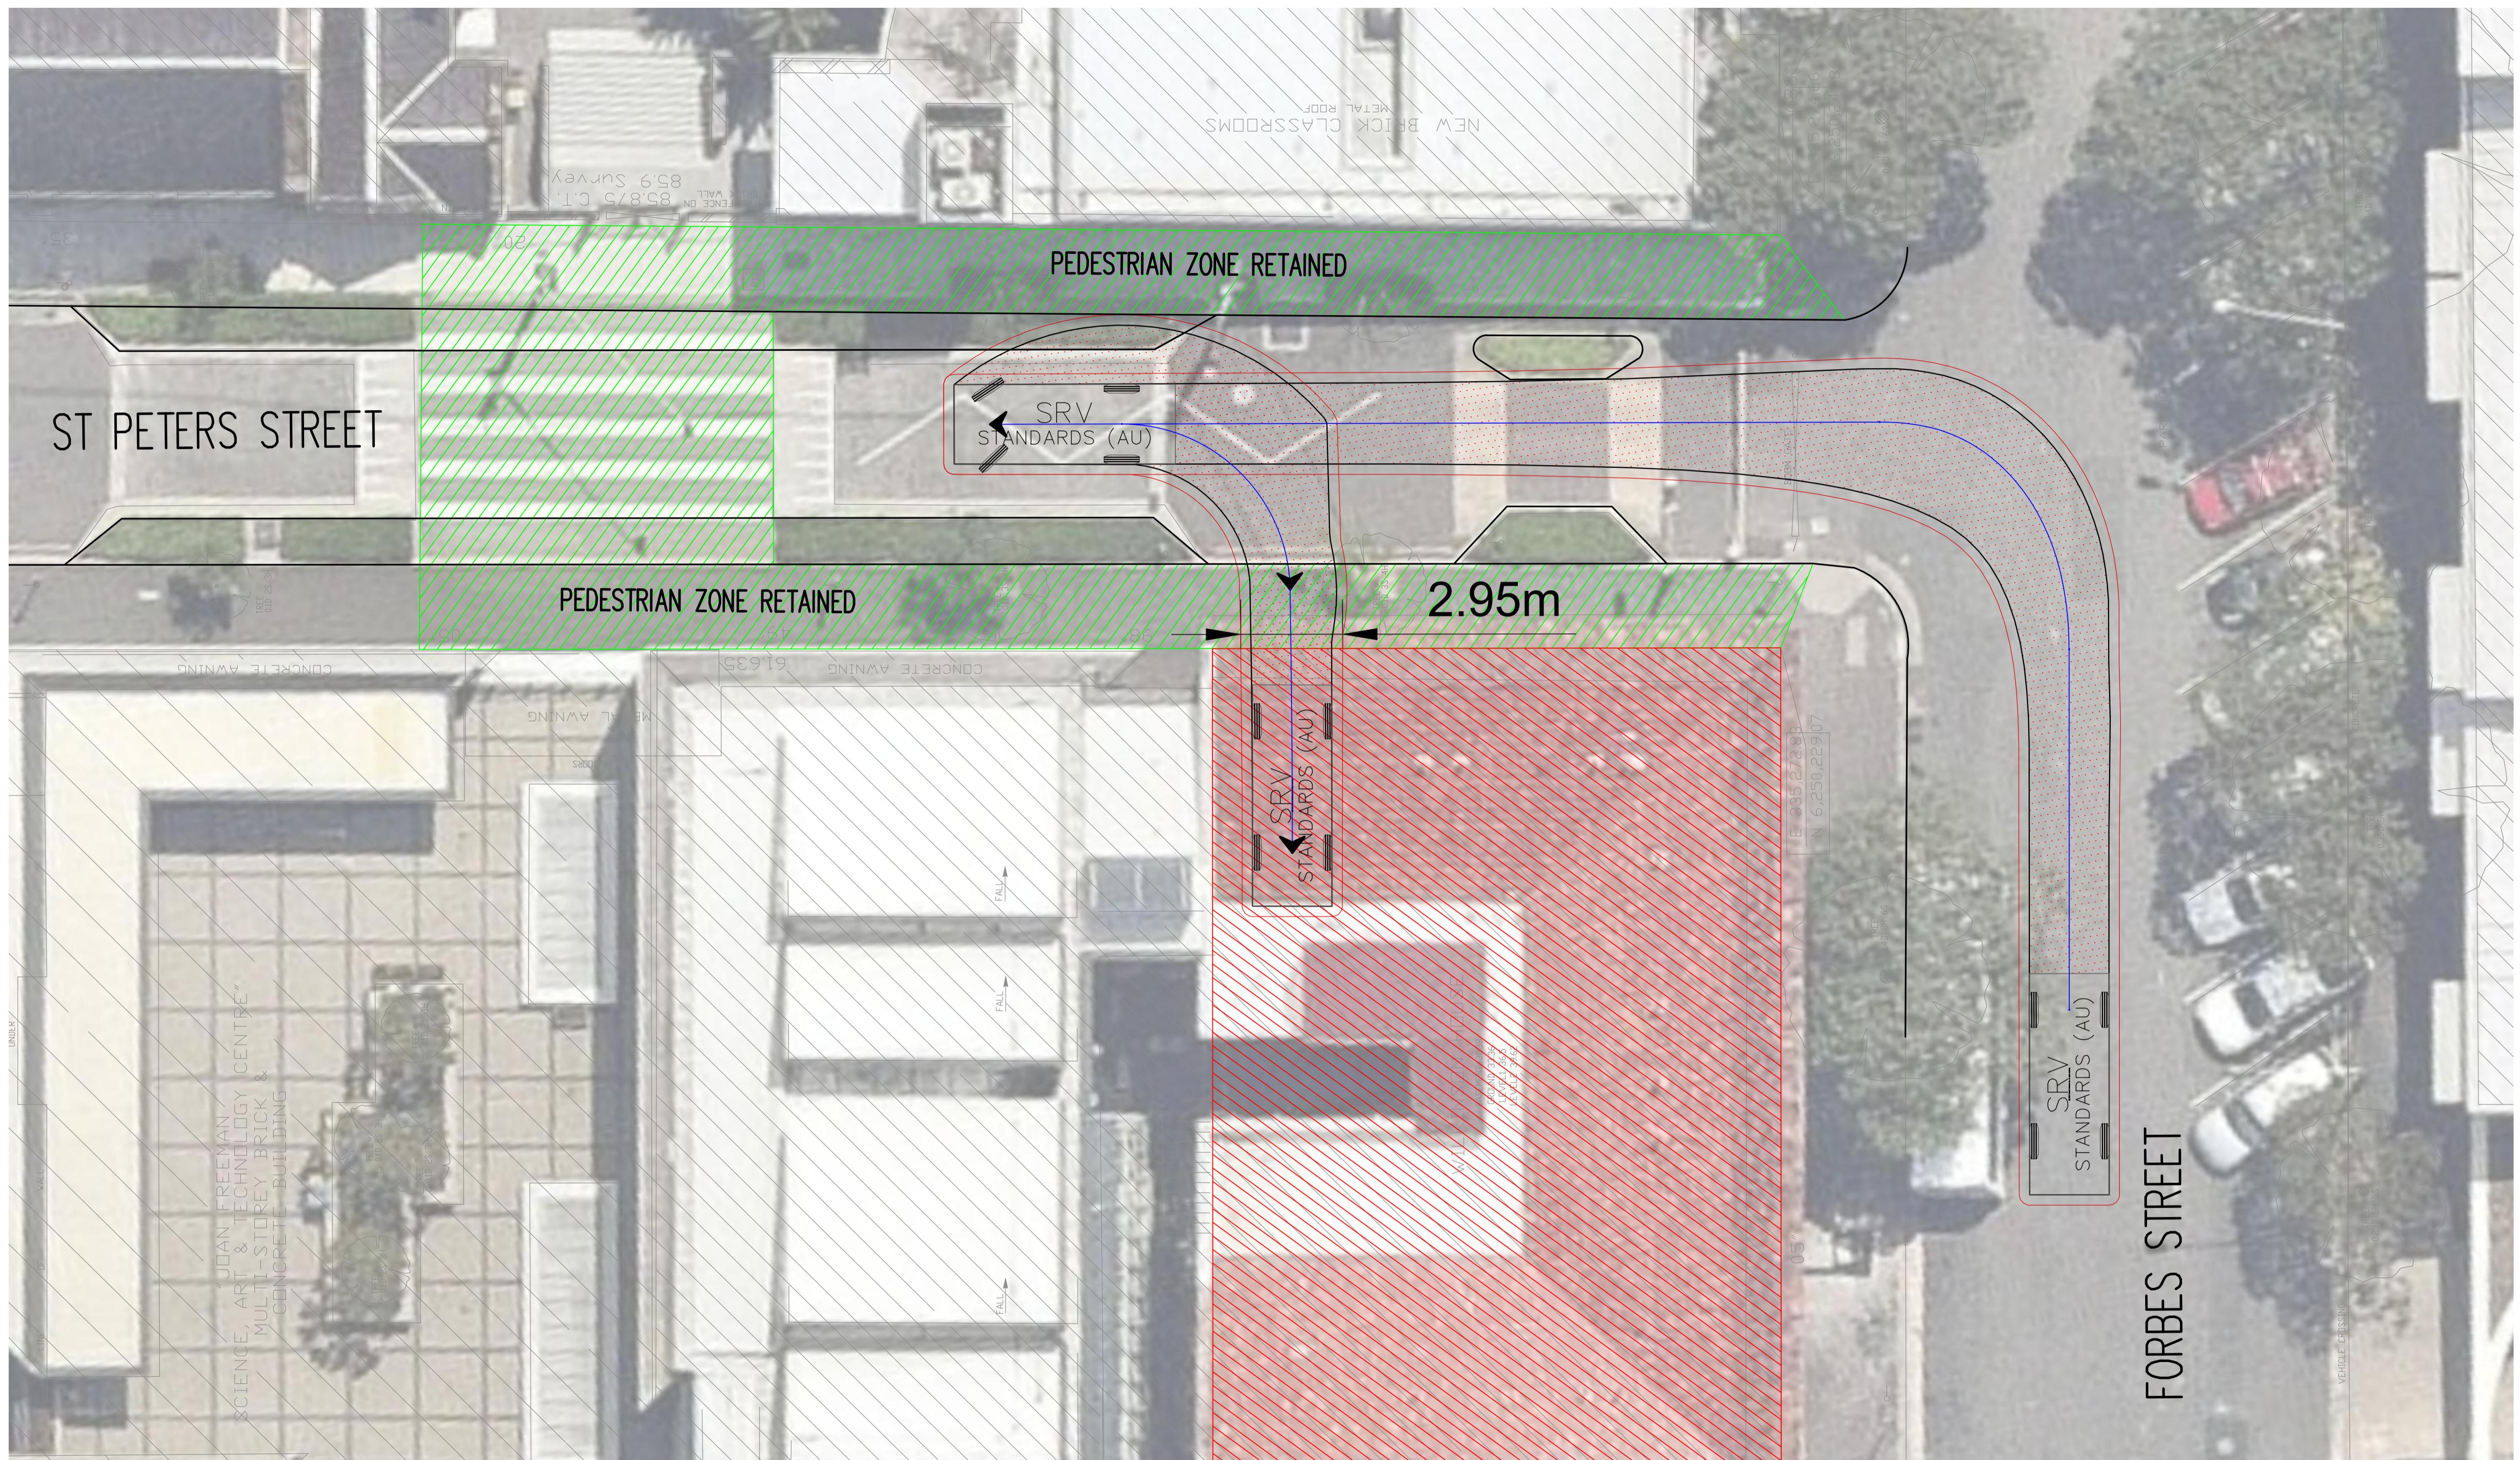
Sheet Subject **SWEPT PATH ANALYSIS**
SRV (6.4m) ACCESS INTO SITE

**CONSTRUCTION ZONE, POSITION
UNDER REVIEW IN TURNING CIRCLE
DRAWINGS**

SRV
Width: 6.40m
Track: 3.80m
Lock to Lock Time: 6.0s
Steering Angle: 38.0°

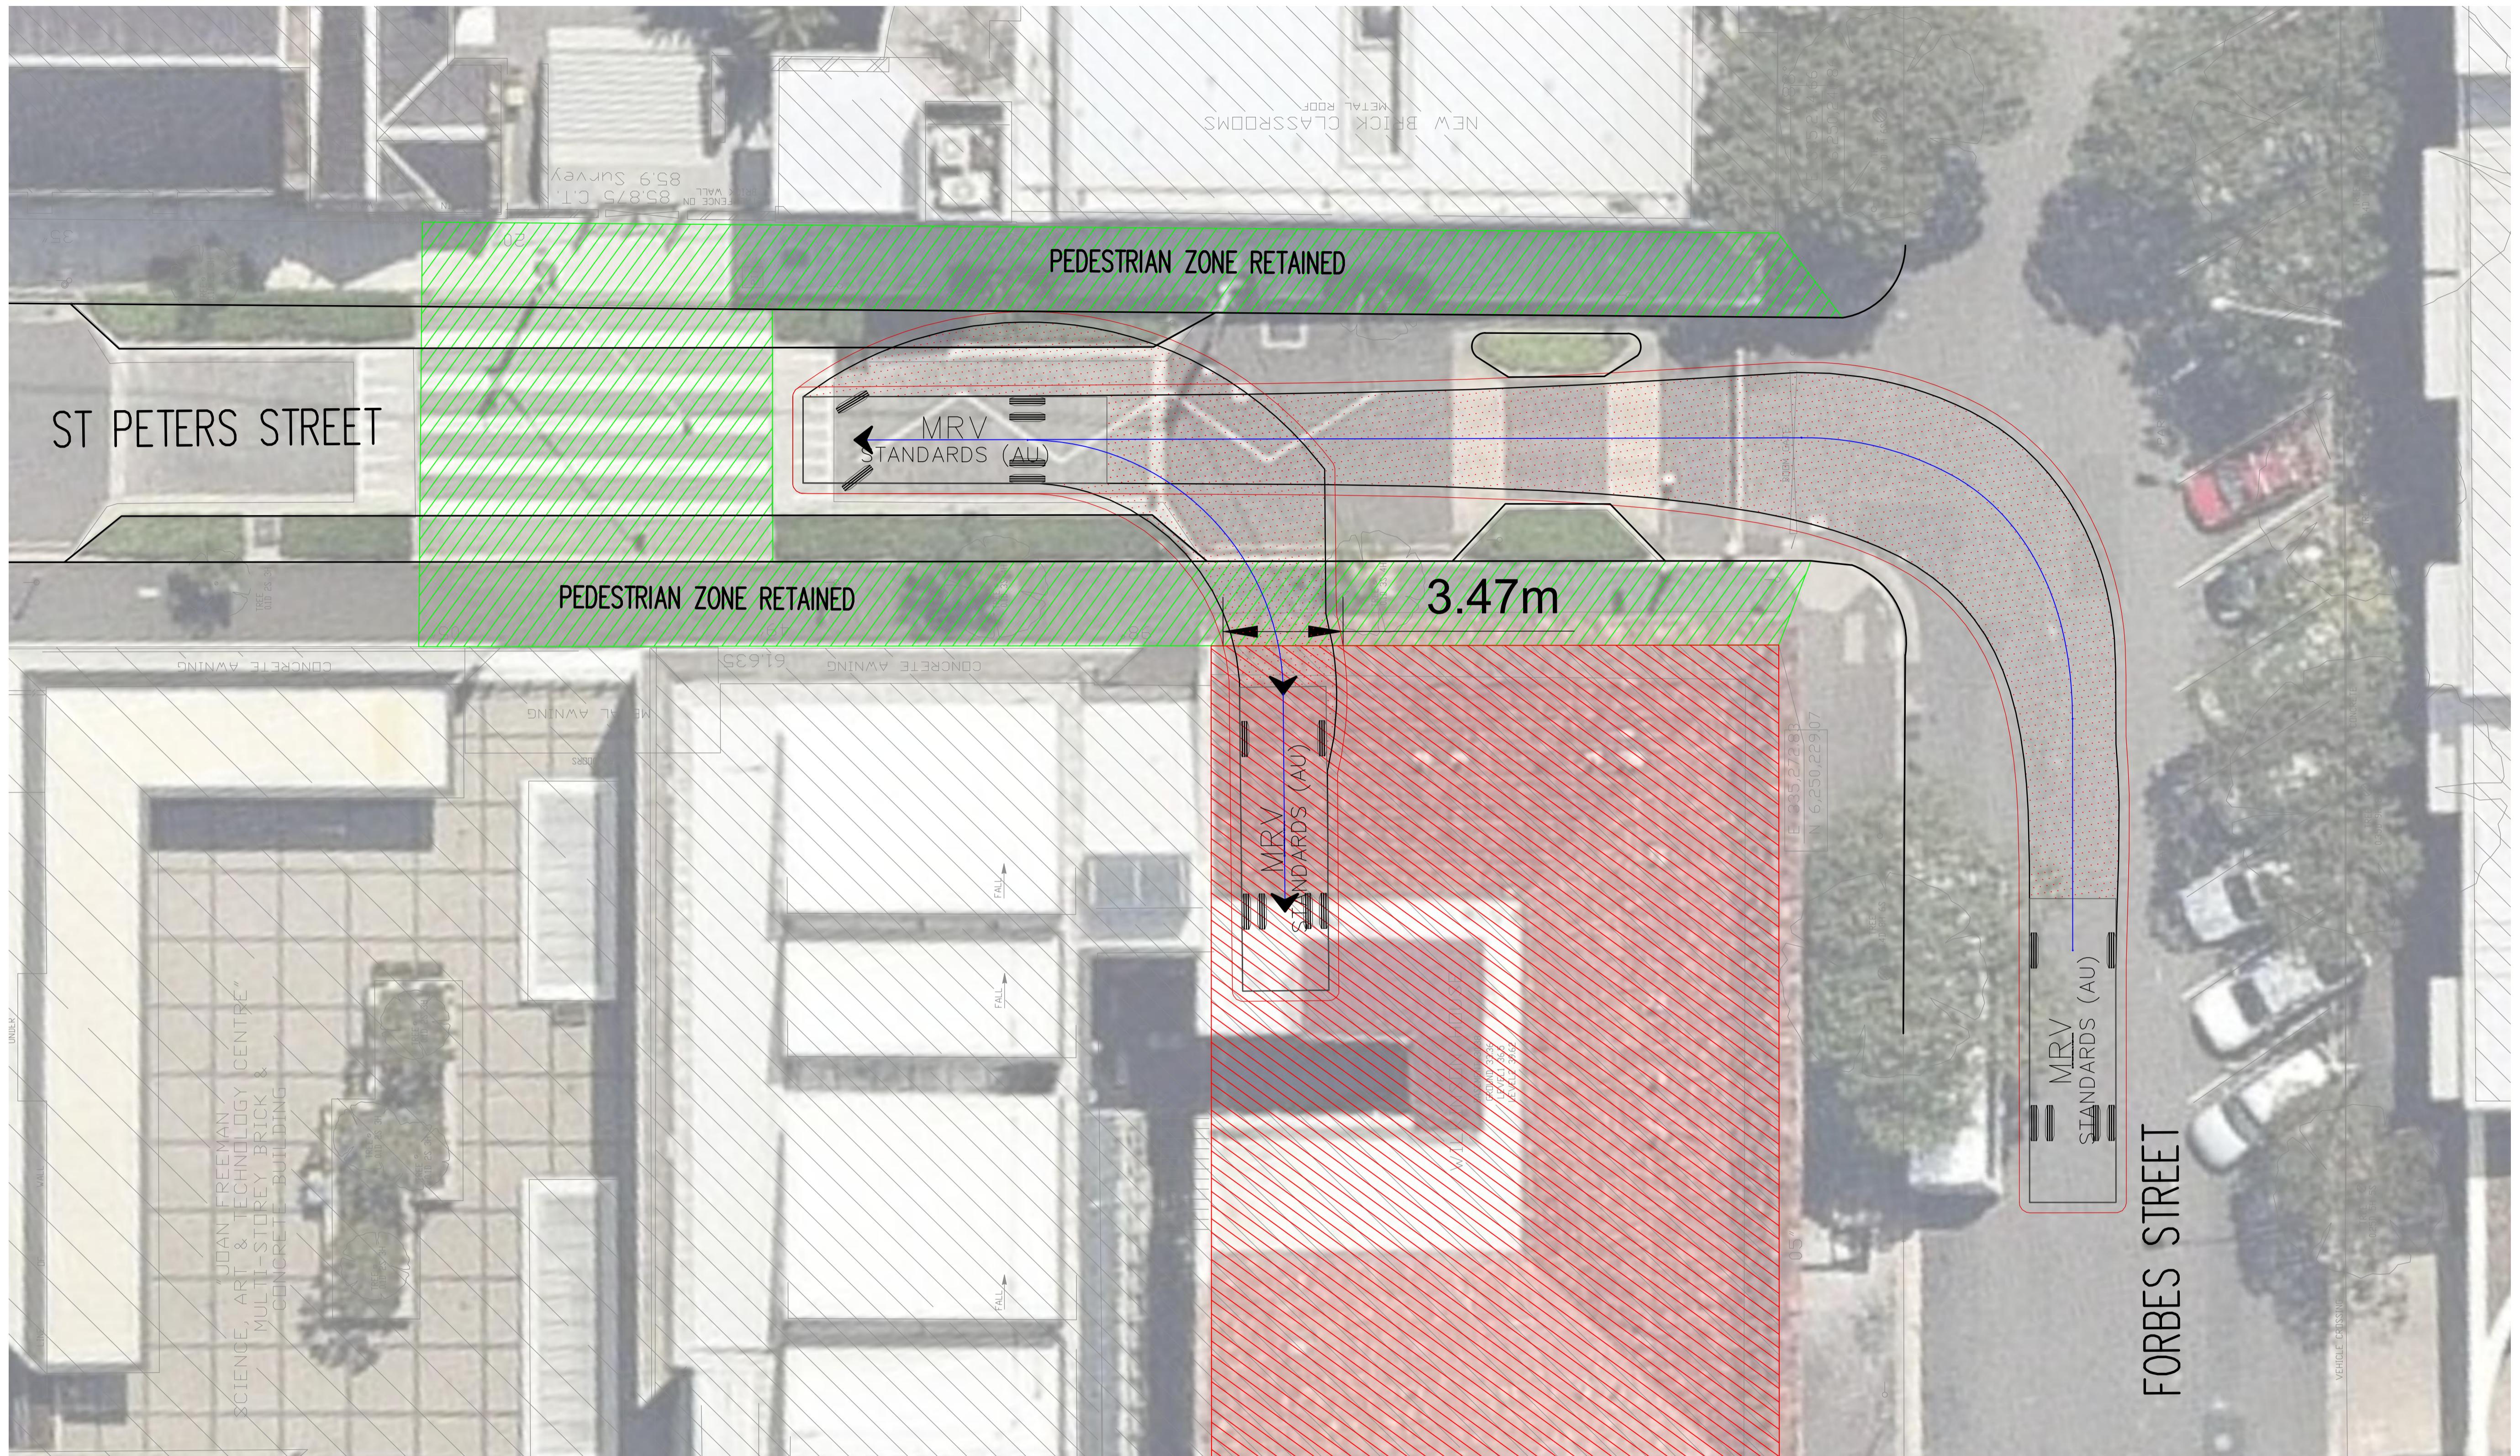
MRV	meters
Width	: 2.50
Track	: 2.50
Lock to Lock Time	: 6.0
Steering Angle	: 34.0

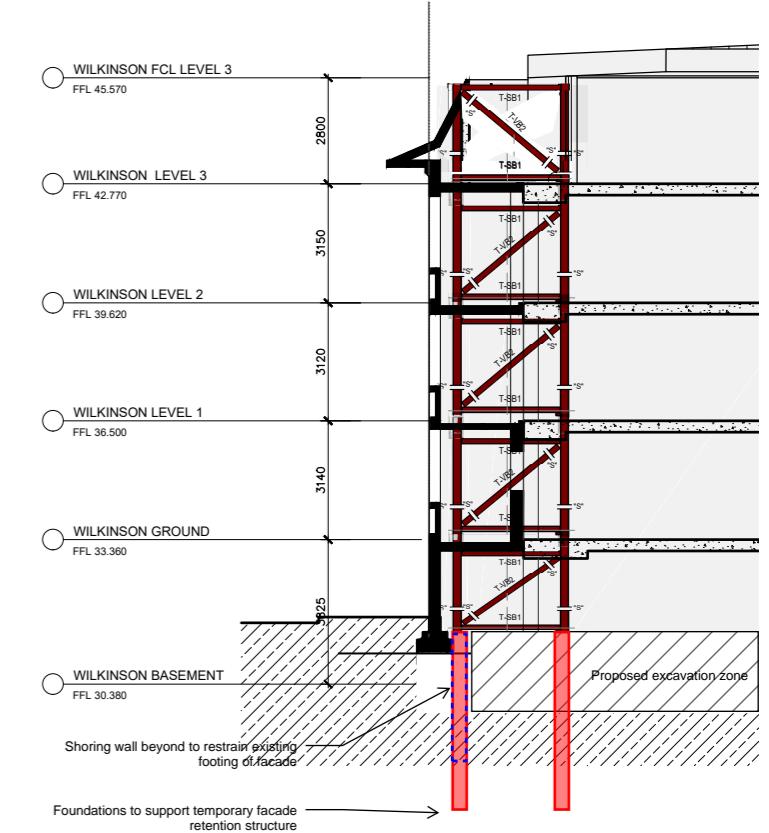
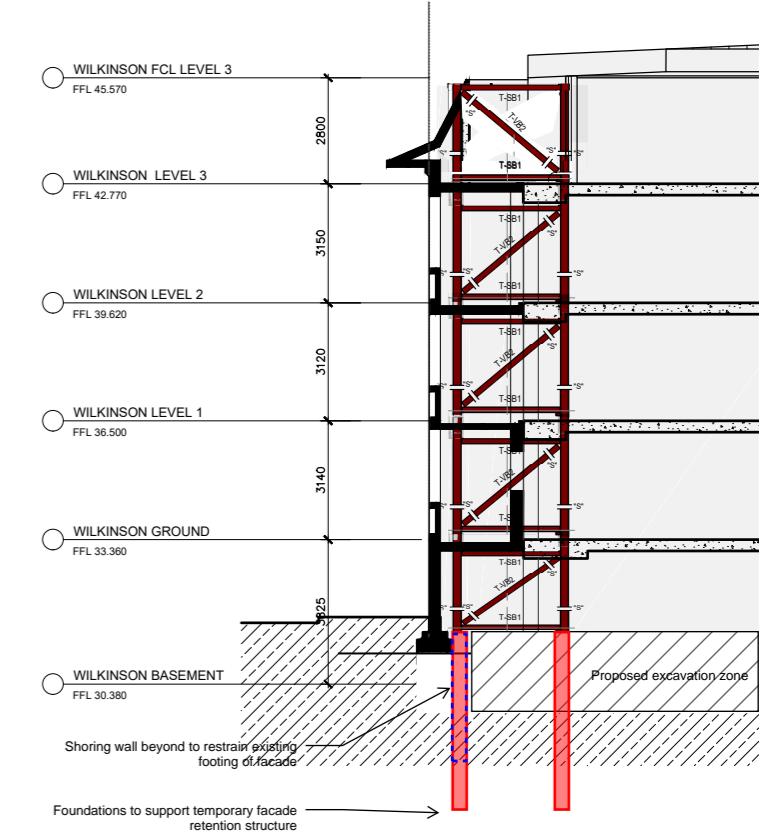
TYPICAL SECTION

TRUSS	MARK	SIZE
T-SB1		310UC137
T-VB2		250 X 9 SHS

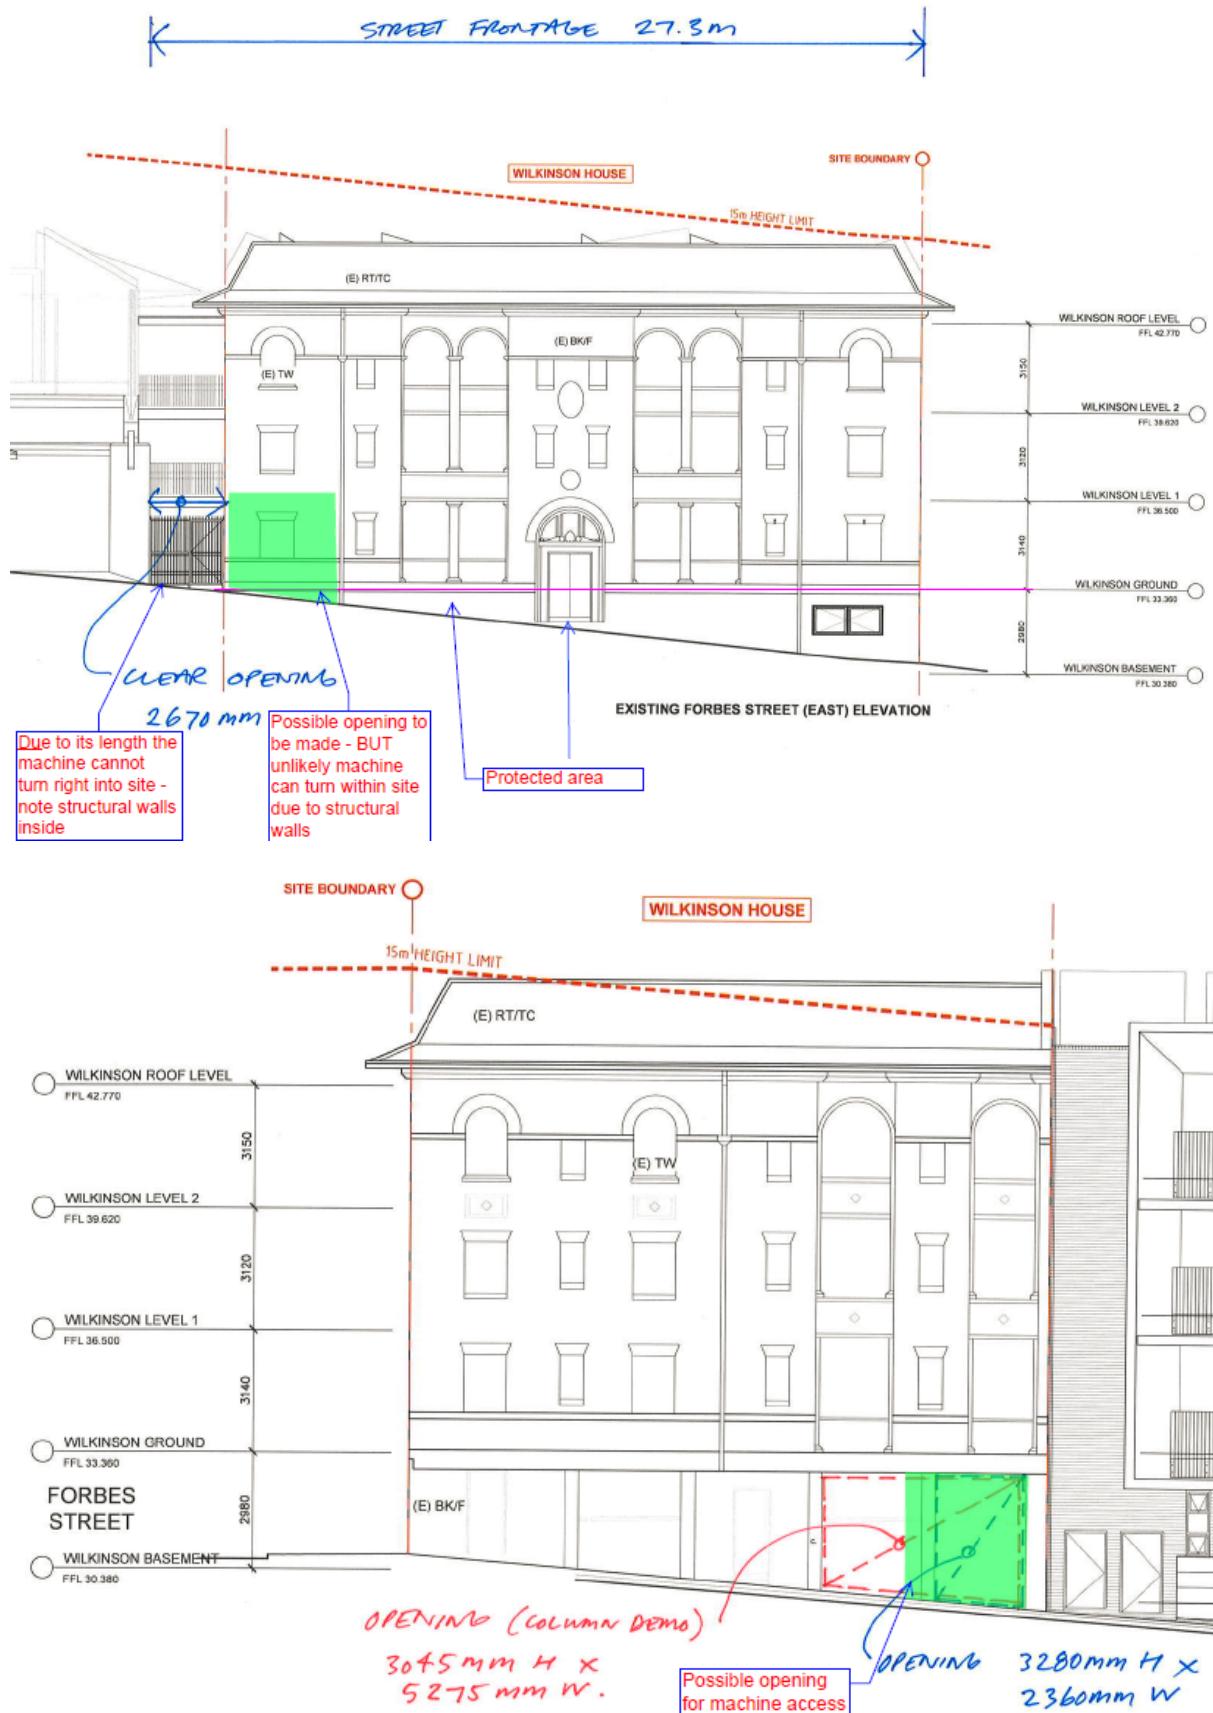
Two access points will be required to access the two different ground levels. These will be from Forbes St and St Peters St

The existing façade will need to be cut and demolished to allow the rig to access the site. Likely areas to access the site may be as shown below.

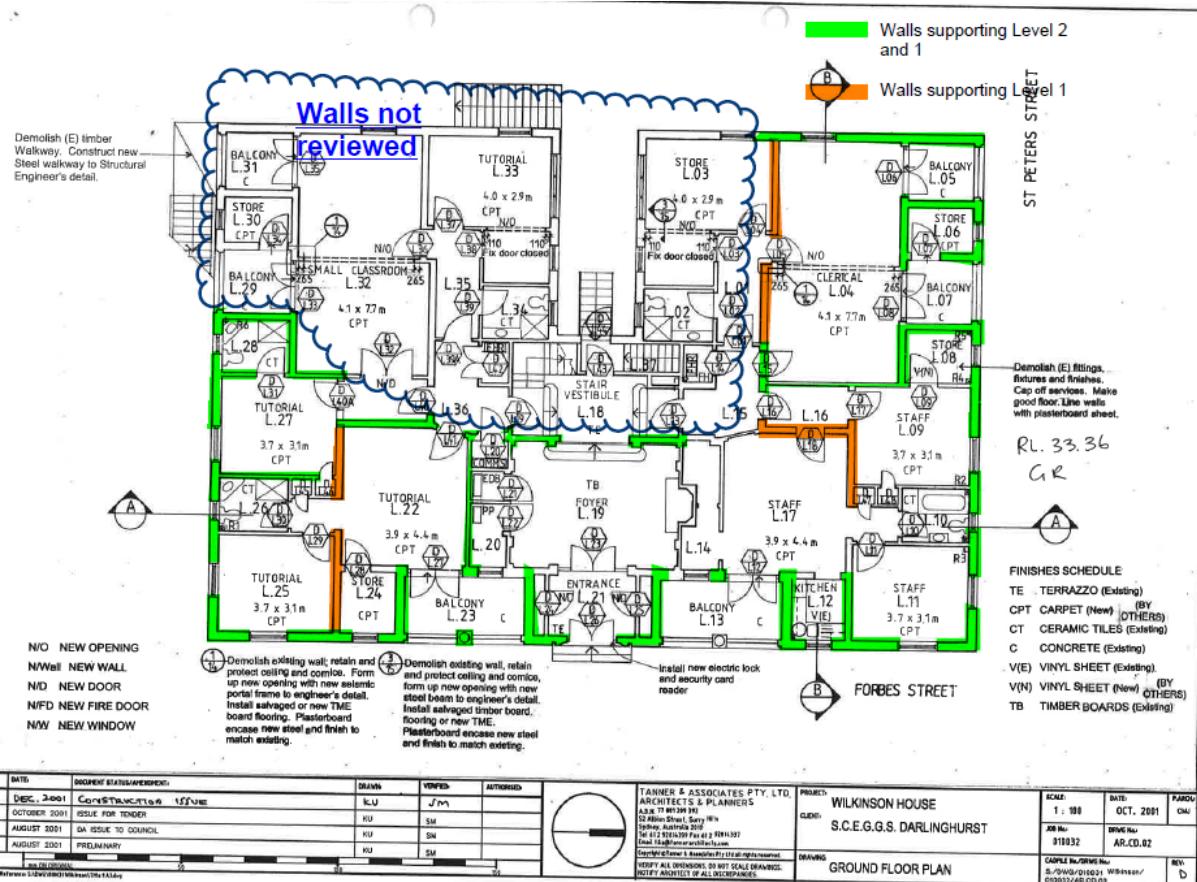
A review of the existing Wilkinson House drawings shows a considerable amount of load bearing walls that will need to be respected.

The figure below shows the considered load bearing walls.

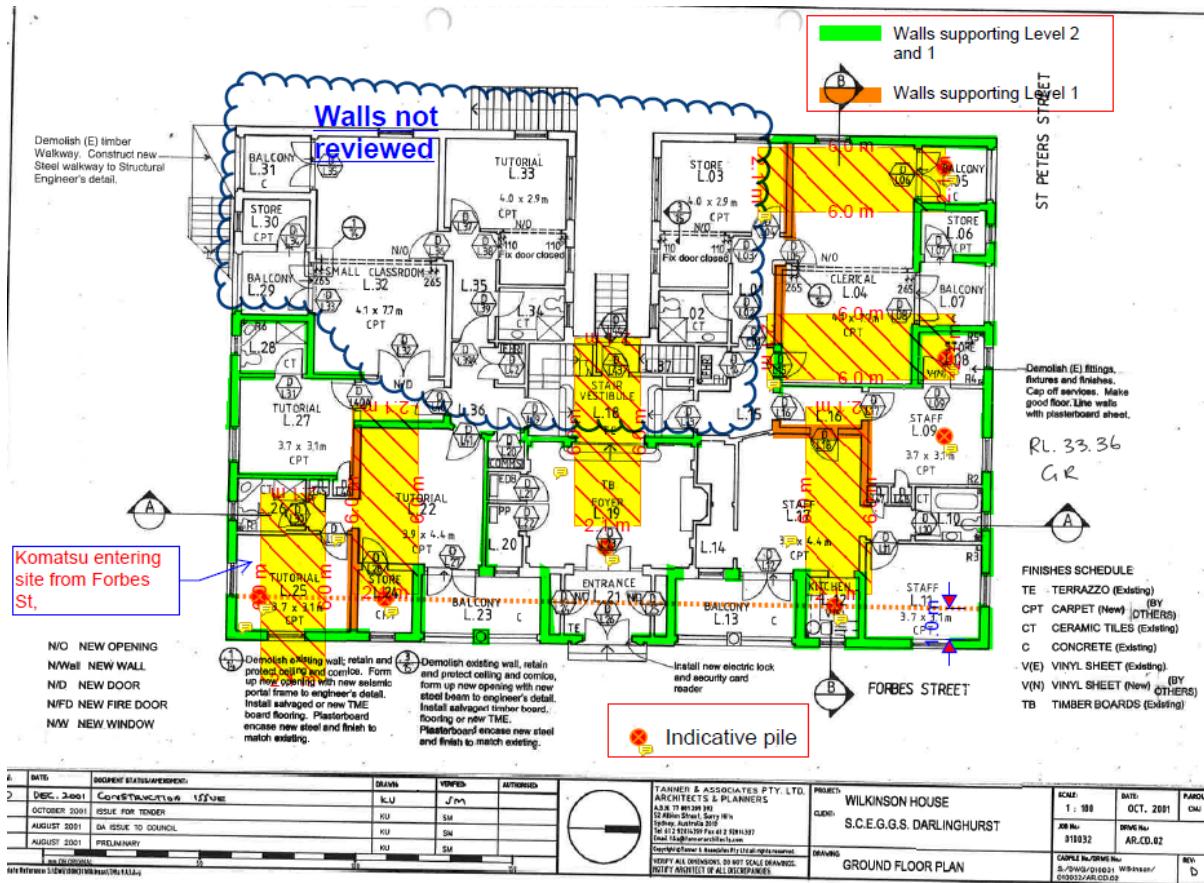
It is evident from the mark up below which has the indicative position of the front façade retention piles and a template of the Komatsu that the machine cannot enter the site and manoeuvre to a pile position without major demolition of load bearing walls.

The analysis of positioning the rig over the required pile position and providing working space, will require further demolition of load bearing walls as well as the existing floors to provide height for the rig to set up and operate over the pile position. The consideration of lifting in reinforcement cages into the newly drilled piles prior to casting concrete has not been reviewed given the considerable challenges with getting the rig into position.

Also not considered is the requirement of a temporary retaining wall and back filling between the high level and low-level ground levels, that can take the piling rig surcharge loads for the rig to work safely.

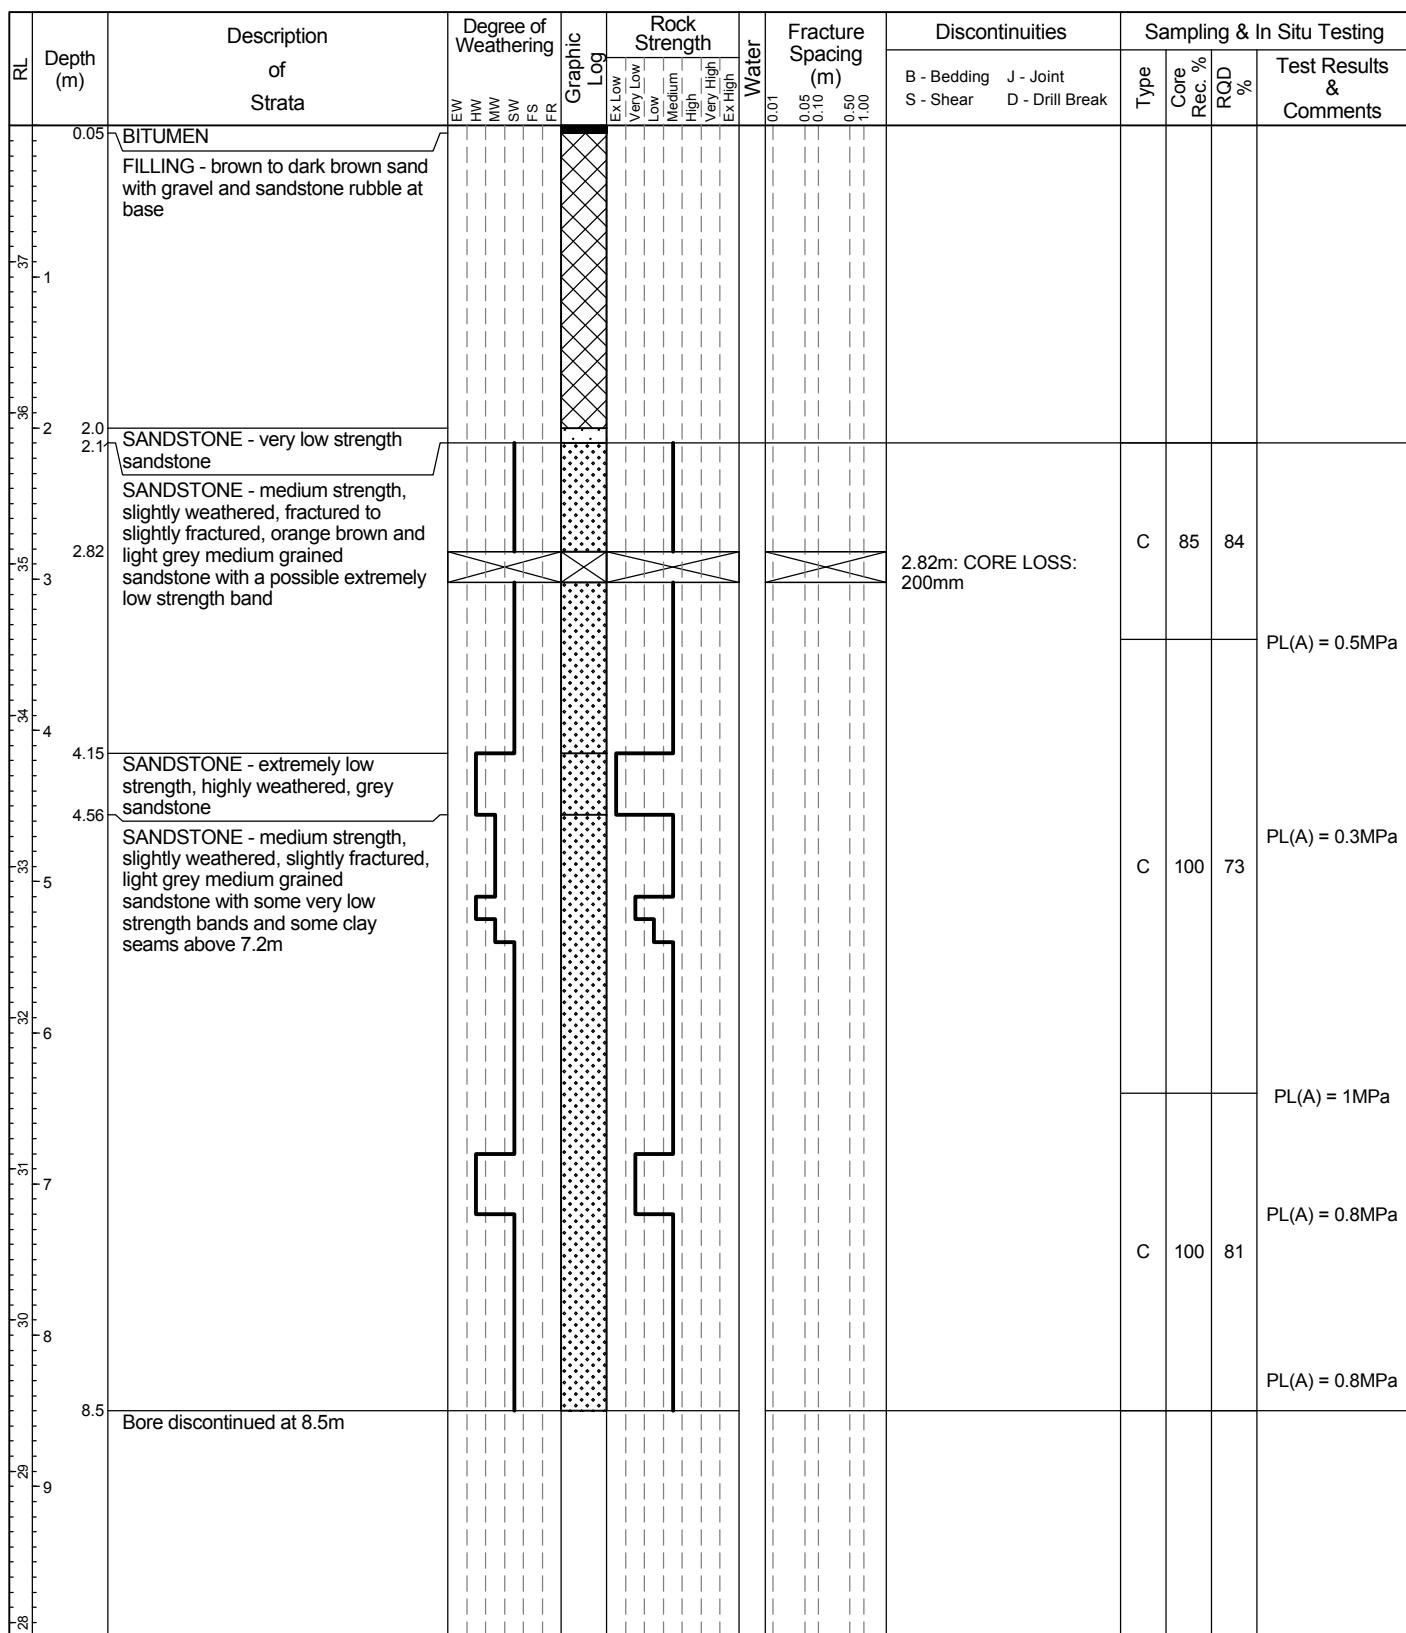
BORE No: 3
PROJECT No: 45427
DATE: 01 Jul 94
SHEET 1 OF 1

SURFACE LEVEL: 37.9
EASTING:
NORTHING:
DIP/AZIMUTH: 90°/--
