Wilkinson House

Structural Options

Retention of Existing Facade

Prepared for SCEGGS Darlinghurst / 26 SEPTEMBER 2019 / Rev D

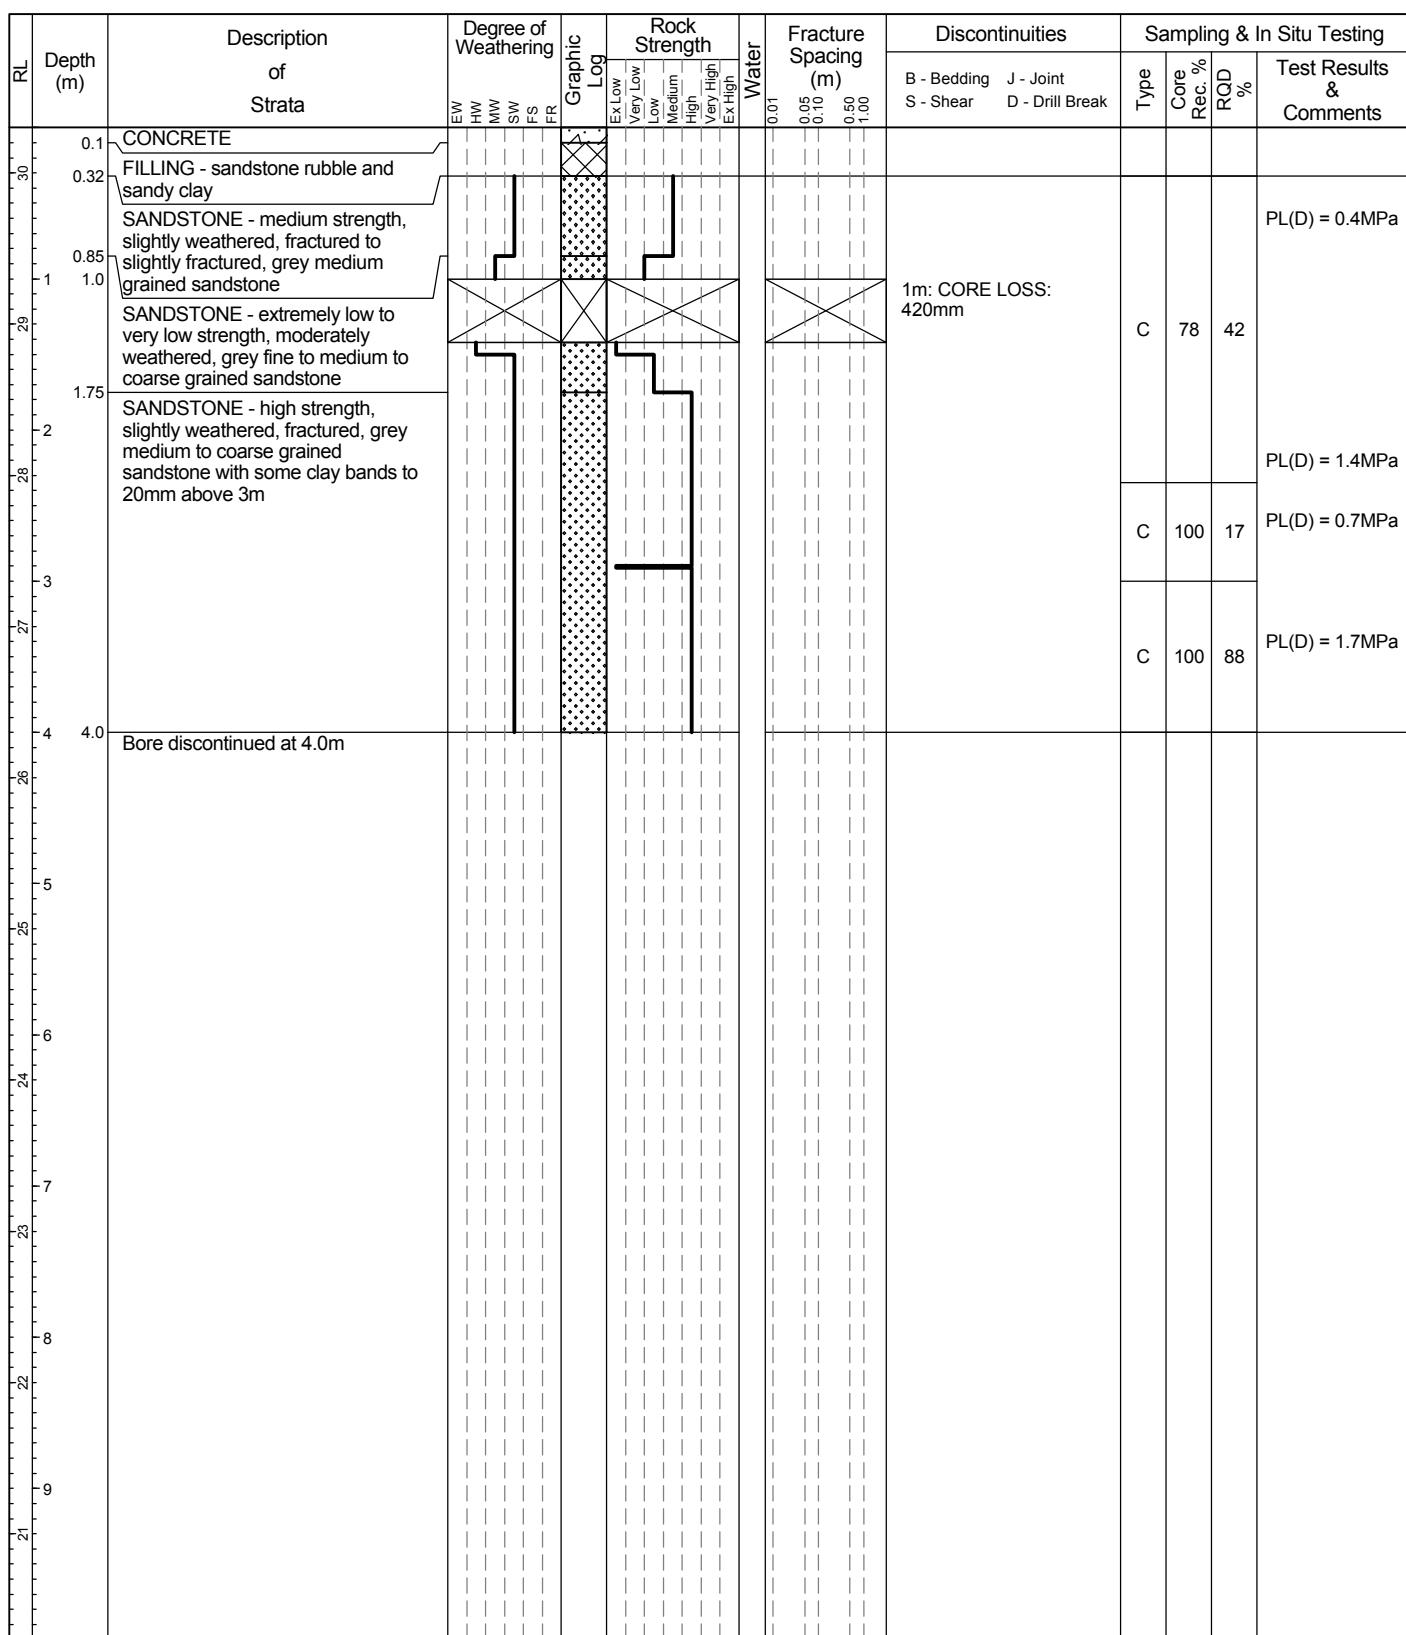
BORE No: 5
PROJECT No: 45427
DATE: 28 Jun 94
SHEET 1 OF 1

SURFACE LEVEL: 30.3
EASTING:
NORTHING:
DIP/AZIMUTH: 90°/--

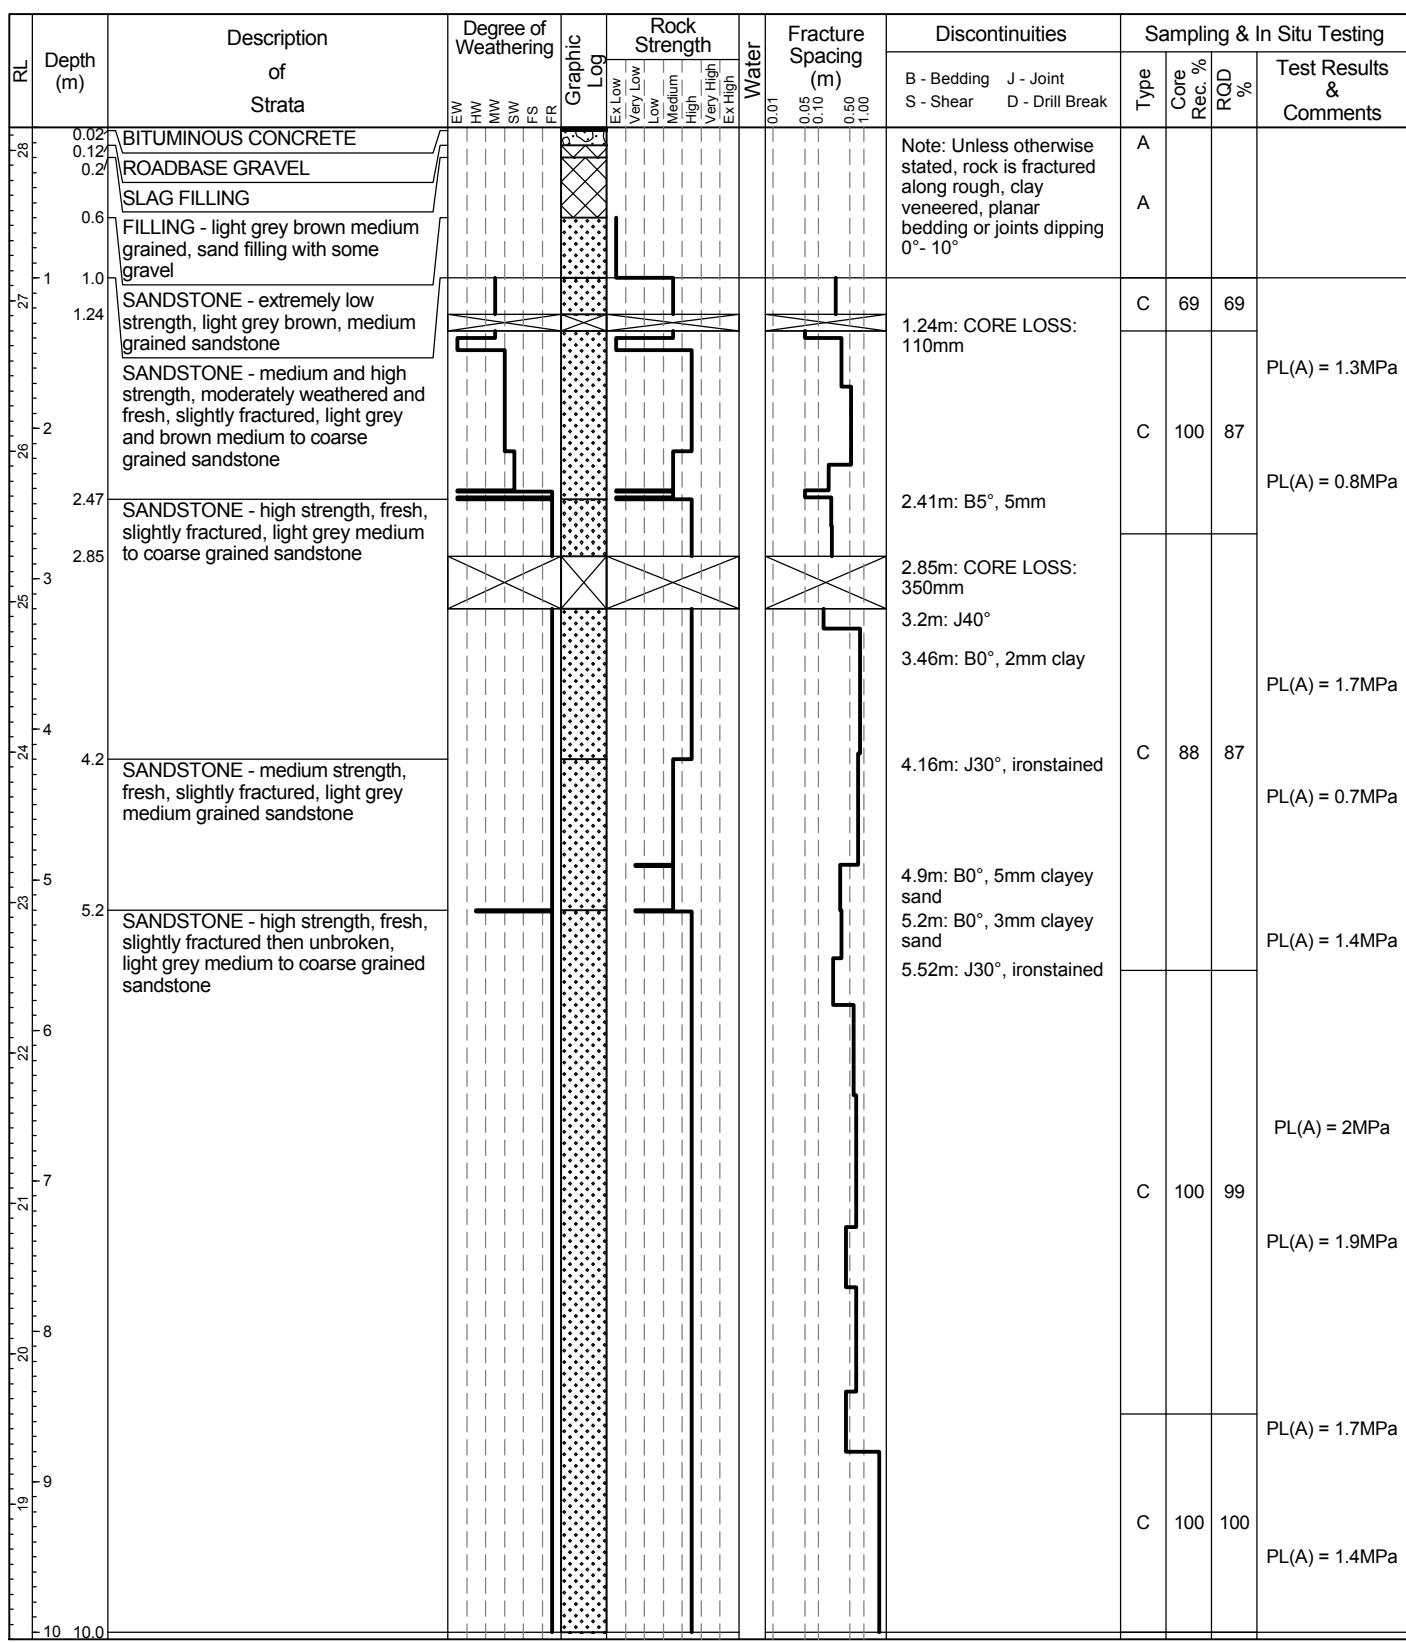
BORE No: 101
PROJECT No: 45427
DATE: 05 Mar 08
SHEET 1 OF 1

SURFACE LEVEL: 28.15
EASTING:
NORTHING:
DIP/AZIMUTH: 90°--

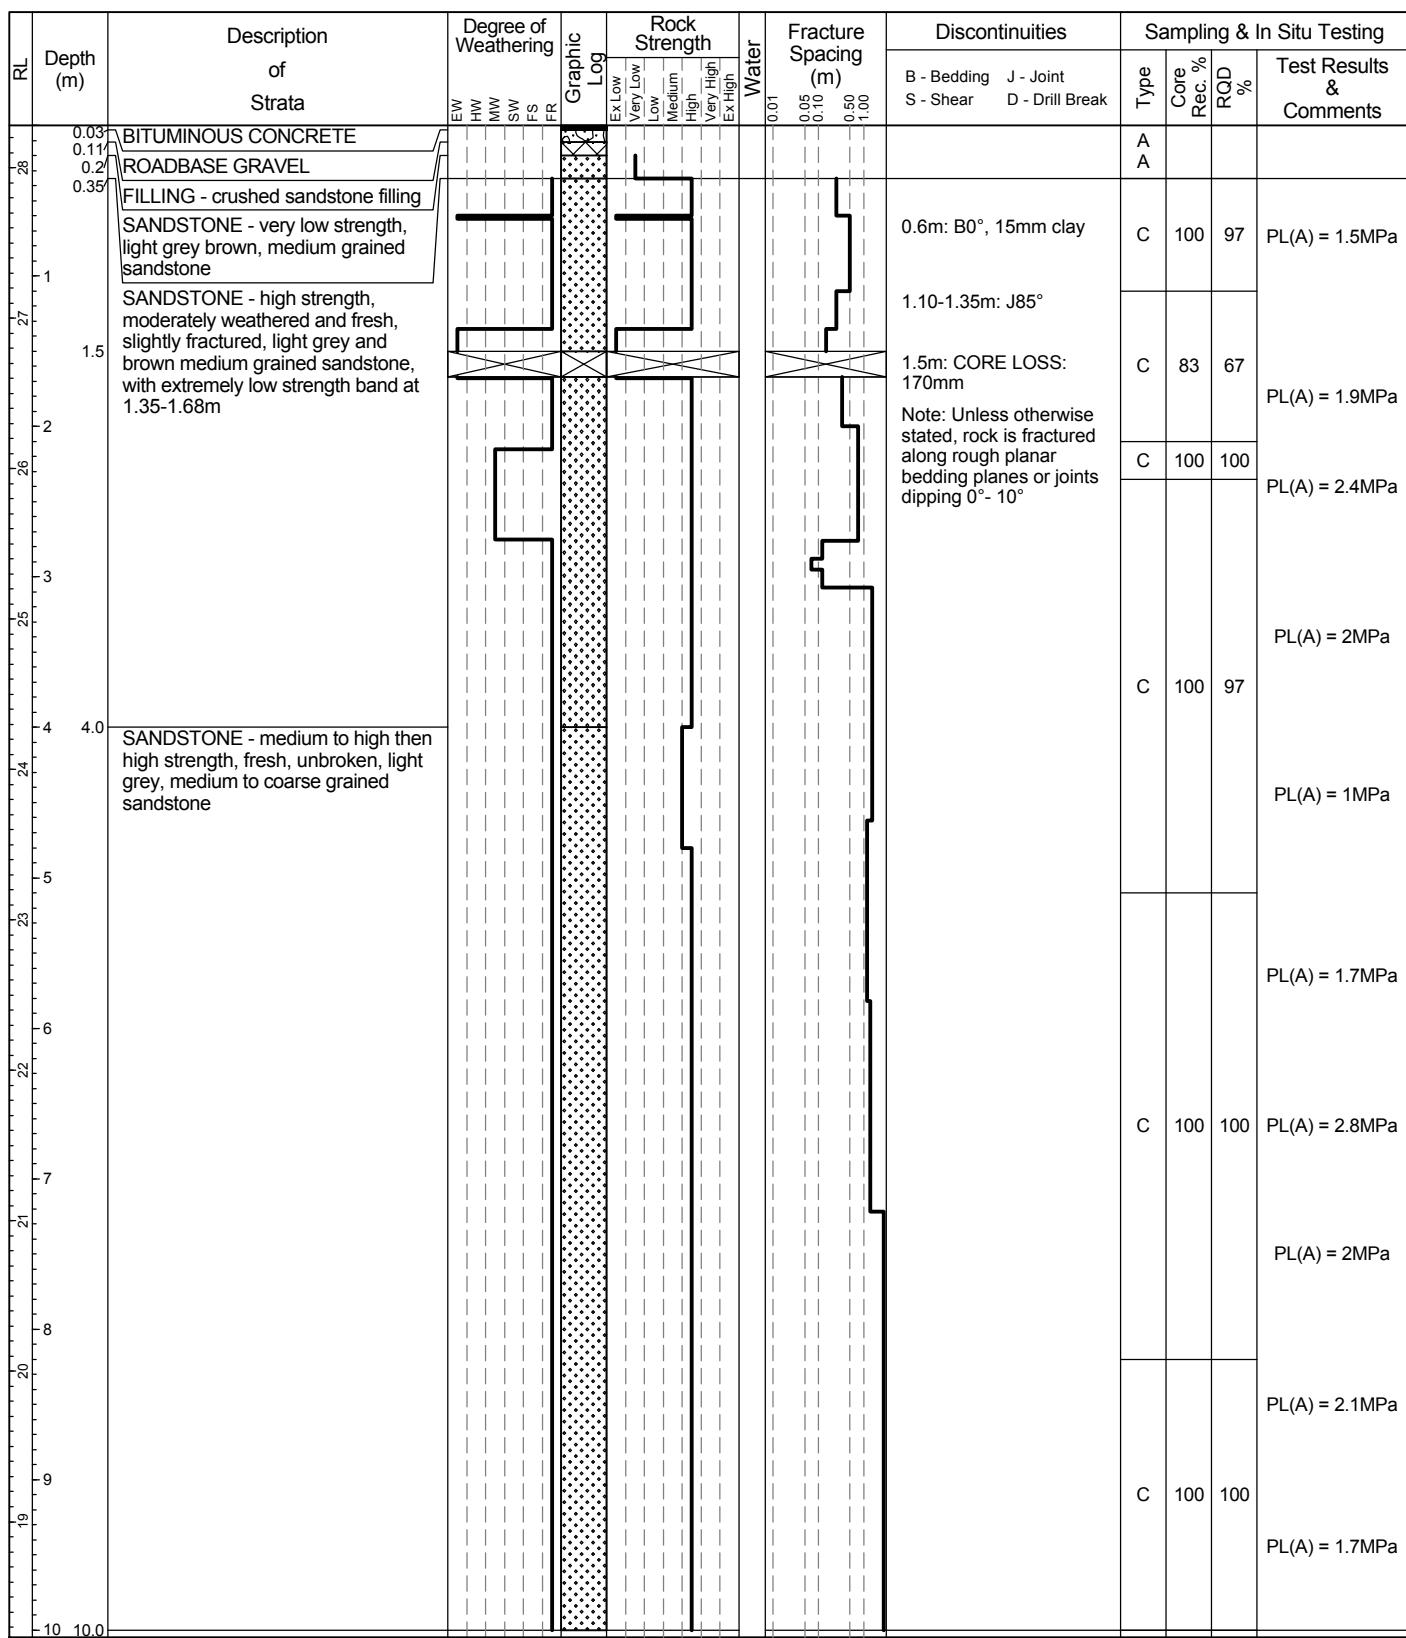
BORE No: 103
PROJECT No: 45427
DATE: 04 Mar 08
SHEET 1 OF 1

SURFACE LEVEL: 28.28
EASTING:
NORTHING:
DIP/AZIMUTH: 90°/--

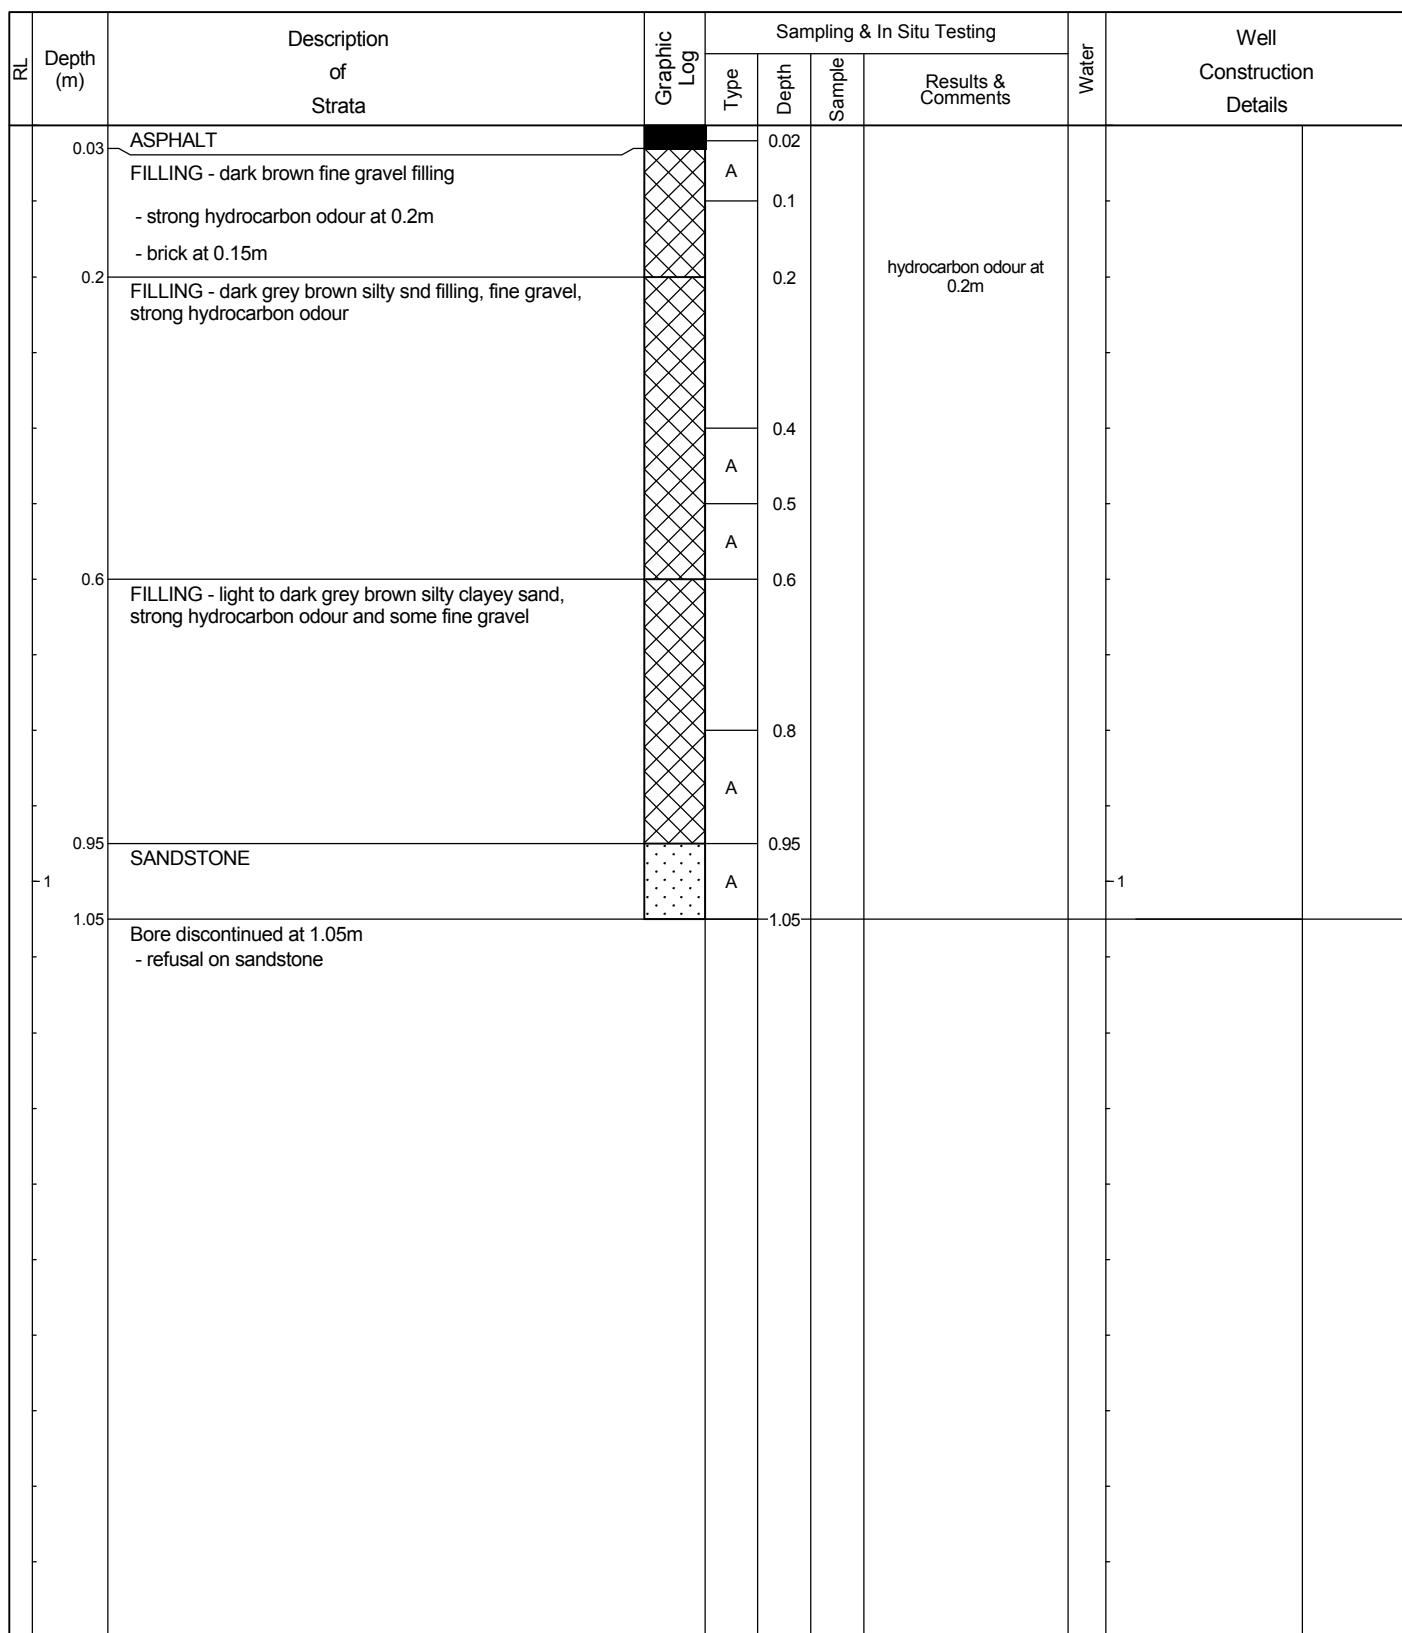
BORE No: 105
PROJECT No: 45427
DATE: 03 Mar 08
SHEET 1 OF 1

SURFACE LEVEL: --
EASTING:
NORTHING:
DIP/AZIMUTH: 90°/--

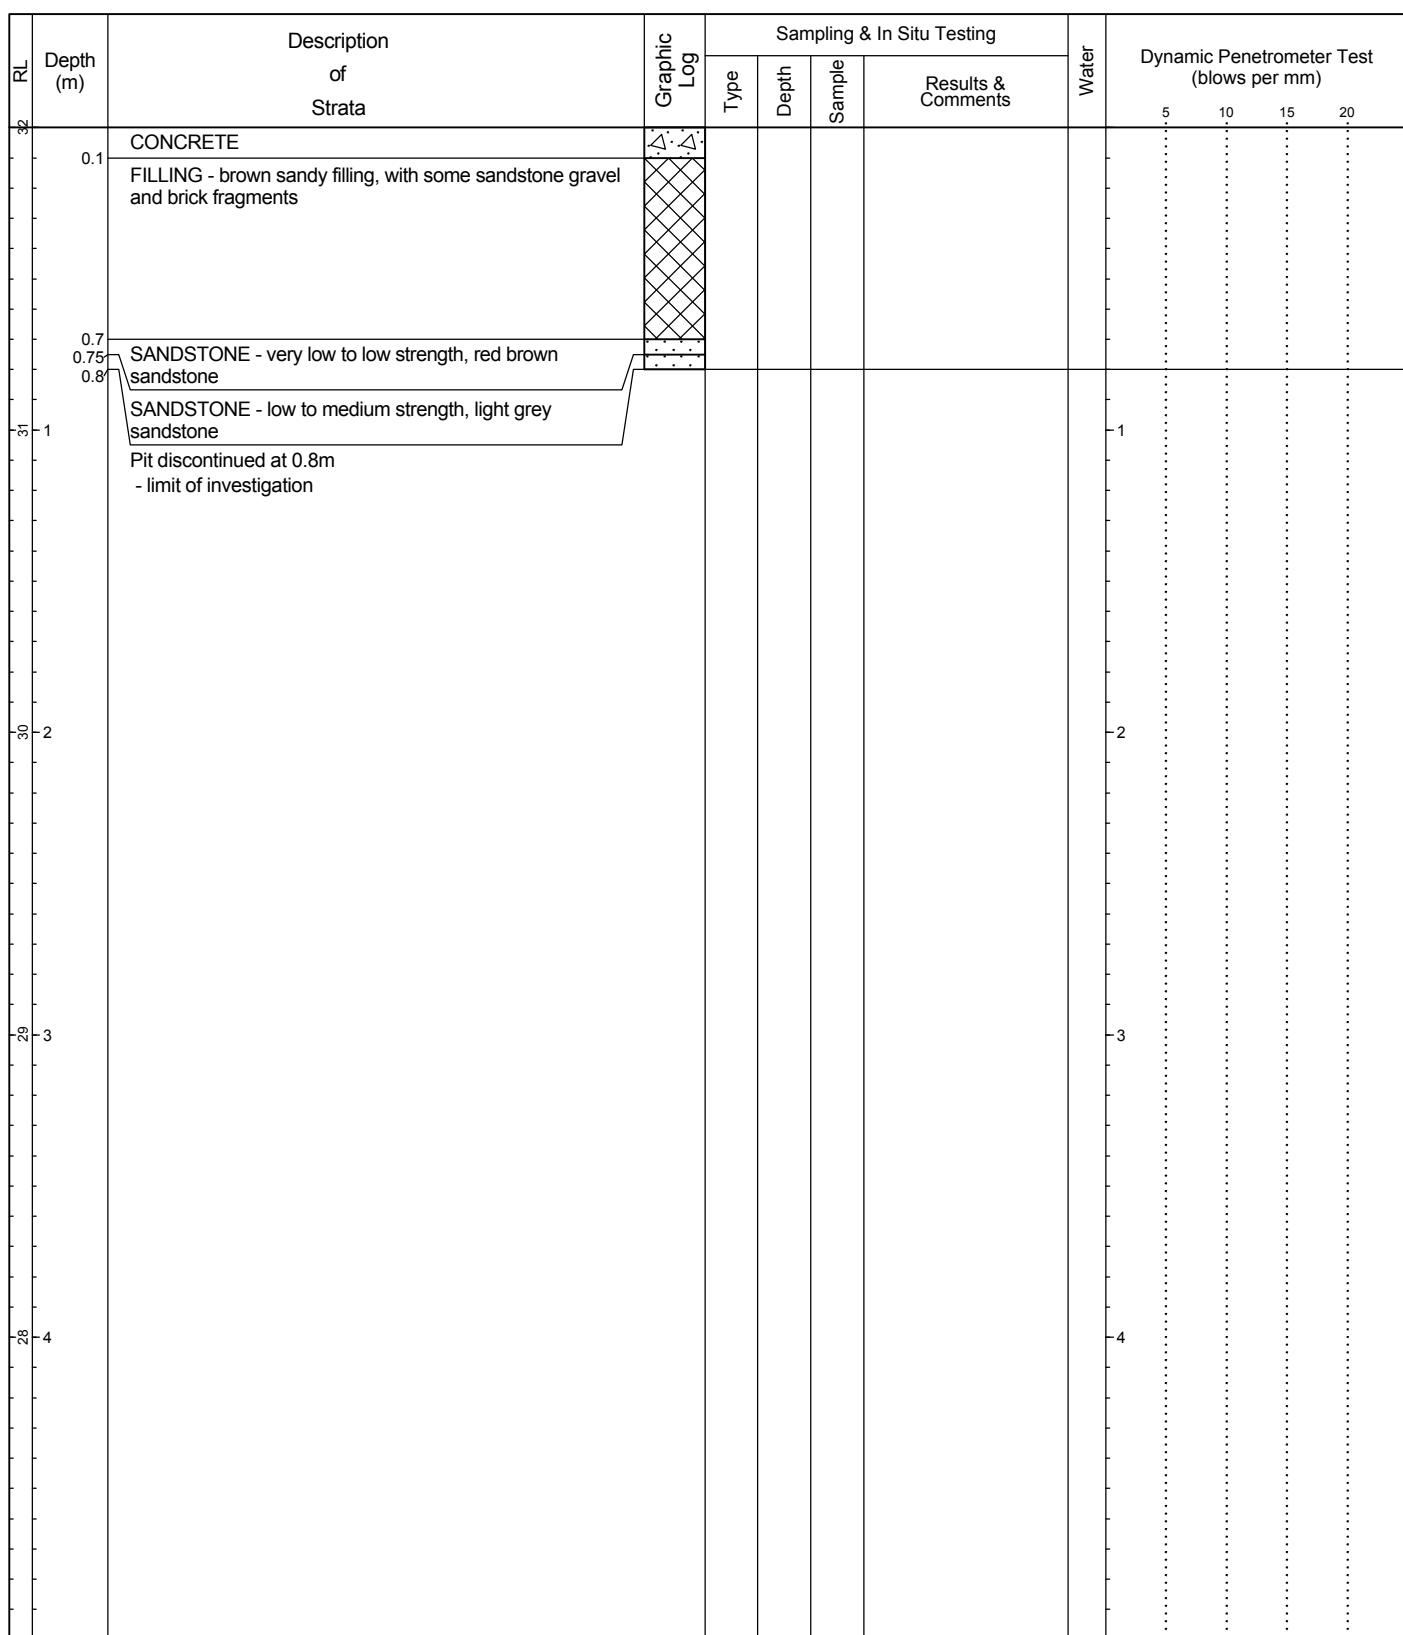
PIT No: 203
PROJECT No: 45427
DATE: 28 Apr 08
SHEET 1 OF 1

SURFACE LEVEL: 32.0
EASTING:
NORTHING:
DIP/AZIMUTH: 90°/--

Test Pits 202 and 203 were excavated by hand to determine bedrock levels and possibly expose the foundations of adjacent buildings. Originally it was intended to excavate a Test Pit 201 adjacent to Wilkinson House but inspections indicated that the footings of Wilkinson House are supported by Sandstone Bedrock above the level of the car parking beneath the demountable building and tennis court. Consequently it was considered sufficient to map the sandstone outcrop and photograph the footings to provide information on the need to underpin footings of Wilkinson House.

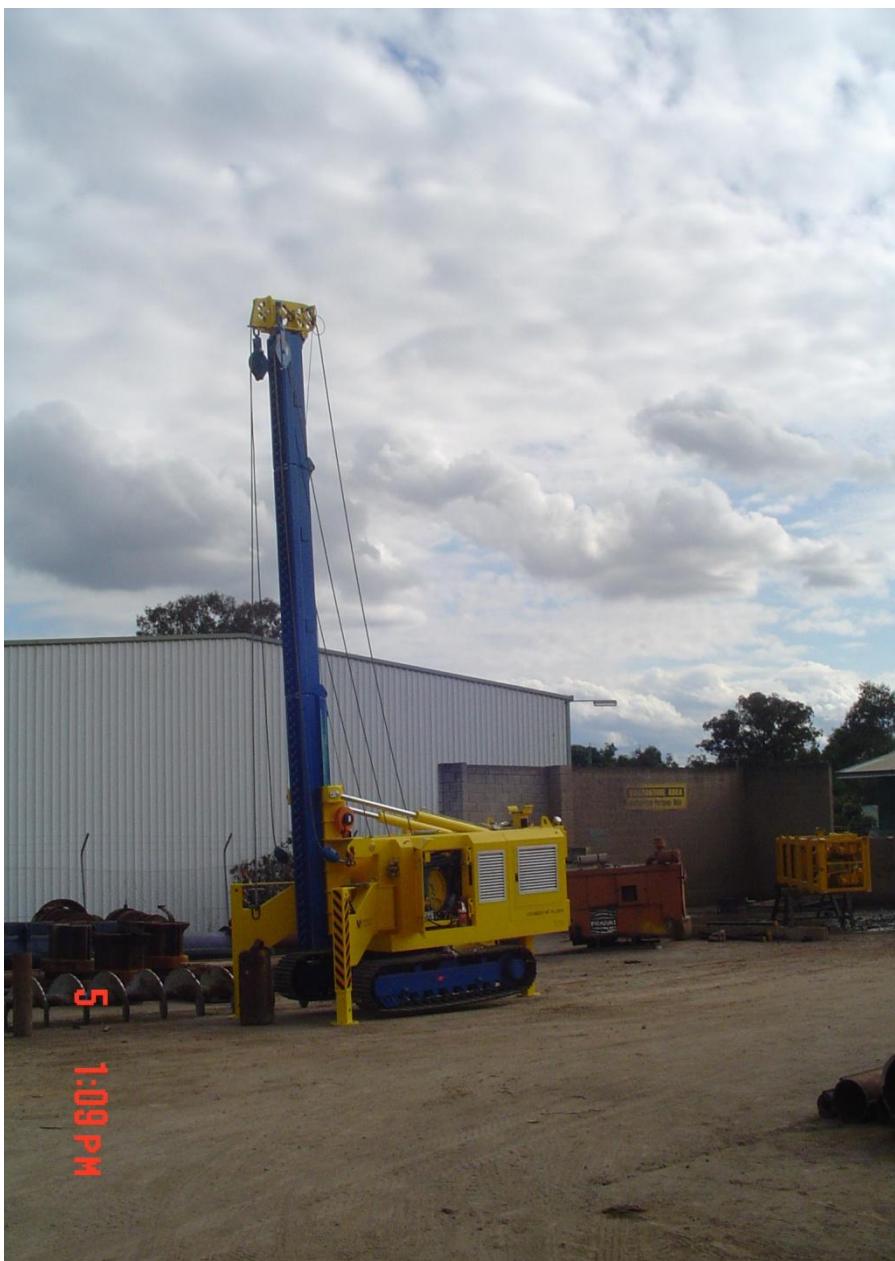
VERMEER HL 2500 RIG

**VERMEER HL 2500 PILING MACHINE
PLANT NOS. FM 12
C.F.A. – BORED – FORUM - DRIVEN TUBES.
VERMEER HL 2500 - PLANT NO. FM 12
TECHNICAL SPECIFICATIONS
VERMEER SERIAL NO. - YEAR BUILT 2007**

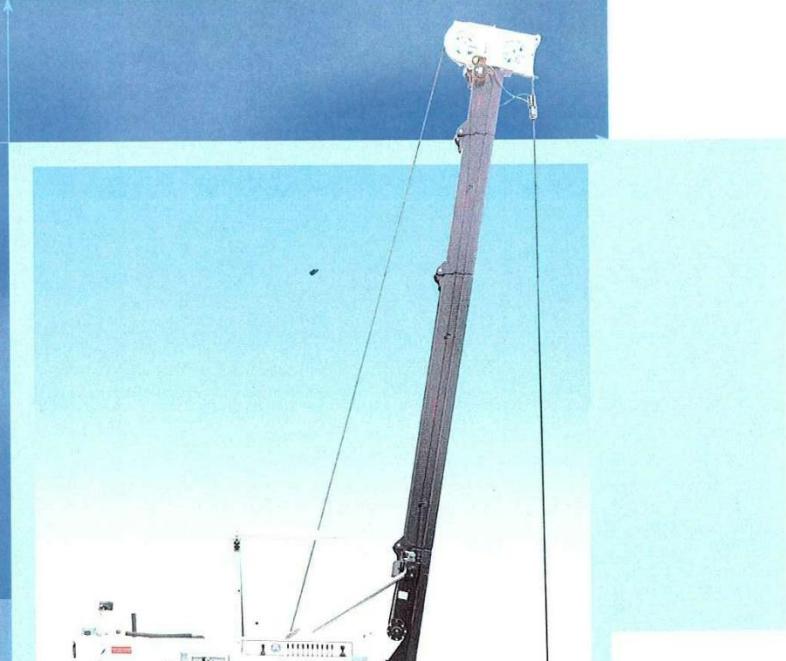
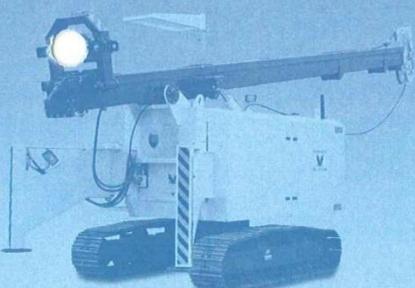
Model HL-2500

TECHNICAL SPECIFICATIONS

VERMEER MACHINE TECHNIEK PILING MACHINES ARE SUITABLE FOR VARIOUS FOUNDATION INSTALLATION TECHNIQUES. IN ADDITION TO PILING ACT A FREE FALL DROP HAMMER INTERNALLY OR TOP DRIVE, CASINGS AND AUGERS CAN BE USED FOR PILING METHODS, INCLUDING BOVI AND VIBRO. VERMEERMT PILING MACHINES ARE MANUFACTURED TO THE HIGHEST QUALITY STANDARDS. THE FULLY AUTOMATIC COMPUTERISED PILING SYSTEM PROVIDES A CONTINUOUS, HIGH FREQUENCY FREE FALL RESULTING IN EXCELLENT PERFORMANCE. VERMEERMT PILING MACHINES ARE AVAILABLE IN SEVEN MODELS USING 750, 1200, 1800, 2500 AND 4000 KGS. WEIGHT DROP HAMMER. THE MACHINES ARE OF MODULAR CONSTRUCTION, ALLOWING SOME REQUESTED SPECIFICATION CHANGES E.G. TRACK WIDTH, 360° SLEWING, AND DIFFERENT MAST TYPES.

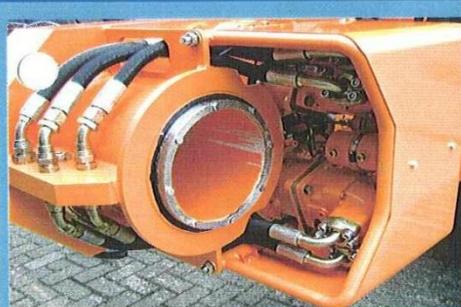
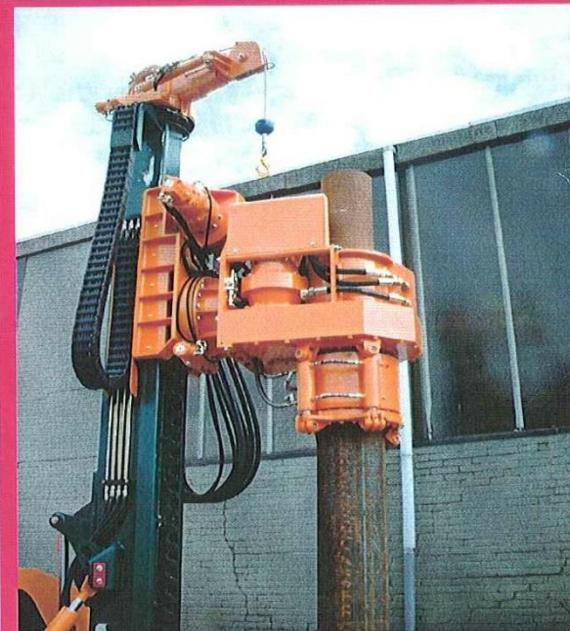
Rotary Table SB-65

Advantages of Displacement Drilling:

- No noise
- No vibrations
- High friction of the pile due to displacement. This results in smaller required diameter casing with higher bearing capacity

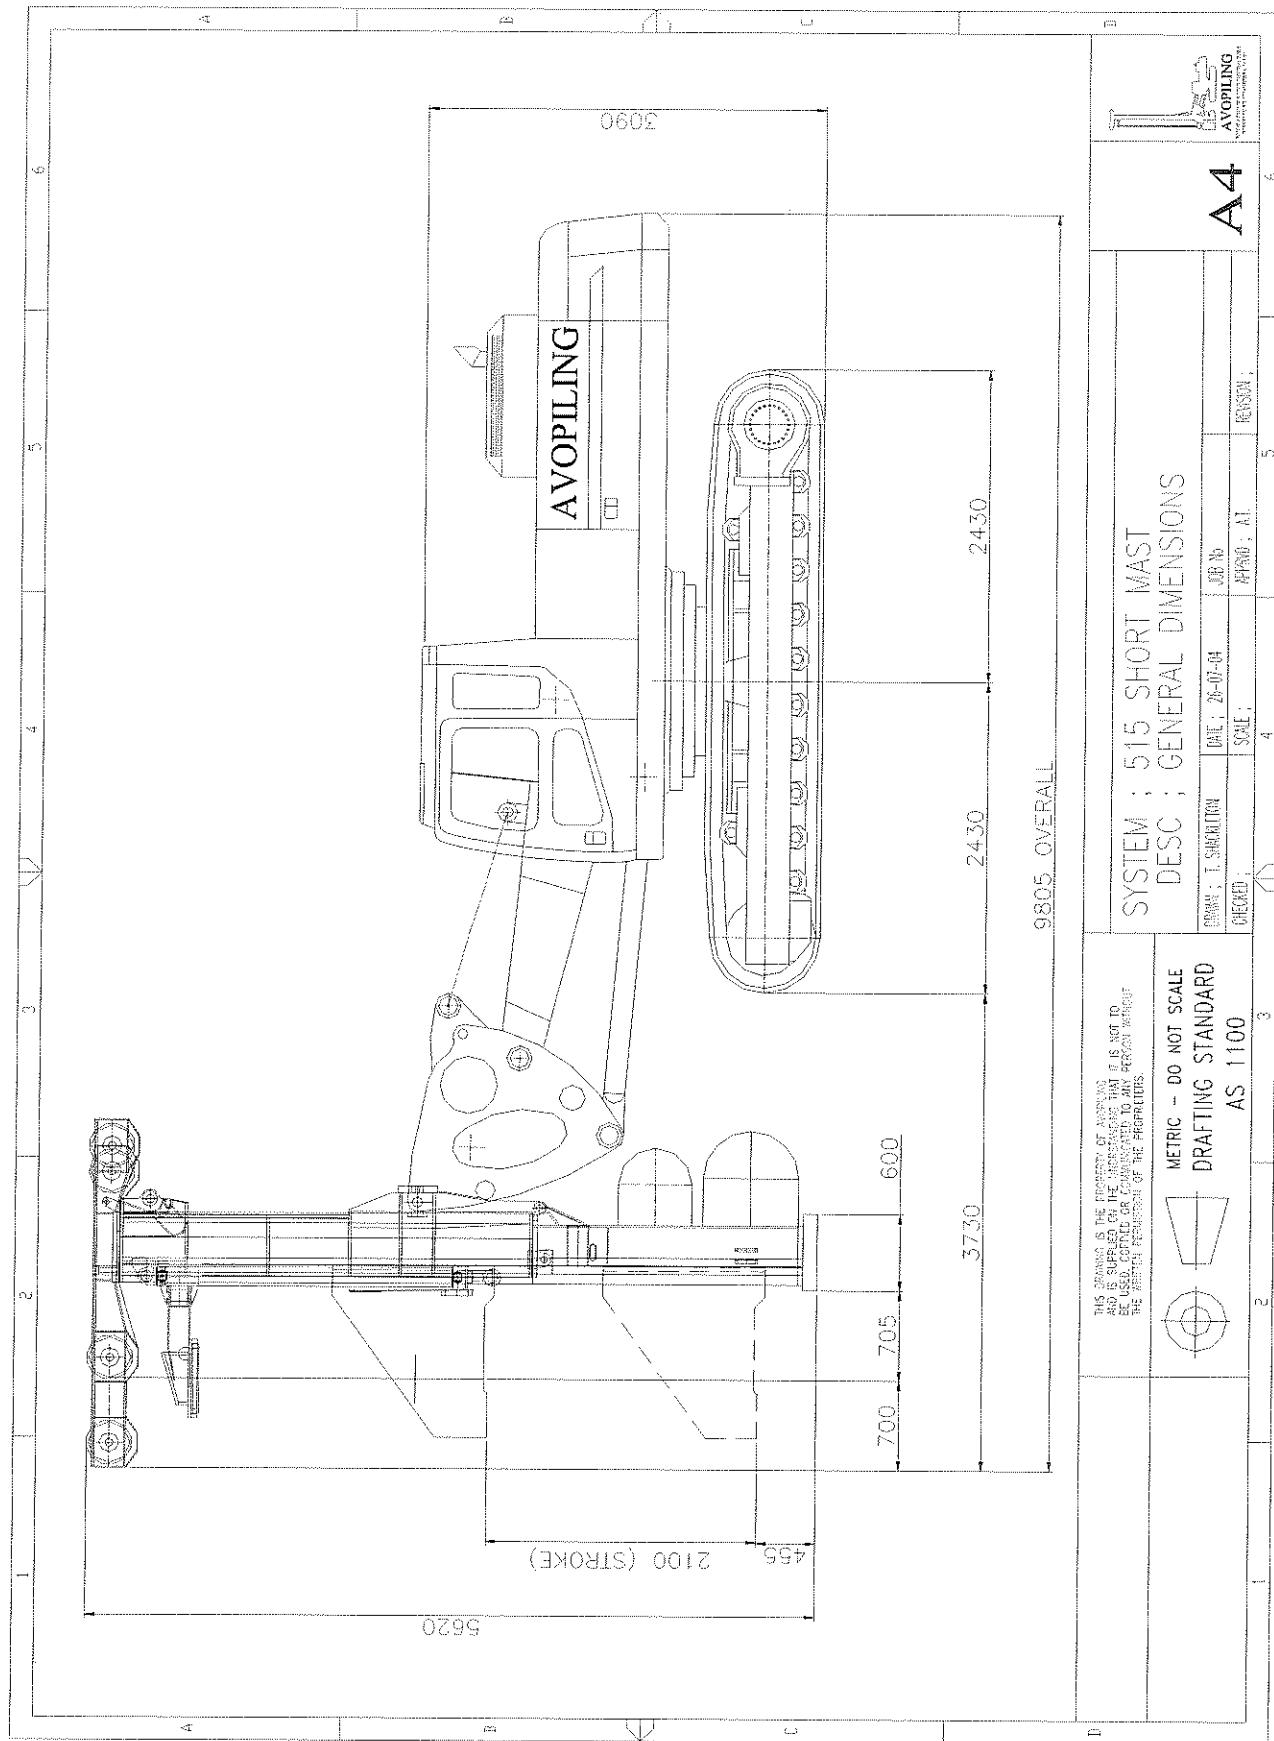
MACHINE WORKING WIDTH 4200 m.m.

BOOM IN LOWEST POSITION.
