# **WATERLOO METRO QUARTER OVER STATION DEVELOPMENT**

## **Environmental Impact Statement Appendix PP – Contaminated Sites Strategy Report**

### **SSD-10437 Southern Precinct and SSD-10438 Basement Car Park**

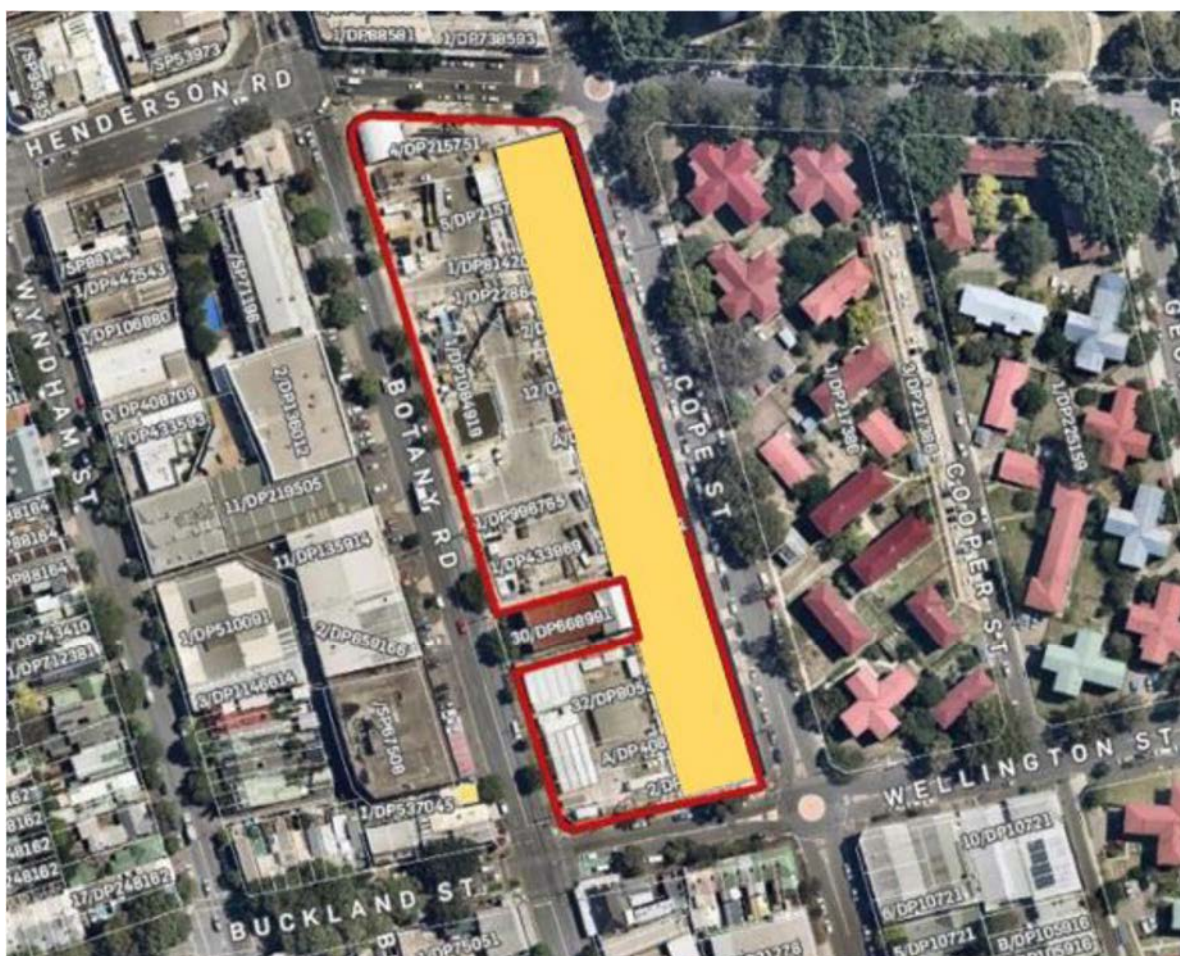
*Figure 6 – WMQ Boundary (red line) and Sub-Areas*

- Waterloo Metro Station Box (the Station Box), comprising the below ground level development in the area shaded yellow on Figure 1;
- The OSD, the area excluding the Station Box, comprising:
  - Above ground level development in the area shaded yellow on Figure 6: and
  - The area not shaded on Figure 6.

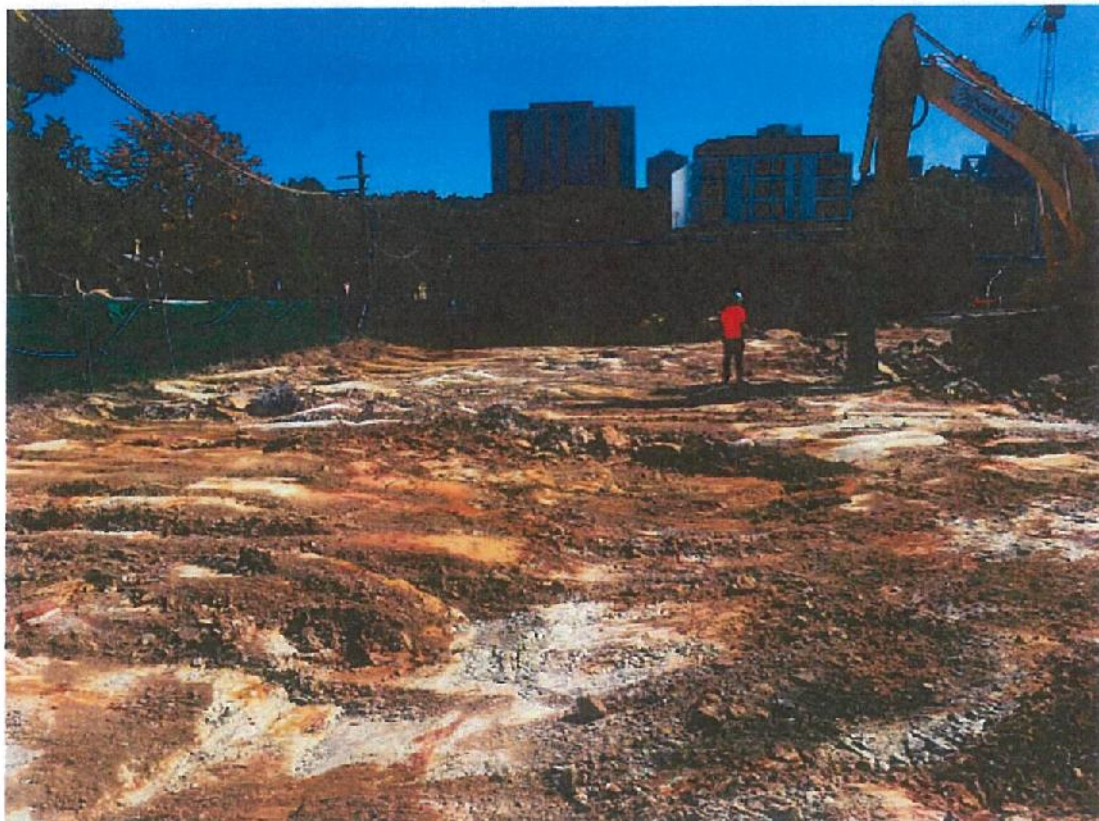
As requested, Douglas Partners visited the above site on 24 October 2017 for the purpose of inspecting an area which had been stripped of existing filling/soil to determine whether the underlying sandstone bedrock can be removed from the site as Virgin Excavated Natural Material (VENM). The area of the inspection is within the basement zone of Building C, excluding the southern boundary where an existing fill embankment is present against which a new embankment to support a working platform for a piling rig is being constructed. A photograph of the site taken at the time of the inspection is shown in Figure 1.

Figure 1: Photograph of inspection area on 24 October 2017

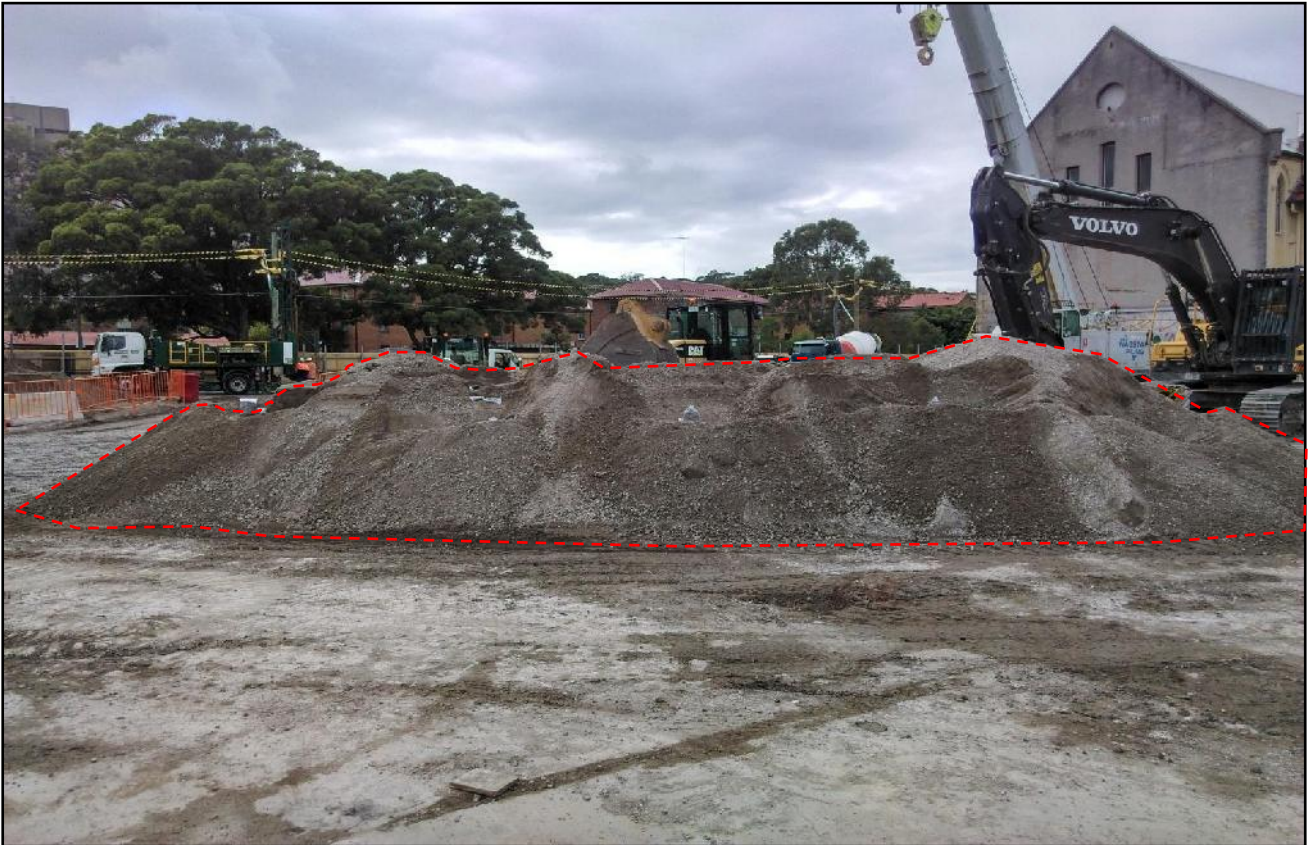
**Photograph 1.** Subject stockpile (facing south). Date: 22.03.2018.

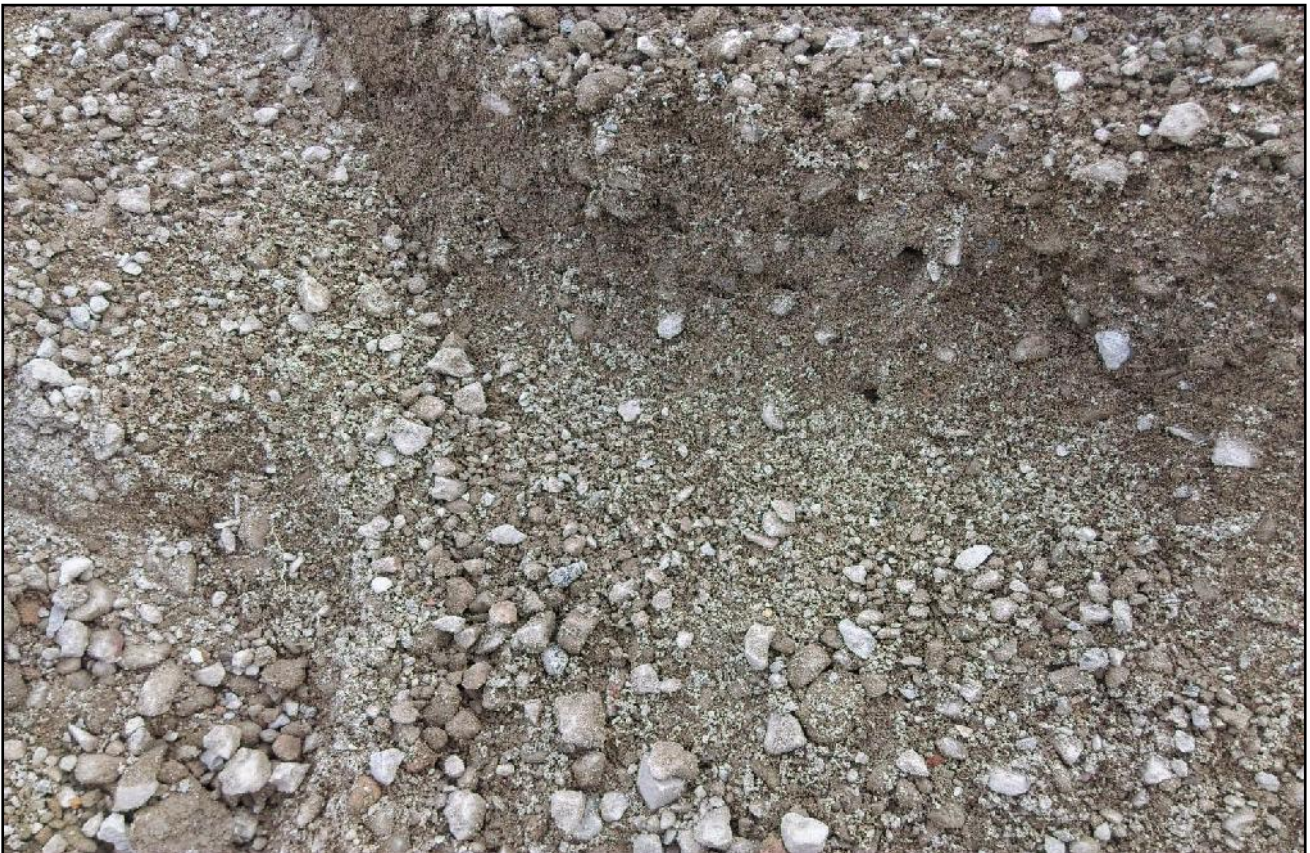
**Photograph 2.** Representative soil matrix throughout the subject stockpile, as observed from Test Pit 2. Date: 22.03.2018.

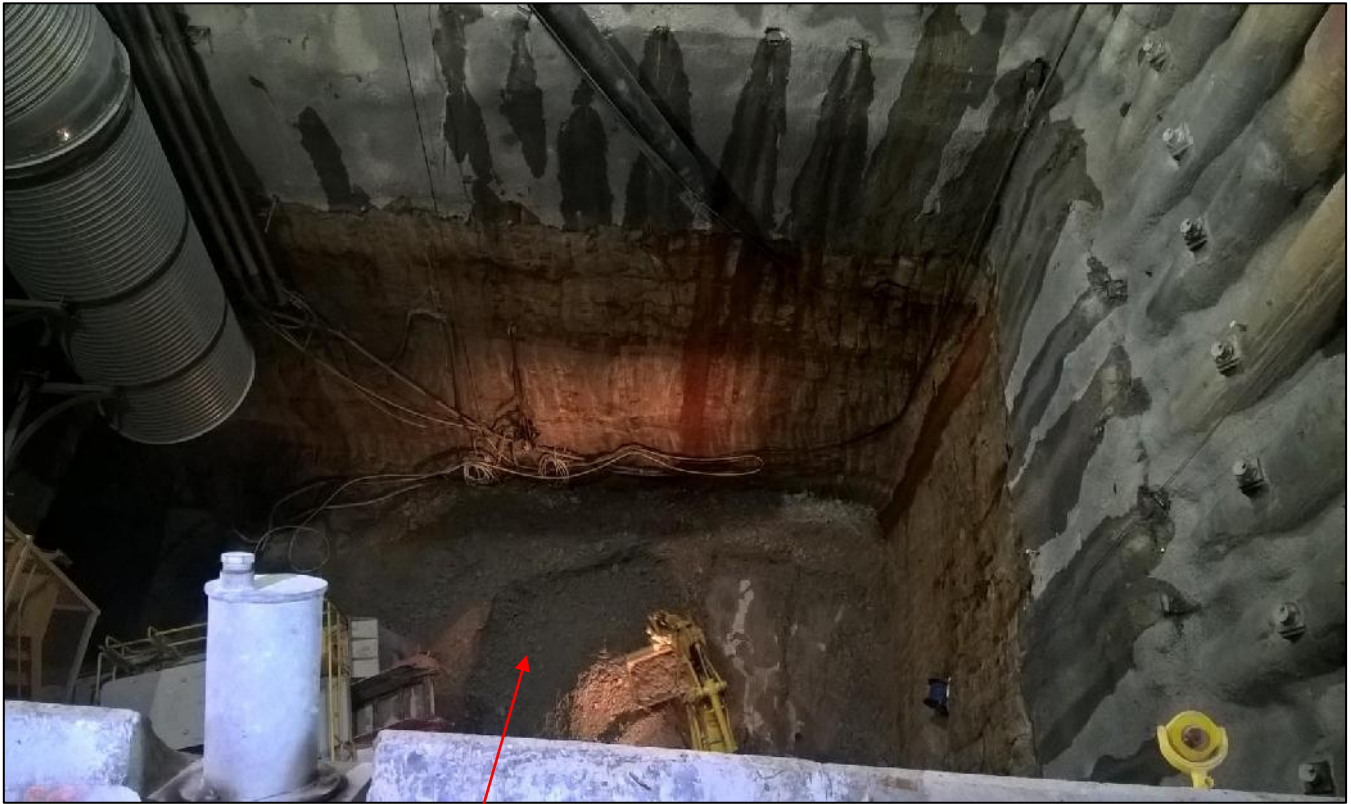
**Photograph 1** – Source of excavated virgin rock materials within shaft, as observed on 17.02.2017.

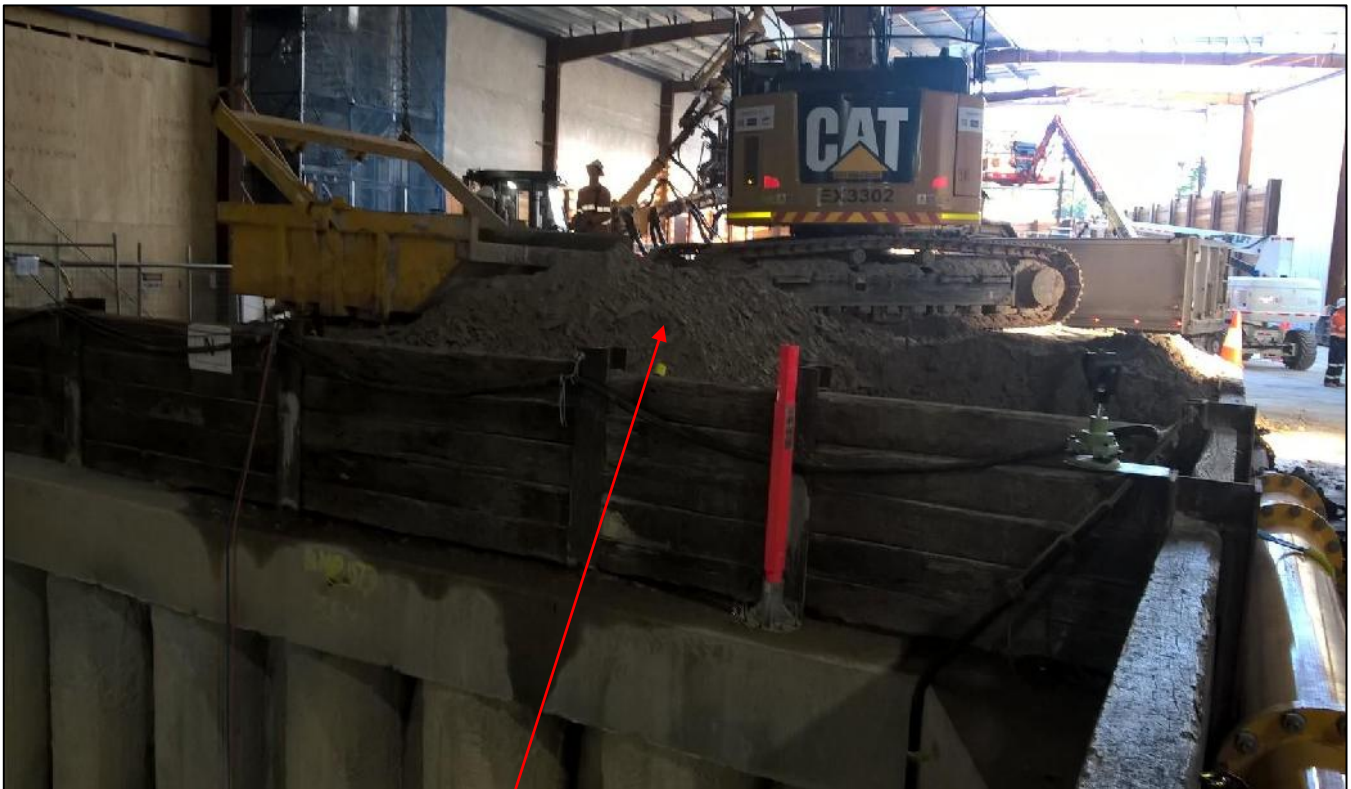
**Photograph 2.** Image of stockpiled virgin rock material situated south of shaft, as observed on 17.02.2017.

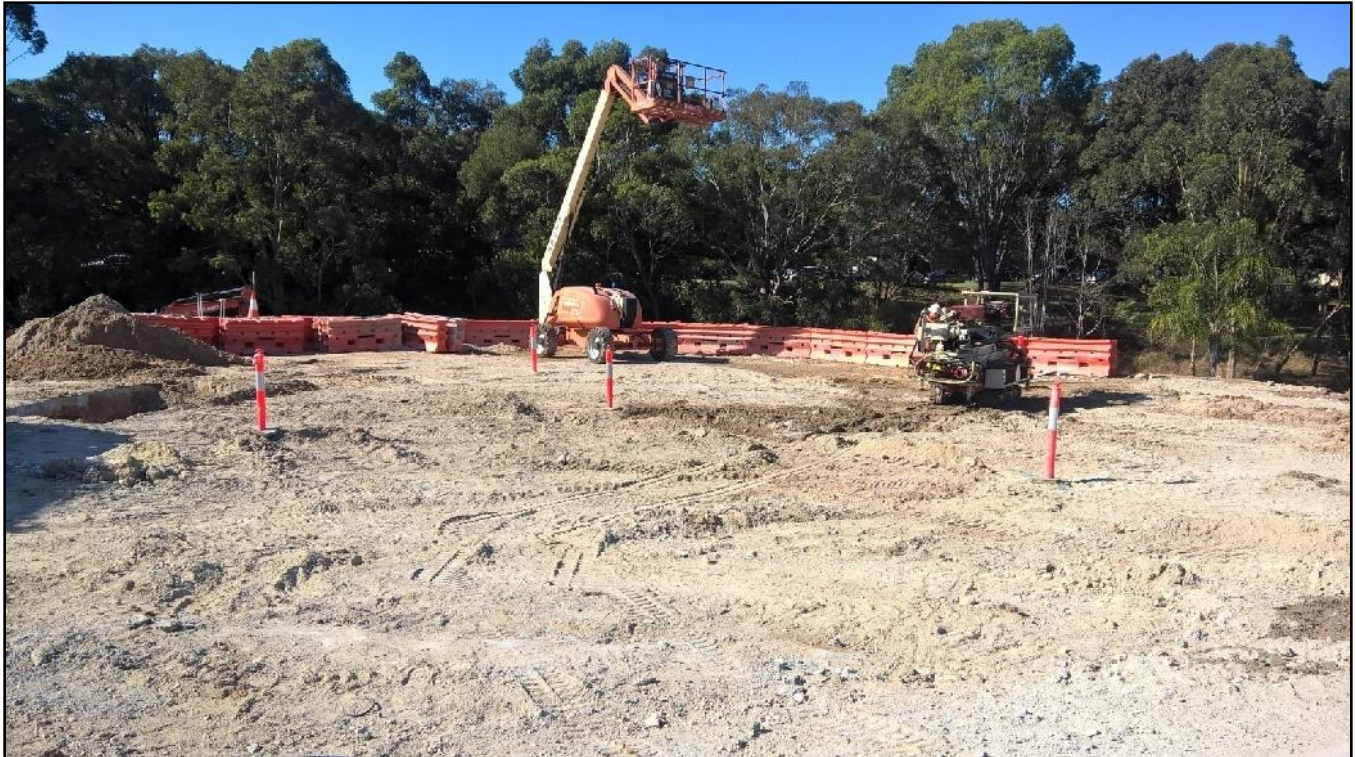
**Photograph 1.** Subject Area (facing south-west) as observed on the 17<sup>th</sup> January 2017.

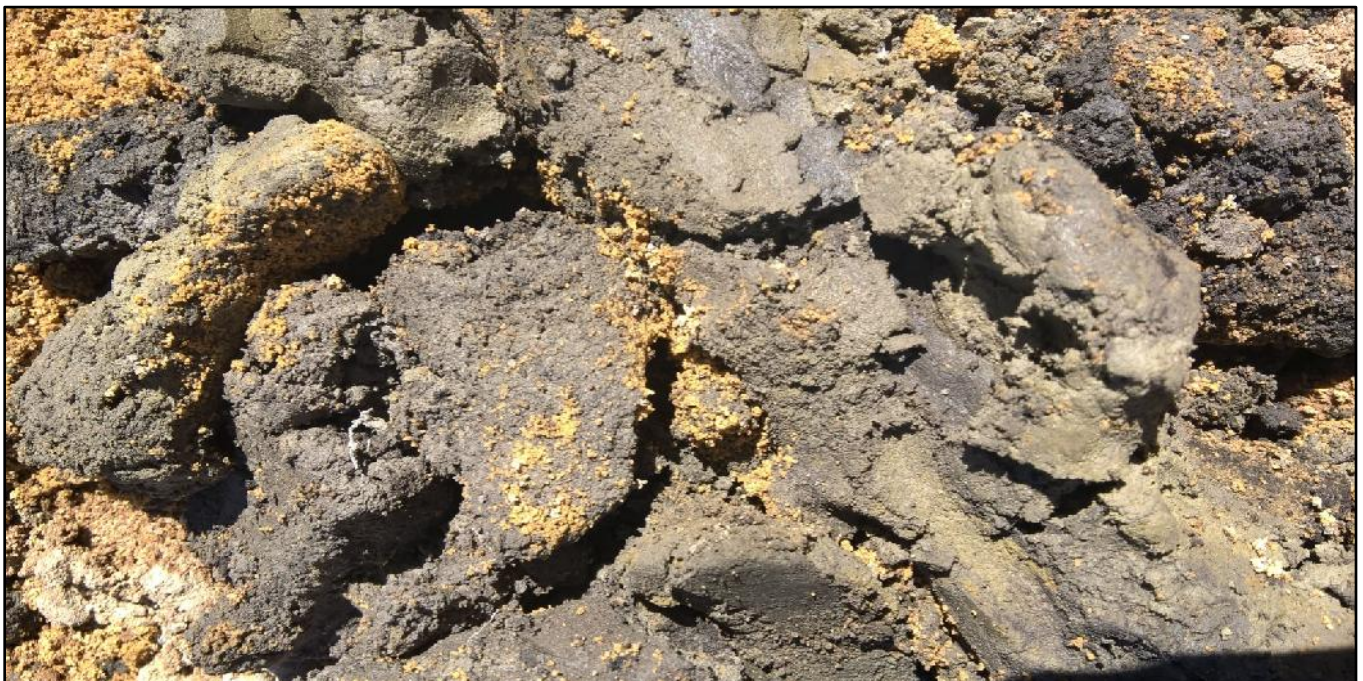
**Photograph 2.** Representative soil material within the subject area.

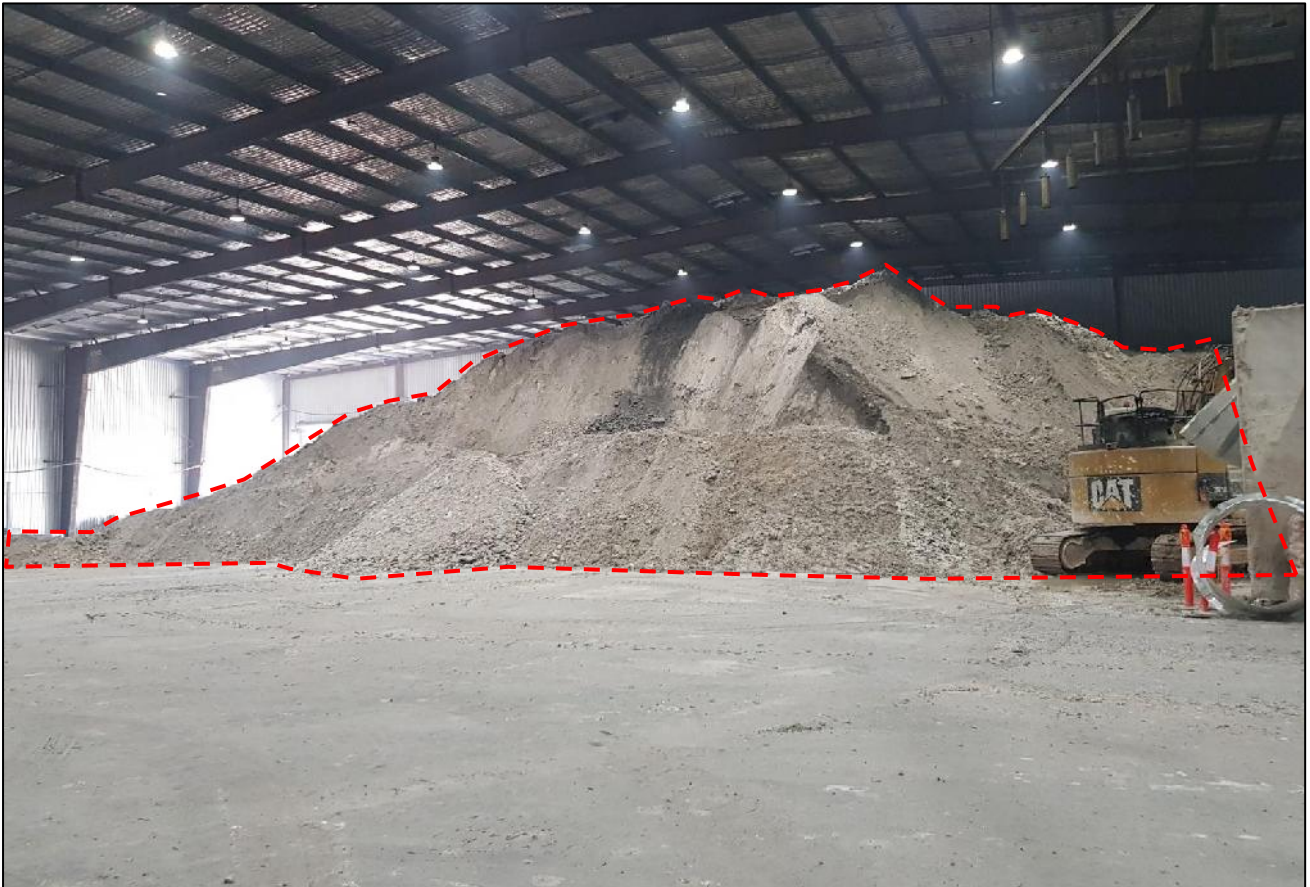
**Photograph 1** – Photograph of the subject stockpile (facing west) as observed on 22.01.2018.

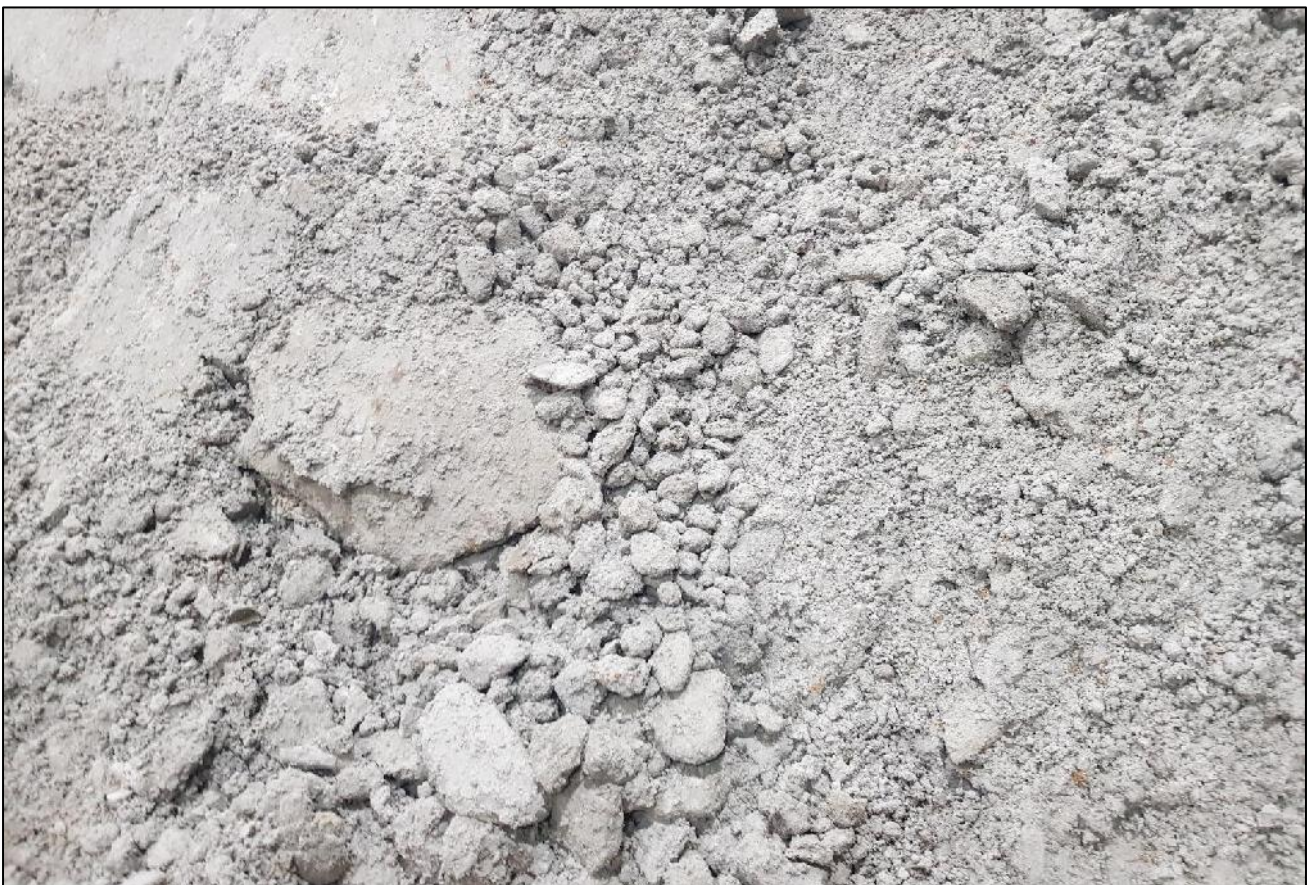
**Photograph 2** – Photograph of the subject material, as observed within test pit 2 on 22.01.2018.

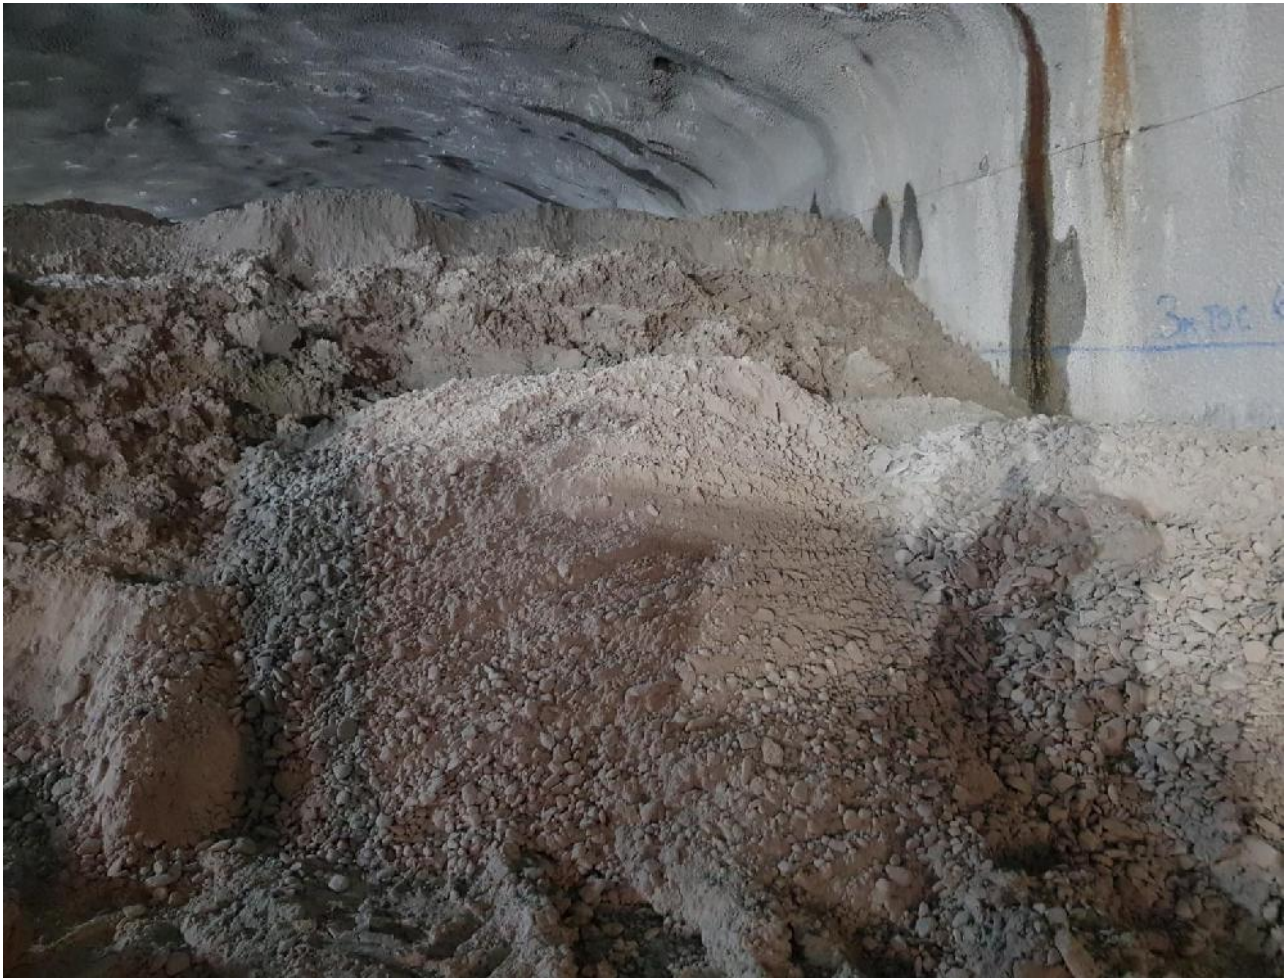
**Photograph 3** – Photograph of the subject material, as observed from VT10, 05.02.2018.

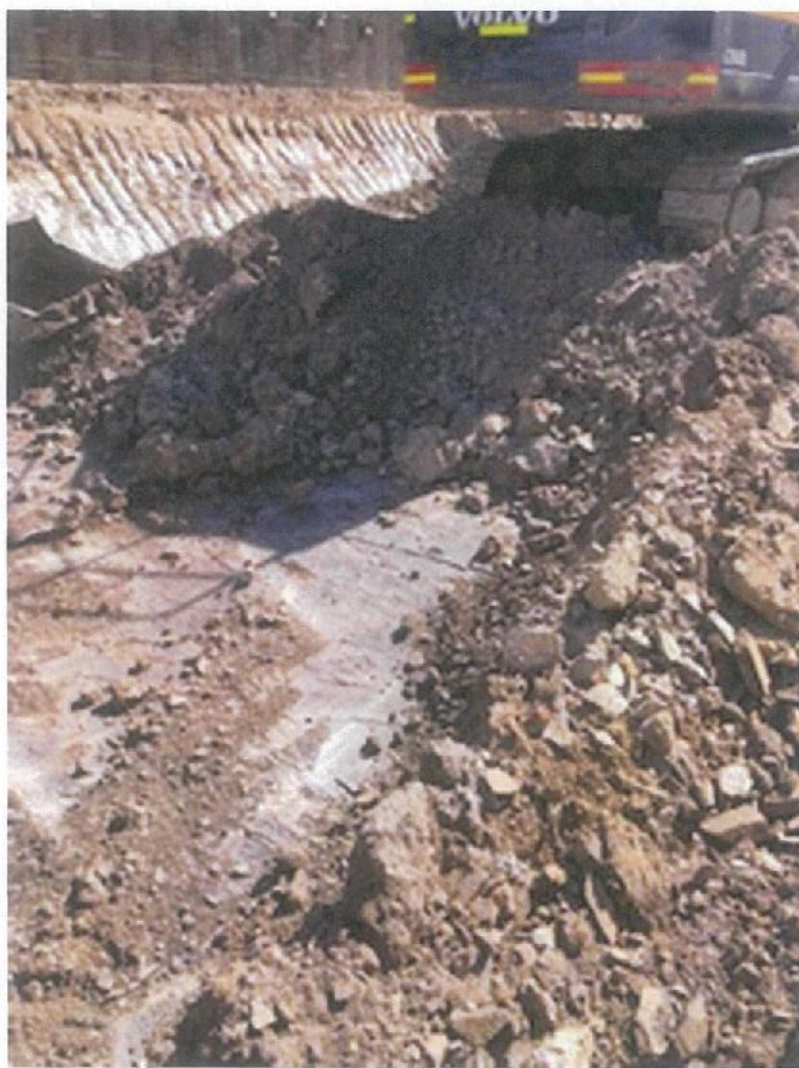
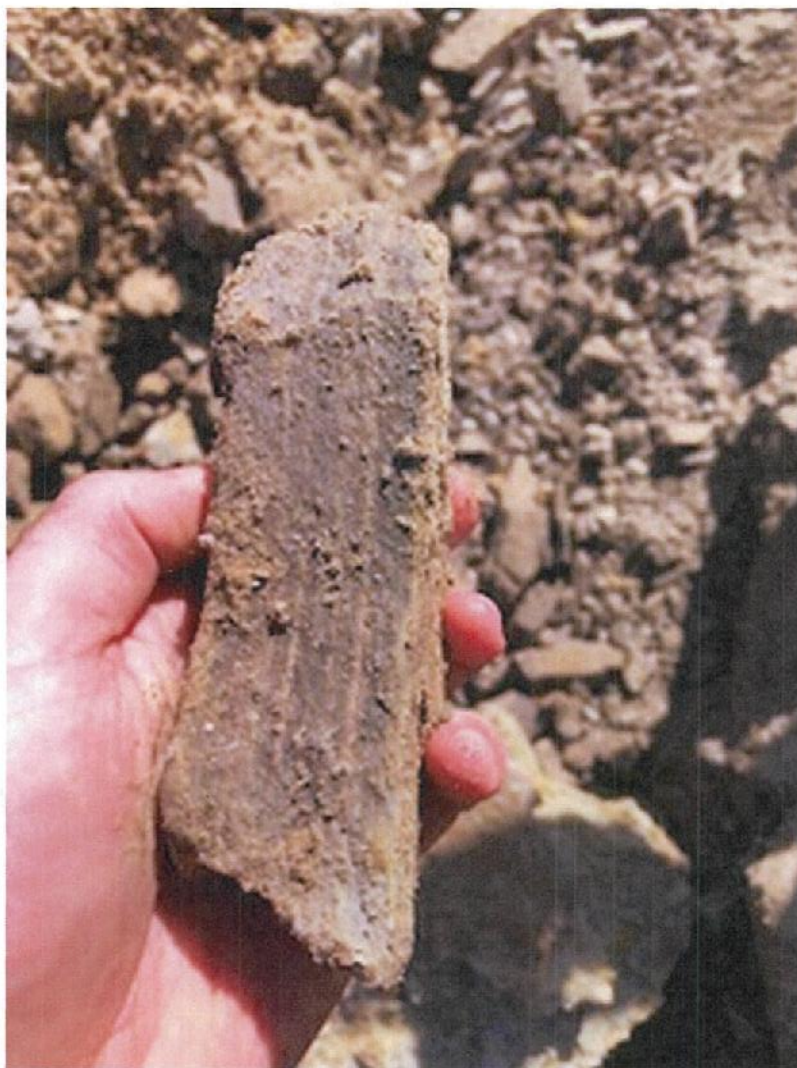
Holocene Sediment Checklist (for ASS)	
Date and Time of review:	29/08/2018
Person carrying out inspection:	Sam Chapman
Area of excavation (A,B,C.....):	D2/E2
Depth of excavation:	8-11RL
Description of soils:	Sand <input type="checkbox"/> Mixed Sand and Clay <input checked="" type="checkbox"/> Clay <input type="checkbox"/> Other <input type="checkbox"/> If Other please describe.....
Colour of soils:	White <input type="checkbox"/> Dark Grey <input type="checkbox"/> Mottled Grey/Red/Yellow <input checked="" type="checkbox"/> Other <input type="checkbox"/> If 'Other' please describe.....
Soil strength:	Weak (excavator easily passes through) <input type="checkbox"/> Medium weak (slight resistance of material) <input checked="" type="checkbox"/> Medium strong (moderate resistance) <input type="checkbox"/> Strong (hard soils, significant resistance) <input type="checkbox"/>
Other Key Descriptors:	Red solid pleistocene clay interspersed with weak yellow sands

Photograph (or Reference):	Attached
Is verification from the Environmental Consultant required?	Yes <input checked="" type="checkbox"/> No <input type="checkbox"/>
Determination:	PASS - Treated as per ASSMP Confirmed with DP
Waste Classification Report Reference:

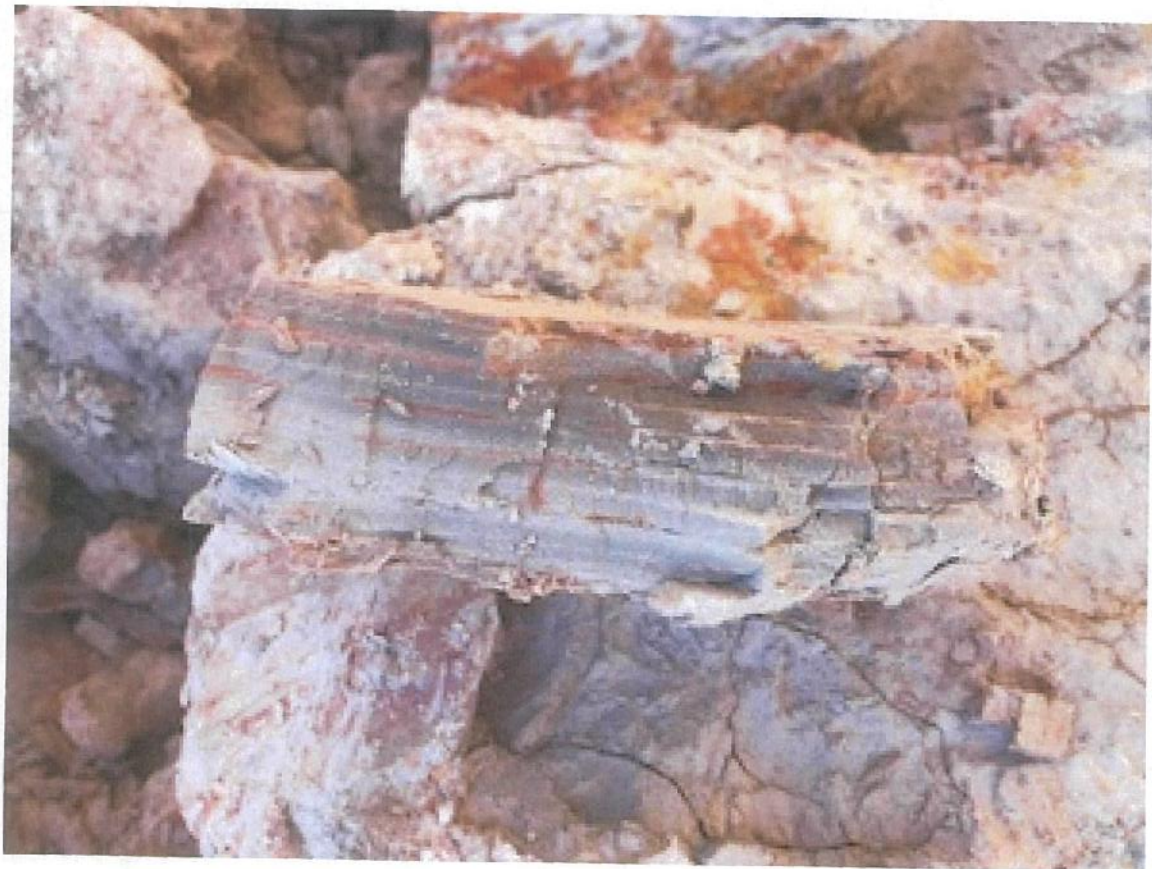
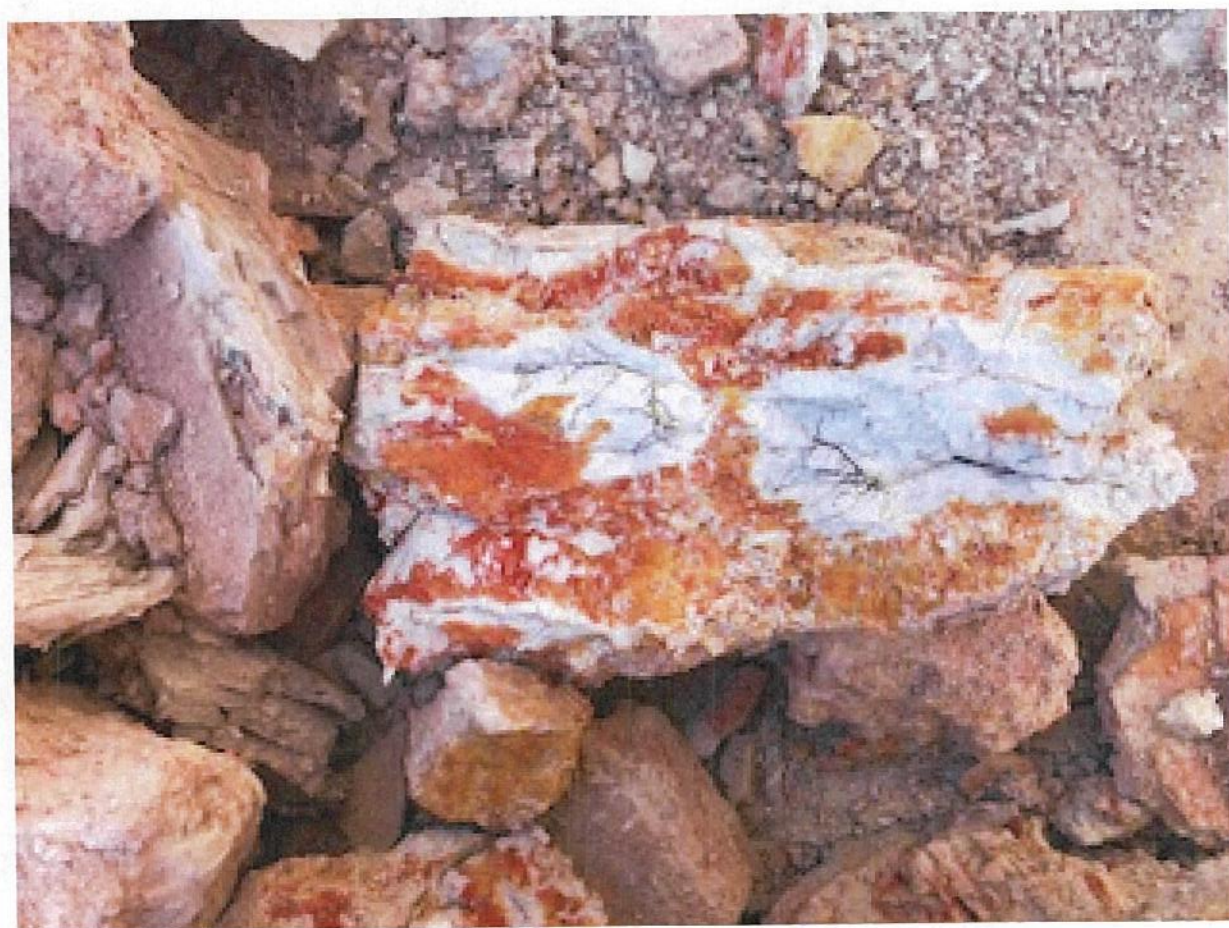
Holocene Sediment Checklist (for ASS)	
Date and Time of review:	16/08/2018
Person carrying out inspection:	Sam Chapma
Area of excavation (A,B,C.....):	C2
Depth of excavation:	80L
Description of soils:	Sand <input type="checkbox"/> Mixed Sand and Clay <input type="checkbox"/> Clay <input checked="" type="checkbox"/> Other <input type="checkbox"/> If Other please describe.....
Colour of soils:	White <input type="checkbox"/> Dark Grey <input type="checkbox"/> Mottled Grey/Red/Yellow <input checked="" type="checkbox"/> Other <input type="checkbox"/> If 'Other' please describe.....
Soil strength:	Weak (excavator easily passes through) <input type="checkbox"/> Medium weak (slight resistance of material) <input type="checkbox"/> Medium strong (moderate resistance) <input checked="" type="checkbox"/> Strong (hard soils, significant resistance) <input type="checkbox"/>
Other Key Descriptors:	
Photograph (or Reference):	Attached

Is verification from the Environmental Consultant required?	Yes <input type="checkbox"/> No <input checked="" type="checkbox"/>
Determination:	Pleistocene Clays (Non-ASS)
Waste Classification Report Reference:	85608.14.R.059
