# Arboricultural Impact Assessment

142-160 OXFORD STREET, 13 GIPPS  
STREET AND 6 SHADFORTH STREET,  
PADDINGTON  
ADENDUM  
MAY 22, 2026

Leigh Brennan  
Tree Management Strategies Pty Ltd

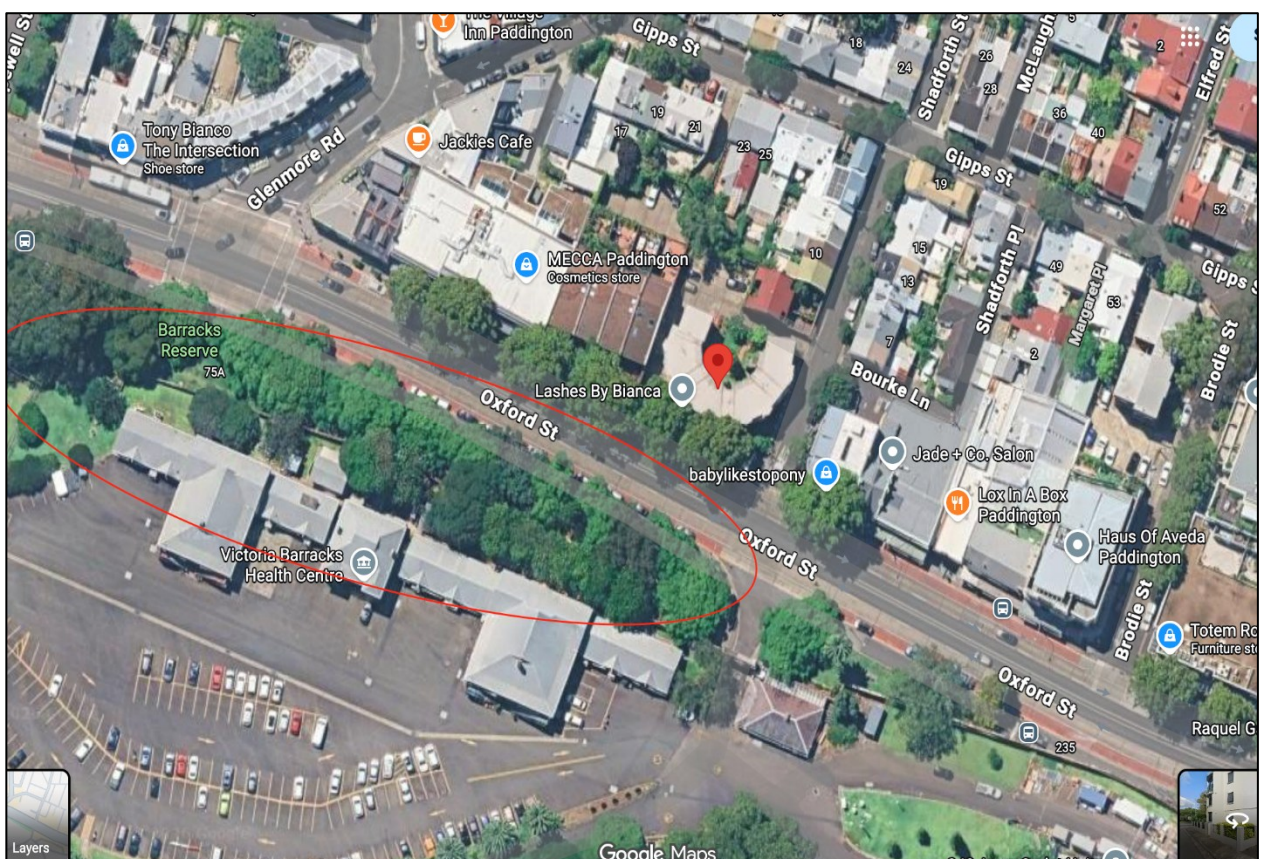
Figure 4: Trees Adjacent to the subject Site

- **Foliage & Deciduous Nature:** It is considered *semi-deciduous* to *dry-season deciduous*. In Sydney's climate, the leaves will often turn yellow and shed during the cooler late winter months before the canopy spectacularly erupts with bare branches covered in blooms. The trees opposite the subject site have the least canopy cover during July and August.

The client has requested a brief description of the trees opposite to the subject site, refer to (Figures 4 and 5).

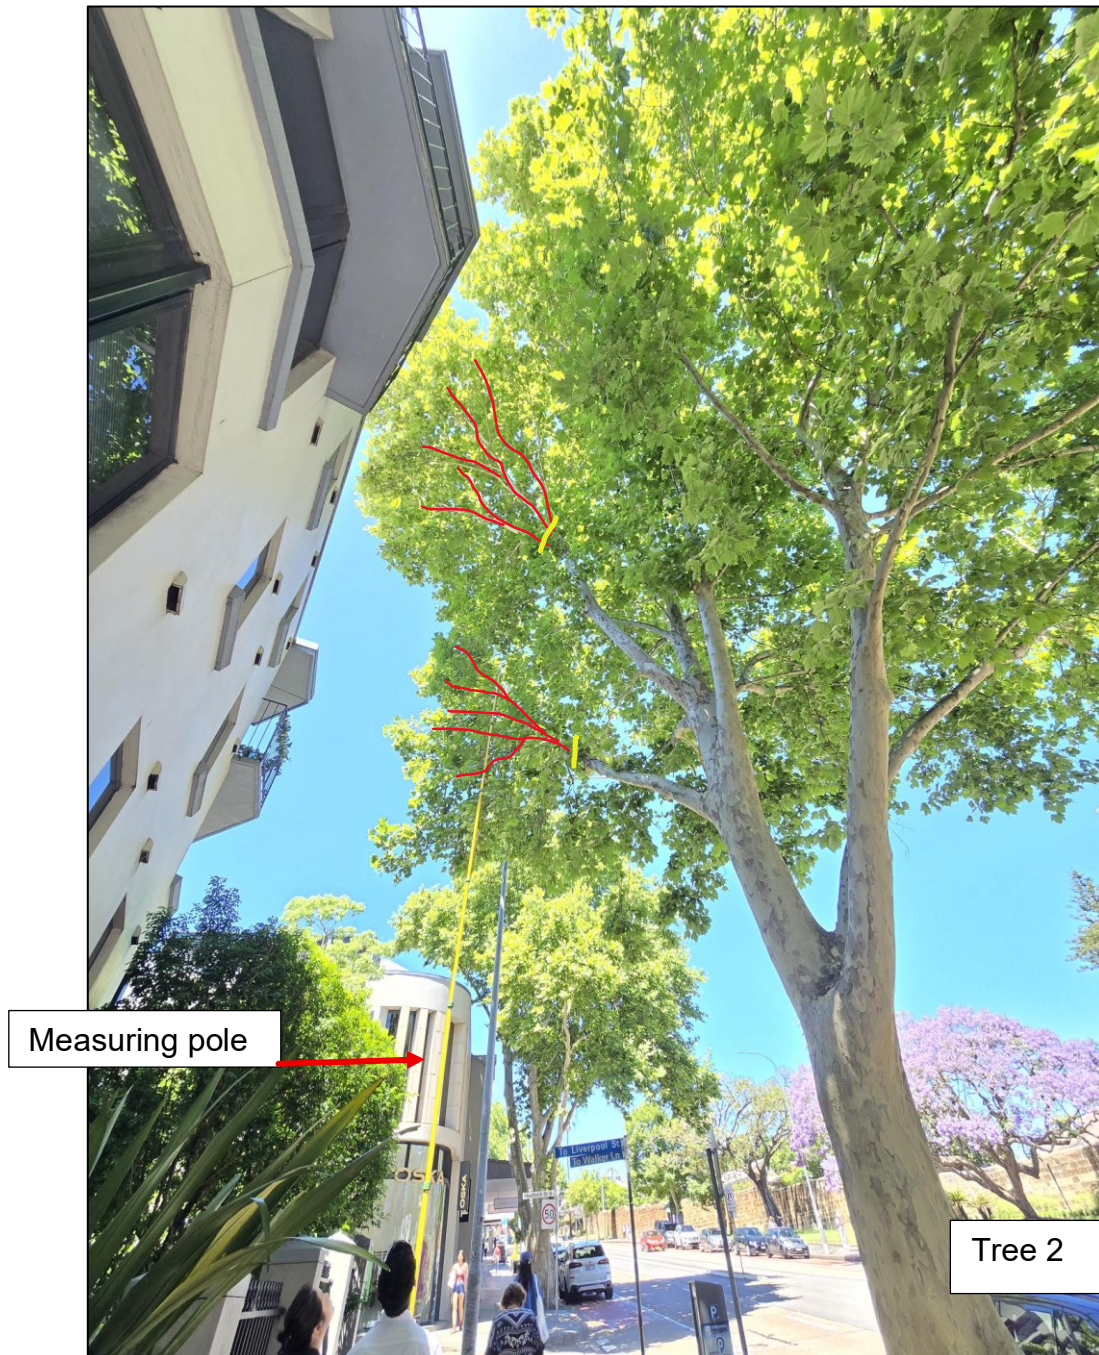
Figure 6: Tree 2

A measuring pole was used to highlight the proposed scaffold location and calculate which branches required removal. (Figure 6) depicts 1 x 60mm branches and 1 x 70mm branch that requires removal to facilitate the required scaffold. The branches requiring removal are highlighted in red with the indicative final cut location highlighted in yellow.

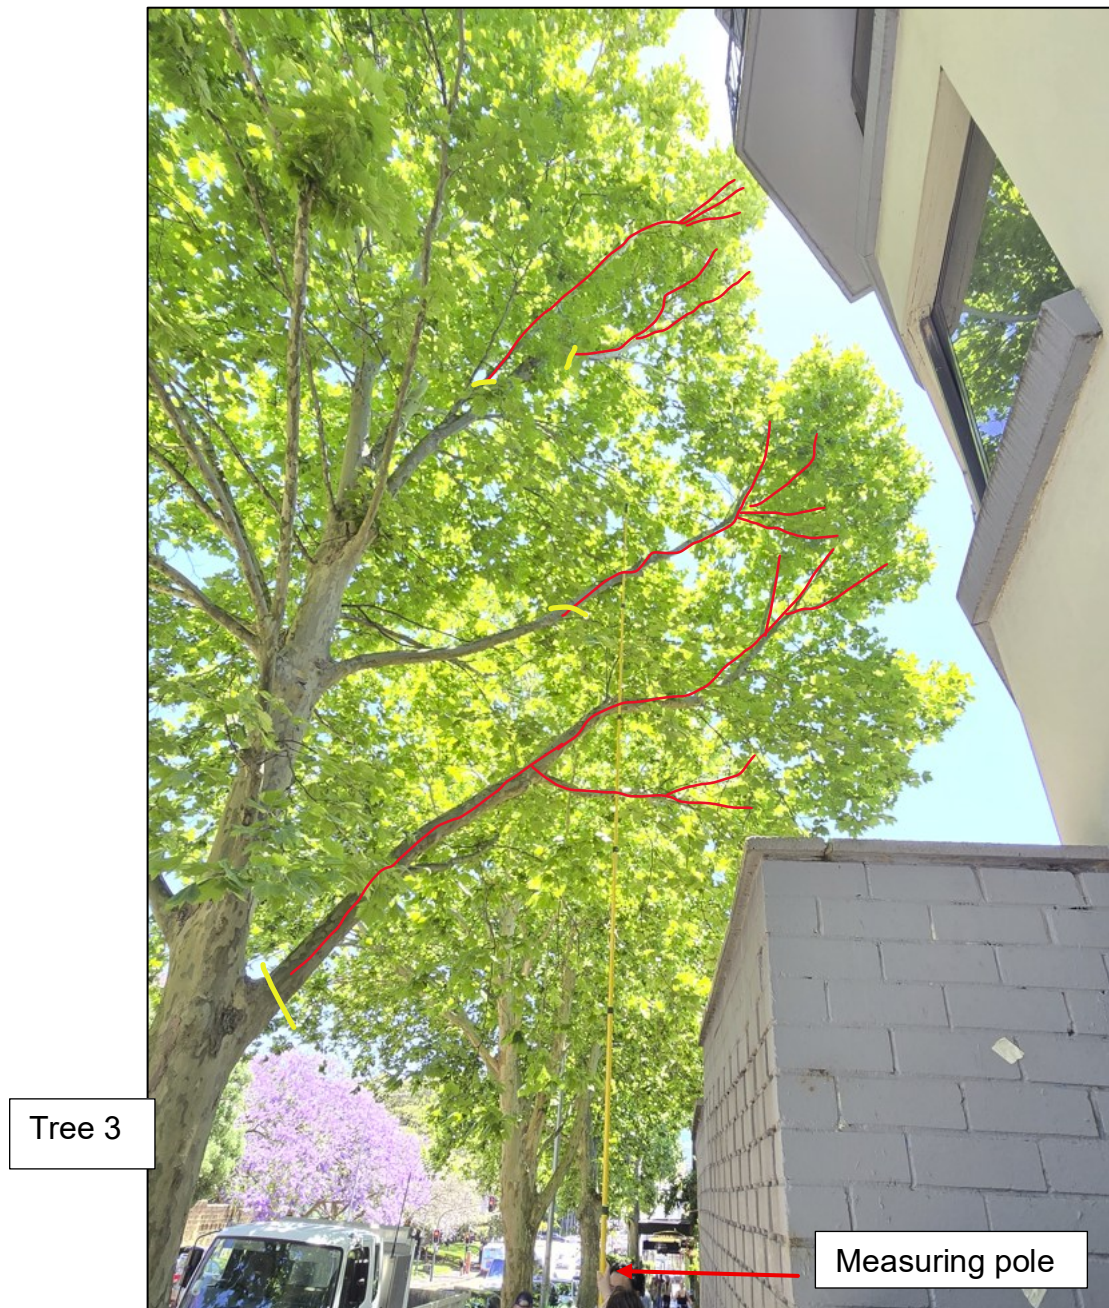
Figure 7: Tree 3

A measuring pole was used to highlight the proposed scaffold location and calculate which branches required removal. (Figure 7) depicts 3 x 60mm branches and 1 x 100mm branch that requires removal to facilitate the required scaffold. The branches requiring removal are highlighted in red, with the indicative final cut location highlighted in yellow.

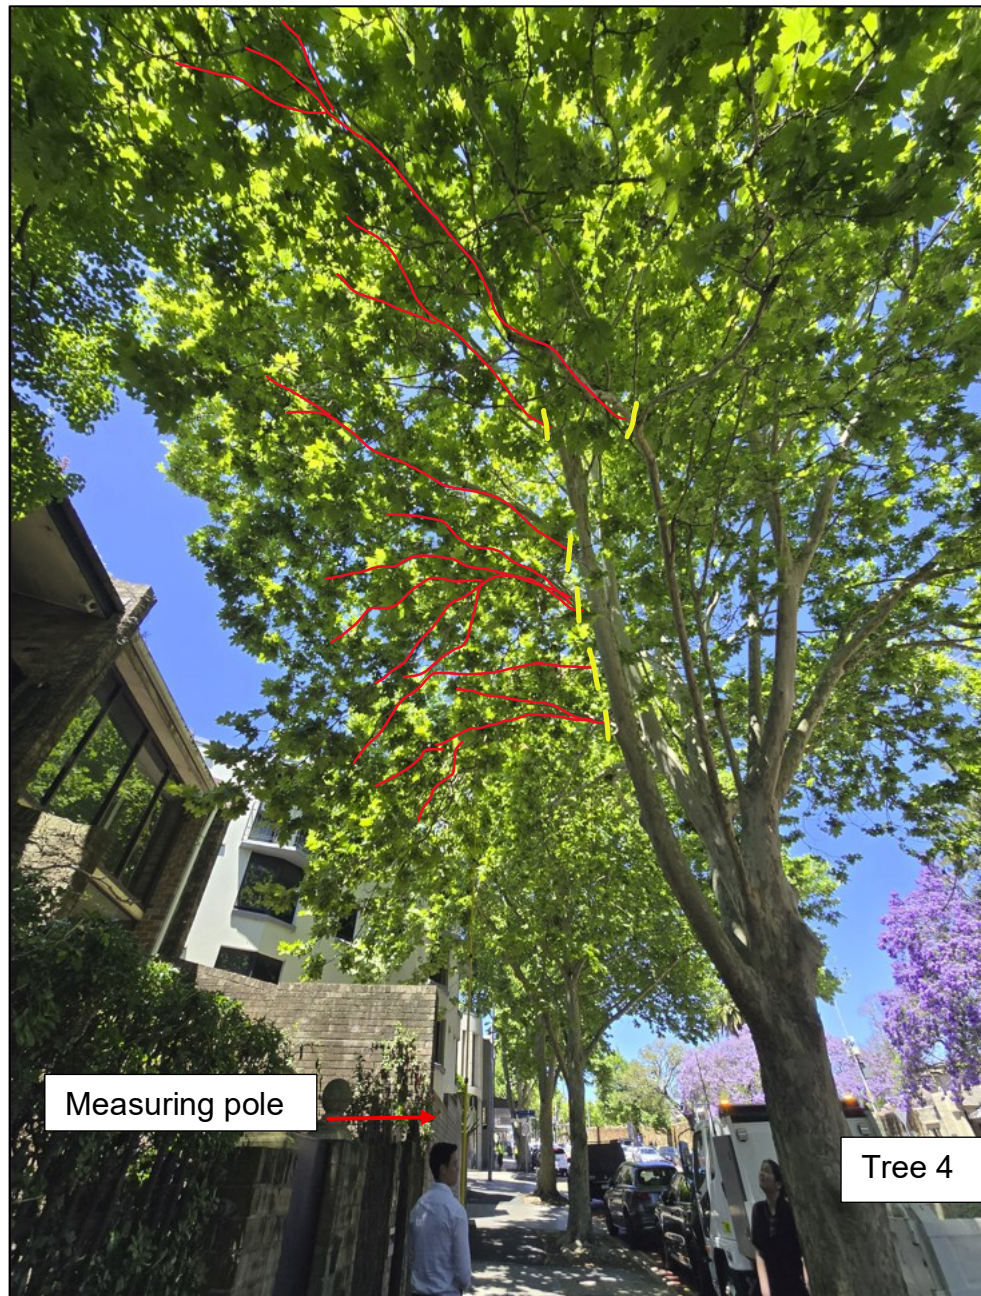
Figure 8: Tree 4

A measuring pole was used to highlight the proposed scaffold location and calculate which branches required removal. (Figure 8) depicts the 6 x 60mm branches that require removal to facilitate the required scaffold. The branches requiring removal are highlighted in red, with the indicative final cut location highlighted in yellow.

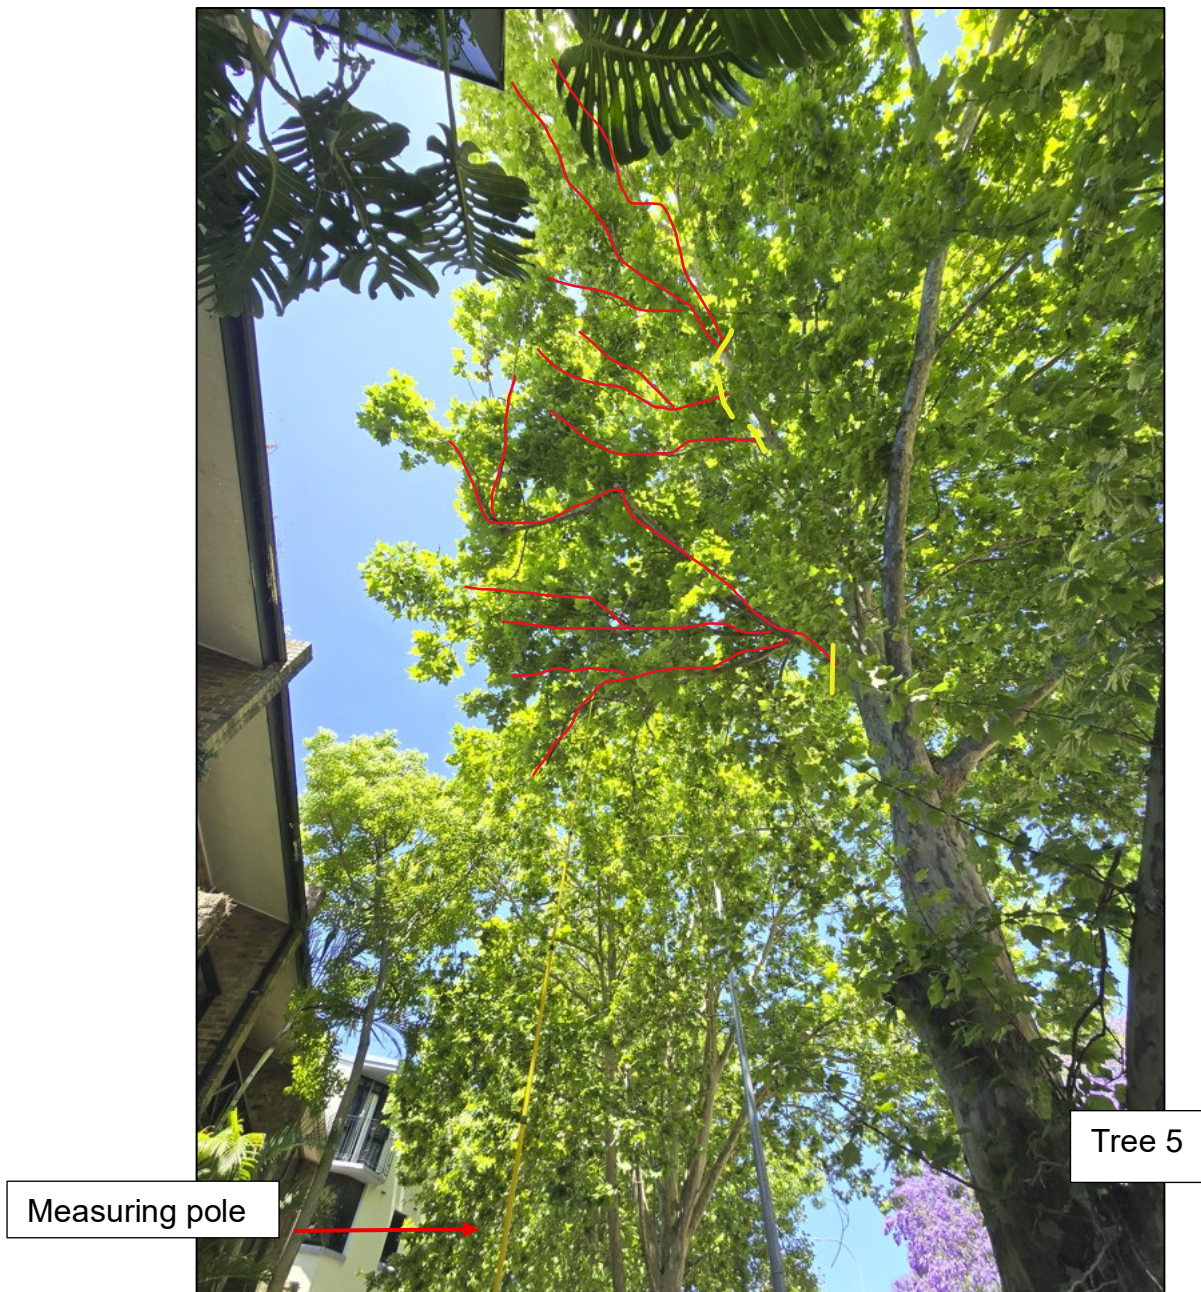
Figure 9: Tree 3

A measuring pole was used to highlight the proposed scaffold location and calculate which branches required removal. (Figure 9) depicts 2 x 50mm branches and 2 x 60mm branches that require removal to facilitate the required scaffold. The branches requiring removal are highlighted in red, with the indicative final cut location highlighted in yellow.

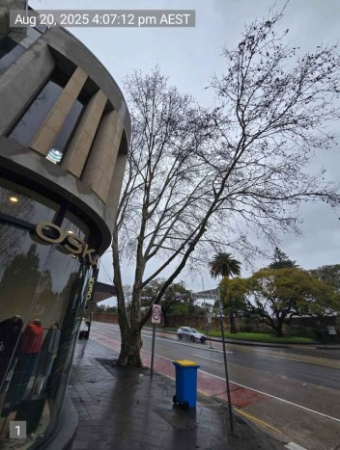
| No | Genus-species | Common Name | DAB<br>metres<br>(radius)<br>Above<br>Buttress | DSH<br>metres<br>(radius)<br>Standard<br>Ht | SRZ<br>(radius)<br>Metres | NRZ<br>(radius)<br>Metres | Height<br>Metres | Canopy<br>Spread<br>(Metres)<br>(radius) | Age<br>Young,<br>Semi-<br>Mature,<br>Mature<br>Over<br>Mature | Health<br>Good<br>Fair<br>Fair/Po<br>or Poor<br>Dead | Condition<br>Good<br>Fair<br>Fair/Poor<br>Poor<br>Failed | Useful Life<br>Expectancy<br>High<br>Medium<br>Low | Landscape<br>significance<br>High<br>Medium<br>Low | Retention<br>value<br>High<br>Medium<br>Low | Retain/Remove | Photo |
|---|---|---|---|---|---|---|---|---|---|---|---|---|---|---|---|---|
| 1 | <i>Platanus acerifolius</i> | London Plane | 1.10 | 1.00 | 3.44 | 12.00 | 16.00 | 8.00 | Mature | Fair | Fair | Medium | Medium | Medium | Retain | |

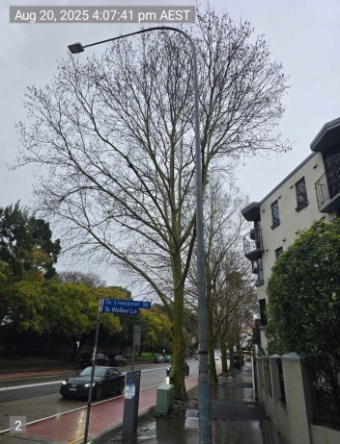
| No | Genus-species | Common Name | DAB<br>metres<br>(radius)<br>Above<br>Buttress | DSH<br>metres<br>(radius)<br>Standard<br>Ht | SRZ<br>(radius)<br>Metres | NRZ<br>(radius)<br>Metres | Height<br>Metres | Canopy<br>Spread<br>(Metres)<br>(radius) | Age<br>Young,<br>Semi-<br>Mature,<br>Mature<br>Over<br>Mature | Health<br>Good<br>Fair<br>Fair/Po<br>or Poor<br>Dead | Condition<br>Good<br>Fair<br>Fair/Poor<br>Poor<br>Failed | Useful Life<br>Expectancy<br>High<br>Medium<br>Low | Landscape<br>significance<br>High<br>Medium<br>Low | Retention<br>value<br>High<br>Medium<br>Low | Retain/Remove | Photo |
|---|---|---|---|---|---|---|---|---|---|---|---|---|---|---|---|---|
| 2 | <i>Platanus acerifolius</i> | London Plane | 0.70 | 0.55 | 2.85 | 6.60 | 16.00 | 8.00 | Mature | Fair | Fair | Medium | Medium | Medium | Retain | |

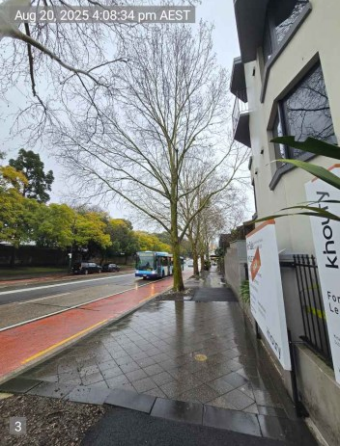
| No | Genus-species | Common Name | DAB<br>metres<br>(radius)<br>Above<br>Buttress | DSH<br>metres<br>(radius)<br>Standard<br>Ht | SRZ<br>(radius)<br>Metres | NRZ<br>(radius)<br>Metres | Height<br>Metres | Canopy<br>Spread<br>(Metres)<br>(radius) | Age<br>Young,<br>Semi-<br>Mature,<br>Mature<br>Over<br>Mature | Health<br>Good<br>Fair<br>Fair/Po<br>or Poor<br>Dead | Condition<br>Good<br>Fair<br>Fair/Poor<br>Poor<br>Failed | Useful Life<br>Expectancy<br>High<br>Medium<br>Low | Landscape<br>significance<br>High<br>Medium<br>Low | Retention<br>value<br>High<br>Medium<br>Low | Retain/Remove | Photo |
|---|---|---|---|---|---|---|---|---|---|---|---|---|---|---|---|---|
| 3 | <i>Platanus acerifolius</i> | London Plane | 0.65 | 0.50 | 2.76 | 6.00 | 16.00 | 6.00 | Mature | Fair | Fair | Medium | Medium | Medium | Retain | |

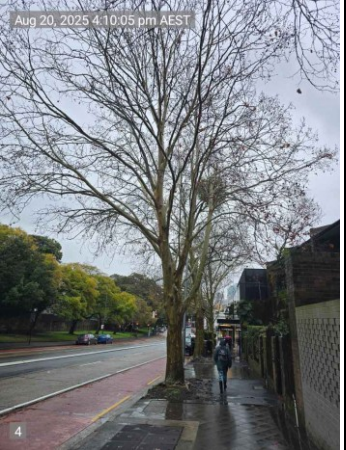
| No | Genus-species | Common Name | DAB<br>metres<br>(radius)<br><i>Above<br/>Buttress</i> | DSH<br>metres<br>(radius)<br><i>Standard<br/>Ht</i> | SRZ<br>(radius)<br><i>Metres</i> | NRZ<br>(radius)<br><i>Metres</i> | Height<br><i>Metres</i> | Canopy<br>Spread<br>(Metres)<br>(radius) | Age<br><i>Young,<br/>Semi-<br/>Mature,<br/>Mature<br/>Over<br/>Mature</i> | Health<br><i>Good<br/>Fair<br/>Fair/Po<br/>or Poor<br/>Dead</i> | Condition<br><i>Good<br/>Fair<br/>Fair/Poor<br/>Poor<br/>Failed</i> | Useful Life<br>Expectancy<br><i>High<br/>Medium<br/>Low</i> | Landscape<br>significance<br><i>High<br/>Medium<br/>Low</i> | Retention<br>value<br><i>High<br/>Medium<br/>Low</i> | Retain/ <i>Remove</i> | Photo |
|---|---|---|---|---|---|---|---|---|---|---|---|---|---|---|---|---|
| 4 | <i>Platanus acerifolius</i> | London Plane | 0.70 | 0.55 | 2.85 | 6.60 | 16.00 | 6.00 | Mature | Fair | Fair | Medium | Medium | Medium | Retain | |

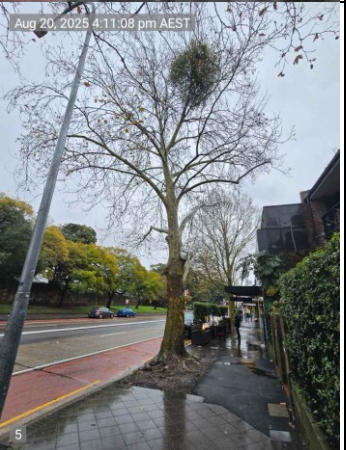
| No | Genus-species | Common Name | DAB<br>metres<br>(radius)<br><i>Above<br/>Buttress</i> | DSH<br>metres<br>(radius)<br><i>Standard<br/>Ht</i> | SRZ<br>(radius)<br><i>Metres</i> | NRZ<br>(radius)<br><i>Metres</i> | Height<br><i>Metres</i> | Canopy<br>Spread<br>(Metres)<br>(radius) | Age<br><i>Young,<br/>Semi-<br/>Mature,<br/>Mature<br/>Over<br/>Mature</i> | Health<br><i>Good<br/>Fair<br/>Fair/Po<br/>or Poor<br/>Dead</i> | Condition<br><i>Good<br/>Fair<br/>Fair/Poor<br/>Poor<br/>Failed</i> | Useful Life<br>Expectancy<br><i>High<br/>Medium<br/>Low</i> | Landscape<br>significance<br><i>High<br/>Medium<br/>Low</i> | Retention<br>value<br><i>High<br/>Medium<br/>Low</i> | Retain/ <i>Remove</i> | Photo |
|---|---|---|---|---|---|---|---|---|---|---|---|---|---|---|---|---|
| 5 | <i>Platanus acerifolius</i> | London Plane | 0.78 | 0.66 | 2.98 | 7.92 | 16.00 | 8.00 | Mature | Fair | Fair | Medium | Medium | Medium | Retain | |

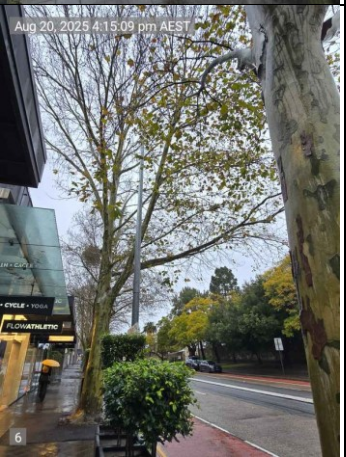
| No | Genus-species | Common Name | DAB<br>metres<br>(radius)<br><i>Above<br/>Buttress</i> | DSH<br>metres<br>(radius)<br><i>Standard<br/>Ht</i> | SRZ<br>(radius)<br><i>Metres</i> | NRZ<br>(radius)<br><i>Metres</i> | Height<br><i>Metres</i> | Canopy<br>Spread<br>(Metres)<br>(radius) | Age<br><i>Young,<br/>Semi-<br/>Mature,<br/>Mature<br/>Over<br/>Mature</i> | Health<br><i>Good<br/>Fair<br/>Fair/Po<br/>or Poor<br/>Dead</i> | Condition<br><i>Good<br/>Fair<br/>Fair/Poor<br/>Poor<br/>Failed</i> | Useful Life<br>Expectancy<br><i>High<br/>Medium<br/>Low</i> | Landscape<br>significance<br><i>High<br/>Medium<br/>Low</i> | Retention<br>value<br><i>High<br/>Medium<br/>Low</i> | Retain/ <i>Remove</i> | Photo |
|---|---|---|---|---|---|---|---|---|---|---|---|---|---|---|---|---|
| 6 | <i>Platanus acerifolius</i> | London Plane | 0.65 | 0.58 | 2.76 | 6.96 | 16.00 | 10.00 | Mature | Fair | Fair | Medium | Medium | Medium | Retain | |

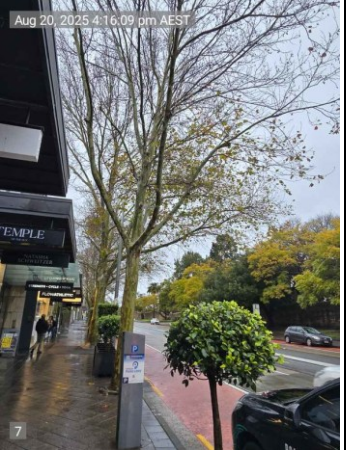
| No | Genus-species | Common Name | DAB<br>metres<br>(radius)<br><i>Above<br/>Buttress</i> | DSH<br>metres<br>(radius)<br><i>Standard<br/>Ht</i> | SRZ<br>(radius)<br><i>Metres</i> | NRZ<br>(radius)<br><i>Metres</i> | Height<br><i>Metres</i> | Canopy<br>Spread<br>(Metres)<br>(radius) | Age<br><i>Young,<br/>Semi-<br/>Mature,<br/>Mature<br/>Over<br/>Mature</i> | Health<br><i>Good<br/>Fair<br/>Fair/Po<br/>or Poor<br/>Dead</i> | Condition<br><i>Good<br/>Fair<br/>Fair/Poor<br/>Poor<br/>Failed</i> | Useful Life<br>Expectancy<br><i>High<br/>Medium<br/>Low</i> | Landscape<br>significance<br><i>High<br/>Medium<br/>Low</i> | Retention<br>value<br><i>High<br/>Medium<br/>Low</i> | Retain/ <i>Remove</i> | Photo |
|---|---|---|---|---|---|---|---|---|---|---|---|---|---|---|---|---|
| 7 | <i>Platanus acerifolius</i> | London Plane | 0.40 | 0.33 | 2.25 | 3.96 | 16.00 | 6.00 | Mature | Fair | Fair | Medium | Medium | Medium | Retain | |

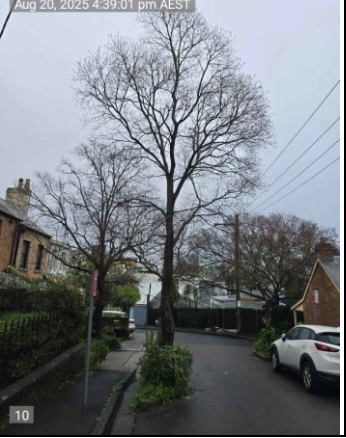
| No | Genus-species | Common Name | DAB<br>metres<br>(radius)<br><i>Above<br/>Buttress</i> | DSH<br>metres<br>(radius)<br><i>Standard<br/>Ht</i> | SRZ<br>(radius)<br><i>Metres</i> | NRZ<br>(radius)<br><i>Metres</i> | Height<br><i>Metres</i> | Canopy<br>Spread<br>(Metres)<br>(radius) | Age<br><i>Young,<br/>Semi-<br/>Mature,<br/>Mature<br/>Over<br/>Mature</i> | Health<br><i>Good<br/>Fair<br/>Fair/Po<br/>or Poor<br/>Dead</i> | Condition<br><i>Good<br/>Fair<br/>Fair/Poor<br/>Poor<br/>Failed</i> | Useful Life<br>Expectancy<br><i>High<br/>Medium<br/>Low</i> | Landscape<br>significance<br><i>High<br/>Medium<br/>Low</i> | Retention<br>value<br><i>High<br/>Medium<br/>Low</i> | Retain/ <i>Remove</i> | Photo |
|---|---|---|---|---|---|---|---|---|---|---|---|---|---|---|---|---|
| 9 | <i>Sapium sebiferum</i> | Chinese Tallow Tree | 0.25 | 0.28 | 1.85 | 3.36 | 10.00 | 2.00 | Mature | Fair | Fair | Medium | Medium | Medium | Retain | |

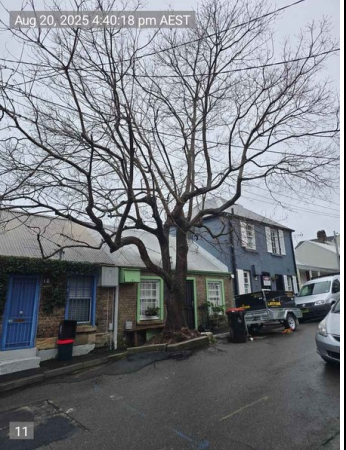
| No | Genus-species | Common Name | DAB<br>metres<br>(radius)<br><i>Above<br/>Buttress</i> | DSH<br>metres<br>(radius)<br><i>Standard<br/>Ht</i> | SRZ<br>(radius)<br><i>Metres</i> | NRZ<br>(radius)<br><i>Metres</i> | Height<br><i>Metres</i> | Canopy<br>Spread<br>(Metres)<br>(radius) | Age<br><i>Young,<br/>Semi-<br/>Mature,<br/>Mature<br/>Over<br/>Mature</i> | Health<br><i>Good<br/>Fair<br/>Fair/Po<br/>or Poor<br/>Dead</i> | Condition<br><i>Good<br/>Fair<br/>Fair/Poor<br/>Poor<br/>Failed</i> | Useful Life<br>Expectancy<br><i>High<br/>Medium<br/>Low</i> | Landscape<br>significance<br><i>High<br/>Medium<br/>Low</i> | Retention<br>value<br><i>High<br/>Medium<br/>Low</i> | Retain/ <i>Remove</i> | Photo |
|---|---|---|---|---|---|---|---|---|---|---|---|---|---|---|---|---|
| 10 | <i>Sapium sebiferum</i> | Chinese Tallow Tree | 0.47 | 0.55 | 2.41 | 6.60 | 14.00 | 4.00 | Mature | Fair | Fair | Medium | Medium | Medium | Retain | |

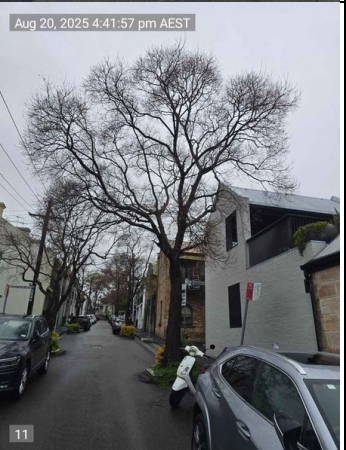
| No | Genus-species | Common Name | DAB<br>metres<br>(radius)<br><i>Above<br/>Buttress</i> | DSH<br>metres<br>(radius)<br><i>Standard<br/>Ht</i> | SRZ<br>(radius)<br><i>Metres</i> | NRZ<br>(radius)<br><i>Metres</i> | Height<br><i>Metres</i> | Canopy<br>Spread<br>(Metres)<br>(radius) | Age<br><i>Young,<br/>Semi-<br/>Mature,<br/>Mature<br/>Over<br/>Mature</i> | Health<br><i>Good<br/>Fair<br/>Fair/Po<br/>or Poor<br/>Dead</i> | Condition<br><i>Good<br/>Fair<br/>Fair/Poor<br/>Poor<br/>Failed</i> | Useful Life<br>Expectancy<br><i>High<br/>Medium<br/>Low</i> | Landscape<br>significance<br><i>High<br/>Medium<br/>Low</i> | Retention<br>value<br><i>High<br/>Medium<br/>Low</i> | Retain/ <i>Remove</i> | Photo |
|---|---|---|---|---|---|---|---|---|---|---|---|---|---|---|---|---|
| 11 | <i>Sapium sebiferum</i> | Chinese Tallow Tree | 0.55 | 0.37 | 2.57 | 4.44 | 12.00 | 3.00 | Mature | Fair | Fair | Medium | Medium | Medium | Retain | |

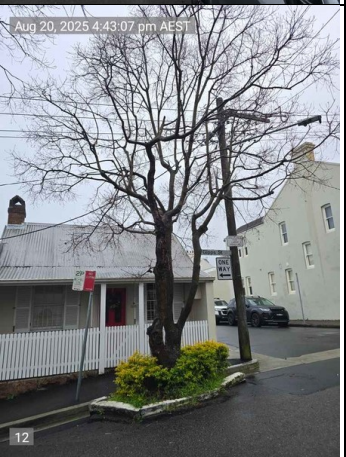
| No | Genus-species | Common Name | DAB<br>metres<br>(radius)<br><i>Above<br/>Buttress</i> | DSH<br>metres<br>(radius)<br><i>Standard<br/>Ht</i> | SRZ<br>(radius)<br><i>Metres</i> | NRZ<br>(radius)<br><i>Metres</i> | Height<br><i>Metres</i> | Canopy<br>Spread<br>(Metres)<br>(radius) | Age<br><i>Young,<br/>Semi-<br/>Mature,<br/>Mature<br/>Over<br/>Mature</i> | Health<br><i>Good<br/>Fair<br/>Fair/Po<br/>or Poor<br/>Dead</i> | Condition<br><i>Good<br/>Fair<br/>Fair/Poor<br/>Poor<br/>Failed</i> | Useful Life<br>Expectancy<br><i>High<br/>Medium<br/>Low</i> | Landscape<br>significance<br><i>High<br/>Medium<br/>Low</i> | Retention<br>value<br><i>High<br/>Medium<br/>Low</i> | Retain/ <i>Remove</i> | Photo |
|---|---|---|---|---|---|---|---|---|---|---|---|---|---|---|---|---|
| 12 | <i>Sapium sebiferum</i> | Chinese Tallow Tree | 0.40 | 0.35 | 2.25 | 4.20 | 8.00 | 3.00 | Mature | Fair | Fair | Medium | Medium | Medium | Retain | |

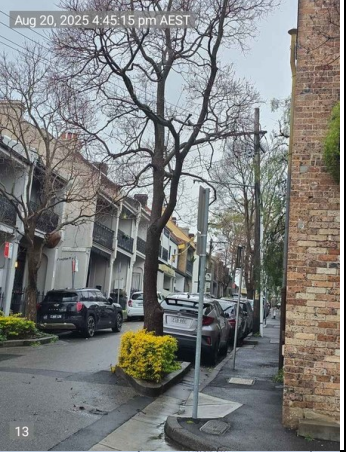
| No | Genus-species | Common Name | DAB<br>metres<br>(radius)<br><i>Above<br/>Buttress</i> | DSH<br>metres<br>(radius)<br><i>Standard<br/>Ht</i> | SRZ<br>(radius)<br><i>Metres</i> | NRZ<br>(radius)<br><i>Metres</i> | Height<br><i>Metres</i> | Canopy<br>Spread<br>(Metres)<br>(radius) | Age<br><i>Young,<br/>Semi-<br/>Mature,<br/>Mature<br/>Over<br/>Mature</i> | Health<br><i>Good<br/>Fair<br/>Fair/Po<br/>or Poor<br/>Dead</i> | Condition<br><i>Good<br/>Fair<br/>Fair/Poor<br/>Poor<br/>Failed</i> | Useful Life<br>Expectancy<br><i>High<br/>Medium<br/>Low</i> | Landscape<br>significance<br><i>High<br/>Medium<br/>Low</i> | Retention<br>value<br><i>High<br/>Medium<br/>Low</i> | Retain/ <i>Remove</i> | Photo |
|---|---|---|---|---|---|---|---|---|---|---|---|---|---|---|---|---|
| 13 | <i>Sapium sebiferum</i> | Chinese Tallow Tree | 0.35 | 0.26 | 2.13 | 3.12 | 12.00 | 3.00 | Mature | Fair | Fair | Medium | Medium | Medium | Retain | |

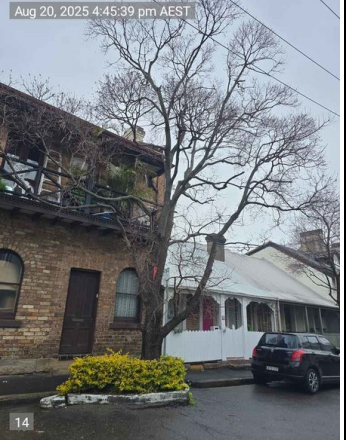
| No | Genus-species | Common Name | DAB<br>metres<br>(radius)<br><i>Above<br/>Buttress</i> | DSH<br>metres<br>(radius)<br><i>Standard<br/>Ht</i> | SRZ<br>(radius)<br><i>Metres</i> | NRZ<br>(radius)<br><i>Metres</i> | Height<br><i>Metres</i> | Canopy<br>Spread<br>(Metres)<br>(radius) | Age<br><i>Young,<br/>Semi-<br/>Mature,<br/>Mature<br/>Over<br/>Mature</i> | Health<br><i>Good<br/>Fair<br/>Fair/Po<br/>or Poor<br/>Dead</i> | Condition<br><i>Good<br/>Fair<br/>Fair/Poor<br/>Poor<br/>Failed</i> | Useful Life<br>Expectancy<br><i>High<br/>Medium<br/>Low</i> | Landscape<br>significance<br><i>High<br/>Medium<br/>Low</i> | Retention<br>value<br><i>High<br/>Medium<br/>Low</i> | Retain/ <i>Remove</i> | Photo |
|---|---|---|---|---|---|---|---|---|---|---|---|---|---|---|---|---|
| 14 | <i>Sapium sebiferum</i> | Chinese Tallow Tree | 0.45 | 0.37 | 2.37 | 4.44 | 12.00 | 3.00 | Mature | Fair | Fair | Medium | Medium | Medium | Retain | |

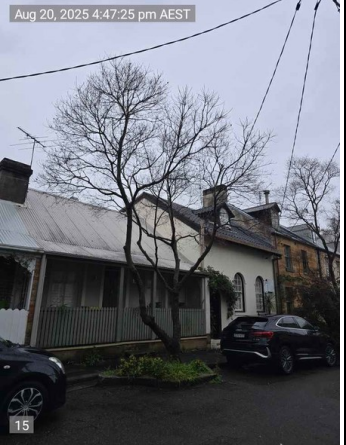
| No | Genus-species | Common Name | DAB<br>metres<br>(radius)<br><i>Above<br/>Buttress</i> | DSH<br>metres<br>(radius)<br><i>Standard<br/>Ht</i> | SRZ<br>(radius)<br><i>Metres</i> | NRZ<br>(radius)<br><i>Metres</i> | Height<br><i>Metres</i> | Canopy<br>Spread<br>(Metres)<br>(radius) | Age<br><i>Young,<br/>Semi-<br/>Mature,<br/>Mature<br/>Over<br/>Mature</i> | Health<br><i>Good<br/>Fair<br/>Fair/Po<br/>or Poor<br/>Dead</i> | Condition<br><i>Good<br/>Fair<br/>Fair/Poor<br/>Poor<br/>Failed</i> | Useful Life<br>Expectancy<br><i>High<br/>Medium<br/>Low</i> | Landscape<br>significance<br><i>High<br/>Medium<br/>Low</i> | Retention<br>value<br><i>High<br/>Medium<br/>Low</i> | Retain/ <i>Remove</i> | Photo |
|---|---|---|---|---|---|---|---|---|---|---|---|---|---|---|---|---|
| 15 | <i>Sapium sebiferum</i> | Chinese Tallow Tree | 0.34 | 0.30 | 2.10 | 3.60 | 8.00 | 2.00 | Mature | Fair | Fair | Medium | Medium | Medium | Retain | |

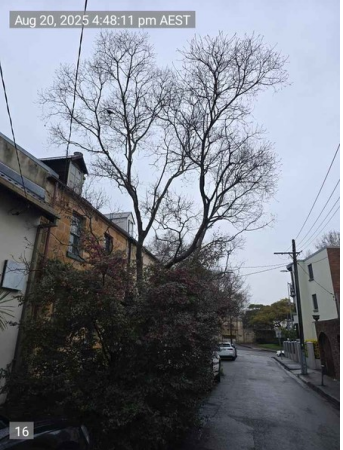
| No | Genus-species | Common Name | DAB<br>metres<br>(radius)<br><i>Above<br/>Buttress</i> | DSH<br>metres<br>(radius)<br><i>Standard<br/>Ht</i> | SRZ<br>(radius)<br><i>Metres</i> | NRZ<br>(radius)<br><i>Metres</i> | Height<br><i>Metres</i> | Canopy<br>Spread<br>(Metres)<br>(radius) | Age<br><i>Young,<br/>Semi-<br/>Mature,<br/>Mature<br/>Over<br/>Mature</i> | Health<br><i>Good<br/>Fair<br/>Fair/Po<br/>or Poor<br/>Dead</i> | Condition<br><i>Good<br/>Fair<br/>Fair/Poor<br/>Poor<br/>Failed</i> | Useful Life<br>Expectancy<br><i>High<br/>Medium<br/>Low</i> | Landscape<br>significance<br><i>High<br/>Medium<br/>Low</i> | Retention<br>value<br><i>High<br/>Medium<br/>Low</i> | Retain/ <i>Remove</i> | Photo |
|---|---|---|---|---|---|---|---|---|---|---|---|---|---|---|---|---|
| 16 | <i>Sapium sebiferum</i> | Chinese Tallow Tree | 0.40 | 0.30 | 2.25 | 3.60 | 10.00 | 2.00 | Mature | Fair | Fair | Medium | Medium | Medium | Retain | |

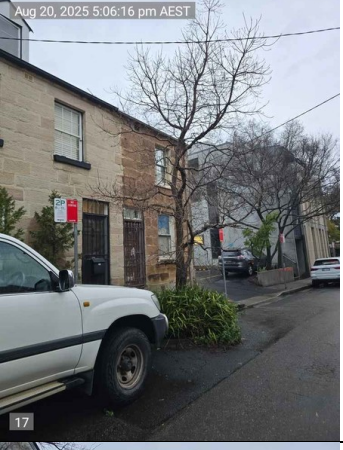
| No | Genus-species | Common Name | DAB<br>metres<br>(radius)<br><i>Above<br/>Buttress</i> | DSH<br>metres<br>(radius)<br><i>Standard<br/>Ht</i> | SRZ<br>(radius)<br><i>Metres</i> | NRZ<br>(radius)<br><i>Metres</i> | Height<br><i>Metres</i> | Canopy<br>Spread<br>(Metres)<br>(radius) | Age<br><i>Young,<br/>Semi-<br/>Mature,<br/>Mature<br/>Over<br/>Mature</i> | Health<br><i>Good<br/>Fair<br/>Fair/Po<br/>or Poor<br/>Dead</i> | Condition<br><i>Good<br/>Fair<br/>Fair/Poor<br/>Poor<br/>Failed</i> | Useful Life<br>Expectancy<br><i>High<br/>Medium<br/>Low</i> | Landscape<br>significance<br><i>High<br/>Medium<br/>Low</i> | Retention<br>value<br><i>High<br/>Medium<br/>Low</i> | Retain/ <i>Remove</i> | Photo |
|---|---|---|---|---|---|---|---|---|---|---|---|---|---|---|---|---|
| 17 | <i>Sapium sebiferum</i> | Chinese Tallow Tree | 0.25 | 0.20 | 1.85 | 2.40 | 10.00 | 2.00 | Semi<br>Mature | Fair | Fair | Medium | Medium | Medium | Retain | |

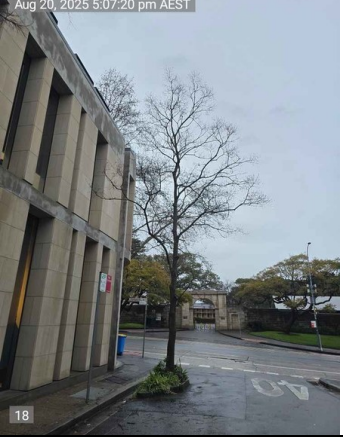
| No | Genus-species | Common Name | DAB<br>metres<br>(radius)<br><i>Above<br/>Buttress</i> | DSH<br>metres<br>(radius)<br><i>Standard<br/>Ht</i> | SRZ<br>(radius)<br><i>Metres</i> | NRZ<br>(radius)<br><i>Metres</i> | Height<br><i>Metres</i> | Canopy<br>Spread<br>(Metres)<br>(radius) | Age<br><i>Young,<br/>Semi-<br/>Mature,<br/>Mature<br/>Over<br/>Mature</i> | Health<br><i>Good<br/>Fair<br/>Fair/Po<br/>or Poor<br/>Dead</i> | Condition<br><i>Good<br/>Fair<br/>Fair/Poor<br/>Poor<br/>Failed</i> | Useful Life<br>Expectancy<br><i>High<br/>Medium<br/>Low</i> | Landscape<br>significance<br><i>High<br/>Medium<br/>Low</i> | Retention<br>value<br><i>High<br/>Medium<br/>Low</i> | Retain/ <i>Remove</i> | Photo |
|---|---|---|---|---|---|---|---|---|---|---|---|---|---|---|---|---|
| 18 | <i>Sapium sebiferum</i> | Chinese Tallow Tree | 0.35 | 0.26 | 2.13 | 3.12 | 12.00 | 2.00 | Mature | Fair | Fair | Medium | Medium | Medium | Remove | |

Following completion of construction activities, Tree 18 will be replaced with a new advanced replacement tree in the same location. Species selection, stock size, and installation methodology are to be undertaken in accordance with relevant Australian Standards.

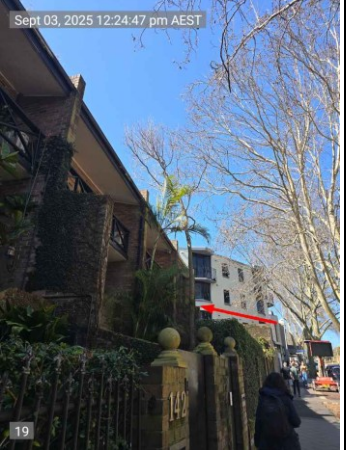
| No | Genus-species | Common Name | DAB<br>metres<br>(radius)<br><i>Above<br/>Buttress</i> | DSH<br>metres<br>(radius)<br><i>Standard<br/>Ht</i> | SRZ<br>(radius)<br><i>Metres</i> | NRZ<br>(radius)<br><i>Metres</i> | Height<br><i>Metres</i> | Canopy<br>Spread<br>(Metres)<br>(radius) | Age<br><i>Young,<br/>Semi-<br/>Mature,<br/>Mature<br/>Over<br/>Mature</i> | Health<br><i>Good<br/>Fair<br/>Fair/Po<br/>or Poor<br/>Dead</i> | Condition<br><i>Good<br/>Fair<br/>Fair/Poor<br/>Poor<br/>Failed</i> | Useful Life<br>Expectancy<br><i>High<br/>Medium<br/>Low</i> | Landscape<br>significance<br><i>High<br/>Medium<br/>Low</i> | Retention<br>value<br><i>High<br/>Medium<br/>Low</i> | Retain/ <i>Remove</i> | Photo |
|---|---|---|---|---|---|---|---|---|---|---|---|---|---|---|---|---|
| 19 | <i>Sapium sebiferum</i> | Chinese Tallow Tree | 0.22 | 0.18 | 1.75 | 2.16 | 8.00 | 1.00 | Semi<br>Mature | Fair | Fair | Medium | Low | Low | Remove | |

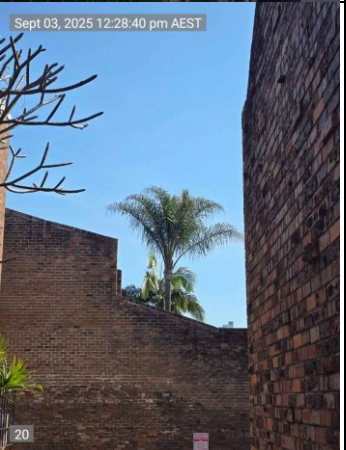
| No | Genus-species | Common Name | DAB<br>metres<br>(radius)<br><i>Above<br/>Buttress</i> | DSH<br>metres<br>(radius)<br><i>Standard<br/>Ht</i> | SRZ<br>(radius)<br><i>Metres</i> | NRZ<br>(radius)<br><i>Metres</i> | Height<br><i>Metres</i> | Canopy<br>Spread<br>(Metres)<br>(radius) | Age<br><i>Young,<br/>Semi-<br/>Mature,<br/>Mature<br/>Over<br/>Mature</i> | Health<br><i>Good<br/>Fair<br/>Fair/Po<br/>or Poor<br/>Dead</i> | Condition<br><i>Good<br/>Fair<br/>Fair/Poor<br/>Poor<br/>Failed</i> | Useful Life<br>Expectancy<br><i>High<br/>Medium<br/>Low</i> | Landscape<br>significance<br><i>High<br/>Medium<br/>Low</i> | Retention<br>value<br><i>High<br/>Medium<br/>Low</i> | Retain/ <i>Remove</i> | Photo |
|---|---|---|---|---|---|---|---|---|---|---|---|---|---|---|---|---|
| 20 | <i>Syagrus romanzoffiana</i> | Cocos Palm | 0.20 | 0.30 | 1.68 | 3.60 | 14.00 | 1.00 | Mature | Fair | Fair | Medium | Low | Low | Remove | |

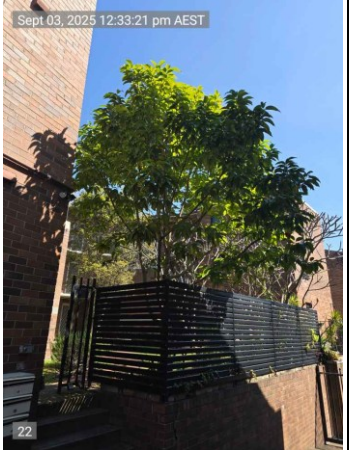
| No | Genus-species | Common Name | DAB<br>metres<br>(radius)<br><i>Above<br/>Buttress</i> | DSH<br>metres<br>(radius)<br><i>Standard<br/>Ht</i> | SRZ<br>(radius)<br><i>Metres</i> | NRZ<br>(radius)<br><i>Metres</i> | Height<br><i>Metres</i> | Canopy<br>Spread<br>(Metres)<br>(radius) | Age<br><i>Young,<br/>Semi-<br/>Mature,<br/>Mature<br/>Over<br/>Mature</i> | Health<br><i>Good<br/>Fair<br/>Fair/Po<br/>or Poor<br/>Dead</i> | Condition<br><i>Good<br/>Fair<br/>Fair/Poor<br/>Poor<br/>Failed</i> | Useful Life<br>Expectancy<br><i>High<br/>Medium<br/>Low</i> | Landscape<br>significance<br><i>High<br/>Medium<br/>Low</i> | Retention<br>value<br><i>High<br/>Medium<br/>Low</i> | Retain/ <i>Remove</i> | Photo |
|---|---|---|---|---|---|---|---|---|---|---|---|---|---|---|---|---|
| 22 | Michelia champaca | Champak | 0.17 | 0.15 | 1.57 | 2.00 | 6.00 | 2.00 | Semi<br>Mature | Fair | Fair | Medium | Low | Low | Remove | |

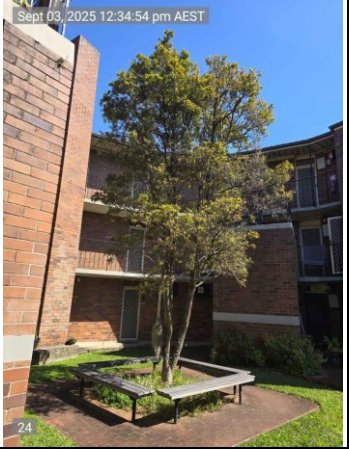
| No | Genus-species | Common Name | DAB<br>metres<br>(radius)<br><i>Above<br/>Buttress</i> | DSH<br>metres<br>(radius)<br><i>Standard<br/>Ht</i> | SRZ<br>(radius)<br><i>Metres</i> | NRZ<br>(radius)<br><i>Metres</i> | Height<br><i>Metres</i> | Canopy<br>Spread<br>(Metres)<br>(radius) | Age<br><i>Young,<br/>Semi-<br/>Mature,<br/>Mature<br/>Over<br/>Mature</i> | Health<br><i>Good<br/>Fair<br/>Fair/Po<br/>or Poor<br/>Dead</i> | Condition<br><i>Good<br/>Fair<br/>Fair/Poor<br/>Poor<br/>Failed</i> | Useful Life<br>Expectancy<br><i>High<br/>Medium<br/>Low</i> | Landscape<br>significance<br><i>High<br/>Medium<br/>Low</i> | Retention<br>value<br><i>High<br/>Medium<br/>Low</i> | Retain/ <i>Remove</i> | Photo |
|---|---|---|---|---|---|---|---|---|---|---|---|---|---|---|---|---|
| 24 | Syzygium australe | Brush Cherry | 0.22 | 0.18 | 1.75 | 2.16 | 8.00 | 1.00 | Mature | Poor | Fair/Poor | Medium | Low | Low | Remove | |

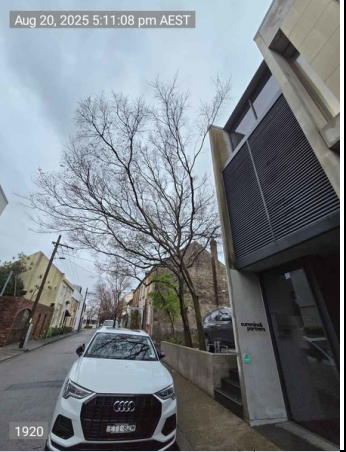
| No | Genus-species | Common Name | DAB<br>metres<br>(radius)<br>Above<br>Buttress | DSH<br>metres<br>(radius)<br>Standard<br>Ht | SRZ<br>(radius)<br>Metres | NRZ<br>(radius)<br>Metres | Height<br>Metres | Canopy<br>Spread<br>(Metres)<br>(radius) | Age<br>Young,<br>Semi-<br>Mature,<br>Mature<br>Over<br>Mature | Health<br>Good<br>Fair<br>Fair/Po<br>or Poor<br>Dead | Condition<br>Good<br>Fair<br>Fair/Poor<br>Poor<br>Failed | Useful Life<br>Expectancy<br>High<br>Medium<br>Low | Landscape<br>significance<br>High<br>Medium<br>Low | Retention<br>value<br>High<br>Medium<br>Low | Retain/Remove | Photo |
|---|---|---|---|---|---|---|---|---|---|---|---|---|---|---|---|---|
| 25<br>and<br>26 | <i>Ulmus parvifolia</i> | Chinese Elm | 0.25 | 0.20 | 1.85 | 2.40 | 8.00 | 2.00 | Semi<br>Mature | Fair | Fair | Medium | Medium | Medium | Retain | |

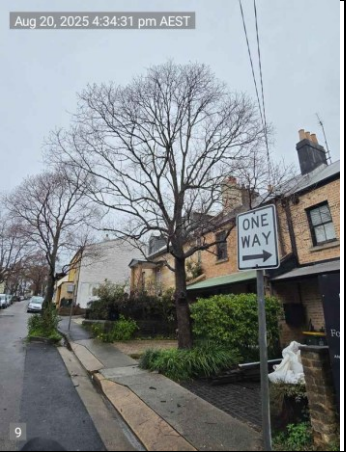
| No | Genus-species | Common Name | DAB<br>metres<br>(radius)<br>Above<br>Buttress | DSH<br>metres<br>(radius)<br>Standard<br>Ht | SRZ<br>(radius)<br>Metres | NRZ<br>(radius)<br>Metres | Height<br>Metres | Canopy<br>Spread<br>(Metres)<br>(radius) | Age<br>Young,<br>Semi-<br>Mature,<br>Mature<br>Over<br>Mature | Health<br>Good<br>Fair<br>Fair/Po<br>or Poor<br>Dead | Condition<br>Good<br>Fair<br>Fair/Poor<br>Poor<br>Failed | Useful Life<br>Expectancy<br>High<br>Medium<br>Low | Landscape<br>significance<br>High<br>Medium<br>Low | Retention<br>value<br>High<br>Medium<br>Low | Retain/Remove | Photo |
|---|---|---|---|---|---|---|---|---|---|---|---|---|---|---|---|---|
| 27 | <i>Sapium sebiferum</i> | Chinese Tallow Tree | 0.43 | 0.37 | 2.32 | 4.44 | 12.00 | 4.00 | Mature | Fair | Fair | Medium | Medium | Medium | Retain | |

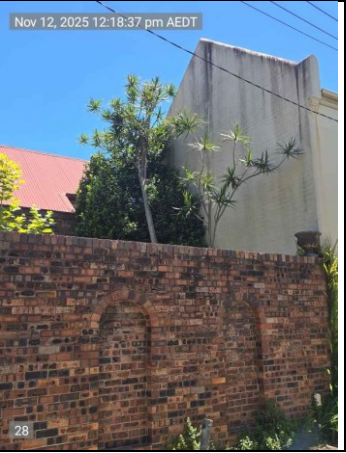
| No | Genus-species | Common Name | DAB<br>metres<br>(radius)<br>Above<br>Buttress | DSH<br>metres<br>(radius)<br>Standard<br>Ht | SRZ<br>(radius)<br>Metres | NRZ<br>(radius)<br>Metres | Height<br>Metres | Canopy<br>Spread<br>(Metres)<br>(radius) | Age<br>Young,<br>Semi-<br>Mature,<br>Mature<br>Over<br>Mature | Health<br>Good<br>Fair<br>Fair/Po<br>or Poor<br>Dead | Condition<br>Good<br>Fair<br>Fair/Poor<br>Poor<br>Failed | Useful Life<br>Expectancy<br>High<br>Medium<br>Low | Landscape<br>significance<br>High<br>Medium<br>Low | Retention<br>value<br>High<br>Medium<br>Low | Retain/Remove | Photo |
|---|---|---|---|---|---|---|---|---|---|---|---|---|---|---|---|---|
| 28 | <i>Dracaena marginata</i> | Dragon Tree | 0.30 | 0.20 | 2.00 | 2.40 | 8.00 | 2.00 | Mature | Fair | Fair | Medium | Low | Low | Remove | |

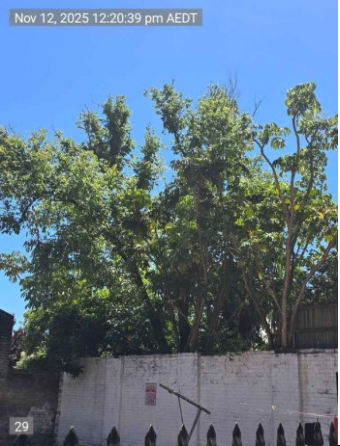
| No | Genus-species | Common Name | DAB<br>metres<br>(radius)<br><i>Above<br/>Buttress</i> | DSH<br>metres<br>(radius)<br><i>Standard<br/>Ht</i> | SRZ<br>(radius)<br><i>Metres</i> | NRZ<br>(radius)<br><i>Metres</i> | Height<br><i>Metres</i> | Canopy<br>Spread<br>(Metres)<br>(radius) | Age<br><i>Young,<br/>Semi-<br/>Mature,<br/>Mature<br/>Over<br/>Mature</i> | Health<br><i>Good<br/>Fair<br/>Fair/Po<br/>or Poor<br/>Dead</i> | Condition<br><i>Good<br/>Fair<br/>Fair/Poor<br/>Poor<br/>Failed</i> | Useful Life<br>Expectancy<br><i>High<br/>Medium<br/>Low</i> | Landscape<br>significance<br><i>High<br/>Medium<br/>Low</i> | Retention<br>value<br><i>High<br/>Medium<br/>Low</i> | Retain/ <i>Remove</i> | Photo |
|---|---|---|---|---|---|---|---|---|---|---|---|---|---|---|---|---|
| 29 | <i>Ulmus procera</i> | English Elm | 0.50 | 0.40 | 2.47 | 4.80 | 12.00 | 4.00 | Mature | Fair | Fair | Medium | Low | Low | Remove | A photograph of a mature English Elm tree with dense green foliage, standing in front of a white fence. The photo is timestamped 'Nov 12, 2025 12:20:39 pm AEDT' and has a small '29' in the bottom left corner. |

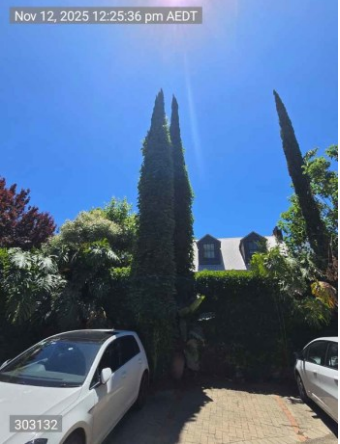
| No | Genus-species | Common Name | DAB<br>metres<br>(radius)<br><i>Above<br/>Buttress</i> | DSH<br>metres<br>(radius)<br><i>Standard<br/>Ht</i> | SRZ<br>(radius)<br><i>Metres</i> | NRZ<br>(radius)<br><i>Metres</i> | Height<br><i>Metres</i> | Canopy<br>Spread<br>(Metres)<br>(radius) | Age<br><i>Young,<br/>Semi-<br/>Mature,<br/>Mature<br/>Over<br/>Mature</i> | Health<br><i>Good<br/>Fair<br/>Fair/Po<br/>or Poor<br/>Dead</i> | Condition<br><i>Good<br/>Fair<br/>Fair/Poor<br/>Poor<br/>Failed</i> | Useful Life<br>Expectancy<br><i>High<br/>Medium<br/>Low</i> | Landscape<br>significance<br><i>High<br/>Medium<br/>Low</i> | Retention<br>value<br><i>High<br/>Medium<br/>Low</i> | Retain/ <i>Remove</i> | Photo |
|---|---|---|---|---|---|---|---|---|---|---|---|---|---|---|---|---|
| 30,<br>31<br>and<br>32 | <i>Cupressus Stricta</i> | Italian Pencil Pine | 0.25 | 0.20 | 1.85 | 2.40 | 14.00 | 1.00 | Mature | Fair | Fair | Medium | Low | Low | Remove | A photograph showing several tall, slender Italian Pencil Pine trees in a residential setting. A white car is parked in the foreground, and a house is visible in the background. The photo is timestamped 'Nov 12, 2025 12:25:36 pm AEDT' and has a small '303132' in the bottom left corner. |

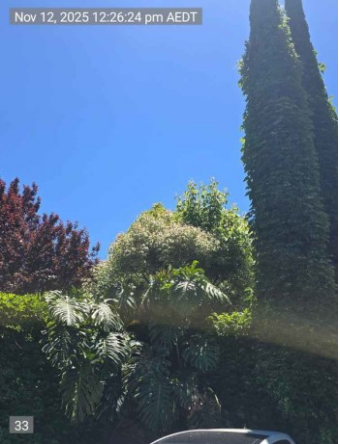
| No | Genus-species | Common Name | DAB<br>metres<br>(radius)<br><i>Above<br/>Buttress</i> | DSH<br>metres<br>(radius)<br><i>Standard<br/>Ht</i> | SRZ<br>(radius)<br><i>Metres</i> | NRZ<br>(radius)<br><i>Metres</i> | Height<br><i>Metres</i> | Canopy<br>Spread<br>(Metres)<br>(radius) | Age<br><i>Young,<br/>Semi-<br/>Mature,<br/>Mature<br/>Over<br/>Mature</i> | Health<br><i>Good<br/>Fair<br/>Fair/Po<br/>or Poor<br/>Dead</i> | Condition<br><i>Good<br/>Fair<br/>Fair/Poor<br/>Poor<br/>Failed</i> | Useful Life<br>Expectancy<br><i>High<br/>Medium<br/>Low</i> | Landscape<br>significance<br><i>High<br/>Medium<br/>Low</i> | Retention<br>value<br><i>High<br/>Medium<br/>Low</i> | Retain/ <i>Remove</i> | Photo |
|---|---|---|---|---|---|---|---|---|---|---|---|---|---|---|---|---|
| 33 | <i>Sapium sebiferum</i> | Chinese Tallow Tree | 0.30 | 0.25 | 2.00 | 3.00 | 8.00 | 3.00 | Mature | Fair | Fair | Medium | Low | Low | Retain | A photograph of a Chinese Tallow Tree with a thick, textured trunk and dense green foliage. The photo is timestamped 'Nov 12, 2025 12:26:24 pm AEDT' and has a small '33' in the bottom left corner. |

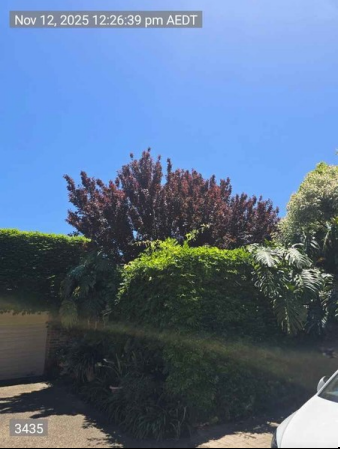
| No | Genus-species | Common Name | DAB<br>metres<br>(radius)<br><small>Above<br/>Buttress</small> | DSH<br>metres<br>(radius)<br><small>Standard<br/>Ht</small> | SRZ<br>(radius)<br><small>Metres</small> | NRZ<br>(radius)<br><small>Metres</small> | Height<br><small>Metres</small> | Canopy<br>Spread<br>(Metres)<br>(radius) | Age<br><small>Young,<br/>Semi-<br/>Mature,<br/>Mature<br/>Over<br/>Mature</small> | Health<br><small>Good<br/>Fair<br/>Fair/Po<br/>or Poor<br/>Dead</small> | Condition<br><small>Good<br/>Fair<br/>Fair/Poor<br/>Poor<br/>Failed</small> | Useful Life<br>Expectancy<br><small>High<br/>Medium<br/>Low</small> | Landscape<br>significance<br><small>High<br/>Medium<br/>Low</small> | Retention<br>value<br><small>High<br/>Medium<br/>Low</small> | Retain/ <small>Remove</small> | Photo |
|---|---|---|---|---|---|---|---|---|---|---|---|---|---|---|---|---|
| 34<br>and<br>35 | <i>Prunus blireana</i> | The Purple-Leafed Plum | 0.25 | 0.20 | 1.85 | 2.40 | 8.00 | 3.00 | Mature | Fair | Fair | Medium | Low | Medium | Retain | <div> <div>Nov 12, 2025 12:26:39 pm AEDT</div> <div>3435</div> </div> |

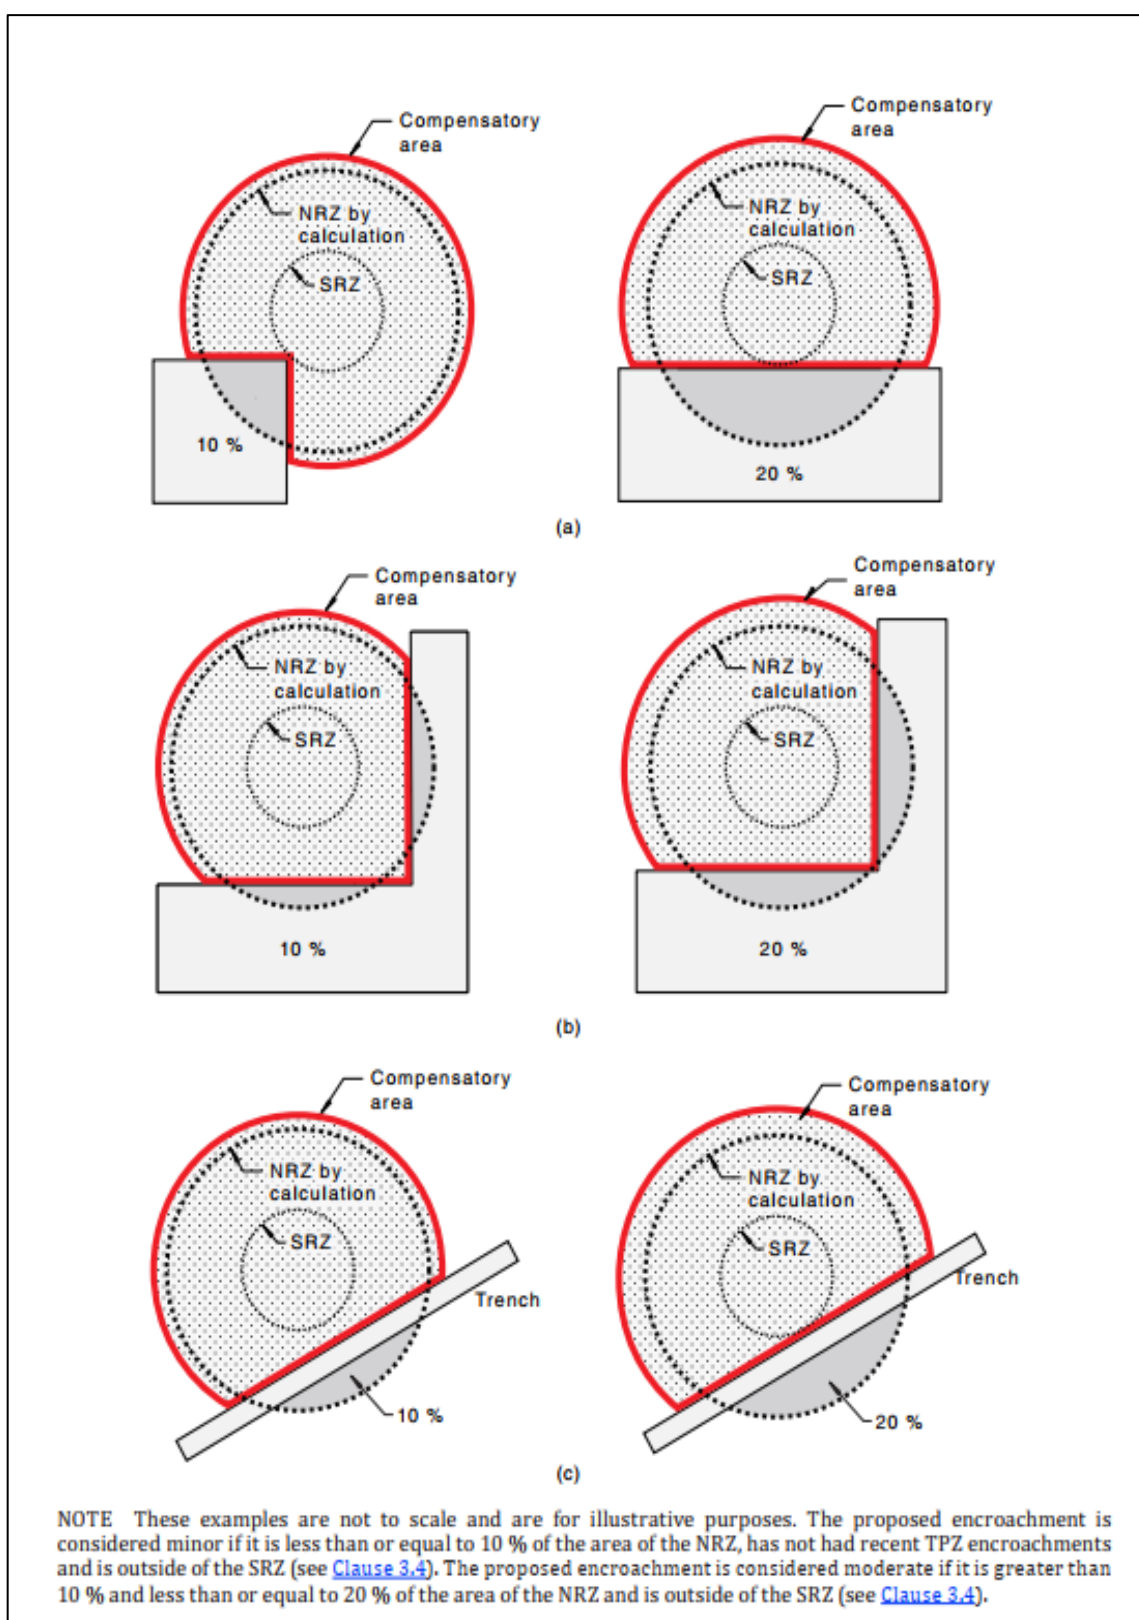
Figure 12: Examples of possible encroachment

For the assessment of major encroachment, a more detailed investigation is necessary. This can include research such as root investigation, soil analysis, historical records of the tree or site, relevant literature and examples of similar encroachments. A TPS and TPP should be prepared to support the retention of the tree. To avoid a net loss of soil area and volume, an area equivalent to the encroachment shall be incorporated into the NRZ, unless the project arborist otherwise demonstrates that the tree will remain viable.
