# Memo

| PROJECT | 160 Oxford Street Paddington |
| RE | SSD 97528708 HNSW Agency Submission - |

This Memo responds to the HNSW Agency Submission (NSW DCCEEW, as delegate of the Heritage Council of NSW) with regard to SS 97528708, a residential redevelopment of 160 Oxford Street, Paddington.

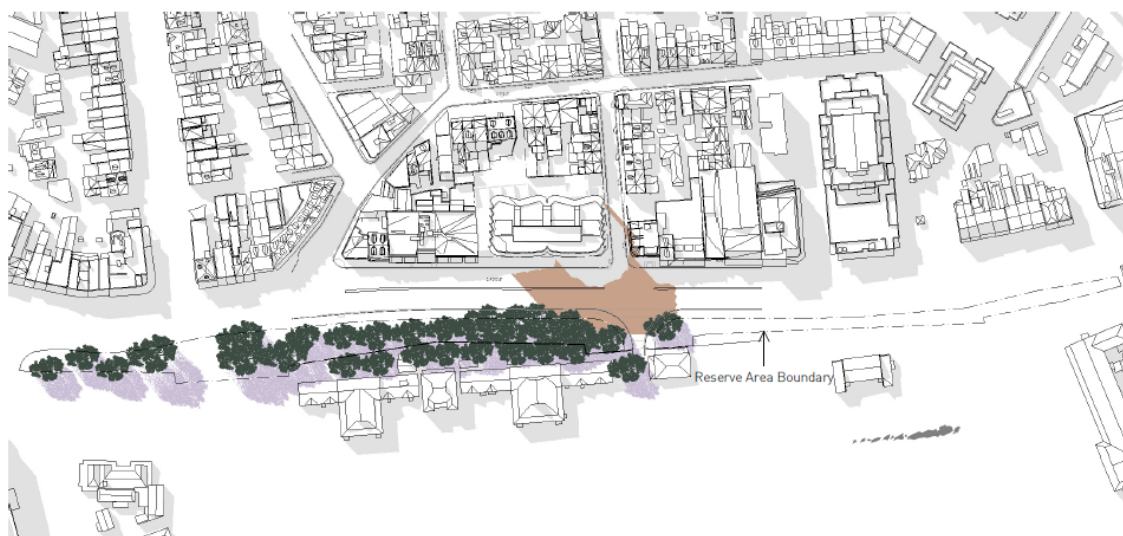
Fig 4

Shadow (brown) thrown from the proposed development at 160 Oxford Street, with existing shadows from the trees along Oxford St are illustrated in purple. at 13.00 hours on 21 June

These set of plan diagrams clearly demonstrate that the proposed development will not throw any shadows over the Oxford Street perimeter sandstone wall. Buildings B94-B96 and the small associated outhouses, are already thrown into shadow from the trees in Oxford Street and others in the narrow space between the subject buildings and the sandstone wall.

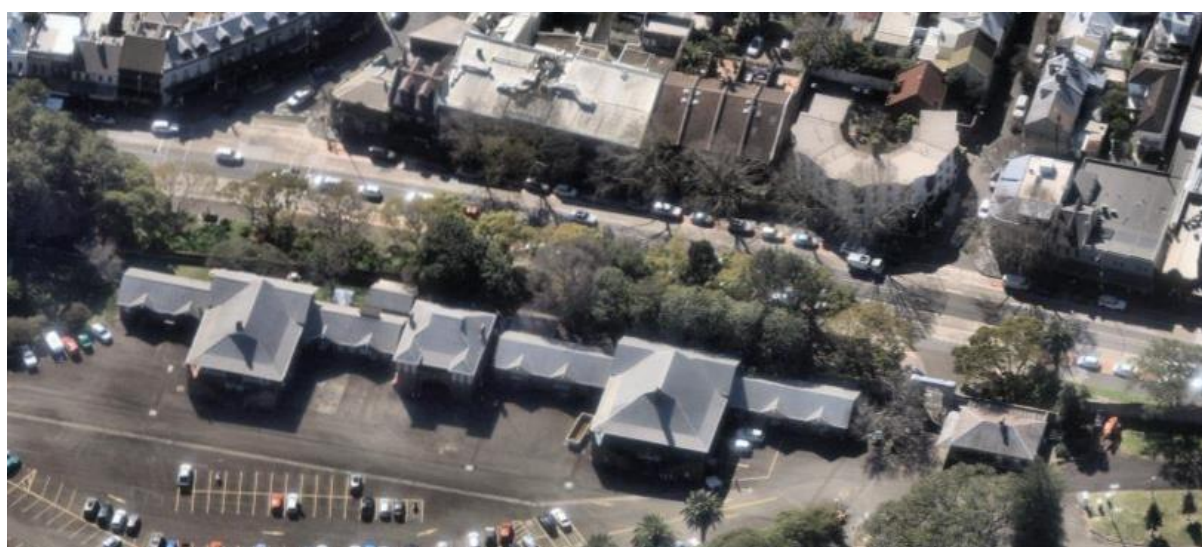
Fig 5

Aerial view of Buildings 94-96 and the rows of trees in Oxford St and within the Barracks perimeter (Source: Nearmap Oblique photo)

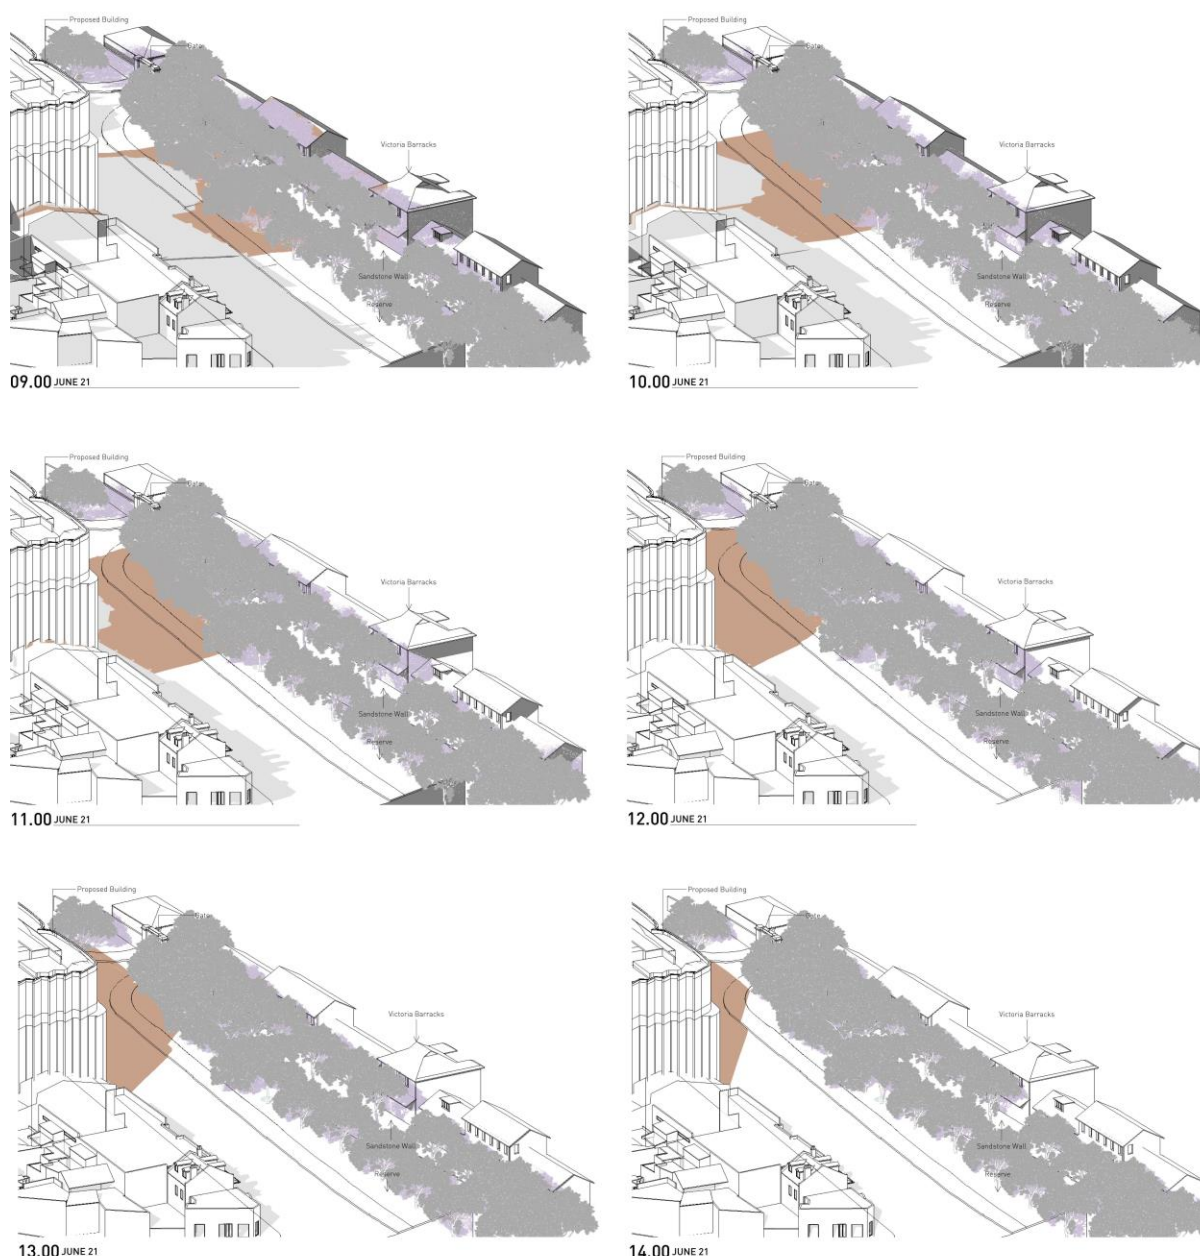
Fig 6

Overshadowing diagrams on 21 June. The shadows from the proposal are shown in brown and those from the trees are shown in purple

Very minor additional overshadowing of buildings 95 and 96 will occur around 9am

The project arborist, Tree Management Strategies, notes that the above overshadowing images show the deciduous trees in and adjacent the Victoria Barracks at their smallest foliage extent. The tree's crowns will have greater foliage in the warmer months.

Shadow diagrams have confirmed that there will be almost no shadows thrown onto Building 94-96. It should be noted that the proposed development has been reduced in height since the preparation of these overshadowing diagrams, thereby further reducing any impacts.

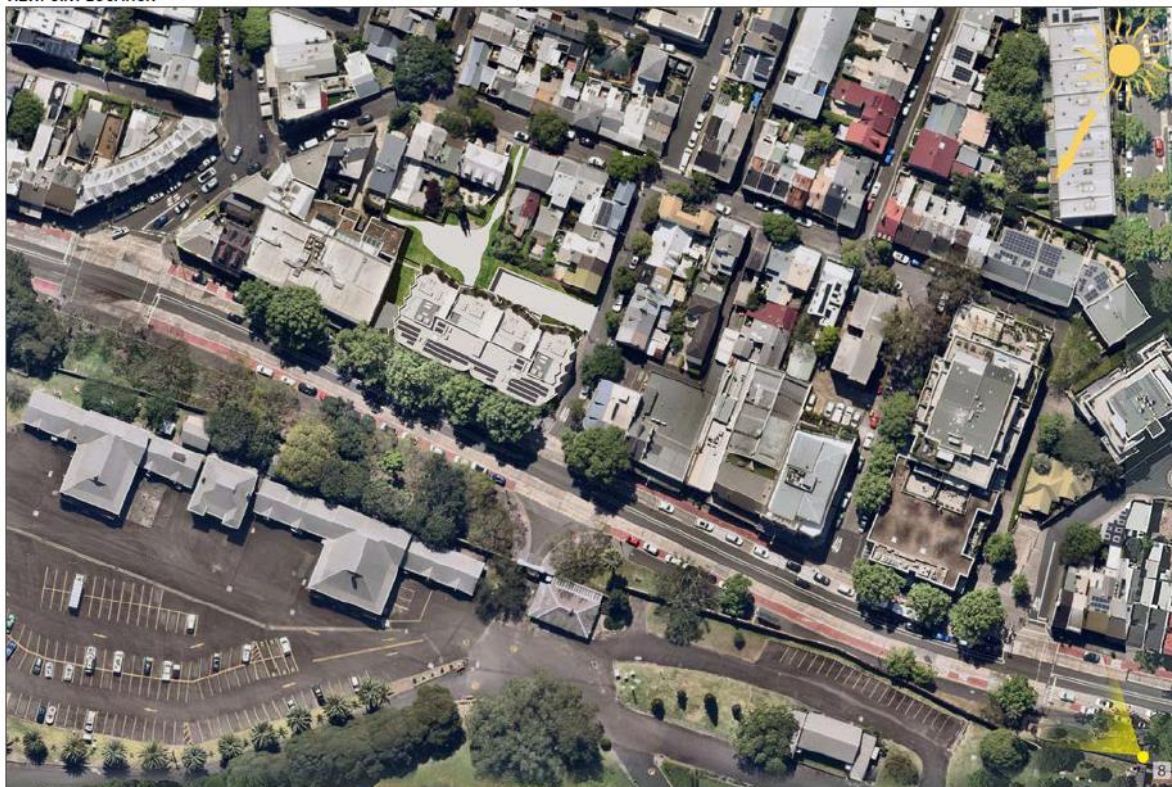
Fig 9

## 12.2 VIEWPOINT POSITION 08 - Oxford Street (Barracks Wall)

The agreed location is identified as Location 8, at the bottom right hand corner of the aerial photograph.

In accordance with this advice from DPHI, an additional viewpoint (No.8) was analysed and added to the formal Visual Impact Assessment report. The distance from Viewpoint 8 to the proposed building is approximately 180m down the sloping topography. From that location there are trees along the southern street footpaths.
