## **Geotechnical Investigation Report 142-160 Oxford, 13 Gipps & 6 Shadforth Streets, Paddington NSW**

**Prepared for: TM No.8 Pty Ltd**

**Reference: P3569\_02 Rev4**

**Date: 4 June 2026**

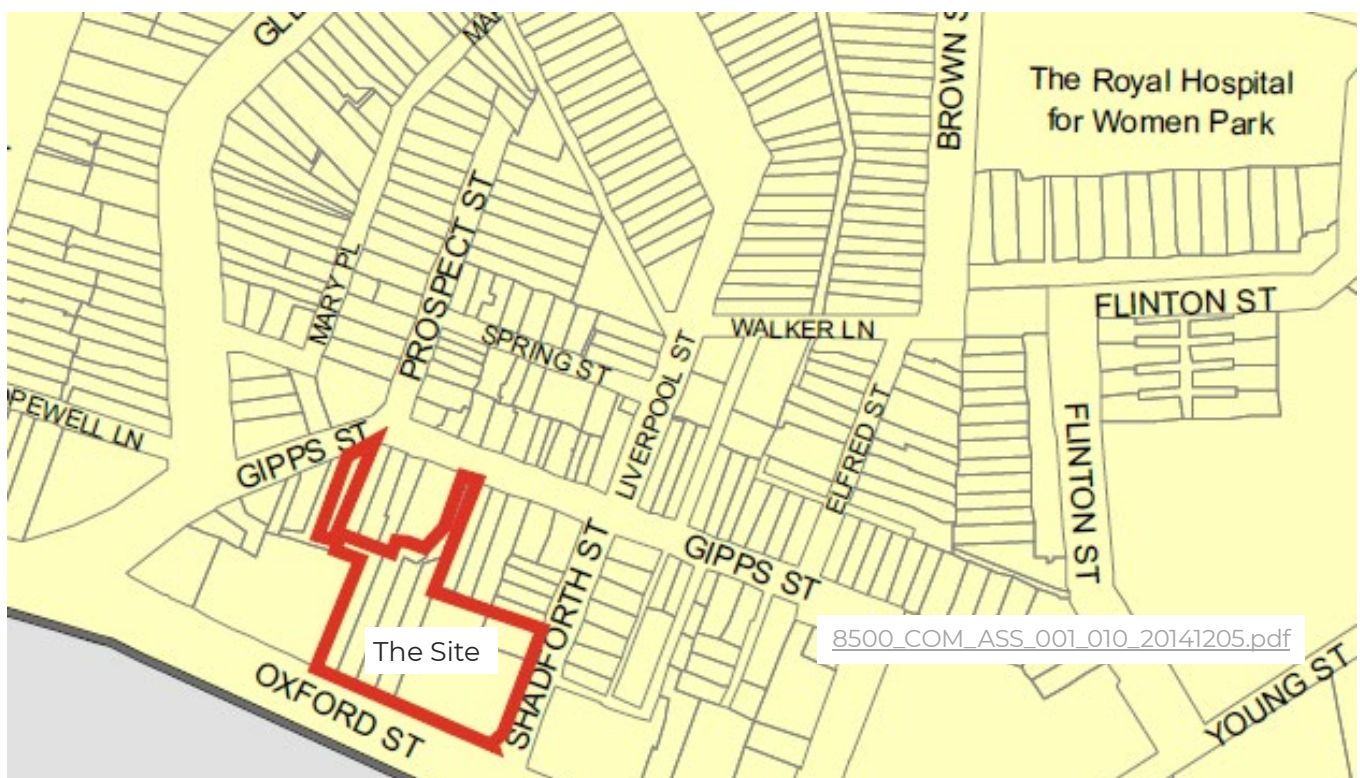
The Woollahra Local Environmental Plan 2014 Acid Sulfate Soils Map – Sheet ASS\_001 locates this site in a Class 5 zone (see **Figure 1** below), which does not typically contain acid sulfate soils.

**Figure 1** Extract from Woollahra Local Environmental Plan 2014 Acid Sulfate Soils Map – Sheet ASS\_001 showing site location.

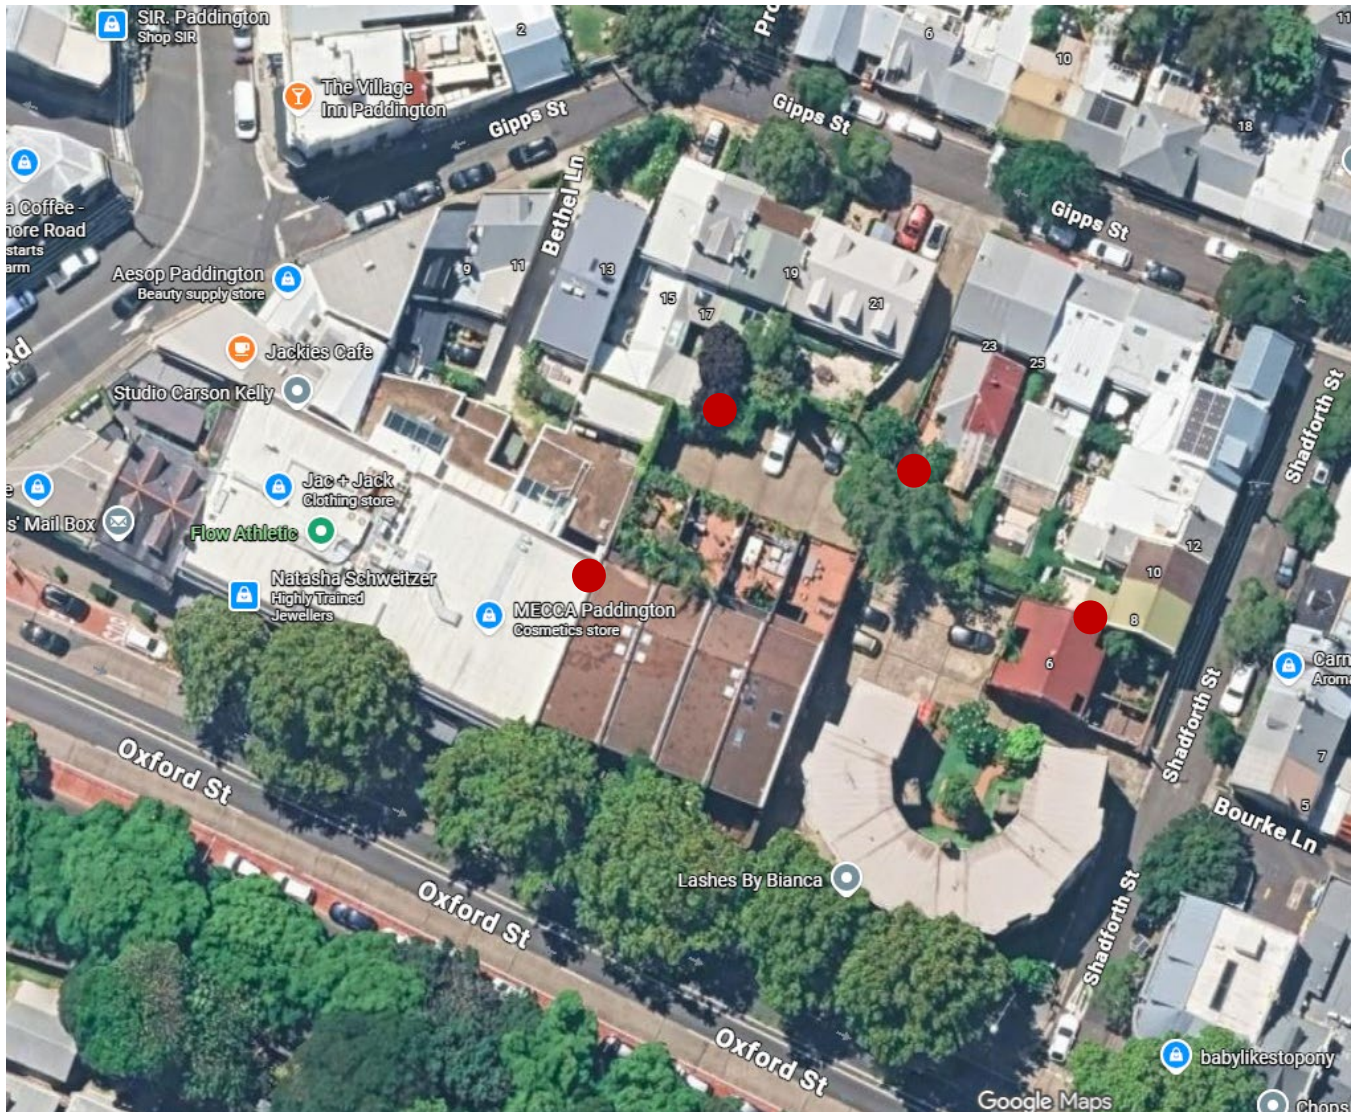
Recommended locations of the vibration monitors are shown on **Figure 2**.

**Figure 2** Location of vibration monitoring points  
● Vibration Monitor Location

Vibration monitors are to be placed within the site boundaries directly adjacent to the northern and western boundaries. Vibration monitors are to be set up for continuous monitoring and with visual and audible alarms for exceedances of the nominated vibration threshold. It is recommended that vibration monitors are placed prior to the early works contractor mobilising to site by a registered acoustic consultant.
