## Kangaroo Creek Dam Photo Monitoring: 30 December 2009 - 8 June 2012

### Springvale Mine's LW401

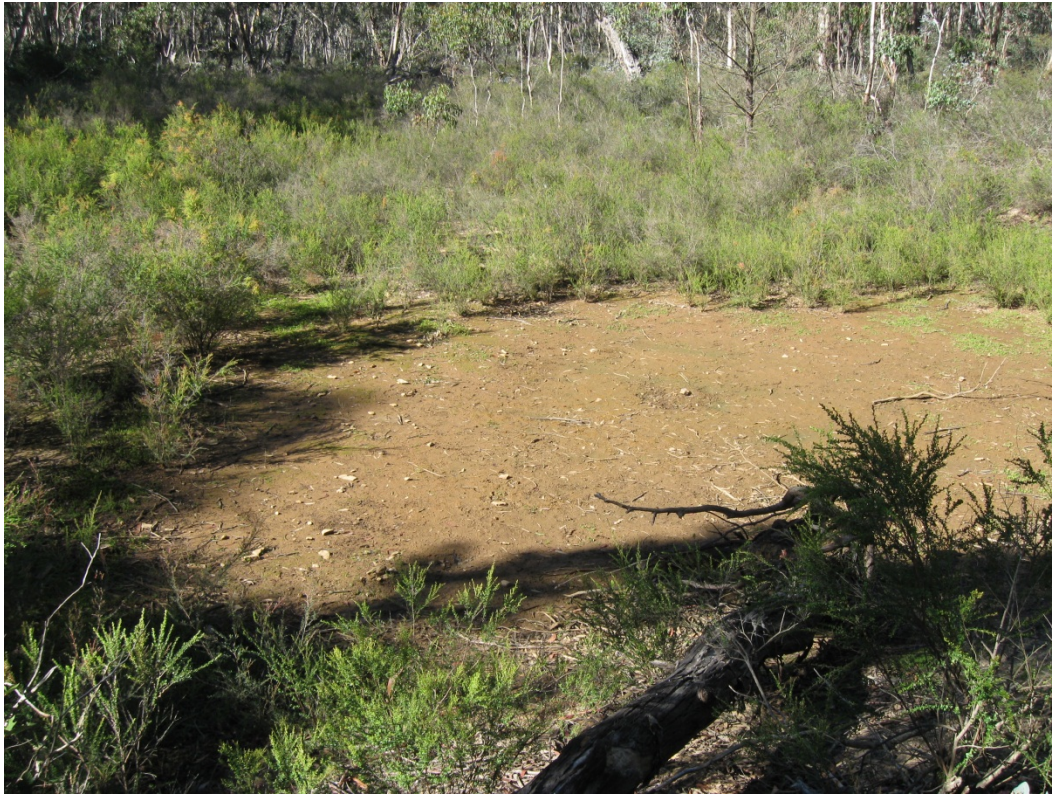
Figure 3 Kangaroo Creek Dam 17 March 2010

Kangaroo Creek Dam photo monitoring conducted in the period 2009 -2012 shows that the dam has contained water on **22 out of 24 monitoring occasions** (conducted monthly or bi-monthly). No or very small pools of water was observed in the dam on 17 March 2010 (Figure 3) and 19 April 2010 (Figure 4).
