Centennial Coal

Response to the Independent Expert Scientific Committee on Coal Seam Gas and Coal Mining Knowledge Report

**Temperate Highland Peat Swamps on
Sandstone: ecological characteristics,
sensitivities to change, and monitoring and
reporting techniques**

September 2014

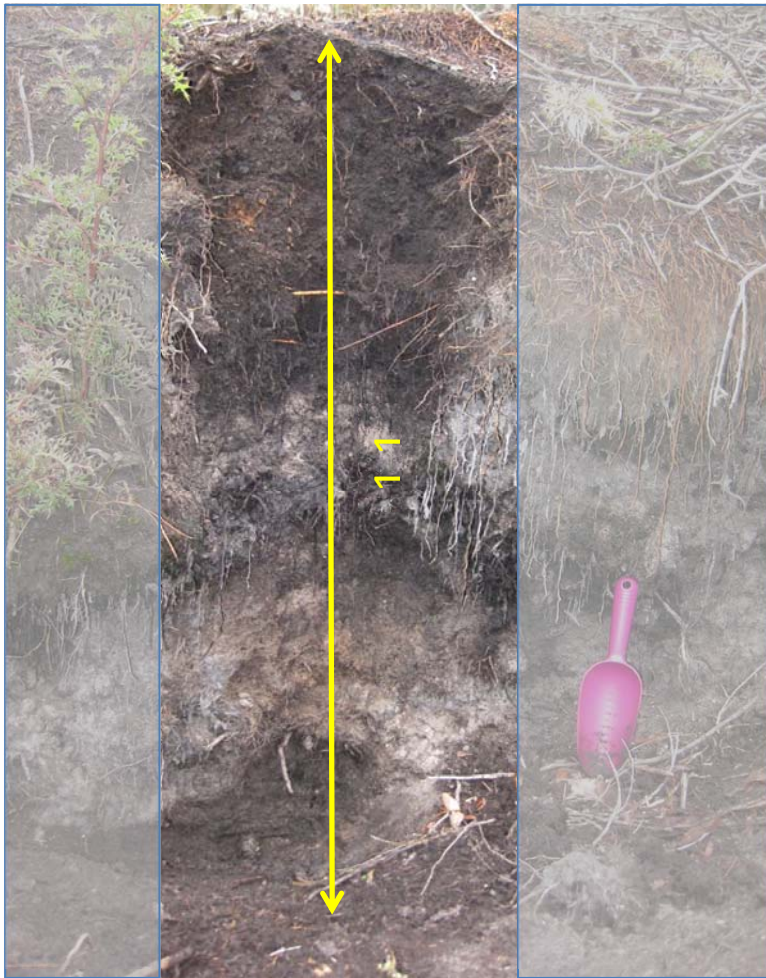
Fig 4: Soil profile at central slump

From the soil profile description it can be deduced that plants are developing roots to a depth of at least 1.1m, i.e. they may be able to reach depths (even beyond the depth of 1.1m) of the soil, which are permanently moist as they lie in the vicinity of units feeding groundwater, whereby the origin of the water may be from valley side seepages, subsurface flow in the valley and deeper draining rainfall. This would allow this water dependent vegetation to sustain periods of dry conditions within the soil profile.

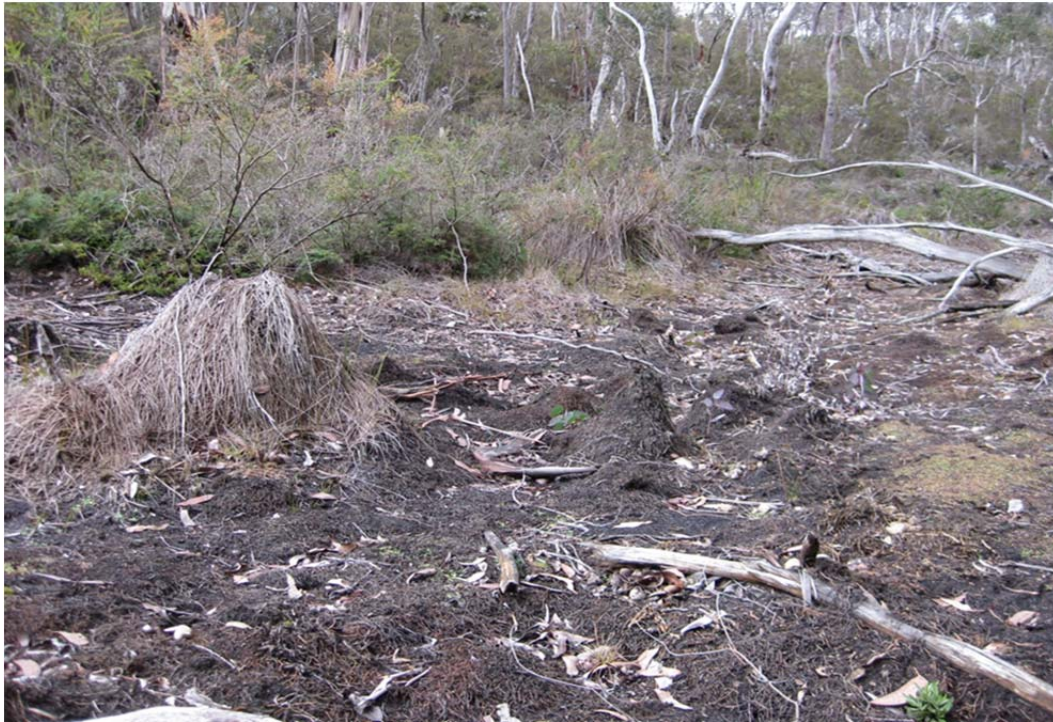
Figure 1.20 East Wolgan Swamp in Area Affected by Mine Water Discharge. Note surface erosion and remnants of topsoil secured from erosion by (dead) root biomass (hummocky surface)

- surface erosion and remnants of topsoil secured from erosion by dead root biomass (hummocky surface)
- erosion channels caused by mine water flows
- sediment deposition caused by mine water flows
- healthy swamp vegetation outside of mine water flow path
- limited regrowth of sedges and weeds within flow path

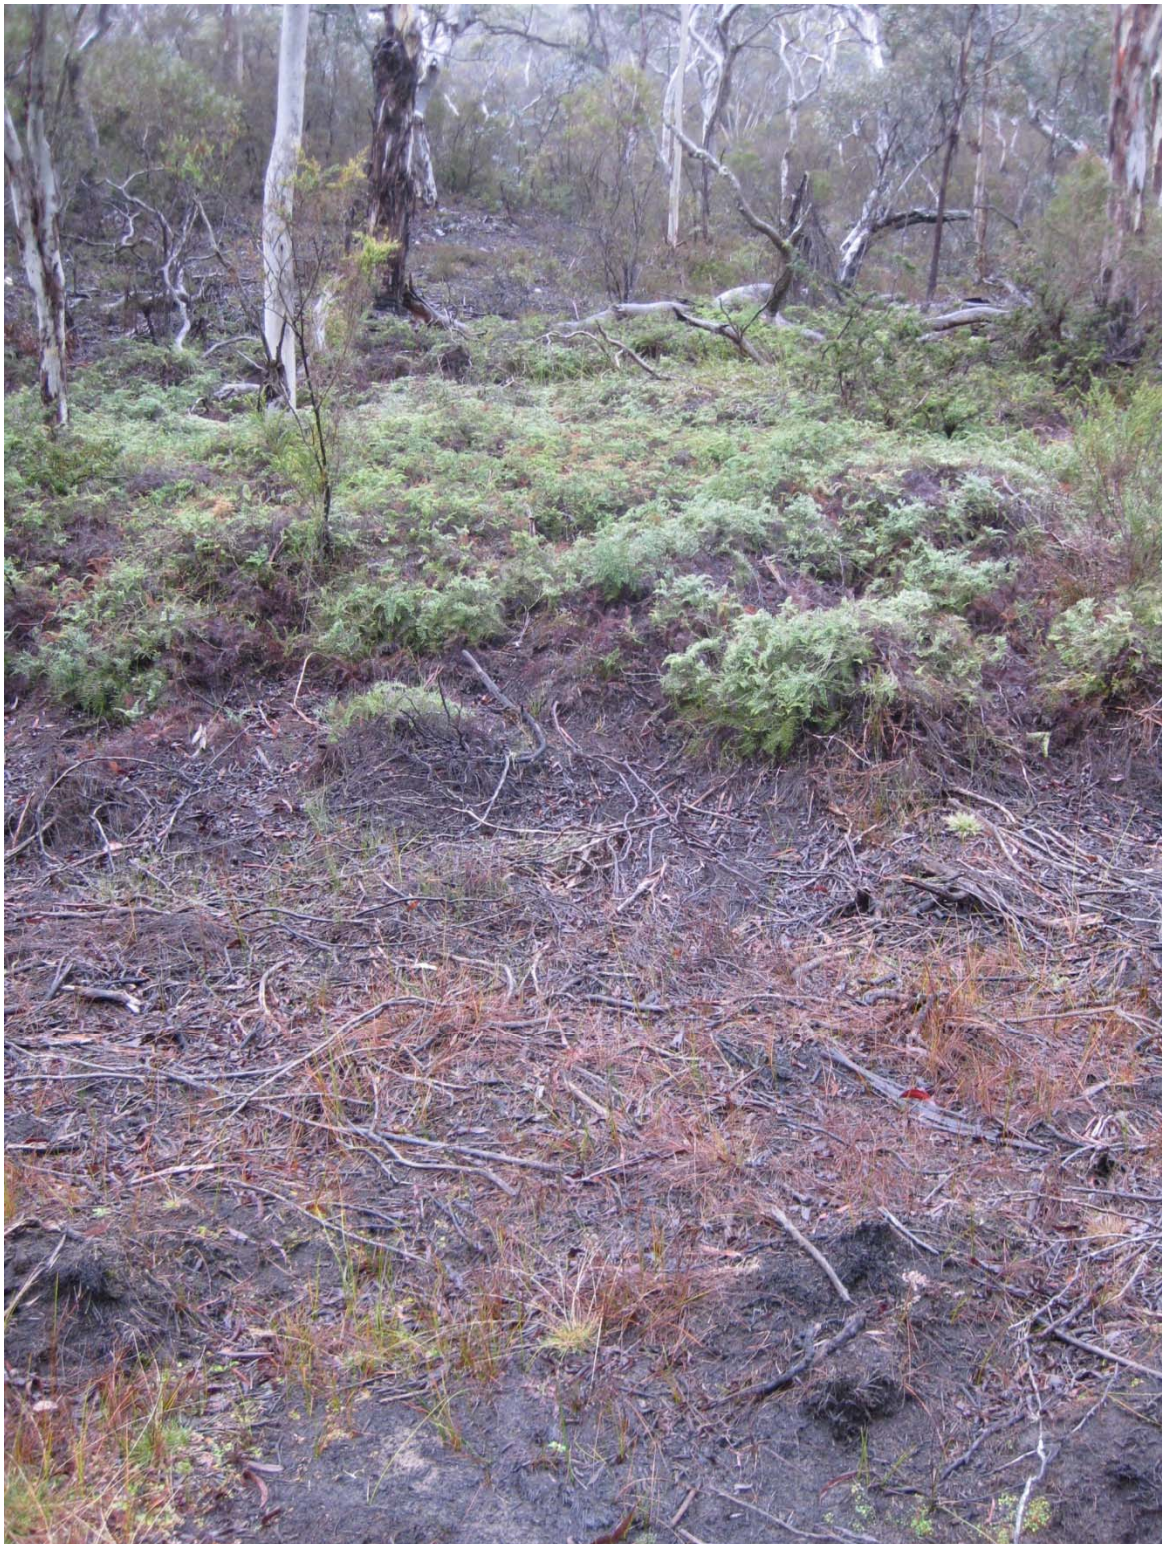
Figure 1.21 - Looking Across East Wolgan Swamp from the Flow Path of Mine Water Discharge Towards Swamp Unaffected by Mine Water Discharge - Note Limited Regrowth of Sedges and Weeds

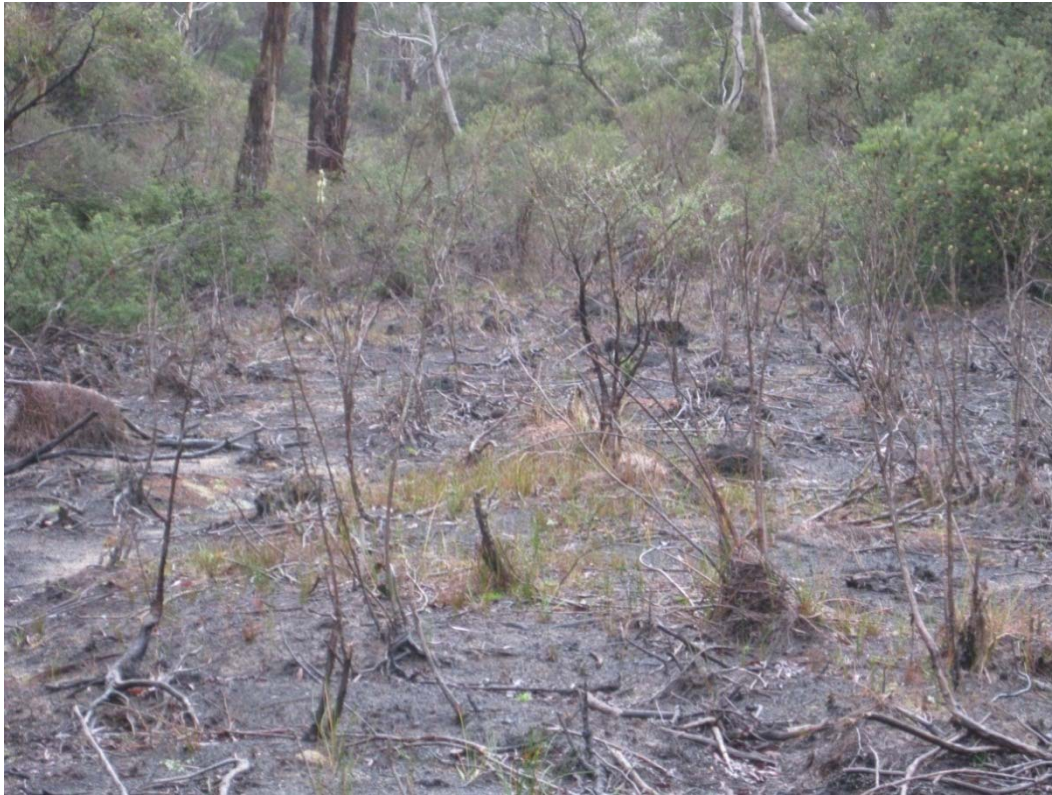
Figure 1.22 - East Wolgan Swamp in Area Affected by Mine Water Discharge – Note Limited Regrowth of Sedges Outside of Erosion Channels

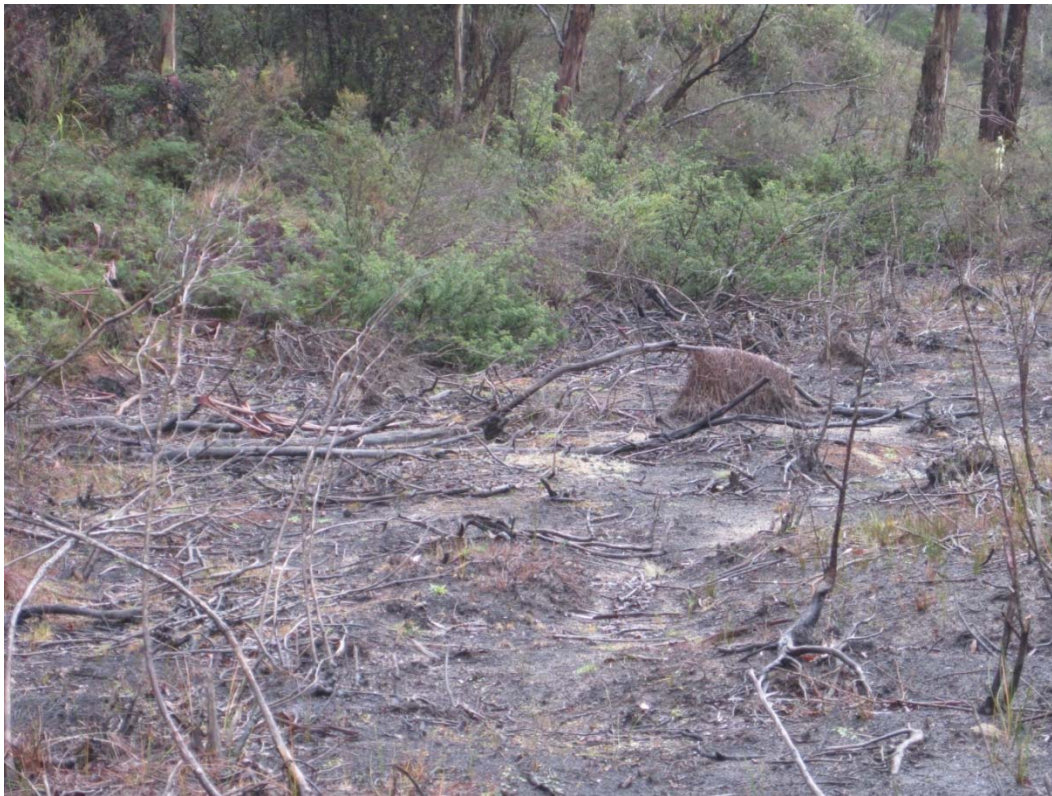
Figure 1.23 - East Wolgan Swamp Between Slumping Locations – Note Erosion Channels and Sediment Deposition Caused by Mine Water Discharge

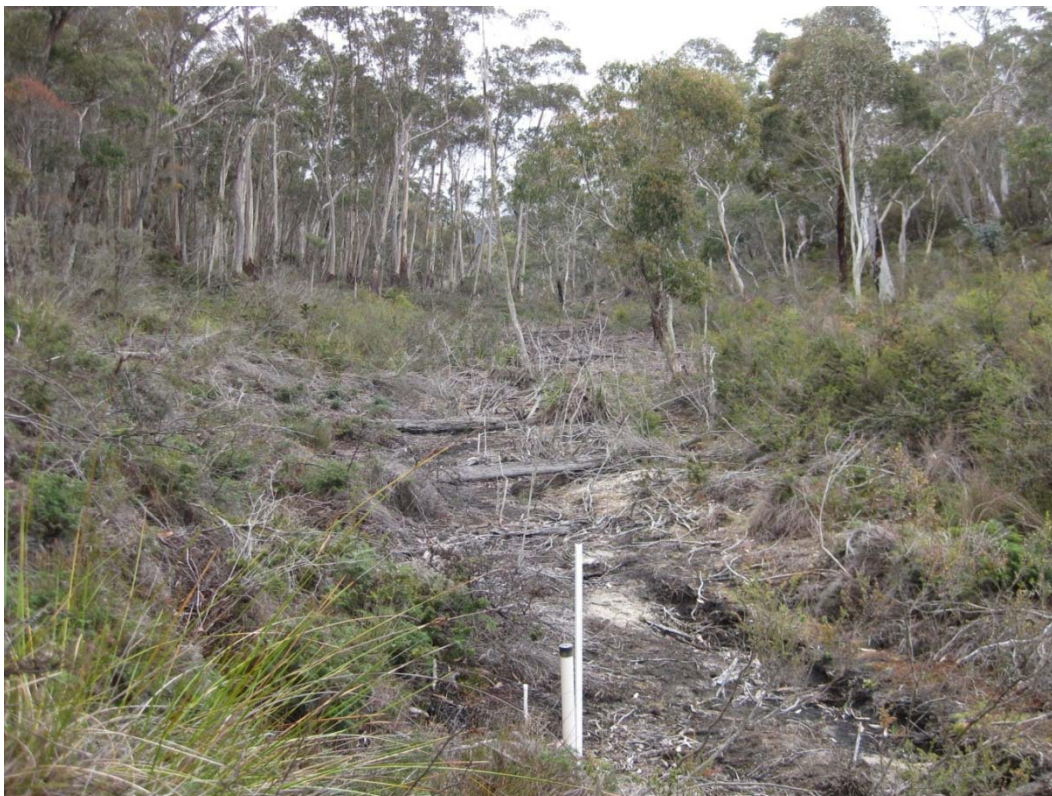
Figure 1.24 Photo of East Wolgan Swamp at WE2 Piezometer location showing vegetation damage along flow path of mine water discharge – not evident outside of flow path

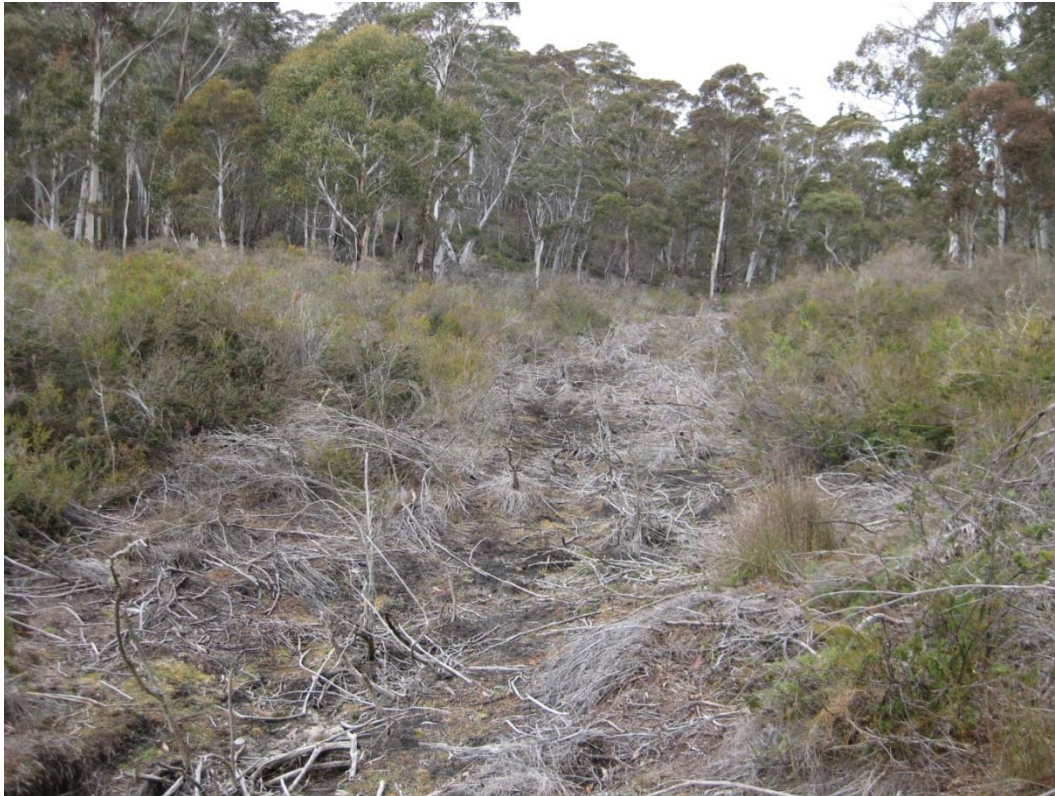
Figure 1.25 Photo of East Wolgan Swamp downstream of WE2 Piezometer location showing vegetation damage along flow path of mine water discharge – not evident outside of flow path.

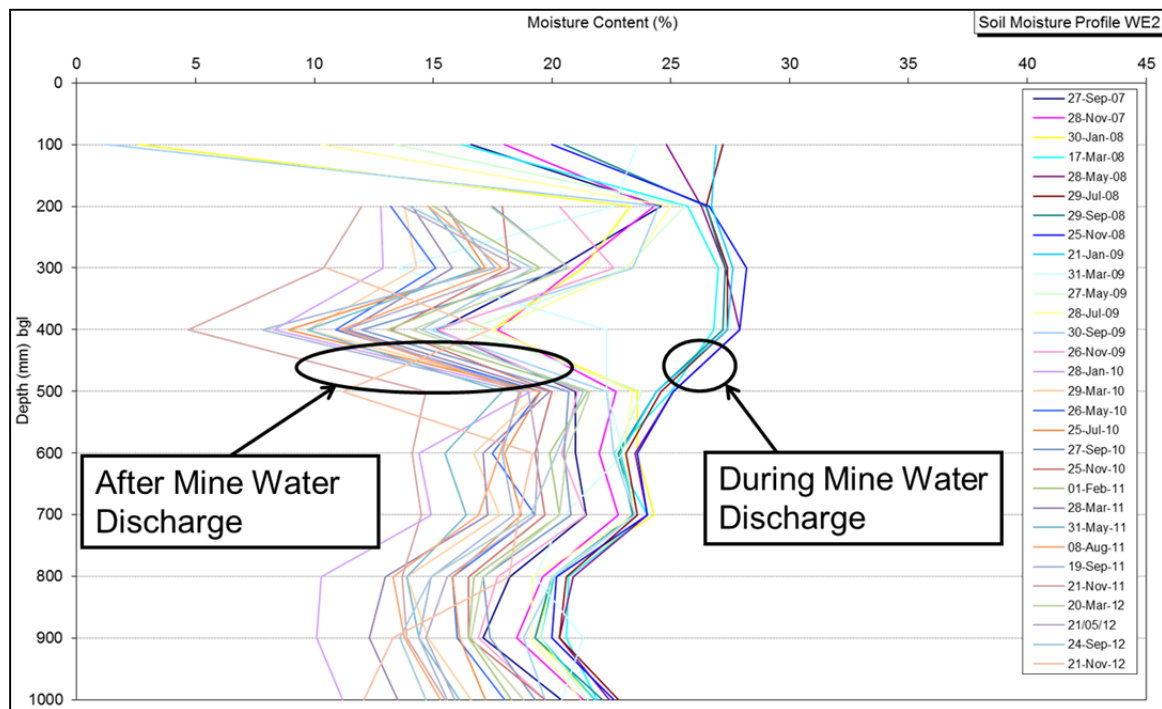
Figure 1.27 Soil Moisture Monitoring Data from WE2 Piezometer Location in East Wolgan – Showing Differences Between Results During and After Mine Water Discharge

Figure 1.27 shows soil moisture monitoring data from WE2 piezometer location, showing significant differences between results during and after mine water discharges. The wetting / drying cycles of Narrow and East Wolgan Swamps due to mine water discharge are evident in the data.

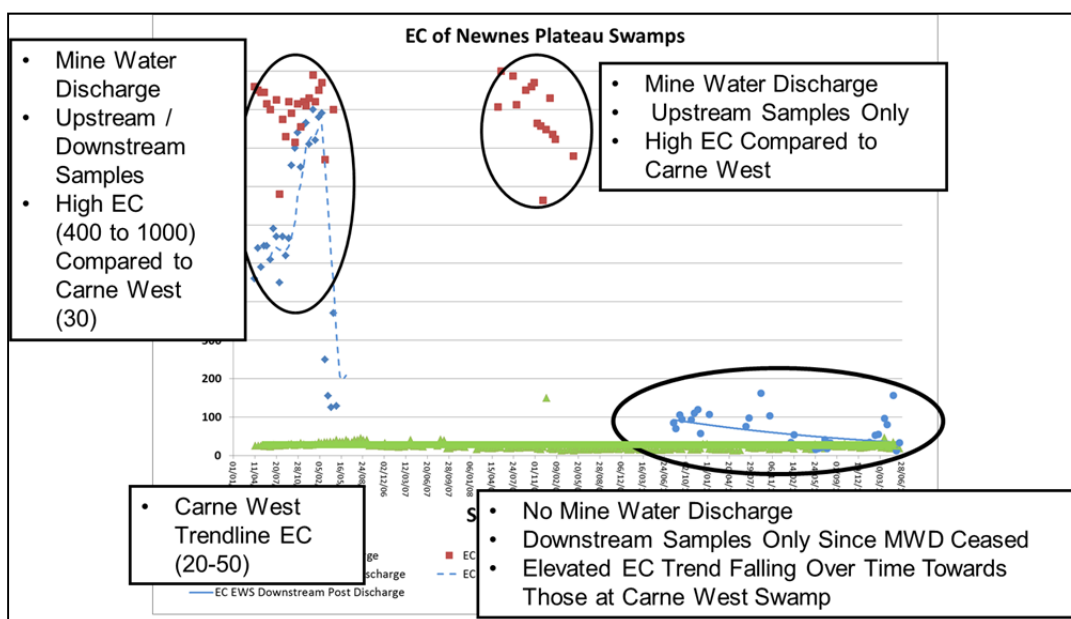
Figure 1.28(a) As per Figure 1.28 with Explanation of Interpretation of Data

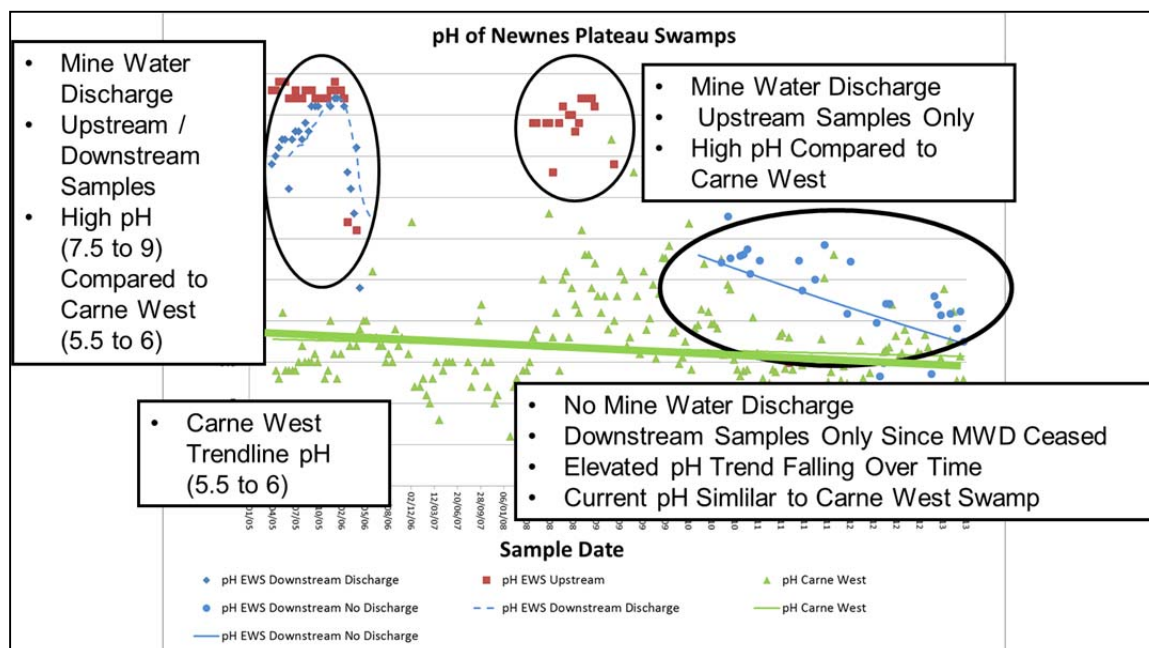
Figure 1.29(a) As per Figure 1.29 with Explanation of Interpretation of Data
