Mamre Road Precinct – Assessment of Riparian and Groundwater Dependent Ecosystems.

Proposed Warehouse, Logistics and Industrial Facilities Hub  
657-769 Mamre Road, Kemps Creek

Prepared for Frasers Property Australia and ALTIS Property Partners Pty Ltd  
July 2020

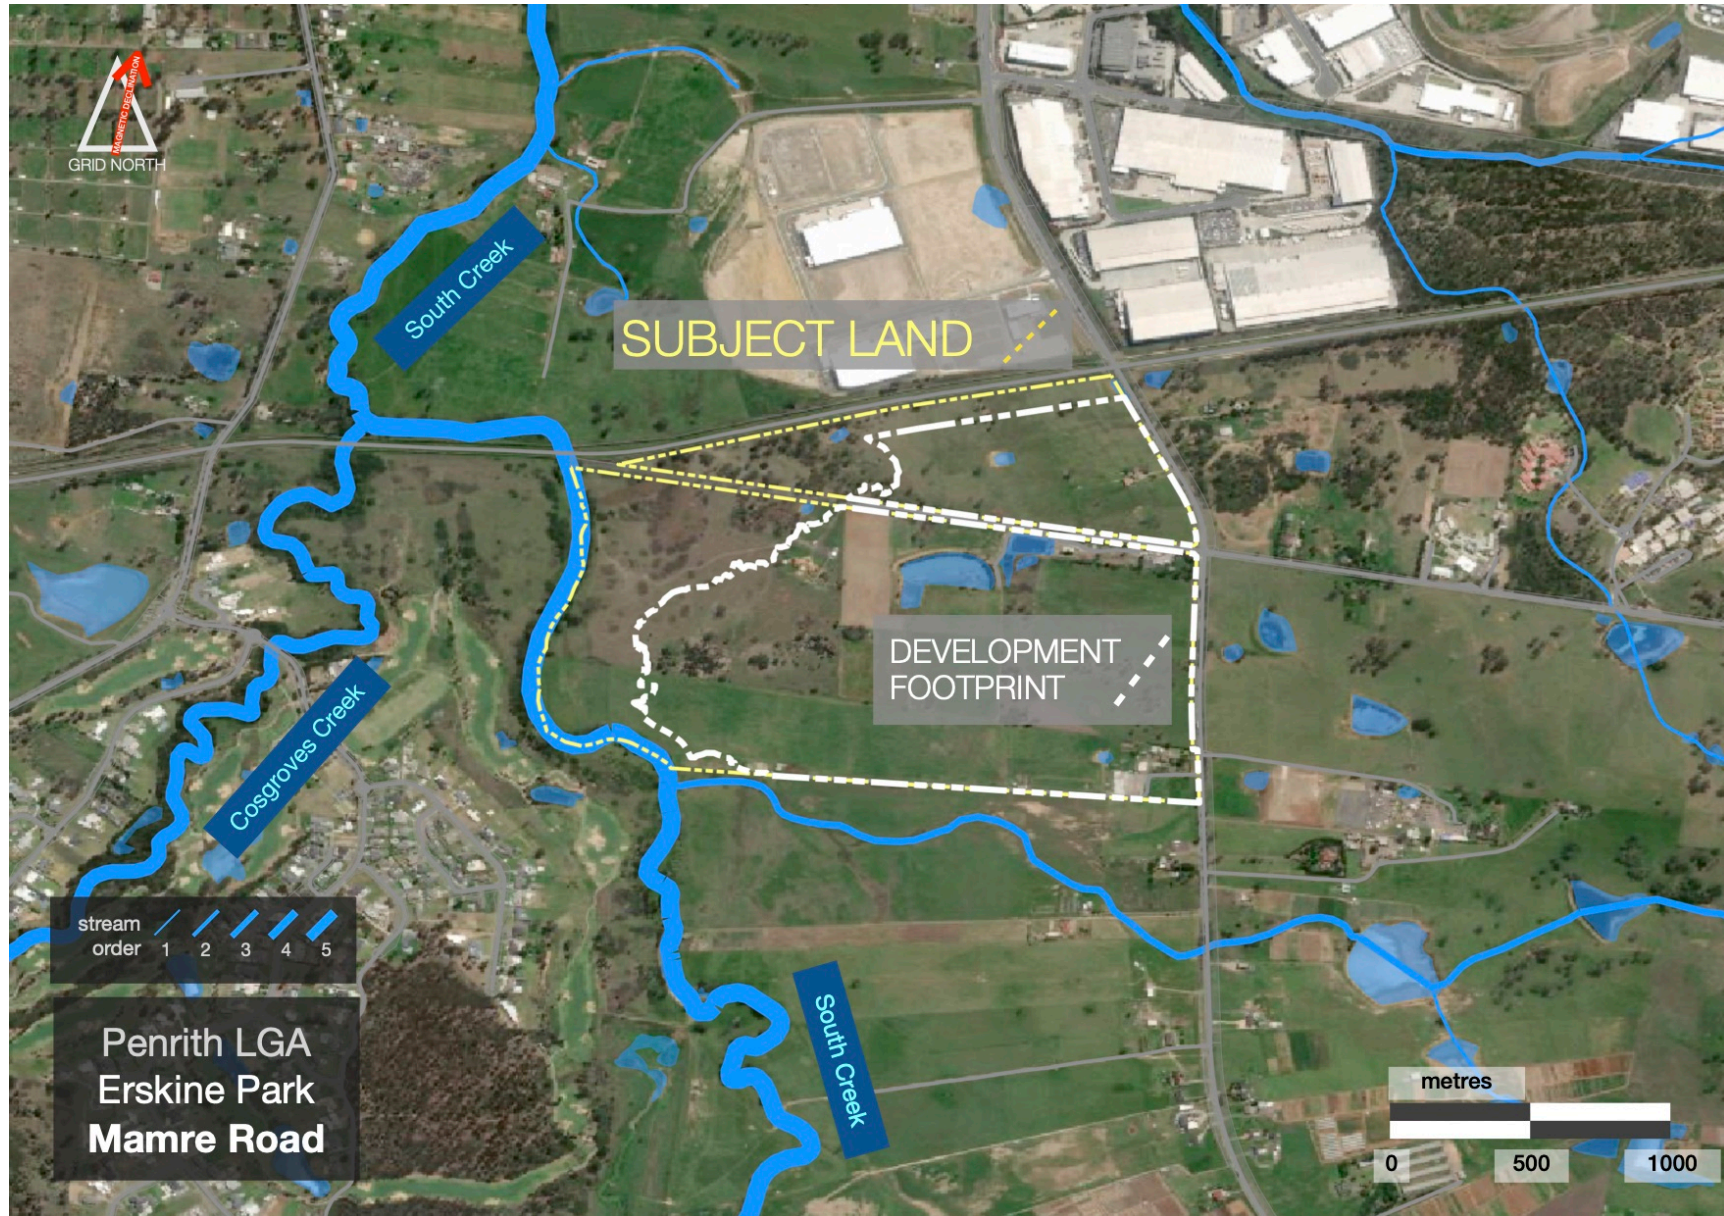
Figure 1: Aerial photograph location of subject land (yellow border), proposed development footprint (white border) and significant waterways.

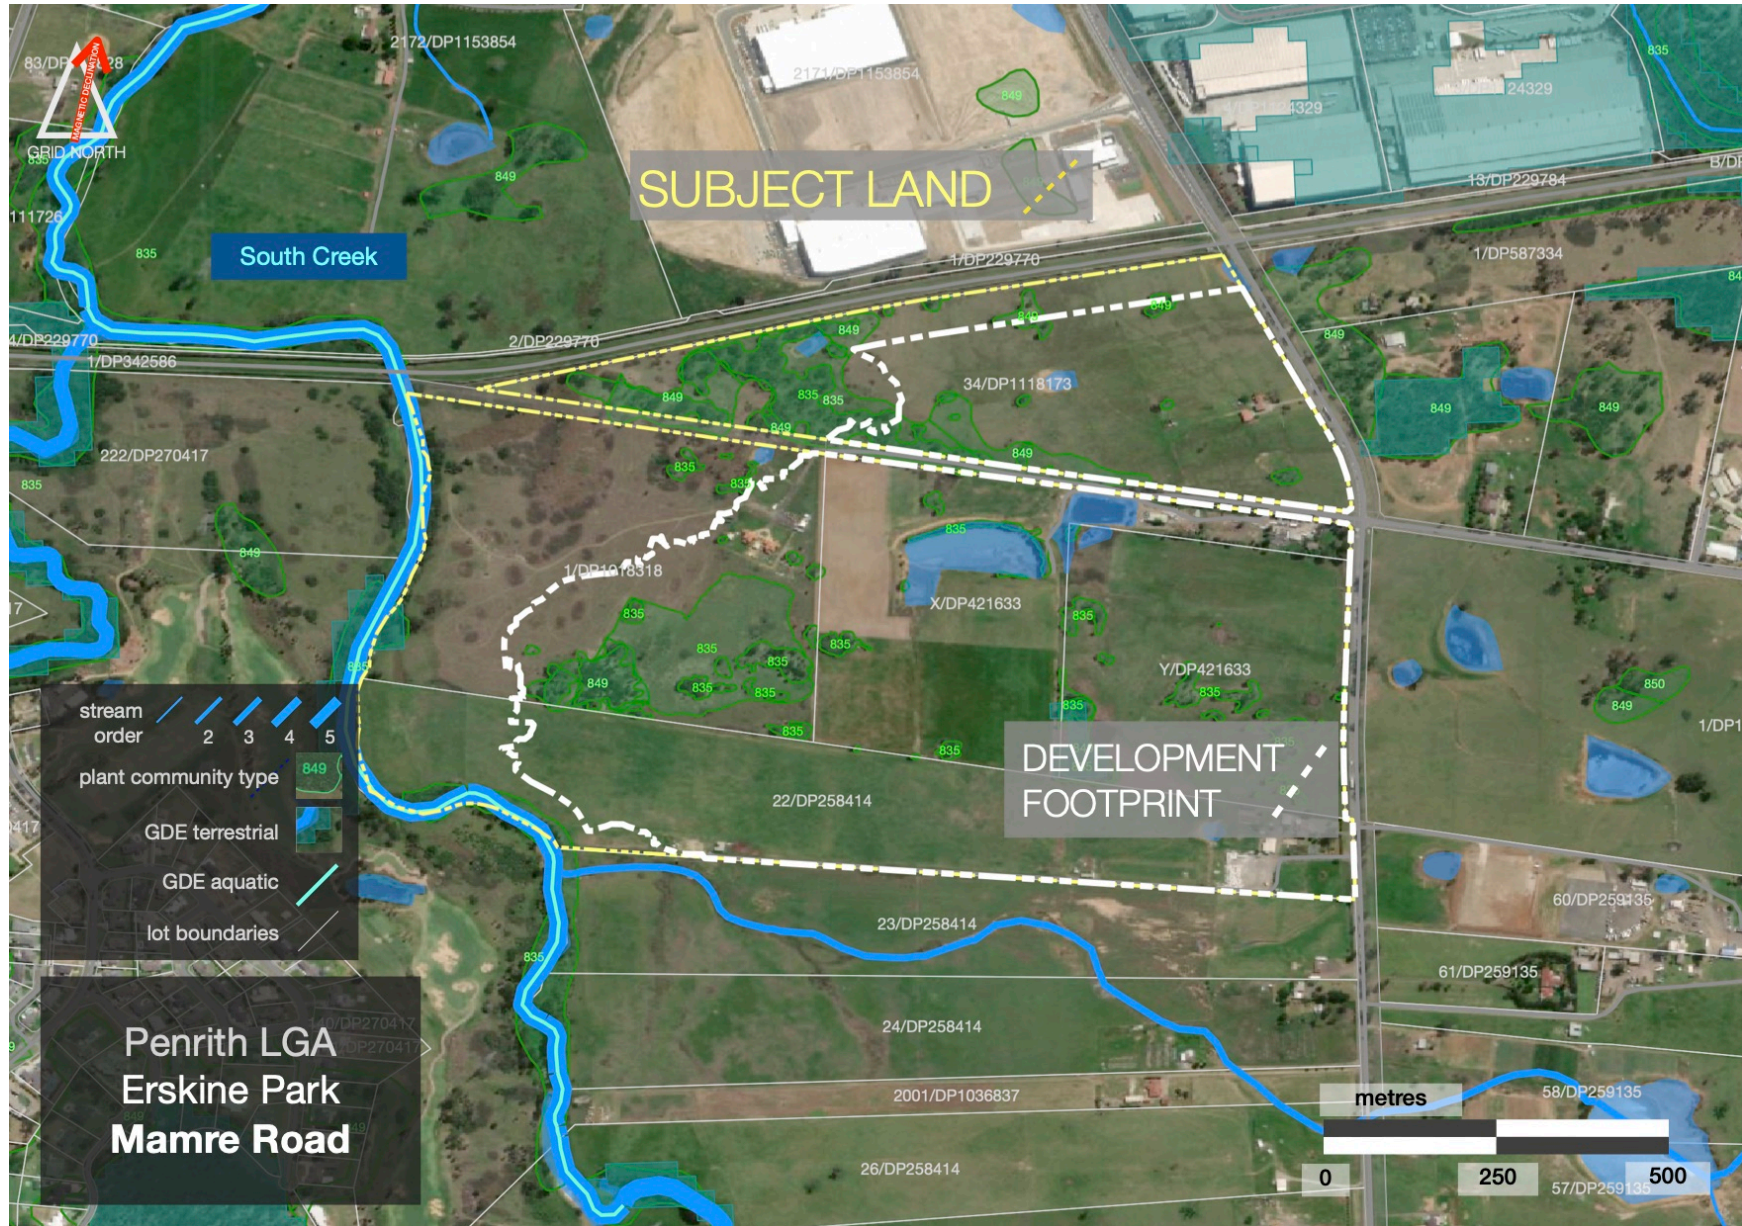
Figure 2: Subject land, waterways, mapped native vegetation and groundwater dependent ecosystems (GDE).

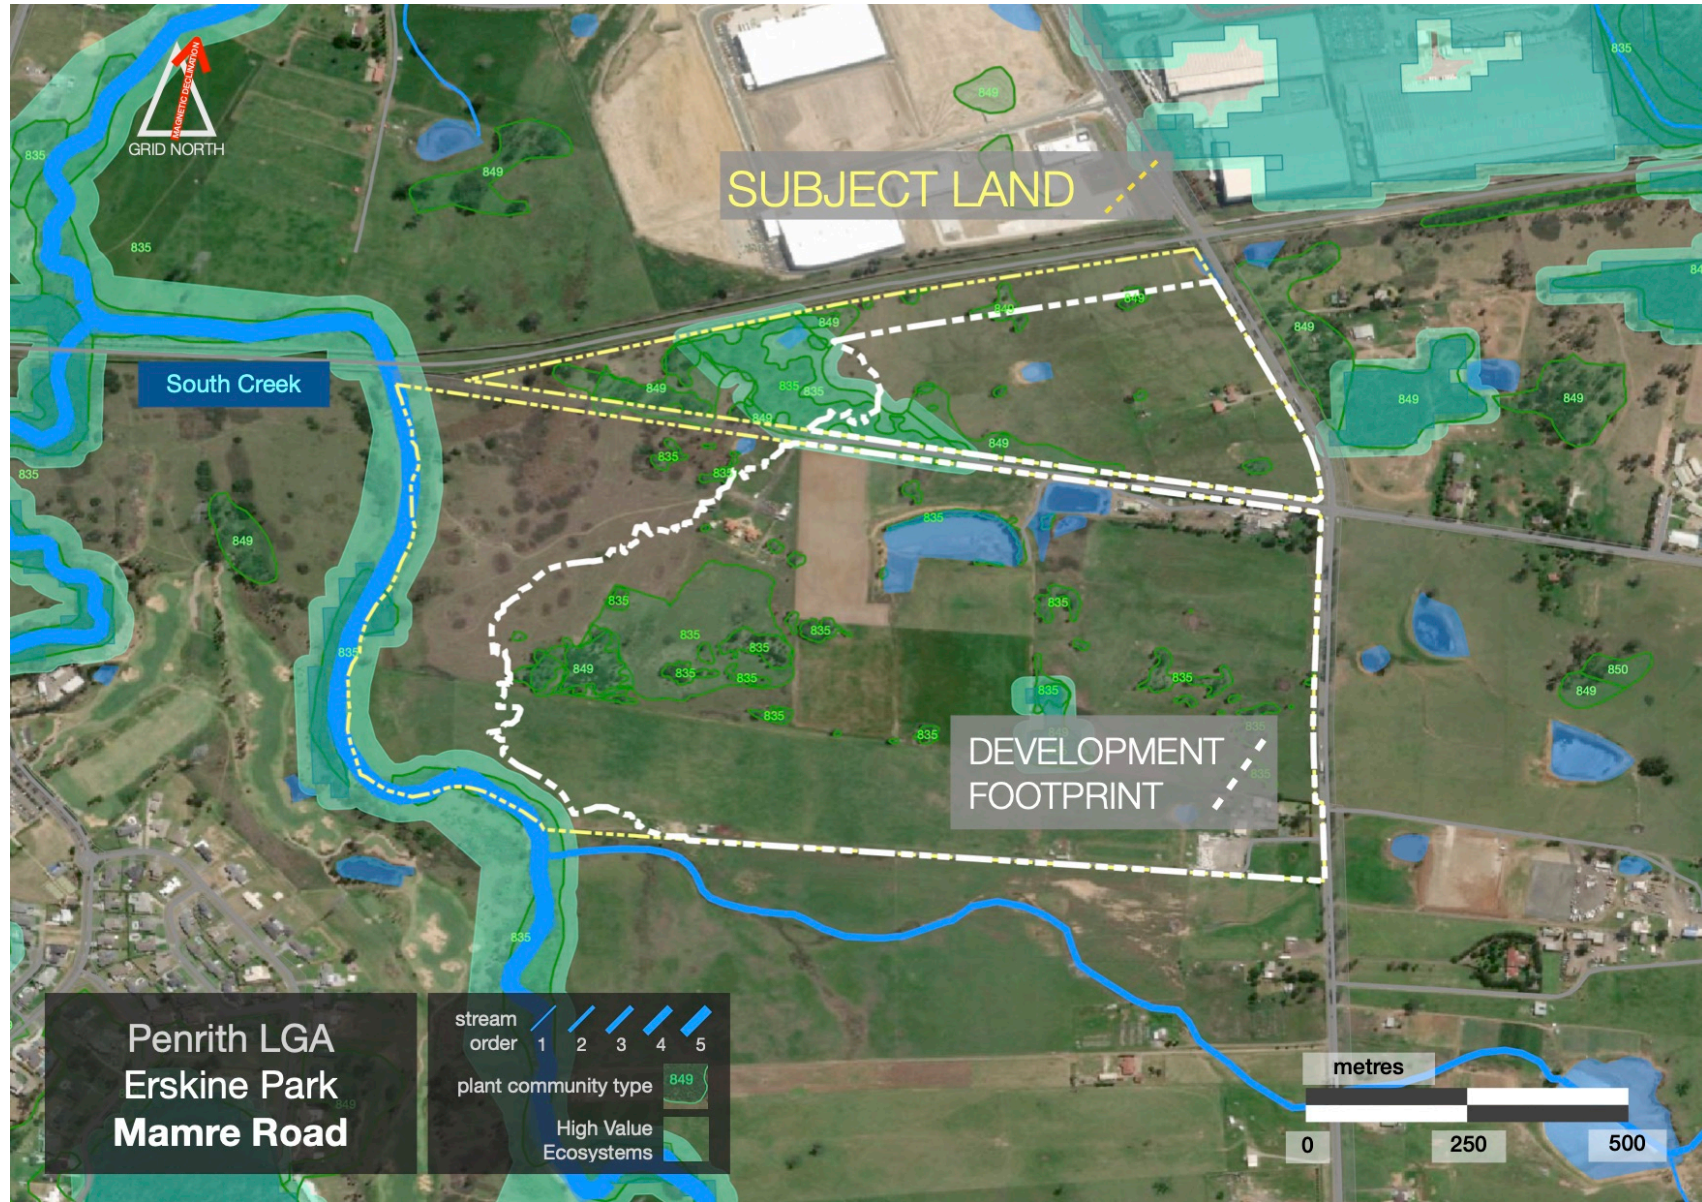
Review of HEV mapping for Penrith LGA (DPIE 2019) shows the South Creek corridor and the patch of PCT 835 within the subject site is considered as High Ecological Value and Water Dependent Ecosystems (Figure 3).

Figure 3: High Ecological Value and Water Dependent Ecosystem (DPIE 2019) within and adjacent to the Subject Land

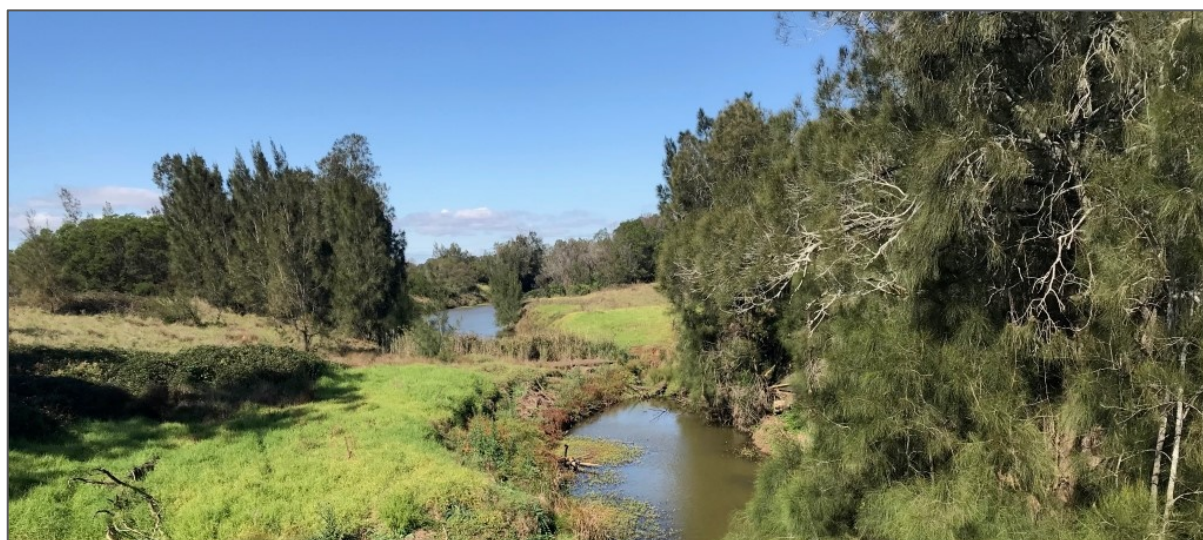
At the time of survey, flow in South Creek was not flowing around/under a historic weir/crossing point on South Creek. Under these flow conditions this structure provides a barrier to fish passage and is maintaining a deep weir pool on its upstream side (Figure 4).

Figure 4: South Creek at the subject land. Historical weir/crossing can be seen mid-image with upstream weir pool.

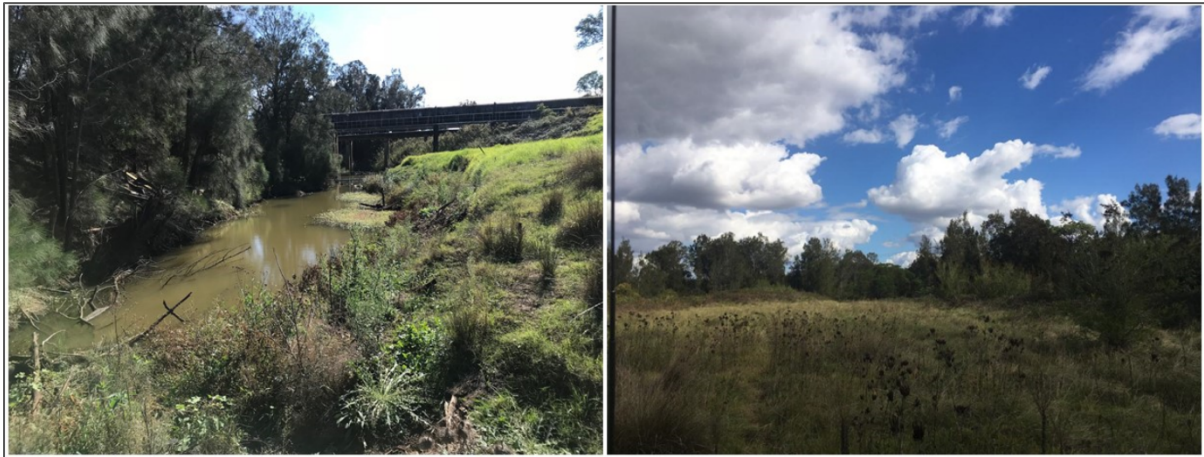
The site-walk over to validate the presence of GDE's and native vegetation confirmed that remnant patches of native vegetation mapped throughout the study area were also mapped as terrestrial GDE's. South Creek is mapped as an aquatic GDE, and at the time of assessment was not flowing and was reduced to a series of long pools of > 1 m in depth (Figure 6).

Figure 6: Photograph of aquatic GDE (left) and terrestrial GDE (right) in subject land.

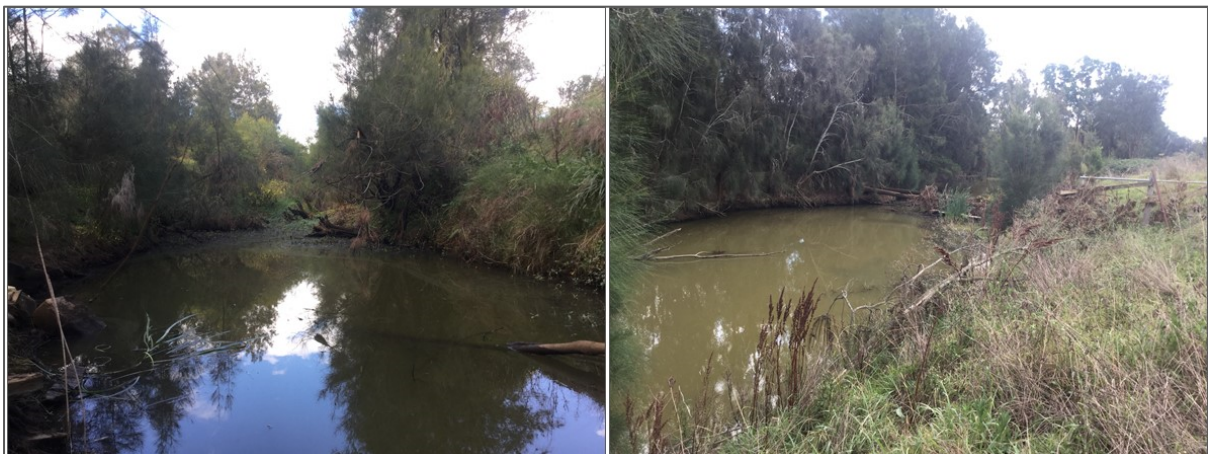
Assessment of KFH type and class following the framework set out by DPI Fisheries (2013) shows at the time of assessment the reach of South Creek within the subject land were classified as Type 1 – highly sensitive fish habitat, Class 2 – moderate key fish habitat.

Classification as Type 1 – highly sensitive fish habitat is due to the presence of instream large woody debris > 300 mm diameter and > 3 m in length and presence of native macrophytes in some areas. The determination of Class 2 – moderate key fish habitat is due to the intermittent flow observed at the time of survey and the presence of a clearly defined creek bed and banks with semi-permanent to permanent waters in pools (Figure 7).

Figure 7: Photographs showing Type 1, Class 2 KFH attributes for South Creek (right) within the subject land.

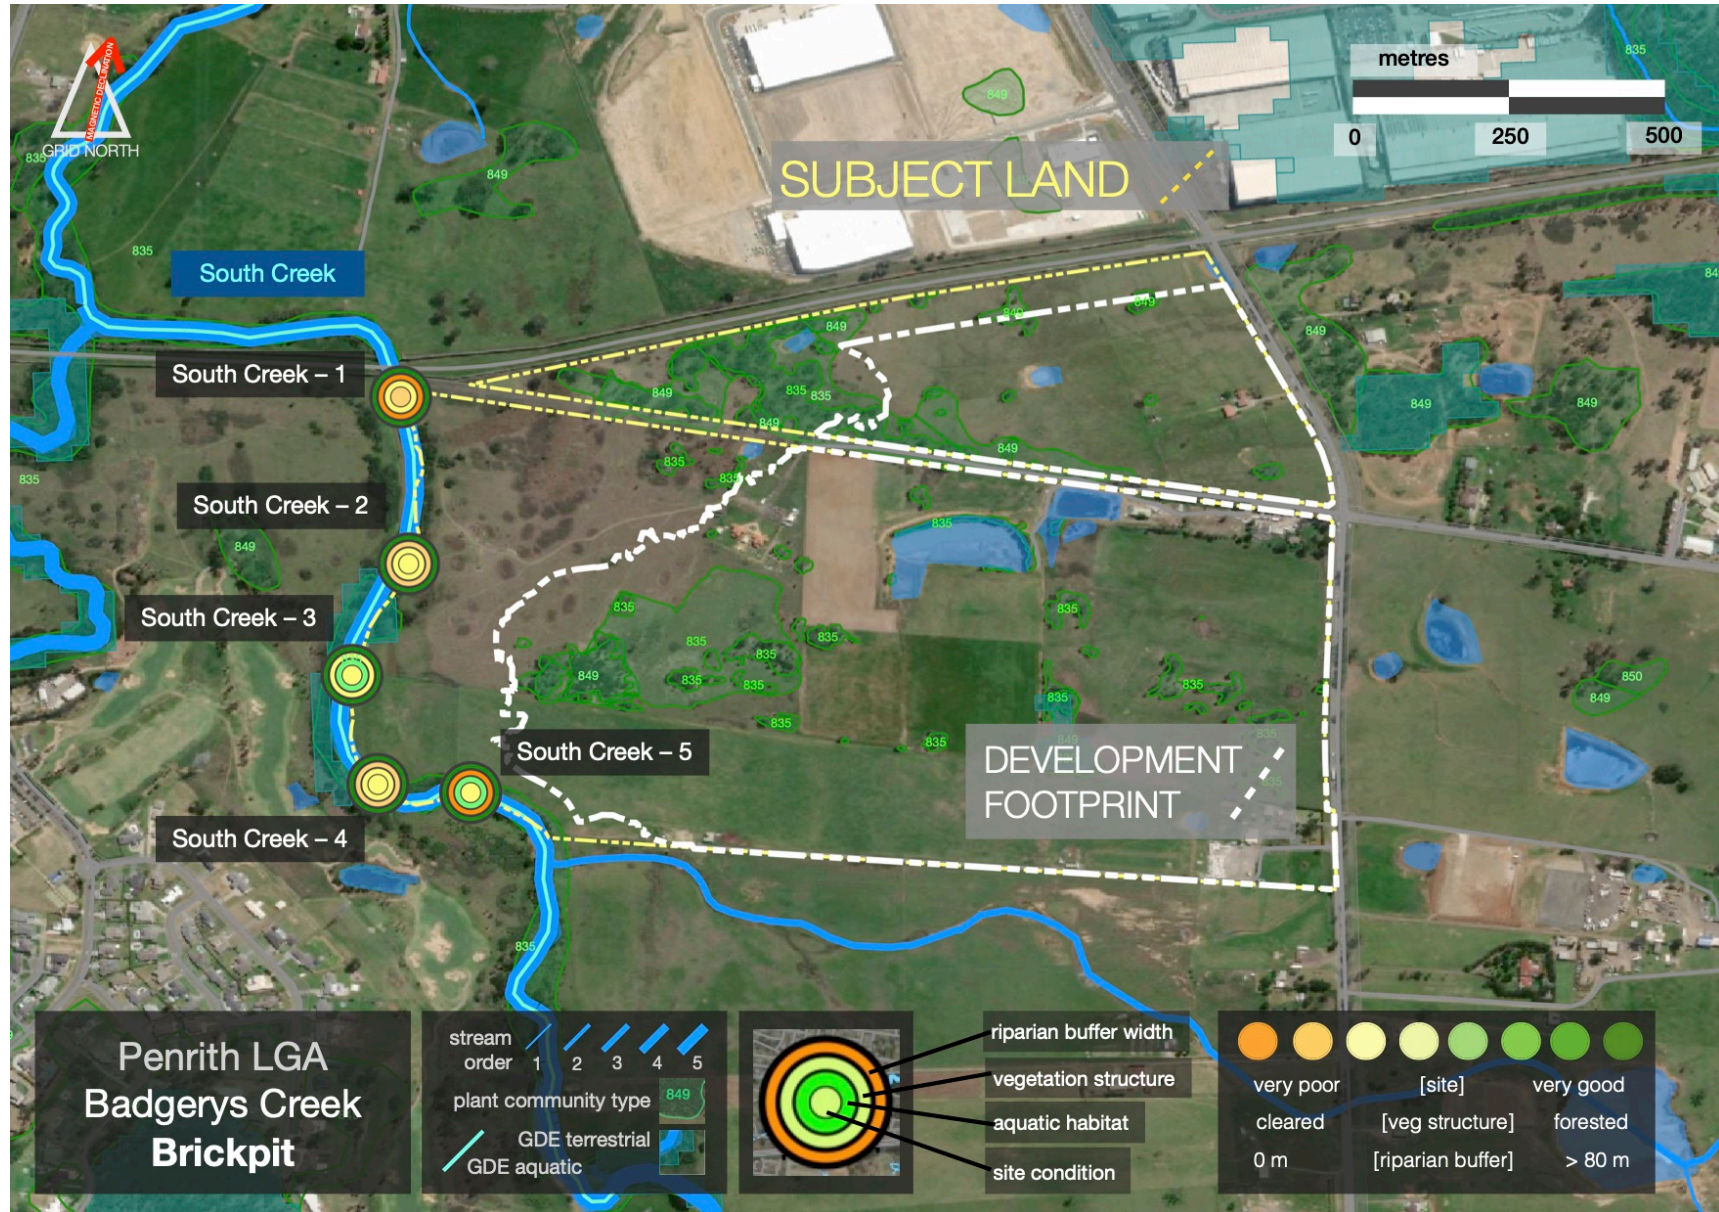
Results of the assessment of riparian vegetation and creek channel condition using the Rapid Riparian Appraisal (Findlay et al 2011) show the condition of assessment sites within the reach of South Creek in the subject land ranged from 'poor' to 'fair' (Table 3, Figure 8).

Site 1 was found to be in poor condition (Table 3, Figure 8), a result which reflects the surrounding landuse which is primarily pasture/grazing. The vegetation community within the 50 m assessment radius is dominated by exotic species with only a thin and scattered band of native vegetation present. A high degree of litter was recorded at the site and a significant bank slump was observed on the western bank which, if left unmanaged will increase in size and potentially threaten future infrastructure.

Sites 2 – 5 were found to be in fair condition (Table 3, Figure 8) which when compared to Site 1 reflects a more complex riparian vegetation matrix and a lesser degree of bank erosion. Although pasture/grazing land use was typical along the entire assessment reach, the percentage of the assessment area covered by this land use varied and contained a greater percentage of remnant native vegetation, less litter and less erosion.

Figure 8: Results of riparian vegetation and creek channel assessment using Rapid Riparian Appraisal (Findlay et al 2011).

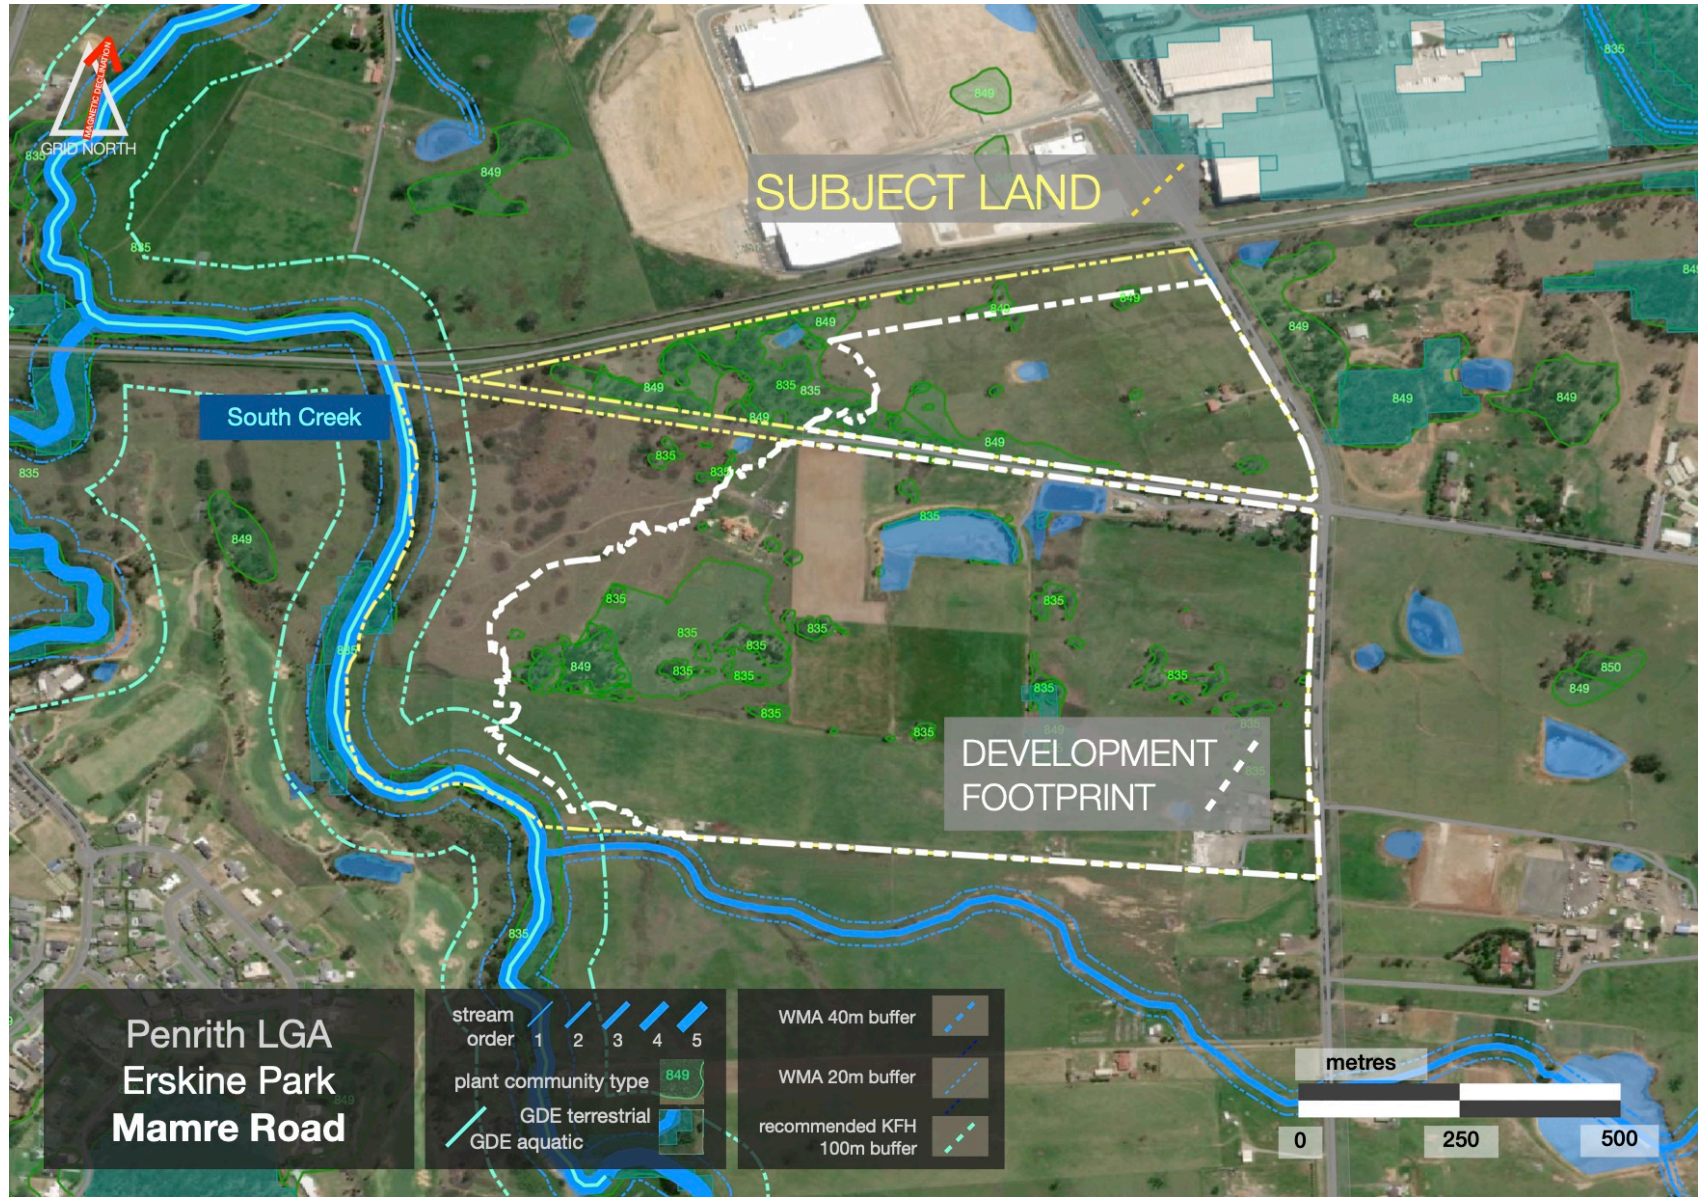
Due to South Creek being assessed as Type 1 – highly sensitive fish habitat, a 100 m VRZ is recommended to protect aquatic habitats in South Creek (Figure 10). It is unlikely the construction and operational phases of the proposed development will directly impact fish habitat as the development footprint does not encroach into the recommended 100 m VRZ. Therefore, no direct impacts to Key Fish habitat is expected.

Figure 10: Required VRZ as per NSW Water Management Act (2000) and recommended Key Fish Habitat VRZ as per NSW DPI (2013). Note buffers on this map are measured from the centre of the creek channel as top of bank was not surveyed as part of this study. Therefore, it is likely the official VRZ as measured from top of bank will extend further into the study area.

**1. Establish appropriate Vegetated Riparian Zones (VRZ).** To protect GDE's, KFH and riparian vegetation it is recommended appropriate VRZ's are established along South Creek corridor. Under the Strahler system of stream ordering South Creek is classed as a 5<sup>th</sup> Order stream and therefore to comply with requirements of the *NSW Water Management Act (2000)* a 40 m VRZ from top of bank is required to be maintained along South Creek. Liaison with NSW Office of Water may be required if implementation of the averaging rule is proposed. Liaison with NSW Office of Water will also be required if stormwater infrastructure is proposed to be constructed within the VRZ as this will be considered a controlled activity as per the *NSW Management Act (2000)* and disturbance of the creek bed and bank will require consent from DPI Fisheries as per *NSW Fisheries Management Act (1994)*.

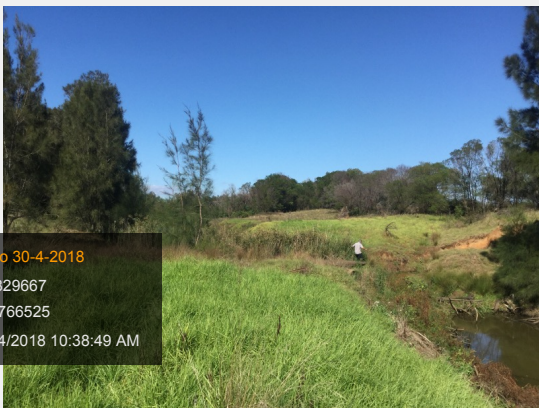
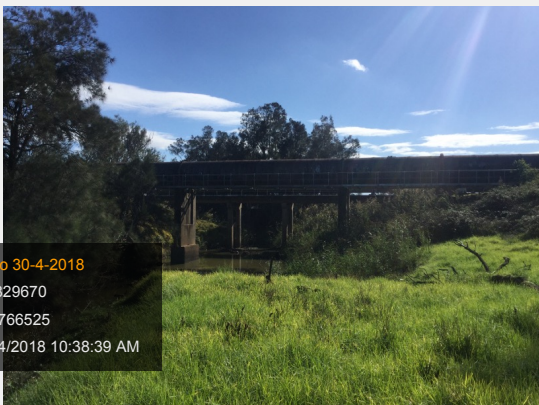
The site is in poor condition, with a score of -2.1 overall. The bed type is natural bed clay - Nvc. The bank type is natural vegetation - Nveg. Assessment point approx 50 upstream of SW pipeline. Weir/ old crossing obstructing creek and fish passage. Bank slump.

Within the 50 metre assessment radius, left bank vegetation structure is 80% pasture grassland, 20% derived native shrubland, approximately. Right bank vegetation structure is 10% forest/woodland, 60% pasture grassland, 30% weed/exotic, approximately. This is reflected in the vegetation structure subtotal.

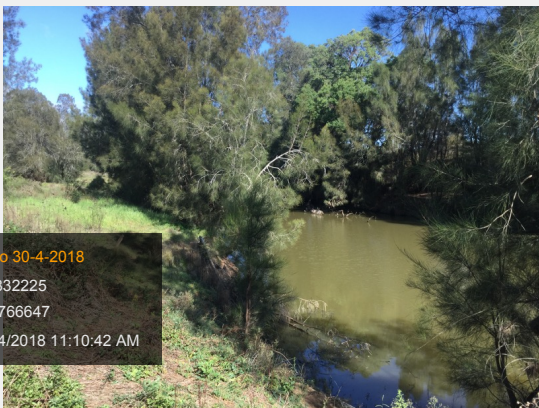
The site is in fair condition, with a score of 12.45 overall. The bed type is natural bed clay - Nvc. The bank type is natural vegetation - Nveg. Observed: Carp and Goldfish.

Within the 50 metre assessment radius, left bank vegetation structure is 10% forest/woodland, 90% pasture grassland, approximately. Right bank vegetation structure is 10% forest/woodland, 20% derived native shrubland, 70% pasture grassland, approximately. This is reflected in the vegetation structure subtotal.

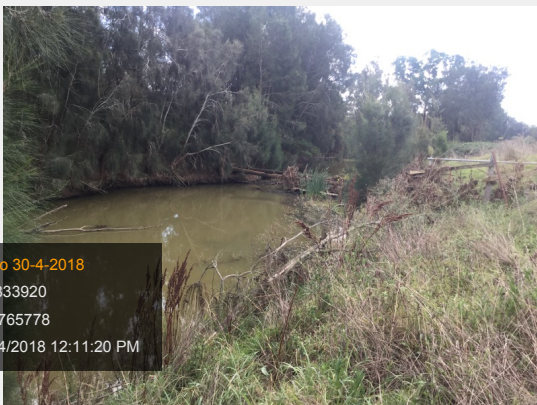
Within the 50 metre assessment radius, left bank vegetation structure is 40% forest/woodland, 40% pasture grassland, 10% weed/exotic, 10% derived native shrubland, approximately. Right bank vegetation structure is 10% derived native shrubland, 70% pasture grassland, 20% weed/exotic, approximately. This is reflected in the vegetation structure subtotal.

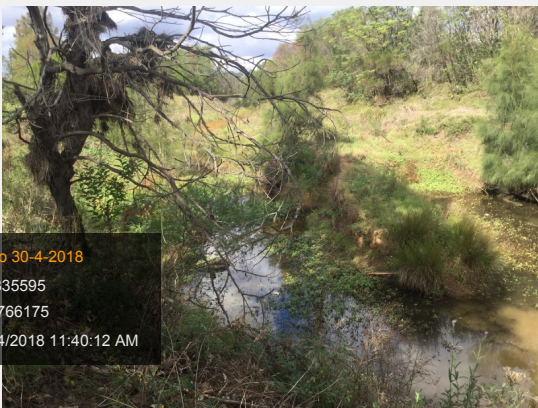
Within the 50 metre assessment radius, left bank vegetation structure is 20% forest/woodland, 50% pasture grassland, 10% derived native shrubland, 20% weed/exotic, approximately. Right bank vegetation structure is 10% forest/woodland, 20% derived native shrubland, 60% pasture grassland, 10% weed/exotic, approximately. This is reflected in the vegetation structure subtotal.

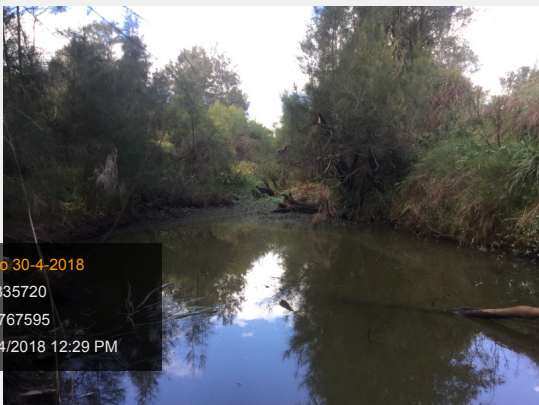
Within the 50 metre assessment radius, left bank vegetation structure is 10% derived native shrubland, 90% pasture grassland, approximately. Right bank vegetation structure is 10% forest/ woodland, 10% derived native shrubland, 80% pasture grassland, approximately. This is reflected in the vegetation structure subtotal.

extraction	absent	▼
excavation	absent	▼
litter	med 6-20	▼
sewer/stormwater	absent	▼
odour	normal/none	▼
turbidity	high	▼
