Eastern Creek Resource Recovery Facility

Addendum Due Diligence Archaeological Assessment

December 2021

Document description: Addendum due diligence assessment

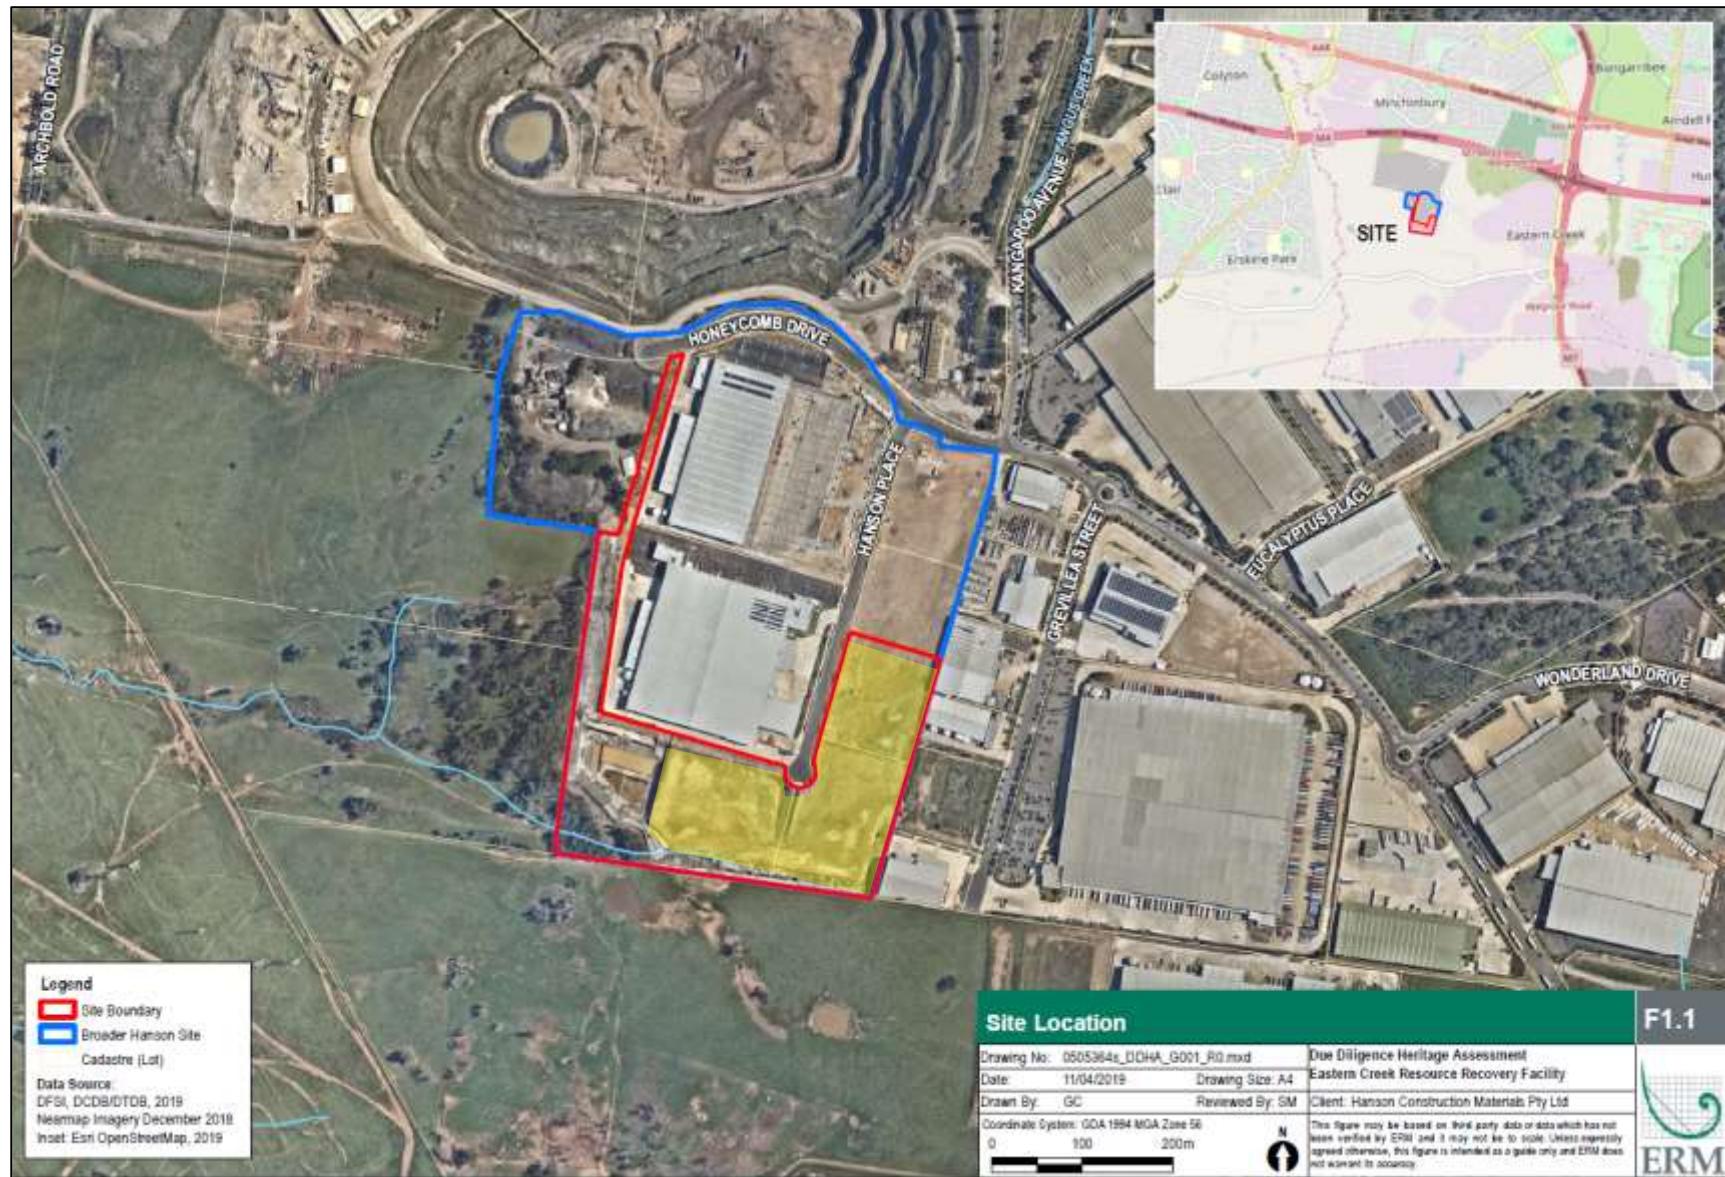
Figure 1.1 Site location (from ERM 2021), current project impact area shaded yellow

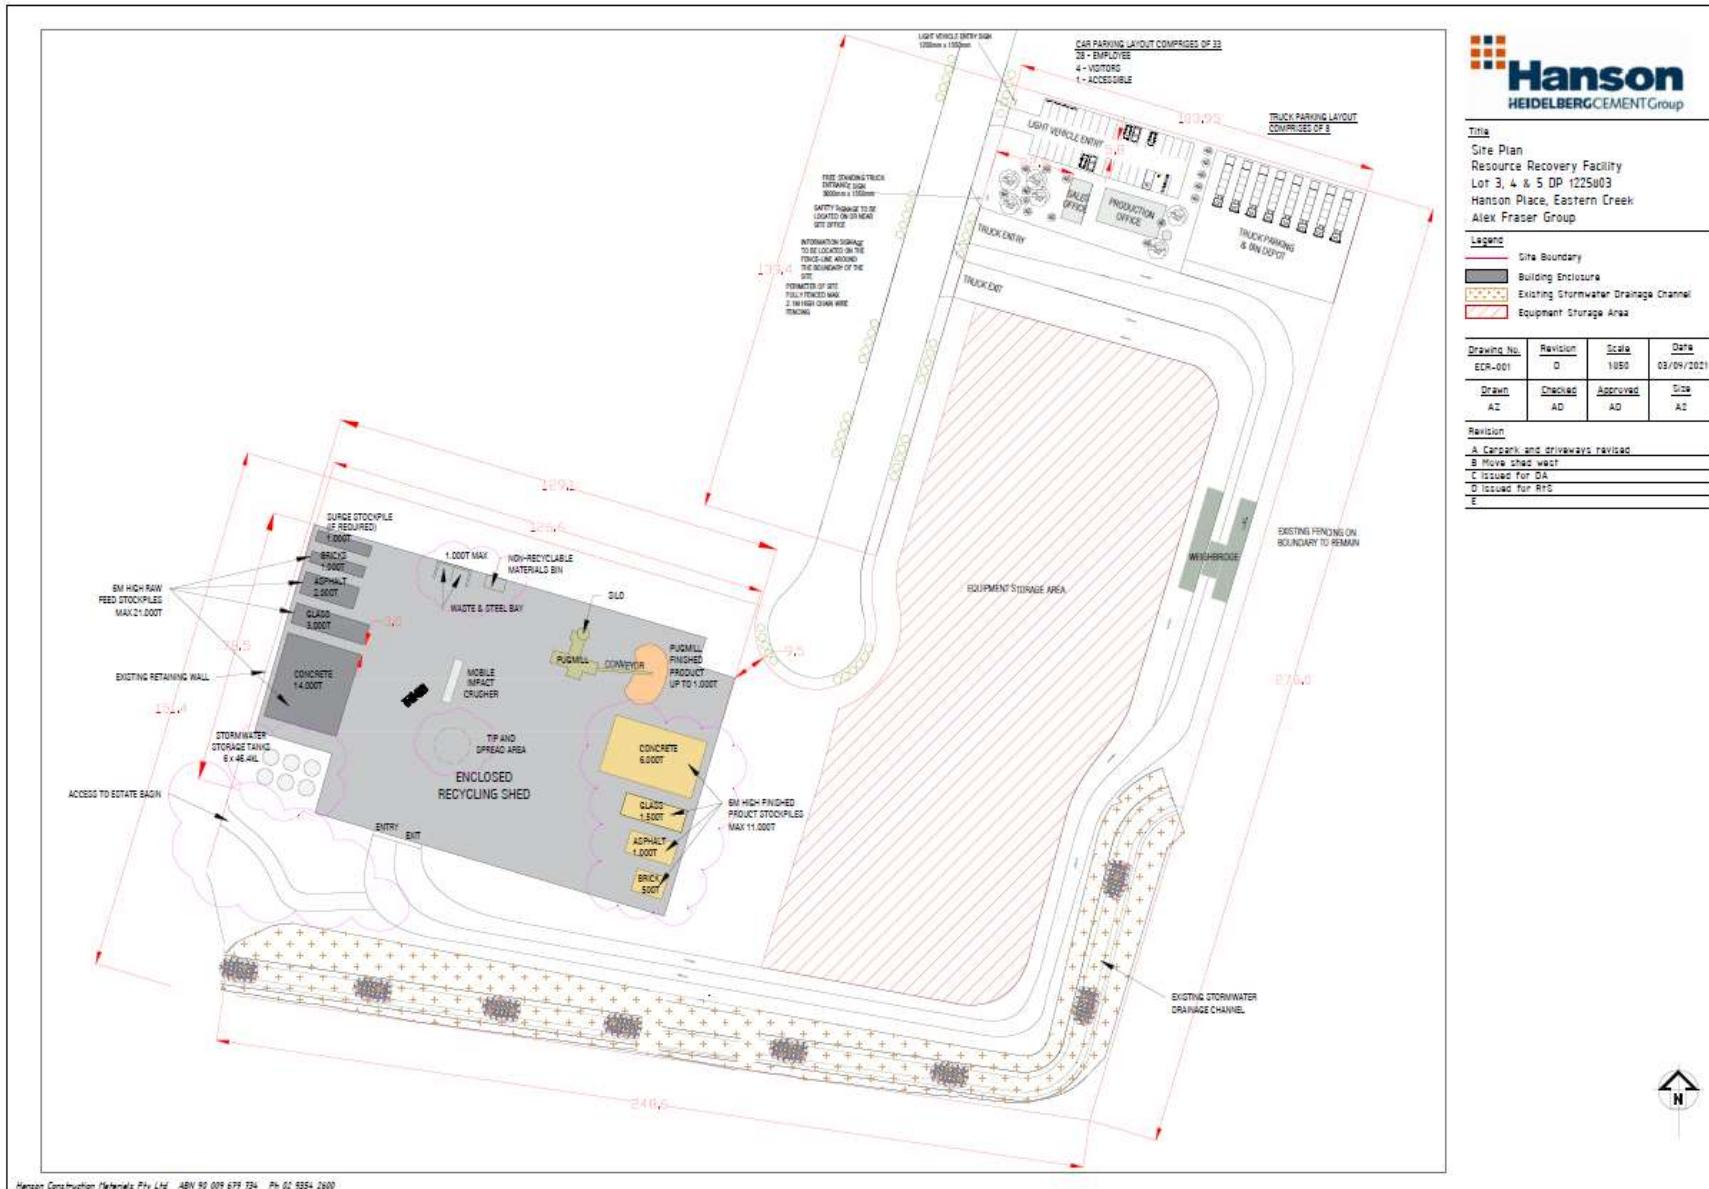
The site is located approximately 1km south of the M4 Western Motorway, and 5km west of Prospect Reservoir and is identified as Lots 3, 4 and 5 in DP1225803, and is one part of a larger site owned and operated by Hanson. The project involves the construction of a recycling facility wholly within the area that has been impacted by the above concept approval. No new ground disturbing works will be undertaken (Figure 1.2).

Figure 1.2 Current project development plan showing area of impact

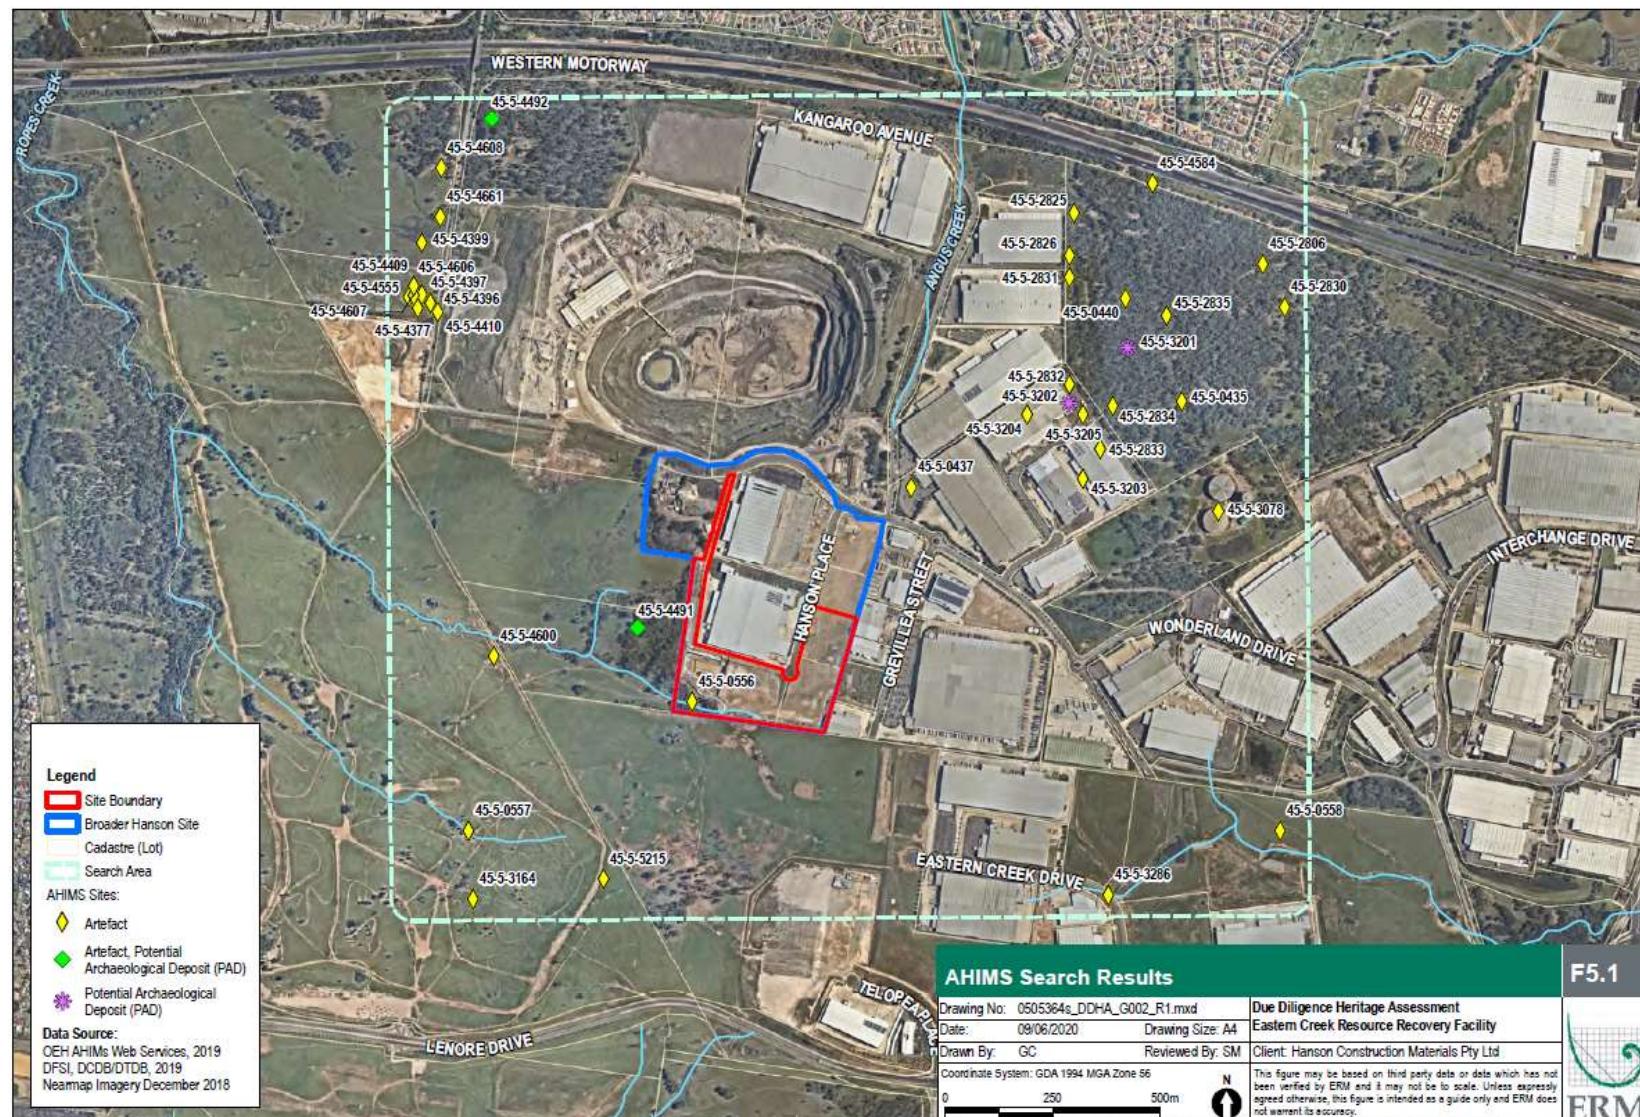
ERM completed an extensive search of the AHIMS database in 2019. 39 Aboriginal recordings are in the search area (Figure 2.1). One of these sites, #45-5-0556 is located in the wider Hanson project area.

Figure 2.1 AHIMS Search Result's ERM 2021

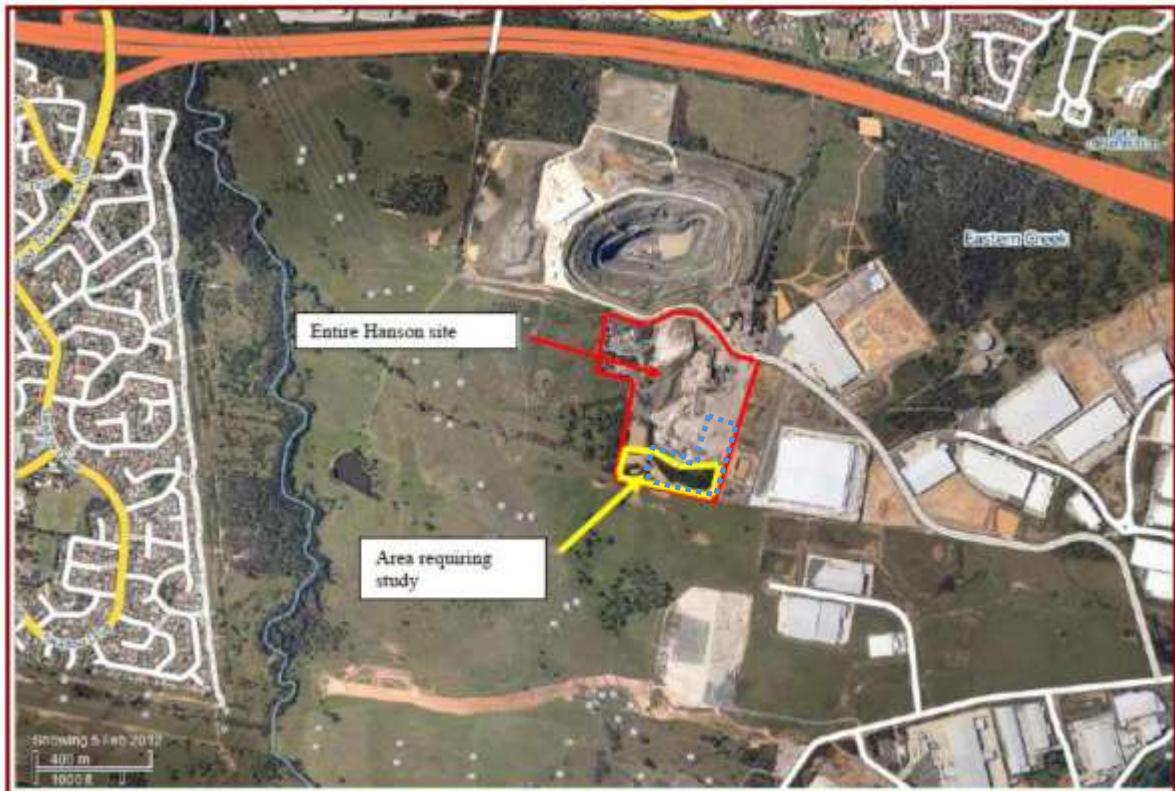
In 2012, Archaeological and Heritage Management Solutions (AHMS) completed an Aboriginal cultural heritage assessment of the Hanson Asphalt and concrete Facility. This project included part of the current project area where impact from the then asphalt and concrete facility had not occurred (Figure 2.2). The assessment was undertaken for the proposed modification to the Hanson Asphalt and Concrete Facility. The Hanson Asphalt and Concrete Facility had Concept Plan and Project Approval (06_0225) under Part 3A of the Environmental Planning and Assessment Act 1979 (EP&A Act). Hanson was seeking to modify the Concept Masterplan under Section 75W of the EP&A Act.

Figure 2.2 Area subject to assessment by AHMS 2012 (figure 2) and current project area (blue dotted line)

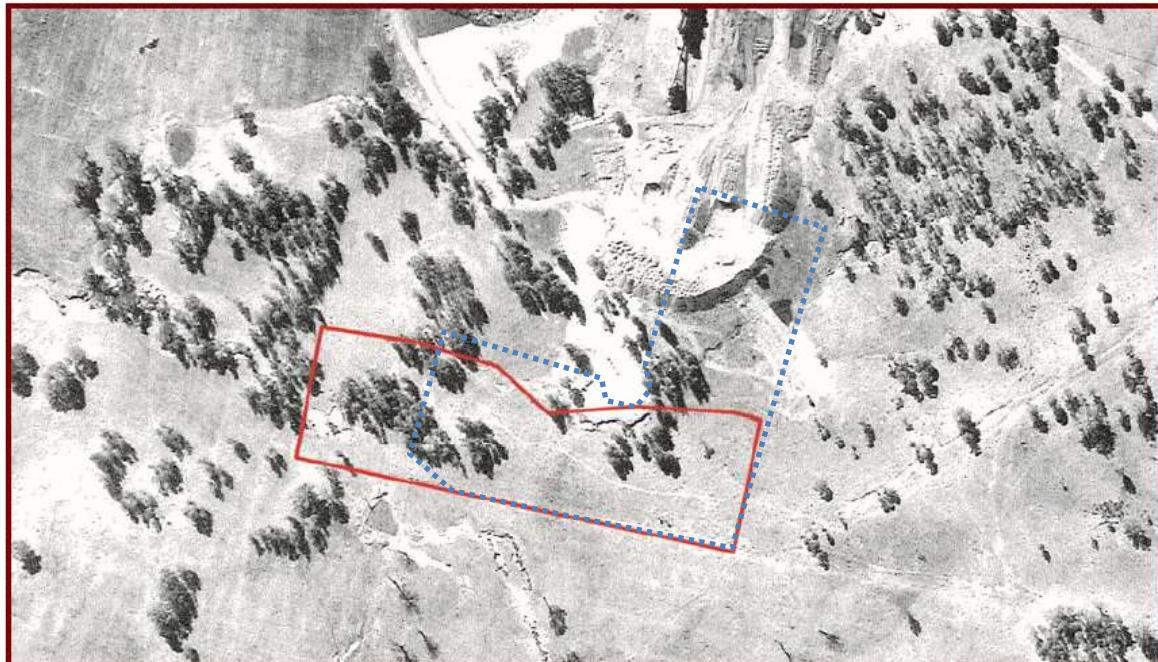
As detailed in the AHMS ACHAR the wider Hanson block has undergone extensive impact from the industrial uses and the recent development of the site. The 1965 aerial image show the use of the area as a quarry/processing facility (Figure 3.1). The project area was used for this purpose for many years and expanded as can be seen in the 2006 aerial image (Figure 3.2). The 2017 aerial image shows the works following the project modification in 2012 (Figure 3.3) and the 2018 aerial shows the surrounding development (Figure 3.4)

Figure 3.1 1965 aerial photograph with the approximate location of the 2012 assessment area marked in red, and current project area in blue dotted line
(Land and Property Information Services)

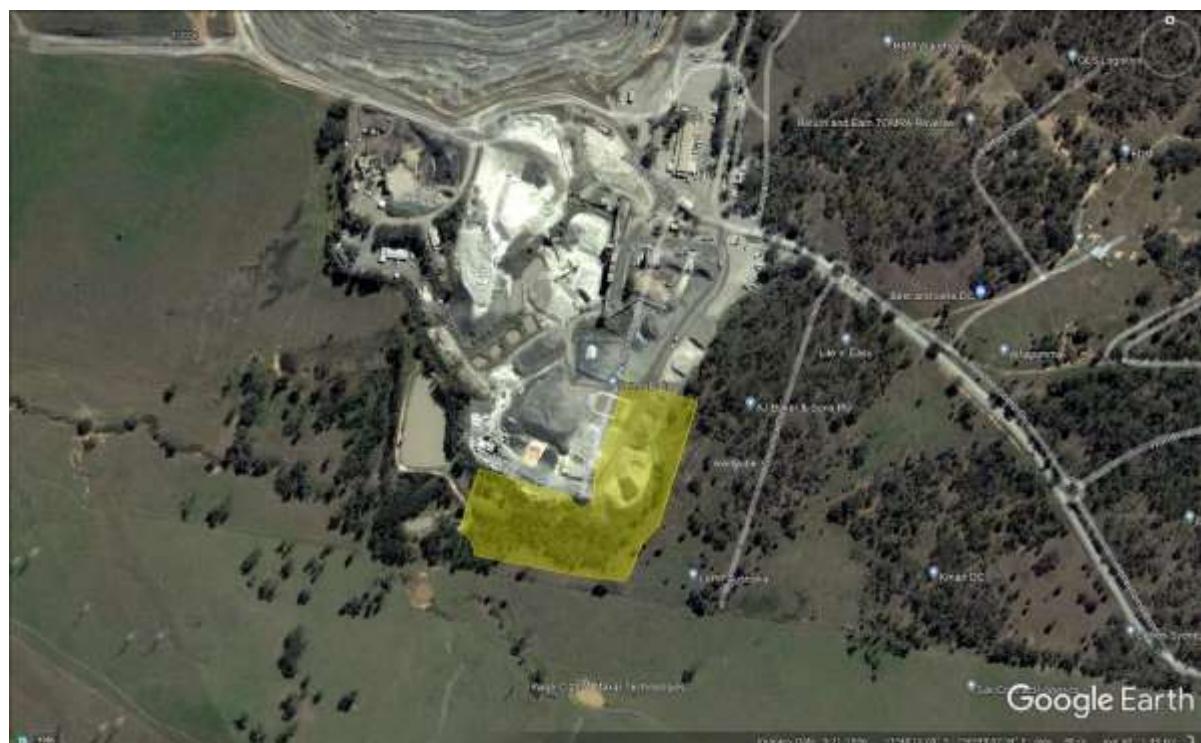
Figure 3.2 Current project area (yellow) and 2006 aerial image (Google Earth 2021)

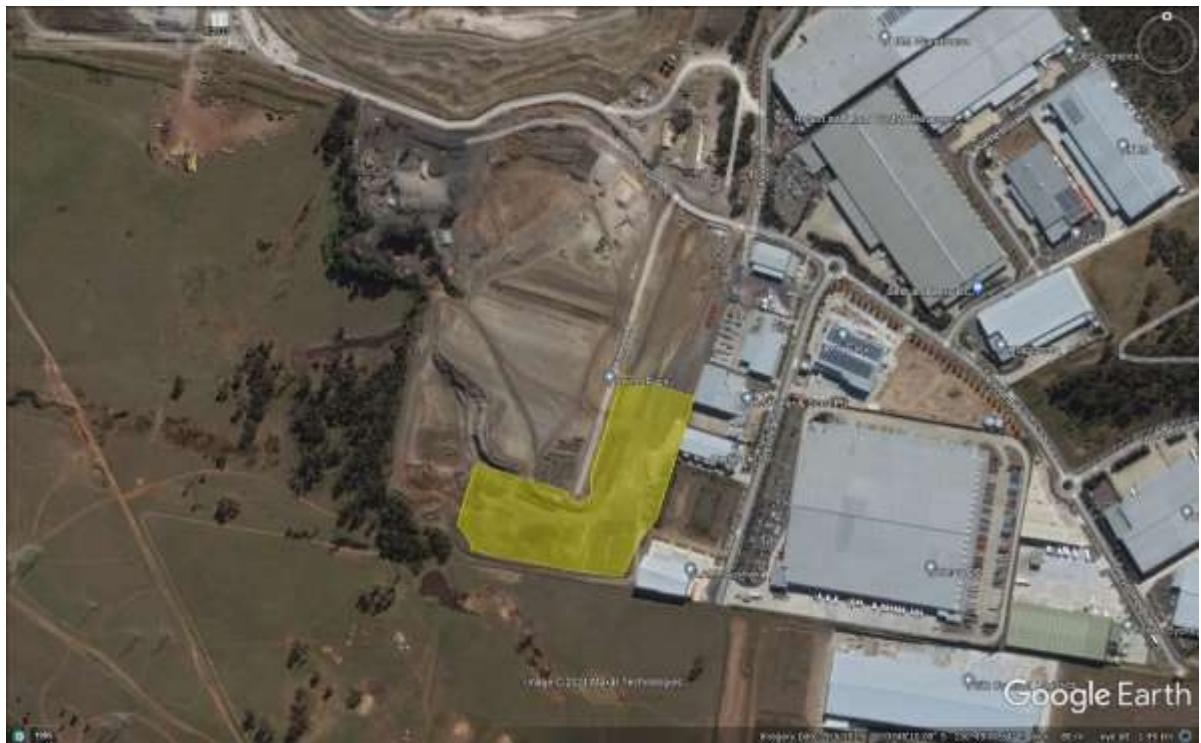
Figure 3.3 Current project area (yellow) and 2017 aerial image (Google Earth 2021)

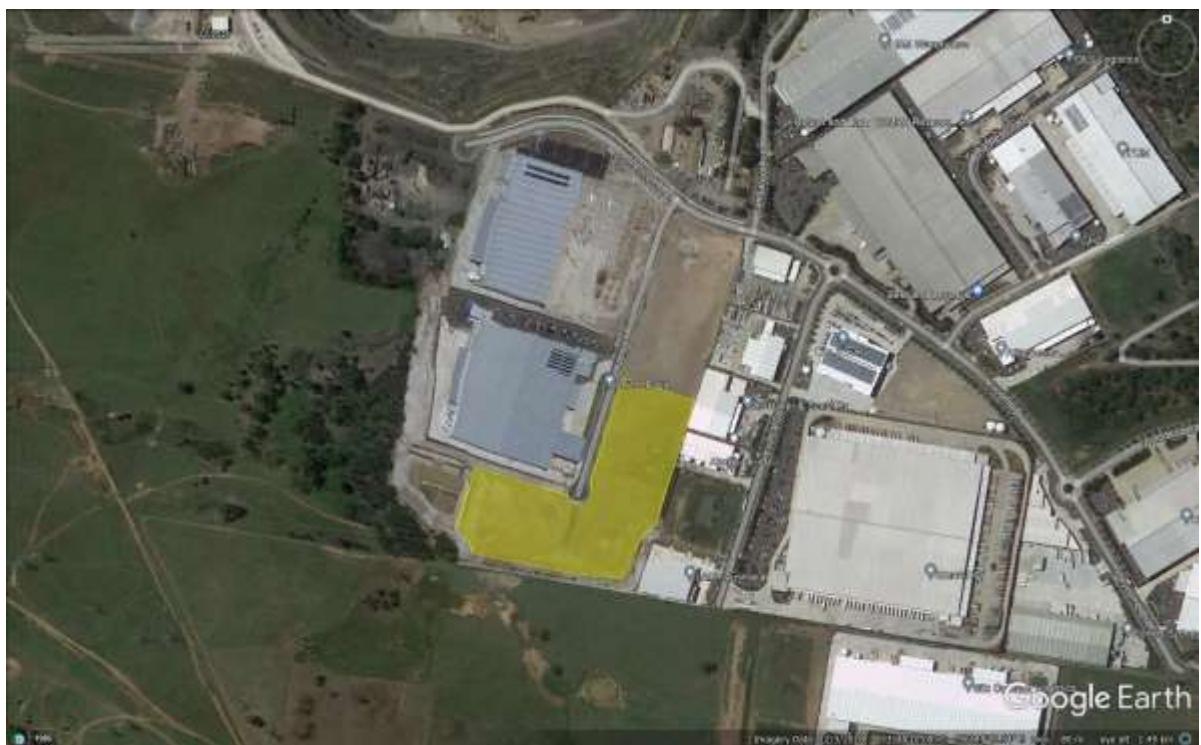
Figure 3.4 Current project area (yellow) and 2018 aerial image (Google Earth 2021)

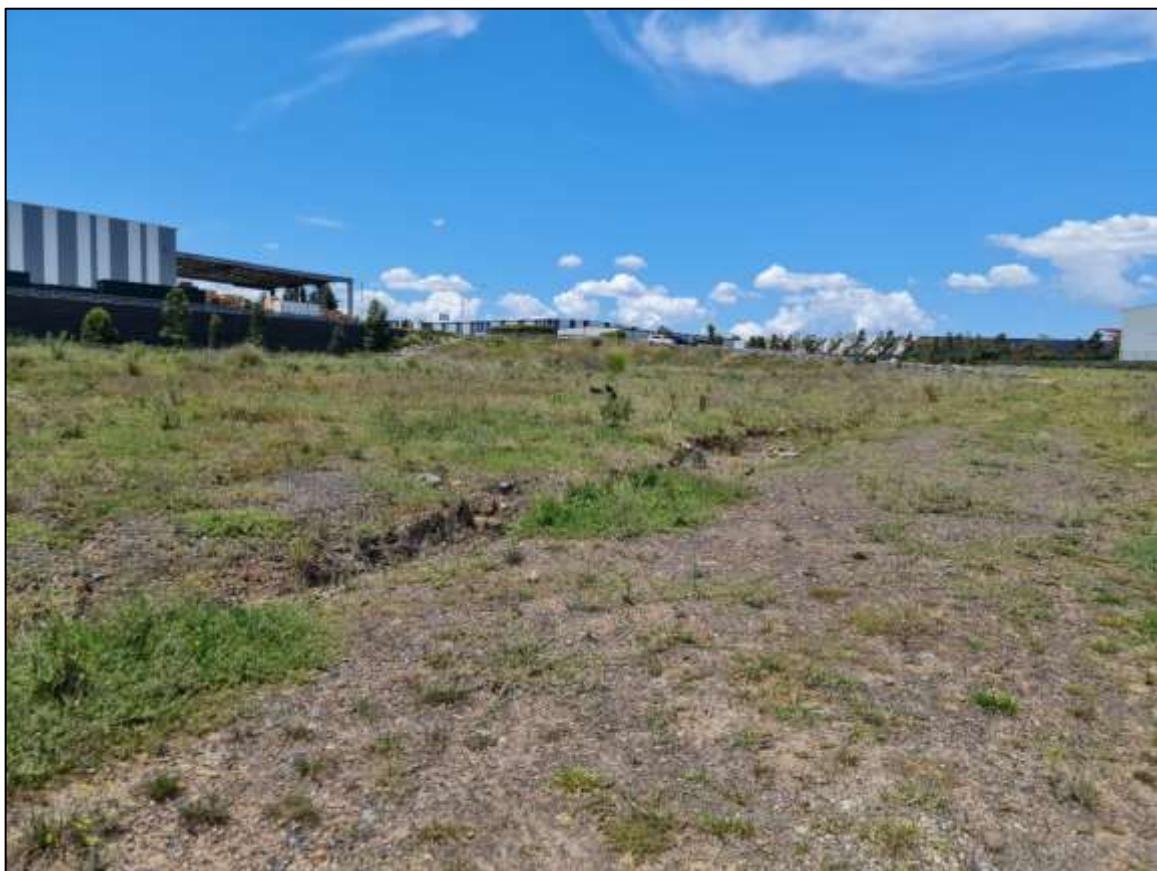
The northern third of the property to the east of the road has been filled and there is approximately 1.5 – 2 metre drop to the remaining 2/3 of that rectangular block. The southern block (at right angles to the other) has also been filled. There is a 4 metre drop from the existing factory on the northern boundary to this block which is a black besa-block wall. A large erosion rill could be seen running through the fill.

Figure 4.1 Project area looking back to the entrance from the south-west corner, note erosion rill through the fill

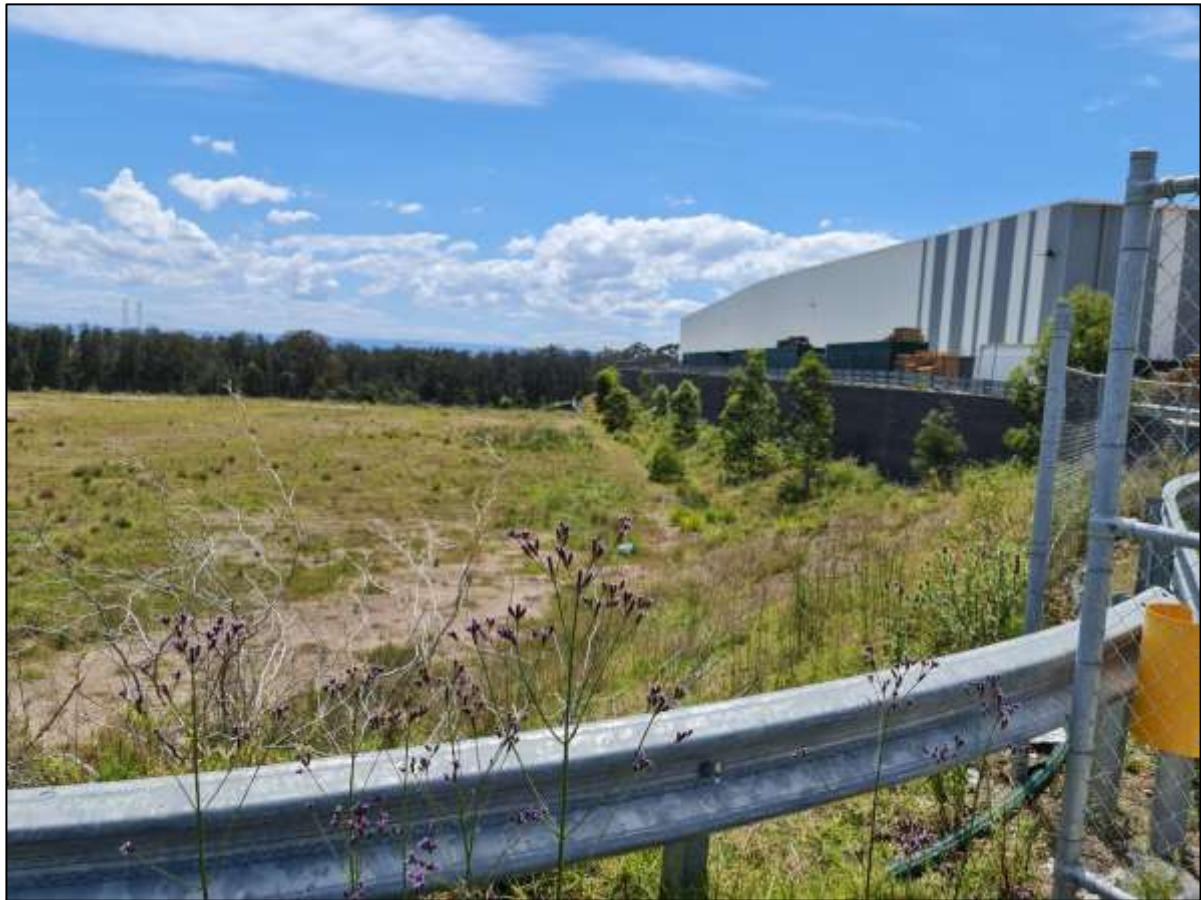
Figure 4.2 Looking west along the northern boundary

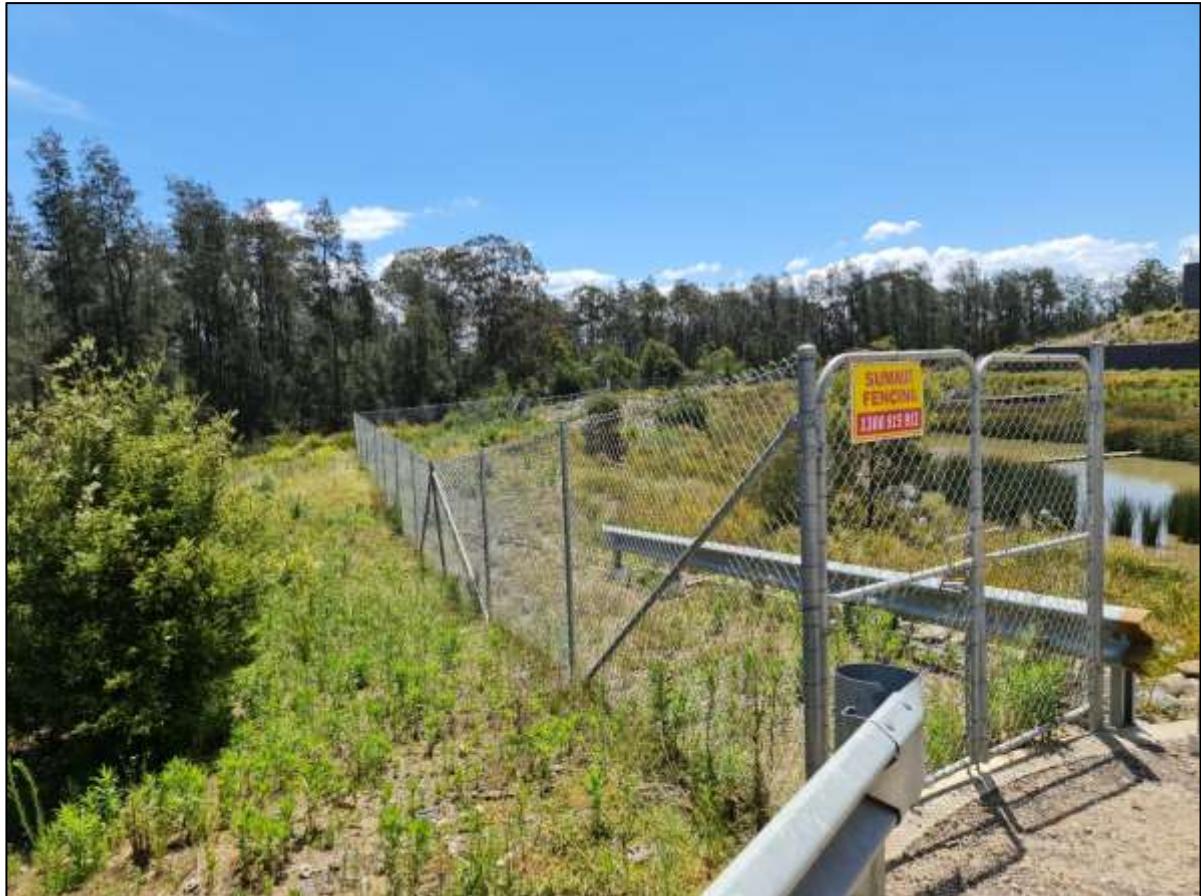
In order to determine the condition of AHIMS site #45-5-0556, the south-west corner of the property was inspected where a short stretch of concrete road extends from what is almost a small concrete viewing area bounded on the western side by a safety barrier. The concrete road extends to a locked gate on the dam wall. The Conservation zone is a riparian management area comprising a dam to catch surface run off. The dam wall (between Dam and Creek) appears to coincide with the location of AHIMS site #45-5-0556. The original recording states that the site is adjacent to a dam, the area is currently swampy and covered in vegetation. This is the same as the AHMS 2012 report which stated that the location of the site was in a swampy waterlogged area surrounded by dense vegetation (pp47). The site area has therefore not been impacted since its visitation in 2012 and since the surrounding development has occurred.

Figure 4.3 View across location of recorded AHIMS site #45-5-0556

The recommendations from ERM 2021 stand and include that in the event that items of heritage value are identified during construction works that an unexpected finds protocol be implemented on site. This protocol would include the following key elements:

- In the unlikely event that heritage items, archaeological objects, or Aboriginal objects are located within the Site, works should cease immediately;
- The location of the finds should be cordoned off and a suitably qualified heritage consultant should be contacted; and
- Works will only recommence once the area has been cleared by further assessment.
