Our Ref: PSM3750-006L

**RE: SCHOOL INFRASTRUCTRE NSW (SINSW)
RESULTS OF GEOTECHNICAL INVESTIGATION ON LANDCOM 6.0 HA LAND**

This letter presents the results of geotechnical investigation undertaken by Pells Sullivan Meynink (PSM) at Lot 375 Edmondson Park. The work has been undertaken in accordance with the PSM proposal PSM3750-002L dated 4 December 2018. The land size for geotechnical investigation was changed from 8.06 ha to 6.0 ha based on Satya Mandalika (APP)'s email on 7 January 2019.

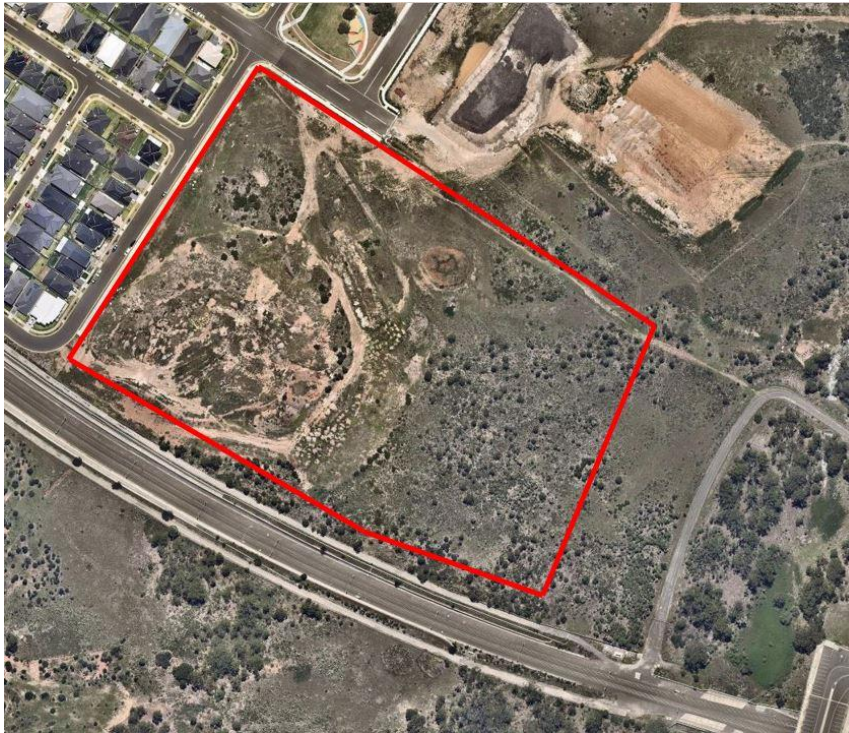
Inset 2: Nearmap aerial photograph of site condition on 28 December 2018

The site is located at Lot 375, Edmondson Park. The site is approximately 6.0 ha in area, and it is bounded by Faulkner Way to the west, railway lines to the south and rural land to the north and east.

The ground is generally sloping towards the east and has a large 9.0 m high stock pile located in the southwest corner. The majority of the ground surface was grassed with tall bushes and trees covering the central, southern and eastern portions of the site. There are a few dirt roads previously used by trucks.

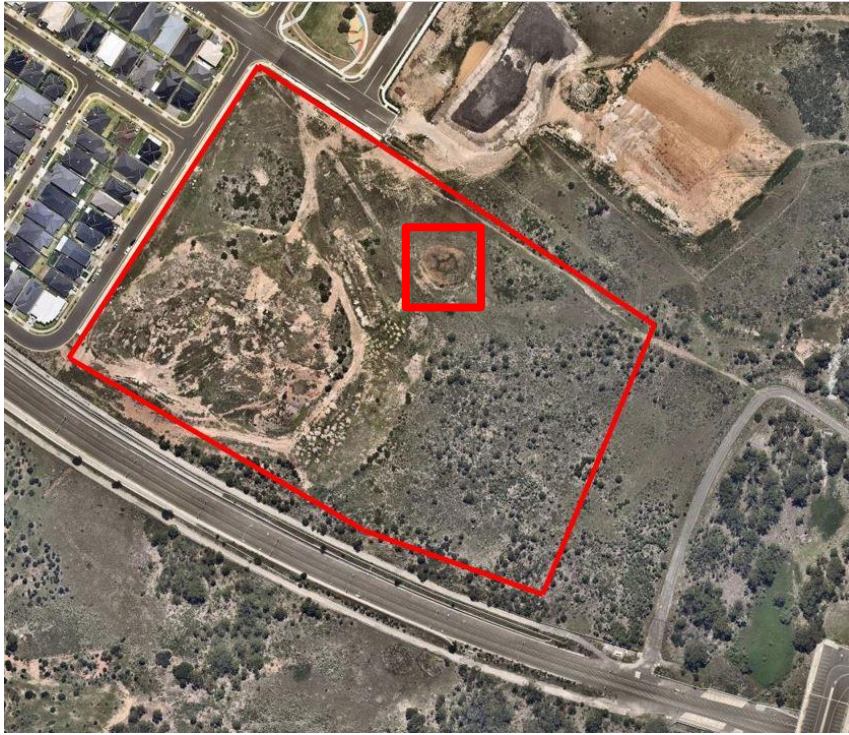
Inset 3: Location of backfilled dam

Although aerial imagey of the site shows there is a dam towards the northern boundary of the site, we did not observe the dam at the time of the fieldwork.

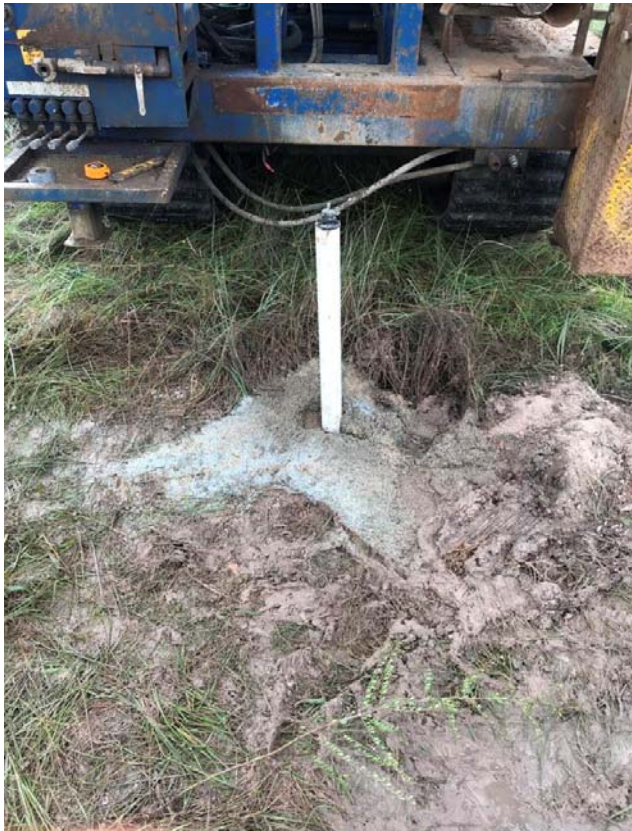
Photo 2 - Typical Standpipe piezometer (monitoring well) setup (BH03)

No groundwater seepage was observed during the borehole drilling (augering), though it is noted that the drilling water used in the cored boreholes (BH01 and BH03) would have prevented any groundwater from being observed. Standpipe piezometers (monitoring wells) were installed in BH01 and BH03. A water logger was installed in BH01 to measure water levels at regular 30 minute intervals. Attachment E includes the piezometer construction records. Water was observed in the wells immediately after wells were completed.

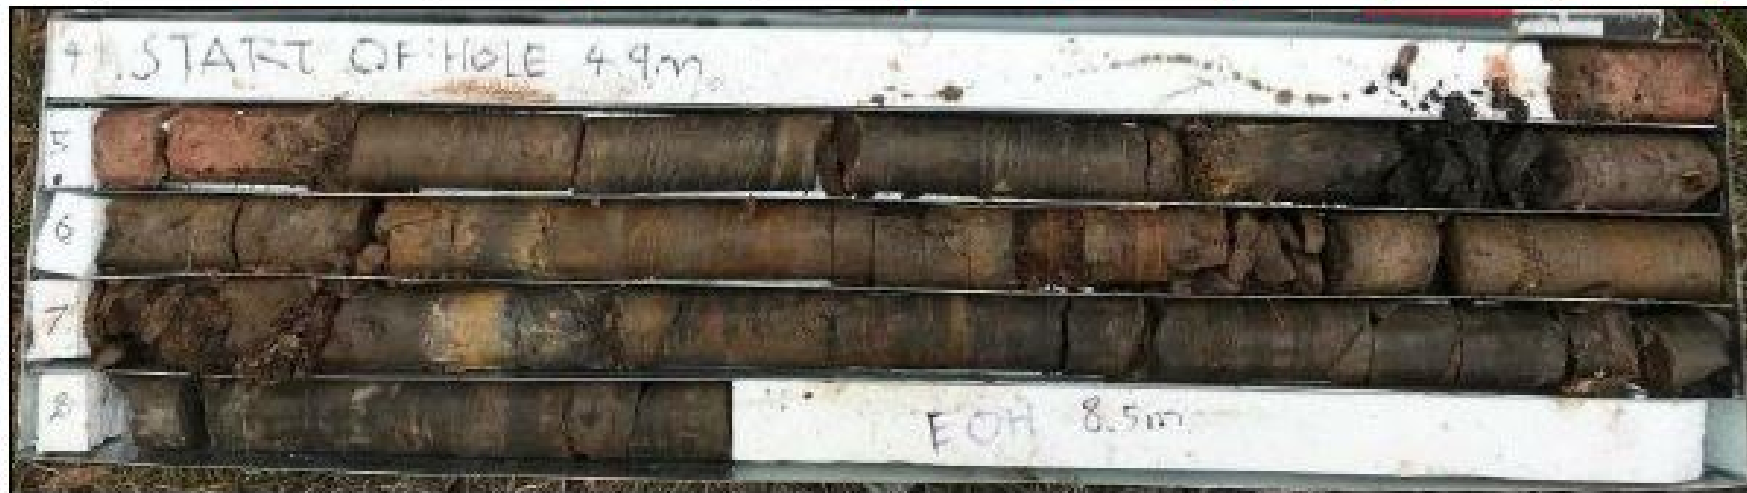
BH ID: BH 01

Drilling Information				Soil Description						Observations				
Method	Penetration	Support	Water	Samples Tests Remarks	Recovery	RL (m)	Depth (m)	Graphic Log	Classification Symbol	Material Description SOIL NAME: Colour, structure, plasticity, additional	Moisture Condition	Consistency / Relative Density	Hand Penetrometer UCS (kPa)	Structure and Additional Observations
AD/V		N		SPT 1.00 - 1.45 m 4, 7, 10 N = 17 PP 1.00 m = 300 kPa		56.0	1		CL	SILTY CLAY: dark brown, low to no plasticity.		S		0.00: Topsoil - roots and rootlets observed. 0.20: Inferred Natural Soil.
AD/T		N	Not Observed	PP 2.00 m = 400 kPa SPT 2.50 - 2.95 m 8, 11, 17 N = 28		55.0	2		CH	CLAY: red and grey, medium to high plasticity.	M	F to St	x	1.00: SPT recovered: 0.45 m 1.70: Drill resistance increases. 1.90: V-bit refusal.
		N		ES 4.00 m SPT 4.00 - 4.10 m Refusal		54.0	3		D	SILTSTONE: Pale brown, extremely weathered, extremely low strength.		VSt	x	2.50: SPT recovered: 0.45 m 2.70: Extremely weathered shale fragments observed, up to 5mm. 3.00: Inferred Bedrock, strength and weathering inferred from cuttings.
