Site Audit Report - Residential  
Zone North of Rail Alignment,  
Zouch Road, Edmondson Park  
NSW

Prepared for:  
**Landcom**

Prepared by:  
**ENVIRON Australia Pty Ltd**

Audit Number:  
**GN263-1**

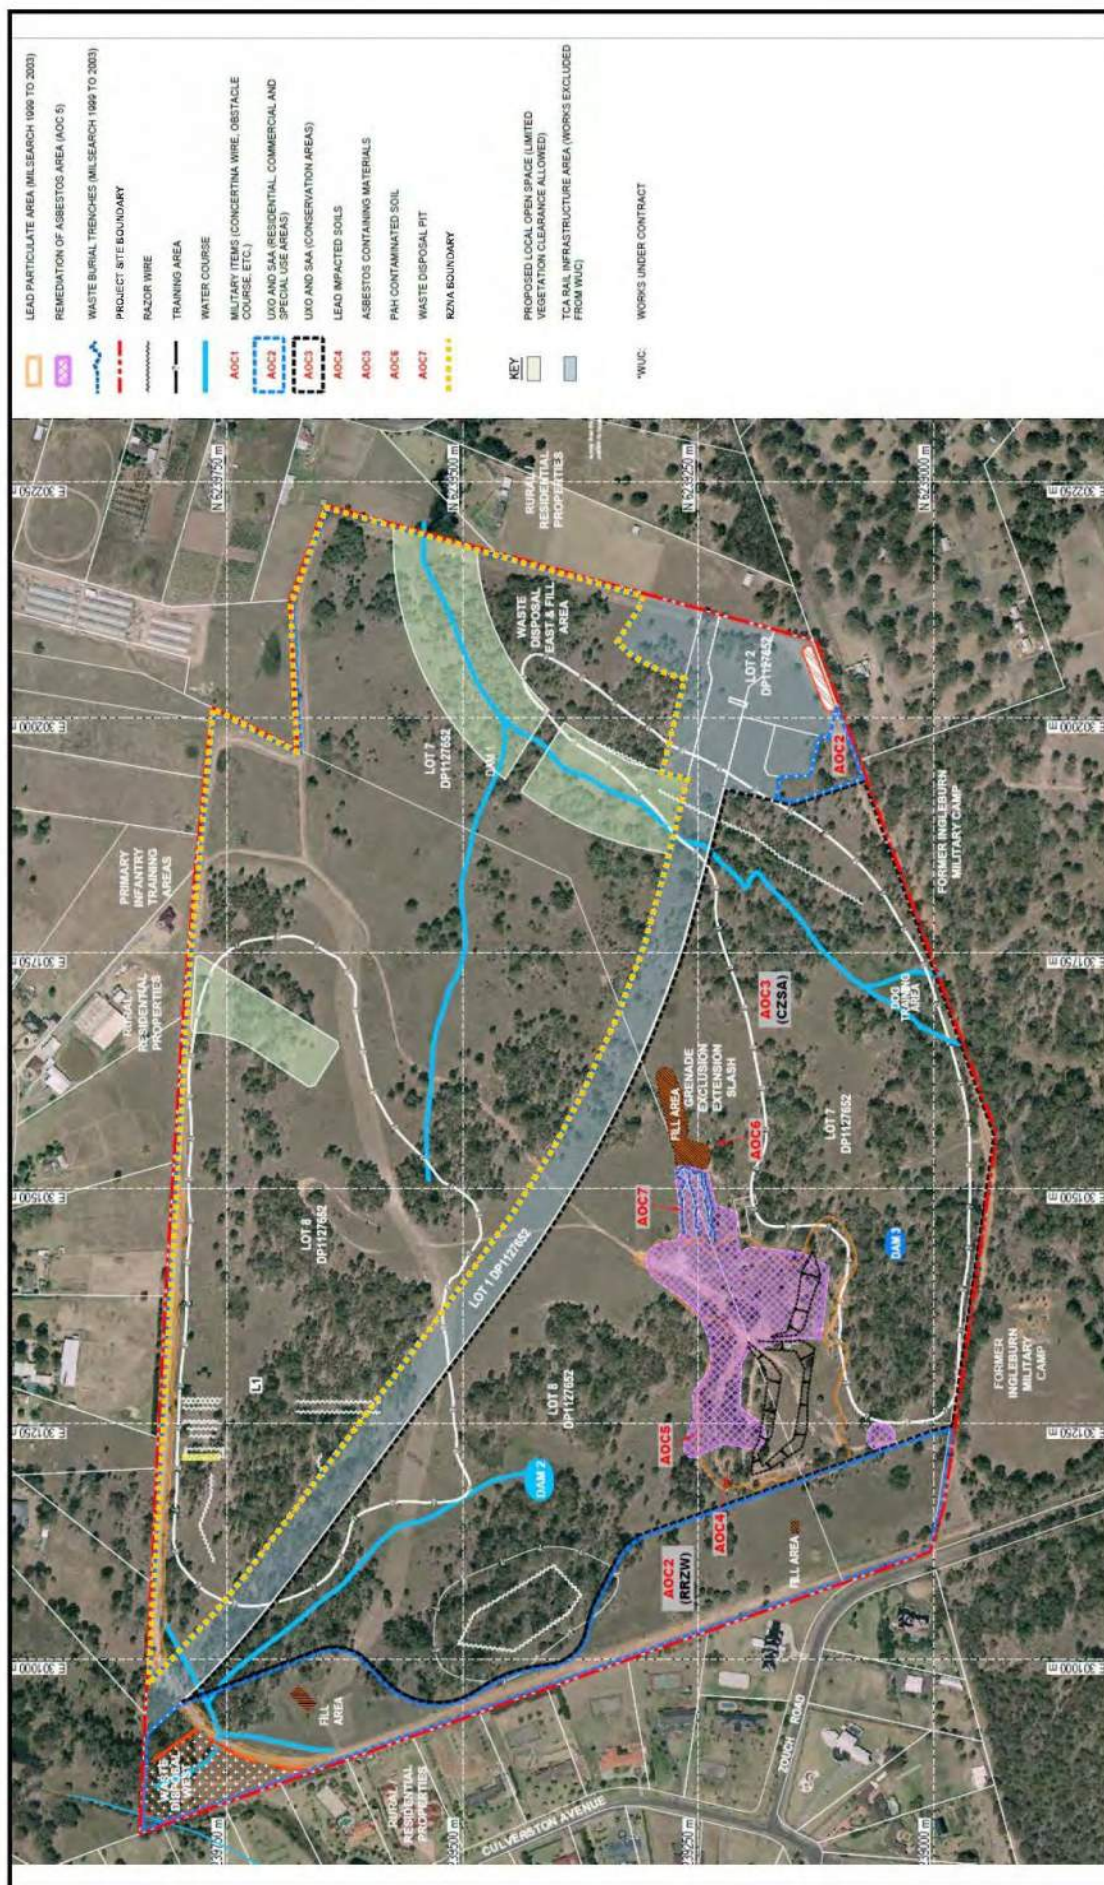
**Figure 3: Pre-remediation Site Layout and Areas of Environmental Concern**

- Site features related to the former military use of the site included pits, trenches, barbed wire fencing, concertina wire, concrete slabs (former structures/building foundations) and small arms ammunition (SAA) debris. Former grenade ranges and additional areas were identified in the east of the site (REM1 to REM5).

- Waste material was identified in an open trench adjacent to the northern boundary. Waste materials included scrap metal, wire, building waste and general waste. Two stockpiles of soil (SP5 and SP6) were observed near the trench. Waste material was observed at a number of other locations on the site.

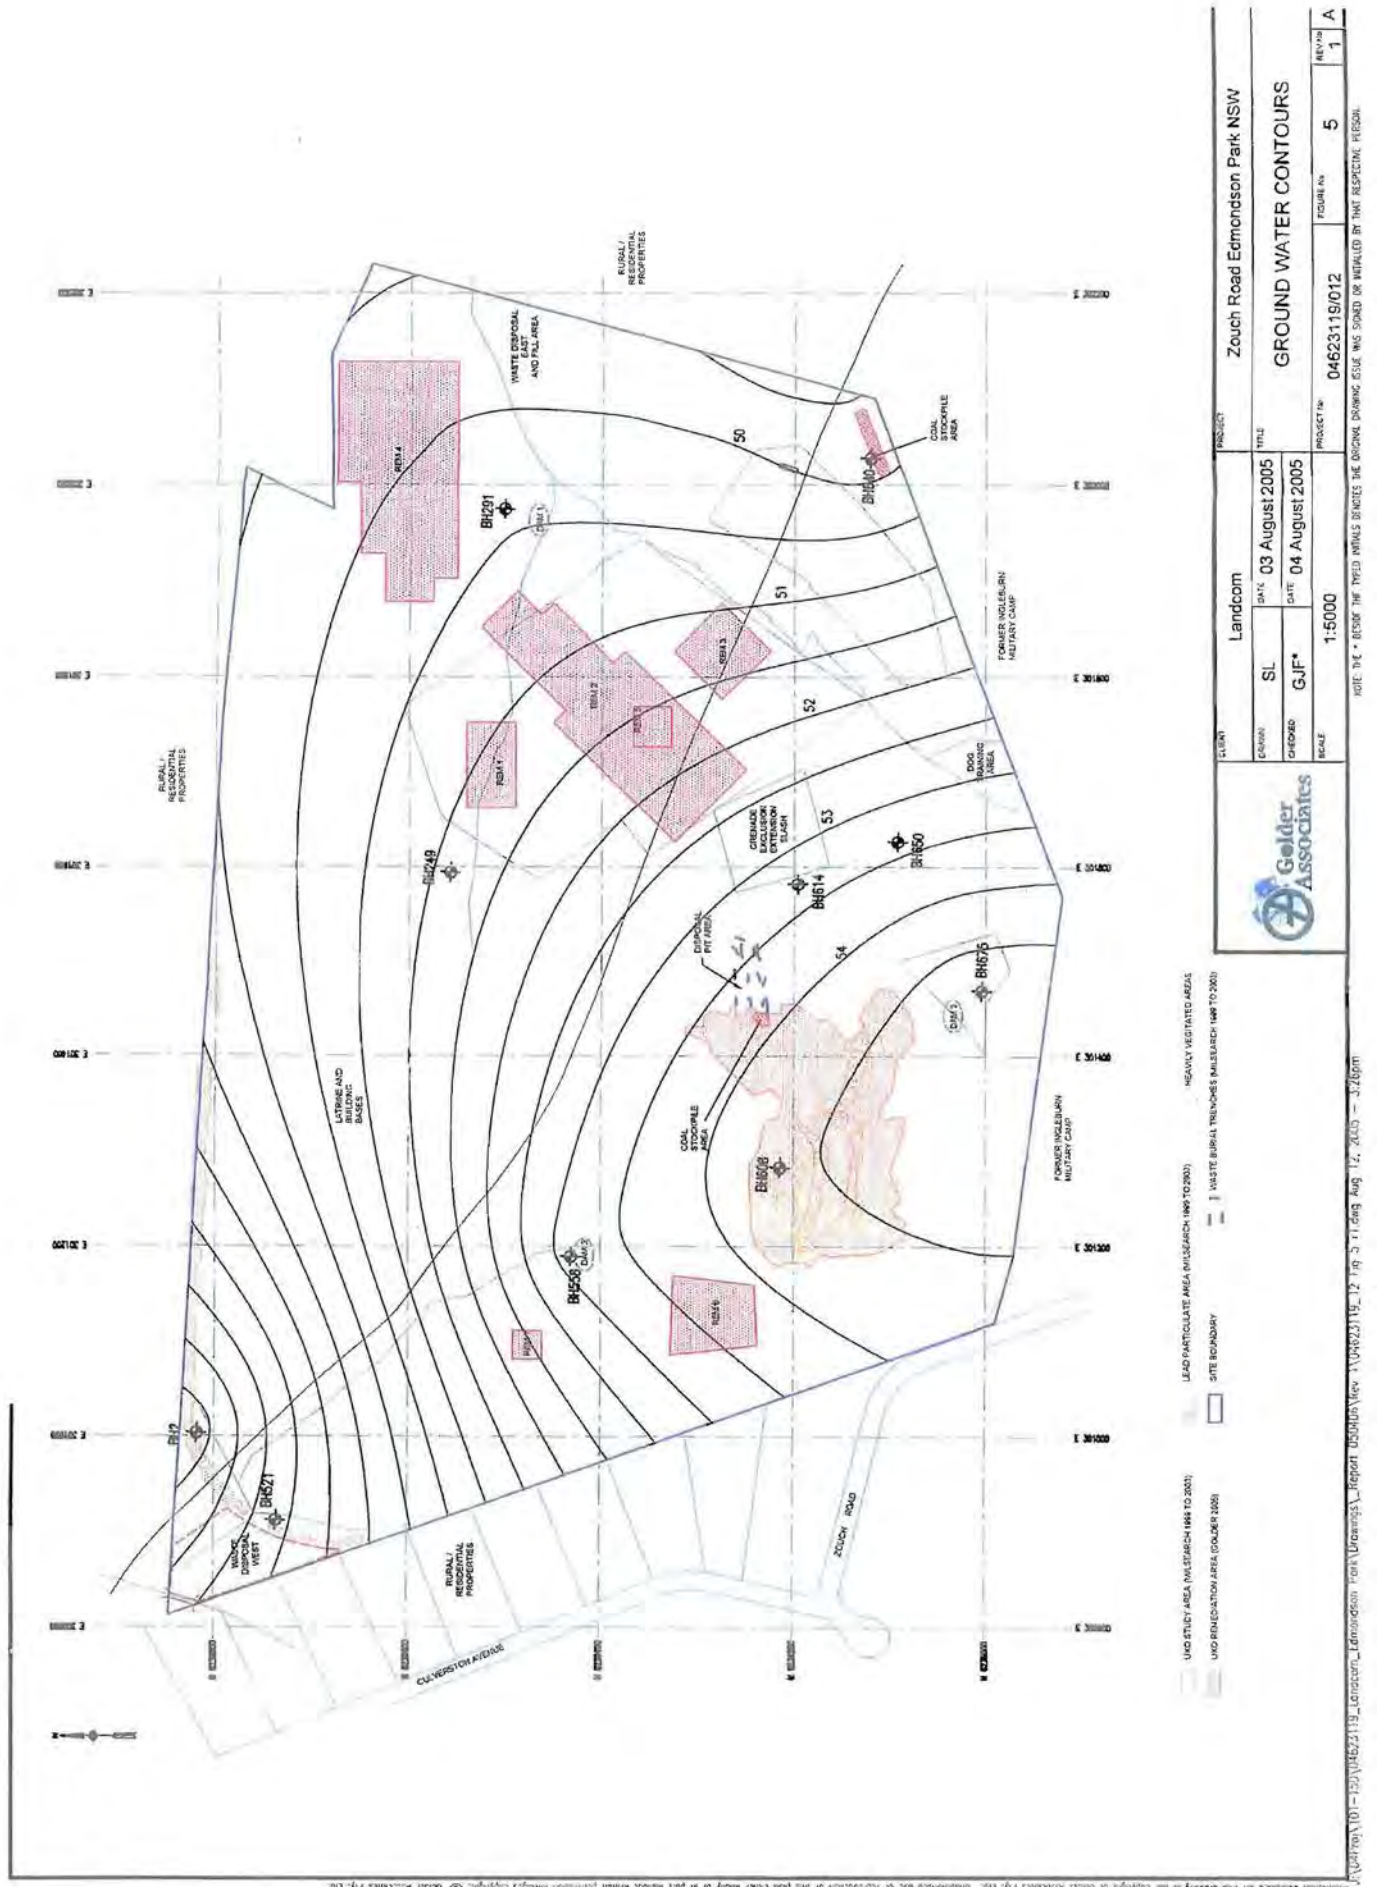
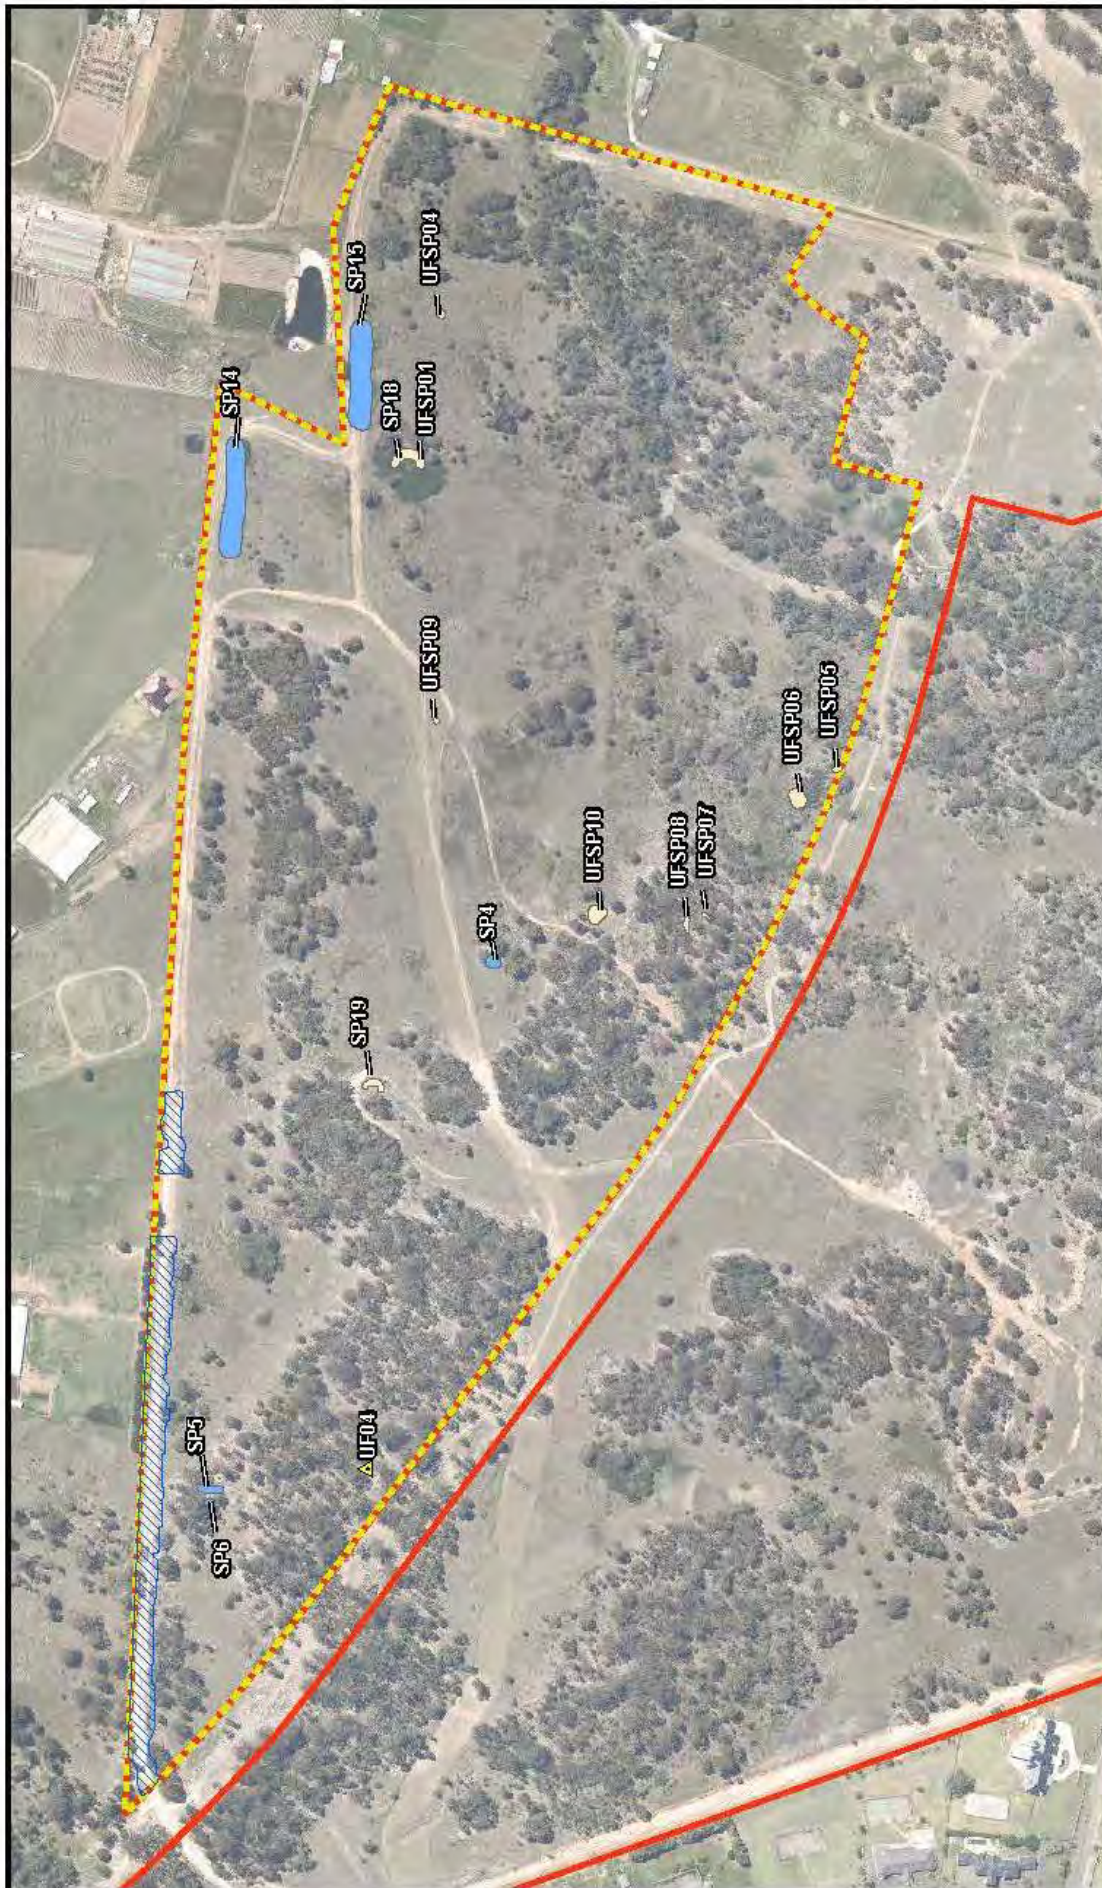
## Attachment 6: Groundwater Monitoring Well Locations

Groundwater remediation was not required by the RAP. Groundwater was assessed at the site before and after remediation to ensure no impacts occurred as a result of the remedial works. A total of ten monitoring wells were installed across the greater site in February 2005. Three of these (BH2, BH249 and BH291) were located with the RZNRA area, however BH249 was found to be dry (Attachment 6, Appendix A).

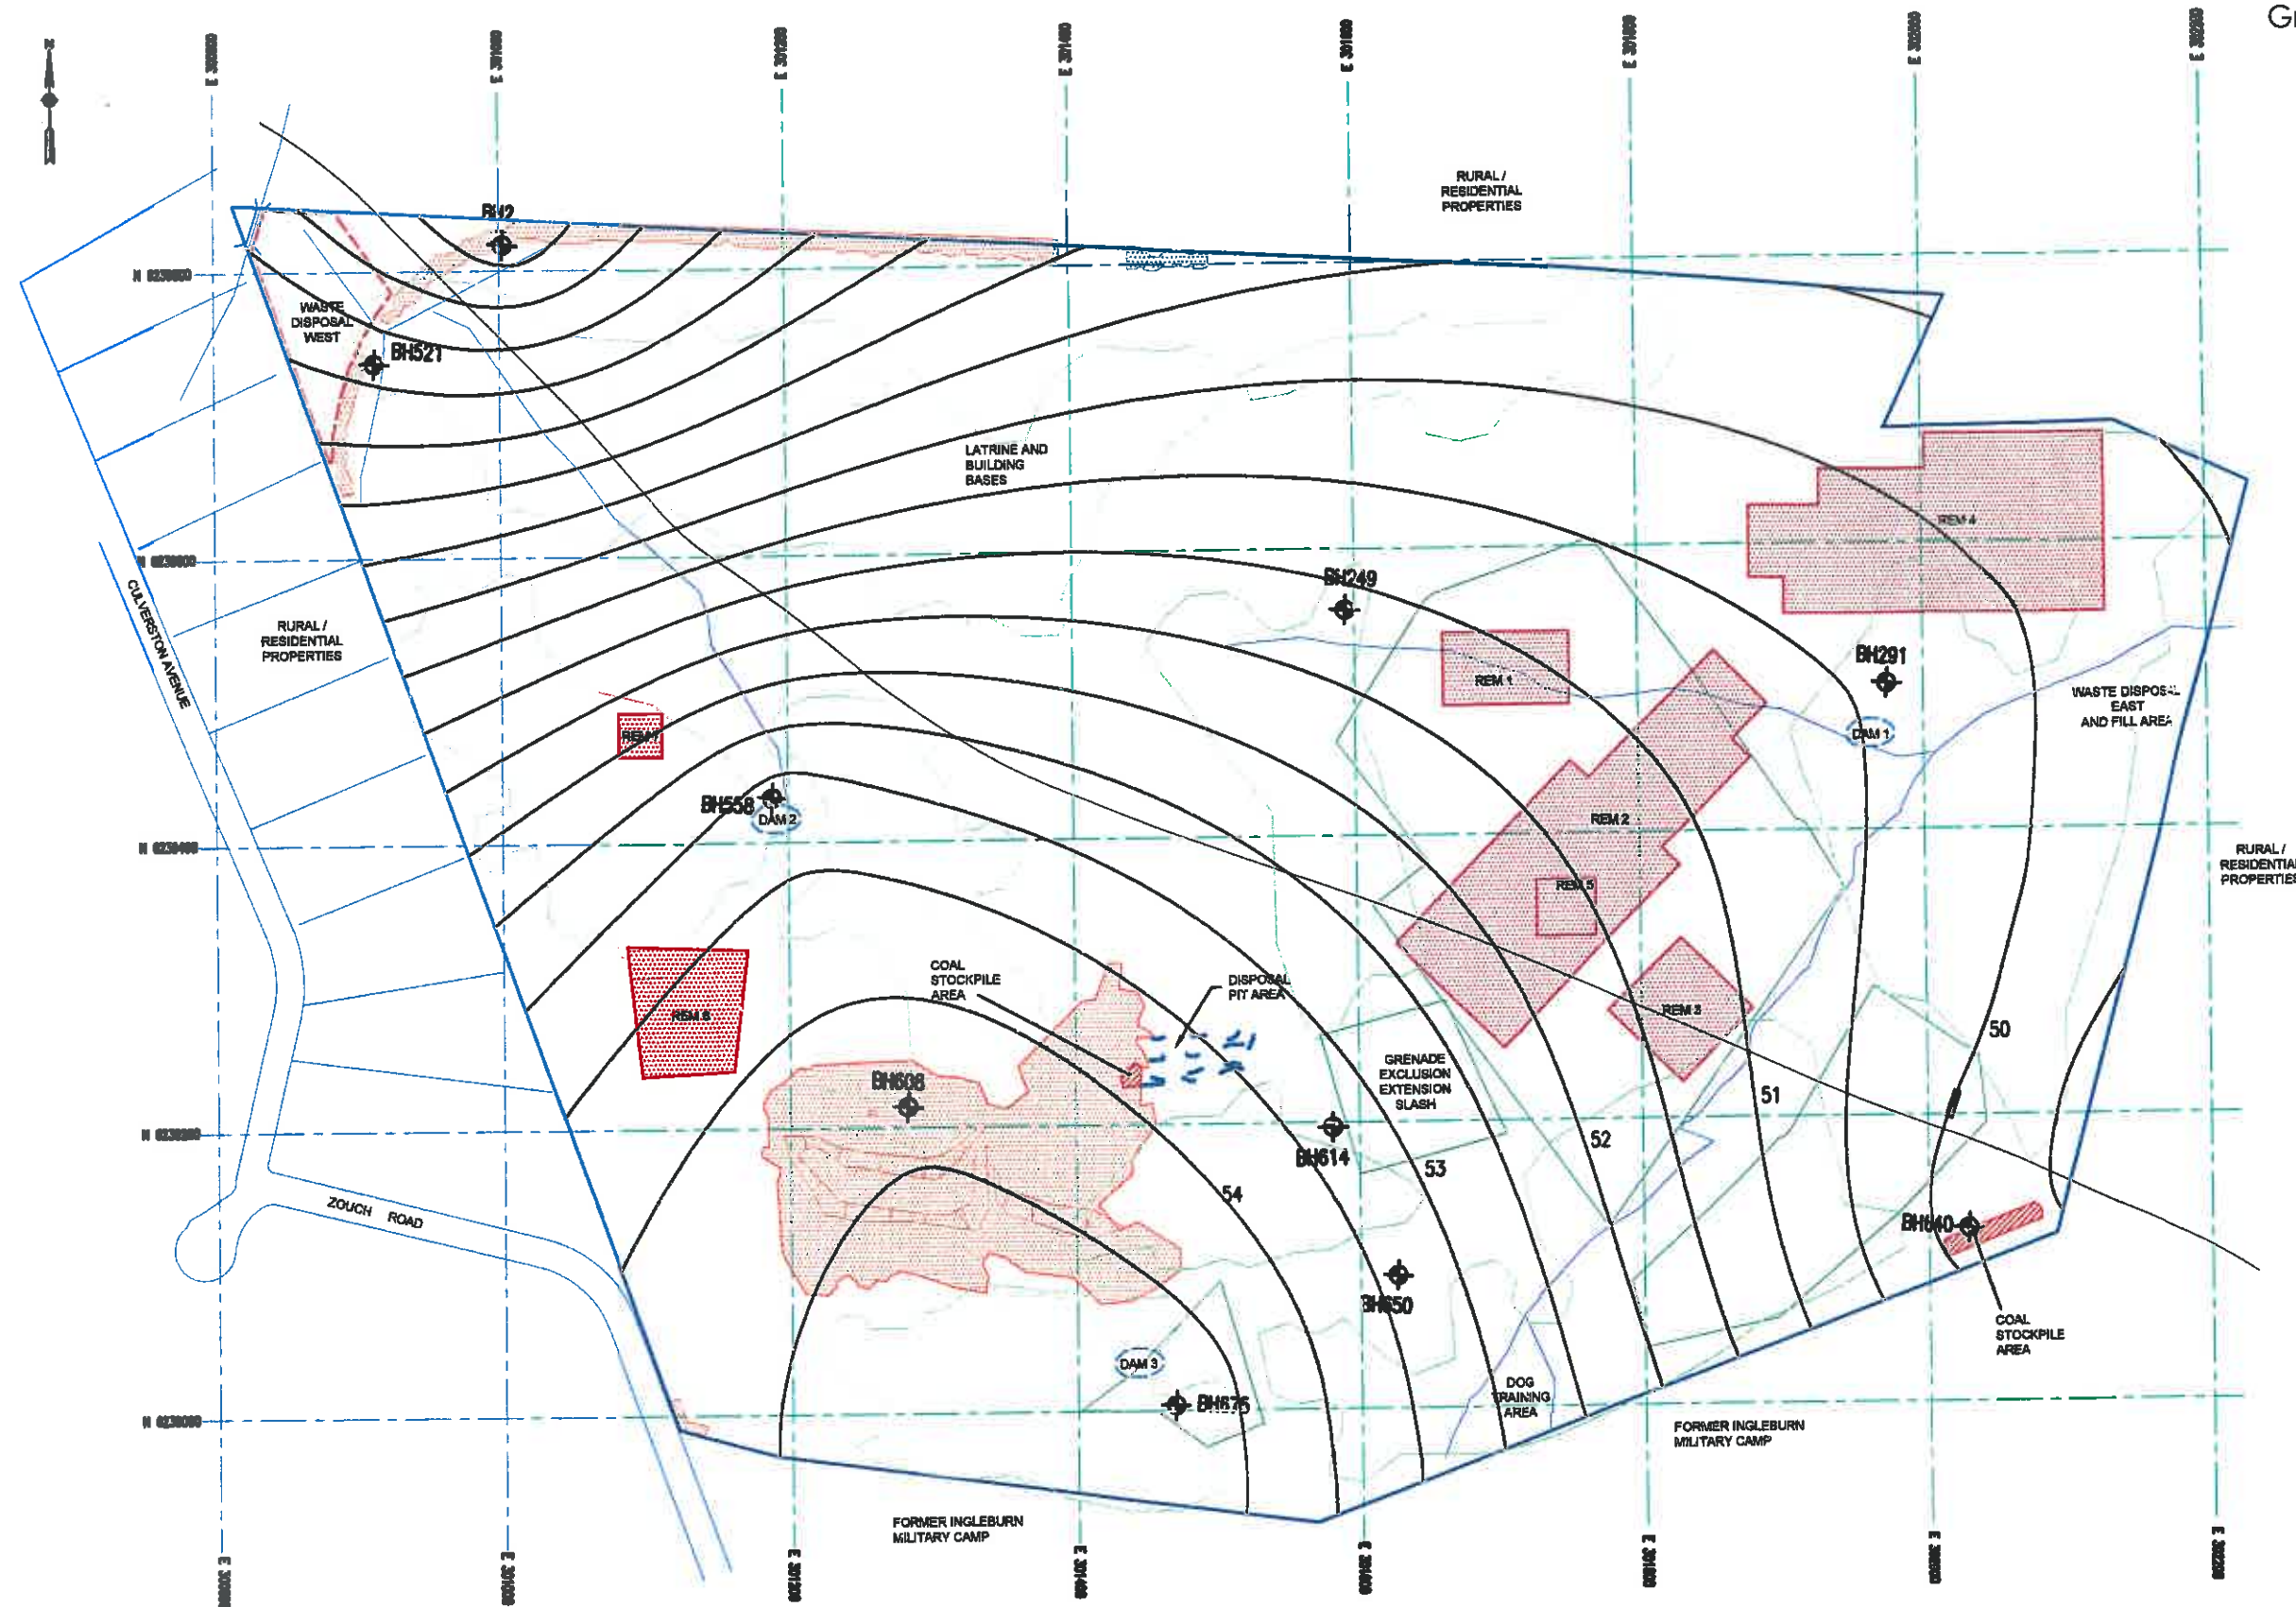
UXO STUDY AREA (MILSEARCH 1999 TO 2003)  
 LEAD PARTICULATE AREA (MILSEARCH 1999 TO 2003)  
 UXO REMEDIATION AREA (GOLDER 2005)  
 SITE BOUNDARY  
 WASTE BURIAL TRENCHES (MILSEARCH 1999 TO 2003)  
 HEAVILY VEGITATED AREAS

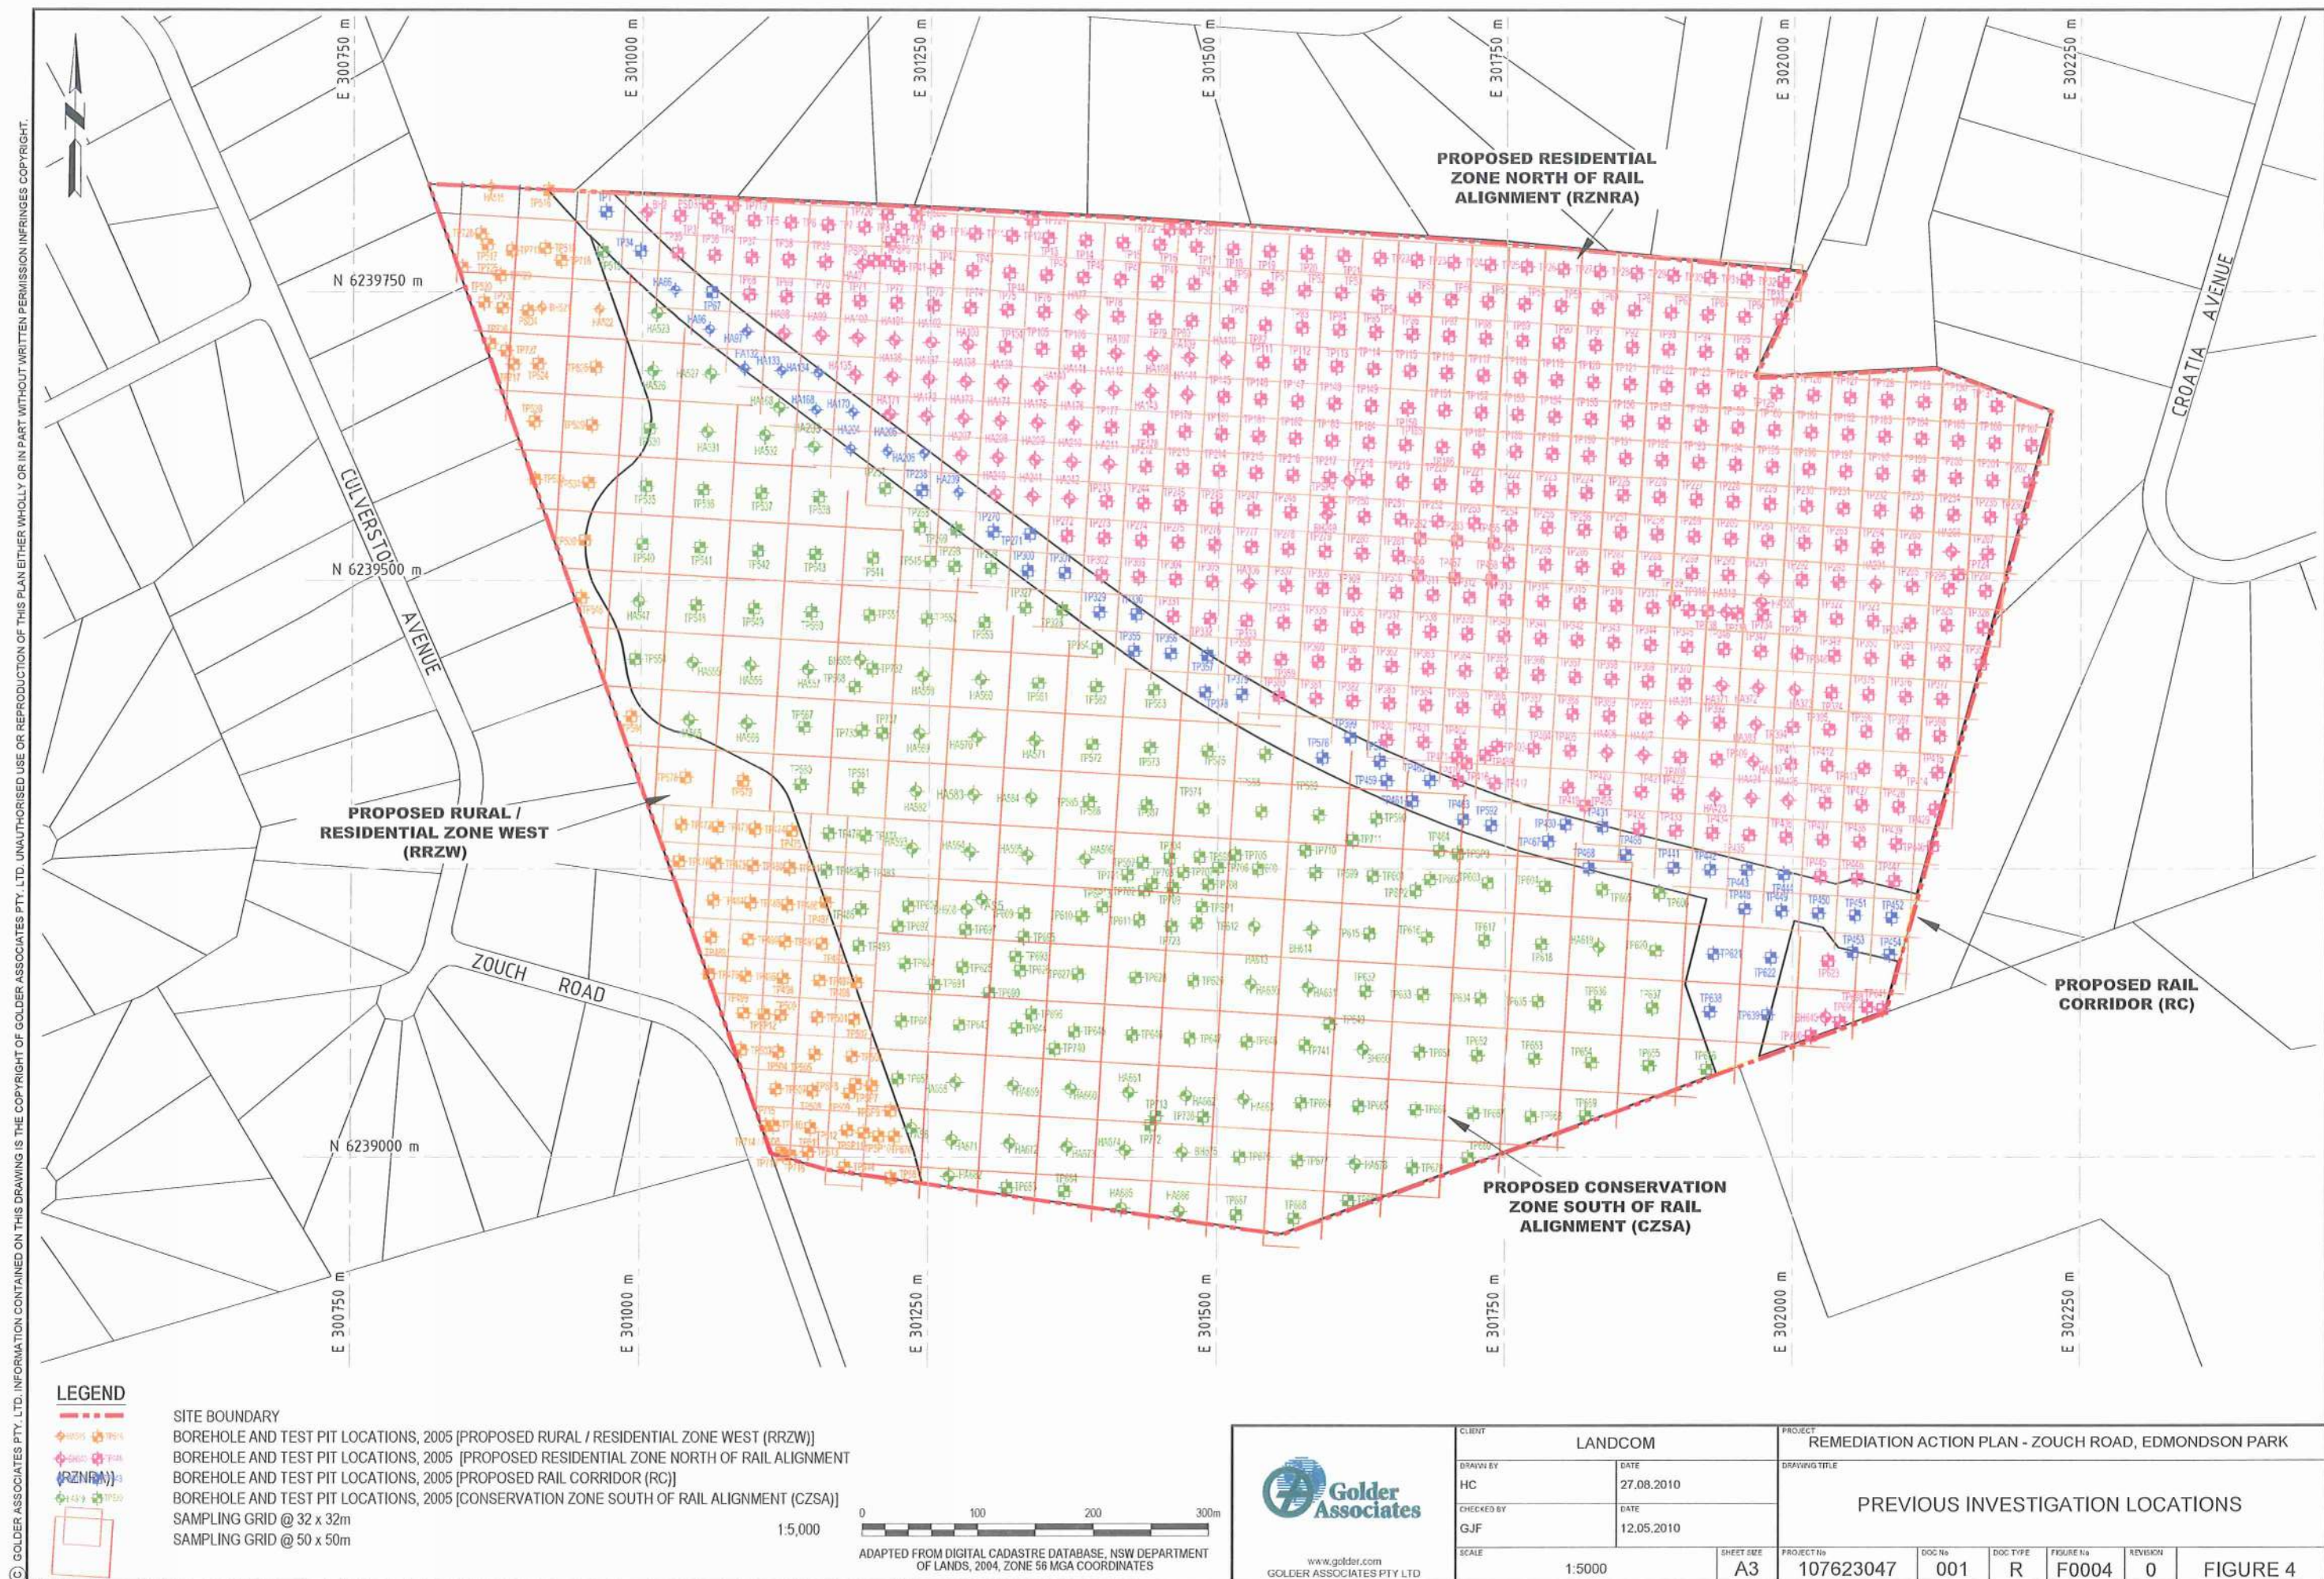
# ATTACHMENT 5 Proposed Remediation Areas

- M1 CONCERTINA WIRE COMPOUND (PRISONER CAMP)
- M2 STOCKPILE OF CONCERTINA WIRE
- CONCERTINA WIRE
- M3 INFANTRY TRENCH
- M4 INFANTRY TRENCH
- M5 INFANTRY TRENCH
- TRAINING PITS
- R1 GENERAL RUBBISH / ASBESTOS PILES
- R2 GENERAL RUBBISH (USED CAR TYRES)
- M6 INFANTRY TRENCH / COMMAND POST
- B1-B9 BLACKBERRY INFESTATION
- M7 RAISED PLATFORM / FORMER STRUCTURE
- M8 CONCRETE SLAB / FORMER STRUCTURE
- M9 GENERAL RUBBISH / CAR PARTS
- R3 GENERAL RUBBISH
- M11 OBSTACLE COURSE
- M12 OBSTACLE COURSE
- M13 BUILDING FACADE
- L1-L2 FORMER LATRINE
- R4 GENERAL RUBBISH
- M14 WASTE DISPOSAL TRENCH
- SP5 STOCKPILE

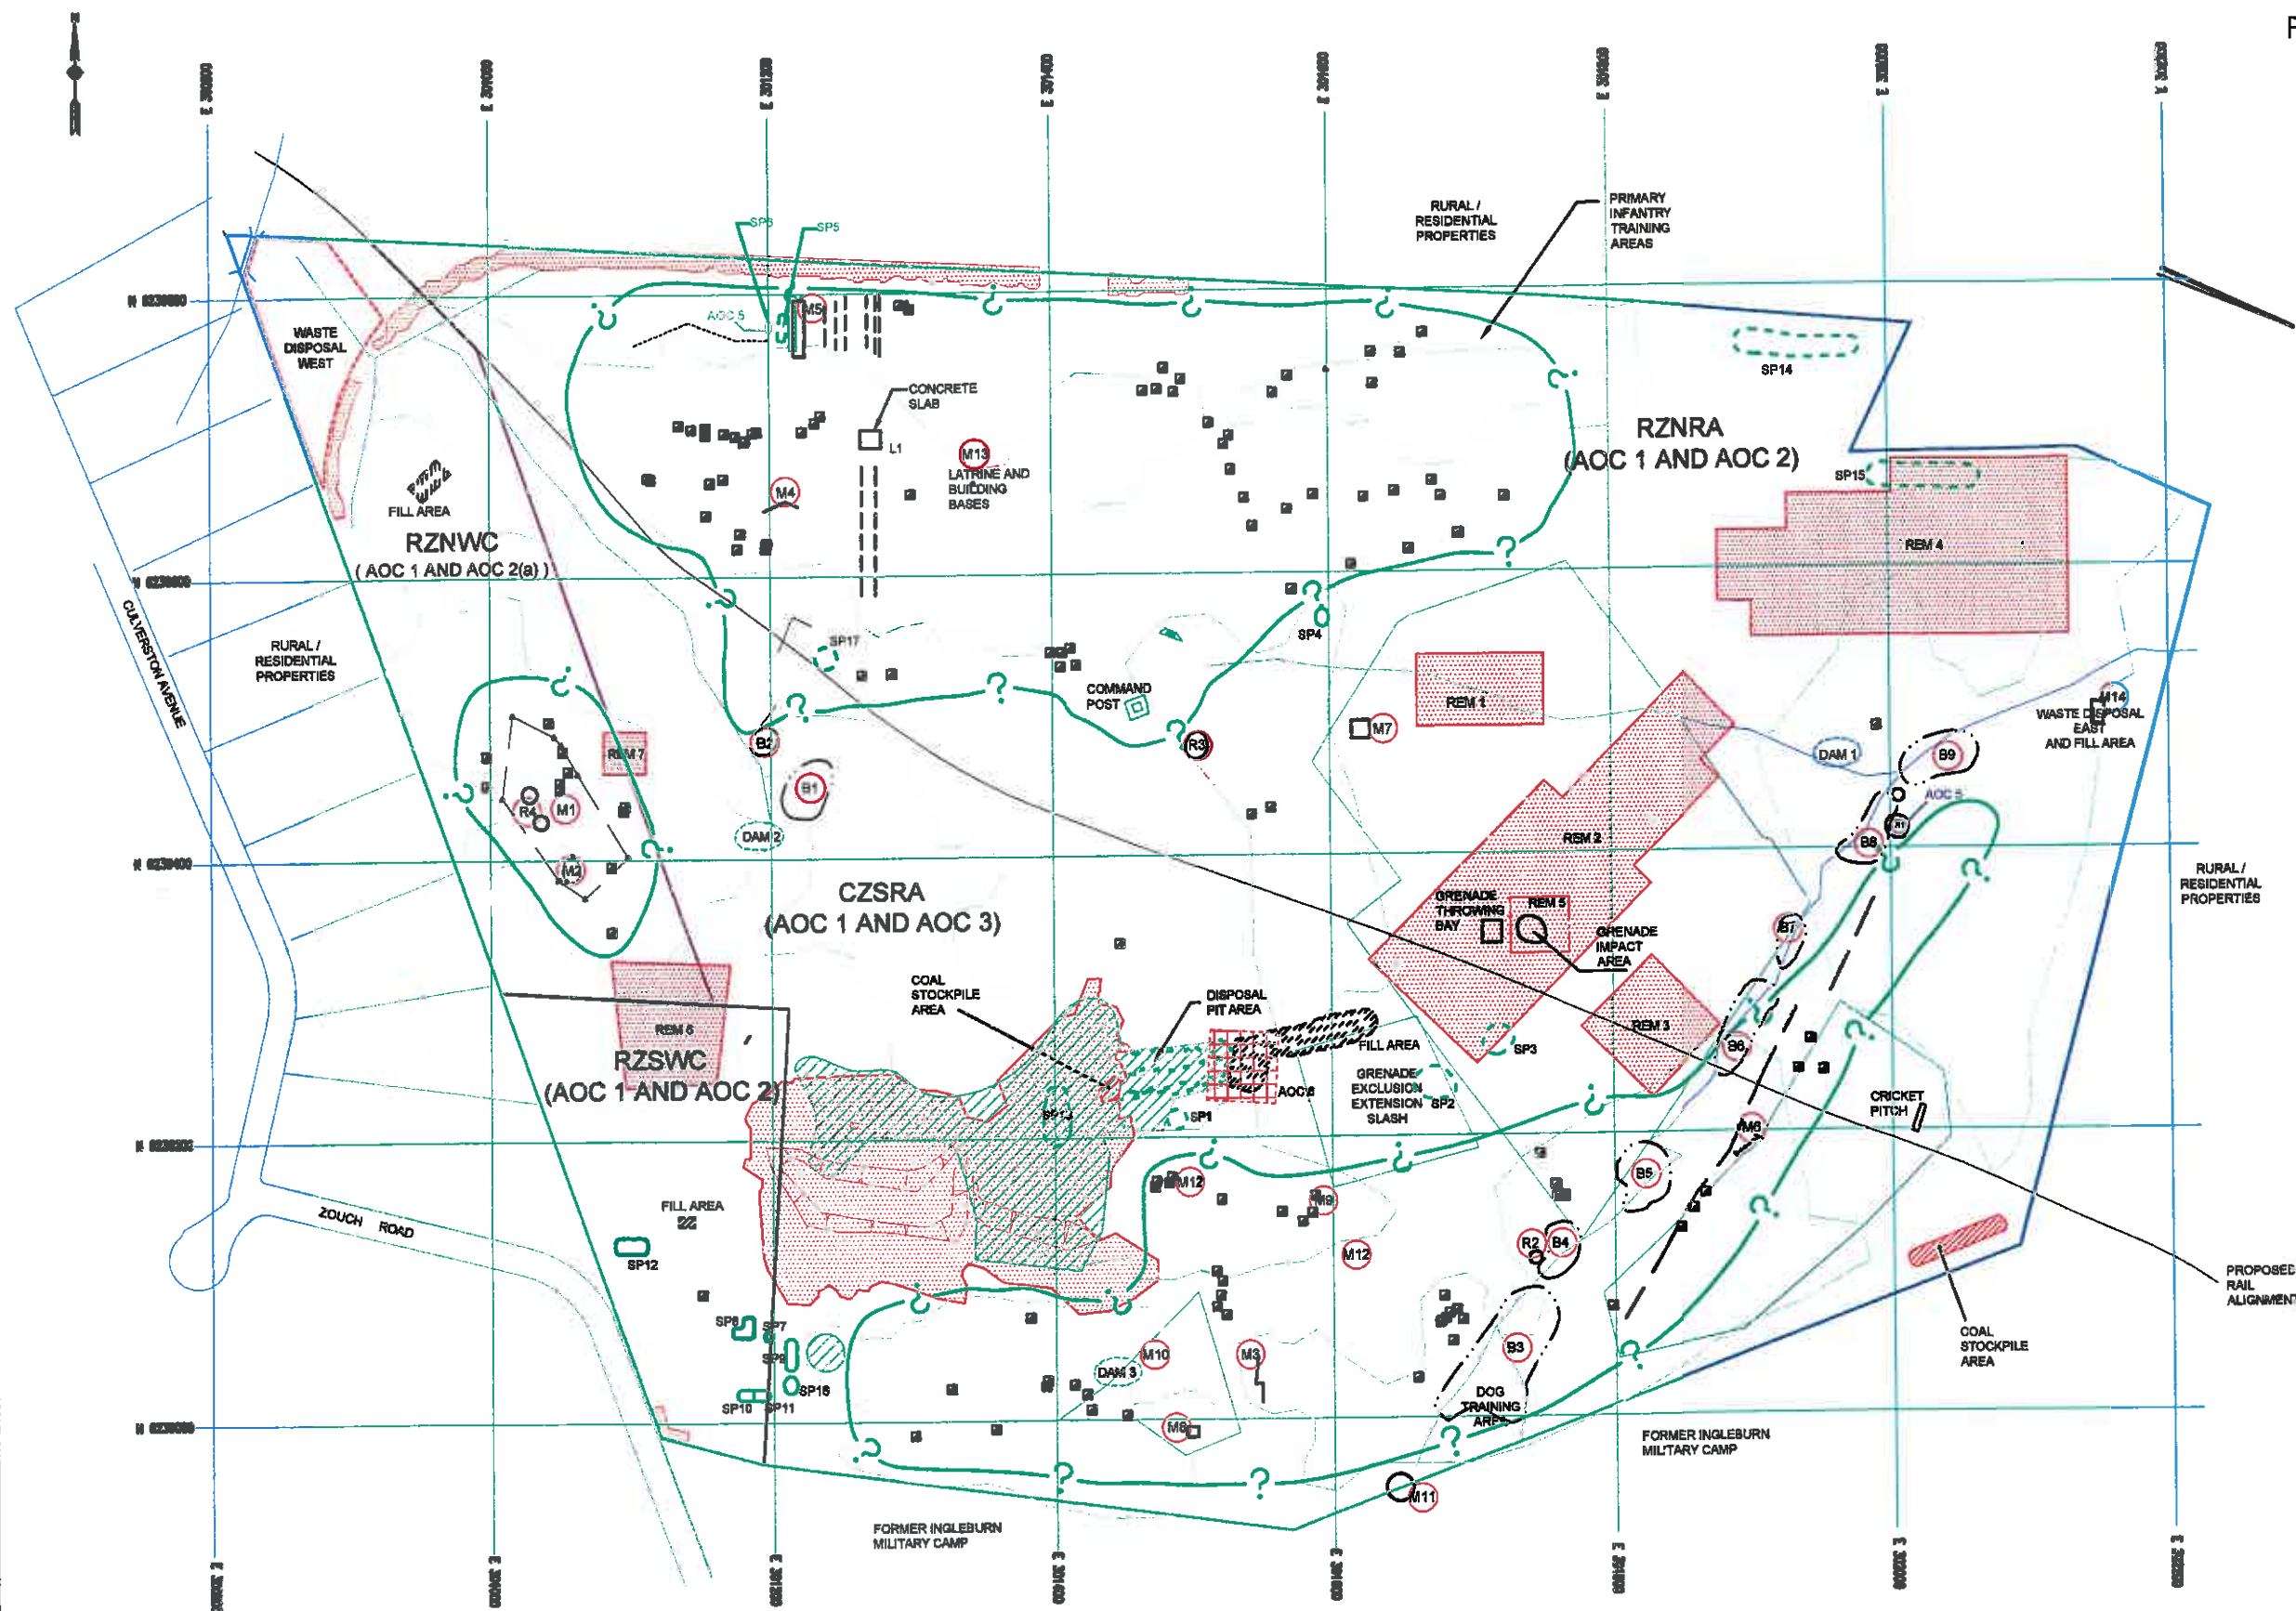
AOC 1- REMOVAL OF GENERAL WASTE (ENTIRE SITE)

AOC 2- REMEDIATION OF SAA AND POTENTIAL UXO (RESIDENTIAL ZONES)

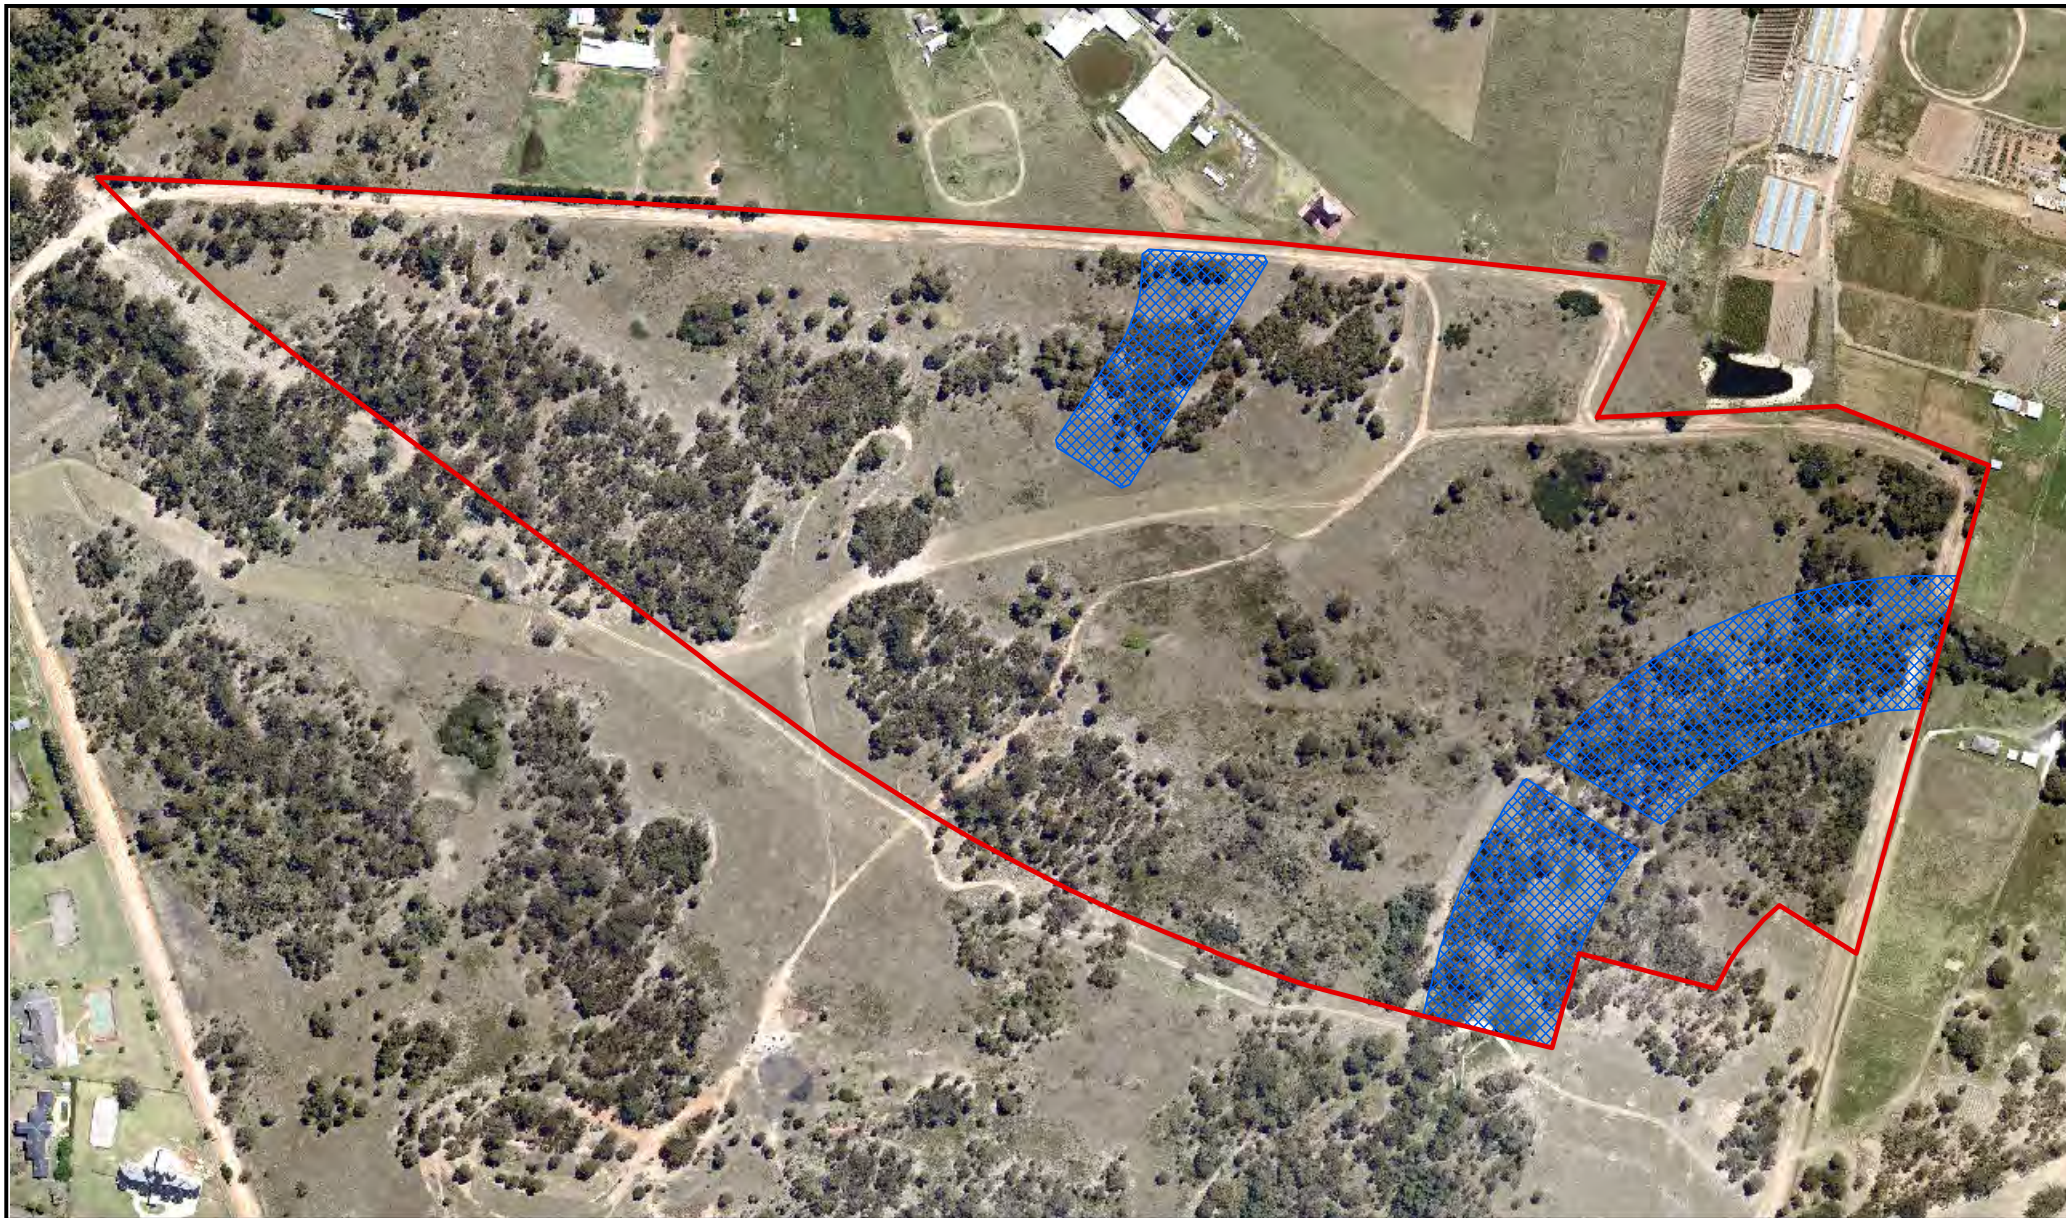
**JBS&G** Figure 3: Local Open Space Locations

The SEMP applies to two areas as shown in **Figure 3**, comprising a local park in the central northern portion of the site and a vegetated riparian zone including the Maxwell's Creek tributary in the eastern section of the site. In addition to the Public Open Space zoning, the riparian zone corridor is also required to be managed for conservation objectives in accordance with the Edmondson Park Precinct Conservation Agreement<sup>6</sup>. The extent of the site falling within this classification is shown in the plan included in **Appendix B**.

For the purposes of the remediation contract, the project site has been divided into a number of development areas as shown in **Figure 2**, including a parcel of approximately 43 ha known as the Residential Zone North of the Railway Alignment (RZNRA) located in the northern portion of the project site. Previous remediation works within the RZNRA portion, as documented separately in JBS&G (2013<sup>1</sup>), concluded that the RZNRA site is suitable for the proposed residential use with accessible soils contingent upon application of a site environmental management plan (SEMP) to address the residual potential for buried unexploded ordnance (UXO) and small arms ammunition (SAA) risks with the proposed local public open space areas of the RZNRA site. The extent of the proposed public open space areas are shown in **Figure 3**.

The Site details are summarised in **Table 2.1** and shown in **Figures 1, 2** and **3**. It is noted that this SEMP applies only to those proposed public open space areas as shown in **Figure 3** and also conservation areas as shown in the plan included as **Appendix B**.

The vegetation retention requirements for the proposed public open space areas located as shown in **Figure 3** resulted in clearance of the residual military items, including UXO/SAA, being limited to removal of visually identifiable items on the ground surface at the time of remediation works during 2012. This generally comprised removal of items of 25 mm or larger in size apparent on the ground surface when assessed by teams of qualified technicians completing survey methods using 1 m width transects within the vegetated areas.

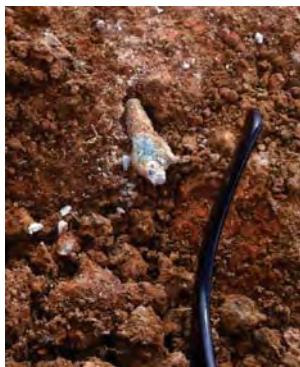
Plastic Blank Casing

According to Milsearch, while live blank SAA constitutes a lesser hazard than live ball ammunition, blanks can still cause significant injury, particularly eye damage, if detonated through tampering. Brass blank ammunition is understood to be particularly dangerous. While presenting no explosive hazard, the discovery of expended blank SAA could be alarming to site workers or occupants.

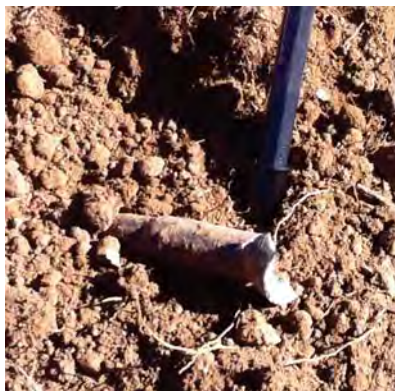
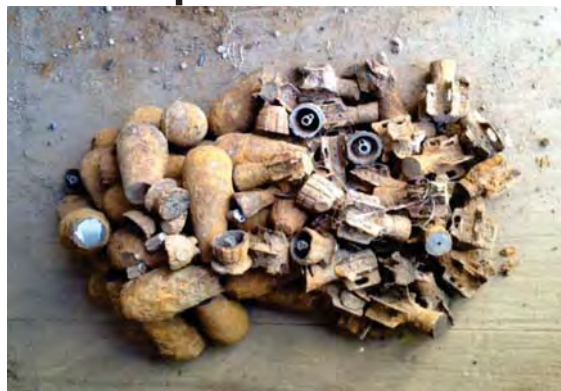
# EOW Examples

Examples of EOW (grenade, mortar etc components) removed from the Edmondson Park Site During Works
