Landcom

Edmondson Park Precinct 9  
Site Contamination Assessment

Buchan Avenue, Edmondson Park

59033/136,760 (Rev 0)

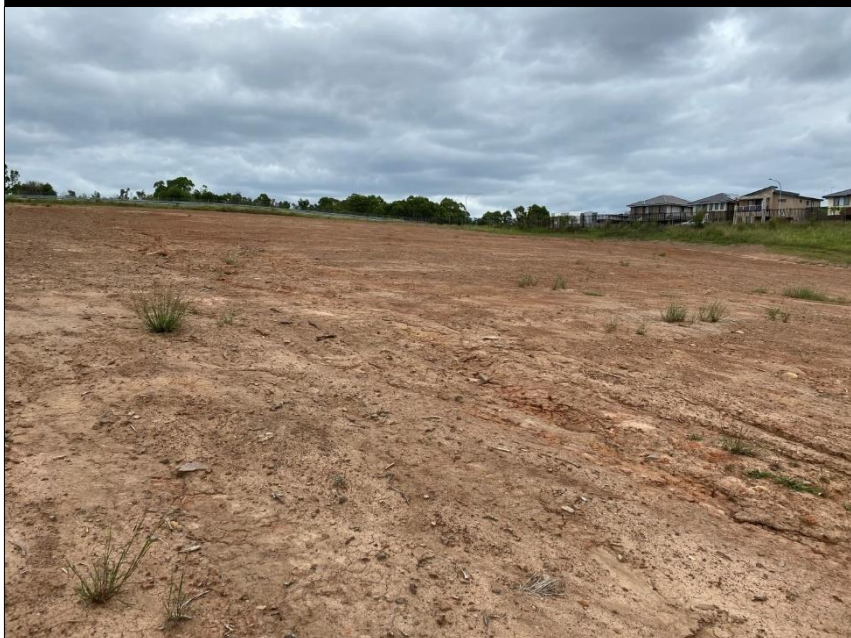
**PHOTO 4: SITE LOOKING WEST ACROSS THE STOCKPILE  
FOOTPRINT (09/02/2021)**

At the time of investigation, the site was identified to be vacant land, with the previous stockpile footprint characterised as exposed clay soil and shale. The entire site was devoid of any trees or with minimal vegetation observed in the north-western and south eastern corners of the site.

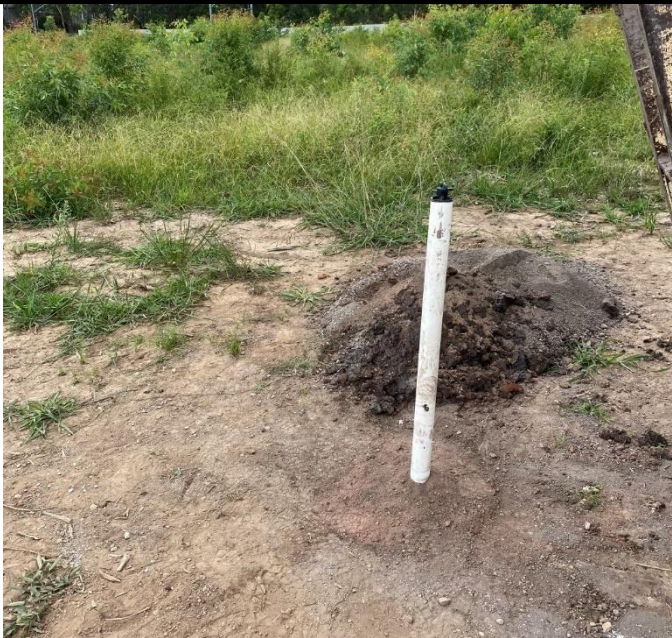
PHOTO 1: MONITORING WELL INSTALLATION (08/02/2021)

Three groundwater wells were installed on 8 February 2021 at locations across the site. The wells were installed by a drill rig using solid flight auger. Boreholes were advanced to the target depth based on conditions encountered (lithology/geology conditions encountered) during drilling the depth of monitoring wells, being up to approximately 15.5 m bgs, as 2 m below encountered groundwater seepage levels. The wells were constructed in accordance with relevant NSW EPA endorsed guidance such as National Uniform Drillers Licensing Committee, 2012, *Minimum*

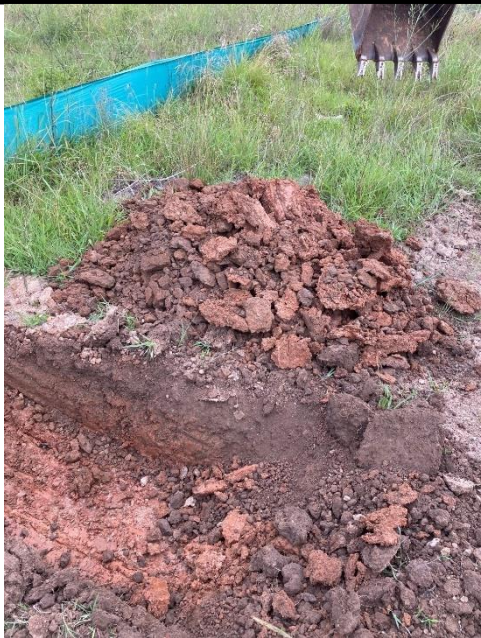
PHOTO 2: TEST PIT LOCATION TP03 (09/02/2021)

Generally, the lithology was characterised by fill (gravelly clay and silty clay) with the total depth of fill occurrence ranging from 0 to 0.3m bgs (TP06). The underlying natural clay soils were observed to be red to red/grey stiff clay, with underlying weathered grey shale identified at TP08. No anthropogenic materials were observed in any of the test pit locations.

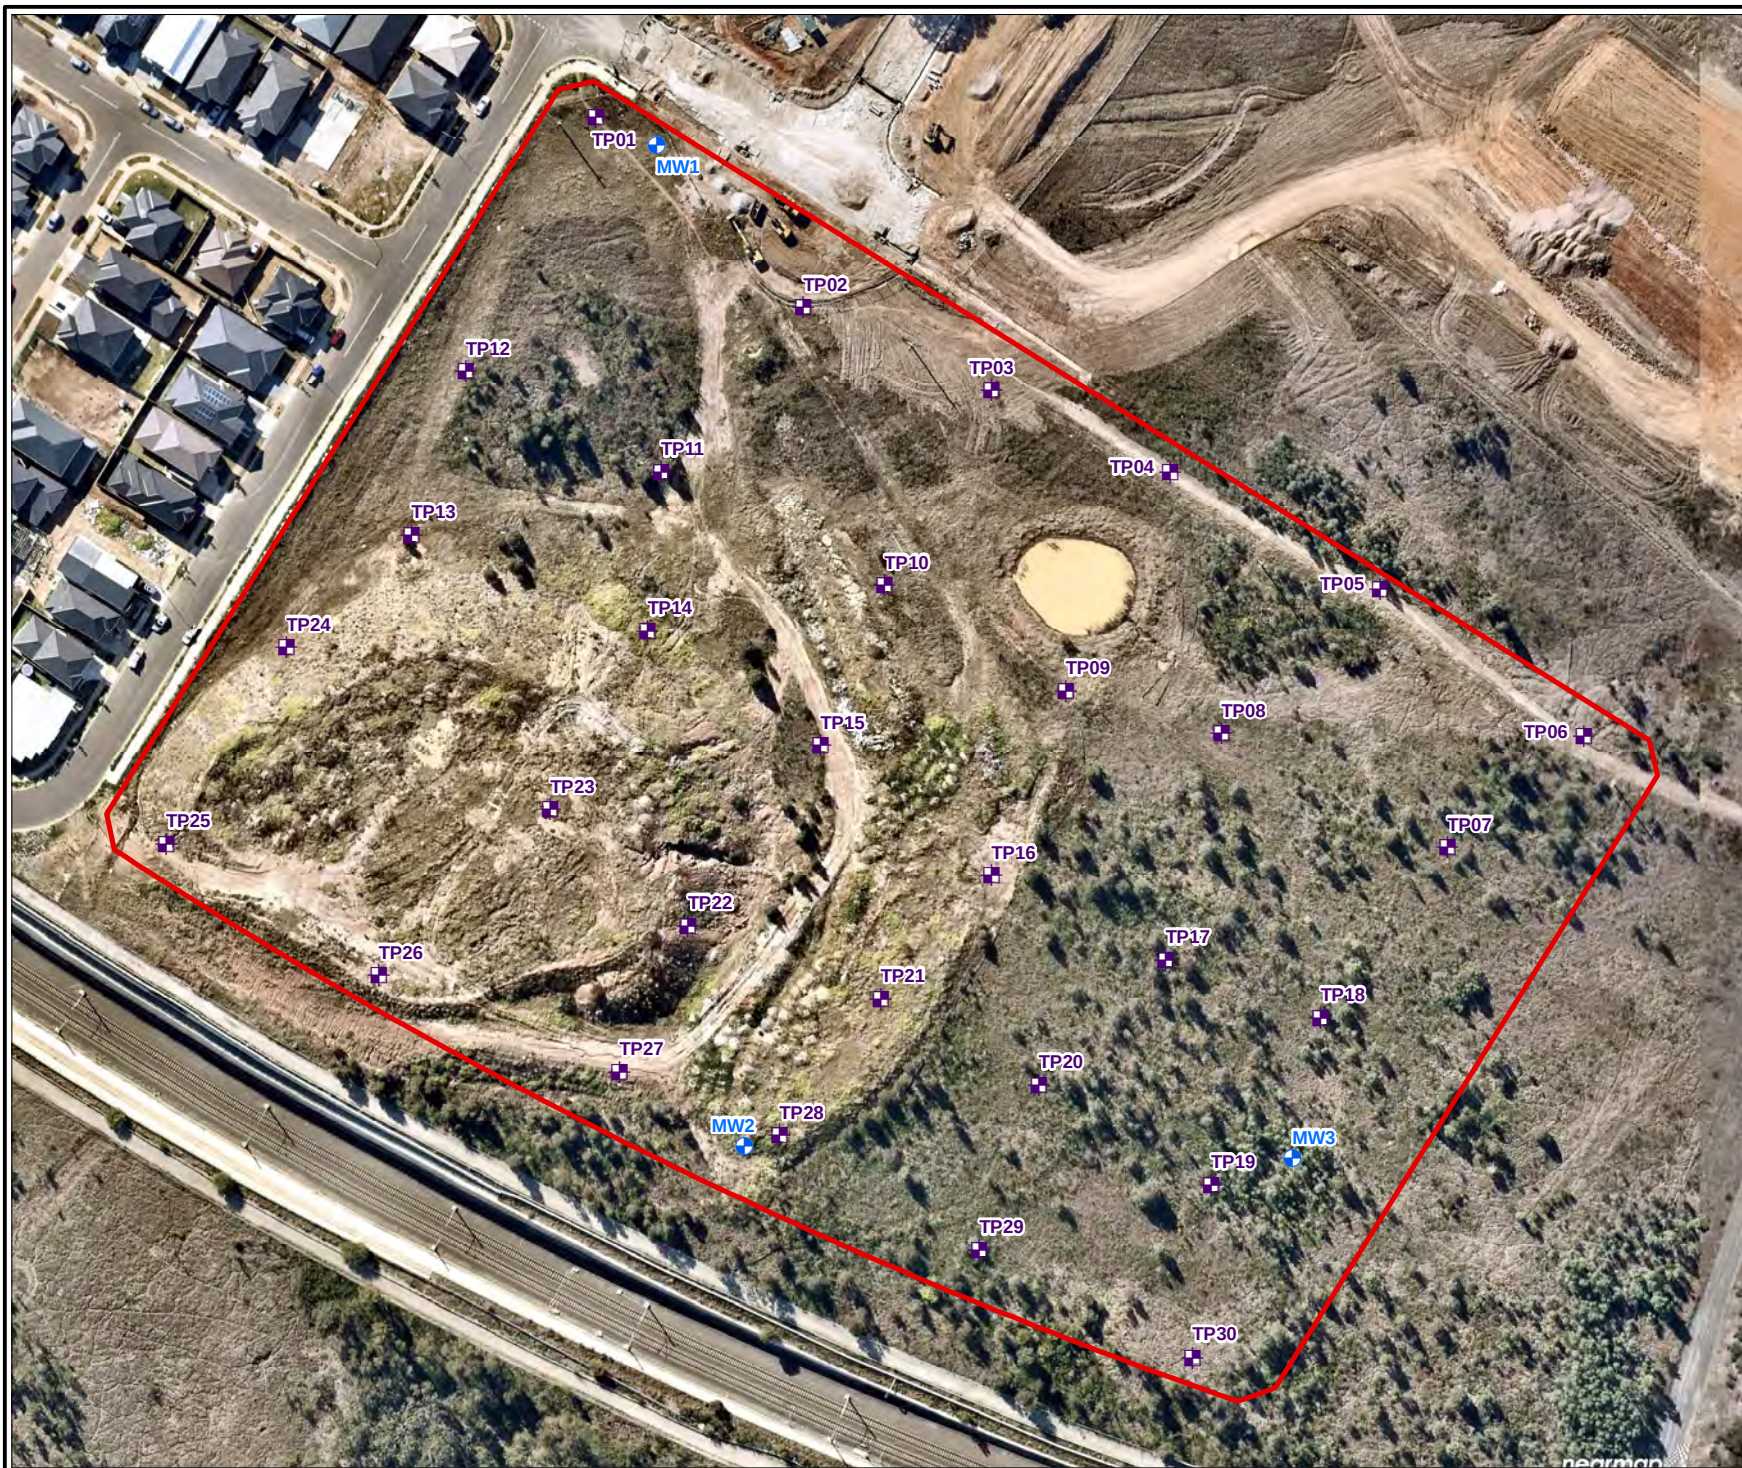
**HISTORICAL AERIAL  
PHOTOGRAPH - OCTOBER 2015**

**October 2015** –The stockpile appeared to be similar in size and character to the May 2015 aerial. The roads within the Precinct 4 development had been paved and the pads for the housing appeared to have been completed to the west of the site. The smaller stockpiles observed remain similar to those identified in the previous historical aerial May 2015, however they appeared to have been shaped.
