## Appendix C Site Plans

TWEED VALLEY HOSPITAL

## Appendix D Consultant's Figures

Residential house site: 771 Cudgen Road  
Location: Cudgen, NSW  
Details: Soil Investigation Report

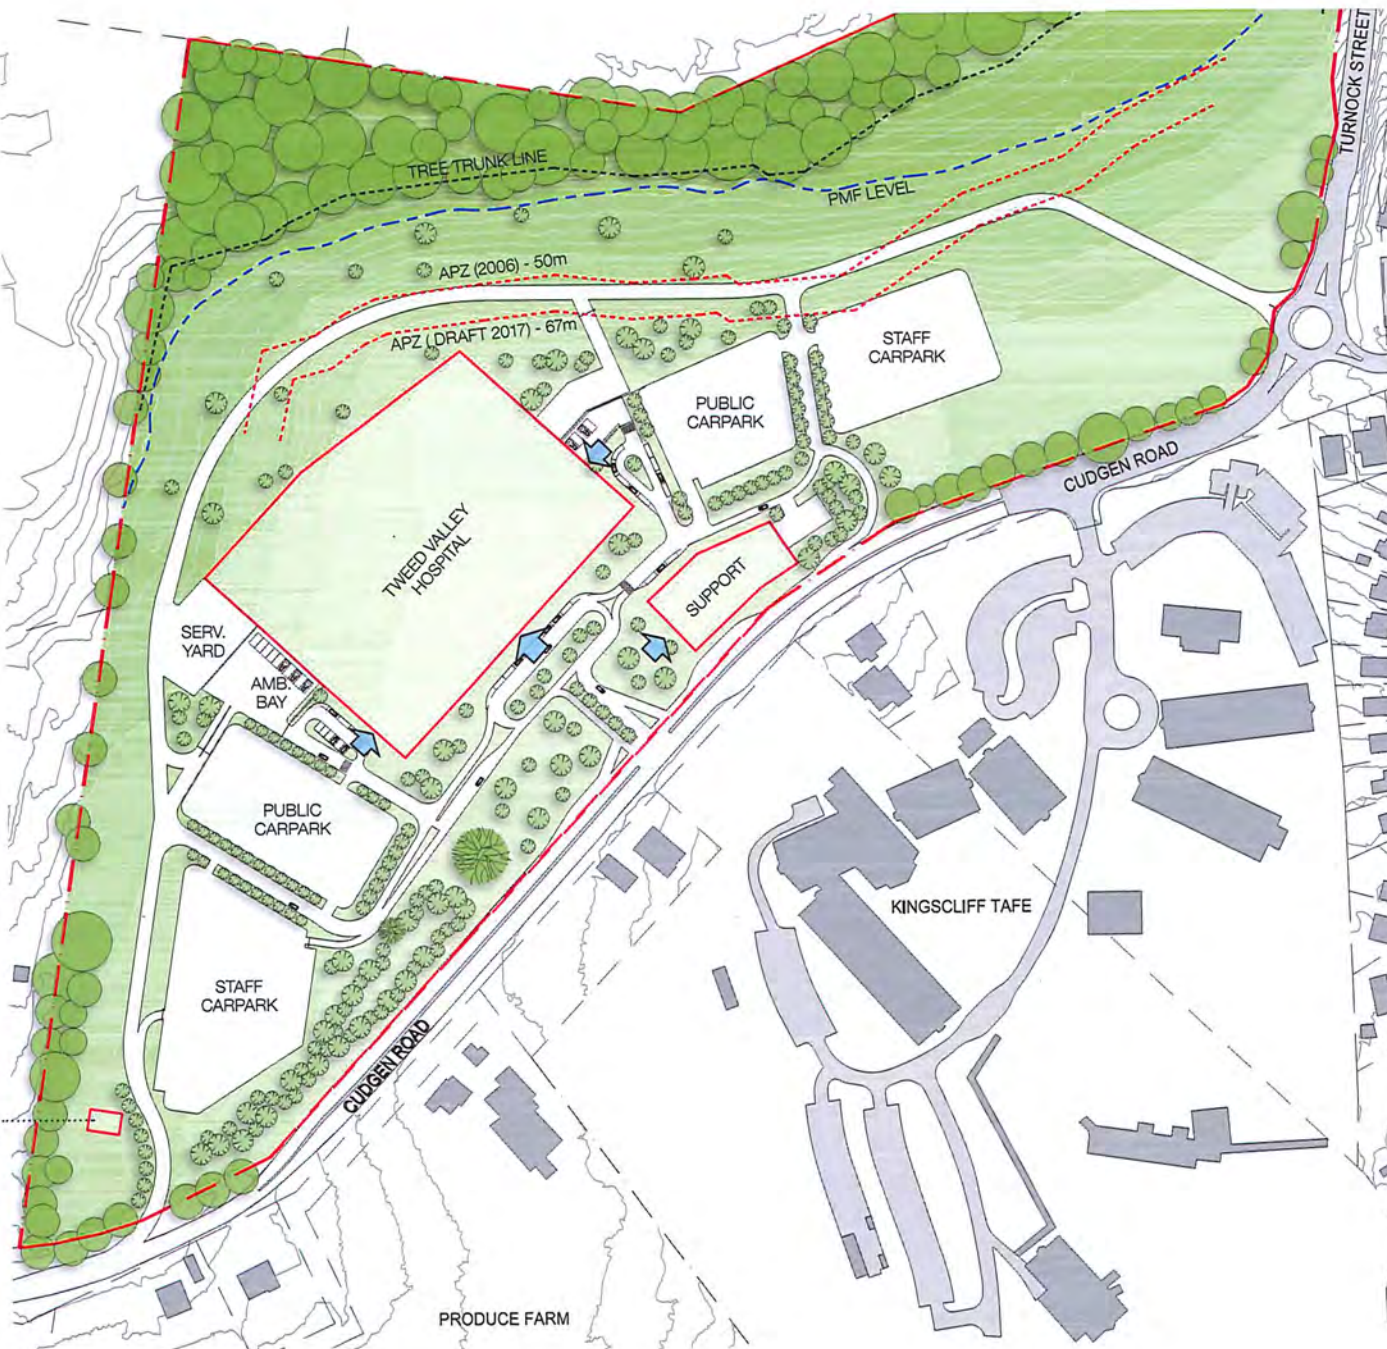
| SCALE | DATE | DRAWN BY | CHECKED |
|---|---|---|---|
| 10363 | AR-SKE-10-006 | 04 | |

**MASTERPLAN**  
**CONCEPT PLAN**

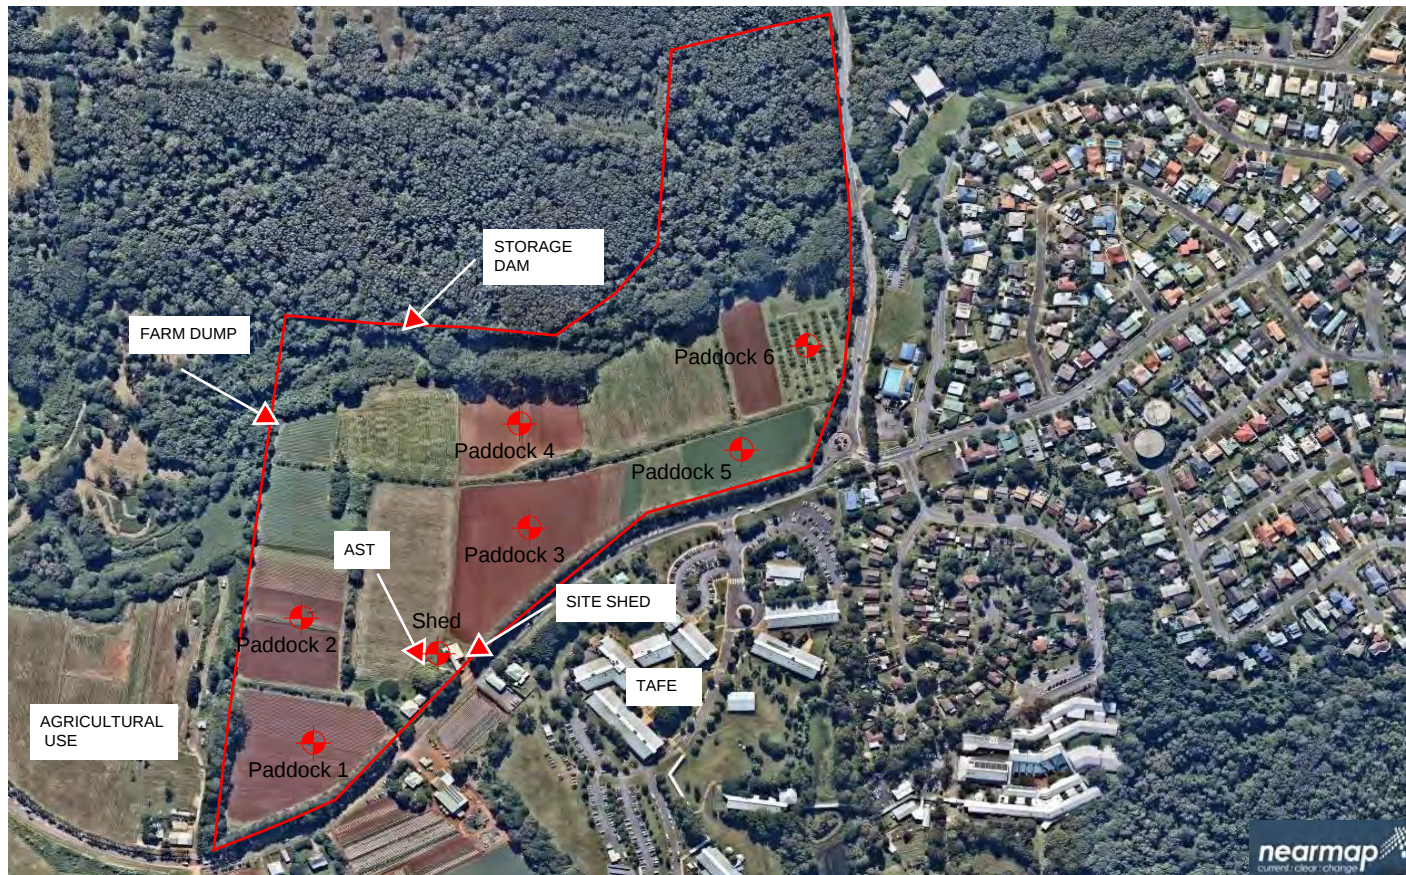
| DRAWING TITLE: | Areas of Potential Environmental Concern | JOB No: | J8961 |

Sampling locations - PSI  
Site Inspection (14/6/2018)

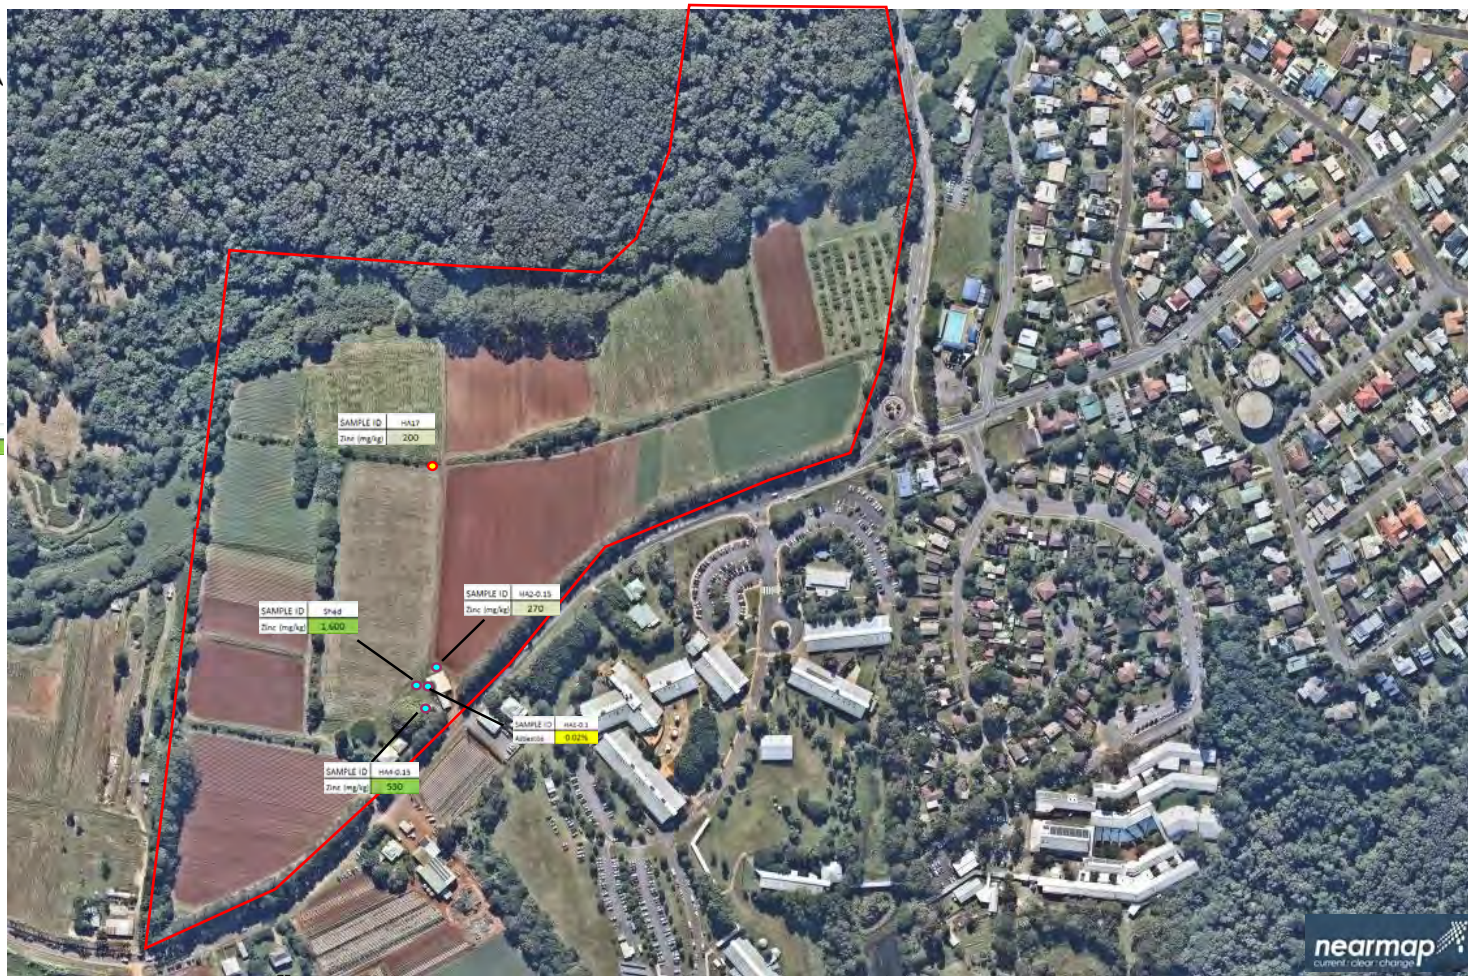
| DRAWING TITLE: | Sample locations exceeding investigation guidelines | JOB No: | J8961 |

SAMPLE ID SH48  
Zinc (mg/kg) 1,600

Sample  
results  
exceeding  
guidelines

SAMPLE ID HA32-03  
Asbestos 0.02%

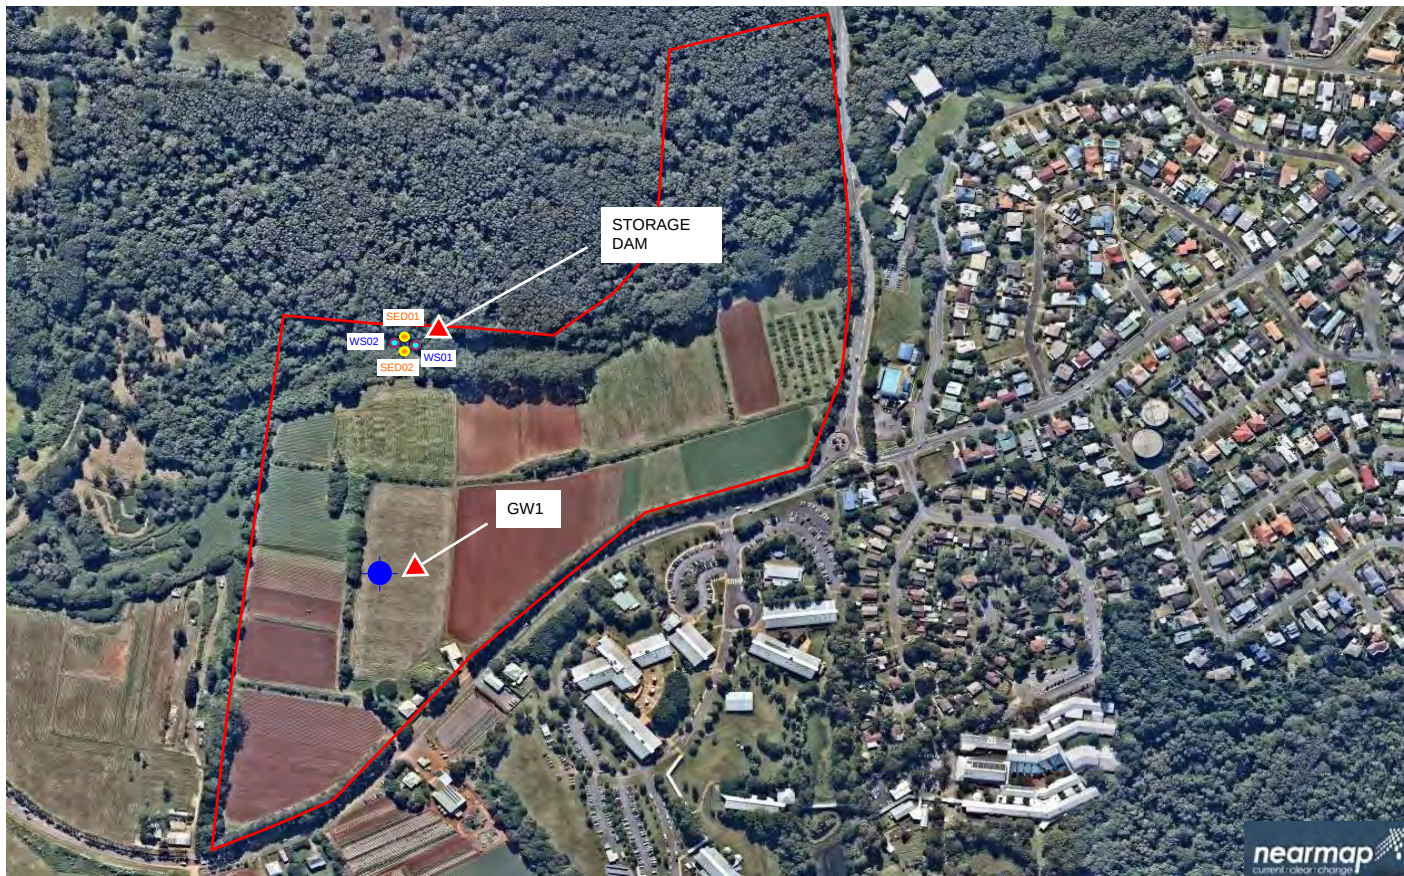
| DRAWING TITLE: | Groundwater and Surface Water Samples | JOB No: | J8961 |

Monitoring well GW1

SED01 Sediment Sample

WS01 Surface Water Sample

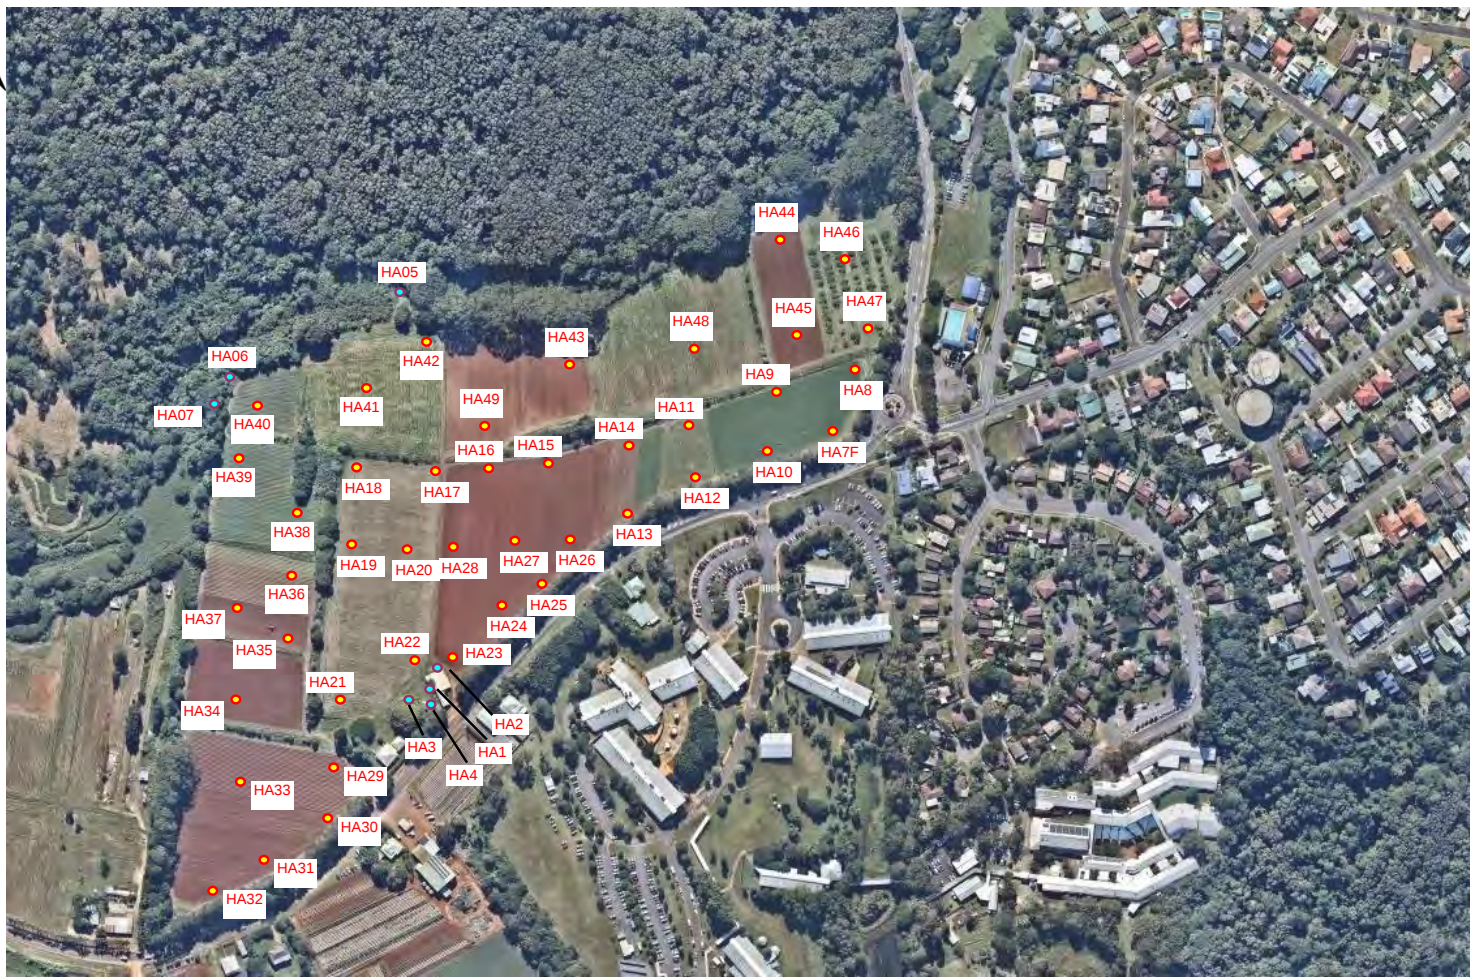
| DRAWING TITLE: | DSI Sampling Locations | JOB No: | J8961 |

HA37

Hand Auger  
location

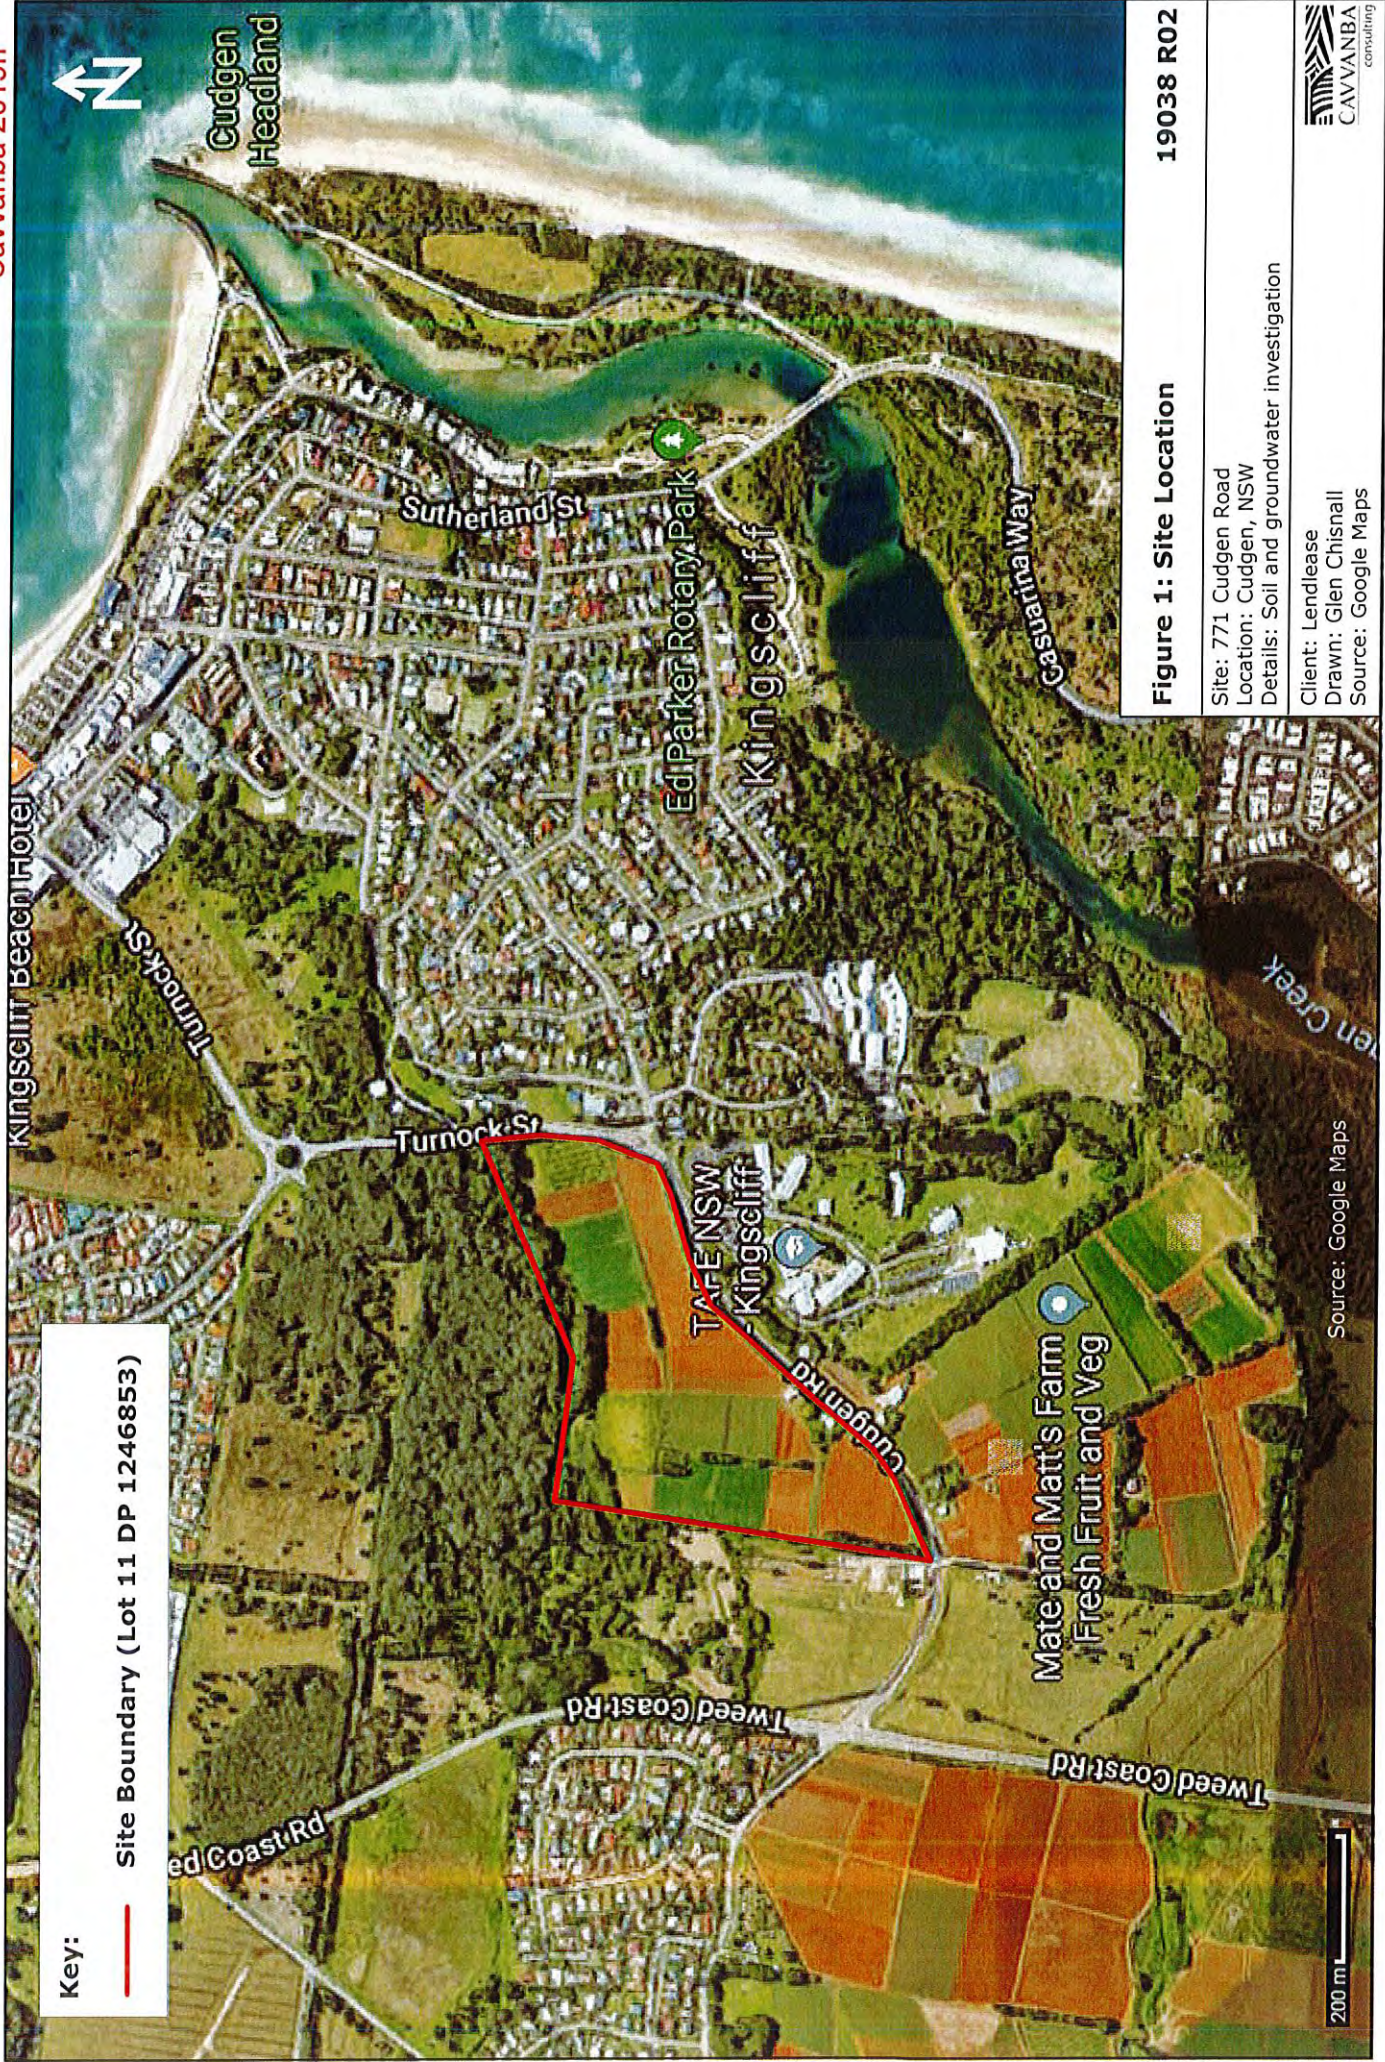
Figure 2: Farm pit investigation area 19038 R02

Pit feature (1.1 m in depth)  
Pit water contained freshwater  
and drinking water criteria  
exceedances for heavy metals.  
Elevated TRHs and PAHs

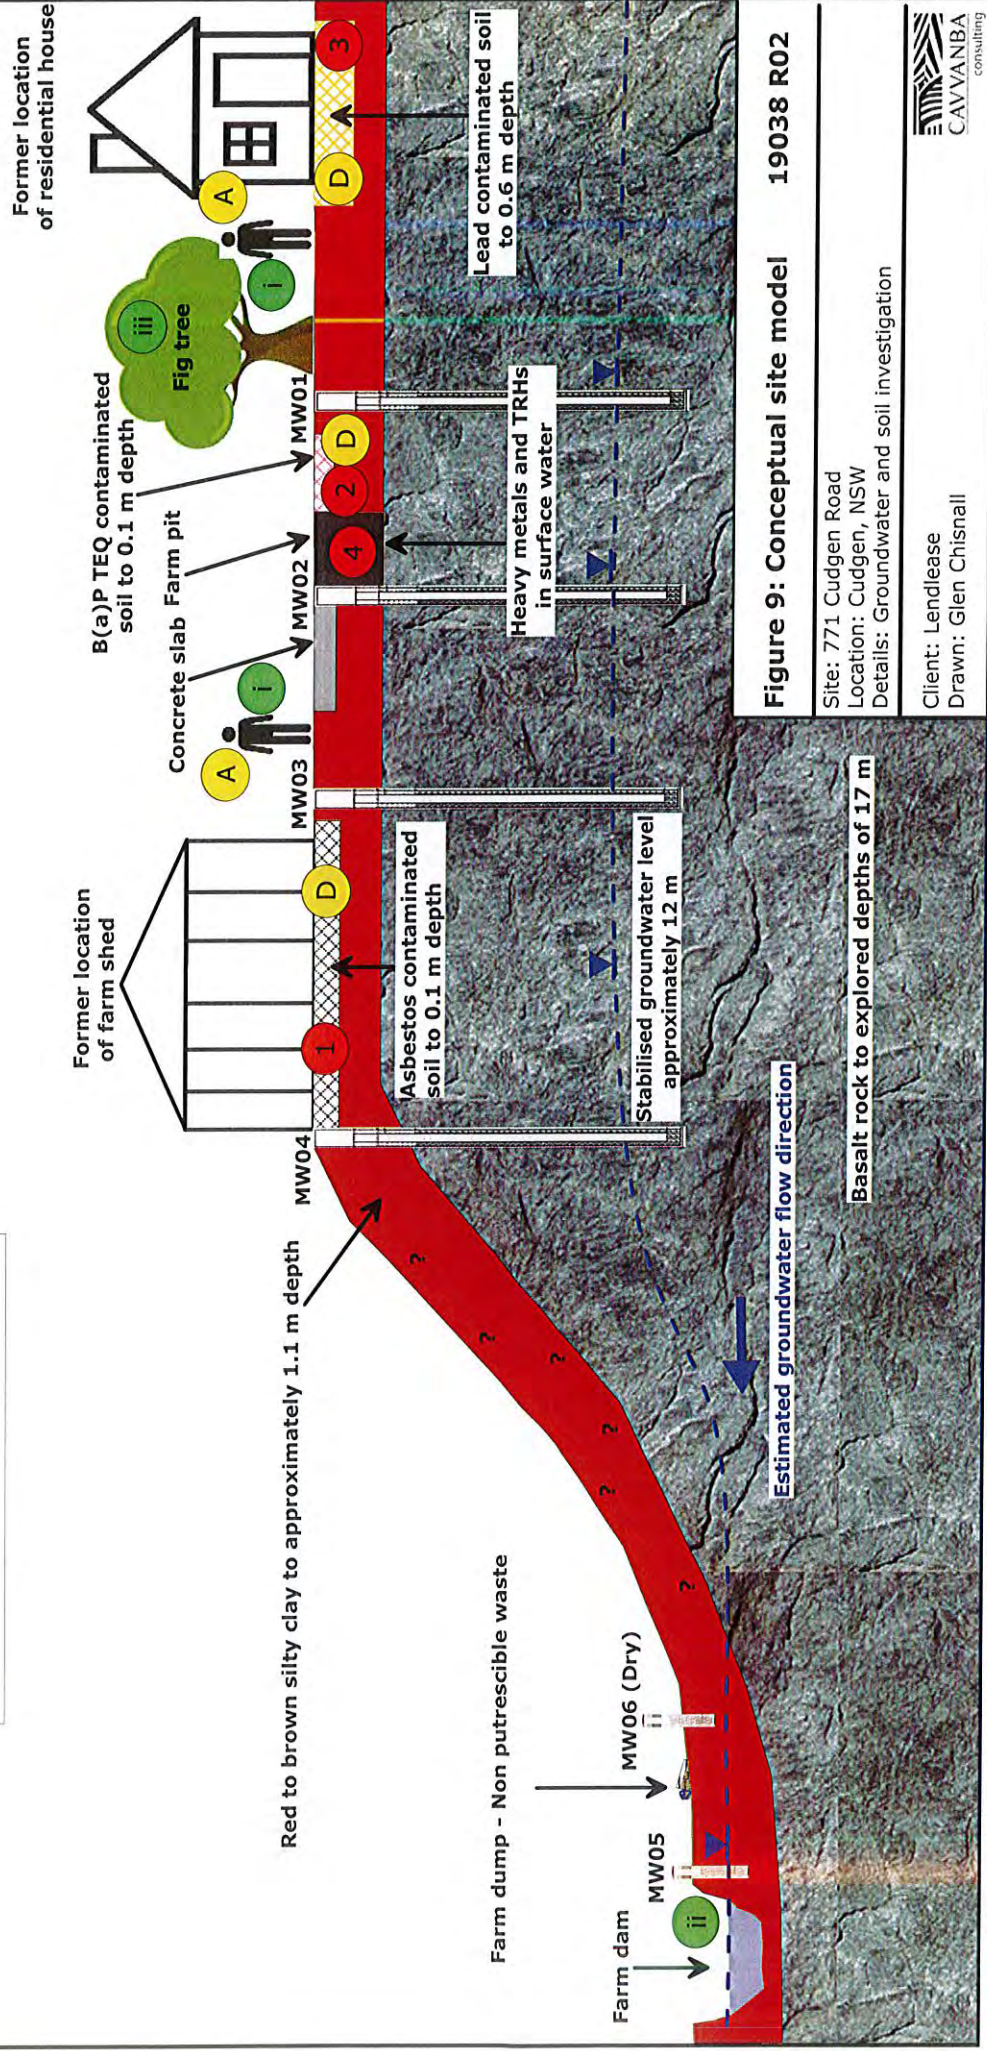
### CONTAMINATION SOURCES

- 1 - Asbestos in soil
- 2 - B(a)P TEQ in soil
- 3 - Lead in soil
- 4 - Heavy metals & TRHs in surface water

### EXPOSURE PATHWAYS

- A - Direct contact (dermal or incidental ingestion)
- D - Excavation/disturbance

### RECEPTORS On-site

- i Site users
- ii Surface Water
- iii Ecological
