Technical and Approvals Consultancy Services: Narrabri to North Star

Addendum Historic Heritage Assessment and Statement of Heritage Impact

Moree, Gurley, Bellata and Edgeroi Stations

3-0001-260-EEC-00-RP-0001

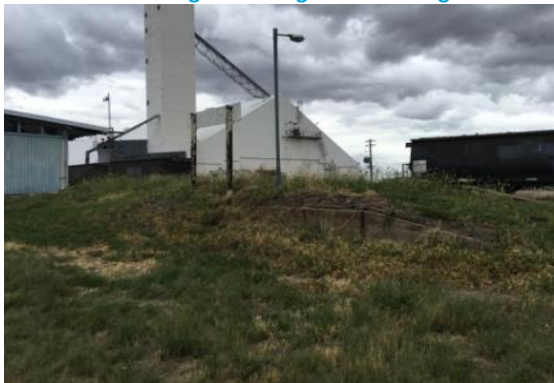
Photo 4.4 Concrete retaining wall at northern end of platform. View to south west

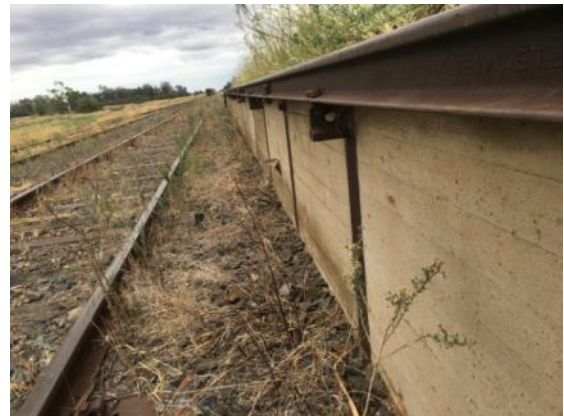
Photo 4.7 View north along up side track showing concrete platform facing

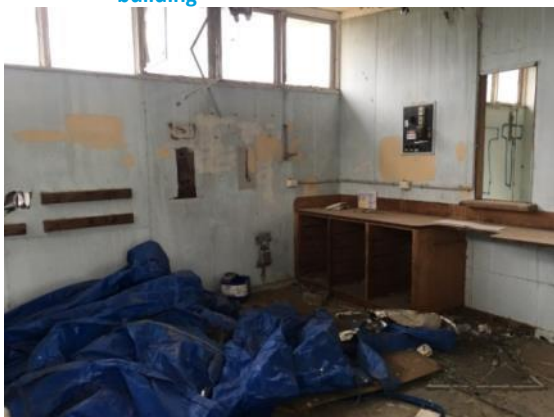
Photo 4.8 Dilapidated interior of former safe work room

The interior is divided into two rooms, both accessed from doors on the platform side. The northern room was previously used as a safe work room for rail staff. The dividing wall contains a single (empty) window opening between the two rooms with an extended timber sill/ledge at the base. Interior walls are fibro sheeting. The building is dilapidated, unstable and in poor condition. The station has a strong visual and spatial relationship with the grain transport infrastructure but a poor relationship with the village.

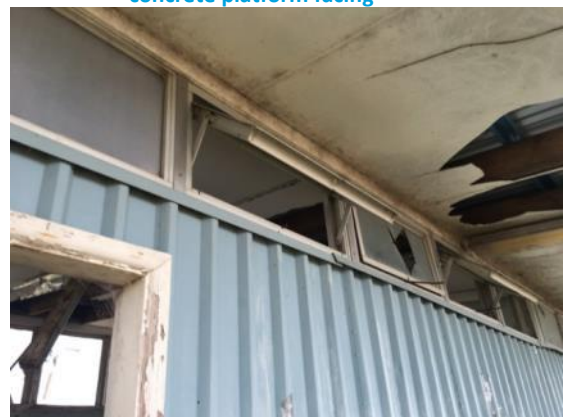
Photo 4.9 Detail of station building

The station sign is in poor condition and affected by rust, and is supported by two painted rails with metal brackets. The station building is constructed from corrugated sheet metal atop a brick pillar foundation. The single slope shed roof is corrugated tin with both metal and timber beams, faced on the underside with sheets of fibro. Interior floors are nailed timber planking. The building has elevated awning windows on the eastern, northern and western faces.

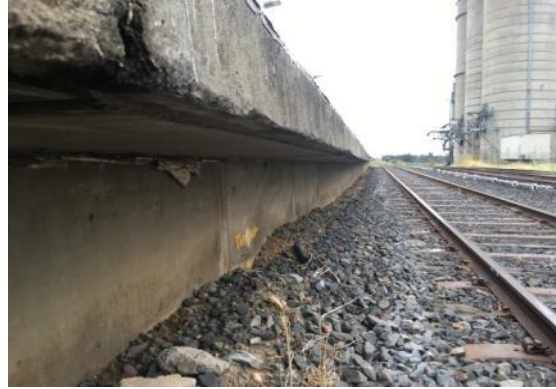
Photo 4.13 View south along up side track showing concrete platform facing and overhang

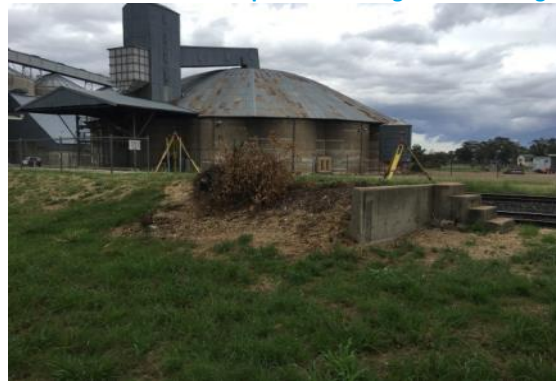
Photo 4.15 View south west of northern end of platform showing steps and concrete wall

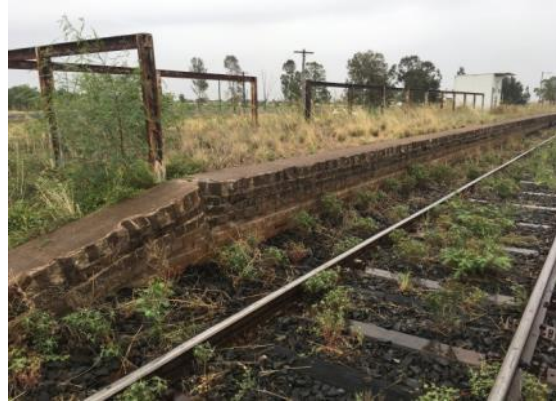
Photo 4.22 View north west from track showing damaged brick platform

Given the low archaeological potential, general absence of remaining heritage fabric at Edgeroi and Bellata and the poor condition of the brick platform at Gurley, archival photographic recording is considered to be an appropriate and adequate management measure to ensure that a full understanding and record of the former stations is documented and available for future generations.

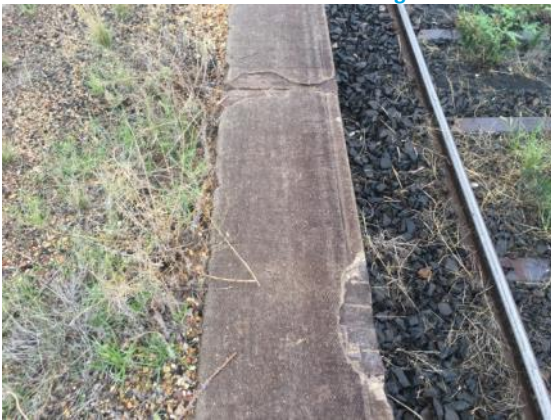
Photo 4.25 Damaged concrete along platform edge showing exposed brick

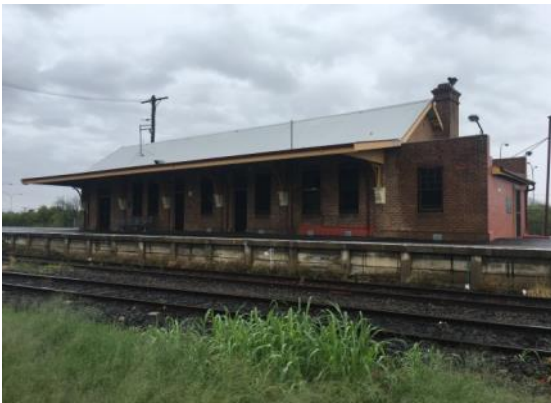
Photo 4.32 View south west to Platform 2 showing platform concrete post and panel construction

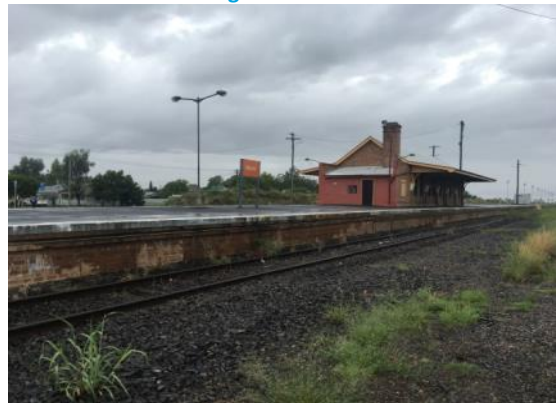
Photo 4.33 View south east to Platform 1 and station building showing brick platform construction

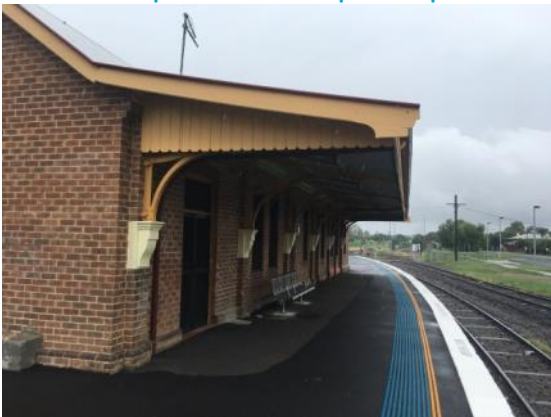
Photo 4.34 View north along Platform 2 showing station building awning

The sole remaining station building is the brick refreshment room, originally built in 1929. The building has an open gable roof of corrugated iron and is faced on both platform sides with bracketed awnings. The cantilevered awnings are supported by iron brackets resting on cement corbels and are bordered on each end with decorative timber planking. The northern end of the building has a short extension below the awning roofline with a skillion shed roof of corrugated iron inset below brick side walls of the same height as the awnings. The main building has a single corbelled chimney running down its northern face. Double-hung timber windows run along the eastern and western sides of the building, with a single-paned lower sash and a multi-paned upper sash.

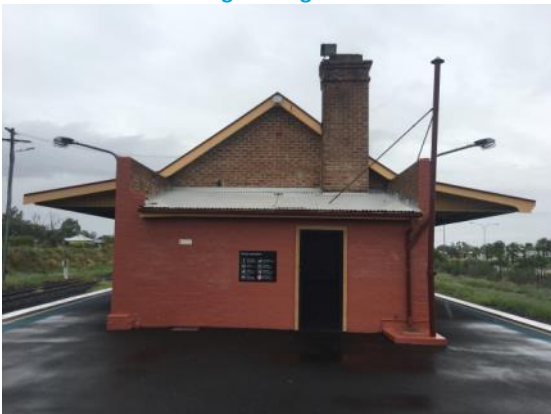
Photo 4.36 Station building – northern elevation

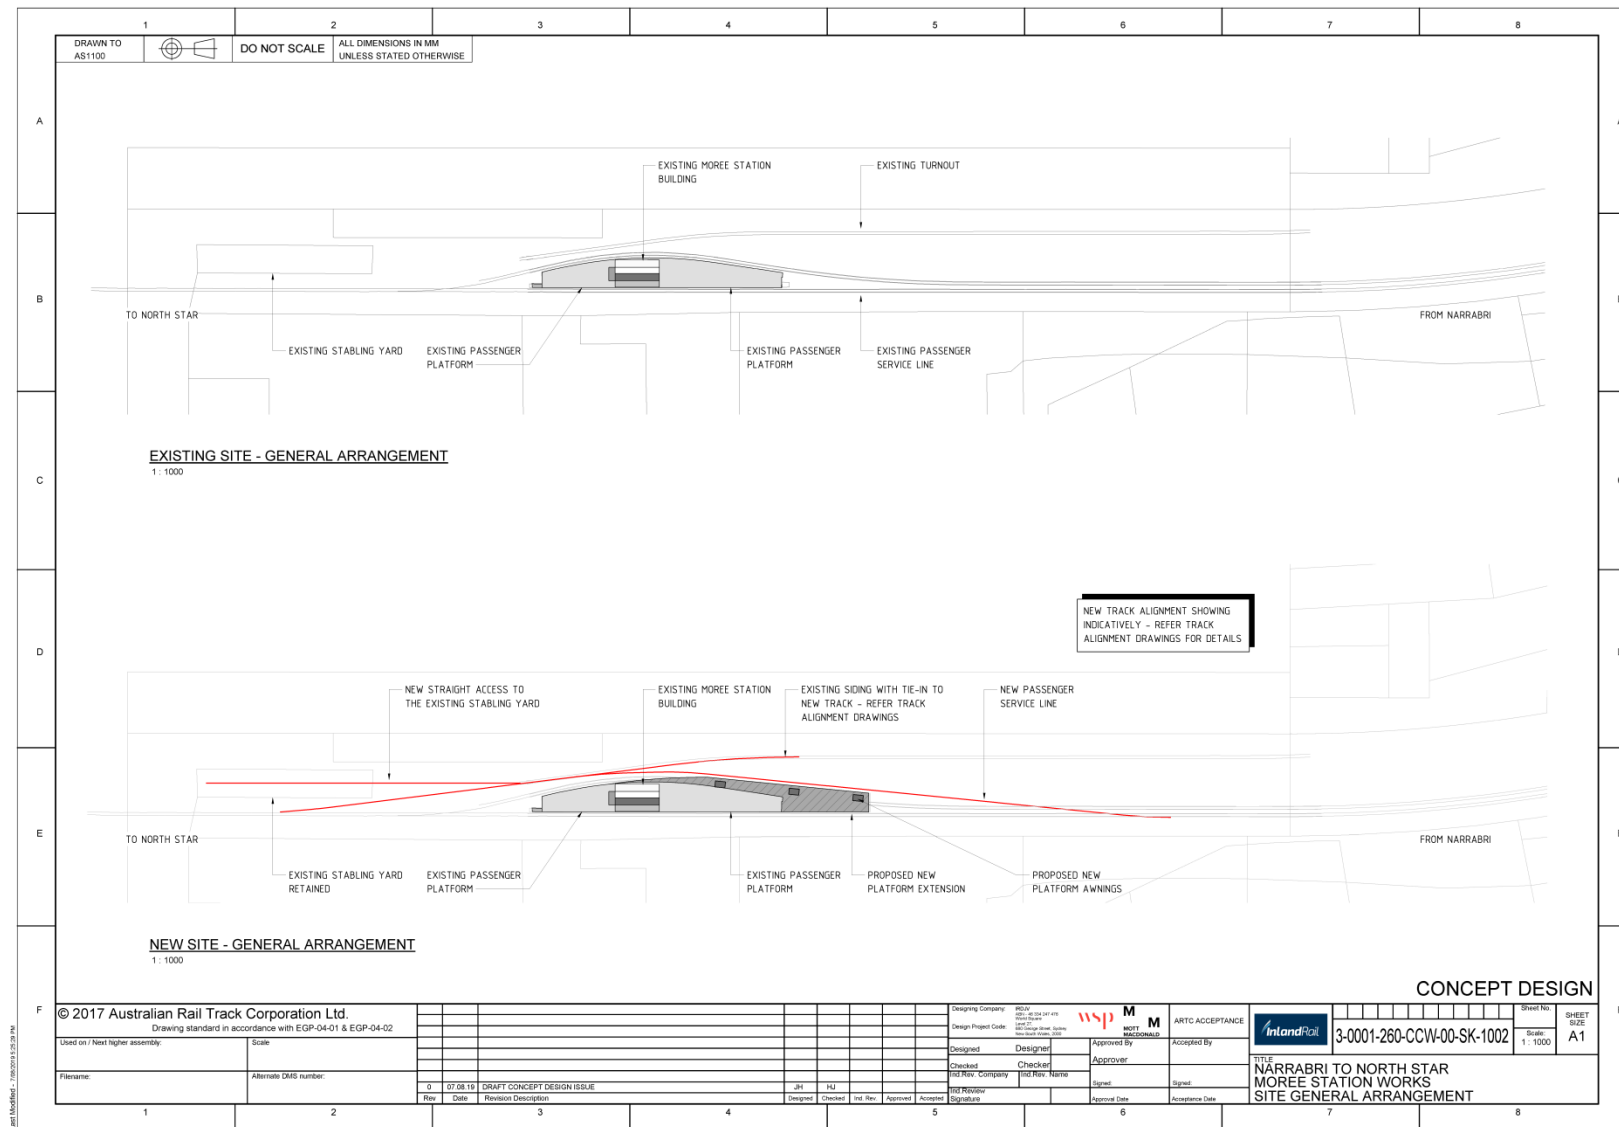
Figure 6.1 Concept design for Moree Station works – site general arrangement

- New platform extension structure would comprise a reinforced concrete retaining wall and foundation with a reinforced concrete cope unit to the platform edge. Existing platform cope edge units along Platform 2 would be removed along the extent of the interface with the new platform extension.

- A new asphalt platform surface across the extension, with the level tied to the existing platform.
- New platform shelters (awnings) would be installed on the extension, comprising steel framed cantilevered awnings on piled foundations. The exact form of these structures would be designed in consultation with a heritage architect.

- New signalling equipment room at southern end of extension to replace the existing room at this location.
- Existing help point to be relocated to new passenger platform.

- Demolition and relocation of solar lights.
- Removal of overhead electricity lines and replacement with new underground electrical supply for station building and for lighting within platform shelters. Existing power lines and power poles to be removed.
