Western Harbour Tunnel and Warringah Freeway Upgrade

Appendix B –
Archaeological site
inspection memorandum

B WHT Archaeological Site Inspection

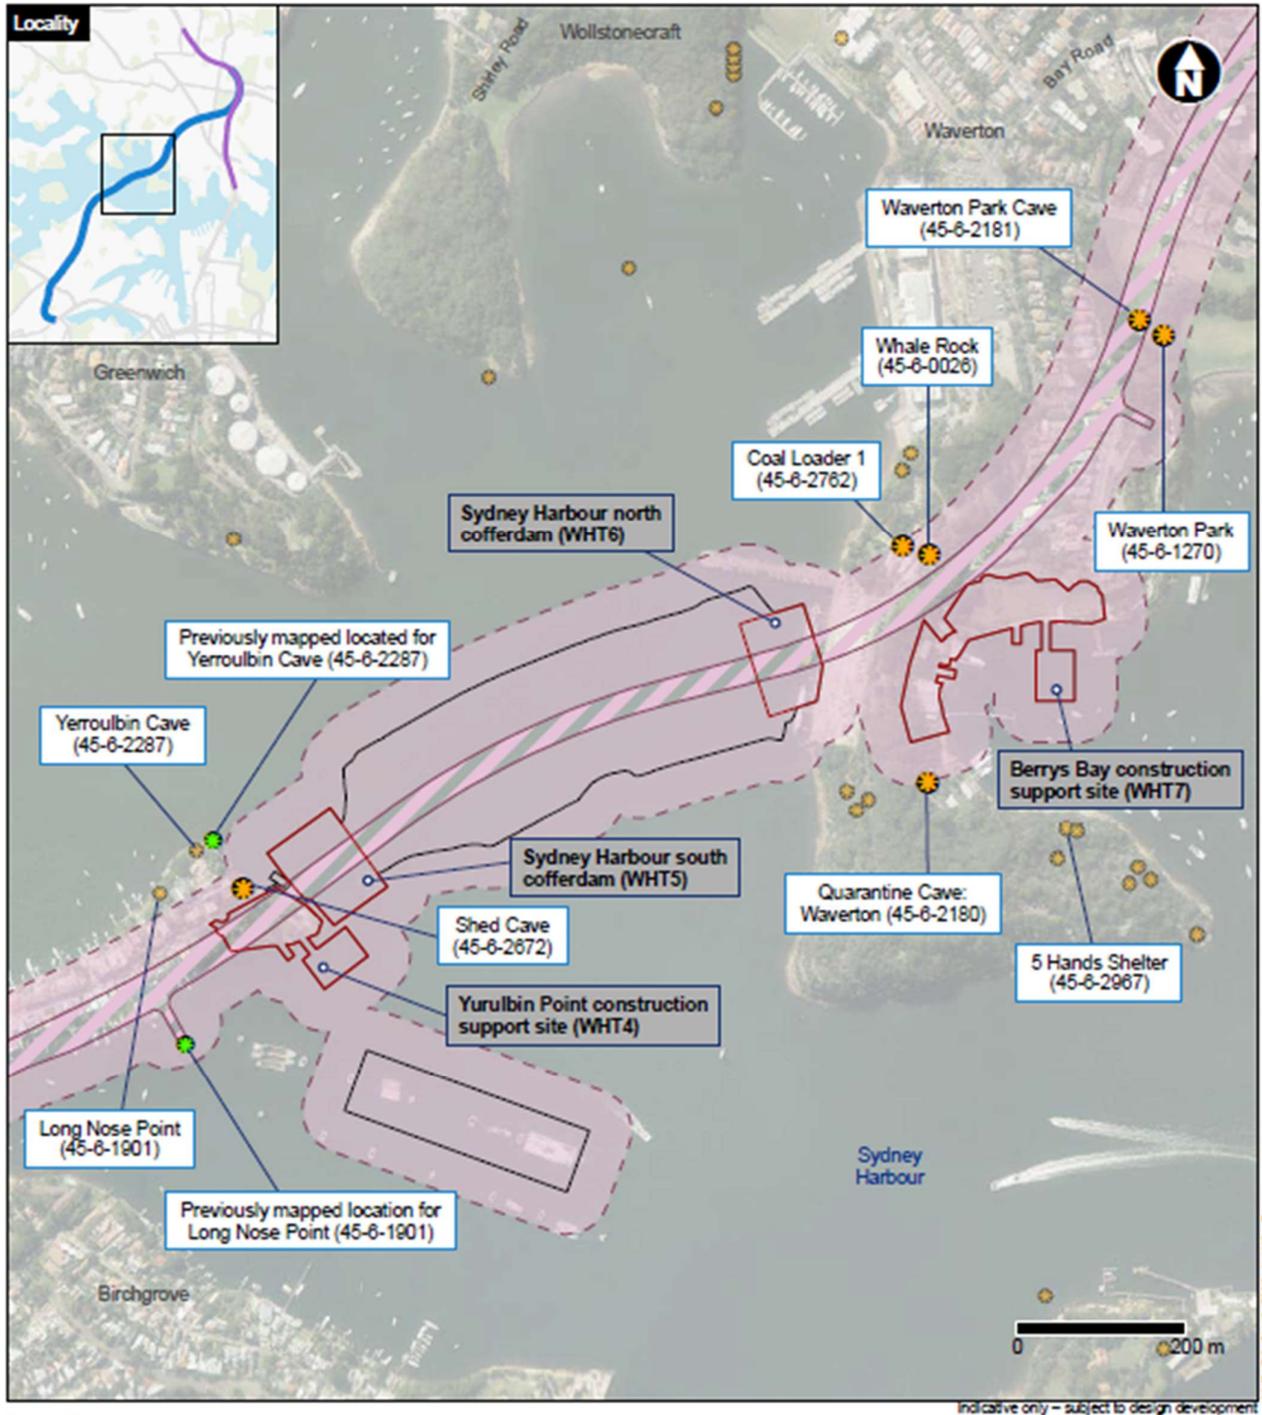
Figure B.1-1 Aboriginal sites (registered on AHIMS) in the project study area (update to Figure 15-1 of the environmental impact statement and Figure 4-2 of Appendix L (Technical working paper: Cultural heritage assessment report))

As shown in Figure B.1-1, of the four previously un-surveyed sites, only Shed Cave (45-6-2672) occurs within the study area. The 5 Hands Shelter (45-6-2967) site was determined to be located around 170 metres outside of the study area. The remaining two sites, Yerroulbin Cave (45-6-2287)

and Long Nose Point (45-6-1901), were confirmed to be located outside of, but adjacent to, the study area.

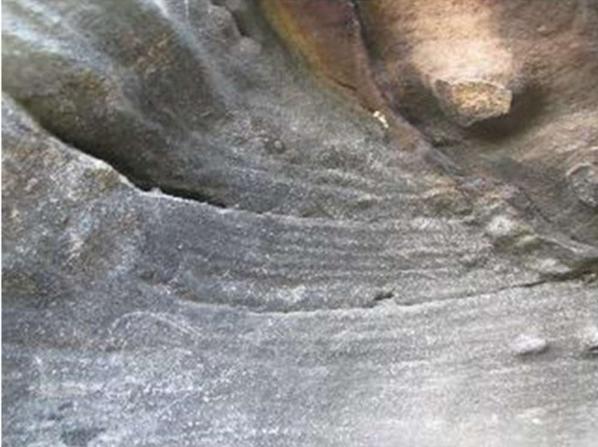
Cultural value name (AHIMS ID)	Description	Image
<p>Yerroulbin Cave (45-6-2287)</p>	<p>The site is an open-faced rockshelter with an easterly aspect. The rockshelter is approximately seven metres in length and three metres in height. The rockshelter is surrounded by vegetation which partially covers the site.</p> <p>Previous archaeological recordings of the site report rock art inside of the rockshelter with shell midden and shell fragments surrounding the entrance and within the dripline. The site photos on the AHIMS file matched the location inspected.</p> <p>During inspection of the site, the rock art was extremely difficult to discern with the naked eye, and the art appears to have faded and degraded over time. Regarding the previously recorded shell midden, some traces of material are visible throughout the site and it is likely the subsurface deposit remains intact.</p> <p>The Yerroulbin Cave site is located greater than 50 metres from the construction footprint and is not subject to further significance assessment or impact assessment in this memorandum.</p>

<p>Photo by A Costello, showing the inside of Yerroulbin Cave</p>

The sites at Yerroulbin Cave (45-6-2287), Long Nose Point (45-6-1901) and 5 Hands Shelter (45-6-2967) are located greater than 50 metres from surface works and the tunnel alignment and are not subject to impact or requiring ongoing management recommendations.

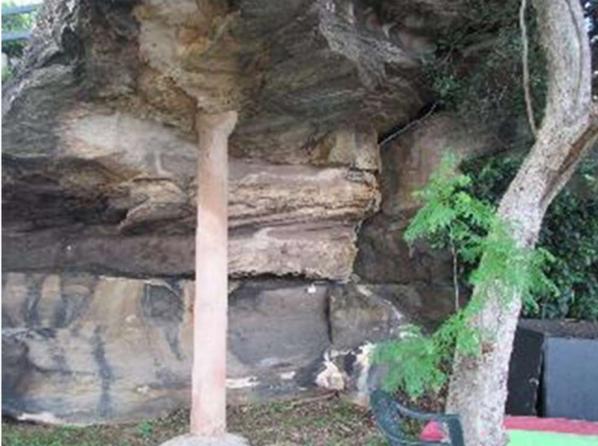
Cultural value name (AHIMS ID)	Description	Image
<p>Long Nose Point (45-6-1901)</p>	<p>The site is situated on the foreshore and consists of a north facing rock shelter, next to Yerroulbin Cave. The site photos on the AHIMS file matched the location inspected.</p> <p>There is evidence of erosion and rockfall at the site. A metal seat appears to be a permanent fixture and a concrete pillar has been installed to prevent further collapse of the overhang and support the sandstone structure.</p> <p>Past archaeological recordings of the site state that there is a substantial midden retained under the grass and protected at the front by a sandstone retaining wall. This is likely to still be intact and retained in the subsurface deposit. During the inspection, visible traces of shell midden were observed in the vicinity of the shallow rockshelter which can be seen through patches of the grass.</p> <p>The past recording of the site noted that no art was visible in the rockshelter. No Aboriginal rock art could be identified during the inspection so it is unclear whether exposure and interference has reduced any art work to a state invisible to the naked eye, or whether no art is present.</p> <p>The Long Nose Point site is located greater than 50 metres from the construction footprint and is not subject to further significance assessment or impact assessment in this memorandum.</p>

<p>Photo by A Costello, showing the front of Long Nose Point</p>

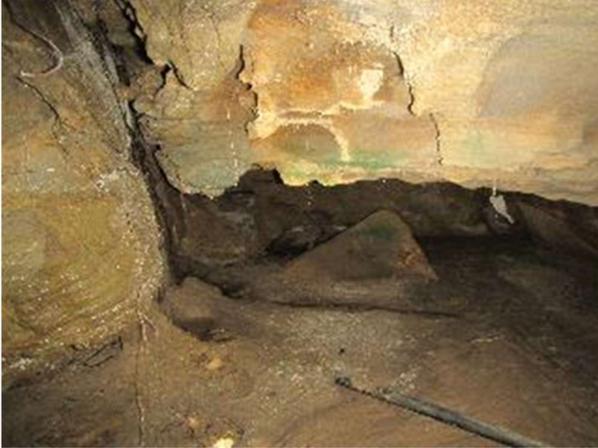
Cultural value name (AHIMS ID)	Description	Image
Shed Cave (45-6-2672)	<p>The archaeological site of Shed Cave (45-6-2672) comprises a rockshelter near the waterfront, adjacent to Yurulbin Park and Birchgrove Wharf. The site photos and descriptions on the AHIMS file matched the location inspected.</p> <p>The rockshelter entrance is partially hidden by overhanging leaves behind a gate towards the northern end of the property. The rockshelter is approximately two metres high and three metres long. It is a shallow rockshelter with a lower rear compartment which declines further into the sandstone escarpment. The rockshelter is being used to store various domestic items and there is dampness associated with recent rainfall in the recesses of the rockshelter.</p> <p>Remnants of the previously recorded midden were observed and the rockshelter appears to have been disturbed, aggraded with sand and debris. Some traces of shell material can be seen scattered throughout the rockshelter, which extend back beyond visibility. It is likely the subsurface deposit containing midden and shell material remains intact.</p> <p>The past recording of the site noted that no art was visible in the rock shelter. No evidence of art was noted during the site inspection.</p>

<p>Photo by A Costello, showing the lower compartment of Shed Cave</p>

The site at Shed Cave (45-6-2672) is located within 50 metres of surface works and within 50 metres of the mainline tunnels and may be subject to indirect impacts associated with vibration and settlement.

Environmental management measure AH1 has now been satisfied following conclusion of the four additional site inspections and consultation on the findings of this document with the MLALC (refer Table D2-1 of the submissions report). AH10 (refer to Table B.6-1) has been added to state that subject to private landowner consent and access, environmental management measures AH2, AH3 and AH4 (for vibration monitoring) will apply to the Shed Cave (45-6-2672) site.

Ref	Phase	Impact	Environmental Management measure	Location
AH10	Pre-construction	Aboriginal heritage	Transport for NSW will consult with the landowners of the private property where the Shed Cave (45-6-2672) AHIMS site is located. Subject to private landowner consent and access, AH2, AH3 and AH4 will apply to the AHIMS site Shed Cave (45-6-2672).	Shed Cave (45-6-2672)

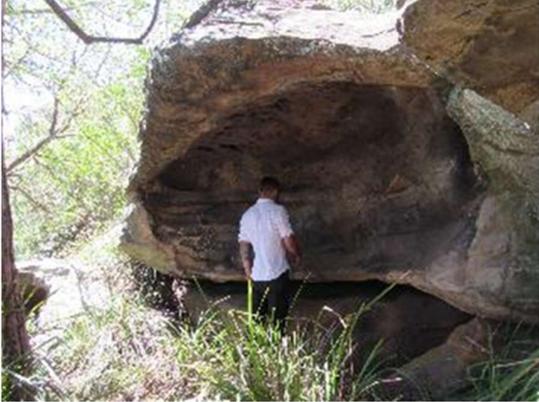
Cultural value name (AHIMS ID)	Description	Image
<p>5 Hands Shelter (45-6-2967)</p>	<p>5 Hands Shelter (45-6-2967) is located at Balls Head Reserve, situated on a headland overlooking Sydney Harbour.</p> <p>The coordinates on the AHIMS site card incorrectly show the site as being located close to Yurulbin Park and Birchgrove Wharf. This has been corrected and updated on AHIMS following site inspection undertaken to confirm the location of the site using site descriptions and photographs. The 5 Hands Shelter (AHIMS 45-6-2967) is situated adjacent to Balls Head Reserve 5 Hands Cave (45-6-0891). Both of these sites are located around 170 metres from the construction footprint. As such, while the description of the 5 Hands Shelter (45-6-2967) is noted here, it is not subject to further significance assessment or impact assessment in this memorandum.</p> <p>The shelter has a northwest aspect overlooking Sydney Harbour. The shallow rockshelter has had moderate disturbances through casual passer-by visitation due to being in an urban environment as well as some general environmental and erosional factors. The previously recorded midden can be seen scattered throughout the shelter showing the evidence that an intact subsurface deposit has been retained.</p> <p>No Aboriginal rock art could be identified during the inspection and it is presumed that exposure and interference has reduced to any art work to a state invisible to the naked eye.</p>

<p>Photo by A Costello, showing the front of 5 Hands Cave</p>
