Report on
Detailed Site Investigation (Contamination)

New High School in Bungendore
Majara Street, Bungendore

Prepared for
Hindmarsh Construction Pty Ltd

Project 202107.04
July 2022

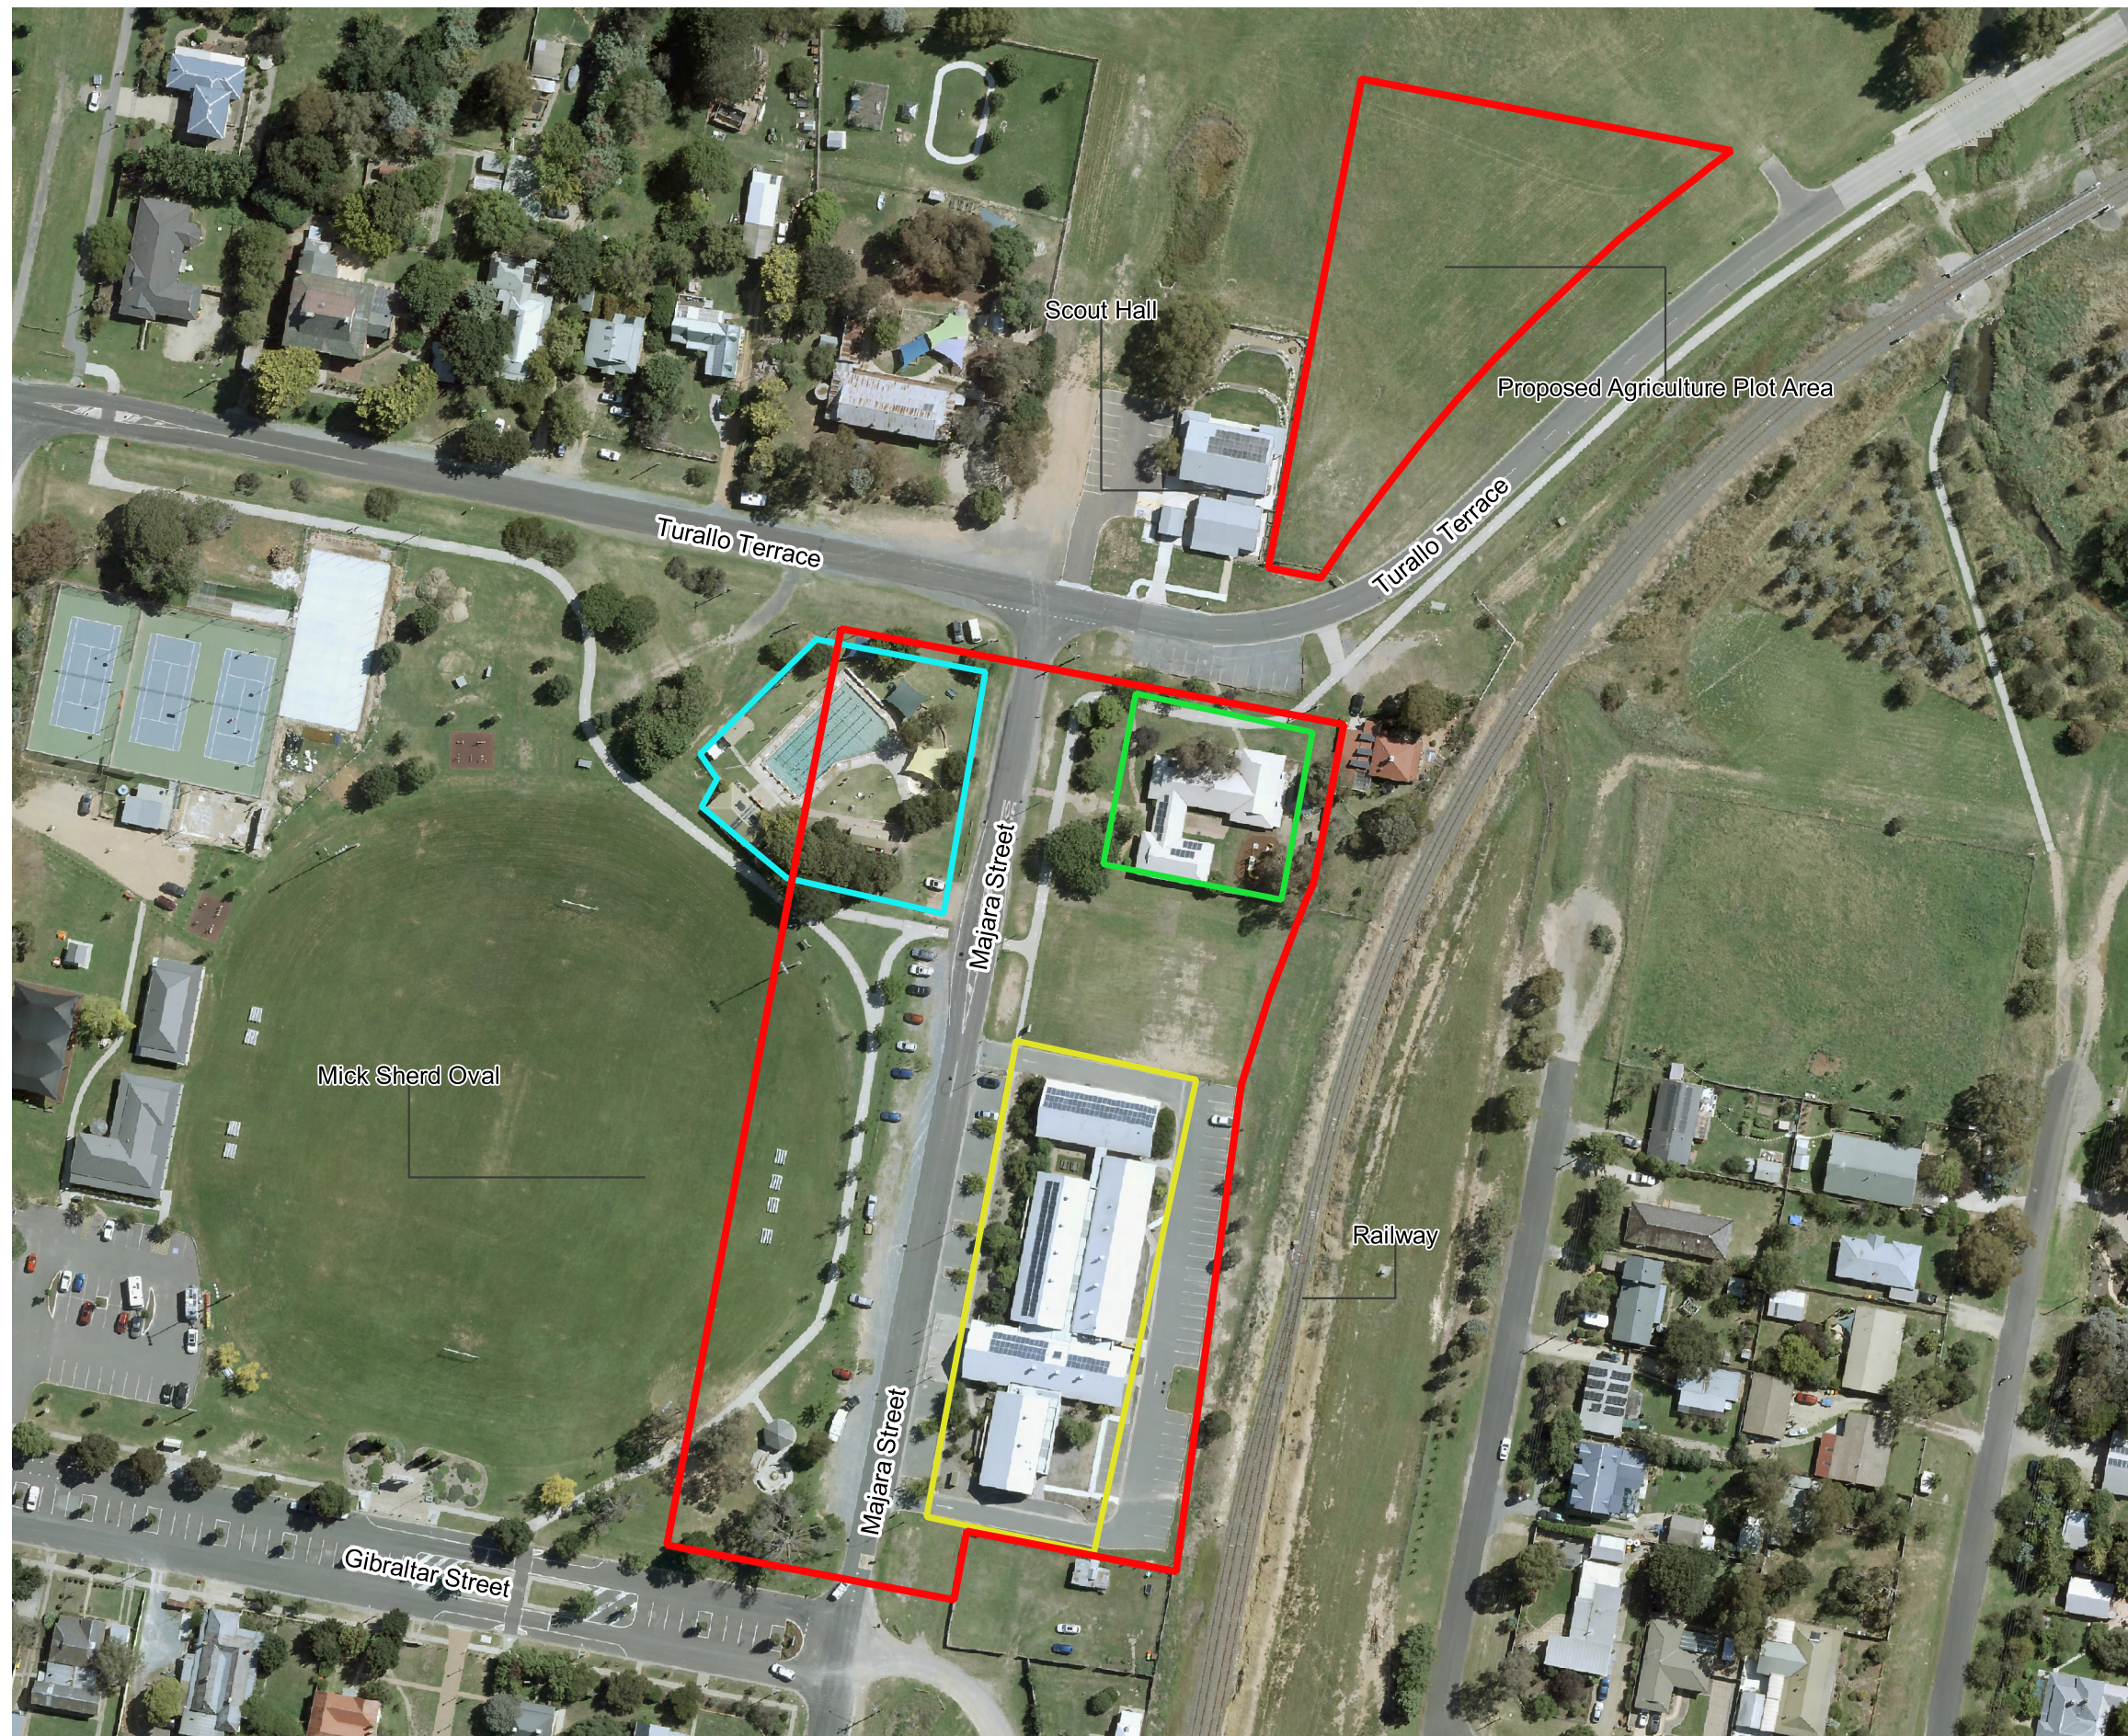
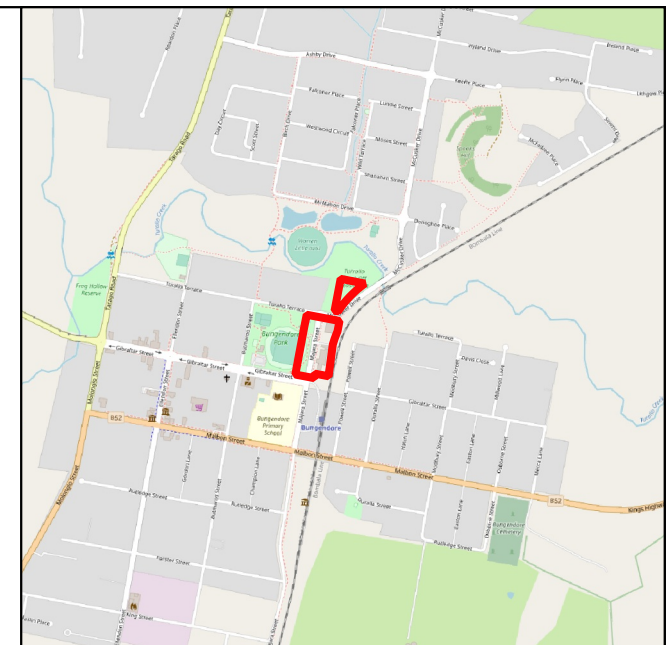
- Notes:
1. Drawing projection GDA94 / MGA zone 55
 2. Latest available aerial imagery sourced from metromap.com accessed 28/02/2021
 3. Test locations shown are approximate only

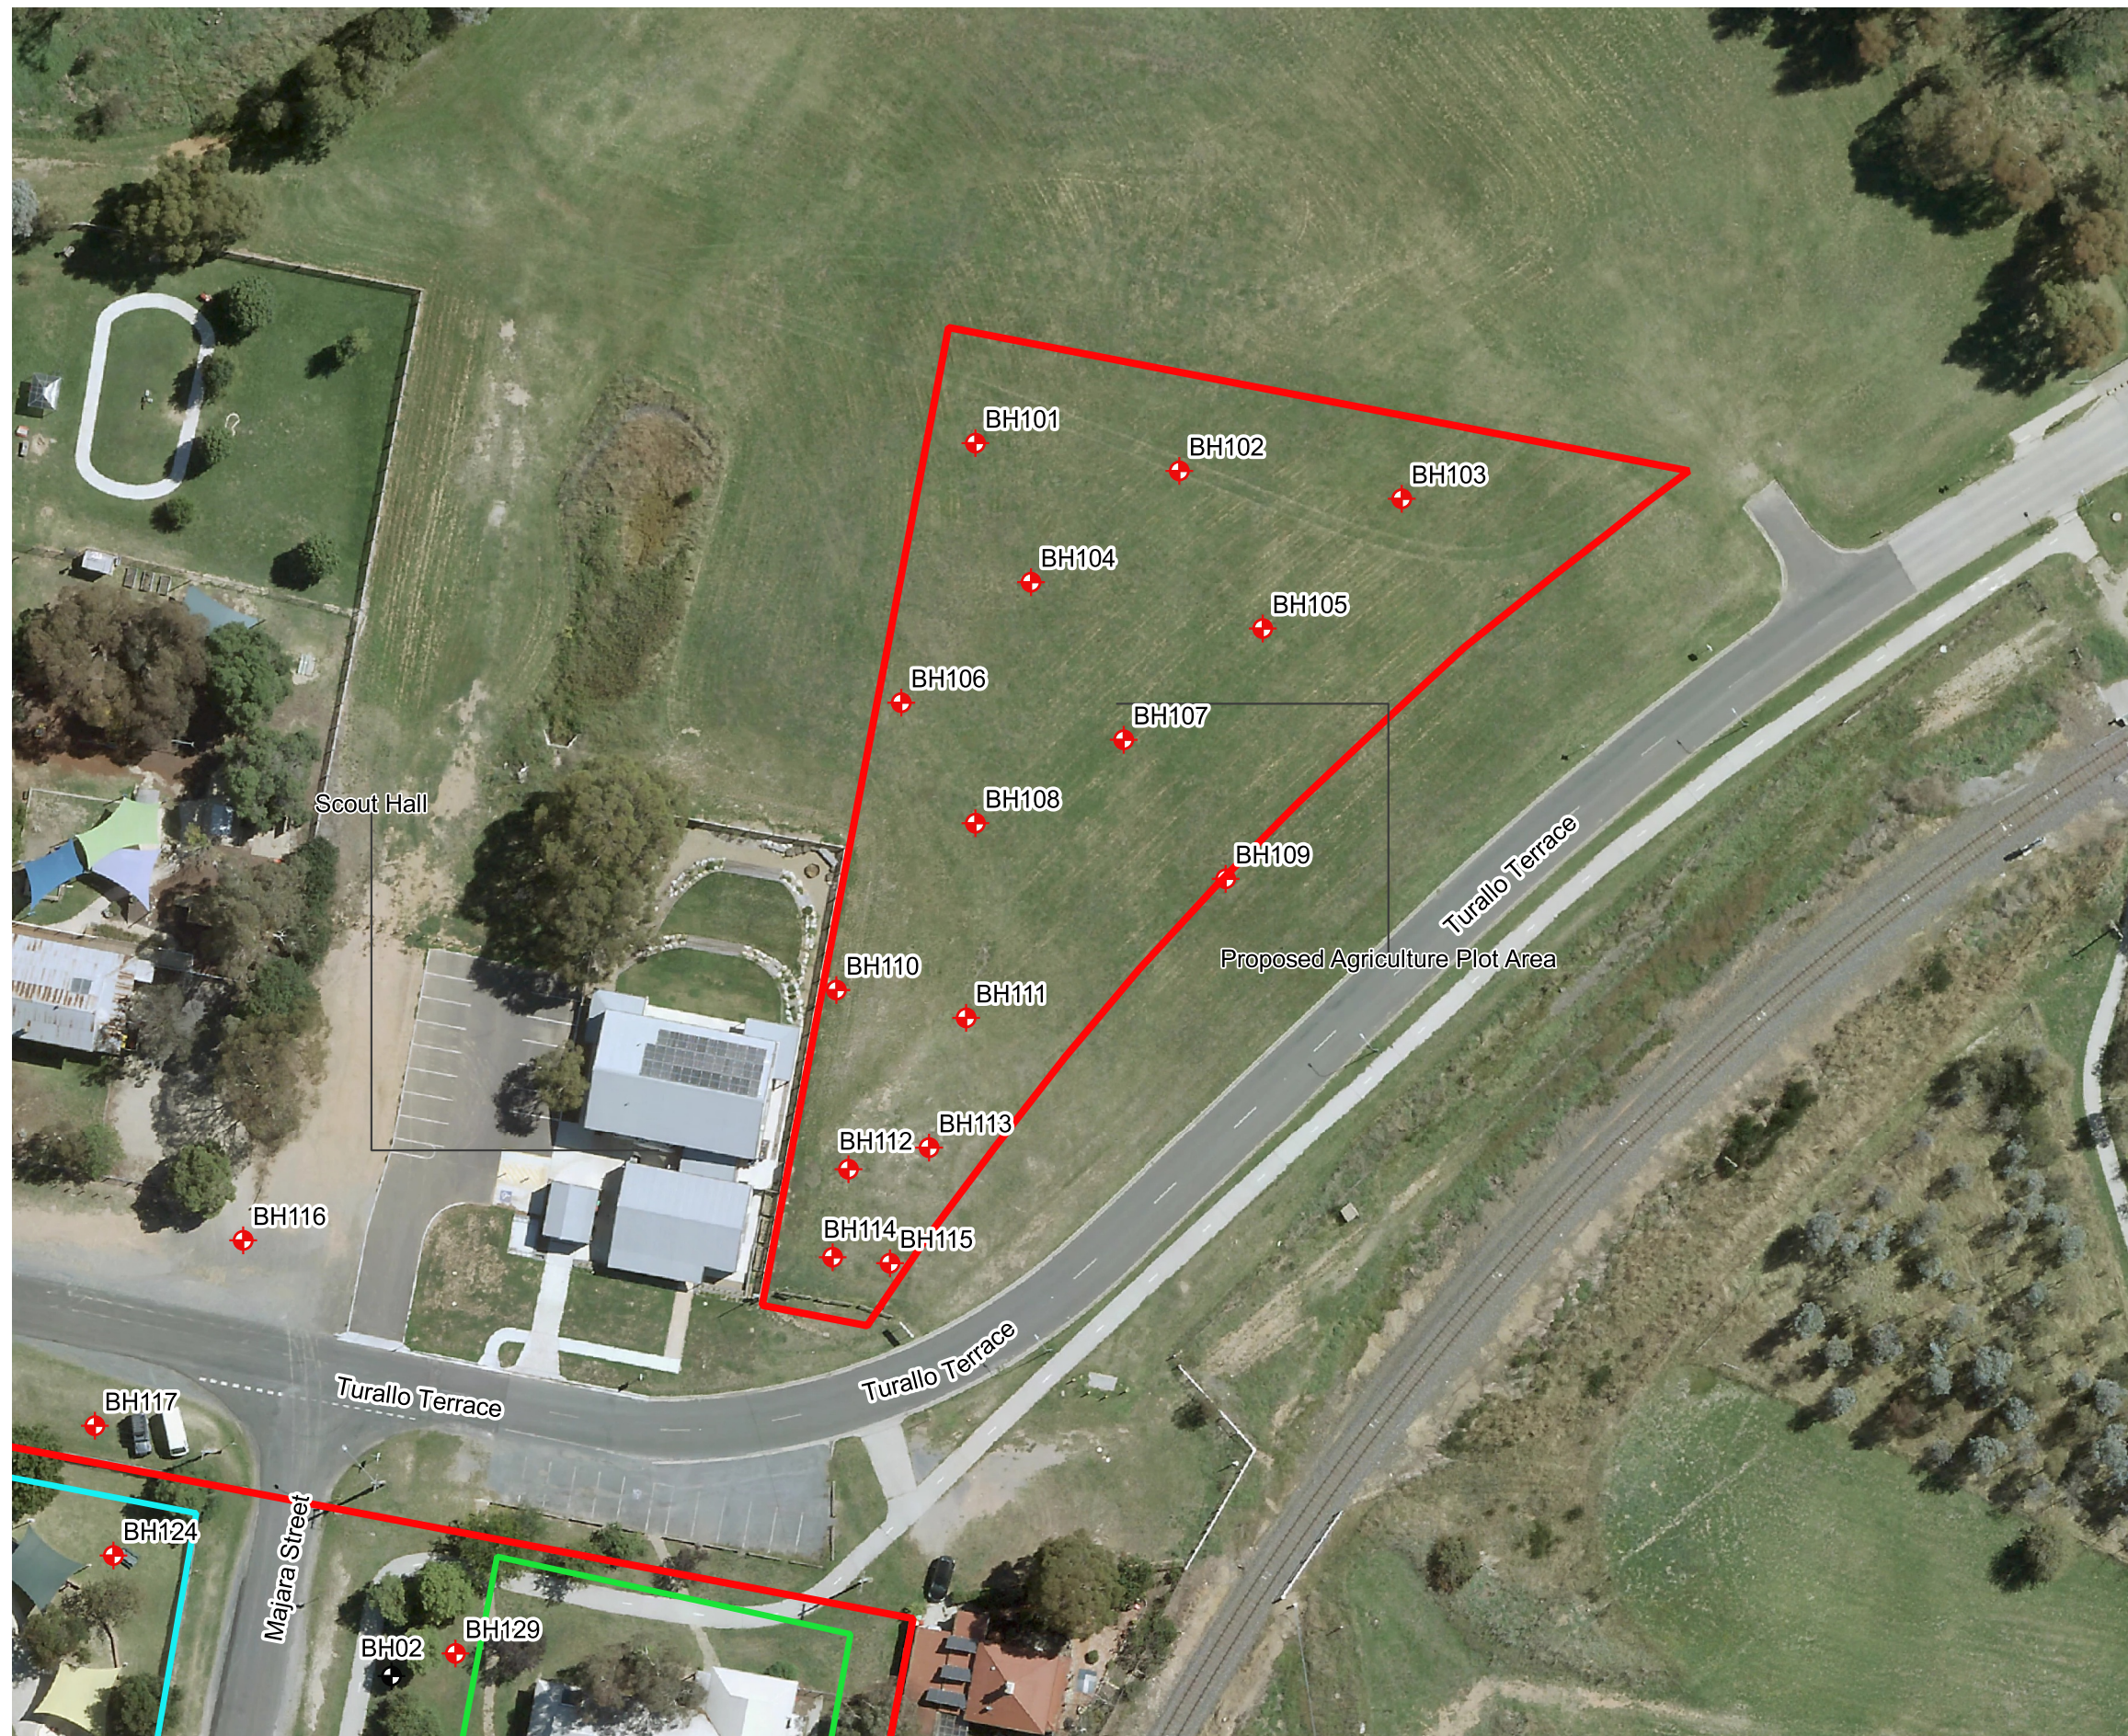
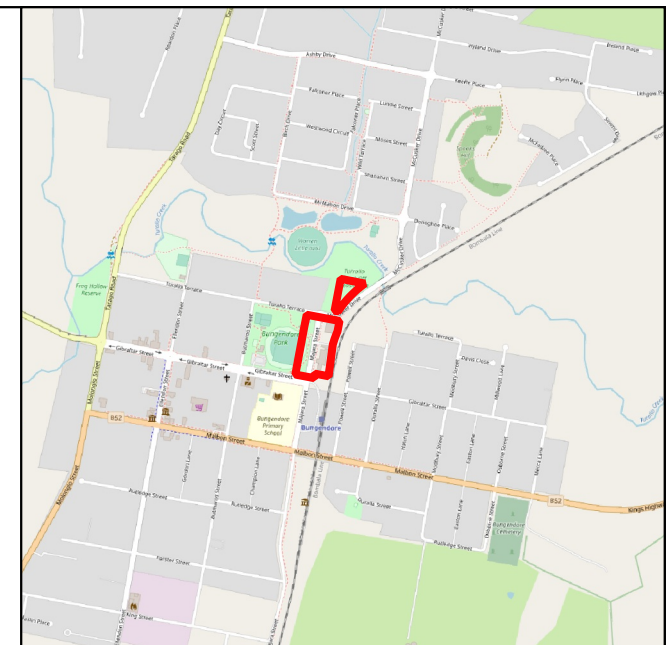
- Notes:
1. Drawing projection GDA94 / MGA zone 55
 2. Latest available aerial imagery sourced from metromap.com accessed 28/02/2021
 3. Test locations shown are approximate only

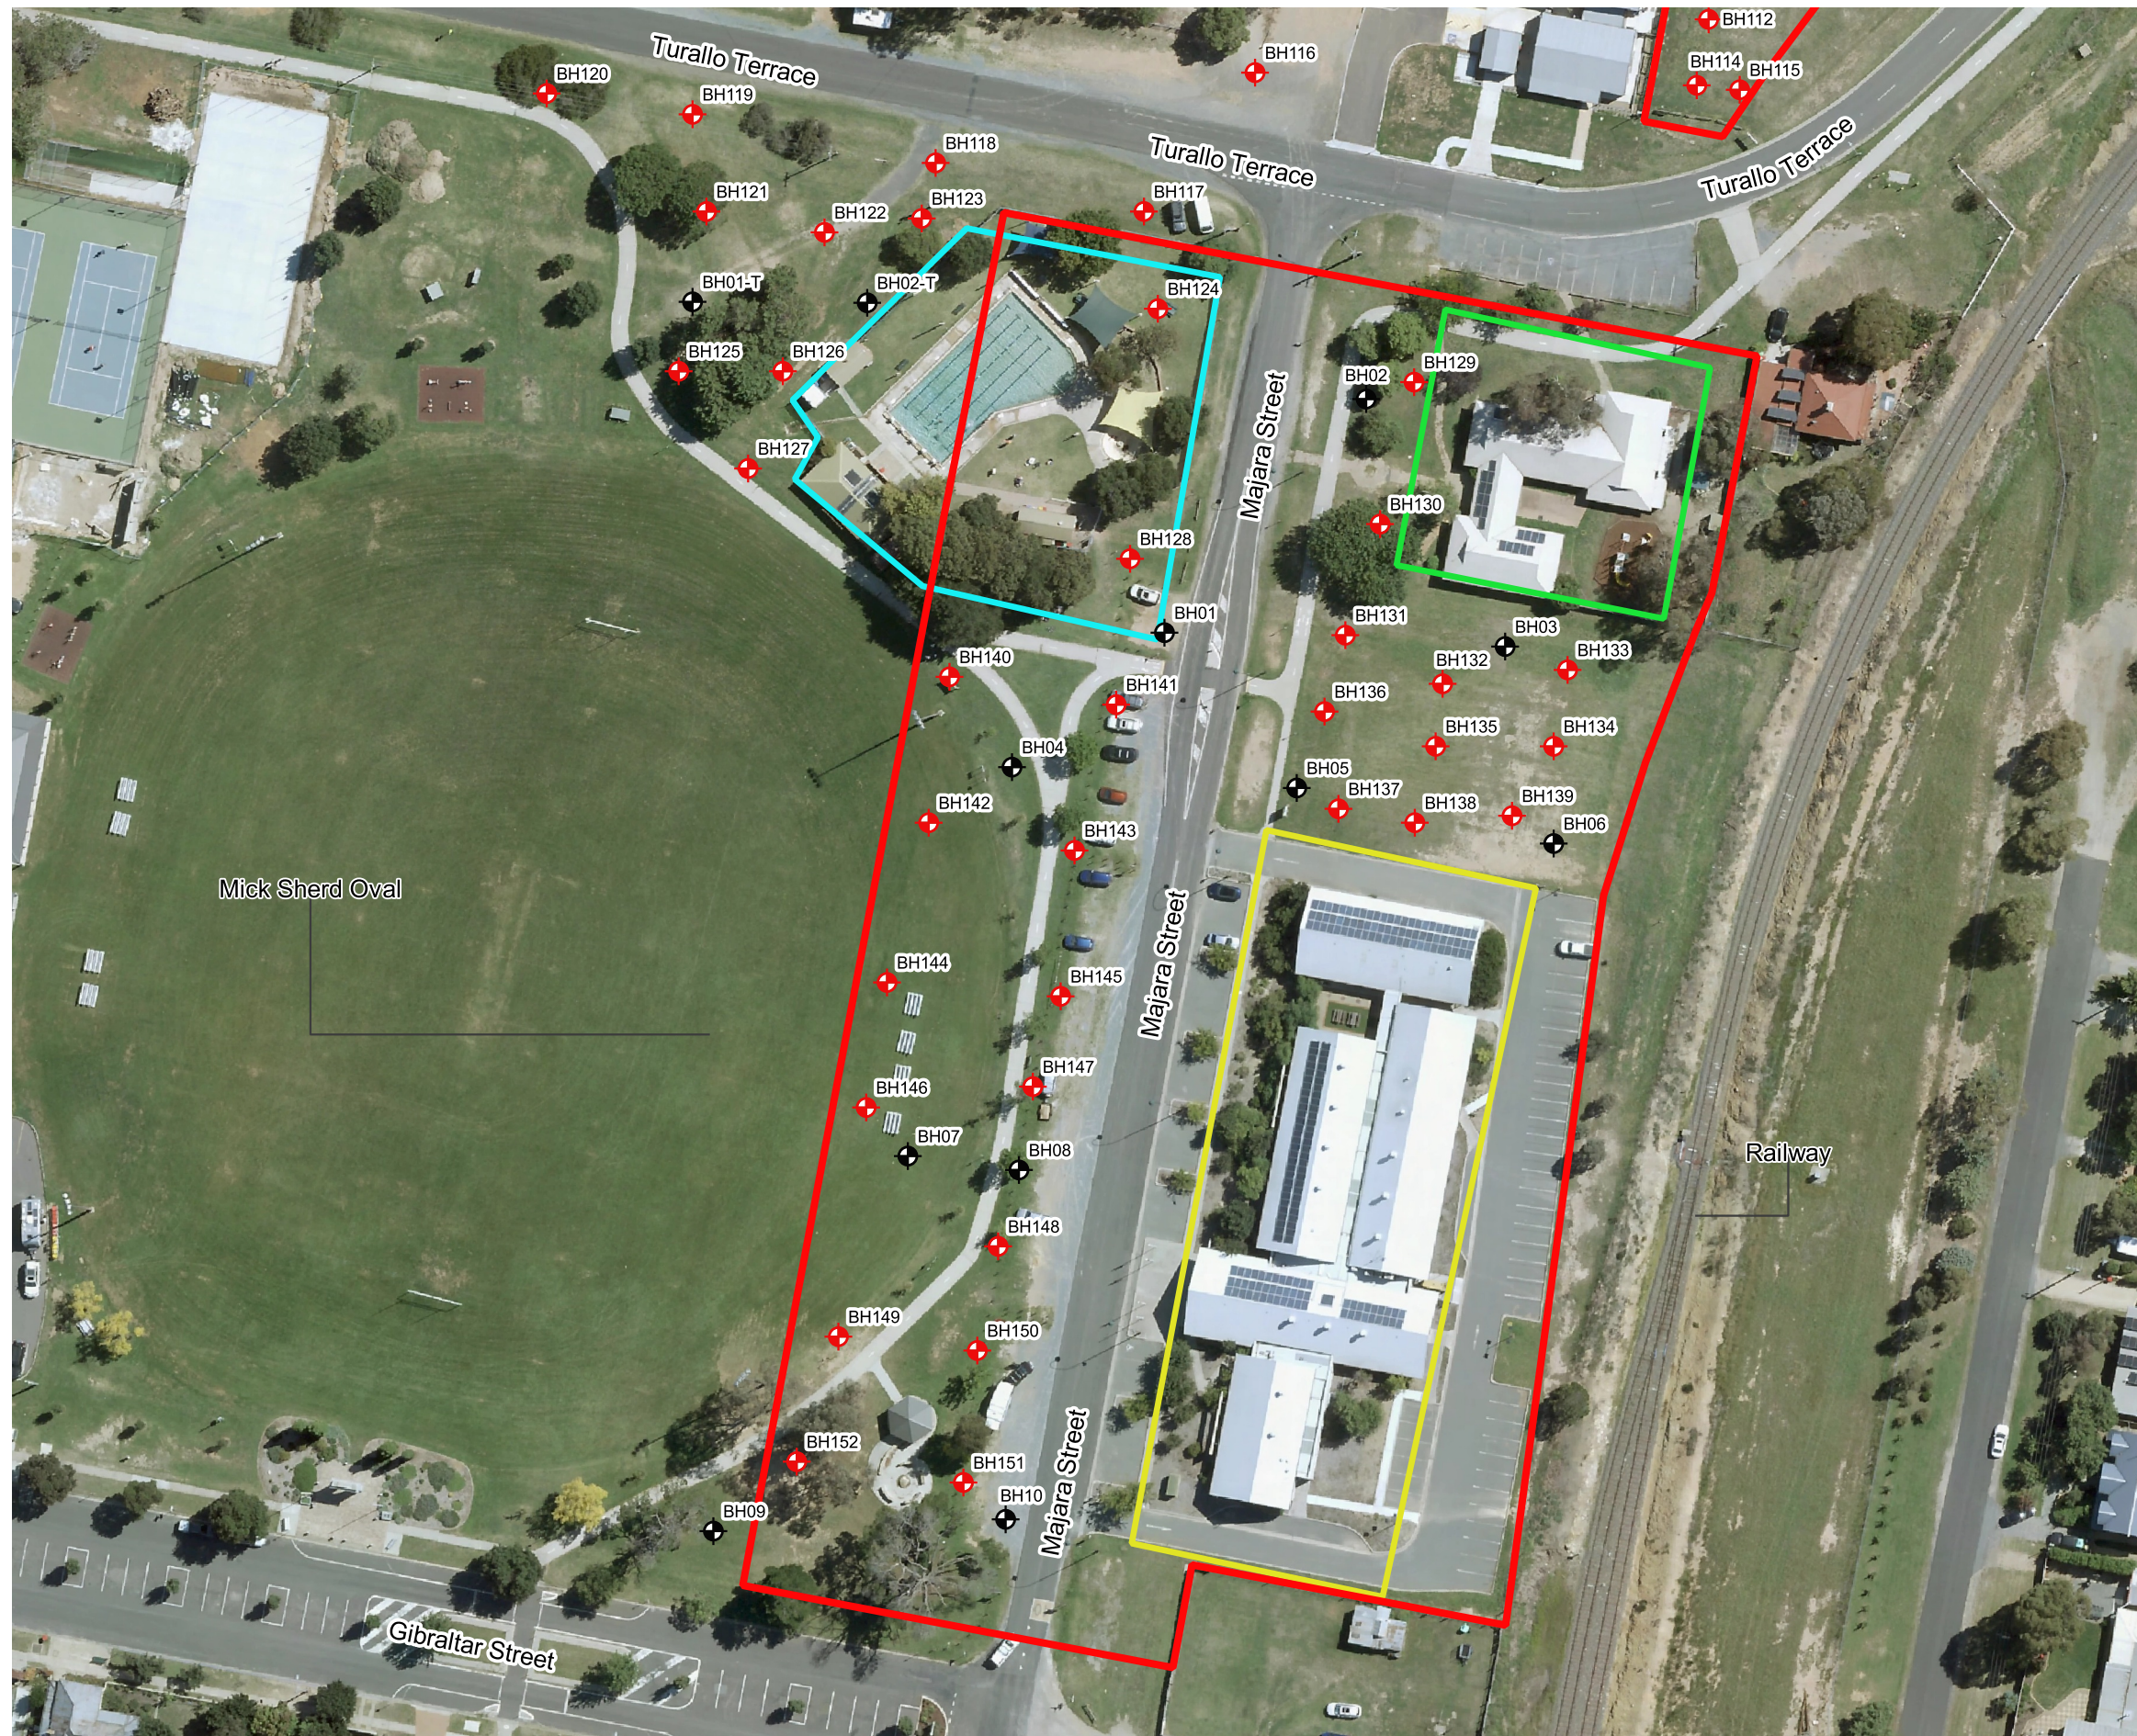
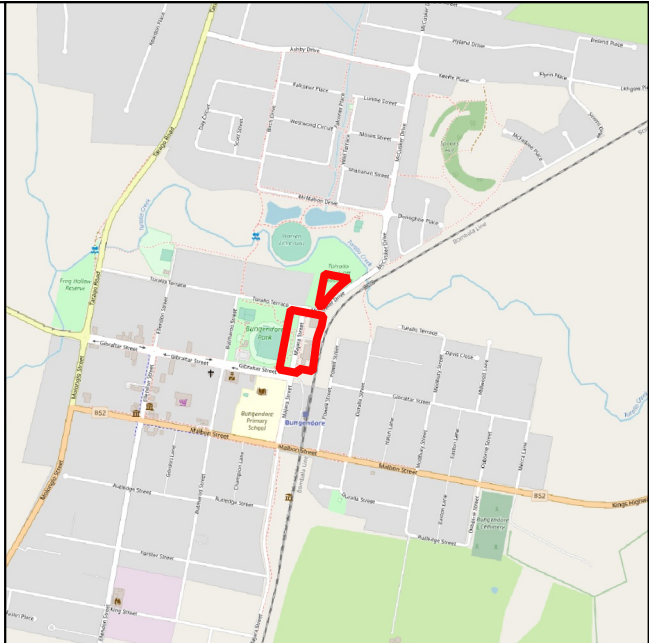
- Legend**
- Approximate Site Boundary
 - Site Features
 - Queanbeyan-Palerang Regional Council Offices
 - Community Centre
 - Swimming Pool
 - Test Locations
 - Approximate Borehole Location - PSI
 - Approximate Boehole Location - DSI
