## **Photomontages that Appear to be Grossly Misleading**

### **Anatomy of a Biala photomontage.**

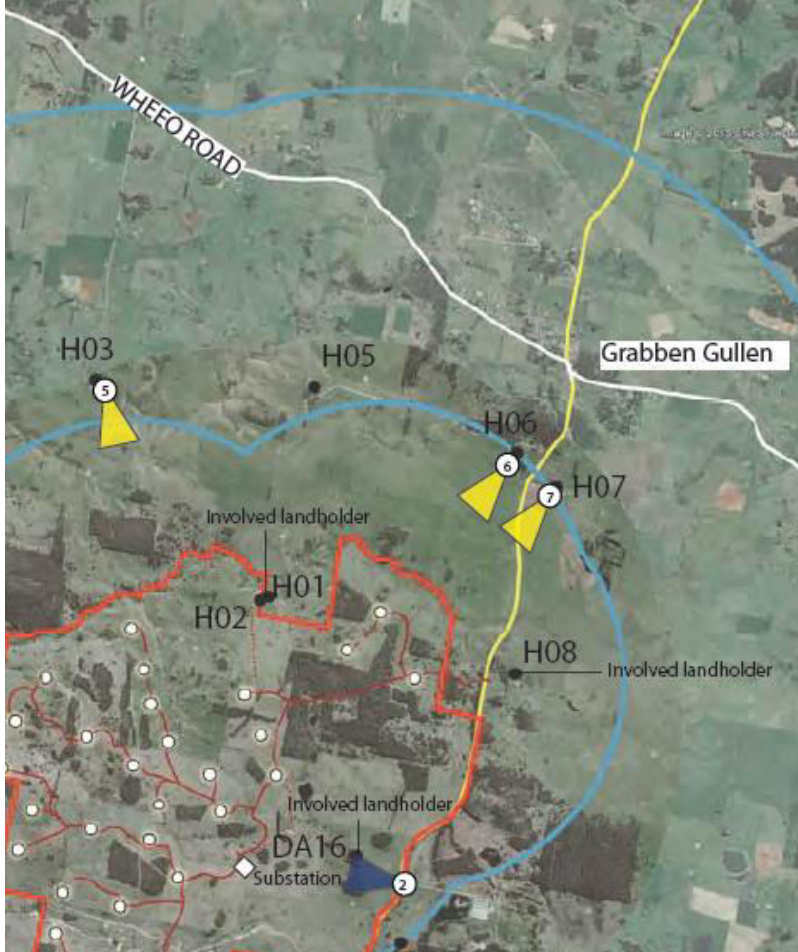
Source: Biala LVIA. Page 90.

The location from which photograph number 7 was taken is approximately:

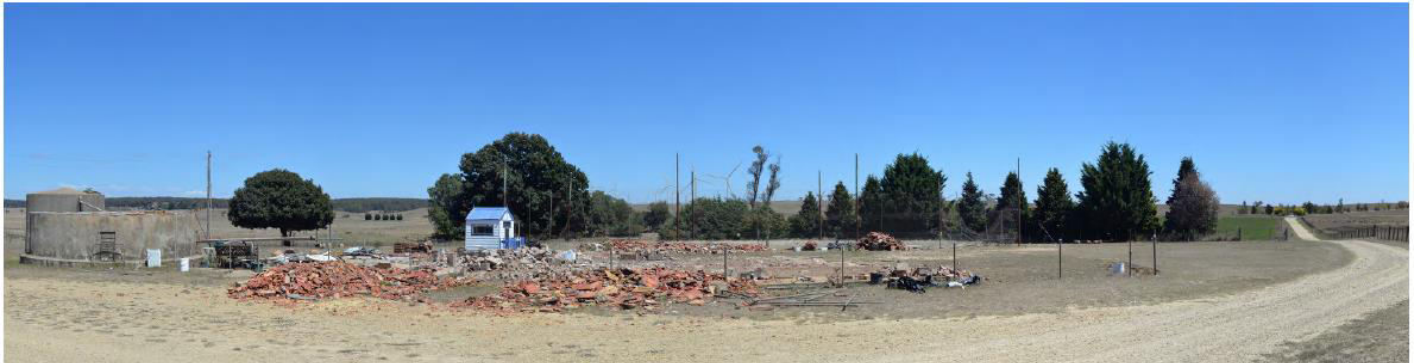
Source: Biala LVIA. (No page number)

The photomontage prepared from the photograph was:

Note: photomontage was published in landscape format, so this image is reduced.

The turbine configuration is difficult to verify. Which are the three closest turbines, T1, T2 and T3?

Let us leave aside the fact that the photomontage, as published, gives a totally misleading assessment of the Visual Impact of the wind farm on this property. (If you find the turbines, the closest of which is 2.08 kms away, difficult to see, they are not much clearer as published)

We draw your attention particularly to the flood light towers of the tennis court with the turbines just behind them. No doubt the choice of photograph location was coincidental.

- that Newtricity provide GPS coordinates for each photomontage location.
- that Newtricity redo this photomontage with reference to the current or prospective residence.
- that Newtricity redo any photomontage that is misleading in accordance with the Scottish National Heritage Visual representation of wind farms - version 2.1 - December 2014.
- that Newtricity advise the dates and times on which all photomontage base photographs were taken.

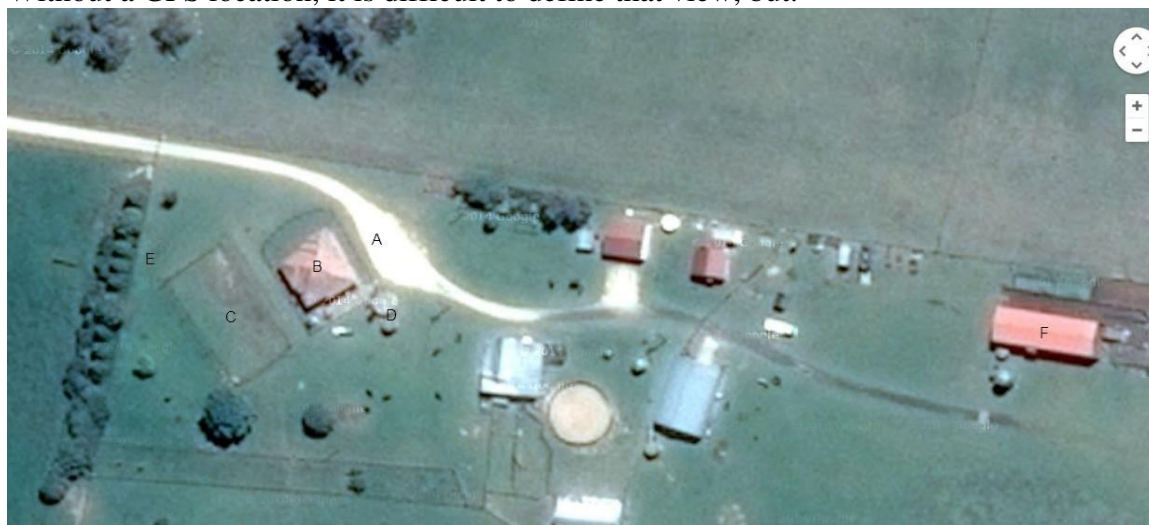
Source: Google Maps.

Without a GPS location, it is difficult to define that view, but:

A= approximate location from which the photograph was taken

B= building demolished before the photograph was taken.

C= tennis court

D= the two tanks visible in the photomontage

E= the row of screening trees behind the tennis court visible in the photomontage.

F= the current residence?
