Arboricultural Development Assessment Report

Darlington Public School
Chippendale NSW 2008
August 2020

Prepared for: SINSW - Darlington Public School
c/o Mace Australia Pty Ltd

Prepared by: Paul Vezgoff
Consulting Arborist
ISA, AA
Arboriculture Australia Registered
Consultant

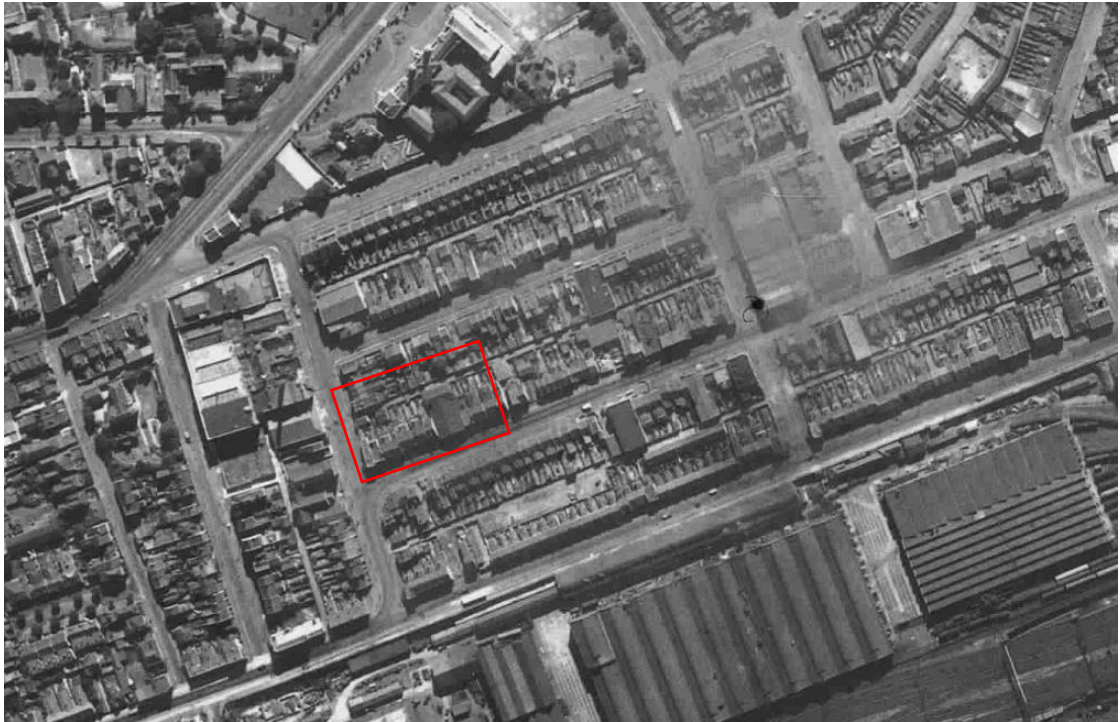
Diagram 2: The site as seen in 1943, devoid of trees (RTA From the skies, 2007).

- 3.1 Darlington Public School is located in Chippendale in Sydney. Darlington Public School is an inner city school servicing the suburbs of Chippendale, Darlington, Redfern and Waterloo. The school was built in the 1970s (Diagram 2) however the school's trees are well established, with some being almost twenty (20) metres in height and spread.

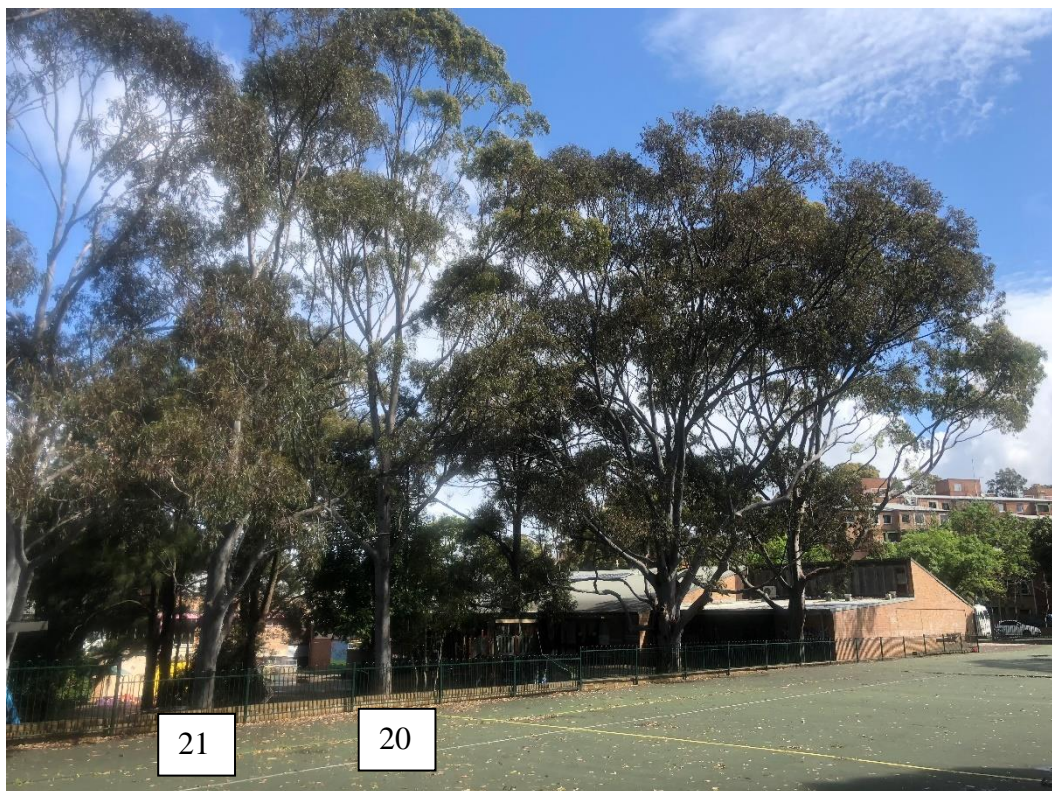
Plate 1: Image showing Trees 21, 20. P. Vezgoff

- 3.6** Trees 20 and 21 are some of the larger trees on site being some twenty (20) metres in height (Plate 1). The majority of the root zone of these trees is covered with hard surface. These trees have some previous failures which is to be expected from trees of this size and age. These trees were assessed as being in good health and condition. The main trunks, first and second order branches are free of any cracks, splits or fruiting bodies. New extension growth was noted. The basal area and woody root zones were free of any ground heaving, or lifting. Ideally an aerial inspection should occur to fully determine the condition of the main branch unions if they were to be retained.

3.13 Impacts: Based on the plans, it appears possible to retain trees numbered as 33, 35-39, 44-46. Trees 20-25, 34, 40-43, 49, 50 and 51 are proposed to be removed. Trees 20-25 are located within the sports court footprint and Trees 49, 50 and 51 are located within an area required to be resumed for the levelling of the sports court area. Trees 34, 40-43 are smaller suppressed specimens that will never reach their full potential. Provided the existing steps along Trees 33, 35-39, and the small wall along Trees 44-46, can be retained or at least no excavations beyond these trees, then these trees could be successfully retained. As seen in the Tree Protection Plan the TPZ distances are within the sports court works area however the roots from these trees will have been restricted in radial growth due to these steps and footings currently present. Any roots under the sports court area should be reasonably deep and provided the existing finished levels can be maintained impacts to these trees will be minimal.

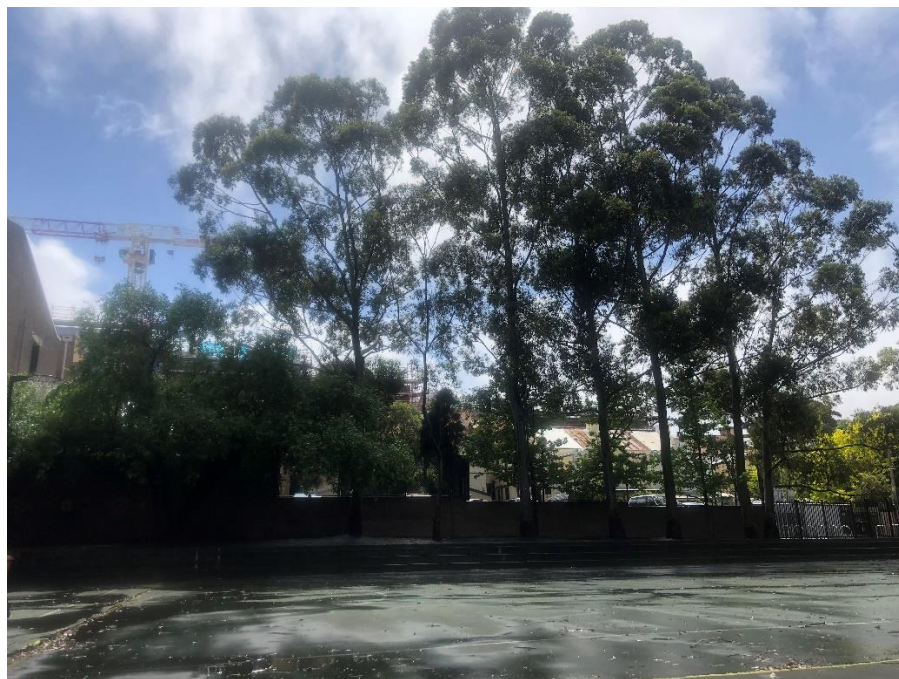
Plate 2: Image showing Trees 32-43. P. Vezgoff

- 3.7** Trees 32-43 are growing along the northern boundary fence (Plate 2). These are a mixed group of large mature *Eucalyptus* specimens but competing with some exotic specimens that have been planted between and under the large *Eucalyptus* specimens. These trees are also tightly grouped specimens that have a restricted root space and are covered with asphalt and playground rubberised matting up to the trunks. Varied levels are present as these trees have been planted on a stepped area (Plate 3).
- 3.8** Under these larger more dominant specimens are Trees 40-43 that are Liquidambar (*Liquidambar styraciflua*) and a single *Cupressus* specimen. These trees can be seen in Plate 3. Now suppressed, these trees will not reach maturity and as such are not long term viable specimens.

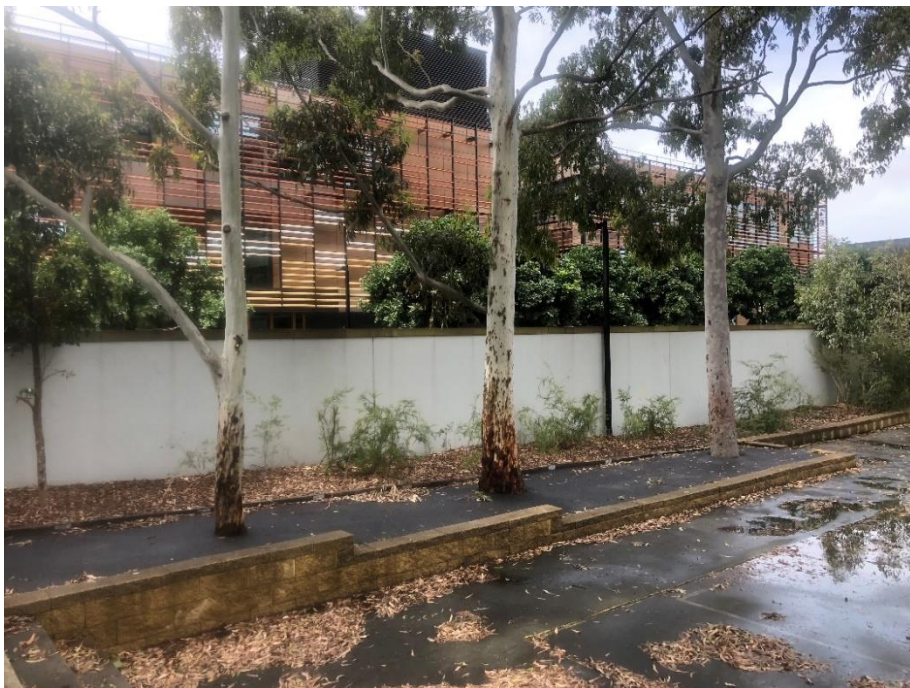
Plate 4: Image showing Trees 44-46. P. Vezgoff

- 3.9** Trees 44-46 (Plate 4) are growing along the eastern boundary fence. These trees are younger specimens in excellent health and condition and provide a good screen between two properties. The majority of the root zones of these trees is covered with hard surface.
- 3.10** Although this part of Sydney may be high in sand content that would normally encourage deeper root systems, the site has an uncertain history. Based on Diagram 2, it appears that prior to the school being built, there were rows of terrace houses and warehouse structures, so subsoil conditions will be far from natural and would be highly disturbed. This will mean that old footings or foundations that may be subsurface will deflect woody roots keeping them close to the surface such as near Tree 20 (Plate 5).

- 4.2** Trees 33, 35-39 and 44-46 will require tree protection fencing as specified in Section 5.2 of this report. This fencing will be located at the Tree Protection Zones (TPZ) listed in the Tree Schedule (Appendix 2). The specifications for a TPZ are in Section 5.3 of this report. This fencing is to stay in place until all works are completed.

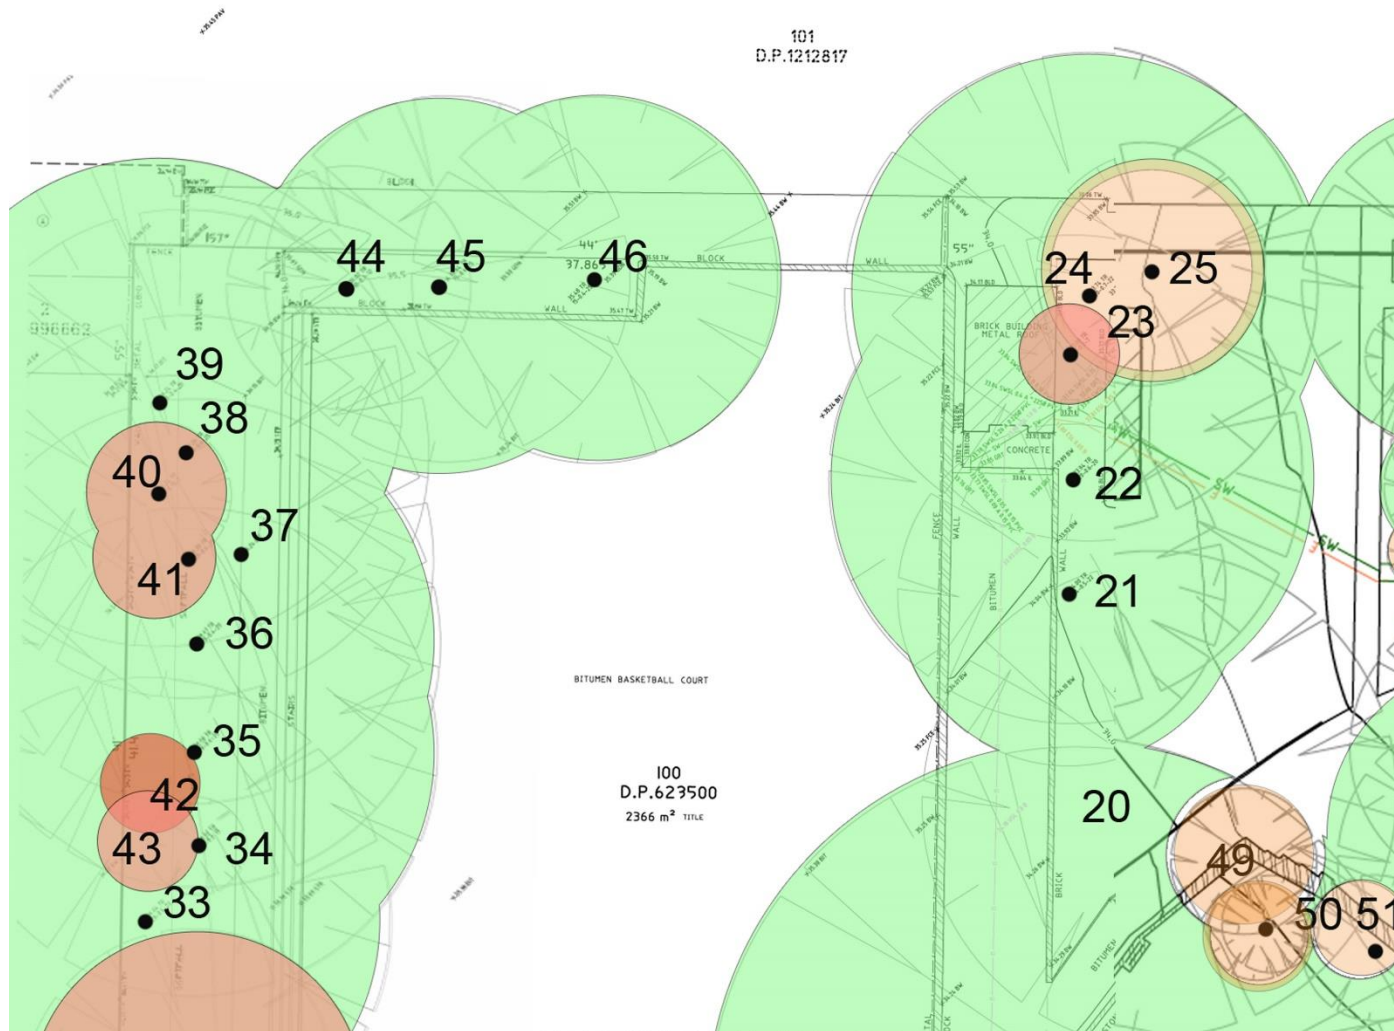
Plan 1

Tree Retention Values

Note: The tree condition plan is separate to the SULE categories that have been allocated to the site trees.

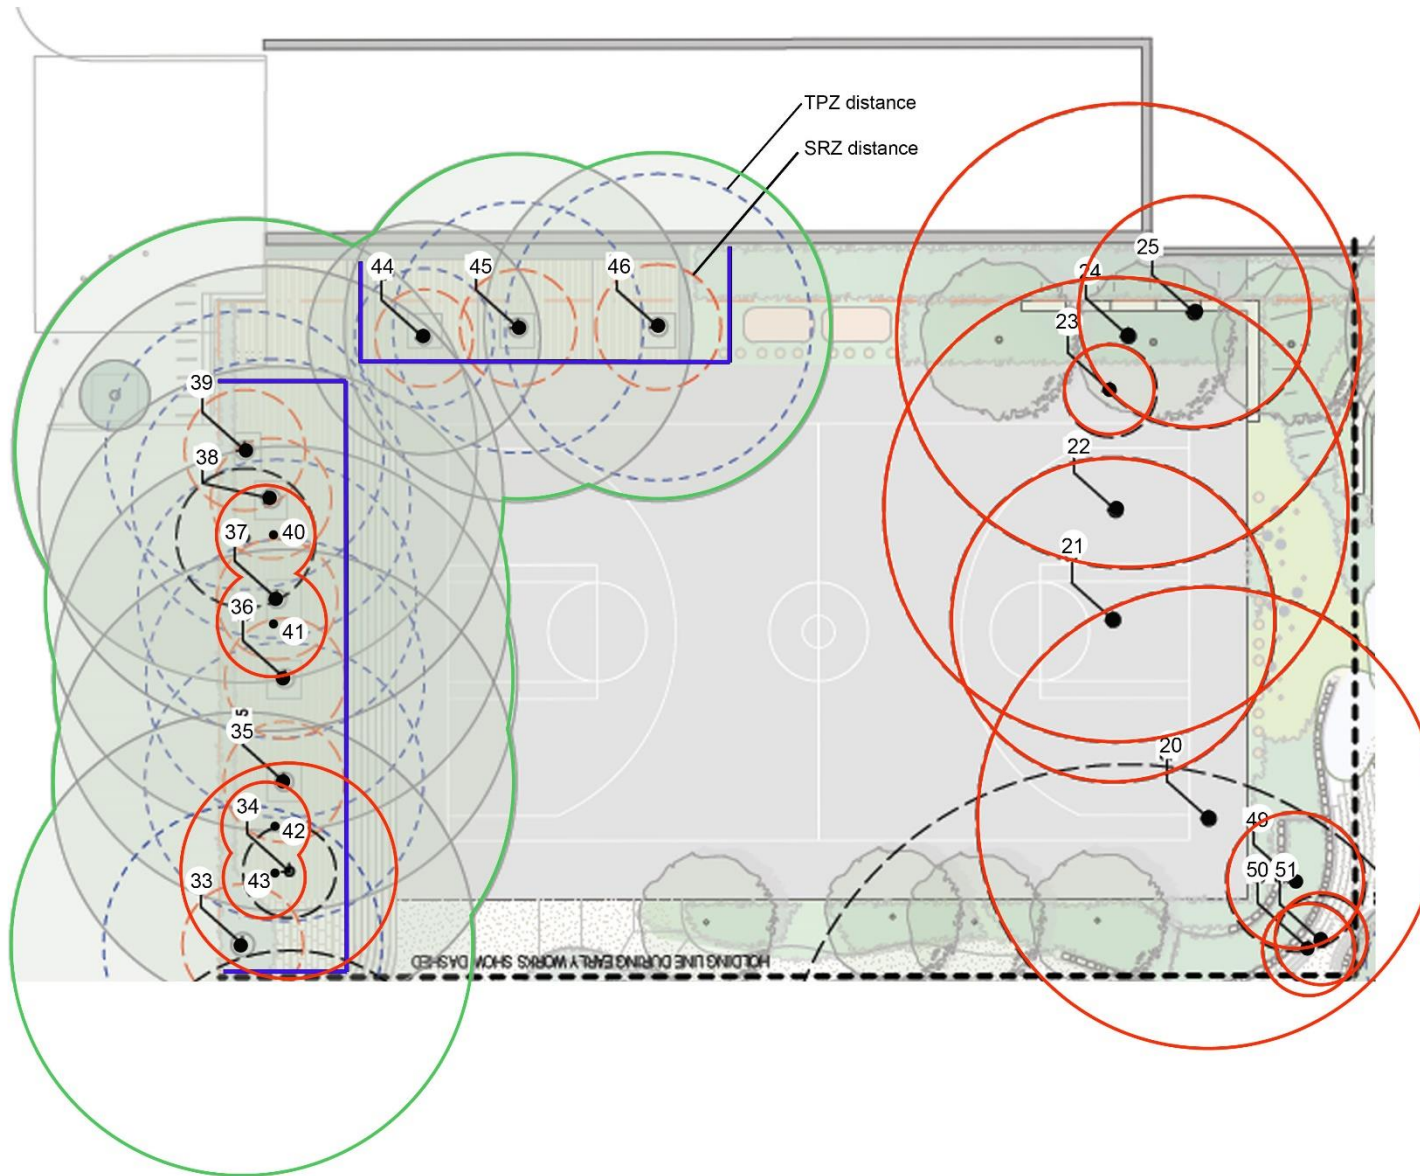
Plan 2

Tree protection plan

20-25, 34, 40, 41, 42, 43, 49, 50, 51

Fence. Implementation of tree protection zone (TPZ). All tree protection works should be carried out before the start of demolition or building works. It is recommended that chain mesh fencing with a minimum height of 1.8 metres be erected

5.1 Trees to be protected: 33, 35-39 and 44-46 will be required to be fenced for protection. All fencing shall be installed as specified in Section 5.2 (Tree Protection – Implementation of Tree Protection Zone). Indicative locations of the fencing are shown in the Tree Protection Plan (Appendix 1).

5.2 Implementation of Tree Protection Zone: All tree protection works should be carried out before the start of demolition or building work. It is recommended that chain mesh fencing with a minimum height of 1.8 metres be erected as shown in the Tree Protection Plan (Appendix 1). Specifications for this fencing are shown in Tree Protection Fencing Specifications (Appendix 6). Typically the fencing is set at the TPZ measurement (Table 1) however for this project the top area of the steps in front of trees 33, 35-39 and the wall along Trees 44-46 shall have to be used to locate the fences to allow the works to proceed.

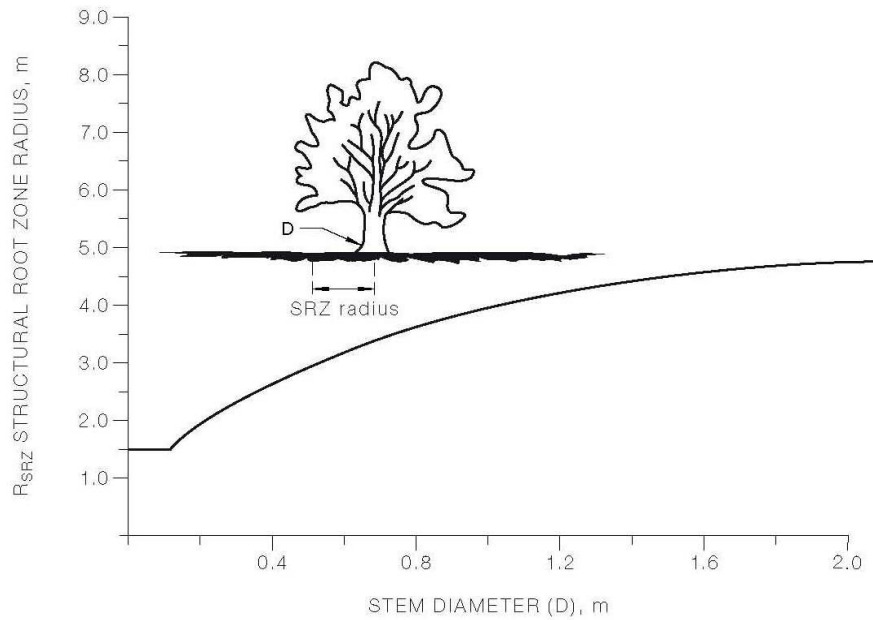
FIGURE 1 - STRUCTURAL ROOT ZONE

NOTE: The SRZ for trees with trunk diameters less than 0.15m will be 1.5m (see Figure 1).

The curve can be expressed by the following formula:
 $R_{SRZ} = (D \times 50)^{0.42} \times 0.64$

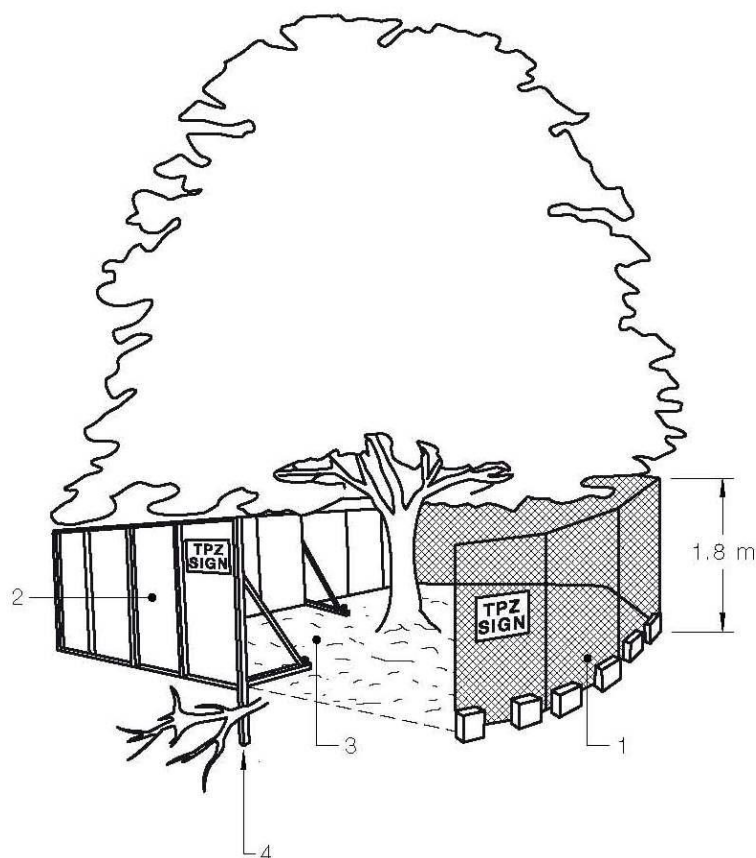
Tree protection fencing **specifications**

- 1 Chain wire mesh panels with shade cloth (if required) attached, held in place with concrete feet.
- 2 Alternative plywood or wooden paling fence panels. This fencing material also prevents building materials or soil entering the TPZ.
- 3 Mulch installation across surface of TPZ (at the discretion of the project arborist). No excavation, construction activity, grade changes, surface treatment or storage of materials of any kind is permitted within the TPZ.
- 4 Bracing is permissible within the TPZ. Installation of supports should avoid damaging roots.
