# Remediation Action Plan Addendum

7-9 Burroway Road, Wentworth Point, NSW 2127

21067 RAP Addendum

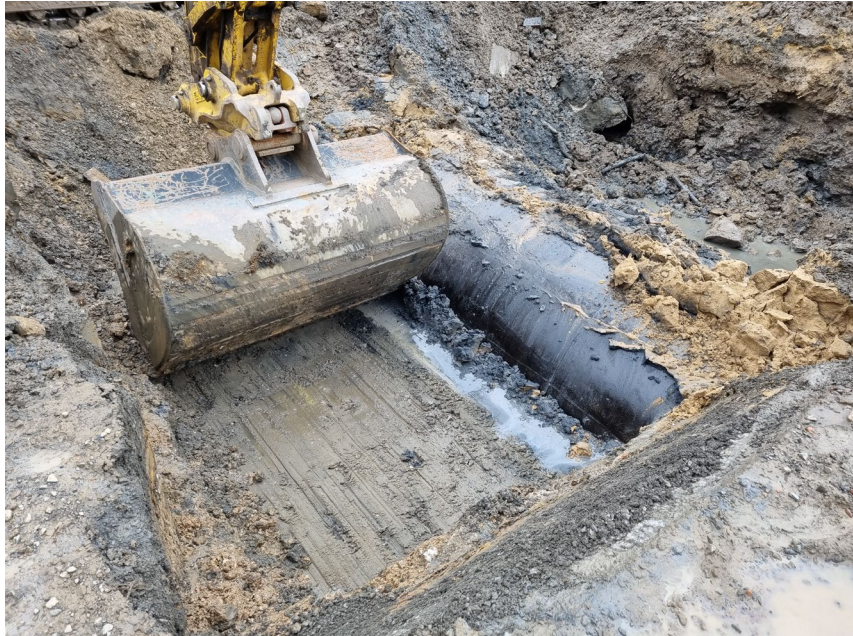
Photo Number: 1	Date: 30 November 2021

Description:  UST Location 1 test pitting.

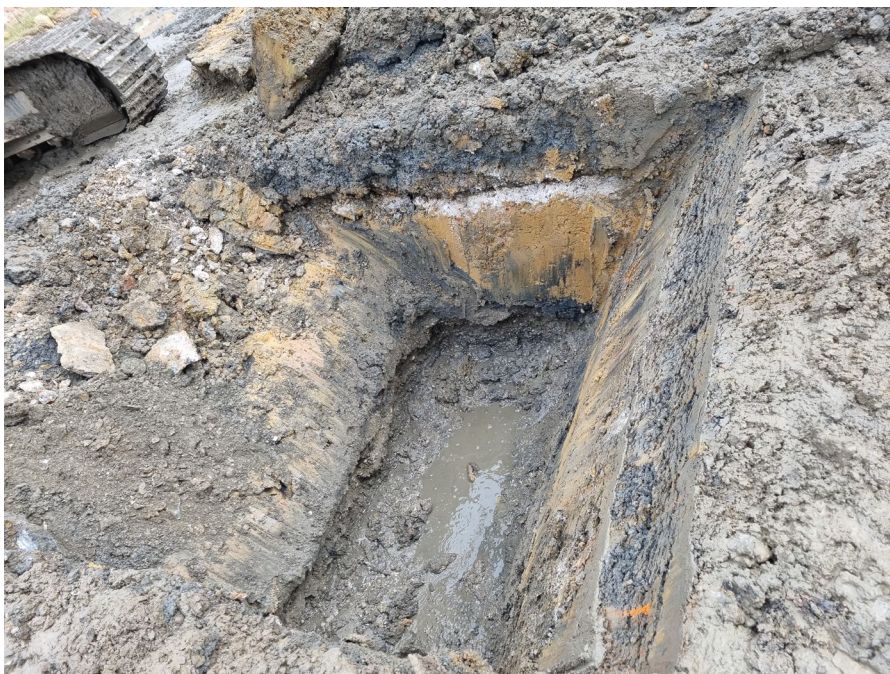
Photo Number: 3	Date: 1 December 2021

Description:  Former wash bay test pitting.

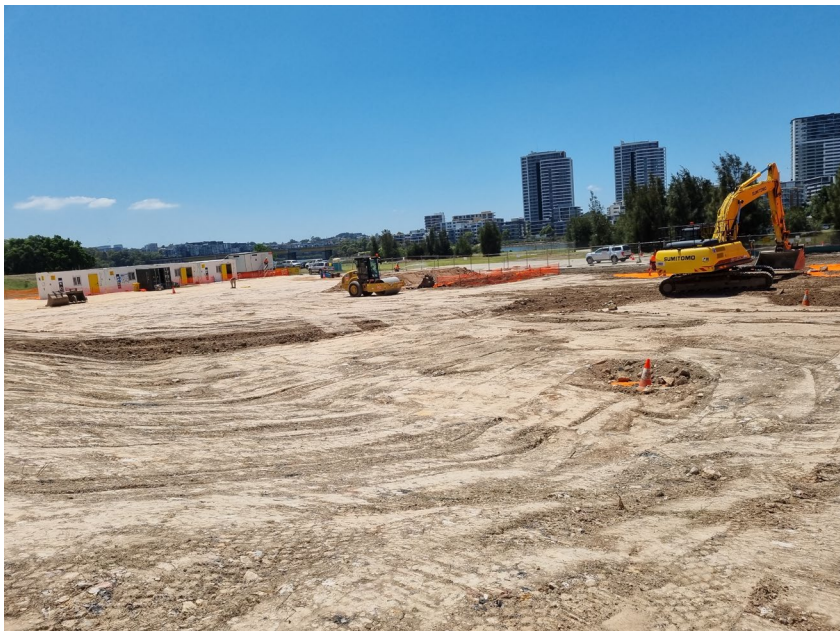
Photo Number: 10	Date: 3 December 2021

Description:  View across the site to the north showing near-completed capping using material from the western portion of the site (Ridges Road).

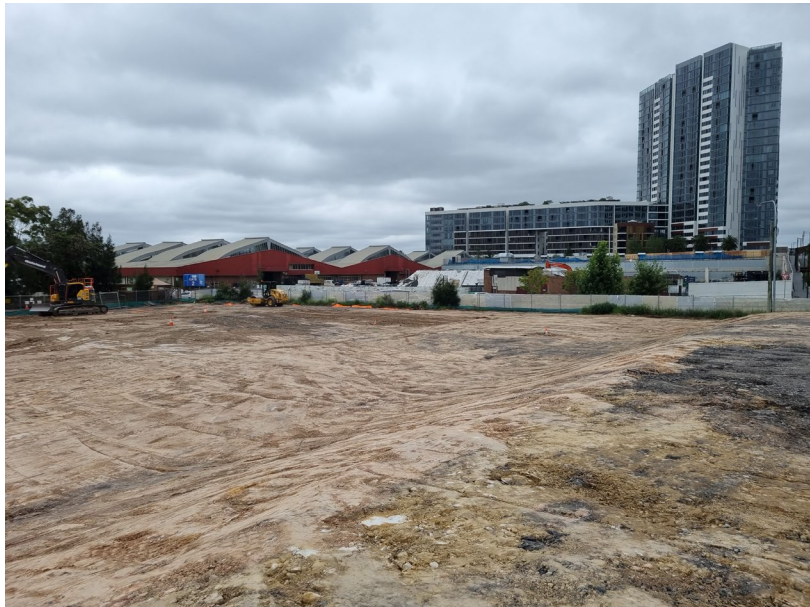
Photo Number: 11	Date: 8 December 2021

Description:  View across the site to the southeast showing completed capping using material from the western portion of the site, noting final level difference between Ridges Road and the rest of the site.

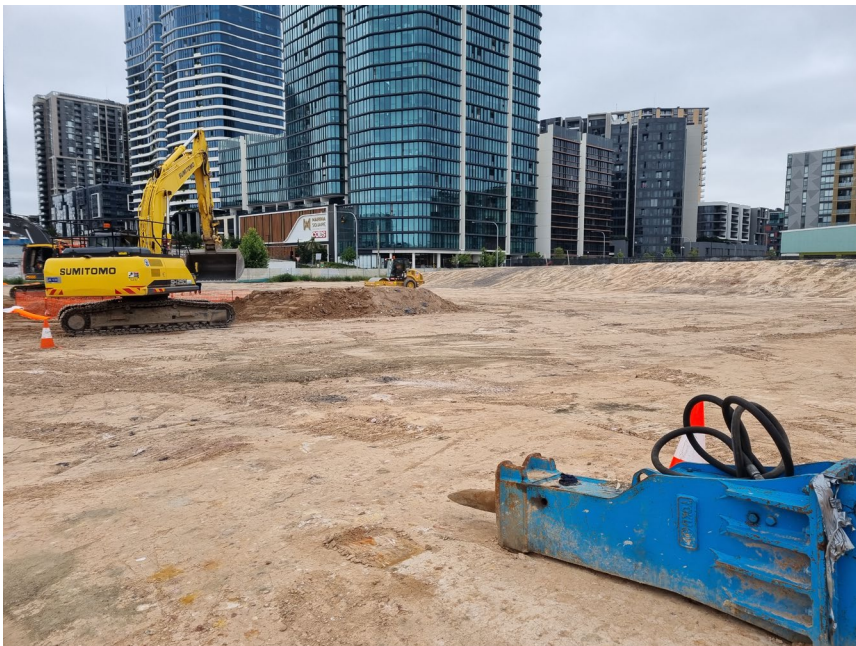
Photo Number: 12	Date: 8 December 2021

Description:  View across the site to the southwest showing completed capping using material from the western portion of the site, noting final level difference between Ridges Road and the rest of the site. Capping of the former mechanics pit area being conducted (centre).
