27 February 2022

L002 Interim Audit Advice (0503-2109-002) – SOPHS Wentworth Point

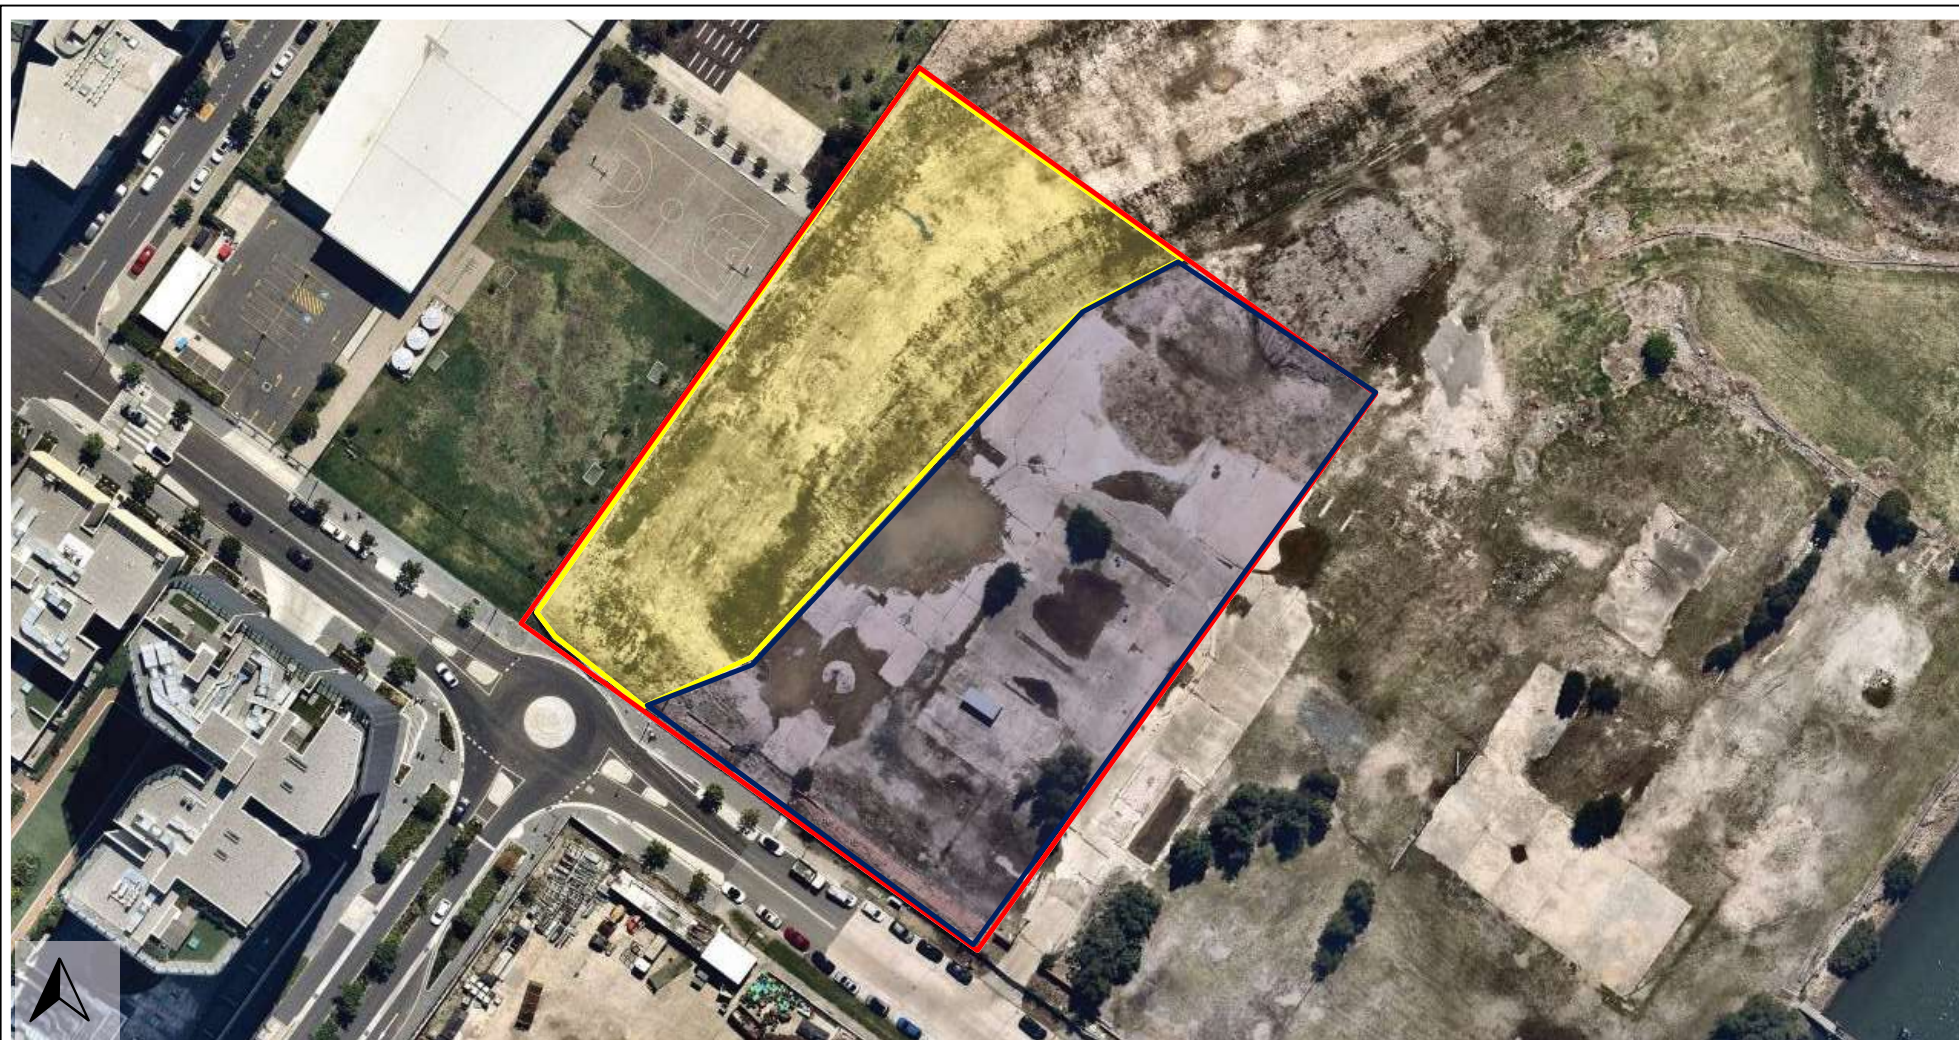
Figure 2: Site Layout Plan – Previously Capped Area from Zoic (2019) Works

Portion of the site previously validated and capped as part of the wider Zoic (2019) Stage 1 validation works

Portion of the site capped as part of the 2021 early works prior to commencement of the main remediation works

- Advice, when available, to the auditor of the condition of tanks and lines removed from the site.
- Appropriate monitoring and control measures should be implemented to ensure that there is no recontamination of the previously validated / capped western portion of the site (Zoic 2020).
- Copies of VENM certification and other relevant details of fill materials proposed to be imported to the site prior to the receipt of materials on the site.
- All future works should be conducted by a consultant suitably experienced in the assessment and management of groundwater contamination issues, and applicable consultant personnel should be Certified Environmental Practitioners (Site Contamination Specialist), or equivalent.

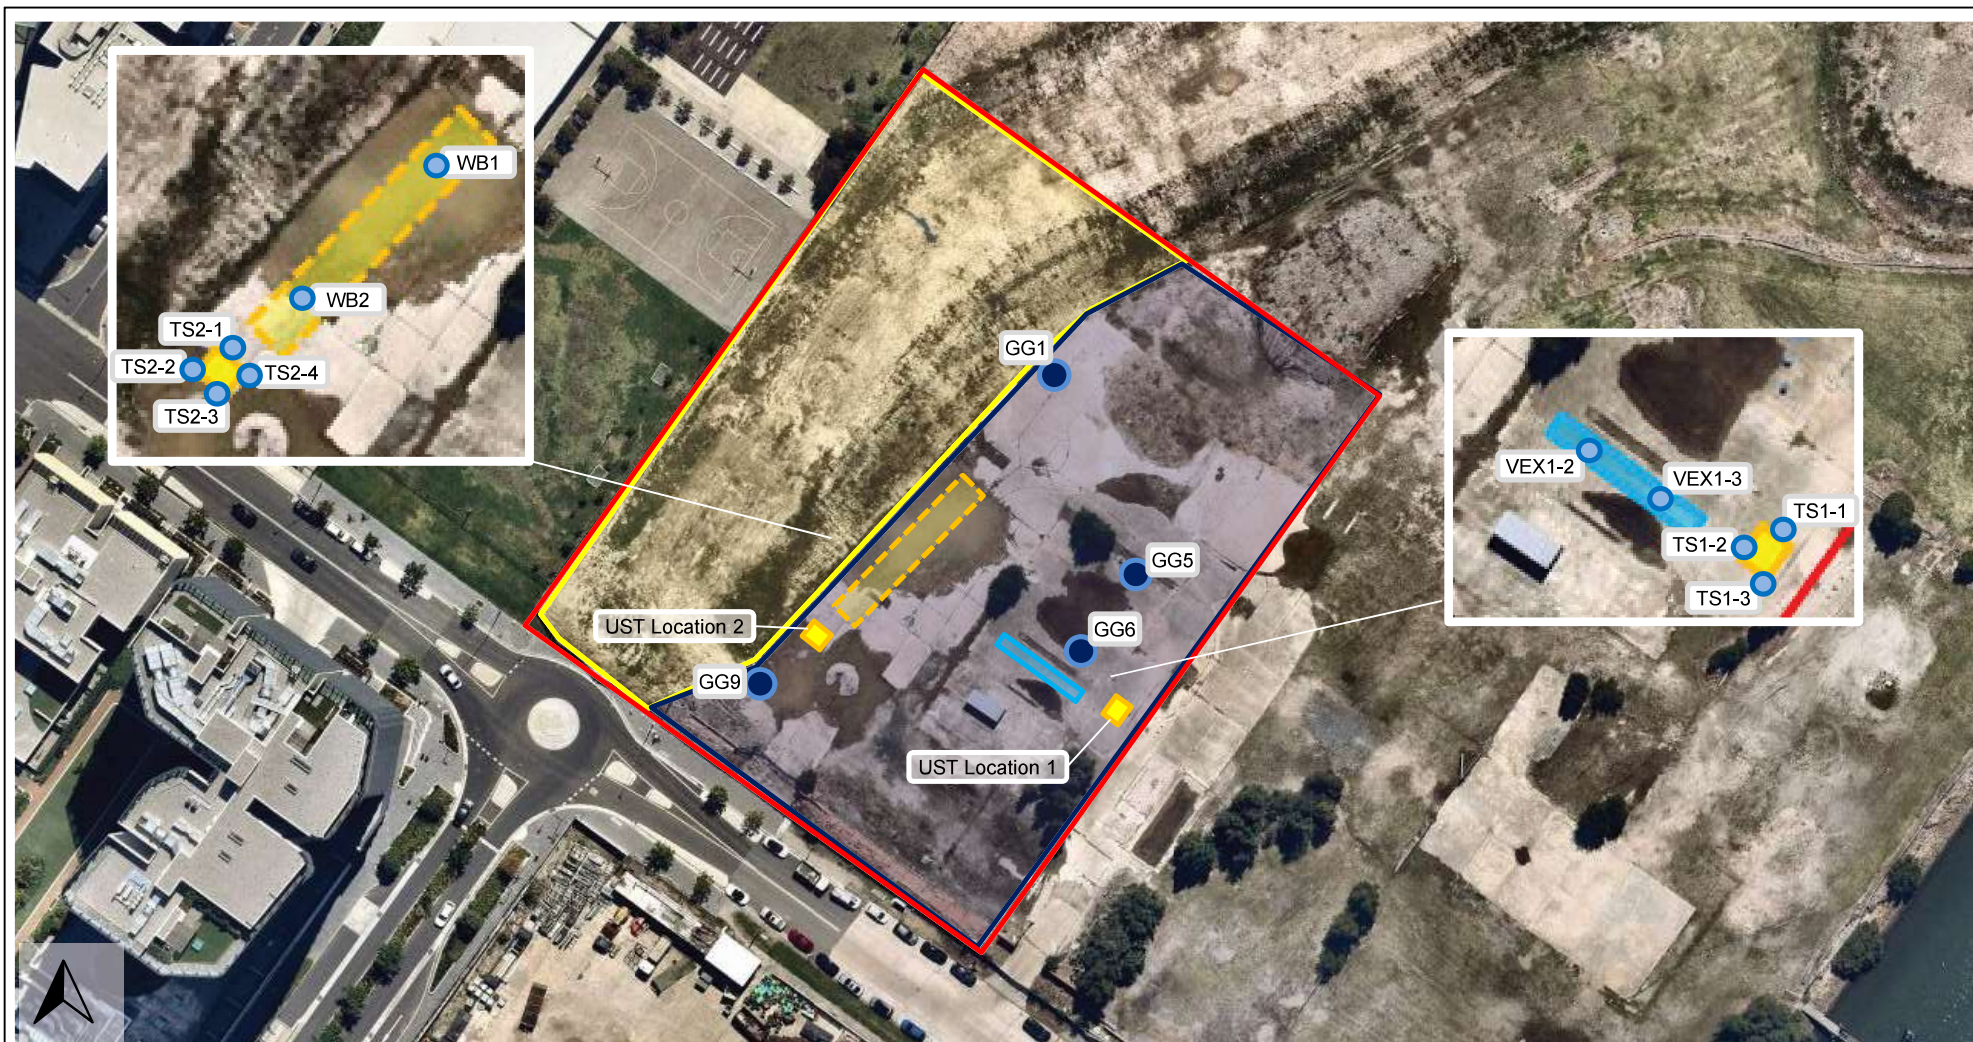
Figure 4: Site Layout Plan – Locations of USTs and Other Infrastructure

- Approximate Site Boundary
- Portion of the site previously validated and capped as part of the wider Zoic (2019) Stage 1 validation works
- Portion of the site capped as part of the 2021 early works prior to commencement of the main remediation works
- Approximate Location of former mechanic pit area
- Approximate Location of former wash bay

- Approximate Test Pit Location
- Approximate location of Sampled Groundwater Well
- Approximate Location of USTs

- Intrusive investigation works confirmed the presence of the historical petroleum storage infrastructure within the central eastern and central western portion of the site. Sampling in the vicinity of the USTs was undertaken, with soil samples collected to a maximum depth of 1.4 m below ground surface (bgs). Preliminary sampling undertaken reported concentrations of TRH and PAHs above the adopted soil criteria.

- A former mechanic pit area was also identified within the central eastern portion of the site, in the vicinity of the USTs. Sampling in this area reported concentrations of TRH exceeding the adopted soil criteria, with field observations reporting the presence of a hydrocarbon sheen / odour in water which had accumulated within the pit. It has been reported that this water was pumped and disposed offsite.

- The former wash bay was confirmed within the central portion of the site, also adjacent to the USTs. Sampling was undertaken at two locations. It is noted that sampling within the former wash bay area was not undertaken as per the requirements of the SAQP. Preliminary soil sampling confirmed concentrations of <C10-C16 (F2) above adopted soil criteria at WB1 at a depth of 0-0.2 m bgs. Impact at WB1 did not extend deeper. PAHs were also reported above the adopted soil criteria at WB2 at a depth of 0.8-1.0 m bgs.

- Removal of identified USTs and associated infrastructure; removal of the mechanical pit; excavation of hydrocarbon impacted soils; and offsite disposal of materials to a NSW EPA approved facility;
- Reinstatement of excavations with validated imported material;
- Capping of remaining areas; and
- Installation of ground gas protection measures in line with CS4.
