## Wee Waa High School Proposal

## Soil and Water Quality Investigation and Report

NSW Department of Education  
George Street, Sydney NSW 2000

January 2022

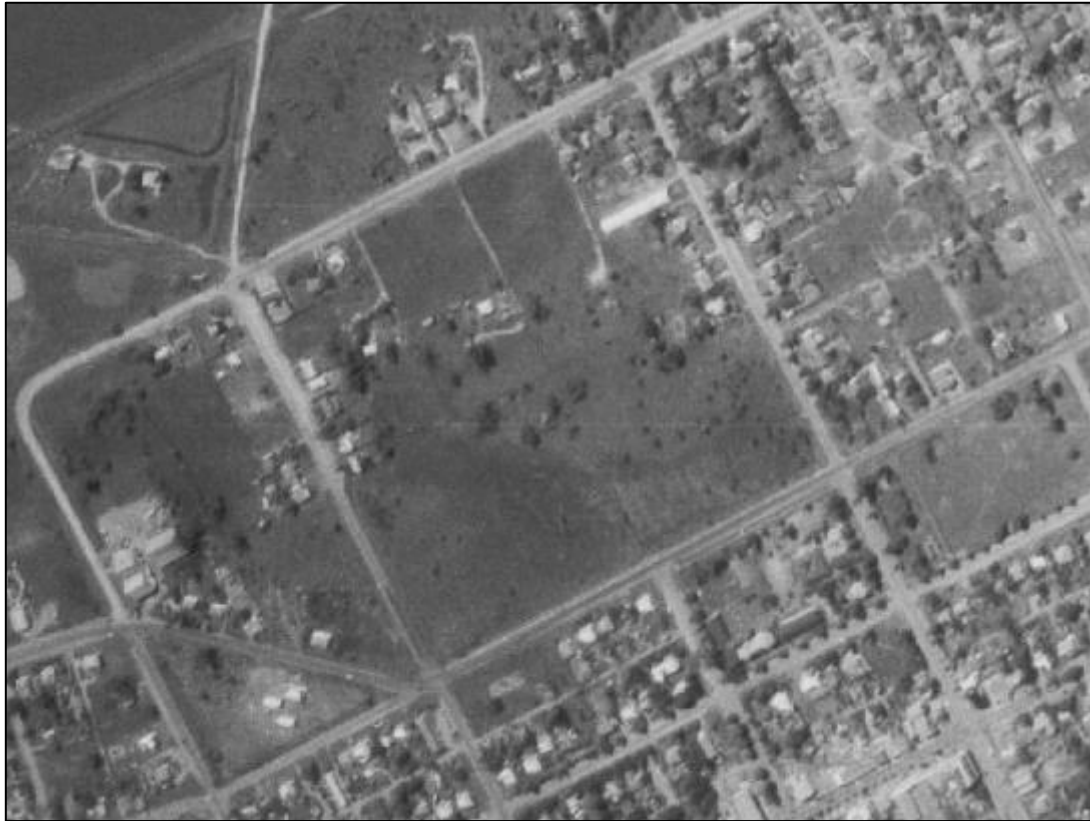
Figure 4: 1983 Aerial image showing drainage issue on the school site

The following 1983 aerial image shows that the original residence is gone. The image shows darker areas of vegetation along Mitchell Street and to the northwest corner of the land chosen for the school. This darker vegetation identifies wetter ground where stormwater may have ponded. This water appears to have originated from George Street to the east.

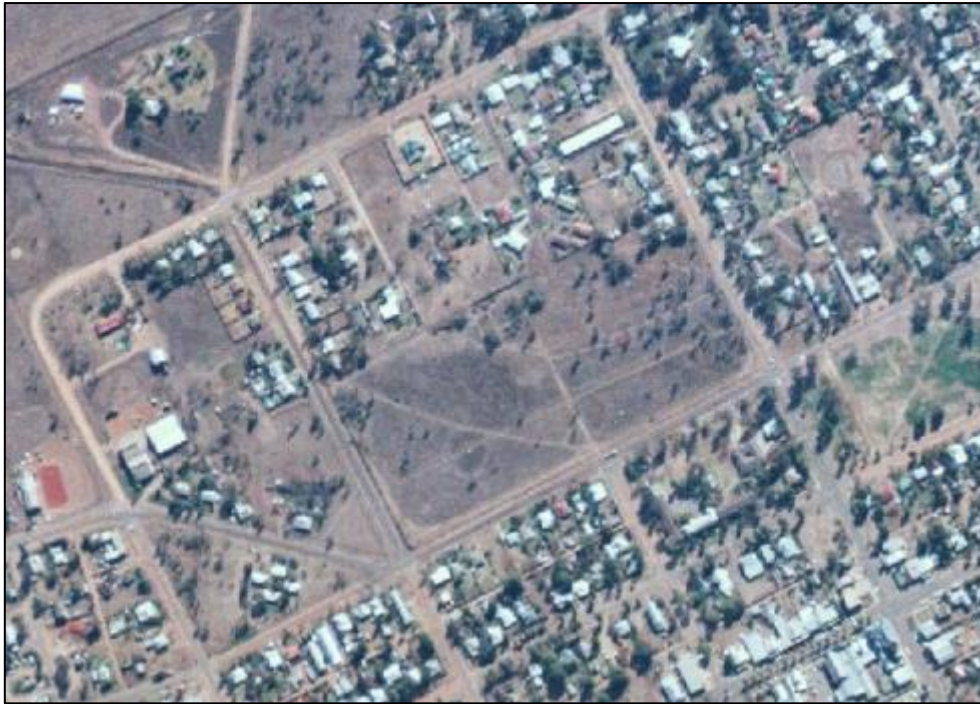
Figure 5: 1989 Aerial image with central stormwater drain

The following 1989 aerial image shows a stormwater drain running east to west through the middle of the land identified for the school site. This drain remains in place and forms an integral part of the stormwater management system for Wee Waa. Based on observation of table drains and culverts in the current stormwater system after a rainfall event on the 29<sup>th</sup> of September 2021, the area bound between George Street directly east of the site, Rose Crescent to the south, Maitland Street to the east and John Grey Avenue to the north, drains onto the proposed high school property.

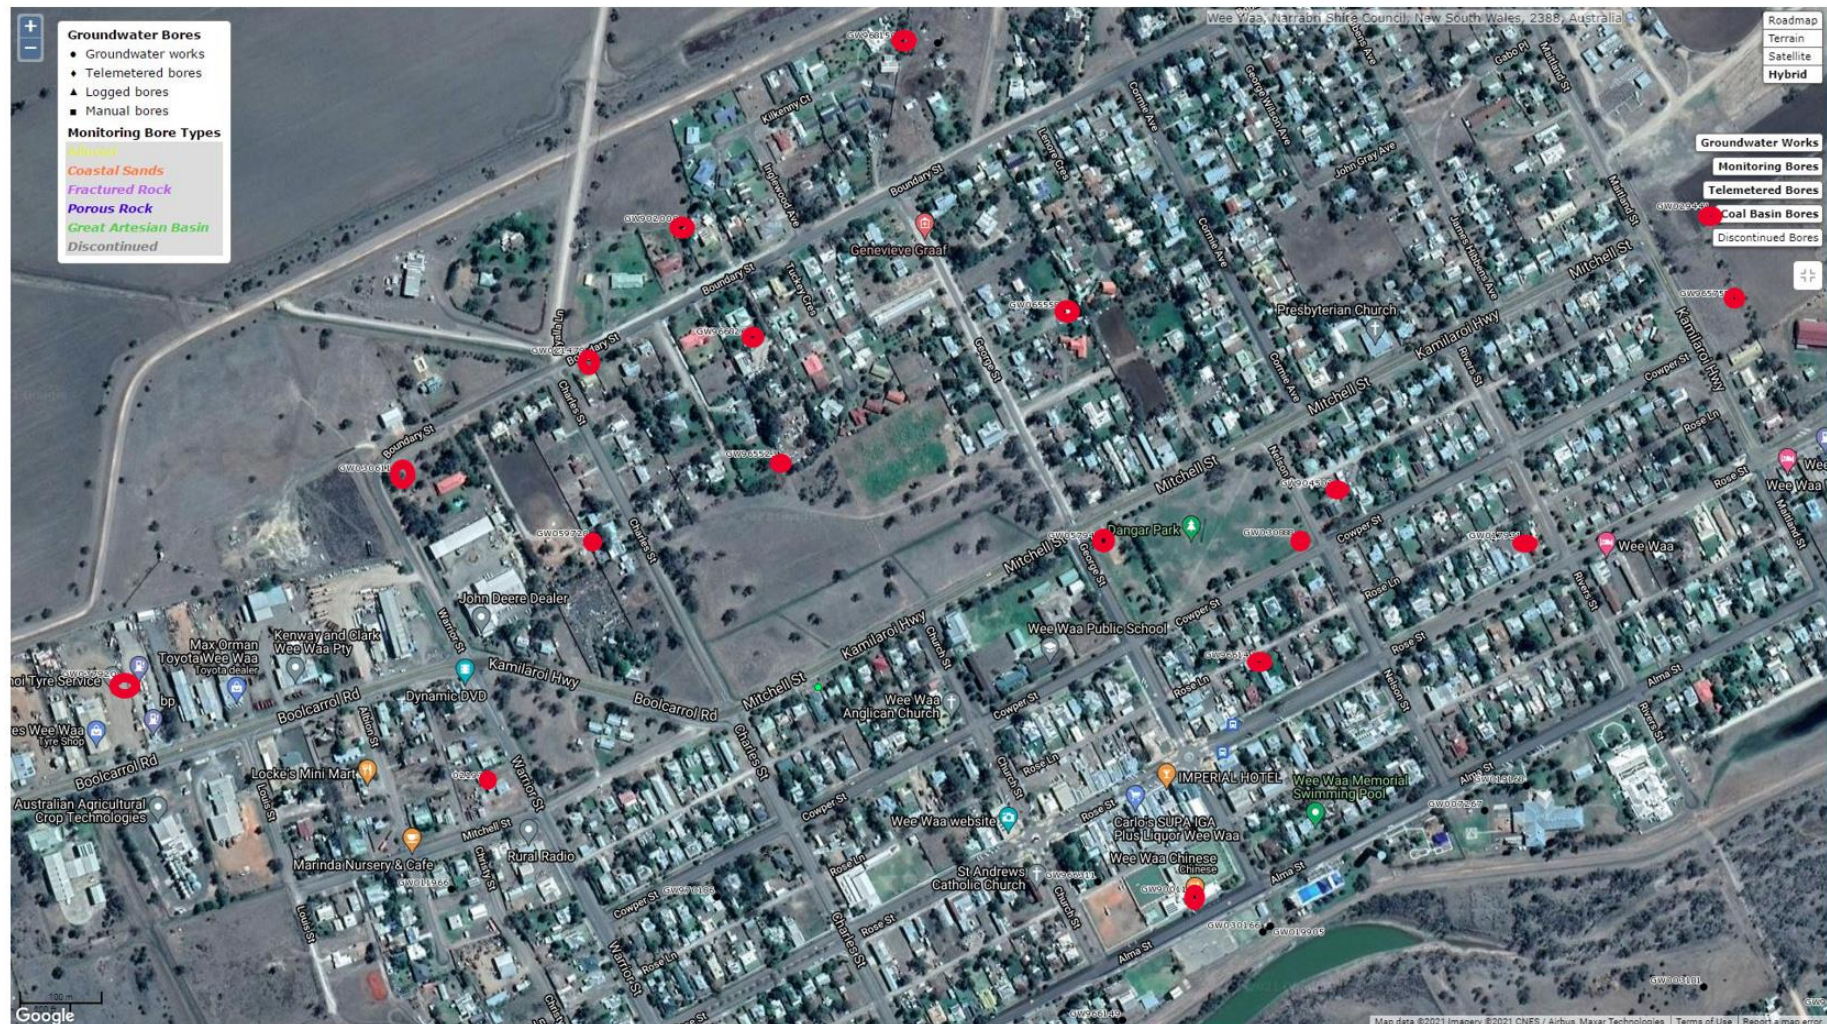
## Appendix 1: Map of registered bores in Wee Waa

Appendix 1 presents an aerial image showing the location of registered bores within Wee Waa. A listing of bores has been obtained from the NSW Water Register. This contains records of bores that have been registered through an application process submitted to Water NSW. Some bores do not get registered and therefore they are not recorded on the plan. Such bores may have been drilled prior to a requirement for registration. The database is not updated regularly and therefore the potential exists that some newer bores are not noted on the plan.

The following table presents a sample of bore logs from several of the bores identified on the plan presented in appendix 1. The data has been obtained from the Water NSW Water Information Hub which presents a groundwater map of NSW with registered bore details that have been uploaded into this data base. The data includes location, water source details, drillers log, standing water level, and yield. The data is generally provided by the driller of the bore. Not all drillers log the complete data set.
