Report on  
Preliminary Dewatering Management Plan

Cockle Bay Park Redevelopment  
241-249 Wheat Road, Darling Harbour, Sydney

Prepared for  
DPT Operator Pty Ltd

Project 202546.02  
June 2022

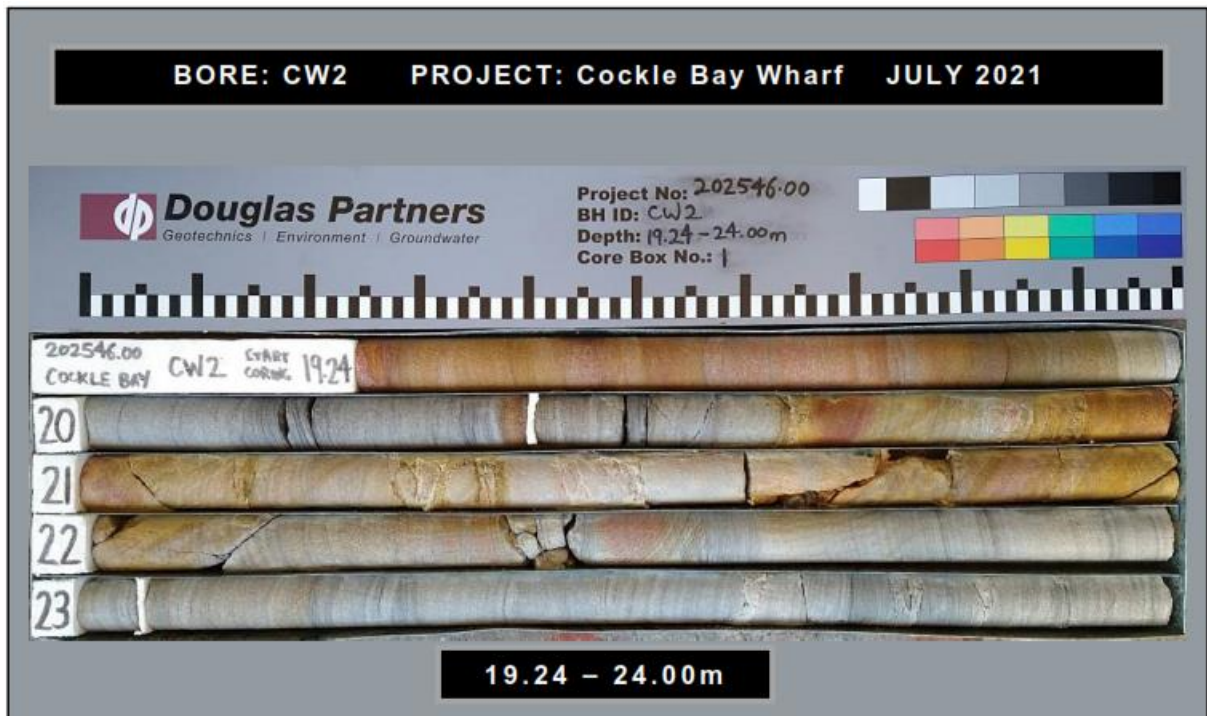
Figure 1: Upper Portion of Recovered Core from CW2. Surface Level 2.9 m AHD

It is expected that sandstone bedrock will be encountered at elevations approximately ranging between -11 m AHD towards the southern end of the proposed excavation and -15 m AHD towards the northern end of the excavation (about 14 m to 18 m below existing surface levels). Boreholes in the vicinity of the proposed excavation (CW2, CW5 and W5) encountered slightly to highly weathered, slightly fractured to fractured sandstone in the upper 3 m to 4 m of the rock profile. The degree of weathering and fracturing typically decreases towards the south, with no sub-vertical defects encountered in CW5 or W5. Photographs of the upper portions of the cores recovered from these boreholes are shown below.

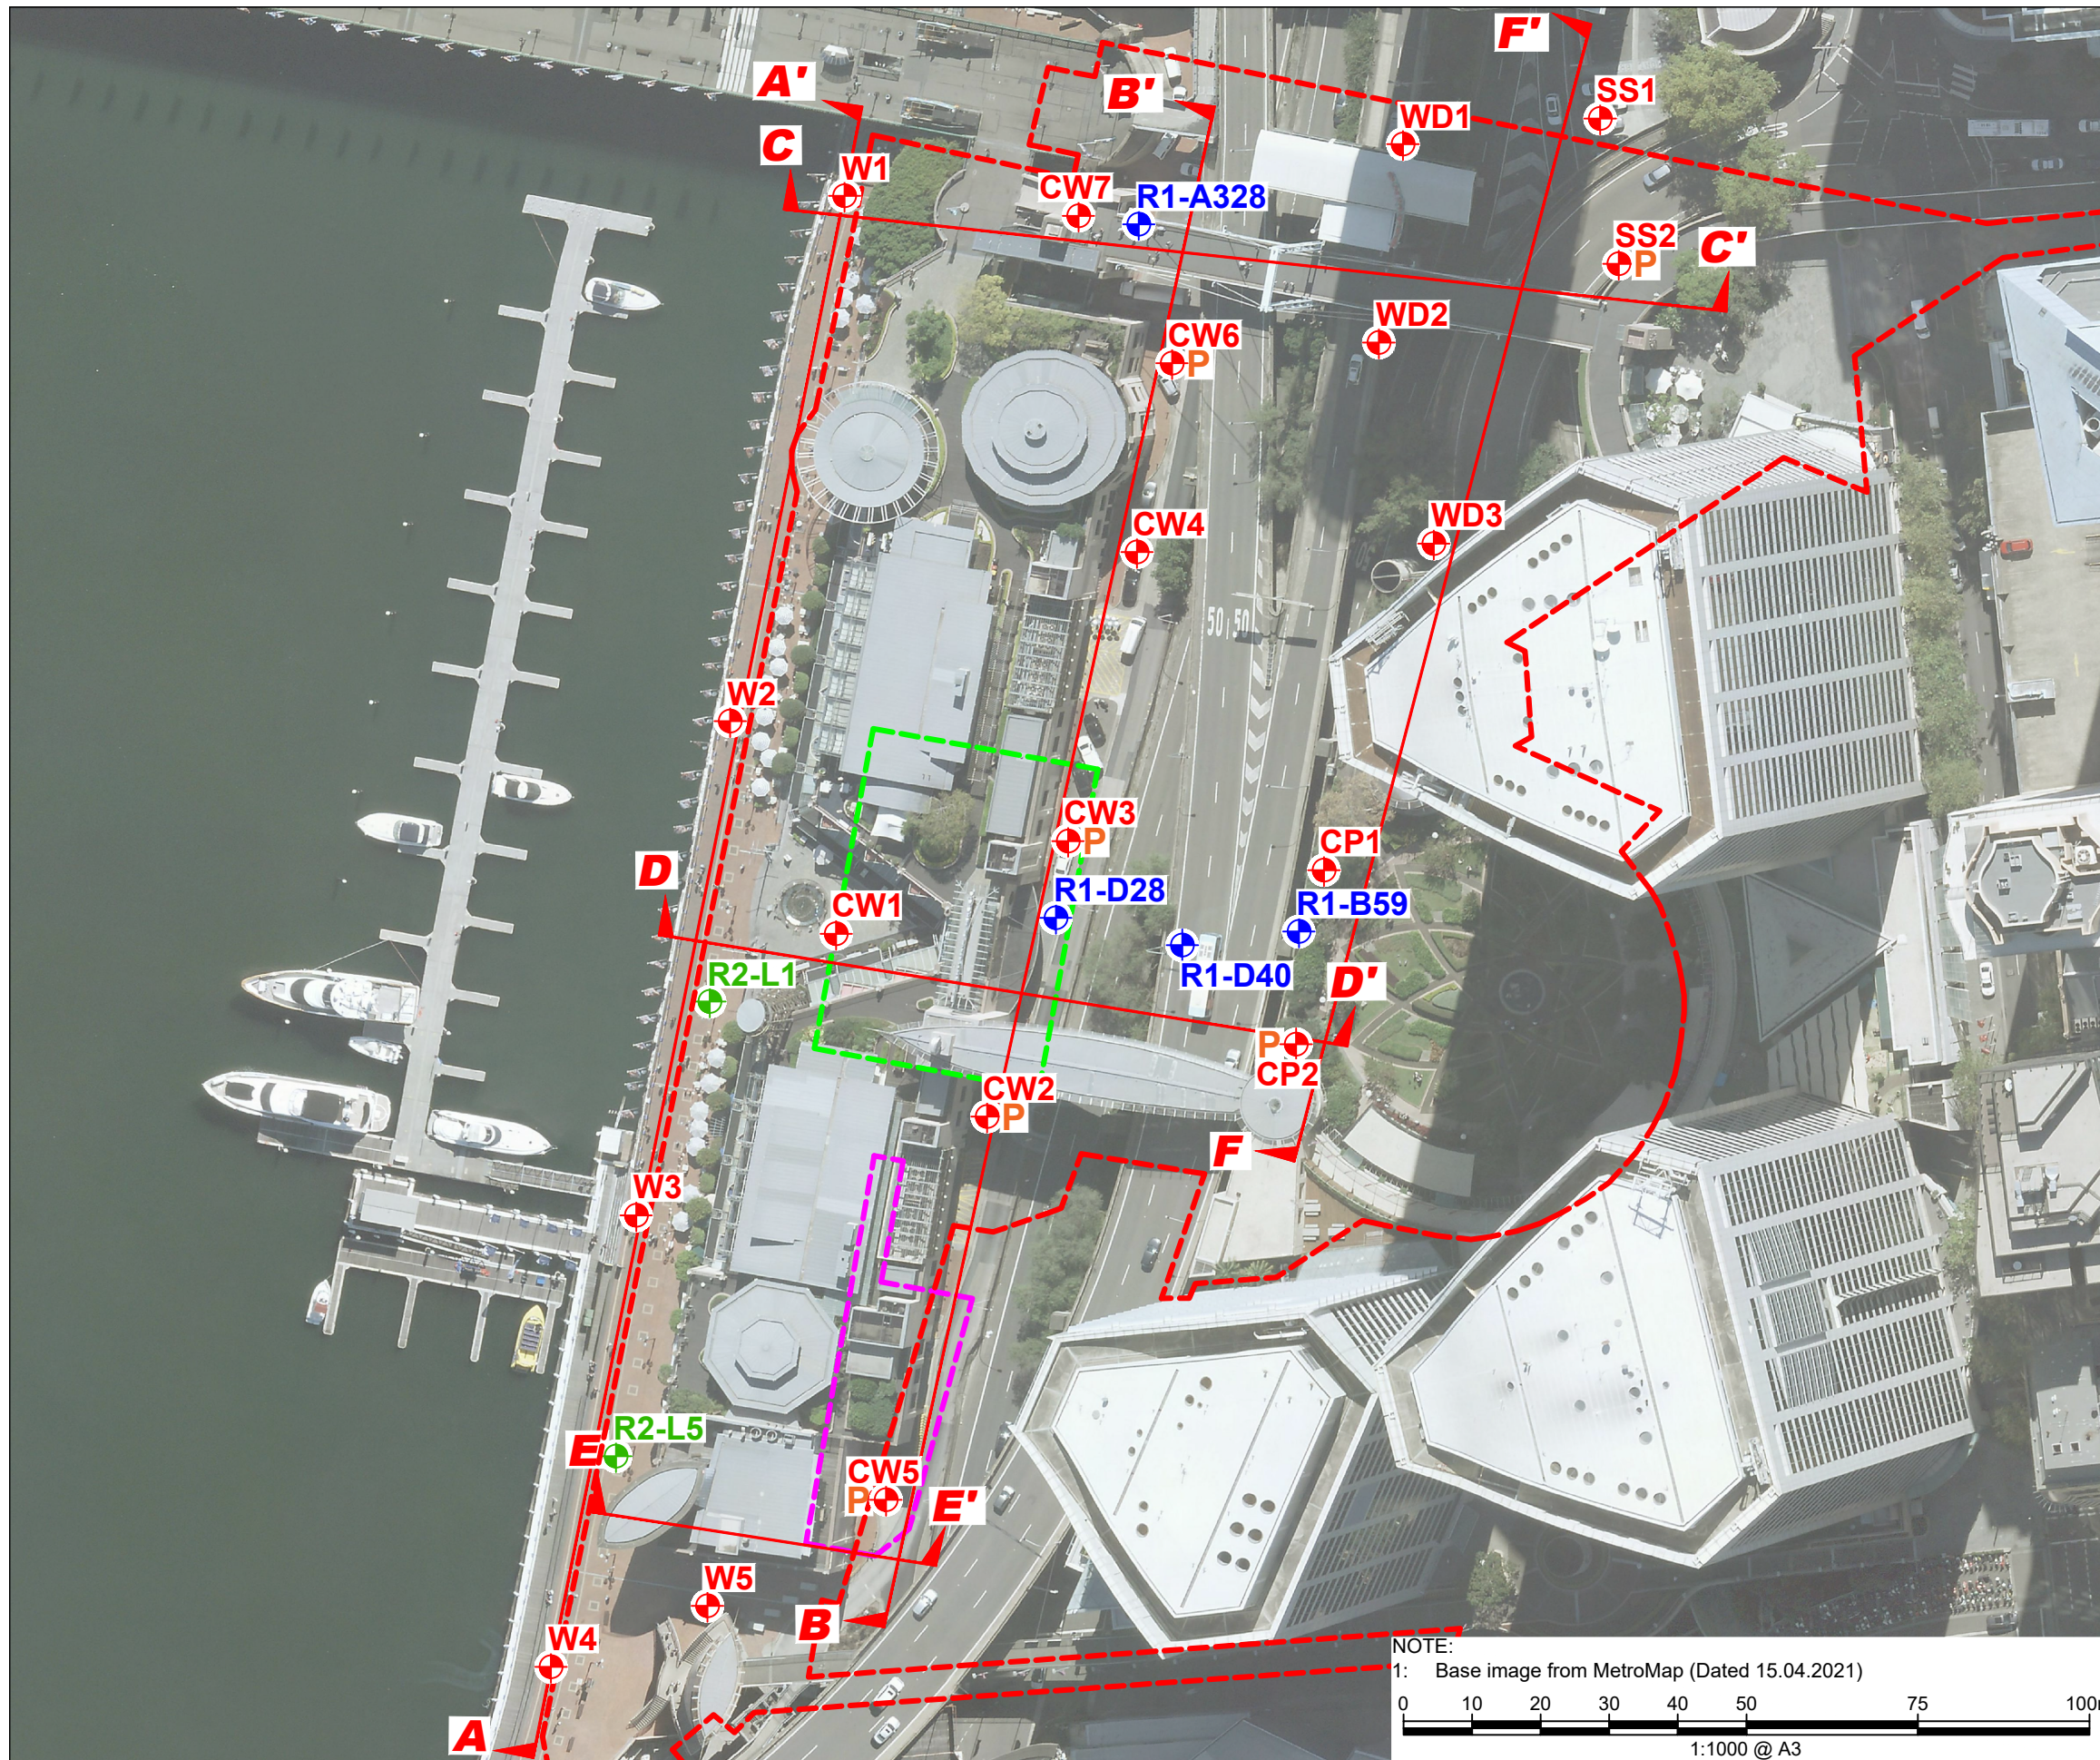
This report should be read in conjunction with the previous investigation reports. The locations of groundwater monitoring wells installed and boreholes drilled as part of the aforementioned works are shown on Drawing 1 in Appendix B.
