## **APPENDIX F: AQUATIC ECOLOGY ASSESSMENT**

**DEEP CREEK QUARRY PROPOSAL**

**DEEP CREEK AQUATIC ECOLOGY BIODIVERSITY  
STUDY**

**Marine Pollution Research Pty Ltd  
December 2022**

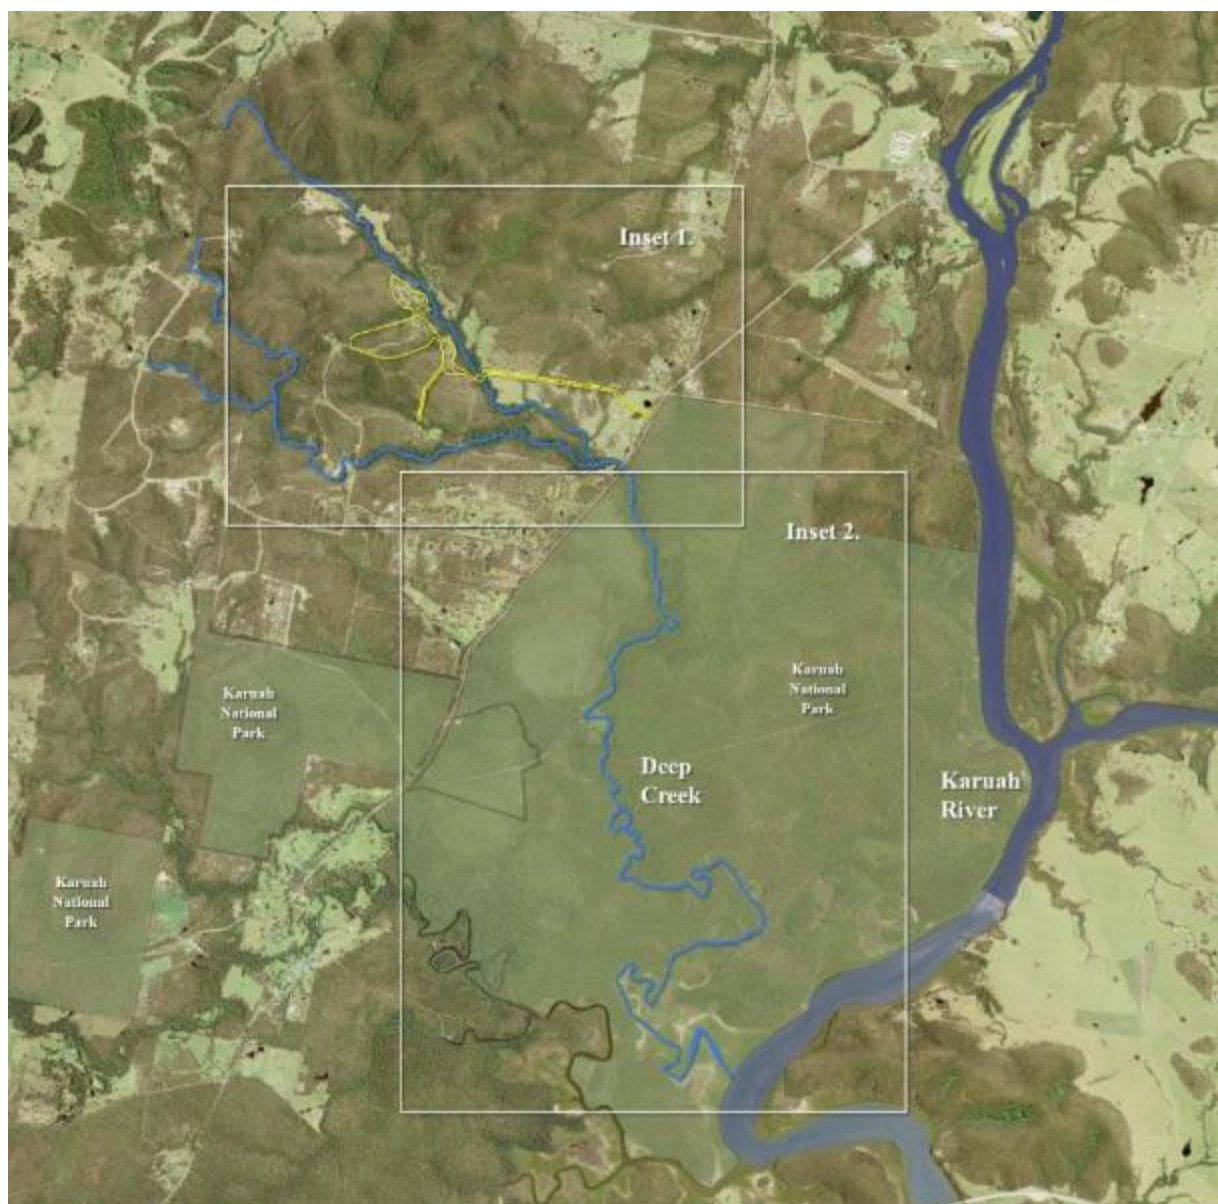
**Figure 3** SIX Map aerial view of the aquatic ecology Deep Creek catchment study area. Refer to **Figure 4** (Inset 1) and **Figure 5** (Inset 2) below for more detail.

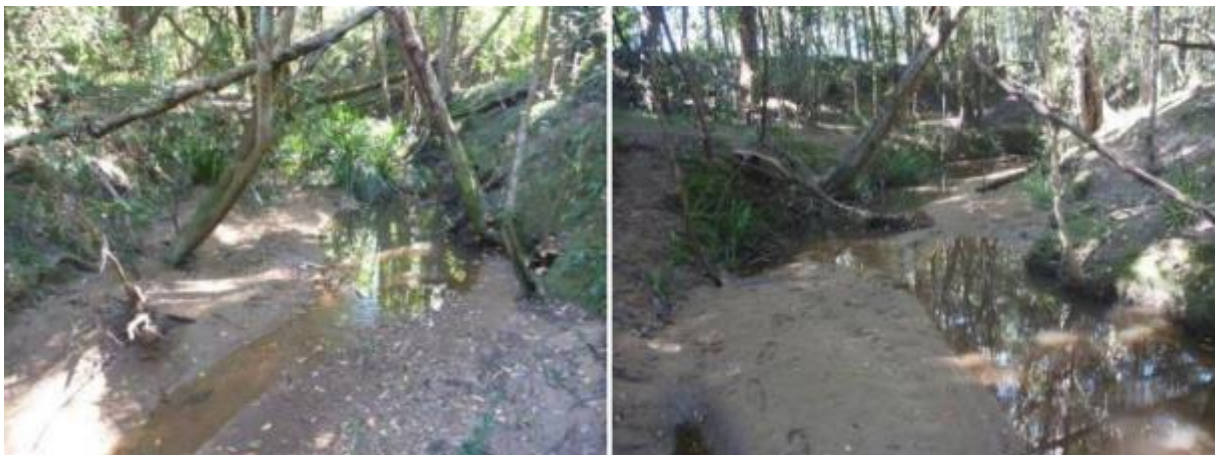
**Figure 6** Typical Deep Creek channel forms in the upper study area, showing shallow sandy gravel runs at DCUp (left) and DC2 (right).

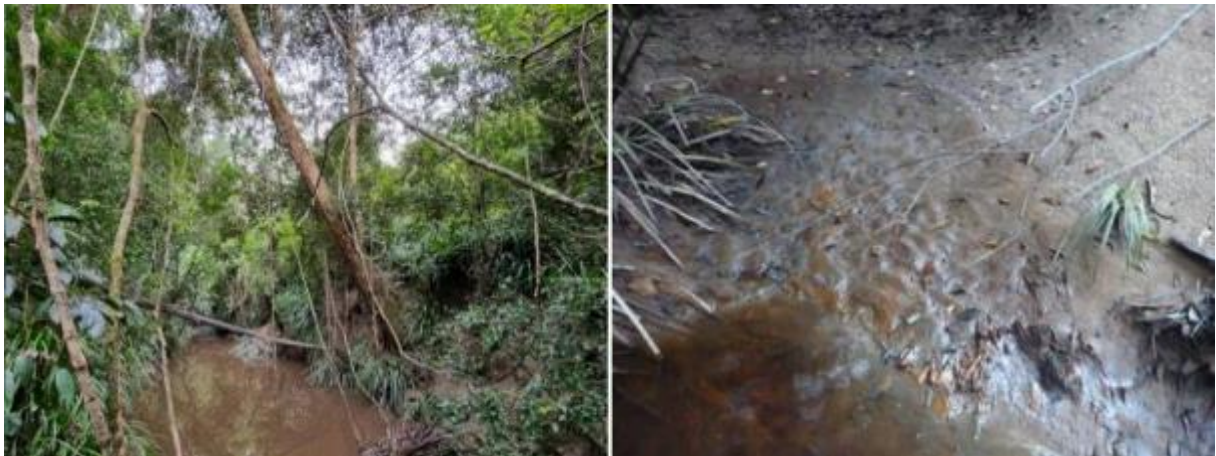
**Figure 8** Looking upstream at Karuah National Park site DC5 (left) and orange bank staining at DC1 (right).

- Orange iron staining and precipitation was present observed on banks and in pool edges at most sites.

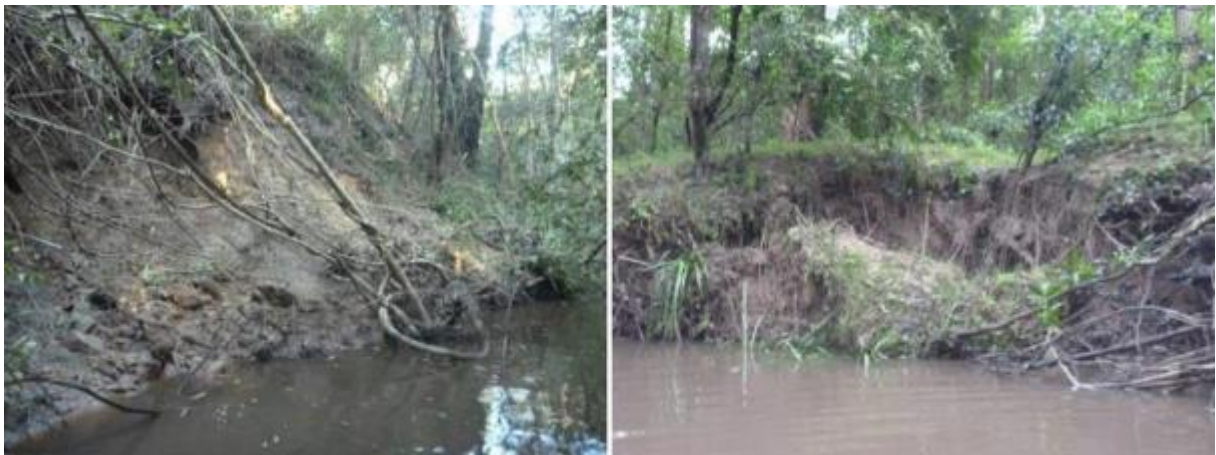
**Figure 9** Areas of active bank erosion were commonly encountered throughout the Deep Creek study area (DC1 left and DC4 right).

- There were sections of bank collapse and recently fallen trees observed throughout the freshwater section of Deep Creek, which were a likely result of flooding during the March flood event/s (**Figure 9** below). Log jams and detrital accumulations were present, however there were no large detrital deposits noted sufficient to cause black water environments or sulphur odours when disturbed.

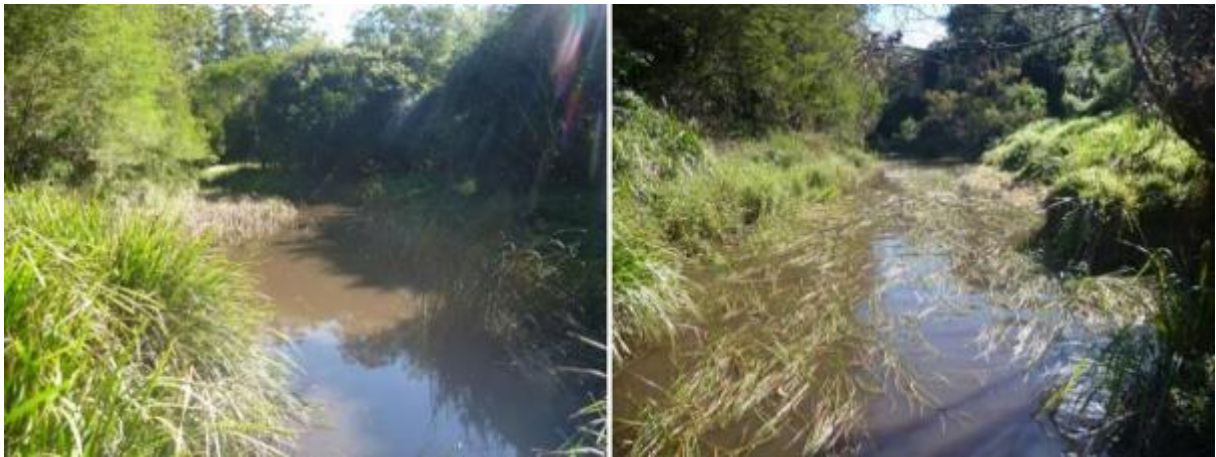
**Figure 10** Site DC6 contained more open pools and supported an assemblage of emergent and floating macrophyte species.

- The channel form contained one large pool, much broader than pools upstream and the vegetation along the channel banks were made up of sedges, grasses, ferns, with minimal canopy coverage over the waterbody. As a consequence, pool areas were more exposed to sunlight than habitats upstream and the site supported macrophyte growths (**Figure 10**).

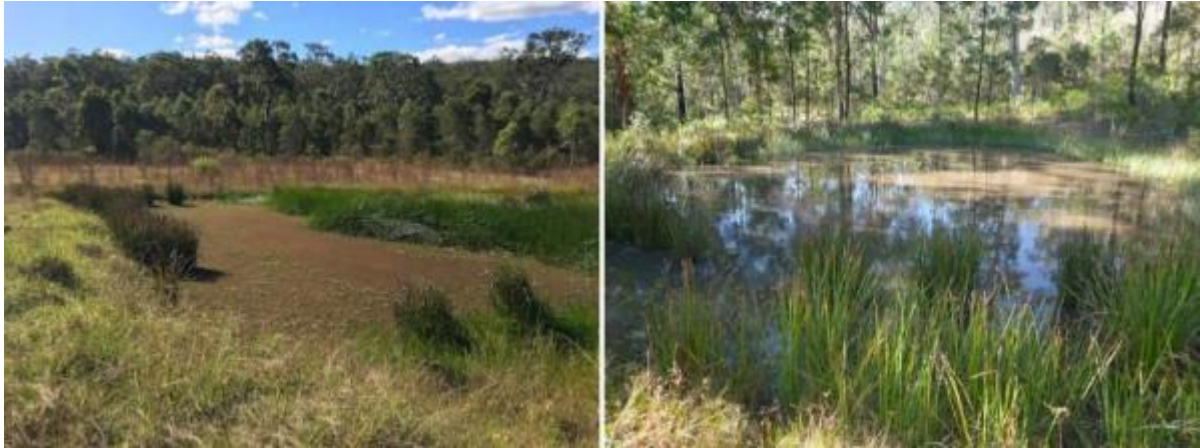
**Figure 11** NT5dam showing dense coverage of the small floating macrophyte *Azolla pinnata* smothering the water surface, with emergents tall spikerush in the middle and bulrush around the edges (left), and ST4dam with bulrush stands around the perimeter, among other species.

Macrophyte occurrences at the tributary drainage channel sites were limited to small quantities of knotweed and *Carex* grasses noted from NT5, NT7, ST2 and ST3, and submerged beds of water milfoil (*Myriophyllum sp*) were noted at ST5SD. Several lentic habitats (dams) were inspected, including two dams on NT5 western tributary, southern tributary site ST4dam and a dam located between the proposed stockpile area and Deep Creek (SPdam in **Figure 11** below).

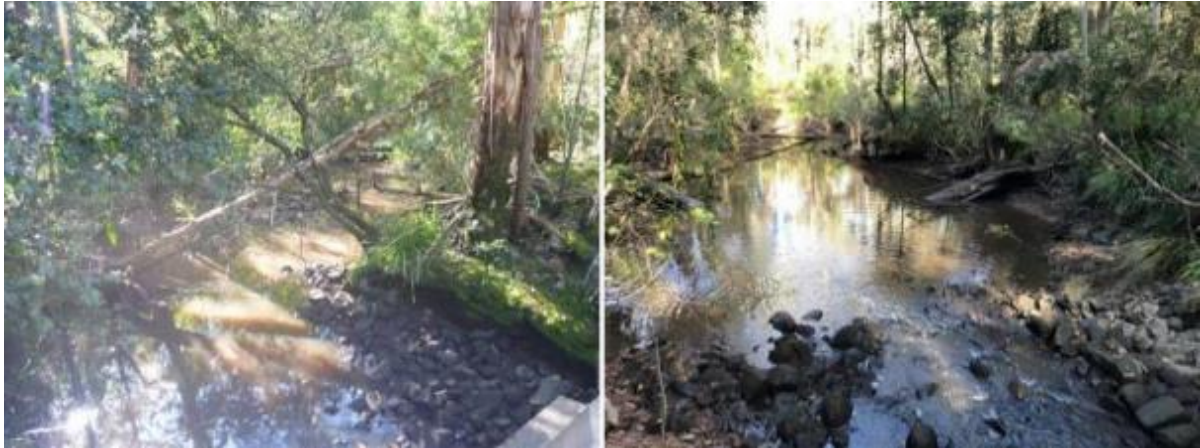
**Figure 14** Looking upstream from Hobarts Forest Rd bridge crossing over Deep Creek (left) and looking downstream (right). This point represents the approximate upstream tidal limit in Deep Creek.

- There were small quantities of river mangroves (*Aegiceras corniculatum*) extending up as far as Hobarts Forest Rd bridge crossing (**Figure 14**).
- There were additional areas of estuarine vegetation noted during the field survey that is not included in the NSW Fisheries mapping, including a more or less continuous strip of mangroves along the Deep Creek edge banks from DCHF to DCDn (for example see **Figure 15**), which increases in density with distance downstream.
- There was a patch of saltmarsh on the north-eastern side of Deep Creek, upstream of DC7 (see **Figures 5** and **16**) which is not included in the Fisheries' mapping, with several other small patches along the periphery of Deep Creek around 1km upstream from DC7 (these are yet to be confirmed).

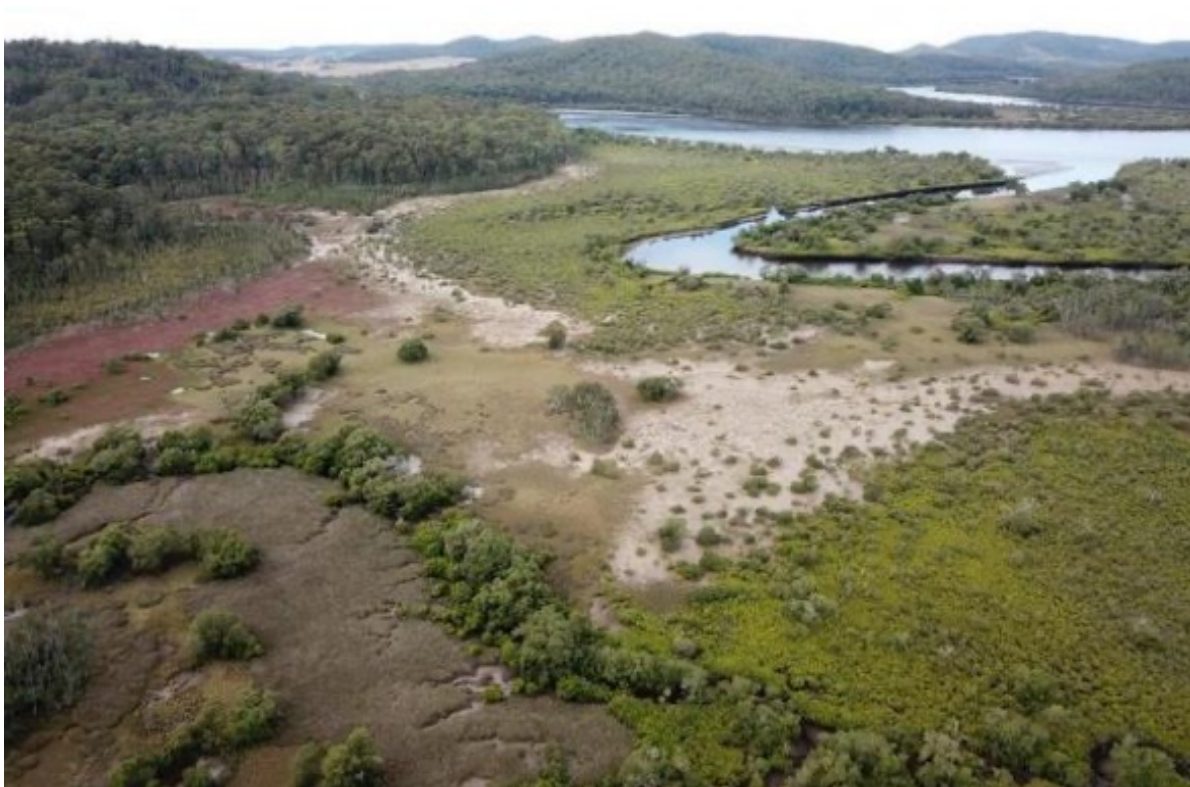
**Figure 19** Aerial image looking east across the lower limits of Deep Creek and the confluence with the Karuah River in the distance.

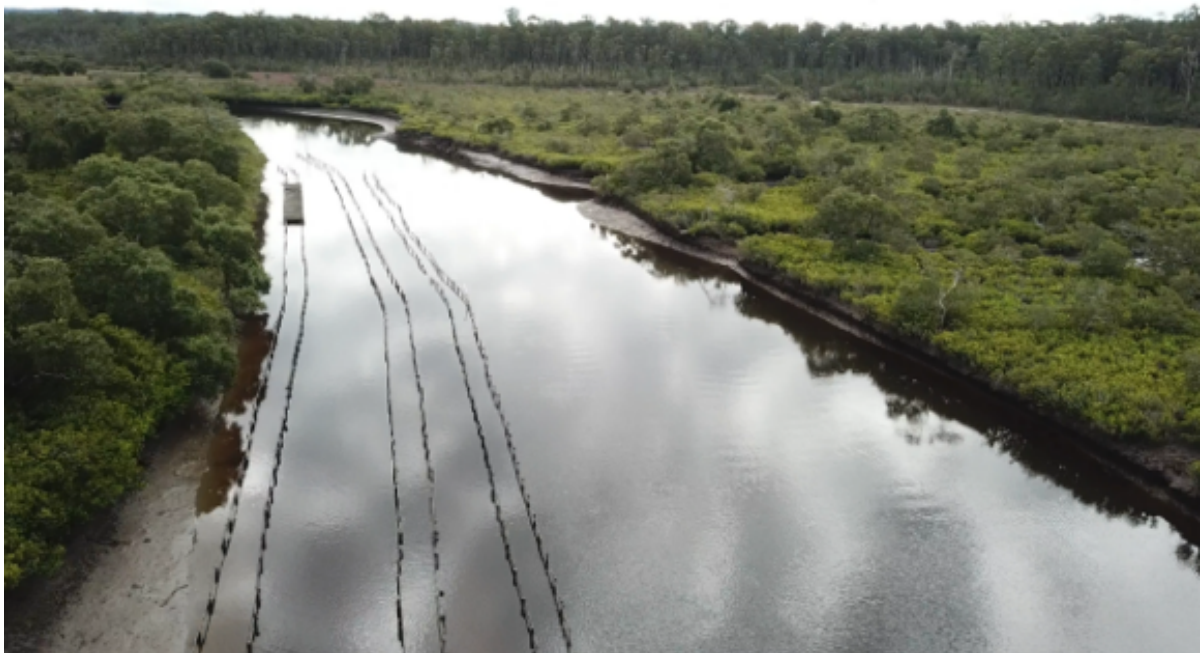
**Figure 23** Looking upstream in Deep Creek at oyster leases (along the southern bank). Note stock on racks at upper left.

As noted on **Figure 5**, oyster leases are present in the downstream limits of Deep Creek and Karuah River up and downstream of the Deep Creek confluence. Aerial drone imagery indicates that some of the oyster farm infrastructure was being utilised using stick and tray culture methods at the time of survey, with stock present on leases in the lower Deep Creek and in Karuah River up and downstream of Deep Creek (**Figures 23** and **24**).

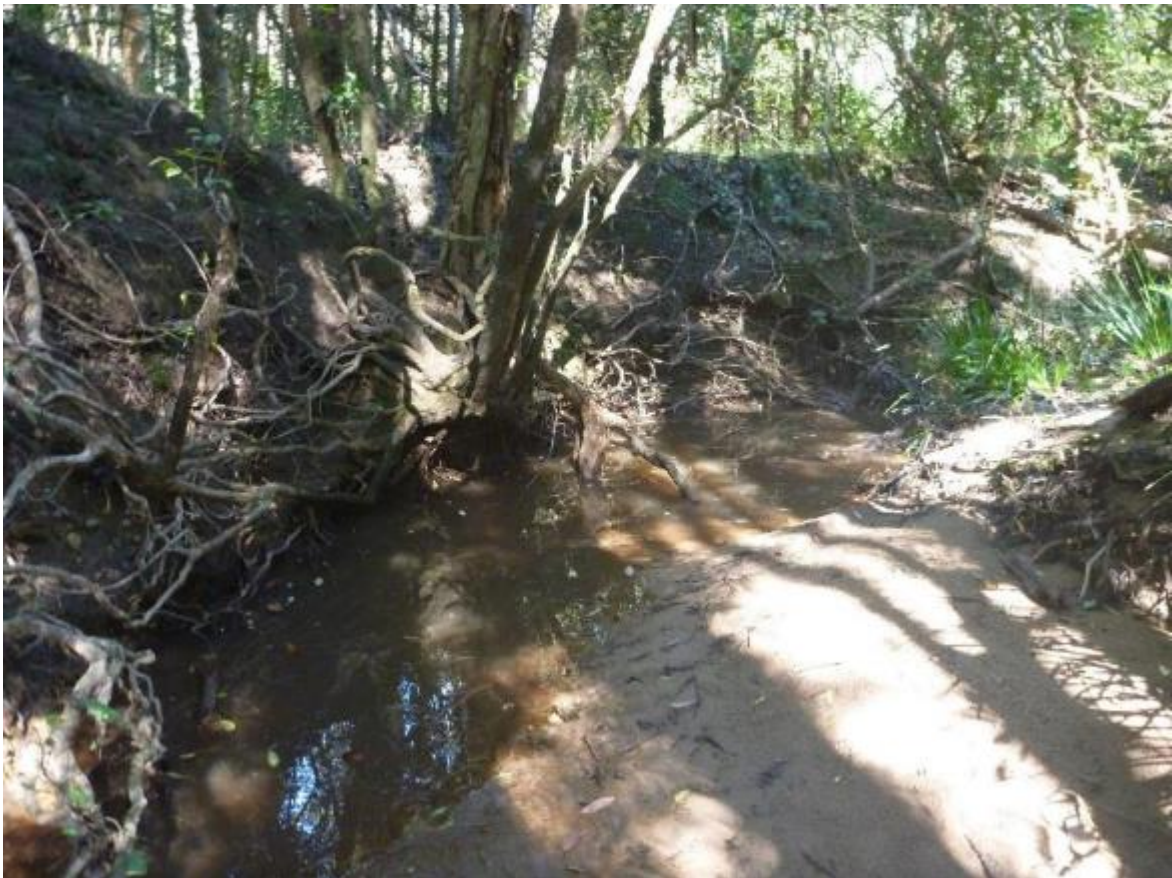
Plate 4: Looking upstream at undercut banks stabilised by tree roots at DCUp.

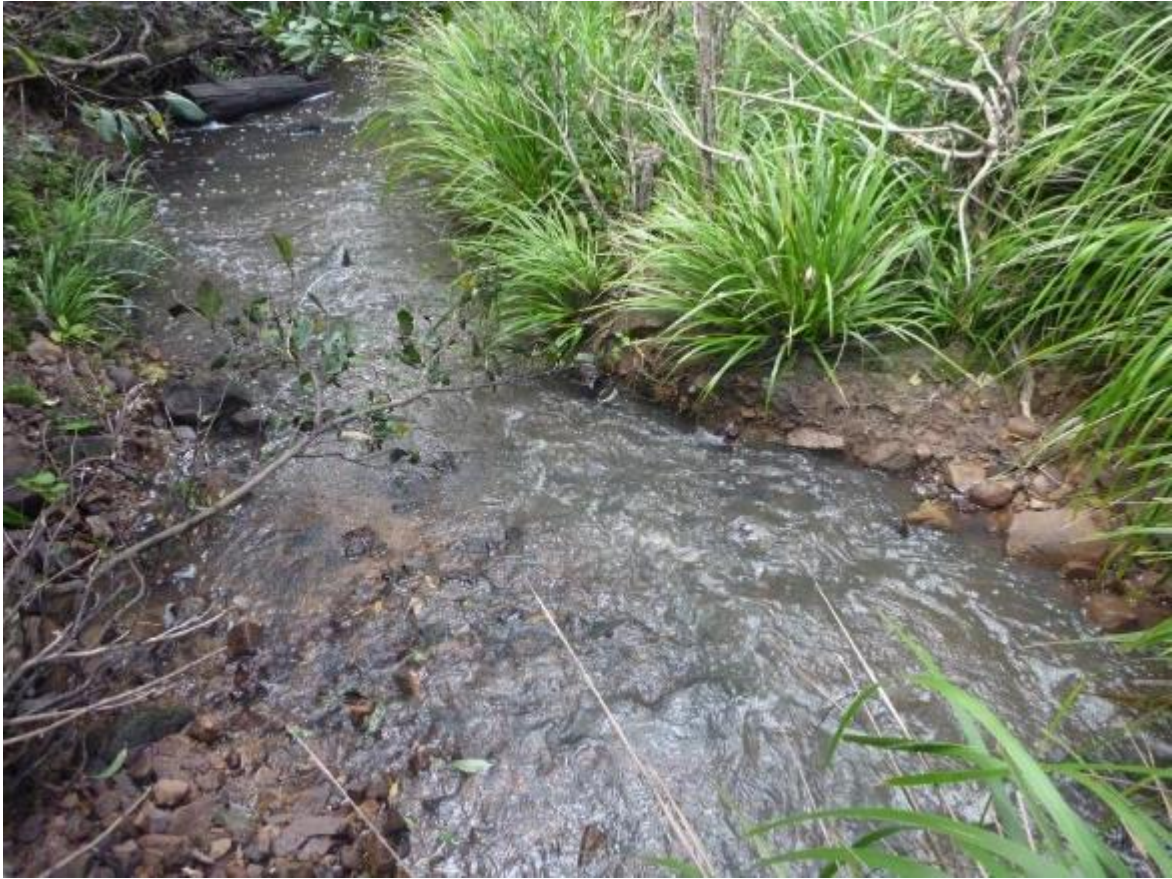
Plate 13: Looking downstream through constricted cobble and gravel riffle section at DC4.

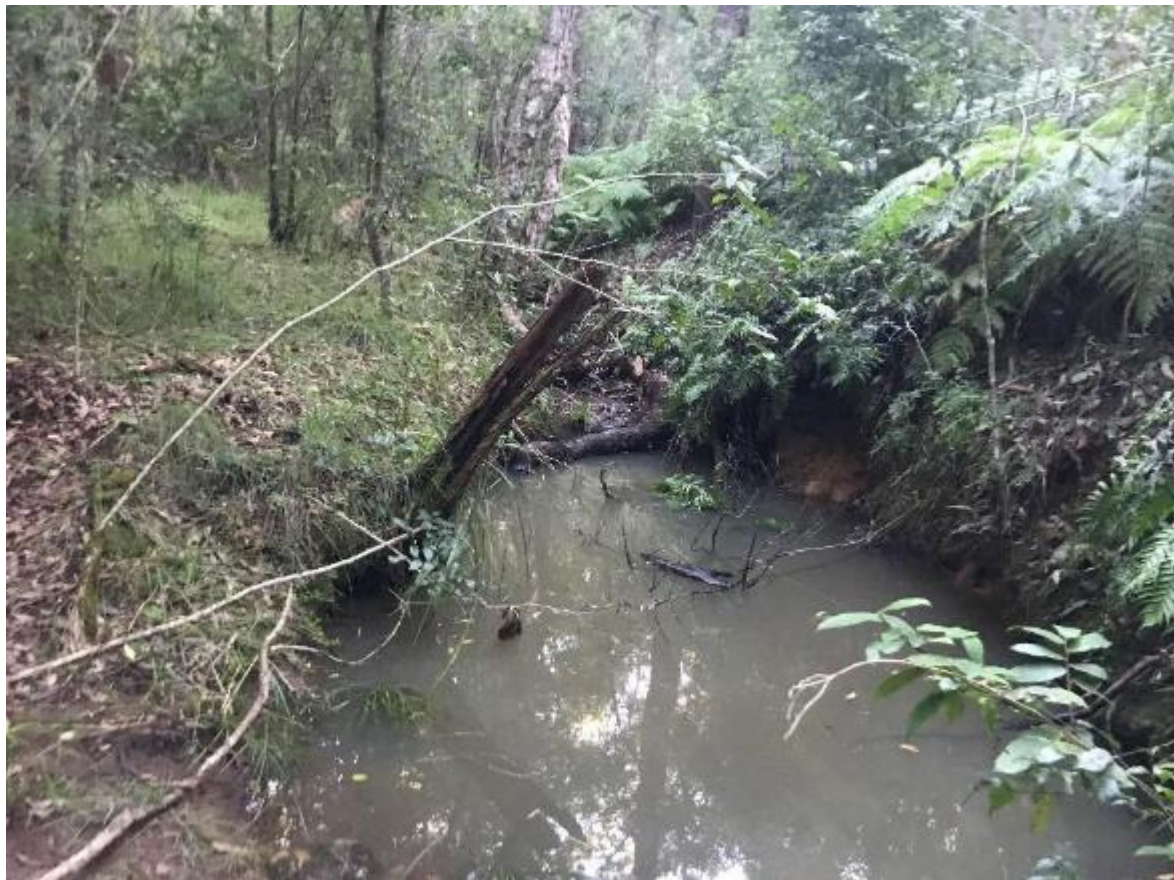
Plate 7: Looking upstream at ST3 up water quality metering pool.

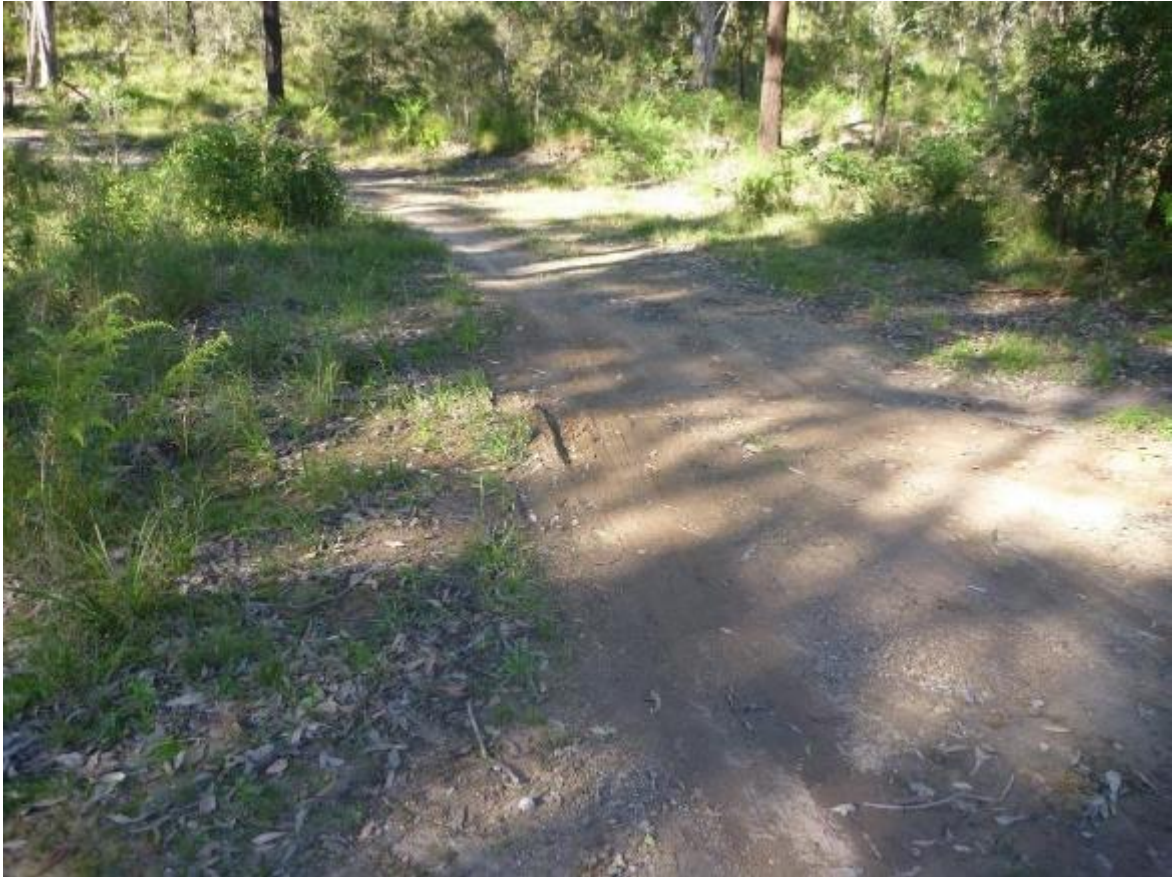
Plate 18: Looking east at Deep Creek Rd crossing.

A small seepage flow was present in one of the dam outlet drains (along the western edge), however there was no surface flow over the road crossing (Plate 18). Downstream from the road crossing, the drainage becomes more channelised, with a series of incised pools separated by dry channel runs.

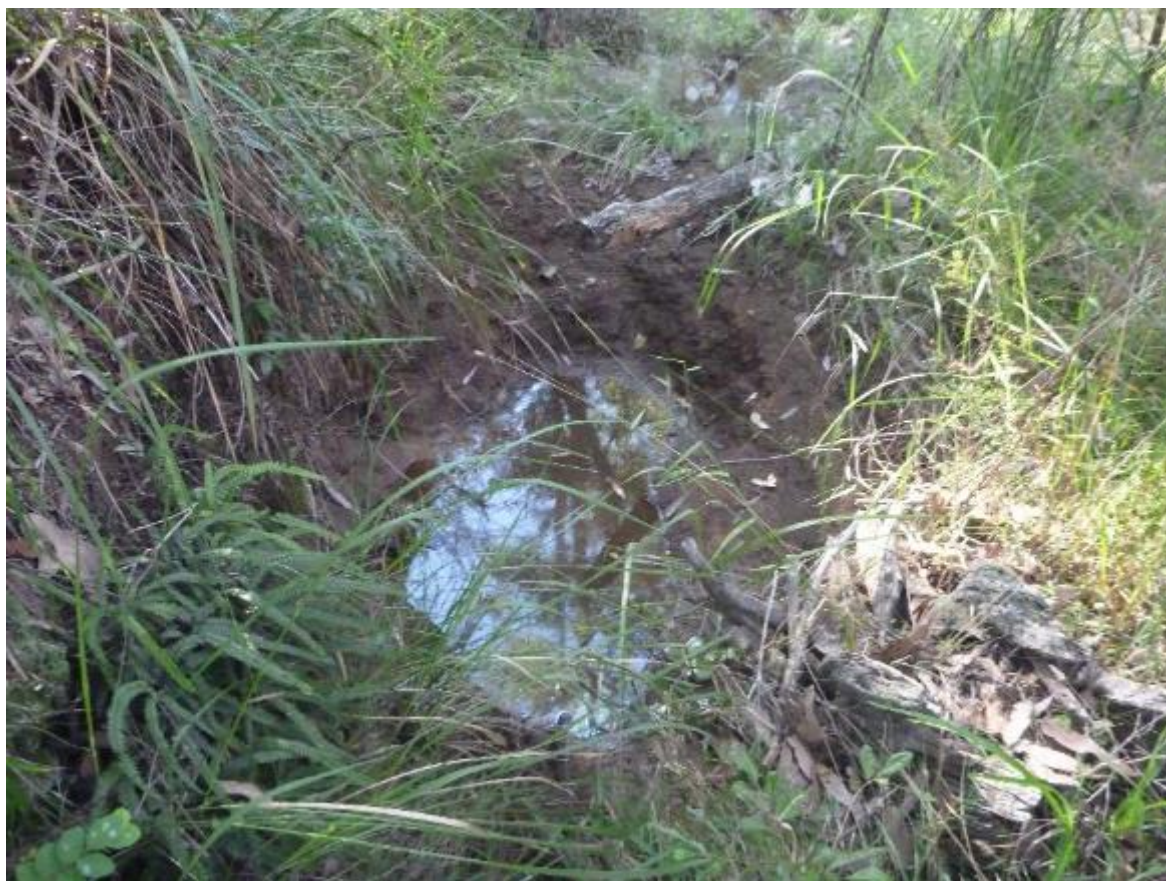
Plate 20: Typical scour pool in the channel area downstream of Deep Creek Rd crossing in ST4.

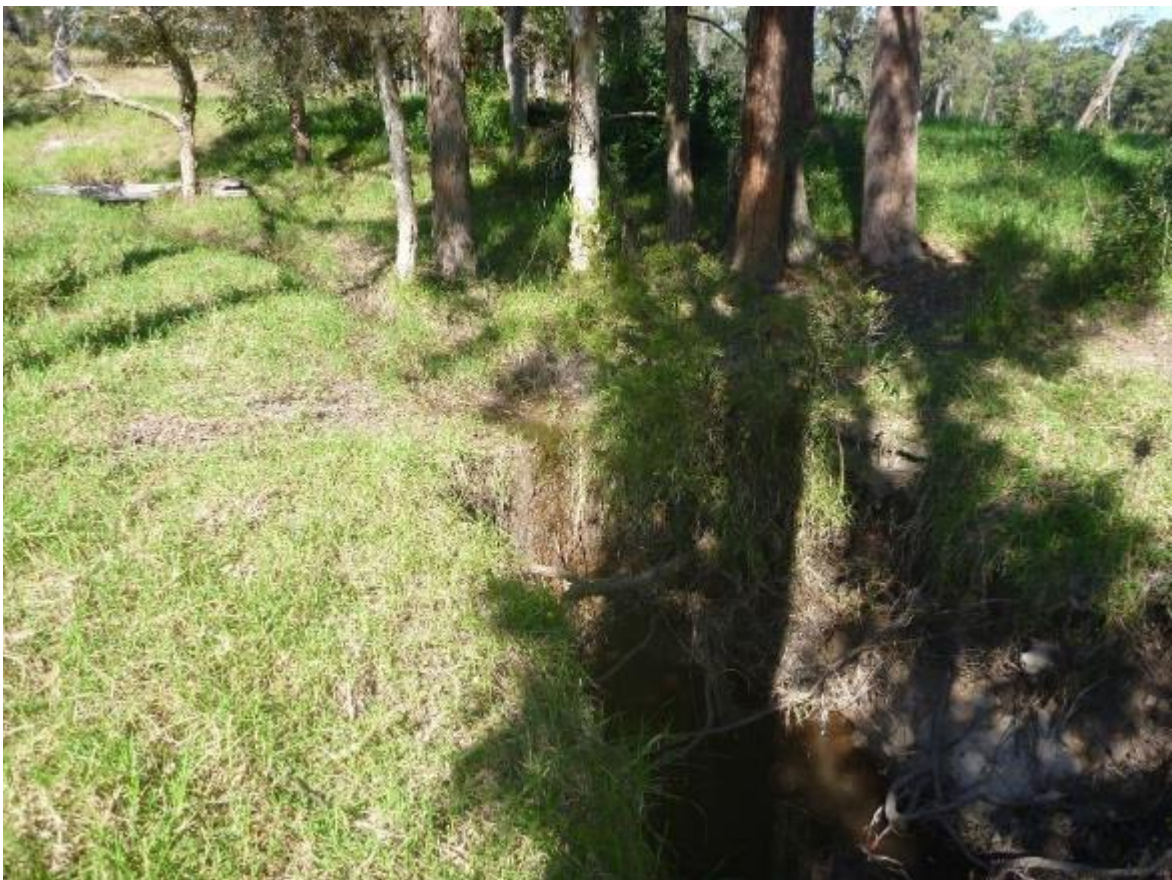
Plate 32: Looking upstream at the upstream limits of the deeply incised, sunken channel headcut.

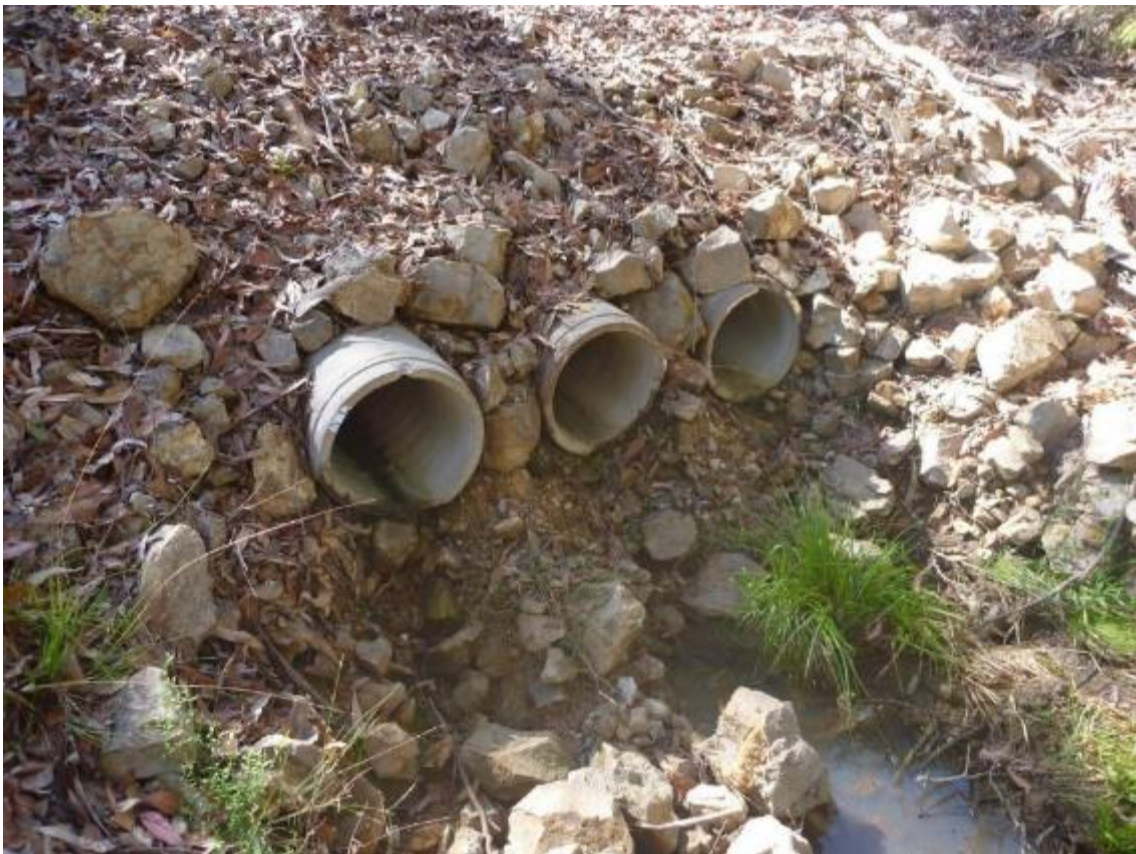
Plate 38: NT6 pipe culverts on the downstream side of the constructed track.
