Wallerawang Aquatic Habitat Assessment

21 April 2022

Greenspot Wallerawang Pty Ltd

Old Wallerawang Power Station

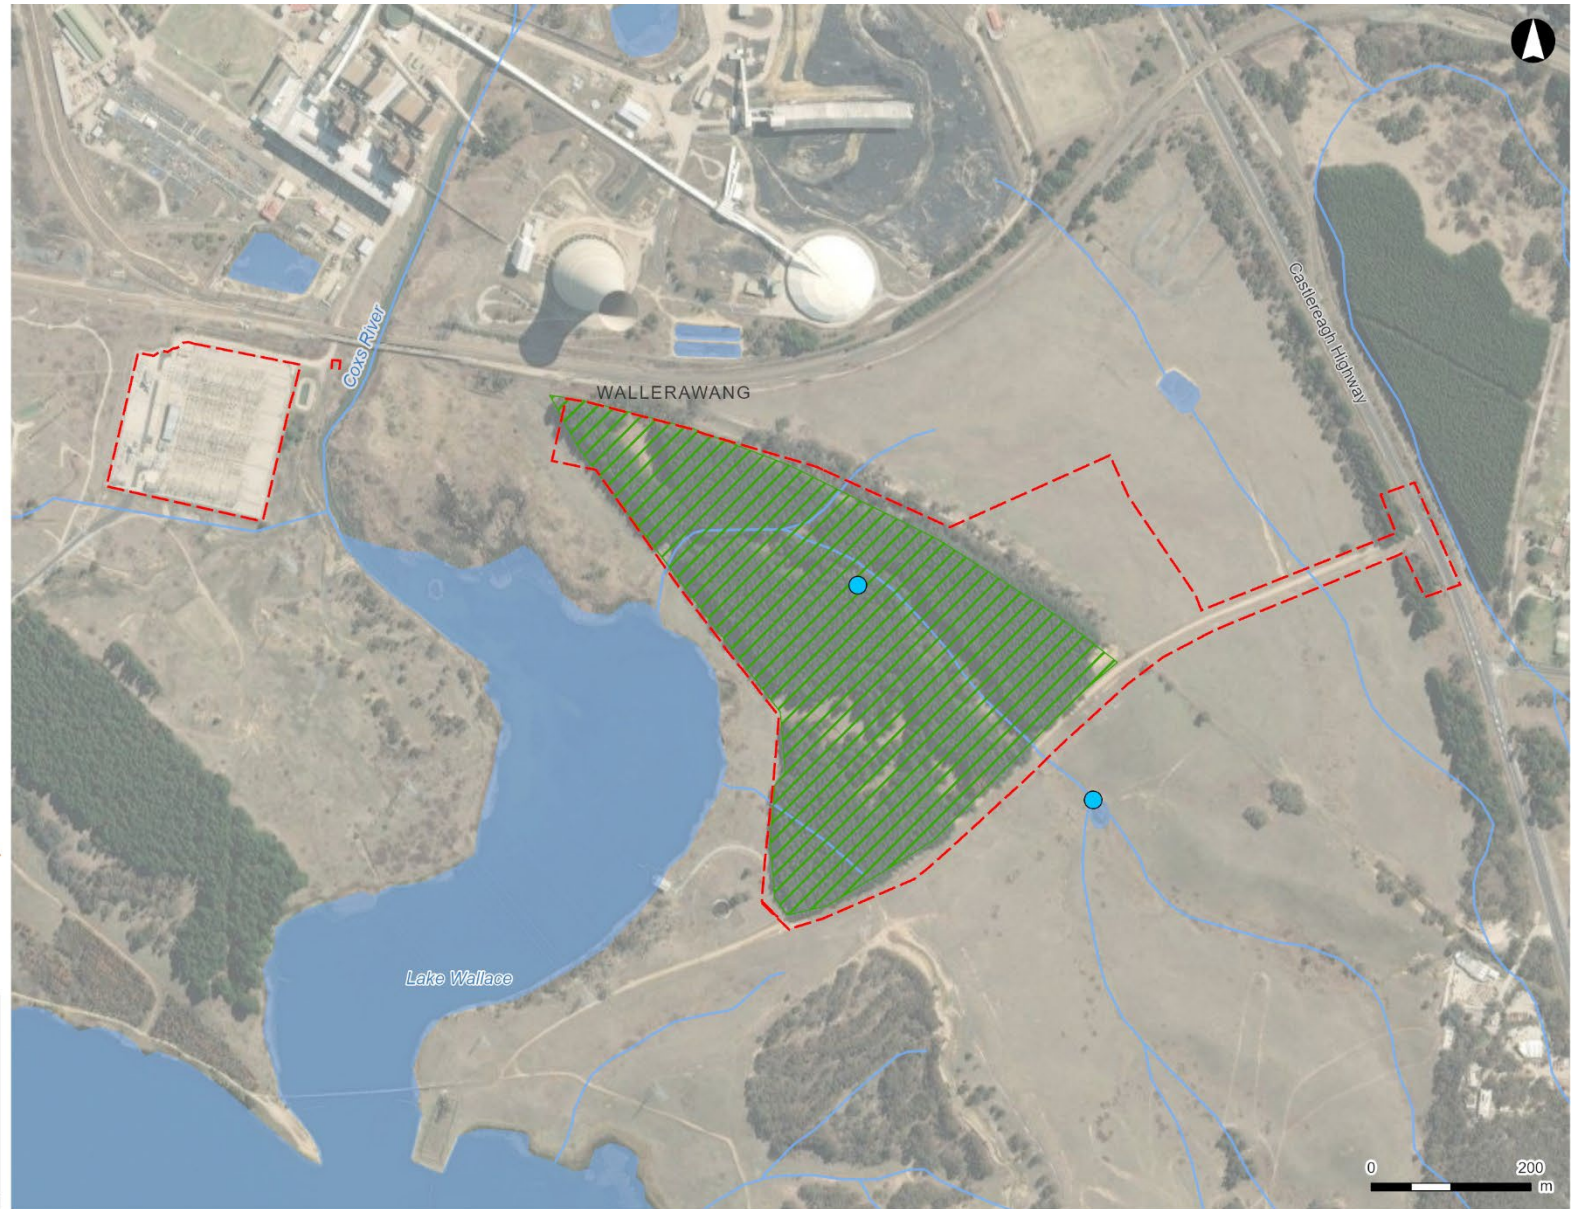
Figure 1 Survey locations within the subject land

Arcadis ecologists Kate Carroll and Taylor Bliss-Henaghan attended the subject land on 31 March 2022 to make an assessment of the aquatic and riparian features of a watercourse running through the forestry area. Watercourse assessments were conducted at two locations, one within the pine plantation within the subject land and another upstream in the paddock outside the southwest extent of the subject land. At each location the aquatic features of the watercourse and adjacent riparian vegetation were investigated, and notes made on the condition of these. Weather on the day of survey was sunny with clear skies, however followed by a period of heavy rainfall. Location of habitat assessment points are shown in Figure 1.

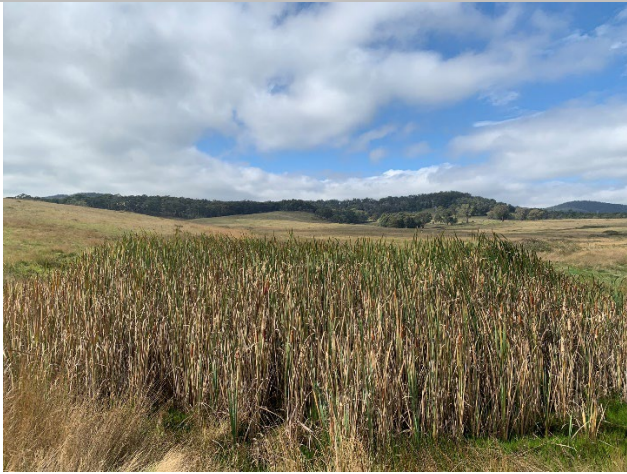
Cleared Paddock: Upstream (farm dam)

Description: Narrow creek which runs through a cleared paddock and links farm dams in the local landscape. Creek channel is generally well defined, narrow, modified, approximately 0.5 metres wide, and snaking through the paddock. Banks short and low sloping.

Hydrological Features: Ephemeral creek with likely intermittent slow flow during high rain. Not flowing at time of survey.

Habitat Features: Dense stands of *Typha orientalis* (Bulrush) in the farm dam, instream vegetation present, other refuges and fish spawning areas absent.

Instream vegetation: Consistent high cover and density of vegetation instream. Mix of exotic and native species including *Typha orientalis*, *Eragrostis sphacelata* (Tall Spike-rush), *Juncus usitatus* (Common Rush), *Cyperus eragrostis* (Tall Flatsedge), *Juncus sp.* and *Setaria sp.*

Water quality: Poor quality - brown algae present, oil slicks visible, water brown/orange in colour, moderate turbidity. Agricultural activity surrounding creek may influence water quality.

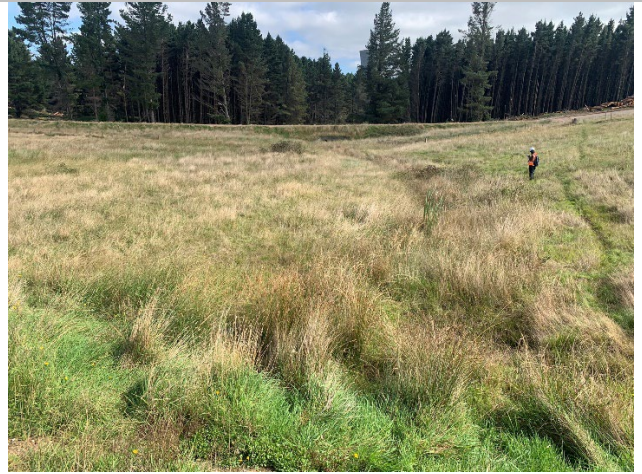
Cleared Paddock: Downstream

Barriers to fish movement: Two medium pipe culverts downstream.

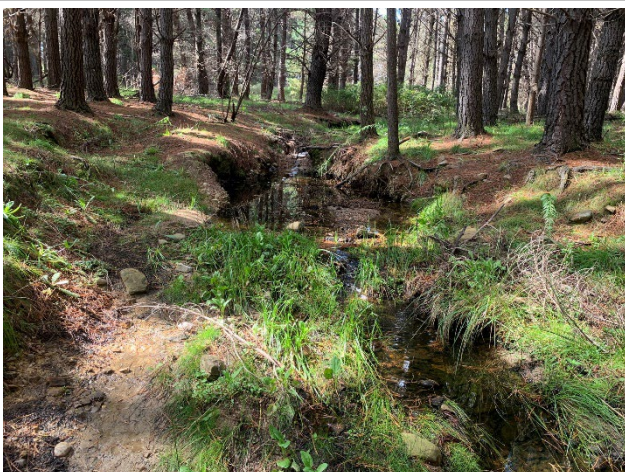
Forestry Area: Upstream

Description: Intermittent creek transecting *Pinus radiata* (Radiata Pine) plantation. Occasional pools and eroded undercut banks with a shallow gradient slope. Channel modified and generally 1.5 metres wide with wider pools up to four metres occurring intermittently. Creek banks were between two and three metres in width.

Habitat Features: Refuge areas limited to pools upstream, undercut banks also present in one location. Gravel substrate/rock in parts and small volume of coarse woody debris.

Barriers to fish movement: Two medium pipe culverts upstream impede movement and dense blackberry stand

Riparian zone: Disturbed Radiata Pine forest with open understory. High cover of *Rubus fruticosus* species agg. In riparian and instream areas upstream and downstream. Exotic species dominant including *Solanum* sp., *Hypochaeris* sp., *Rosa rubiginosa* (Sweet Briar), *Prunella vulgaris* (Self-heal), *Conyza bonariensis*, *Cenchrus clandestinus* (Kikuyu Grass)

Water quality: Moderate quality - Low turbidity, evidence of pollution (foam) in places.

The condition of the creek within the forestry area is degraded with a high cover of weeds and minimal instream vegetation. Fish habitat is limited, though there are occasional pools and one pool contains undercut banks and gravel/rock which could provide fish habitat. The Blackberry infestation is likely reducing the habitat value of the watercourse limiting other aquatic fauna such as birds or turtles from inhabiting the waterway. The watercourse has connectivity to Cox's River which contains Key Fish Habitat and in periods of high flow, the watercourse could provide habitat for fish upstream from the Cox's River, though watercourse features would impede fish movements through the upper reaches of the forestry area and paddock such as the Blackberry infestation and the culvert. The creek modification would remove habitat values which could impact on fish populations in the area, though is unlikely to impact on any threatened fish. It should be noted that the forestry area is currently being harvested and will be fully harvested prior to the construction of the Wallerawang BESS commencing. This could lead to potential impacts on the condition of the creek, leading to further habitat degradation and removing shade.

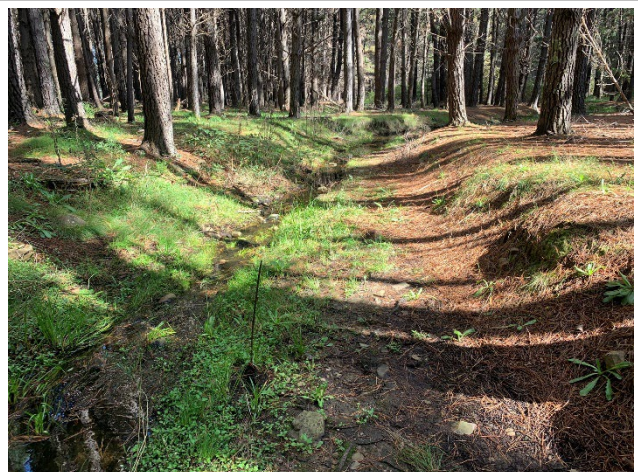
Forestry Area: Downstream

Hydrological Features: Ephemeral creek, moderate flow velocity at time of survey.

Key Fish Habitat: No mapped Key Fish Habitat. Class 3 Minimal Key Fish Habitat. No sensitivity class. The flow velocity increases substantially downstream suggesting the watercourse is a gaining stream. According to Section 3.2.1 of DPI's 'Policy and guidelines for fish habitat conservation and management – Update 2013' first and second order streams on gaining streams are not considered key fish habitat.

Instream vegetation: Sparse in-stream vegetation, exotic species dominant including *Cyperus eragrostis* and *Plantago major* (Large Plantain)
