# Murwillumbah Education Campus development

Statement of Heritage Impact (SSDA 16848913)

Prepared for Built. on behalf of the NSW Department of Education  
August 2022

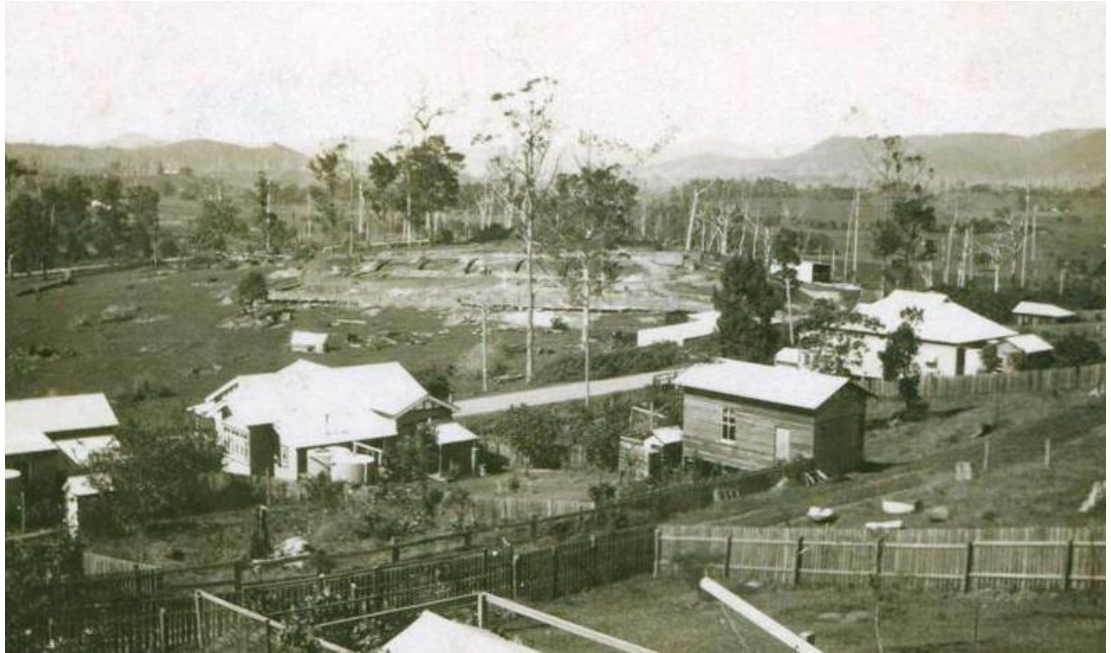
From Hartigan's Hill looking across to Riverview Street showing commencement of construction initial earthworks works on Hartigan's Estate for the future Murwillumbah High School. c. 1928. Source: M19-34, Tweed Regional Museum archives. Photographer Unknown.

The views of Block A while moving along Riverview Street and as viewed within the residential zones to the north-west have historical significance and have been documented in early photography of the site (Plate 5.2). Plate 4.5 and Plate 4.7 illustrate the open viewing of the school site from the north and north-west within the residential zone. Procession along Riverview Street is the primary and historic route to school site and affords significant views to Block A while moving south-west towards the primary drop-off and parking zone located to the west of the school site. The school boundary and open areas to the north and north west of Block A are currently lined with trees that impede the views along Riverview Street. No structures exist within the space to the north of Block A that would greatly obstruct views to and from the building.

Historic photographs of the high school site during the early stages of the construction of Block A (Plate 4.5) indicates two small structures being present at the school site, however they are likely to be associated with the construction process and appear to have been removed upon the completion of works in c.1929 (Plate 4.7).

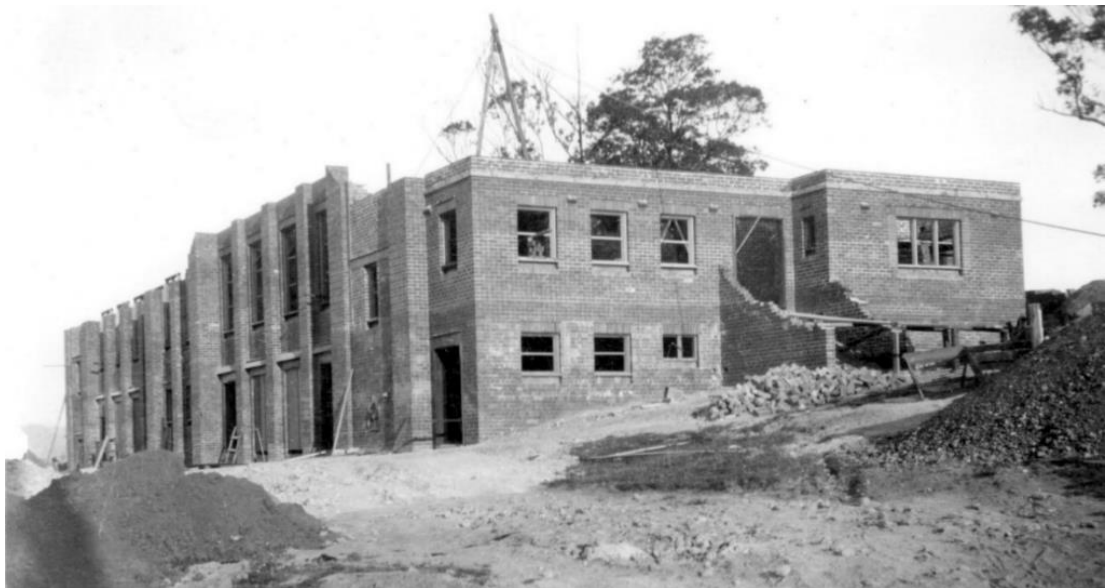
Plate 4.6

Construction of Murwillumbah High School with lower floors c. 1928. Source: M12-33, Tweed Regional Museum archives. Source: Tweed Regional Museum Archives (unknown photographer).

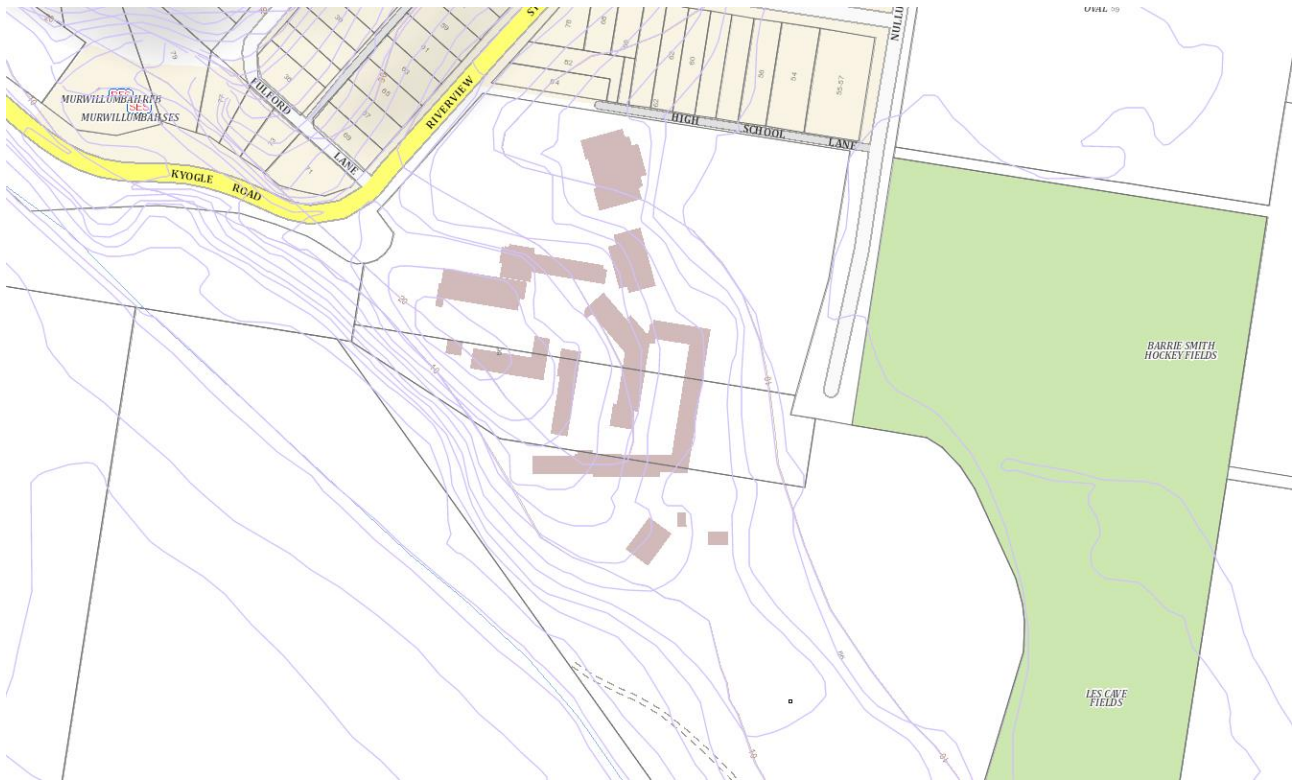
**Plate 5.1** Topographic map of Murwillumbah High School and neighbouring residential zone along natural ridgeline (purple topographic linework). Source: SIX Maps 2020.

Block A building is situated at the peak of a thin extension of the natural ridgeline indicating a topographic connection between the High School and the nearby residential zone (Plate 5.1). Based on historic photographs, the naturally high ridgeline was further heightened through earthworks and landscape manipulation during the construction works (Plate 4.5). As such, Block A sits at a higher elevation than most of the structures and buildings within the site.

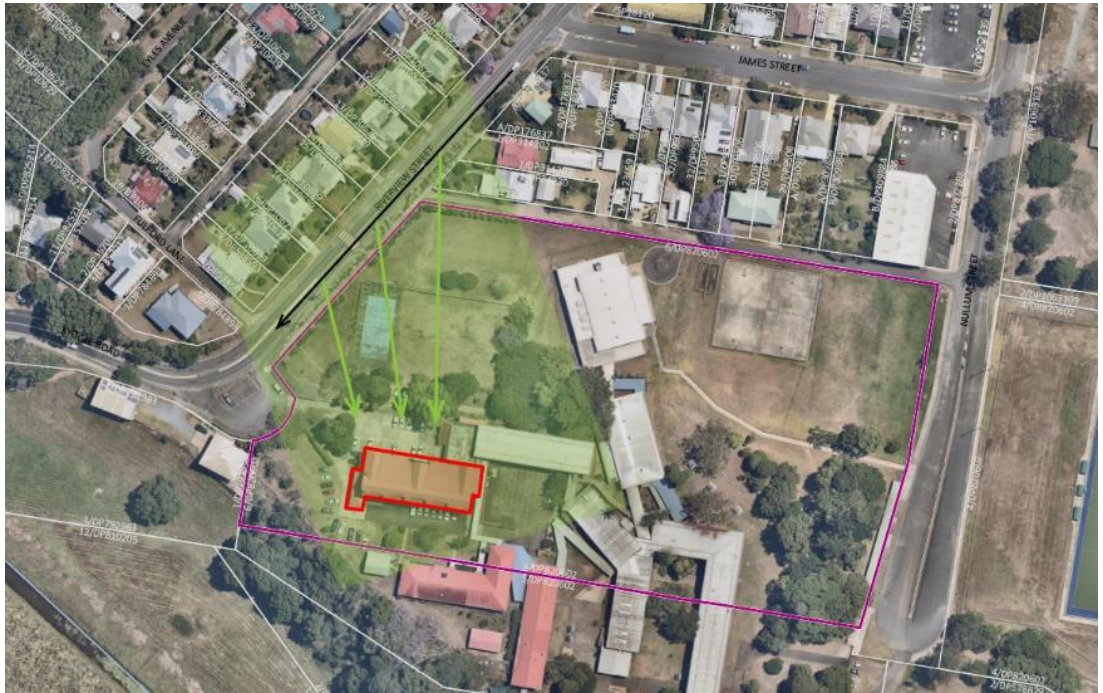
**Plate 5.2** Diagram highlighting prominent View 1. Source: EMM.

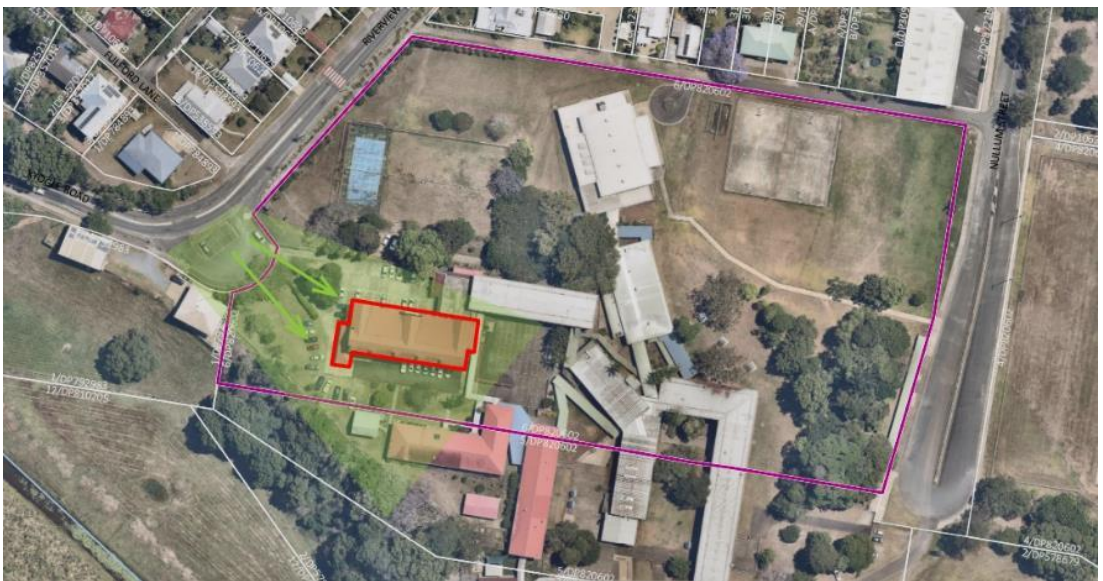
**Plate 5.3** Diagram highlighting prominent View 2. Source: EMM.

Views of Block A are also experienced at the transition point of Riverview Road and Kyogle Street, where students are dropped off (Plate 5.3). The viewing of Block A from this point has historically been important as this is the location where users have first interacted with and access the site. The existing fencing at the drop off zone and plantings including mature trees in the open area to the north-west of the site, at the main entry, currently impeded views.

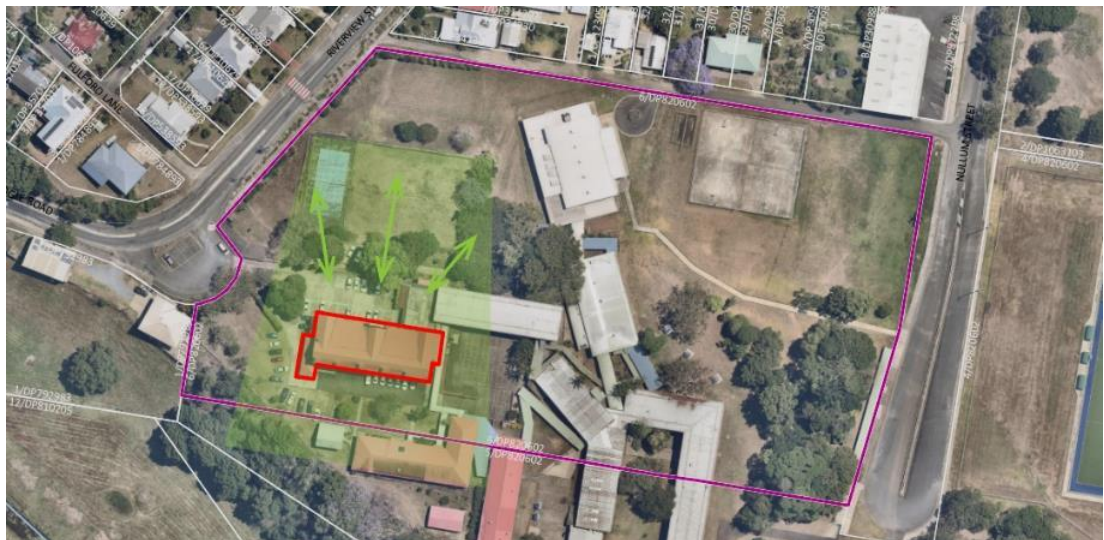
**Plate 5.4** Diagram highlighting prominent View 3. Source: EMM.

This viewing location is within the School grounds and provides full views to the north elevation of Block A and retaining wall. Maintaining a visual connection to and from Block A and the open area to the north where students have historically undertaken outdoor recreation was part of the original intent of the building and one of the main reasons the building was set in its high location. This view should also be maintained for safety and security reasons.

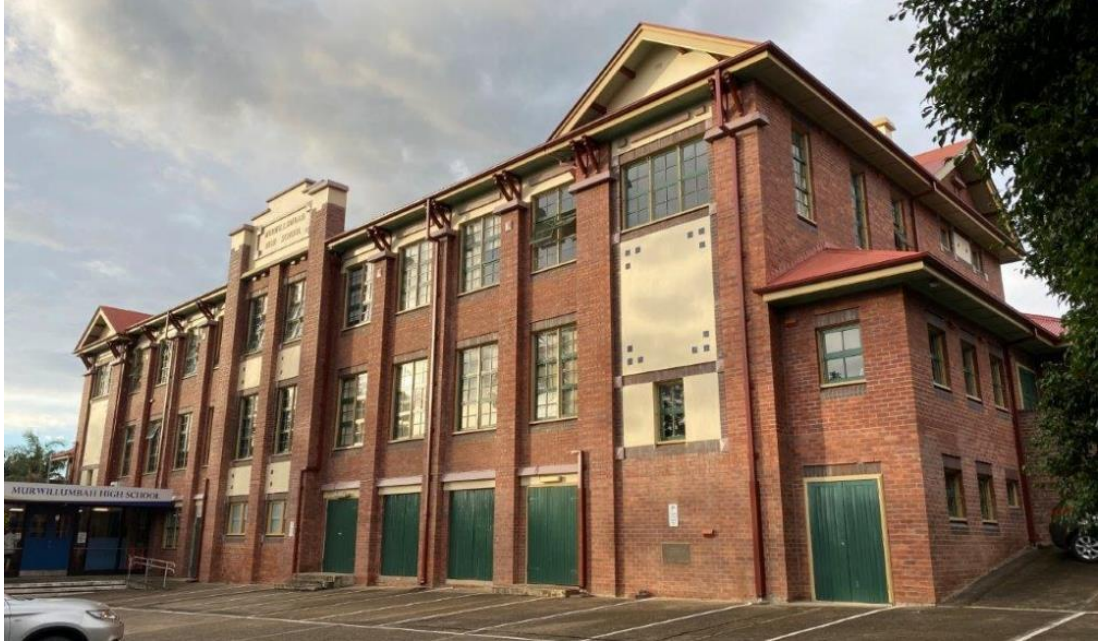
**Plate 5.5** View of the Block A facade (north elevation). Source: EMM 2021.

Murwillumbah High School Block A is a civic example of the inter-war Georgian revival style that gained popularity in Australia in the second decade of the twentieth century (Apperly, Irving and Reynolds, 1989) (Plate 5.5). This style is based on a new twentieth century idiom in conjunction with references to early nineteenth century Australian and American architecture. This style was viewed as synonymous with 'good taste' and national heritage in its time. The Block A building represents all the key characteristics of the style including a clarity of form and plan, a restrained and simplified classicism and reasonable proportions. The building is significant in that most examples of this style are residential or buildings of a domestic scale, where commercial or civic examples such as Block A are less common.

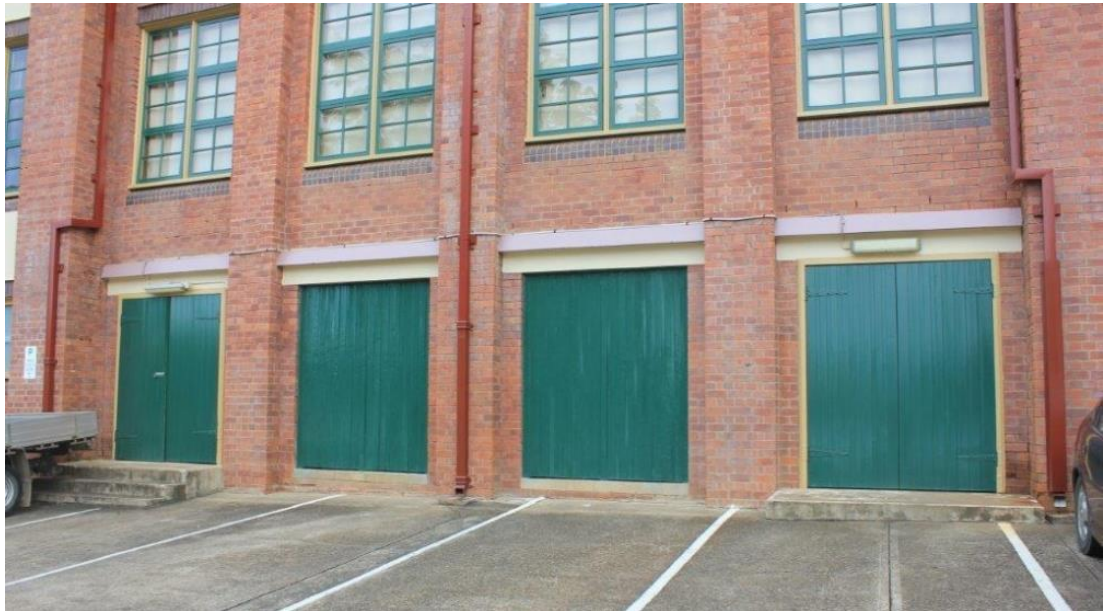
**Plate 5.6** View of the lower portion of Block A with entry ways to basement level. Source: EMM 2021.

The building spans three storeys consisting of a basement level, Ground Level and first floor. The basement level and floor plates to all levels are of a concrete construction with traditional bearing brickwork to internal and external walls. The north elevation (facade) and south elevation are both predominantly an un-rendered, red face brick with regular, repetitive fenestrations between vertical brickwork extrusions (Plate 5.5). Both elevations exhibit a number of large openings and doorways at ground level with timber panel doors that provide access to the internal basement level (Plate 5.6).

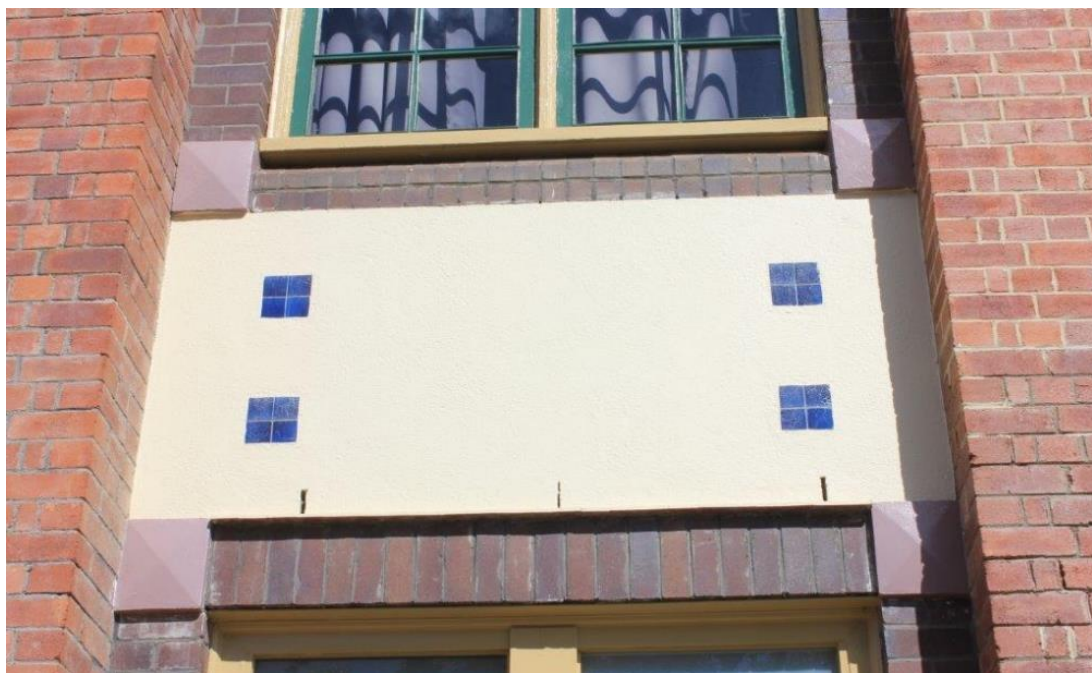
**Plate 5.7** View of facade detail to north elevation. Source: EMM 2021.

Decorative elements include full and partial, brown brickwork borders with square, pyramidion corner tiles to windows, particularly to windowsills and lintels, crème coloured, rectilinear plasterwork panels above and in-between fenestrations and small decorative square tiles inset into plasterwork in simple patterns (Plate 5.7).

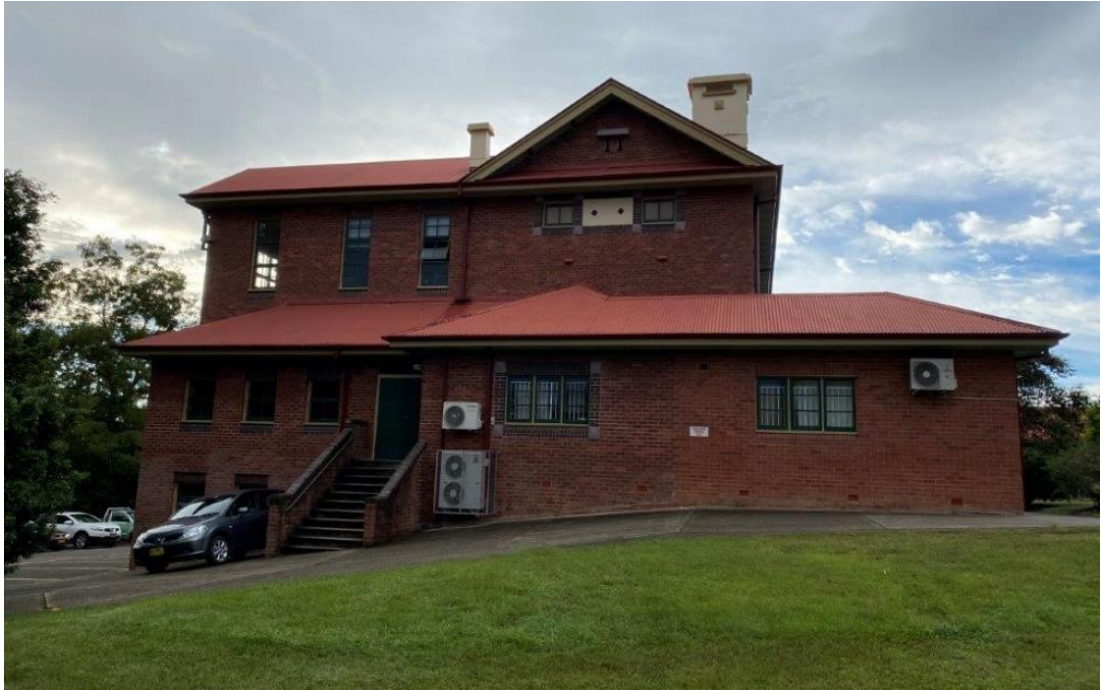
**Plate 5.9** View of the Block A western elevation and entry way indicating change in elevation from north to south. Source: EMM 2021.

The building is inset into the landscape and experiences a swift shift in elevation from the north to the south elevation (Plate 5.9). The basement level is accessed from the facade and internally; the first floor is accessed by staircases to the west, east and south elevations, and a rampway to the south elevation to the staff rooms (formerly the headmasters' rooms till c.1969).

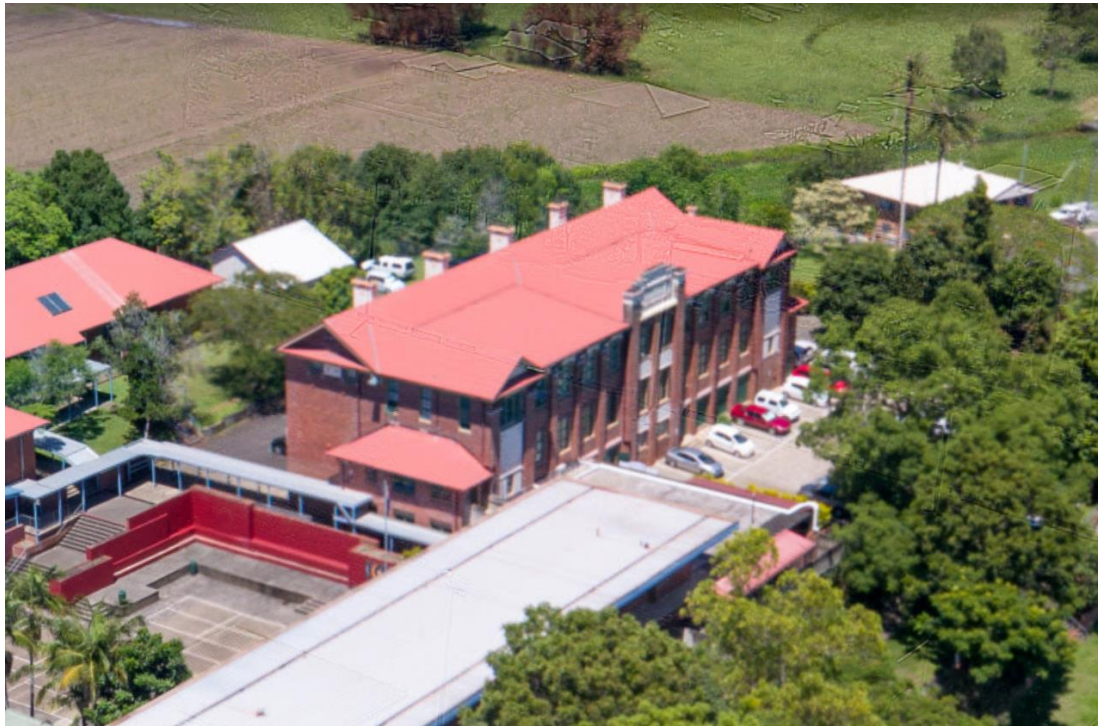
**Plate 5.10** Aerial view of the Block A and adjacent Block E indicating current roof form and materiality. Source: Google Maps © Andre Reis, 2018.

Simple, pitched roofs with corrugated sheeting to the east and west elevations cover the lower, side elements of the structure. Gutters are fixed to simple fascias and soffits are painted with timber truss elements to the north elevation. Downpipes and other services elements including air conditioning units and electrical wiring are fixed to external elevations.

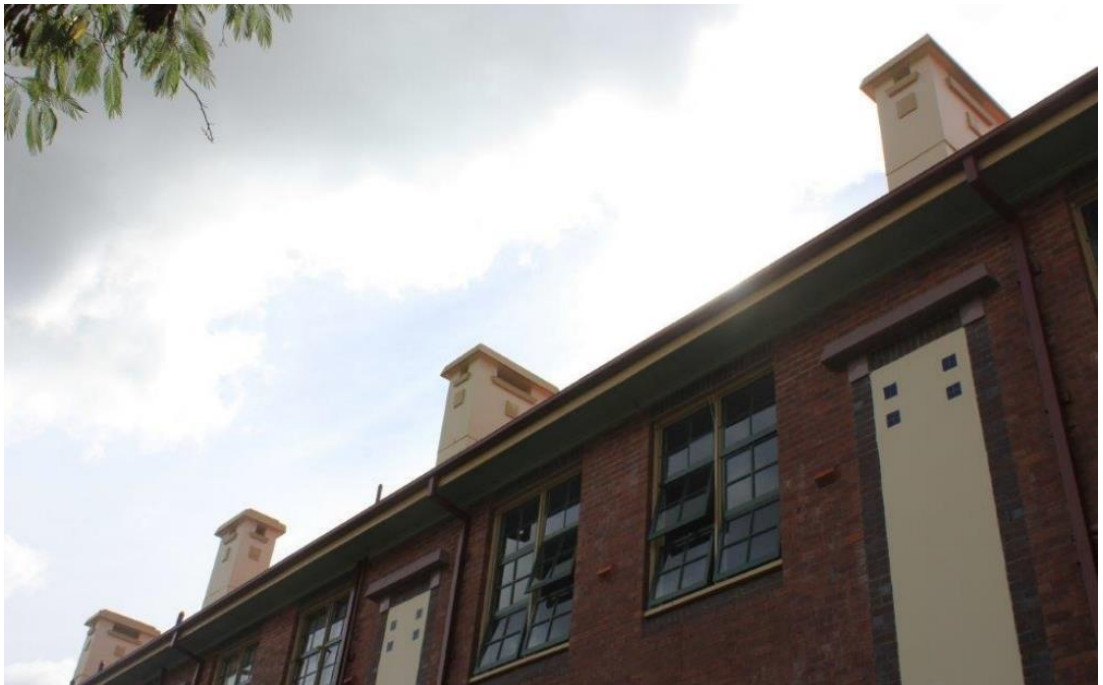
**Plate 5.11** View of Block A south elevation and chimney shafts. Source: EMM 2021.

The roof structure is a simple, pitched form with corrugated sheeting. The form consists of two box gables at both ends of the north elevation that run east-west, transacted by a box gable that extends across the entire rear elevation, east-west (Plate 5.11). Gable rakes extend past the north elevation and are lined with simple eaves that frame inset rendered and face brick walls.

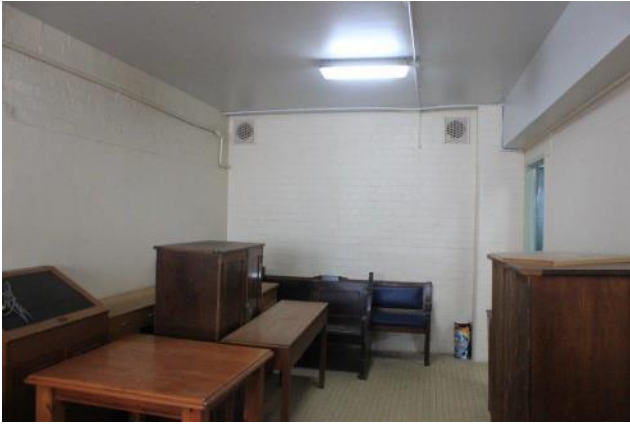
**Plate 5.14** Ground Level - Eastern storage room. Source: EMM 2021.

The Ground Level of Block A consists of a generally symmetrical floor plan separated by a load bearing, partition wall. To the far east and west are two access points to circulation spaces that include staircases to the upper levels, storage rooms (Plate 5.14) and hallways to the central spaces. The use of these spaces has remained consistent since the construction of the building. Directly adjacent to the central partition wall is two storage spaces enclosed by three quarter height brick walls with plasterboard fill to the upper segments (Plate 5.15). These spaces are shown as open in the original floor plans and formerly functioned as the showers and change rooms.

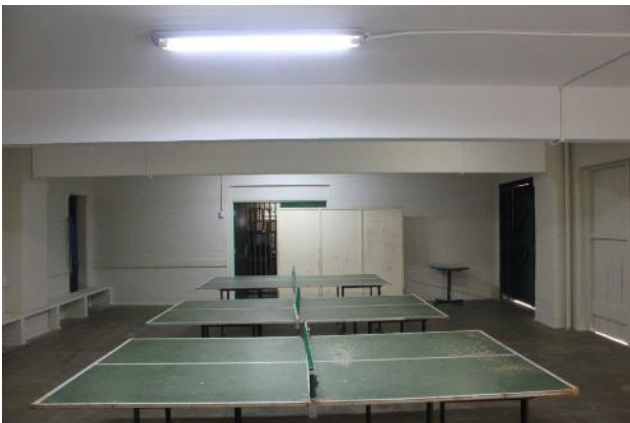
**Plate 5.16** Ground Level – western Performance Hall space. Source: EMM 2021.

The Ground Level includes two large open spaces that formerly functioned as the recreation rooms; the first is a performance hall space to the western segment of the Ground Level accessed primarily from the large doors to the north elevation (Plate 5.16). This space is simple in materiality and includes concrete floors, painted brickwork partition walls and timber seating. To the east of the building is a large vacant room that shares the same finish and characteristics as the performance hall space including timber seating and painted brickwork walls (Plate 5.17). During the construction of Block E in the 1960s, the space to the north of this vacant room appears to have been partitioned and annexing into the new building and can be accessed from within the Block E entry space. These spaces currently function as the sick rooms.

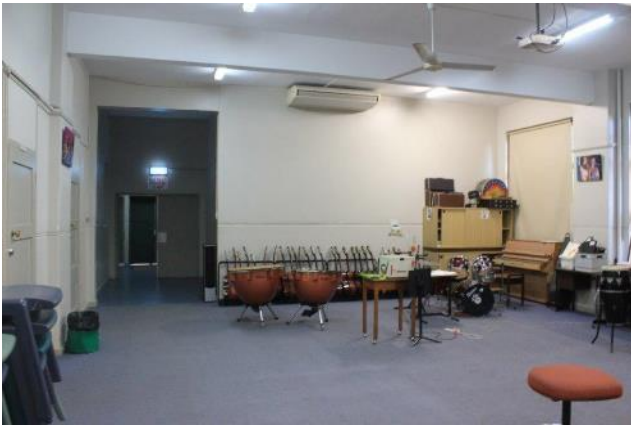
**Plate 5.20**      **Level 1 – Performance room. Source: EMM 2021.**

The two main spaces on the level within the northern segment are the performance room (Plate 5.20) and performance hall (Plate 5.21) that were originally one space that functioned as the assembly hall. These spaces are separated by a recent partition wall and include added elements such as a more recent stage, secondary walls, services, lighting and acoustic panelling to the ceiling to modify the space for its current function. The performance hall has been painted black including original walls and wall elements.

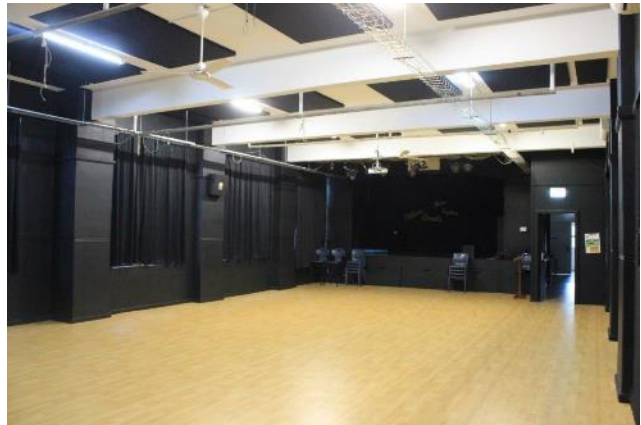
**Plate 5.21**      **Level 1 – Performance hall. Source: EMM 2021.**

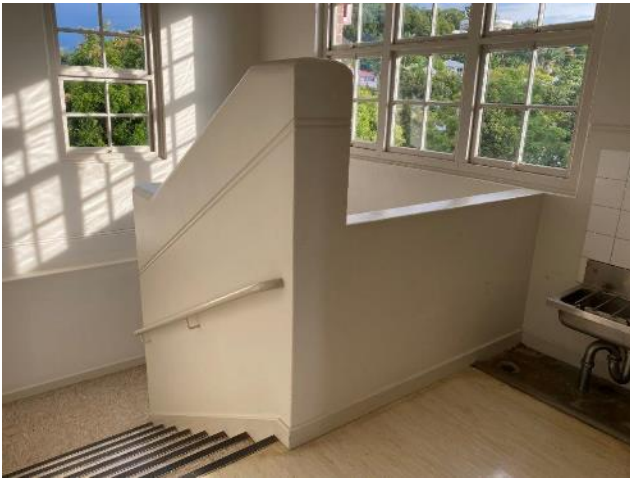
**Plate 5.26** Level 2 – western circulation stairwell. Source: EMM 2021.

Level 2 is accessed only through the eastern and western circulation spaces to small hallways that lead to a larger hallway that extends east-west through the level, connecting both circulation spaces (Plate 5.26).

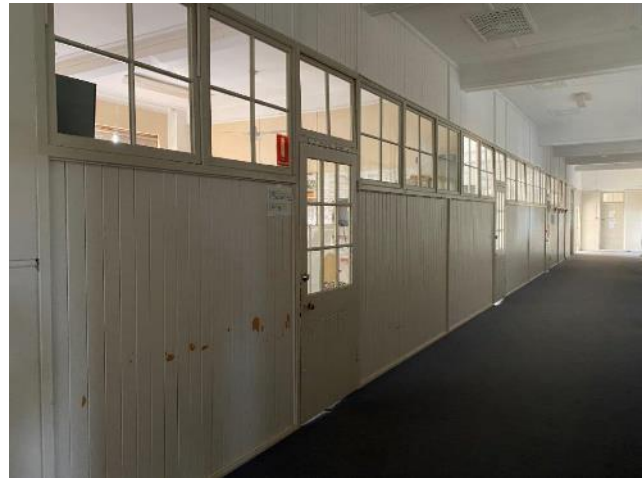
**Plate 5.27** Level 2 – main hallway and later partition wall. Source: EMM 2021.

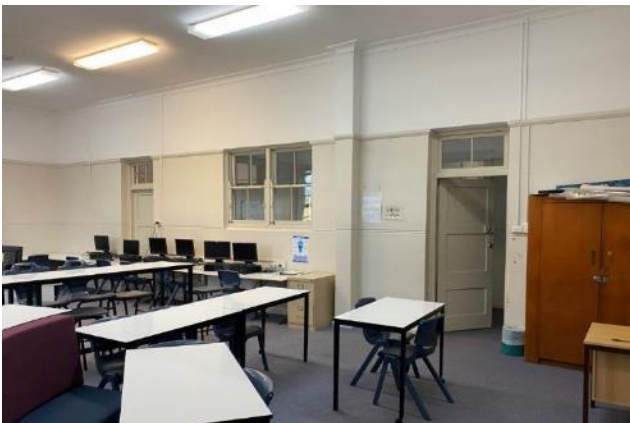
**Plate 5.28** Level 2 – typical classroom space and walls with original windows and doors. Source: EMM 2021.

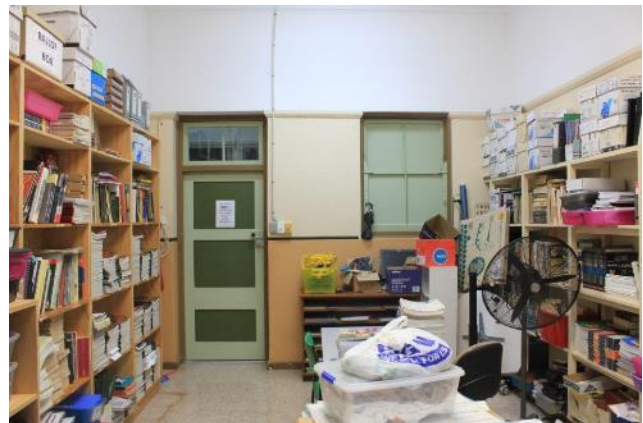
**Plate 5.29** Level 2 – southern segment storage space with varied paintwork. Source: EMM 2021.

As per Level 1, the classroom spaces to the southern segment include original features such as brick and stone wall finishes, blackboards, cupboards, picture rails, skirting and vents. The interior paintwork varies for different rooms; the northern segment and teachers' rooms to the far west and east exhibiting diverse coloured paintwork (see 5.29), and the classrooms to the south, main hallway and circulation spaces exhibit a crème coloured paintwork that is typical of much of the internal spaces to all levels.

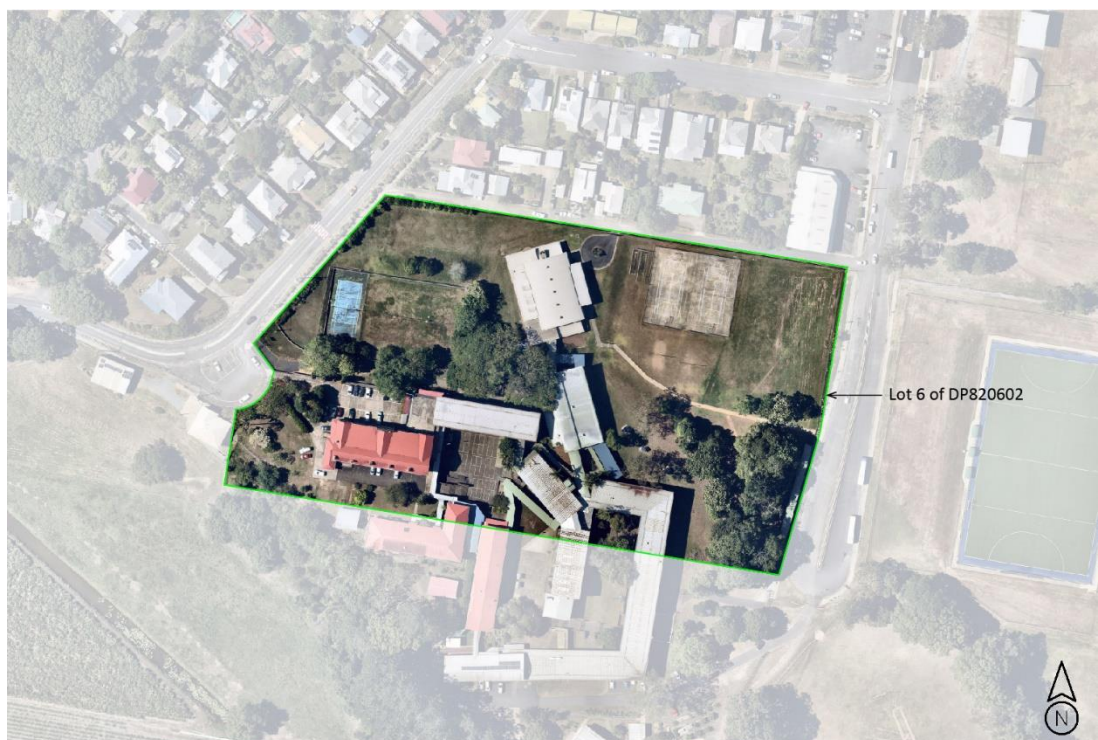
**Plate 5.30**      **Diagram of Lot 6 of DP820602. Source: EMM.**

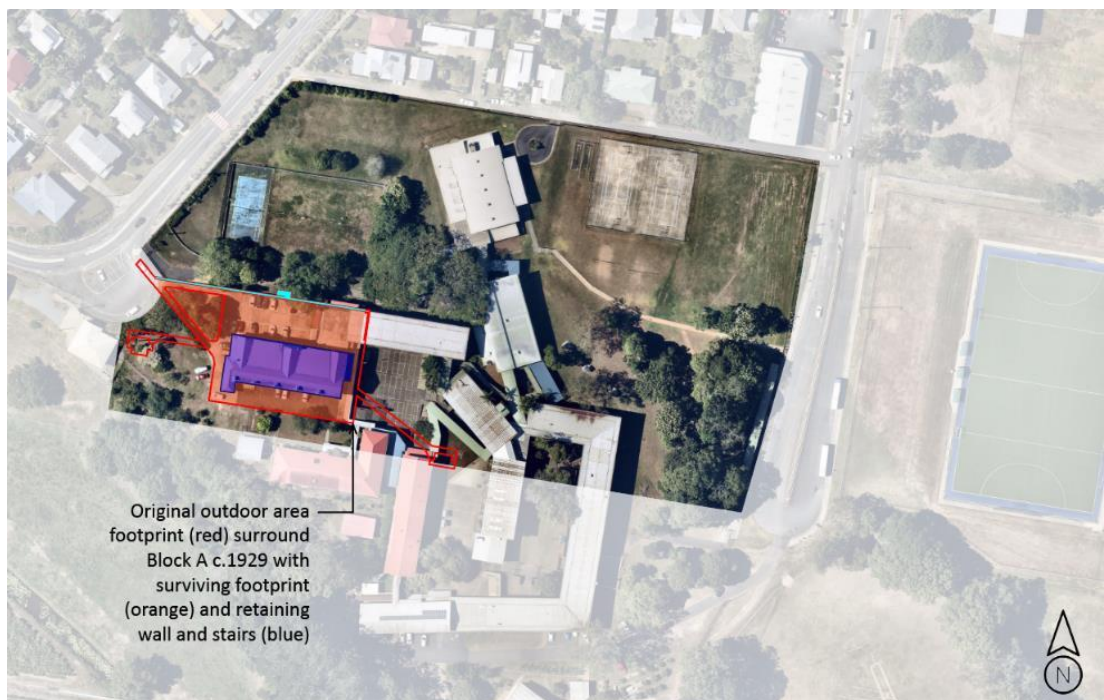
**Plate 5.31**      **Diagram of the former (red) and surviving (orange) footprint of the original High School open courtyard and retaining wall (blue). Source: EMM.**

An open, paved courtyard space and walkways were constructed in the area surrounding the Block A building upon its construction in c.1929. This open space frames Block A and was part of the original design and intent of the High School and included in the c.1925 architectural drawings (Plate 4.10). To the north and east, a retaining wall was also introduced at the edge of the open courtyard space. As noted in the Section 7 condition analysis:

- much of the original footprint of the open courtyard space is extant, including the triangular garden bed, with some significant modifications to its finish, particularly the removal of original concrete tiles and replacement with asphalt. Other modifications include:
  - a segment of the courtyard to the east has been removed due to the introduction of the courts to the east in the mid-twentieth century;

- all original pathways to the east and west leading to the former boys and girls closet blocks, original to the High School, are no longer present.
- the northern segment of the retaining wall and associated stairs are also still present however the eastern segment is may have been fully destroyed due to the construction of Block E.

The original footprint and retaining wall are significant as they are both elements original to the c.1929 High School and are spatially and architecturally associated with the Block A building (Plate 4.7). The open courtyard surrounding Block A also provides movement and visual space around the building. Currently, the western segment of the Block E building abuts the Block A facade (north elevation) and extends within the northern segment of the original courtyard and is considered to be intrusive to both.

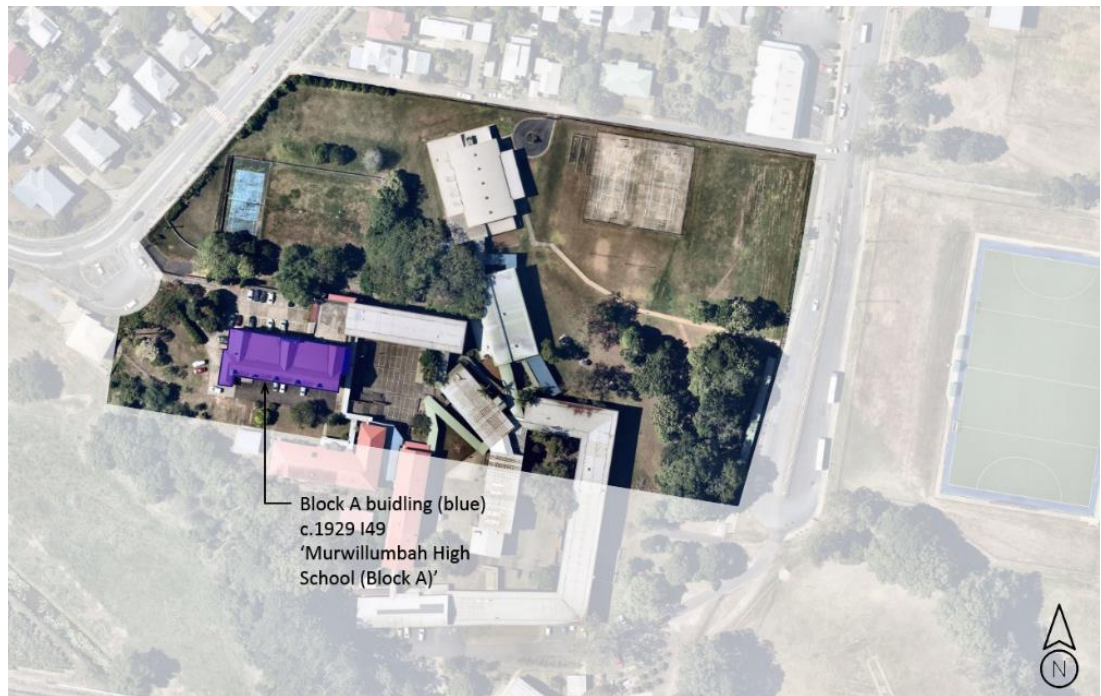
**Plate 5.32** Diagram of the Block A Building in relation to site. Source: EMM.

Refer to Plate 5.32 below for location of the Block A building in relation to the remainder of the school site and Plate 5.33 for a visual representation of the three elements that contribute to the heritage curtilage of the Block A building.

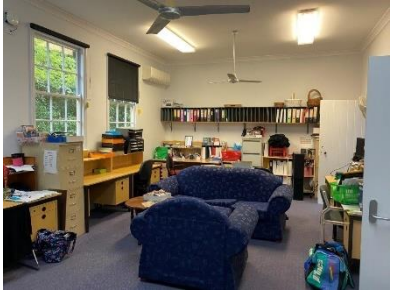
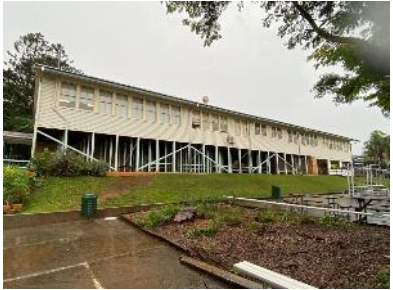
| No | Building | Date | Discussion | Significance attribution in relation to I49<br><i>'Murwillumbah High School (Block A)' (TLEP)</i> | Image |
|---|---|---|---|---|---|
| 3 | Block S | 1957 | <p>Built as a single building containing four classrooms, a canteen, armoury and a science room. Currently functions as a general learning building.</p> <p>The building is a general architectural example of mid-century development at the site and is not identified in the established heritage listings as being of particular significance in relation to the Block A building.</p> | Non-contributory. | <br> |

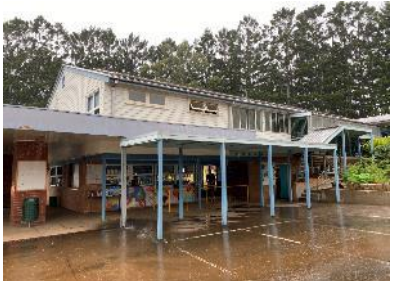
| No | Building | Date | Discussion | Significance attribution in relation to I49<br><i>'Murwillumbah High School (Block A)' (TLEP)</i> | Image |
|---|---|---|---|---|---|
| 4 | Block C | 1957 | <p>Originally the Manual Training building. Currently functions as the Canteen and support unit.</p> <p>The building is a general architectural example of mid-century development at the site and is not identified in the established heritage listings as being of particular significance in relation to the Block A building.</p> | Non-contributory. | |

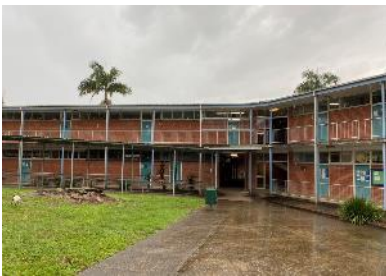
| No | Building | Date | Discussion | Significance attribution in relation to I49 'Murwillumbah High School (Block A)' (TLEP) | Image |
|---|---|---|---|---|---|
| 5 | Block B | 1963-1964 | <p>Constructed as two wings that included a science and classroom block to the northern wing and an arts and music block to the southern wing. Currently functions as a general learning building.</p> <p>The building is a general architectural example of late mid-century development at the site and is not identified in the established heritage listings as being of particular significance in relation to the Block A building.</p> | Non-contributory. | |

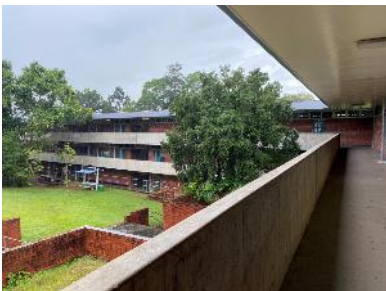
| No | Building | Date | Discussion | Significance attribution in relation to I49 'Murwillumbah High School (Block A)' (TLEP) | Image |
|---|---|---|---|---|---|
| 7 | Block D | 1969-1970 | <p>Constructed as a general learning building that includes classrooms and workshops. Maintains this function.</p> <p>The building is a general architectural example of late mid-century development at the site and is not identified in the established heritage listings as being of particular significance in relation to the Block A building.</p> | Non-contributory | |

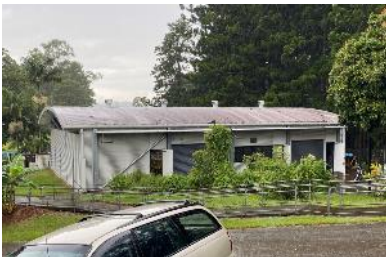
| No | Building | Date | Discussion | Significance attribution in relation to I49 'Murwillumbah High School (Block A)' (TLEP) | Image |
|---|---|---|---|---|---|
| 8 | Block F | Post-1970 | <p>Agricultural building of recent construction. The building is not identified in the established heritage listings as being of particular significance in relation to the Block A building.</p> | Non-contributory. | |

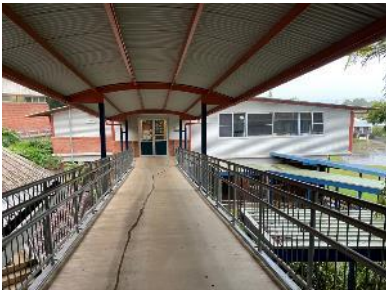
| No | Building | Date | Discussion | Significance attribution in relation to I49 'Murwillumbah High School (Block A)' (TLEP) | Image |
|---|---|---|---|---|---|
| 9 | Block G | 1992 | <p>Constructed as the sole library building and maintains this function.</p> <p>Recent construction. The building is not identified in the established heritage listings as being of particular significance in relation to the Block A building.</p> | Non-contributory. | |

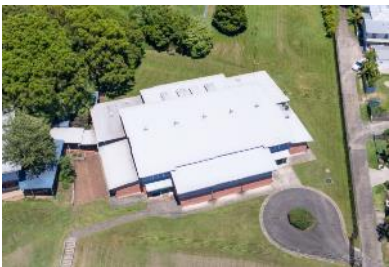
| No | Building | Date | Discussion | Significance attribution<br>in relation to I49<br><i>'Murwillumbah High School (Block A)' (TLEP)</i> | Image |
|---|---|---|---|---|---|
| 10 | Block M | 2000s | Constructed as multi-purpose building. Currently functions as a gymnasium.<br><br>Recent construction. The building is not identified in the established heritage listings as being of particular significance in relation to the Block A building. | Non-contributory. | |

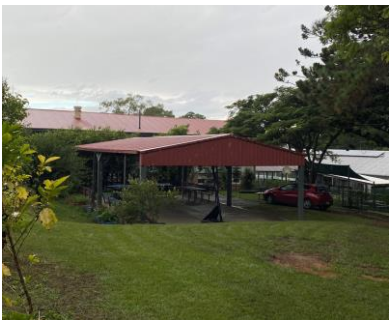
| No | Building | Date | Discussion | Significance attribution<br>in relation to I49<br><i>'Murwillumbah High School (Block A)' (TLEP)</i> | Image |
|---|---|---|---|---|---|
| 11 | SS2 | Recent | Open covered area of a recent construction. The structure is not identified in the established heritage listings as being of particular significance in relation to the Block A building. | Non-contributory | |

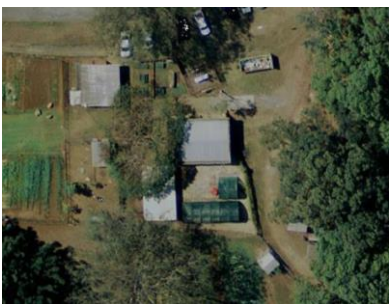
| No | Building | Date | Discussion | Significance attribution<br>in relation to I49<br><i>'Murwillumbah High School (Block A)' (TLEP)</i> | Image |
|---|---|---|---|---|---|
| 12 | AW, AY and AZ | Recent | Simple storage sheds of a recent date of construction. The structures are not identified in the established heritage listings as being of particular significance in relation to the Block A building. | Non-contributory | |

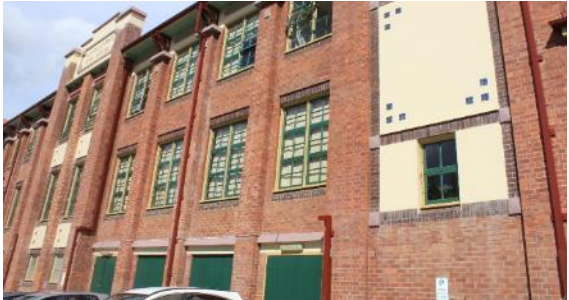
| No. | Element | Significance | Image |
|---|---|---|---|
| 1 | original face brick, external walls including pilasters and spandrels. | High | |

| No. | Element | Policy |
|---|---|---|
| Policy 15 | Brickwork | Original brickwork should be retained intact and maintained. Where brick repairs are required, the original bricks should be reused wherever possible, or recycled bricks of the same size and shape as the originals. |

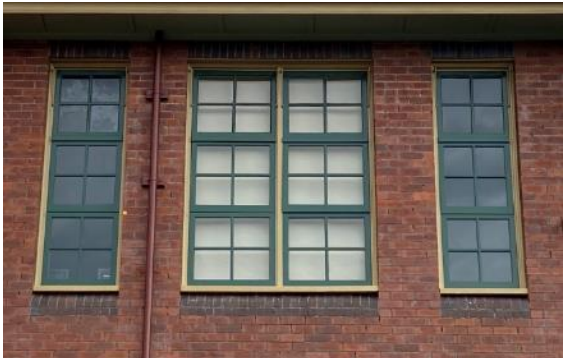
| No. | Element | Significance | Image |
|---|---|---|---|
| 2 | original double hung, timber windows - many exhibit original hardware and glazing. | High | |

| No. | Element | Policy |
|---|---|---|
| Policy 22 | Windows and doors | Original windows and doors are to be retained and repaired, if necessary, including the retention of original hardware and glazed elements. |

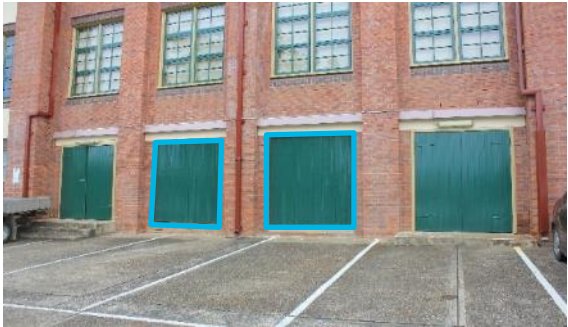
| No. | Element | Significance | Image |
|---|---|---|---|
| 3 | Remaining two original batten panels to north elevation (highlighted in blue). | High | |

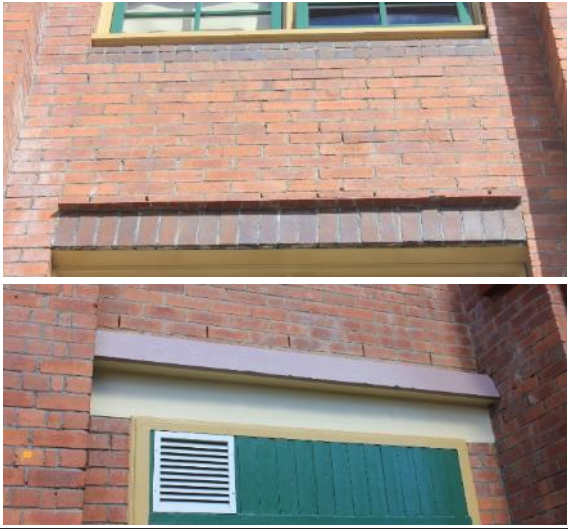
| No. | Element | Significance | Image |
|---|---|---|---|
| 4 | Window and door brickwork and cement lintels, sills and ceramic tile trim above window and door lintels. | High | |

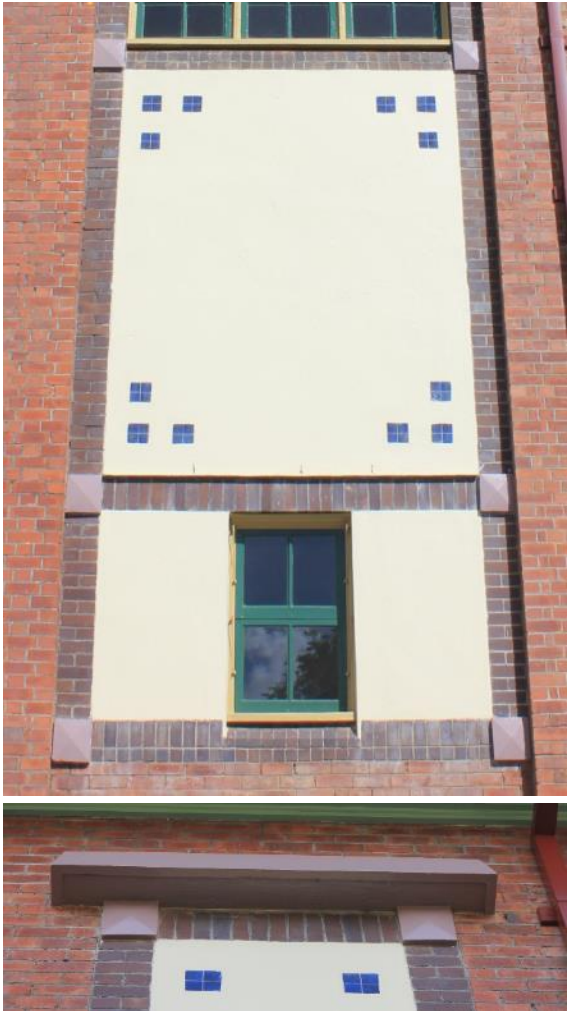
| No. | Element | Significance | Image |
|---|---|---|---|
| 5 | decorative rendered and cement wall elements between narrow bays formed by pilasters and spandrels including darker brickwork framing windows and blue tiles. | High | |

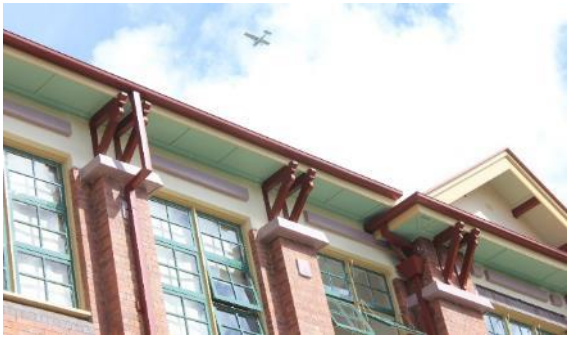
| No. | Element | Significance | Image |
|---|---|---|---|
| 6 | the roof structure and roof features including parapet, eaves, soffits, brackets, gable, gable rakes and decorative moulding. | High | |

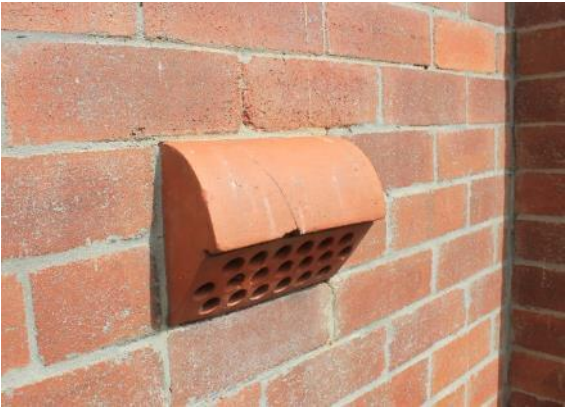
| No. | Element | Significance | Image |
|---|---|---|---|
| 7 | terracotta wall vents to all elevations. | High | |

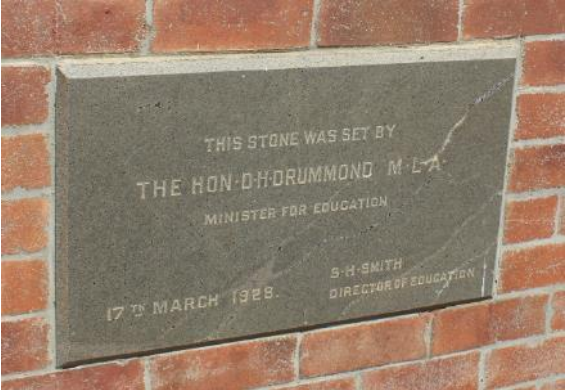
| No. | Element | Significance | Image |
|---|---|---|---|
| 8 | the original foundation stone to north elevation. | High | |

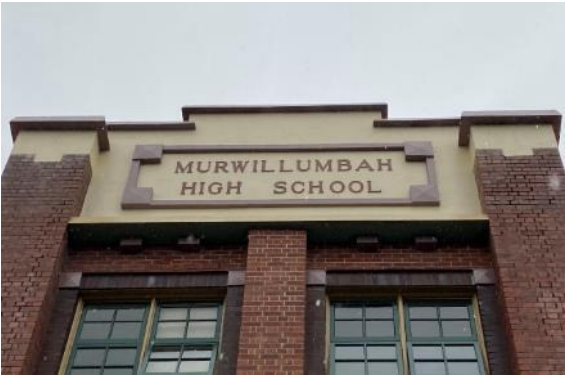
| No. | Element | Significance | Image |
|---|---|---|---|
| 9 | original framed 'Murwillumbah High School' wording applied to the parapet to the north elevation. | High | |

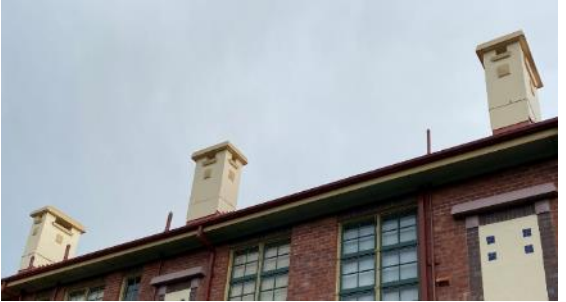
| No. | Element | Significance | Image |
|---|---|---|---|
| 10 | chimney stacks and decorative moulding. | High | |
