# Murwillumbah Education Campus development

Statement of Heritage Impact (SSDA 16848913)

Prepared for Built. on behalf of the NSW Department of Education  
August 2022

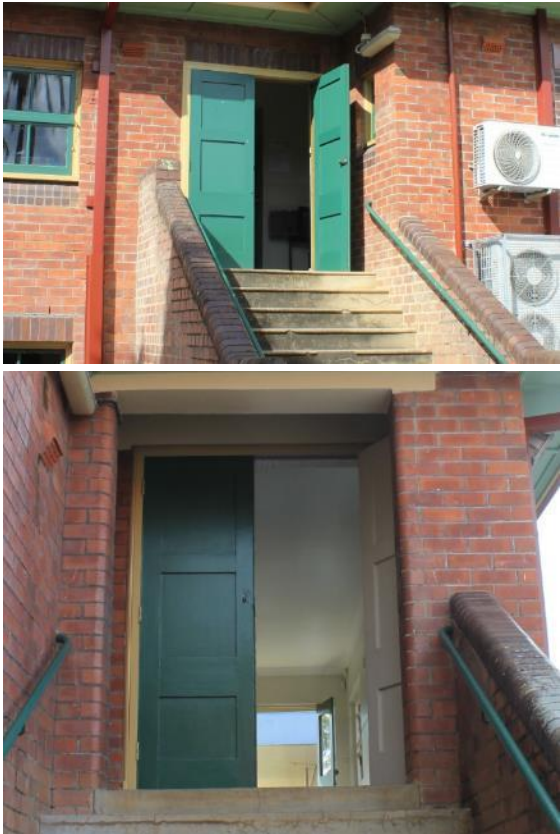
| No. | Element | Significance | Image |
|---|---|---|---|
| 11 | Doors providing access to Level 1 above east and west external staircases. | High | |

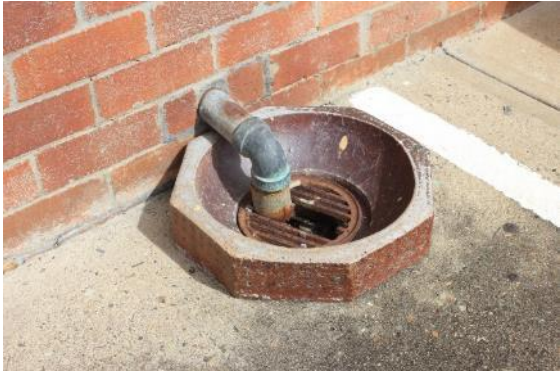
| No. | Element | Significance | Image |
|---|---|---|---|
| 12 | ceramic/terracotta drains to ground level. | Moderate | |

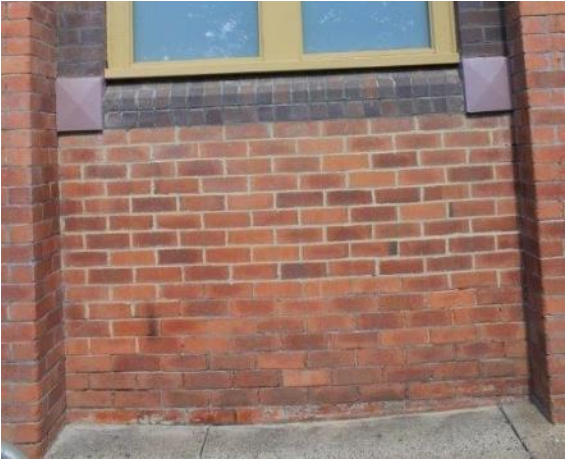
| No. | Alterations/modifications | Significance | Image |
|---|---|---|---|
| 1 | minor replacement of brickwork and general repointing to all elevations. | Little | |

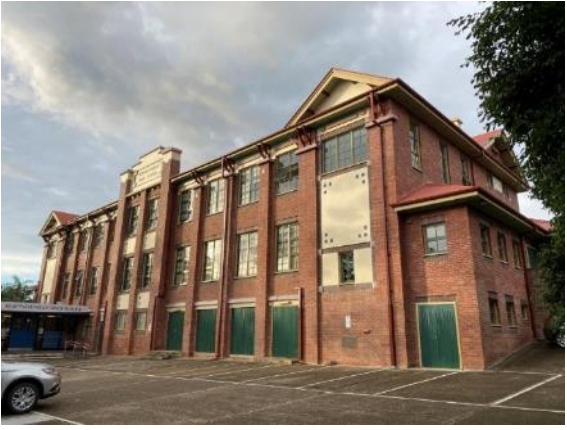
| No. | Alterations/modifications | Significance | Image |
|---|---|---|---|
| 2 | general repainting of all external, painted surfaces incl. decorative elements, windows, doors, chimneys and roof elements has occurred in multiple phases. The building appears to have been recently re-painted. | Recent paintwork – Little<br>Original paintowrk – High | |

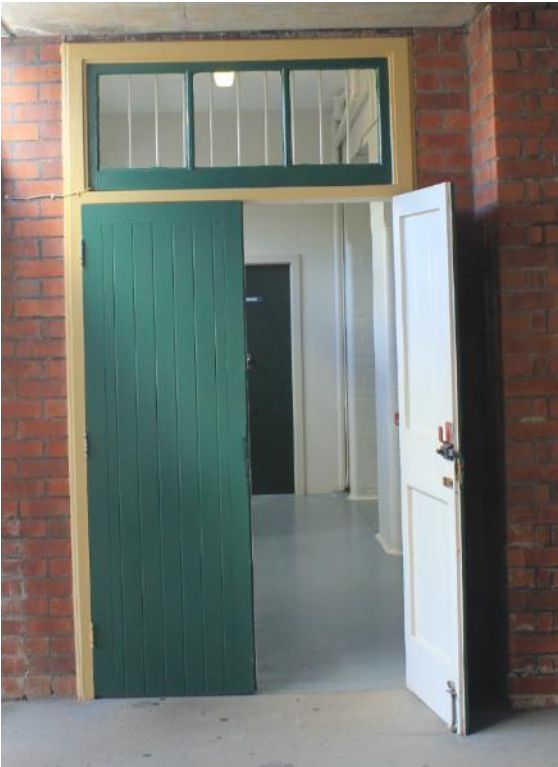
| No. | Alterations/modifications | Significance | Image |
|---|---|---|---|
| 3 | replacement of all original, large timber batten gates and doors to the north elevation with later, sympathetic timber doors including new hardware, panels, architraves and lighting elements. | Moderate | |

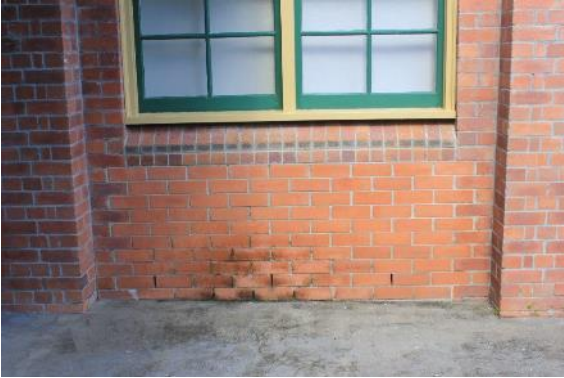
| No. | Alterations/modifications | Significance | Image |
|---|---|---|---|
| 4 | replacement of the original timber batten gate to the north elevation with later window, lintel, sill and brick infill (near to Block E); | Little | |

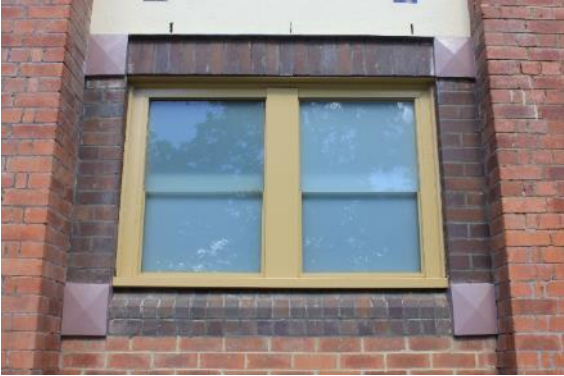
| No. | Alterations/modifications | Significance | Image |
|---|---|---|---|
| 5 | Replacement of glazed window panes and segments of framing of select windows to the north elevation that includes modification of the window frame. | Little | |

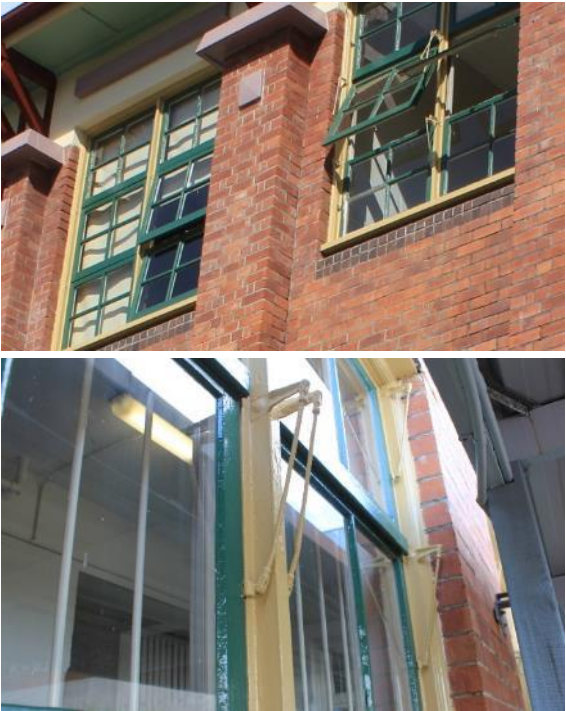
| No. | Alterations/modifications | Significance | Image |
|---|---|---|---|
| 6 | removal of original, external window hardware to majority of large windows to north and south elevations and select windows to west and east elevations. | Remaining original window hardware – High<br><br>Recent window hardware - Little | |

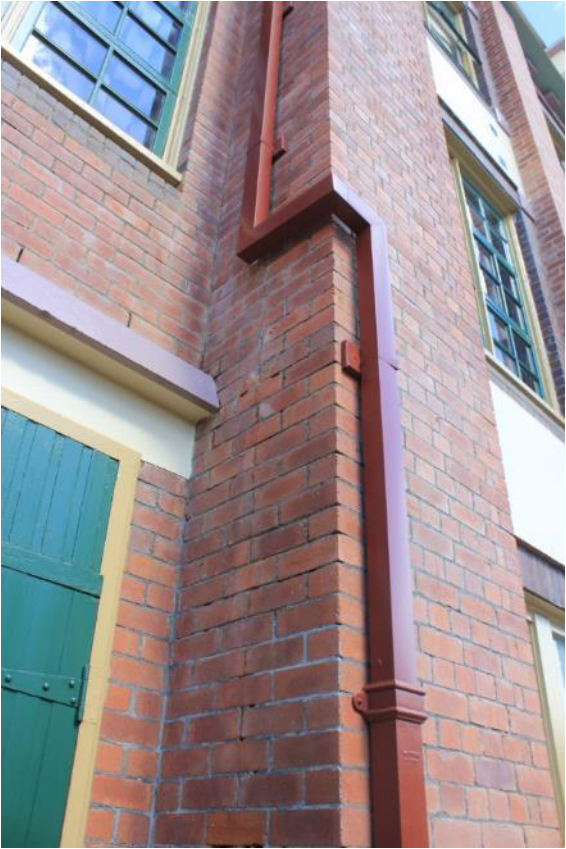
| No. | Alterations/modifications | Significance | Image |
|---|---|---|---|
| 7 | replacement of all guttering and full or partial replacement of downpipes and associated drains. | Recent downpipes and gutters – Little<br><br>'Metters' downpipe segments to north and south elevation – High | |

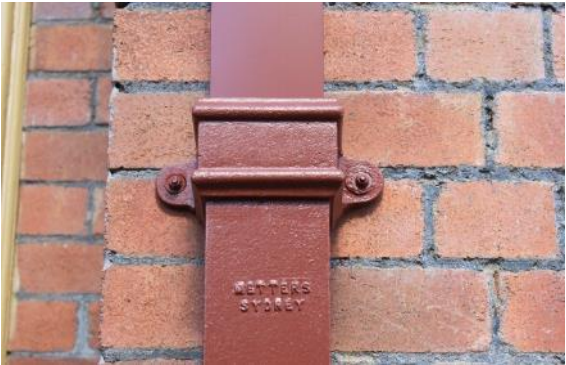
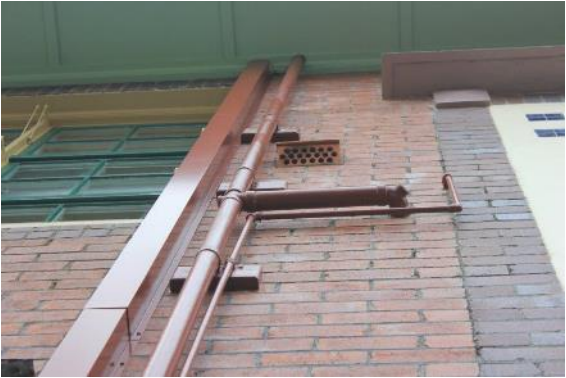
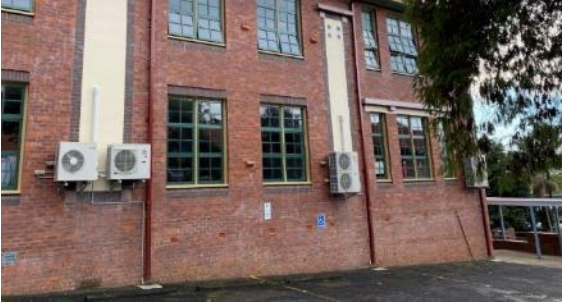
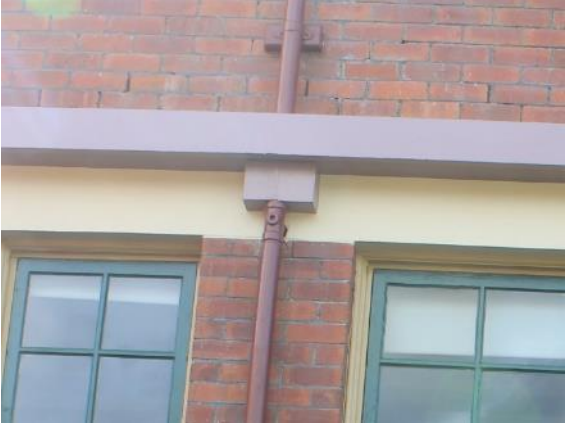
| No. | Alterations/modifications | Significance | Image |
|---|---|---|---|
| 8 | later, services applied to external walls including piping, air conditioning units and signage. | Recent services – Intrusive<br><br>Early services – Moderate | |

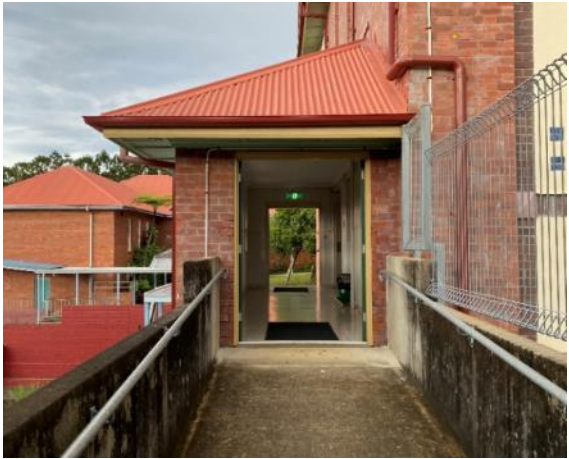
| No. | Alterations/modifications | Significance | Image |
|---|---|---|---|
| 9 | replacement of original window to Level 1 north elevation with later door and concrete bridge to Block E. | Little | |

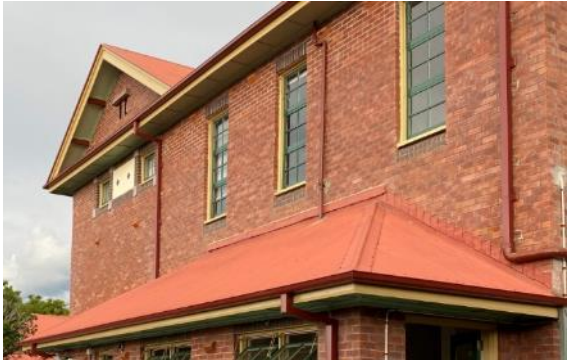
| No. | Alterations/modifications | Significance | Image |
|---|---|---|---|
| 10 | original roof tiles have been replaced recently with corrugated sheeting and flashing. | Little | |

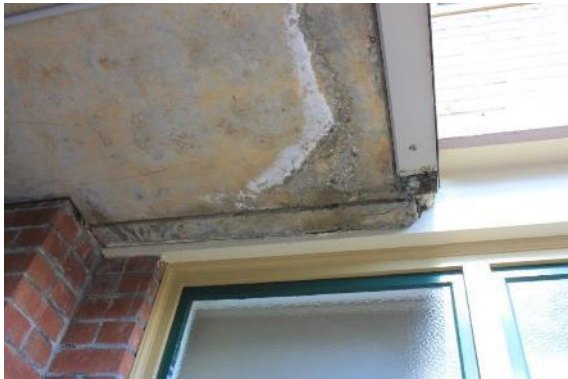
| No. | Alterations/modifications | Image |
|---|---|---|
| 1 | concrete roof plate intersection with north elevation brickwork and window and door lintels. | |

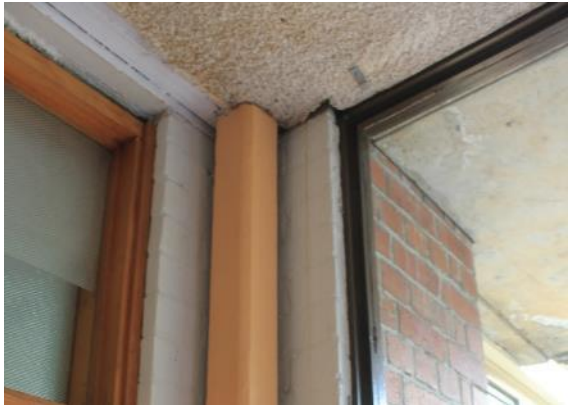
| No. | Alterations/modifications | Image |
|---|---|---|
| 2 | internal ceiling and curtain wall intersection with north elevation brickwork and external features. | |

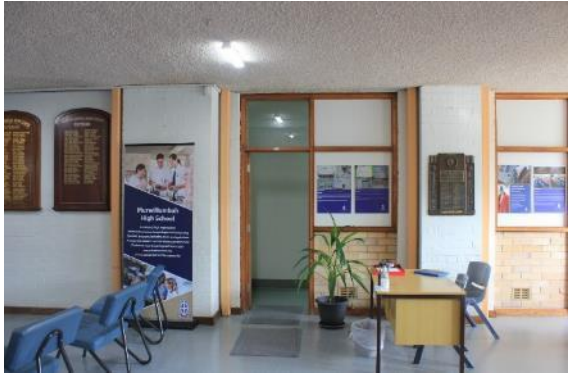
| No. | Alterations/modifications | Image |
|---|---|---|
| 3 | <p>modifications to the western segment of the north elevation in the enclosed reception space including:</p> <ul style="list-style-type: none"> <li>• internal annexation and partition of now vacant space with brickwork walls to create;</li> <li>• removal of original large timber batten doors and batten panels and introduction of timber and brick door and infill segments;</li> <li>• painting of face brick;</li> <li>• introduction of skirting to brickwork;</li> <li>• introduction of series of steel support beams slightly offset from brickwork (appears to be separate from Block A).</li> </ul> | |

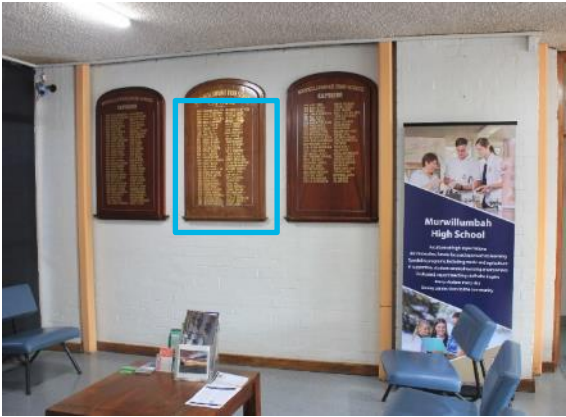
| No. | Alterations/modifications | Image |
|---|---|---|
| 4 | removal of original smaller window and infill of window cavity with brickwork (approximate location in blue). | |

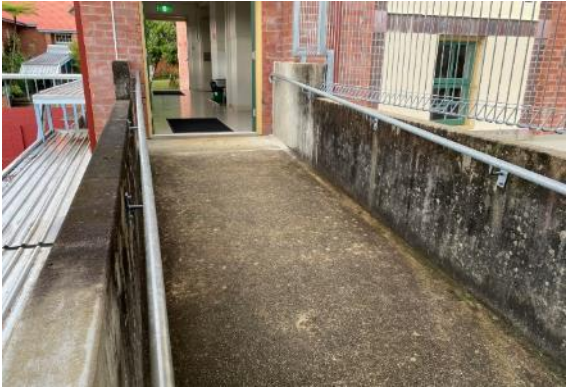
| No. | Alterations/modifications | Image |
|---|---|---|
| 5 | introduction of concrete walkway to Level 1, abutting brickwork to north elevation. | |

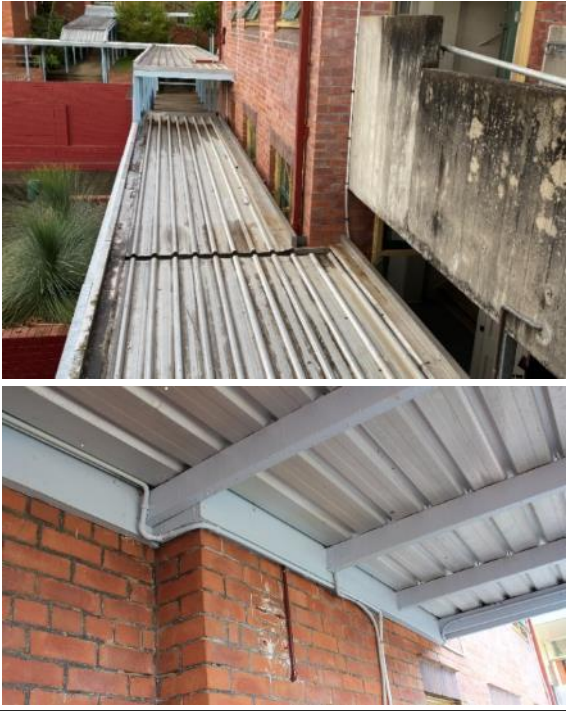
| No. | Alterations/modifications | Image |
|---|---|---|
| 6 | roof elements of walkway canopy fixed to the north and east elevations and obscuring windows to east elevation. | |

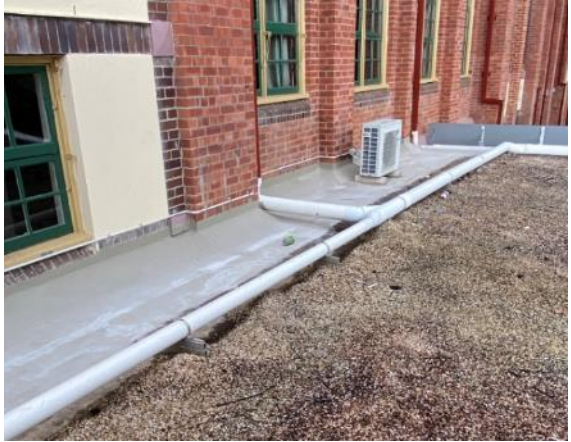
| No. | Alterations/modifications | Image |
|---|---|---|
| 7 | segment of Block E roof structure, waterproofing and services applied to north elevation brickwork and decorative elements. | |

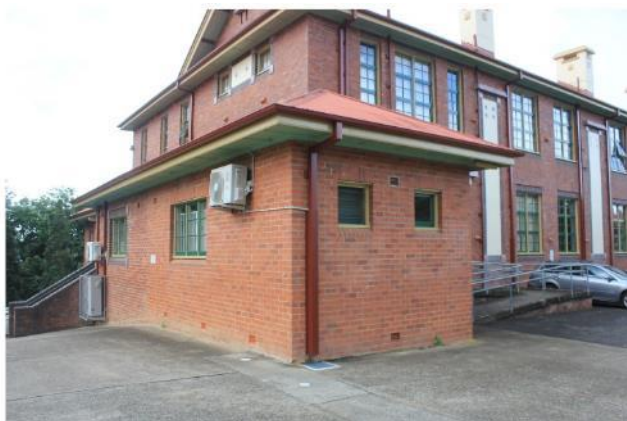
**Plate 7.1** Mid-twentieth century extension. Source: EMM 2021.

- removal of the original south elevation wall to the principal's office;
- removal of brickwork to west elevation wall of office principal's office;
- construction of the building extension including:
  - integration of new brickwork with existing brickwork to west elevation wall;
  - a new roof structure;
  - new windows including replacement of original window frame and casement;
  - replacement of internal doors and removal of internal detailing to original structure; and
  - introduction of disabled access ramp to east elevation wall of extension at a later date that provides access to the building to the east elevation wall of the extension.

**The elements that make up this extension and the various alterations applied to the original structure during its construction is considered to be of little to moderate significance.**

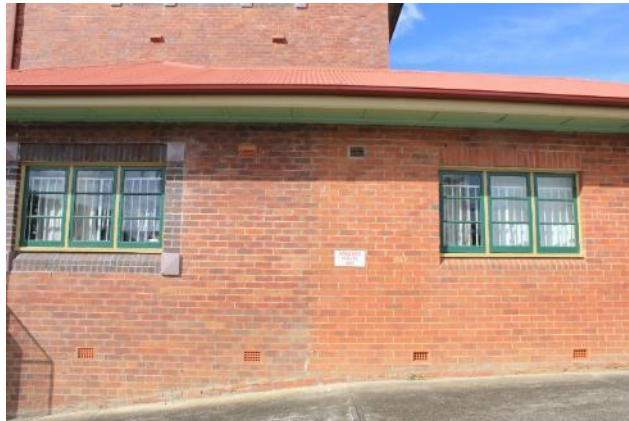
**Plate 7.2** Mid-twentieth century extension at point of intersection with original structure. Source: EMM 2021.

A small extension to former headmaster's office the south-west corner of the main building was completed in 1962 to introduce a new room and toilets to the building. This extension involved the following works:

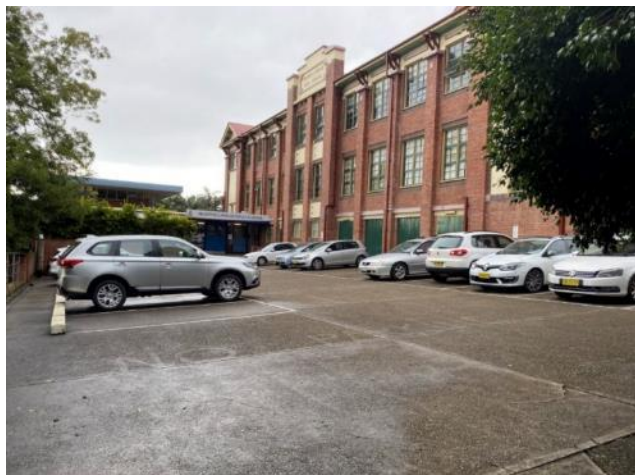
**Plate 7.5** Asphalt car parking zone to north of Block A. Source: EMM 2021.

- the replacement of the original paved surface with asphalt, its conversion to a car park with gutters and the reduction in its extent due to the encroachment of the footprint of buildings built at later dates (Plate 7.5 and Plate 7.6);
- introduction of new plantings and general turfing.

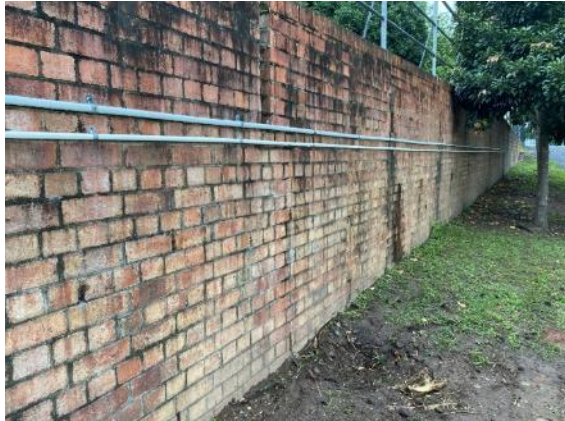
The original northern segment of the retaining wall to the north of Block A remains both exposed and largely intact. The feature is in a stable condition however there is evidence of generalised water and moss damage to brickwork and degradation and discolouration of pointing. Remaining original elements are identified in Table 7.4

| No. | Element | Significance | Image |
|---|---|---|---|
| 1 | a majority of the fundamental structure constructed using similar brickwork to Block A extending from the school drop off zone to the point of intersection with Block E, increasing in height eastward. Balustrade cut-outs to wall are original to the wall. | High | |

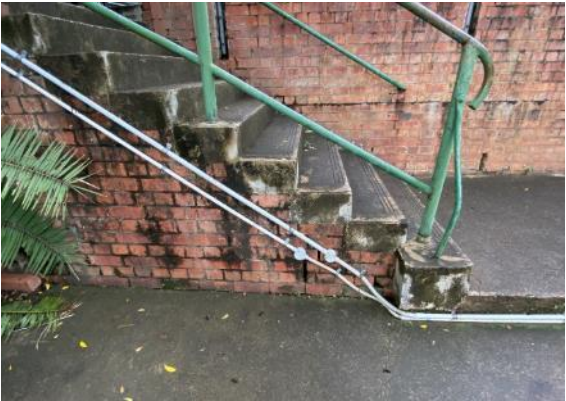
| No. | Element | Significance | Image |
|---|---|---|---|
| 2 | brickwork staircase structure with concrete blocks capping steps. | High | |

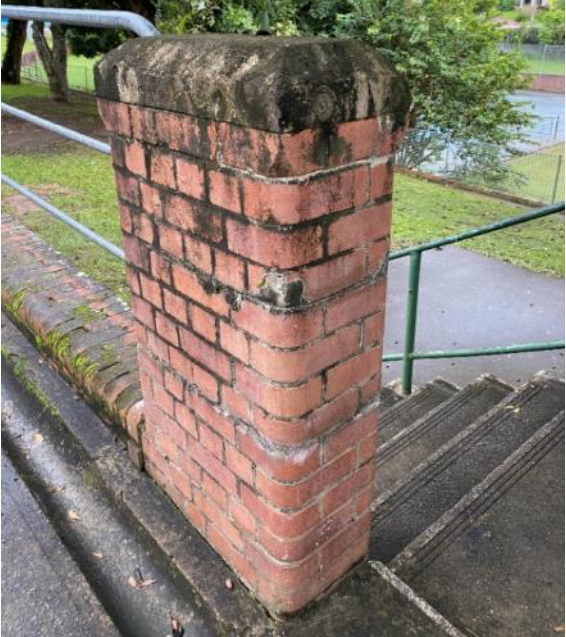
| No. | Element | Significance | Image |
|---|---|---|---|
| 3 | brickwork columns to staircase with concrete capping. | High | |

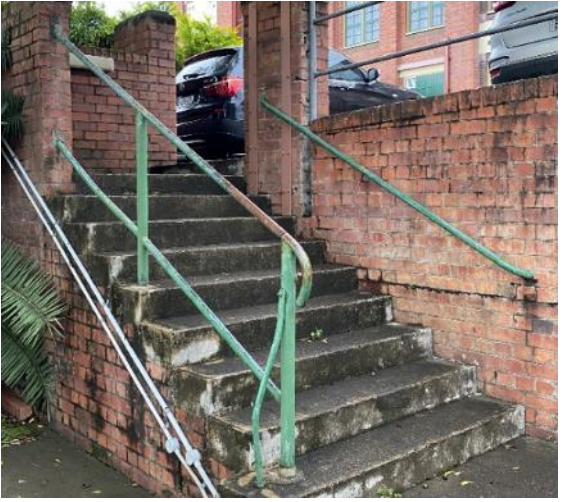
| No. | Element | Significance | Image |
|---|---|---|---|
| 4 | handrails to the staircase. | Moderate | |

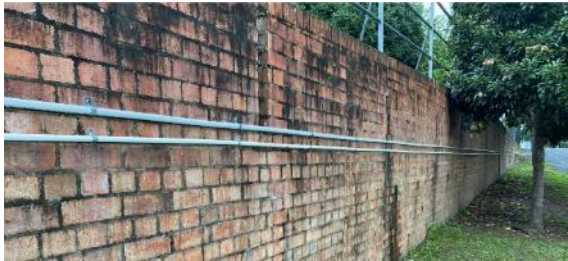
| No. | Alterations/modifications | Image |
|---|---|---|
| 3 | services applied to brickwork. | |

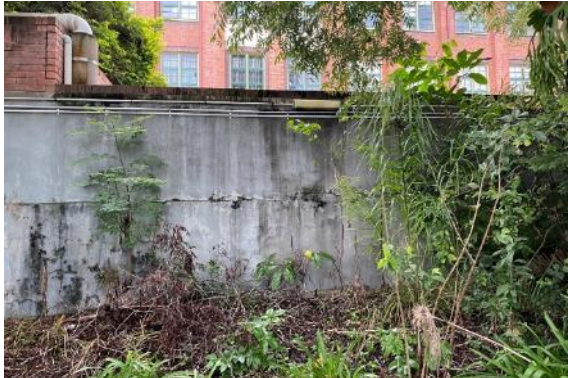
| No. | Alterations/modifications | Image |
|---|---|---|
| 4 | cement rendered segment of the wall. | |

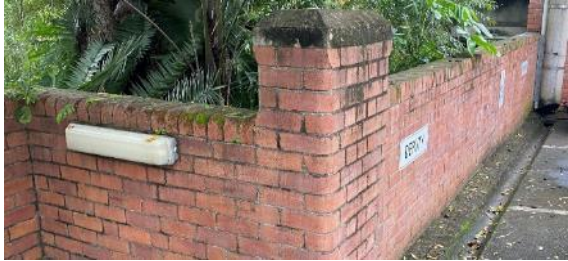
| No. | Alterations/modifications | Image |
|---|---|---|
| 5 | lighting and signage applied to brickwork. | |

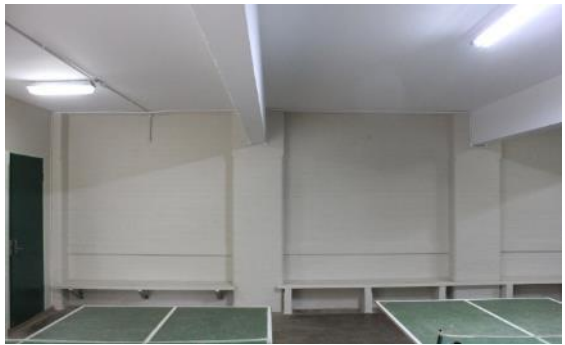
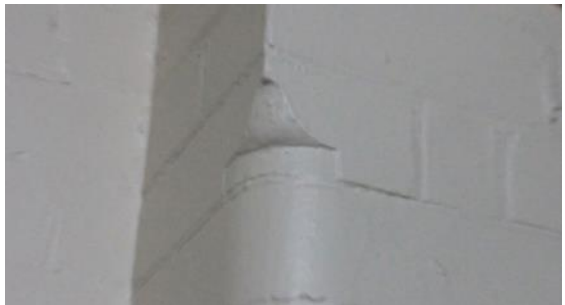
| No. | Element | Significance | Image |
|---|---|---|---|
| 1 | masonry walls, pilasters and ogee brick detailing | High | |

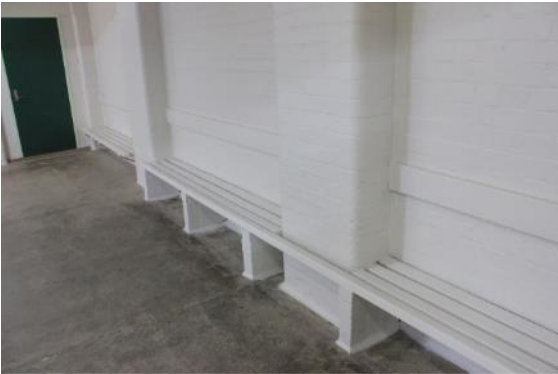
| No. | Element | Significance | Image |
|---|---|---|---|
| 2 | original timber benched and brick supports. | High | |

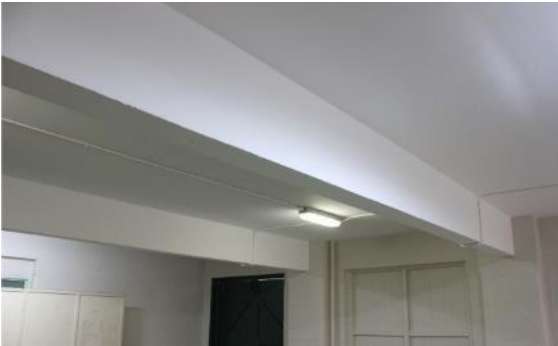
| No. | Element | Significance | Image |
|---|---|---|---|
| 3 | Reinforced steel joists | High | |

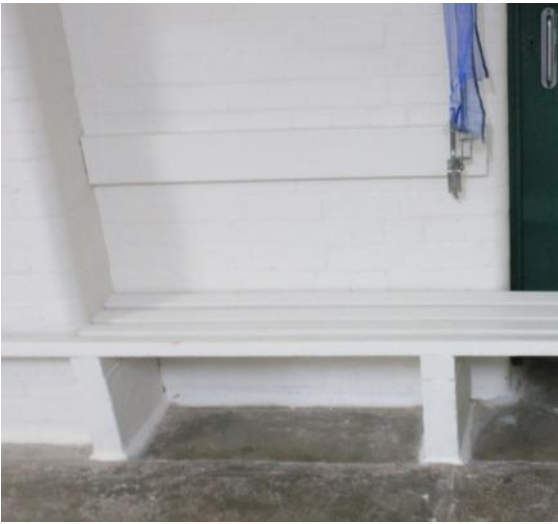
| No. | Element | Significance | Image |
|---|---|---|---|
| 4 | Low rails above seating | Moderate | |

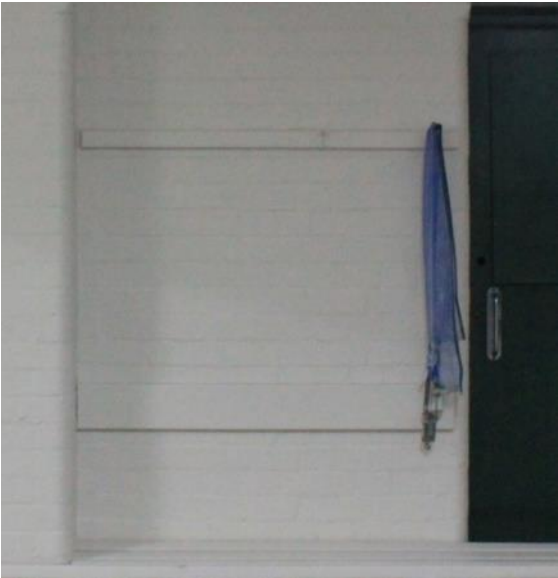
| No. | Element | Significance | Image |
|---|---|---|---|
| 5 | remaining 'hat rails' | Moderate | |

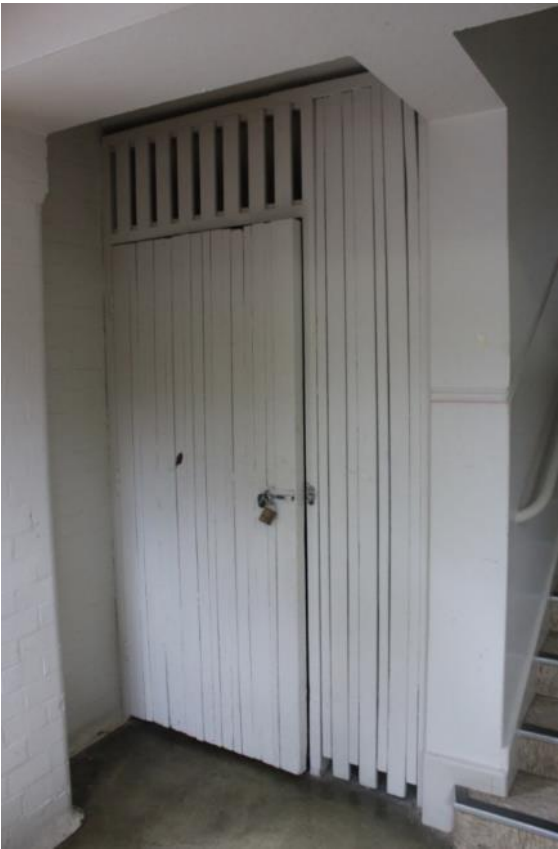
| No. | Element | Significance | Image |
|---|---|---|---|
| 6 | timber batten gate to western storage rooms | Moderate | |

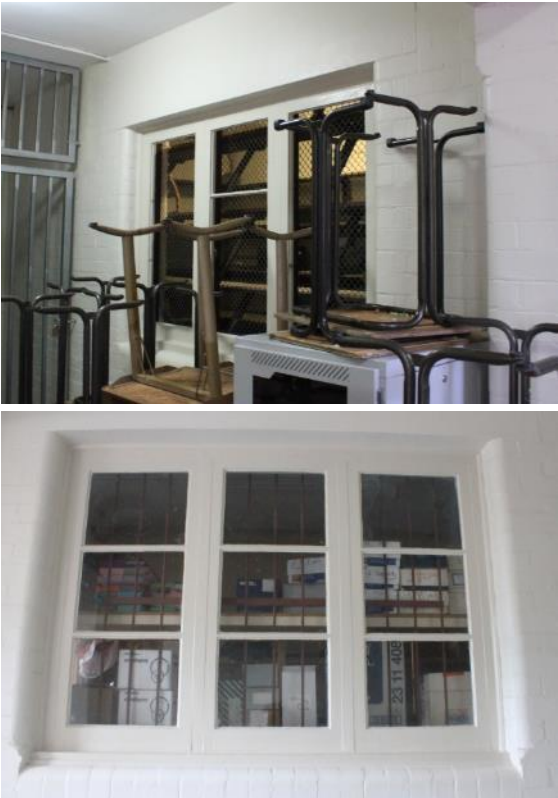
| No. | Element | Significance | Image |
|---|---|---|---|
| 7 | internal windows to all store rooms | Moderate | |

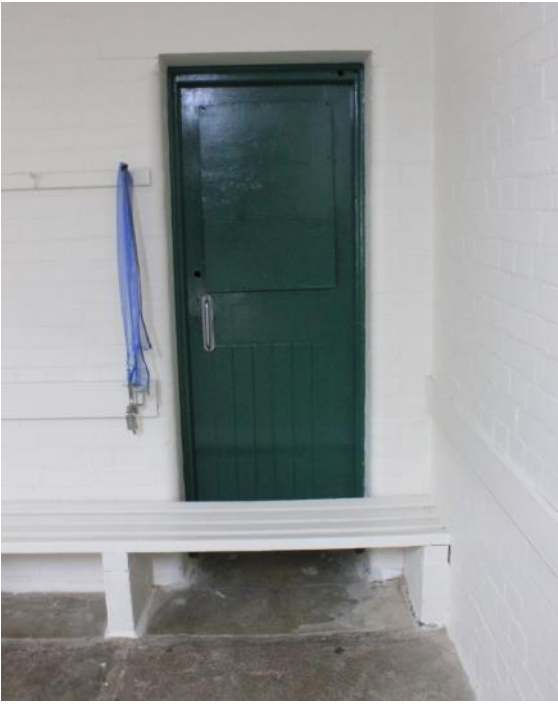
| No. | Element | Significance | Image |
|---|---|---|---|
| 8 | 'foundation doors' panel and frame | Moderate | |

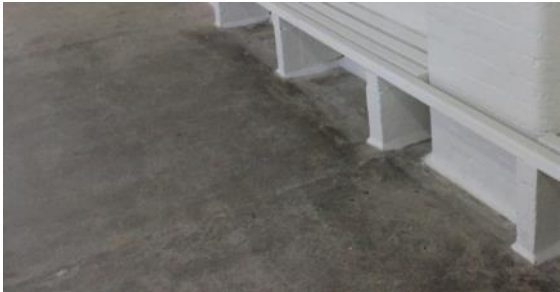
| No. | Element | Significance | Image |
|---|---|---|---|
| 9 | Concrete floor | Moderate | |

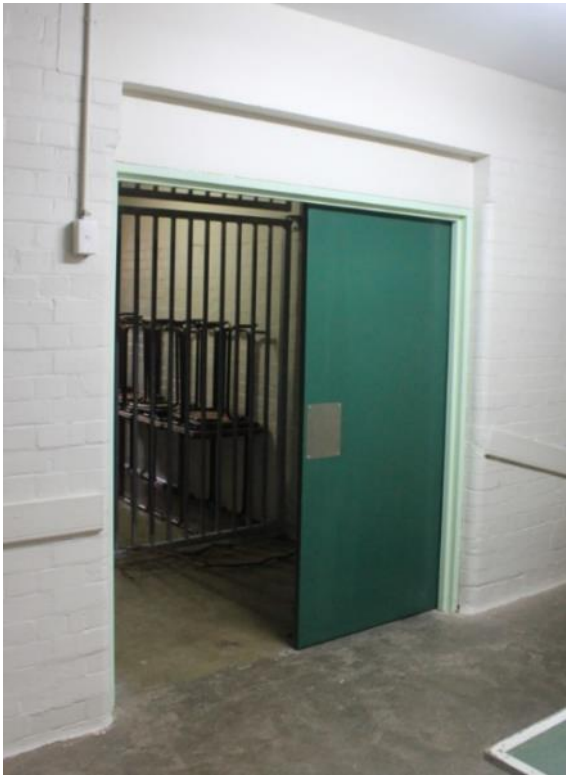
| No. | Alterations/modifications | Significance | Image |
|---|---|---|---|
| 1 | all non-original internal doors and gates incl. large timber doors to north elevation and double swing doors to corridors. | Little | |

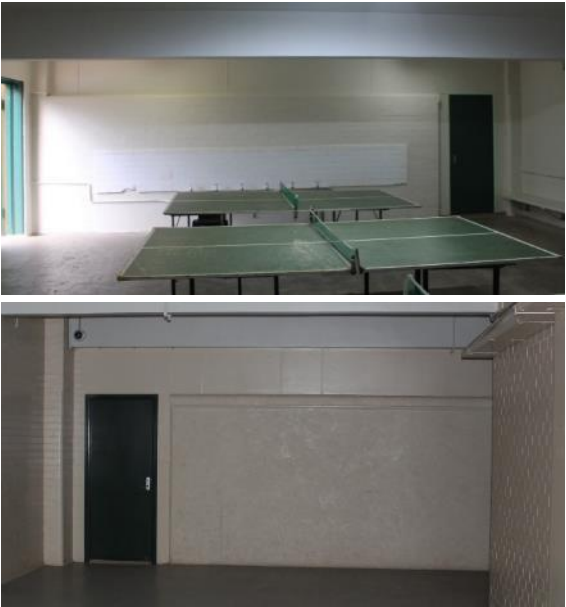
| No. | Alterations/modifications | Significance | Image |
|---|---|---|---|
| 2 | Low internal walls to both sides of central partition wall including lightweight upper infill and doors. | Moderate | |

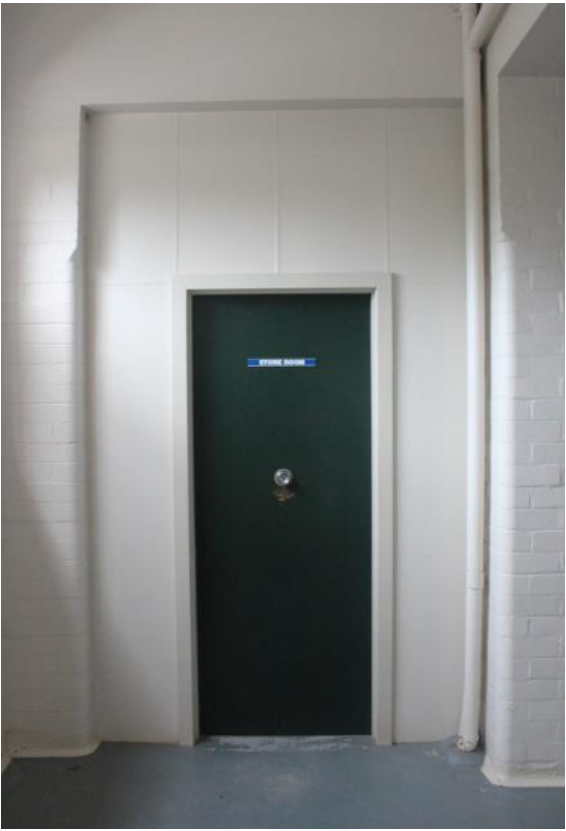
| No. | Alterations/modifications | Significance | Image |
|---|---|---|---|
| 3 | replacement of batten gate with mid-twentieth century infill and door. | Little | |

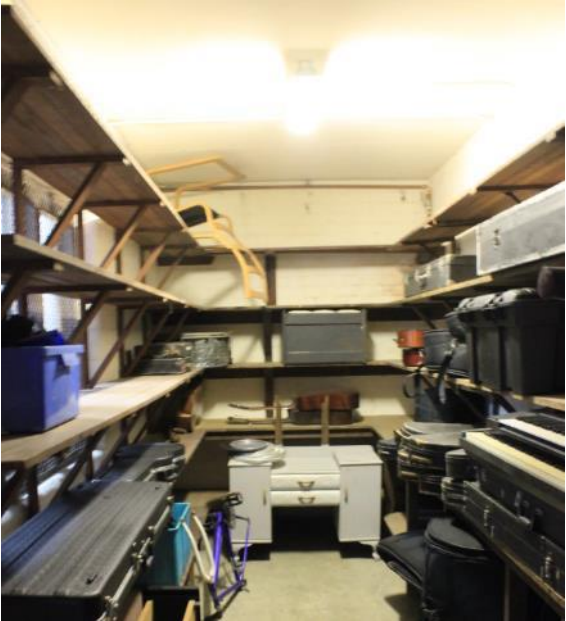
| No. | Alterations/modifications | Significance | Image |
|---|---|---|---|
| 5 | non-original shelving and additions to store rooms. | Intrusive | |

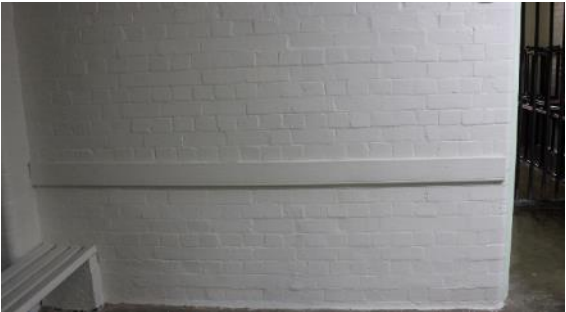
| No. | Alterations/modifications | Significance | Image |
|---|---|---|---|
| 6 | non-original low rails to western wall of performance hall. | Little | |

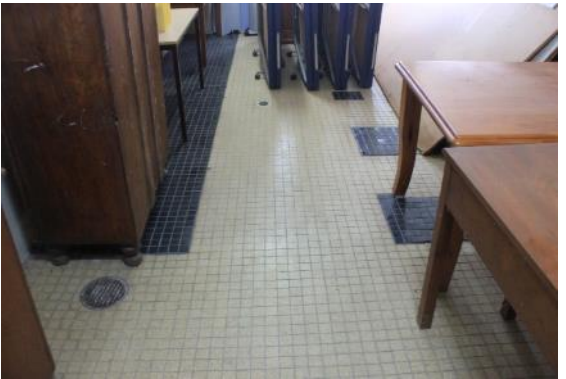
| No. | Alterations/modifications | Significance | Image |
|---|---|---|---|
| 7 | square tile floor finish to former wet areas. | Little | |

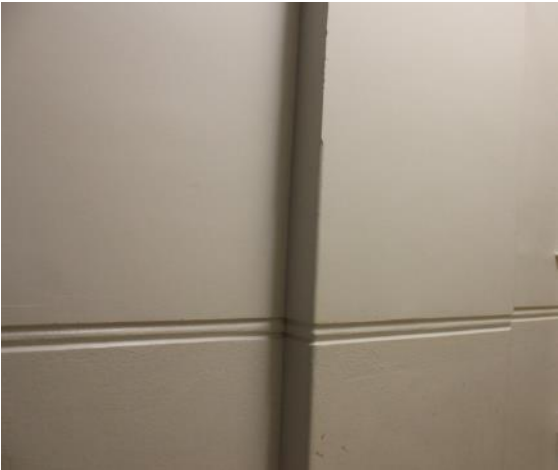
| No. | Element | Significance | Image |
|---|---|---|---|
| 1 | original masonry walls incl. openings, dado and chamfered pilaster and wall edges. | High | |

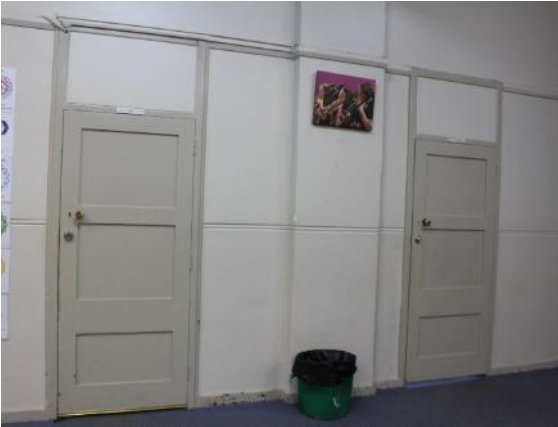
| No. | Element | Significance | Image |
|---|---|---|---|
| 2 | original classroom and store room door panels and frames | High | |

| No. | Element | Policy |
|---|---|---|
| Policy 22 | Windows and doors | Original windows and doors are to be retained and repaired, if necessary, including the retention of original hardware and glazed elements. |

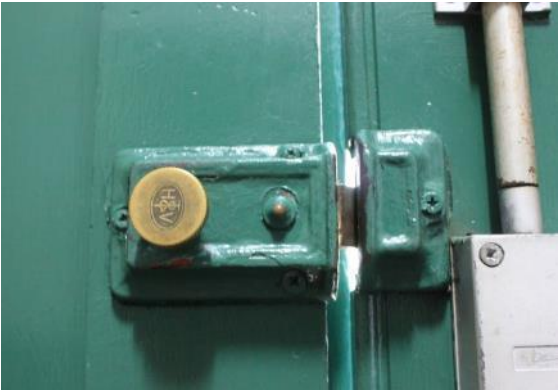
| No. | Element | Significance | Image |
|---|---|---|---|
| 4 | all door hardware identified as original or early | High | |

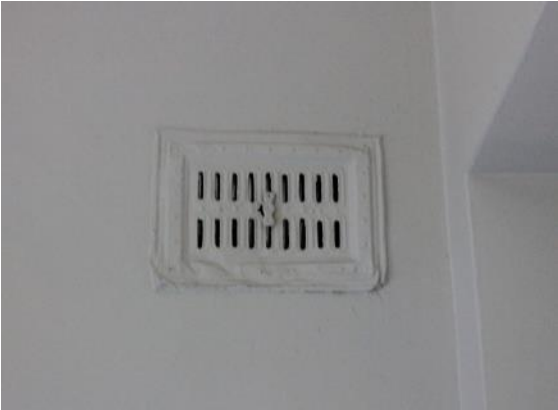
| No. | Element | Significance | Image |
|---|---|---|---|
| 5 | Metal vent plates | Intact – High<br><br>Dilapidated - Moderate | |

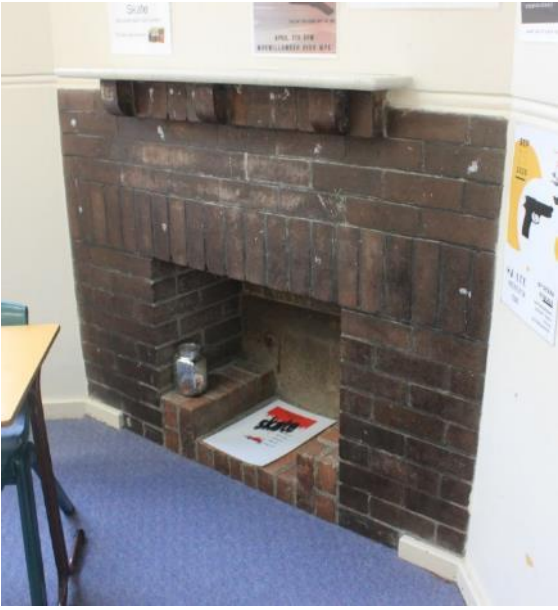
| No. | Element | Significance | Image |
|---|---|---|---|
| 6 | masonry fireplaces to classrooms incl. stone mantle and metal plates. | High | |

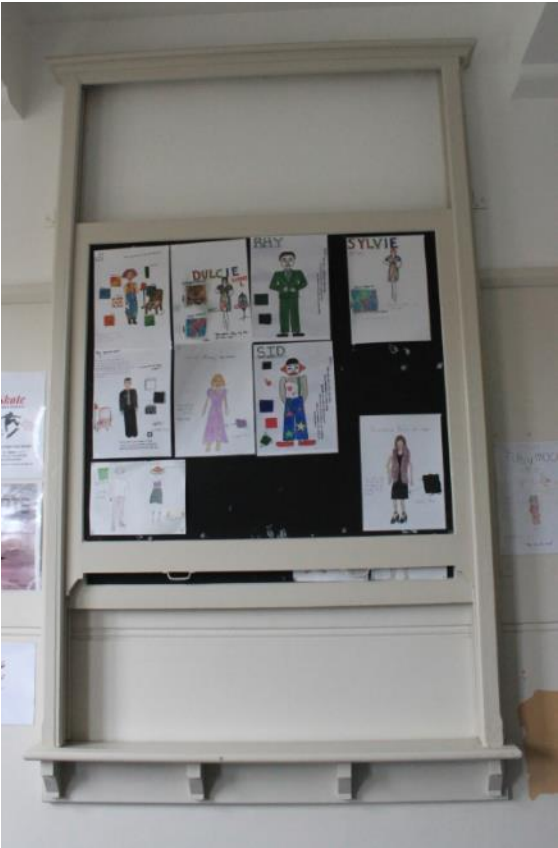
| No. | Element | Significance | Image |
|---|---|---|---|
| 7 | Original sliding black boards | High | |

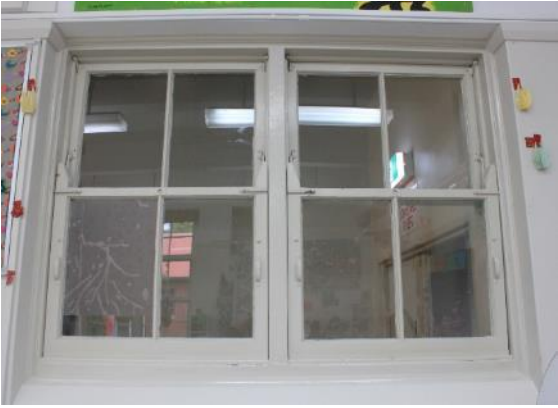
| No. | Element | Significance | Image |
|---|---|---|---|
| 8 | internal classroom and store room windows<br>incl. original hardware | High | |

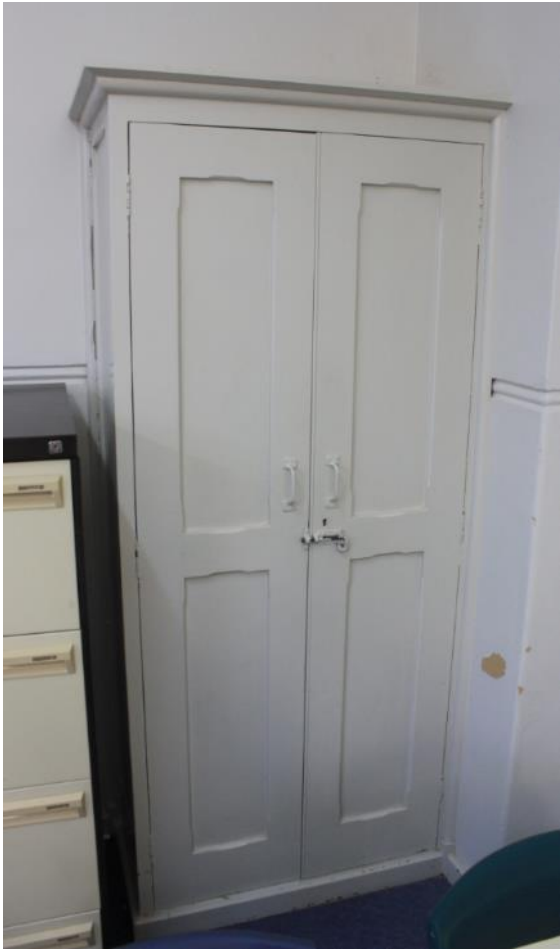
| No. | Element | Significance | Image |
|---|---|---|---|
| 9 | Classroom timber cupboards and original hardware | High<br><br>Non-original hardware - Little | |

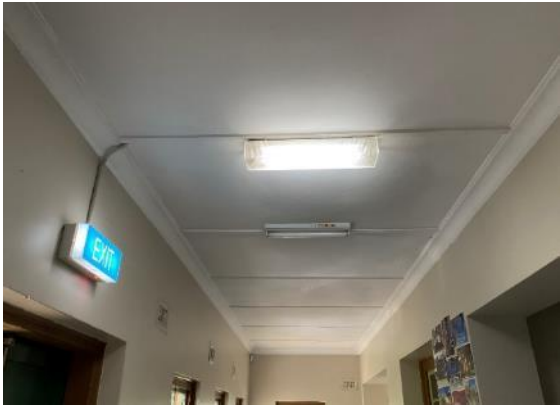
| No. | Element | Significance | Image |
|---|---|---|---|
| 10 | original decorative ceilings to all spaces incl. incl. vents, cornices and moulding. | High | |

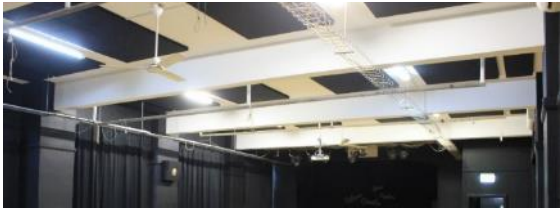
| No. | Element | Significance | Image |
|---|---|---|---|
| 11 | Reinforced steel joists | High | |

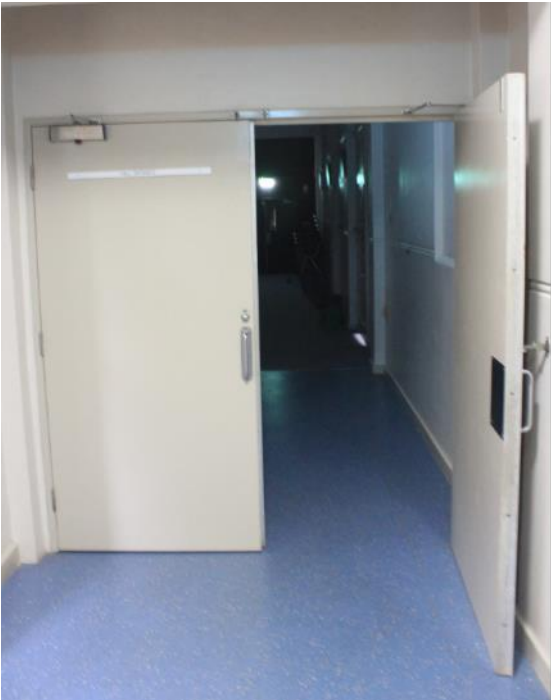
| No. | Alterations/modifications | Significance | Image |
|---|---|---|---|
| 1 | All non-original doors | Little | |

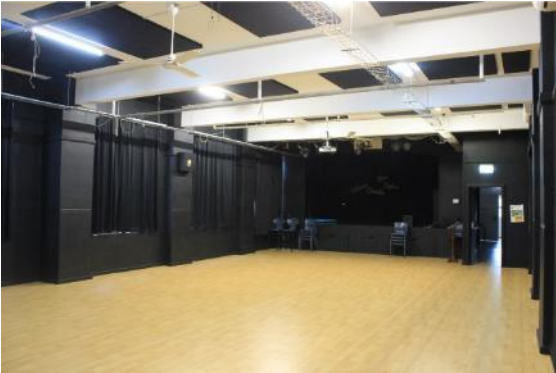
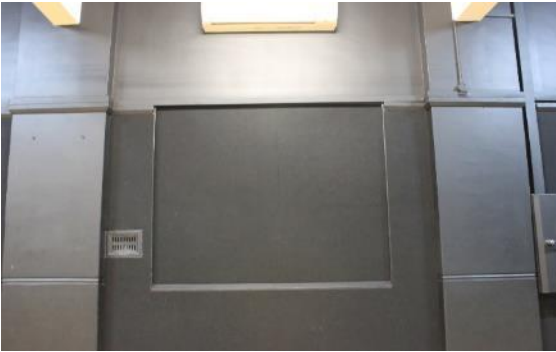
| No. | Alterations/modifications | Significance | Image |
|---|---|---|---|
| 2 | intrusive and modified elements within Level 1 performance hall incl. <ul style="list-style-type: none"><li>• stage and associated lightweight walls;</li><li>• services, wiring, cable trays and lighting applied to walls and ceiling;</li><li>• acoustic panels applied to ceiling;</li><li>• vinyl/recent timber floor finish;</li><li>• black paint to original elements incl. masonry walls;</li><li>• lightweight sheeting applied to openings;</li><li>• drapes/curtains.</li></ul> | Intrusive | <br> |

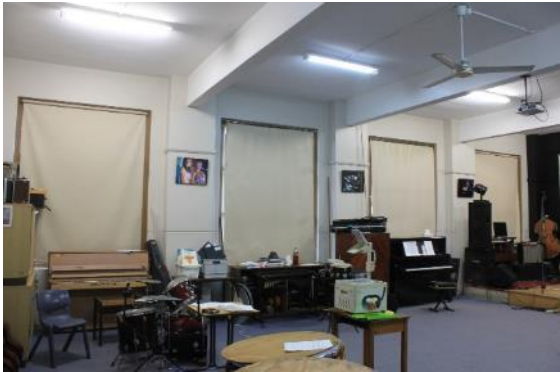
| No. | Alterations/modifications | Significance | Image |
|---|---|---|---|
| 3 | intrusive and modified elements within Level 1 performance room incl. <ul style="list-style-type: none"> <li>carpet flooring;</li> <li>ceiling fans and wall A/C units;</li> <li>blinds;</li> <li>services, wiring, cable trays and lighting applied to walls and ceiling;</li> <li>lightweight sheeting applied to openings;</li> <li>stage and associated structures and elements.</li> </ul> | Intrusive | |

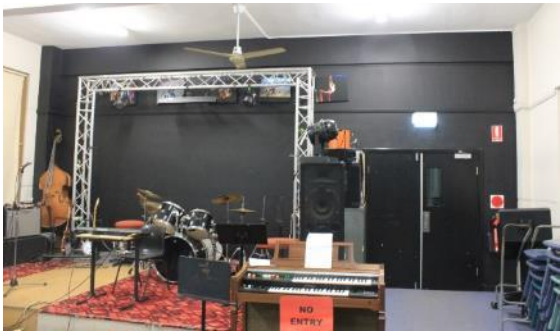
| No. | Alterations/modifications | Significance | Image |
|---|---|---|---|
| 4 | later partition wall incl. door separating performance room and performance hall. | Little | |

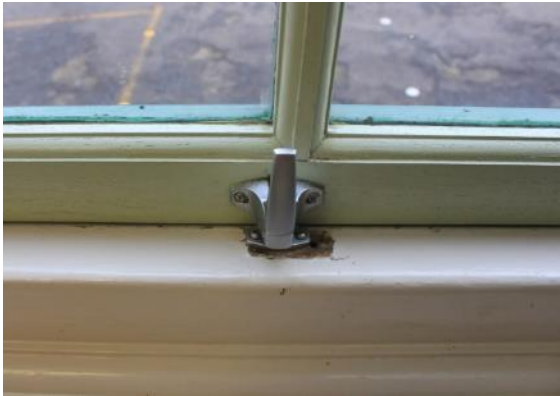
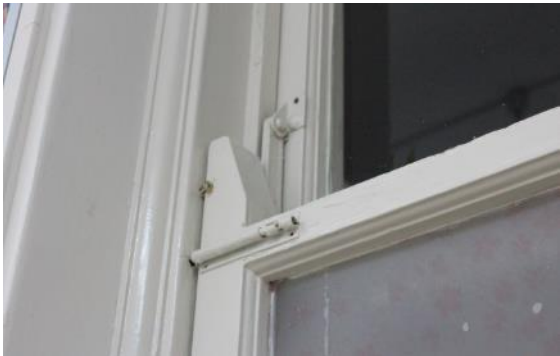
| No. | Alterations/modifications | Significance | Image |
|---|---|---|---|
| 5 | all non-original window hardware to external and internal windows | Early – Moderate<br><br>Recent –<br>Little/Intrusive | |

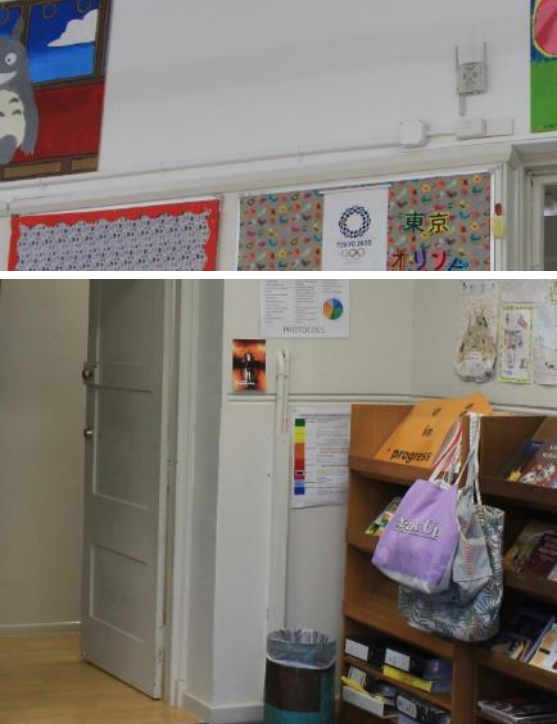
| No. | Alterations/modifications | Significance | Image |
|---|---|---|---|
| 6 | services, wiring, cable trays and other intrusive elements applied to masonry walls and ceilings. | Early – Little<br><br>Recent - Intrusive | <p>The top photograph shows a wall with a colorful mural of a cat and a ceiling with white cable trays and electrical conduits. The bottom photograph shows a doorway with a modern white door and a purple bag hanging on a shelf to the right.</p> |

| No. | Policy |
|---|---|
| Policy 34 | The insertion of new services (for instance for electricity, gas, drainage and communication) is acceptable, so long as their installation minimises damage to fabric and they are concealed from view within areas of lesser significance or located in inconspicuous positions or cavities and designed to be self-effacing. The shortest distance between two points should not be considered necessarily the best solution for the chasing of conduits. |
| Policy 37 | The replacement of existing services (for instance for electricity, gas, drainage, heating, cooling, communication and internal access) is acceptable, so long as removal and installation of replacement services minimises damage to fabric and they are concealed from view within areas of lesser significance or located in inconspicuous positions and designed to be self-effacing. |

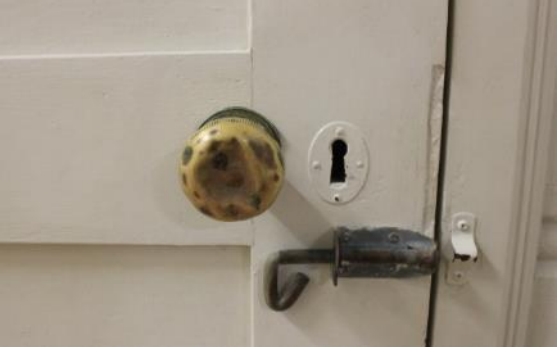
| No. | Alterations/modifications | Significance | Image |
|---|---|---|---|
| 7 | all non-original door hardware. | Early – Moderate<br><br>Recent - Intrusive | <p>The photograph shows a close-up of a door handle and lock mechanism. The handle is a round, brass-colored knob, and the lock is a silver-colored cylinder. A metal strike plate is visible on the door edge.</p> |

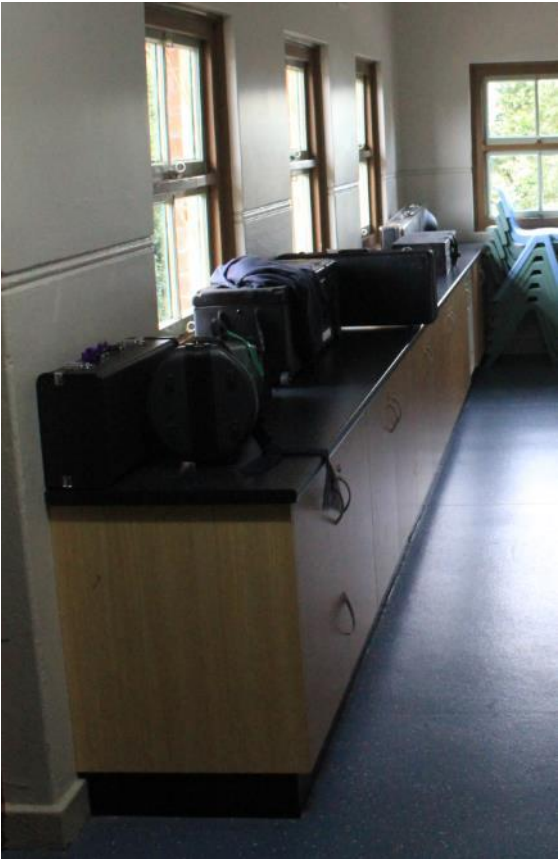
| No. | Alterations/modifications | Significance | Image |
|---|---|---|---|
| 9 | all non-original joinery and furniture | Intrusive | |
