# Murwillumbah Education Campus development

Statement of Heritage Impact (SSDA 16848913)

Prepared for Built. on behalf of the NSW Department of Education  
August 2022

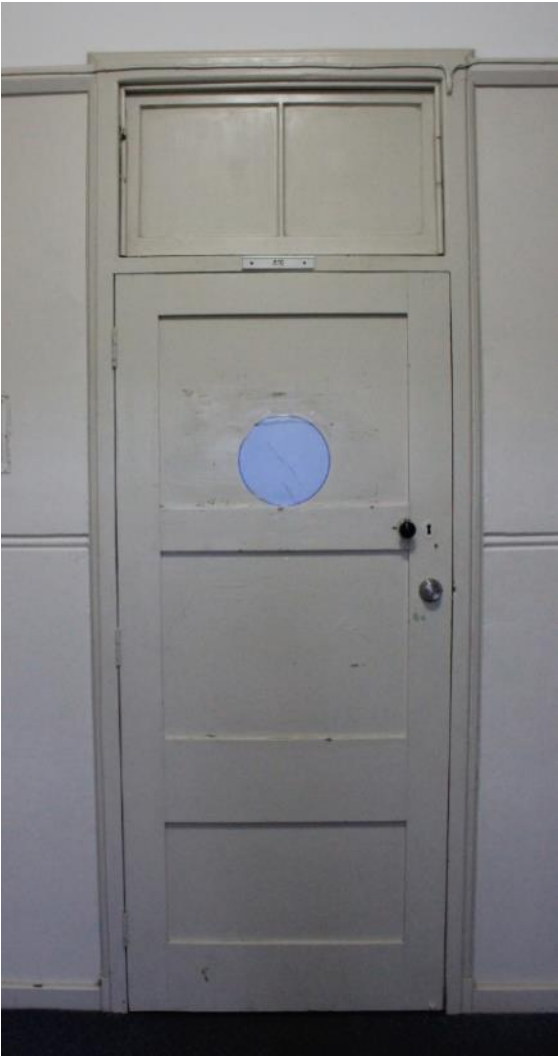
| No. | Element | Significance | Image |
|---|---|---|---|
| 2 | original classroom and store room door panels, frames and transom windows. | High | |

| No. | Element | Policy |
|---|---|---|
| Policy 22 | Windows and doors | Original windows and doors are to be retained and repaired, if necessary, including the retention of original hardware and glazed elements. |

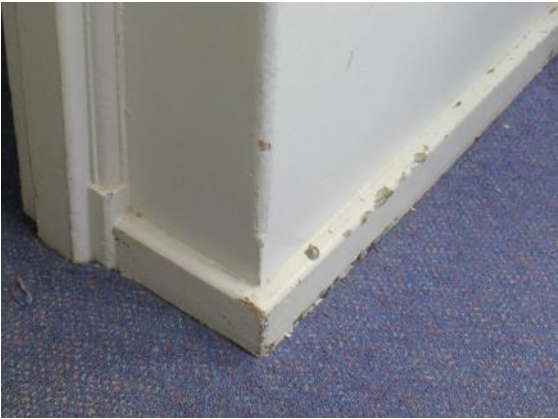
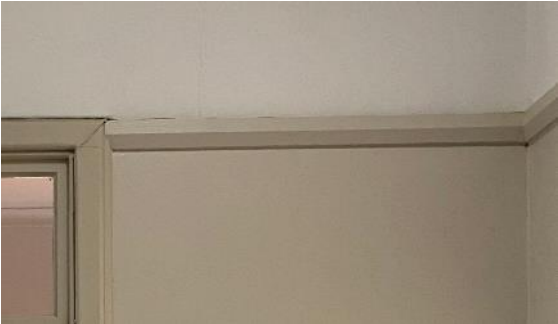
| No. | Element | Significance | Image |
|---|---|---|---|
| 3 | timber skirting and wall rails | High | <br> |

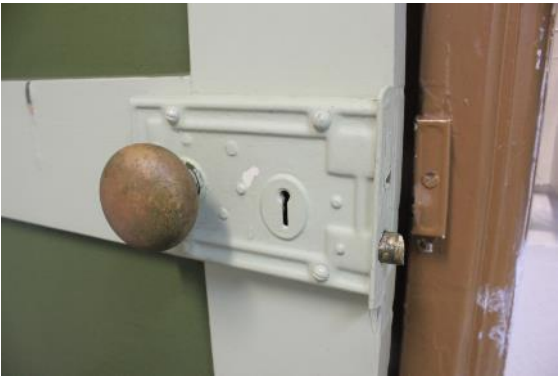
| No. | Element | Significance | Image |
|---|---|---|---|
| 4 | all door hardware identified as original or early | High | |

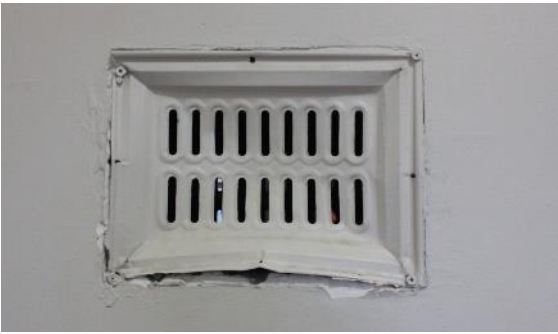
| No. | Element | Significance | Image |
|---|---|---|---|
| 5 | Metal vent plates | Intact – High<br><br>Dilapidated -<br>Moderate | |

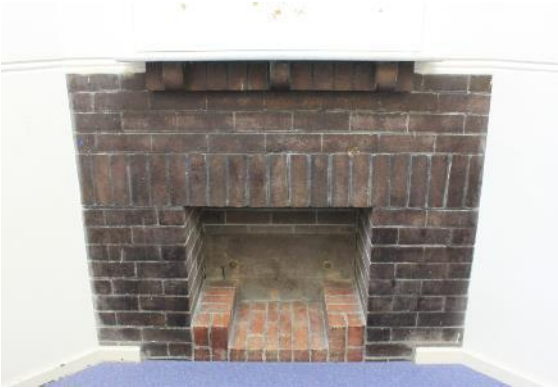
| No. | Element | Significance | Image |
|---|---|---|---|
| 6 | masonry fireplaces to classrooms incl. stone mantle and metal plates. | High | |

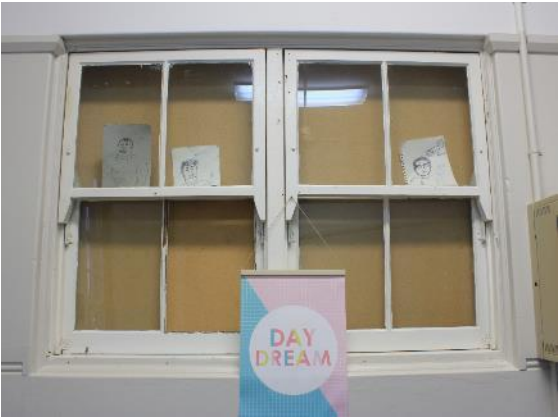
| No. | Element | Significance | Image |
|---|---|---|---|
| 8 | internal classroom and staff room windows<br>incl. all original hardware. | High | |

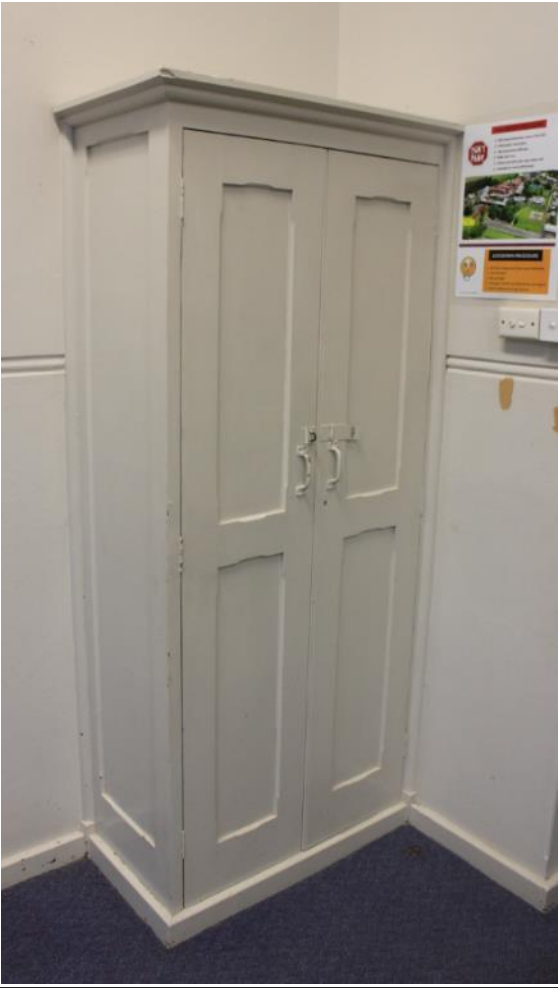
| No. | Element | Significance | Image |
|---|---|---|---|
| 9 | Classroom timber cupboards and original hardware | High<br><br>Non-original hardware - Little | |

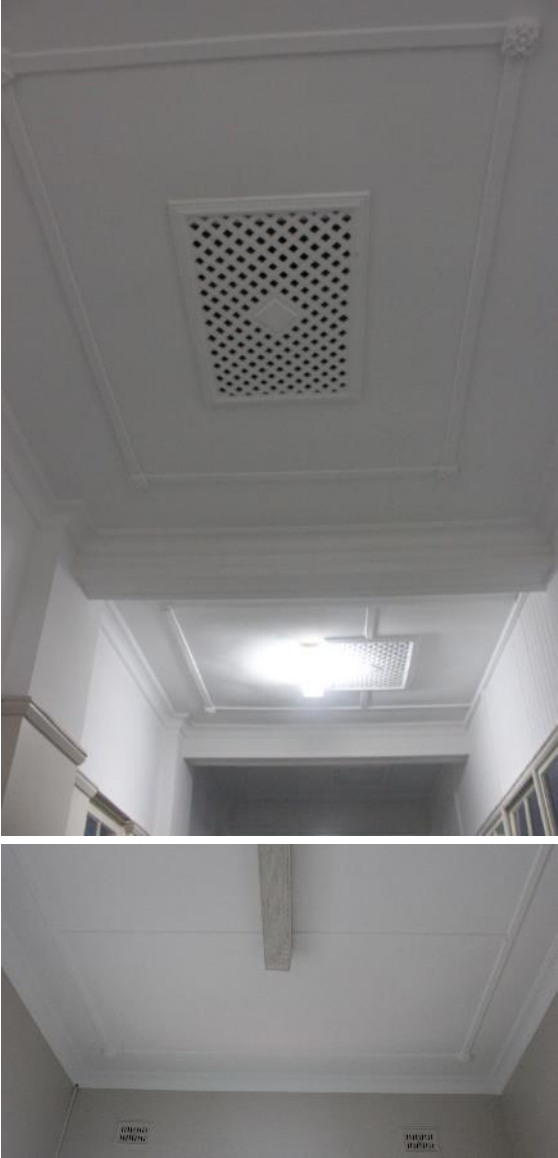
| No. | Element | Significance | Image |
|---|---|---|---|
| 10 | original decorative ceilings to circulation and main hall spaces incl. vents, cornices and moulding. | High | |

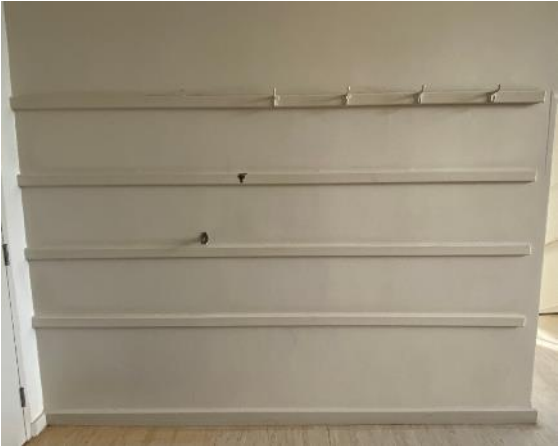
| No. | Element | Significance | Image |
|---|---|---|---|
| 12 | Hat rails to circulation spaces | High | |

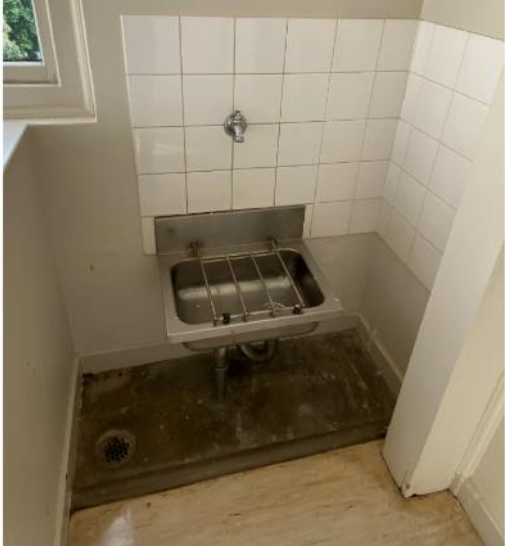
| No. | Element | Significance | Image |
|---|---|---|---|
| 13 | Sink zone | Concrete base and drain – High<br><br>Sink/bubbler – Little<br><br>Tiles - Little | |

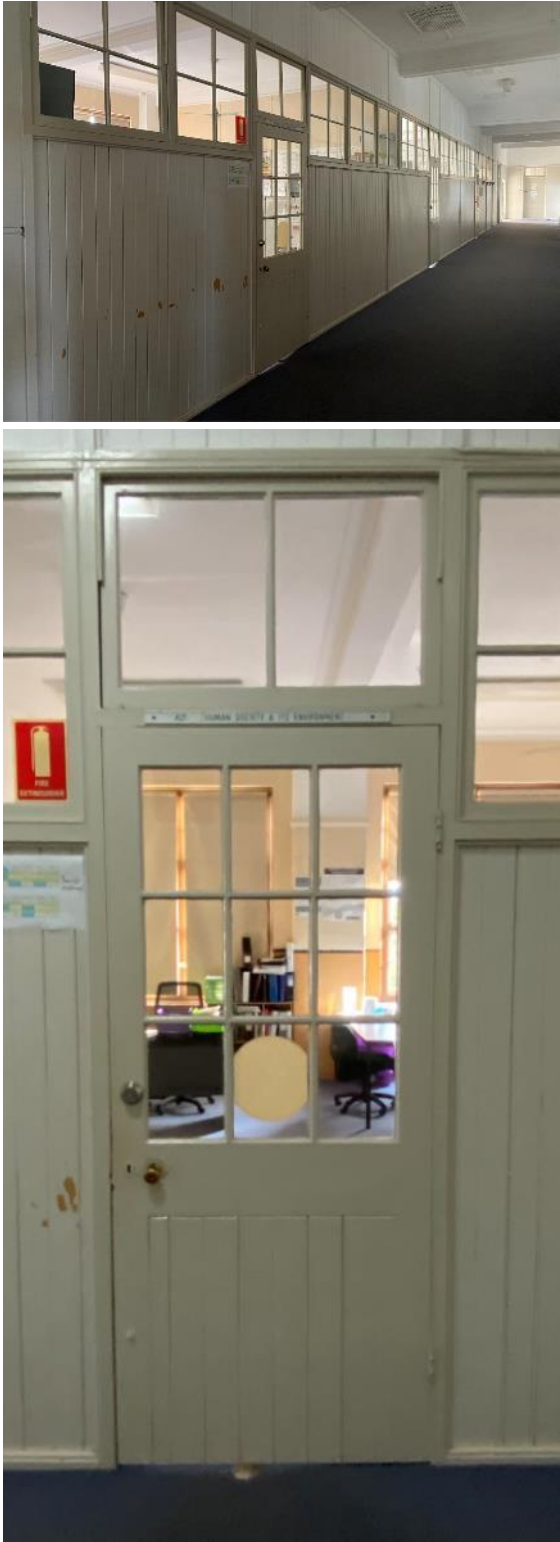
| No. | Alterations/modifications | Significance | Image |
|---|---|---|---|
| 1 | inter-war to mid-twentieth century partition wall to hall way incl. upper segment windows, doors and other associated elements. | Little-Moderate | |

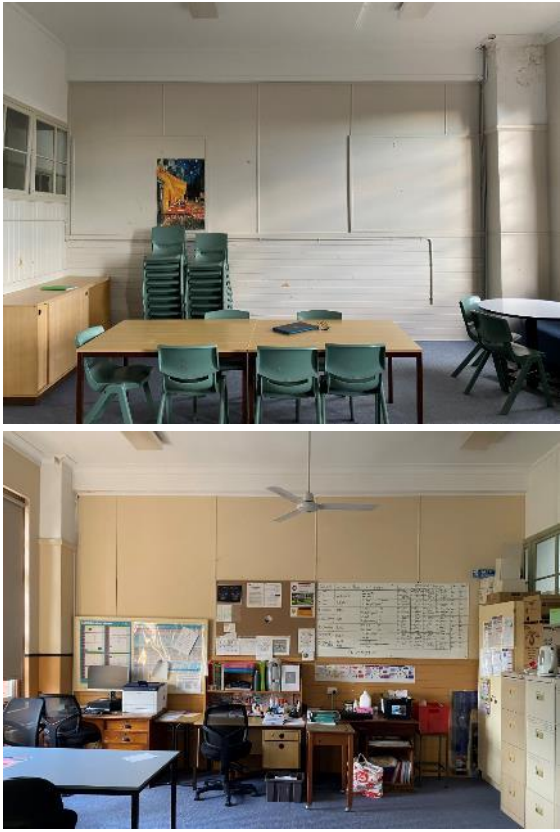
| No. | Alterations/modifications | Significance | Image |
|---|---|---|---|
| 2 | inter-war to mid-twentieth century partition wall within northern segment of Level 2. | Little | |

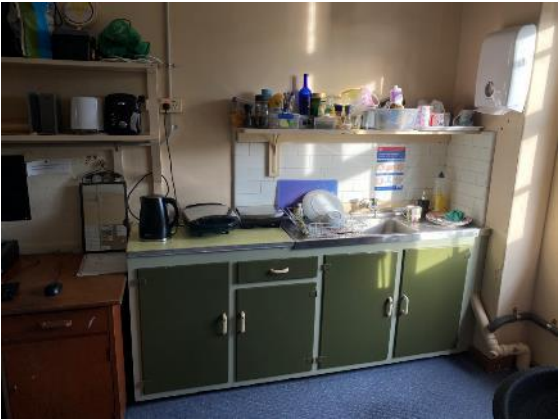
| No. | Alterations/modifications | Significance | Image |
|---|---|---|---|
| 3 | inter-war to mid-twentieth century additions to internal areas incl. kitchenette, shelving | Little | |

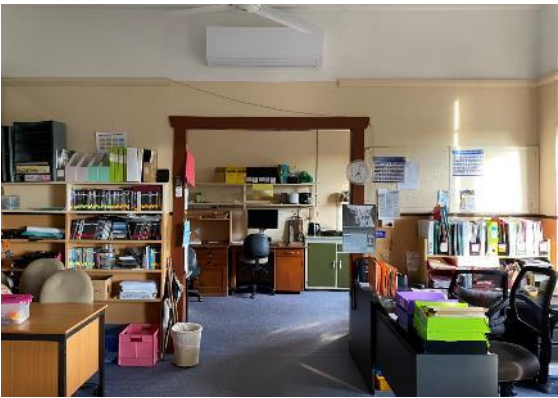
| No. | Alterations/modifications | Significance | Image |
|---|---|---|---|
| 4 | portal through segment of original masonry wall (inter-war to mid-twentieth century) | Intrusive | |

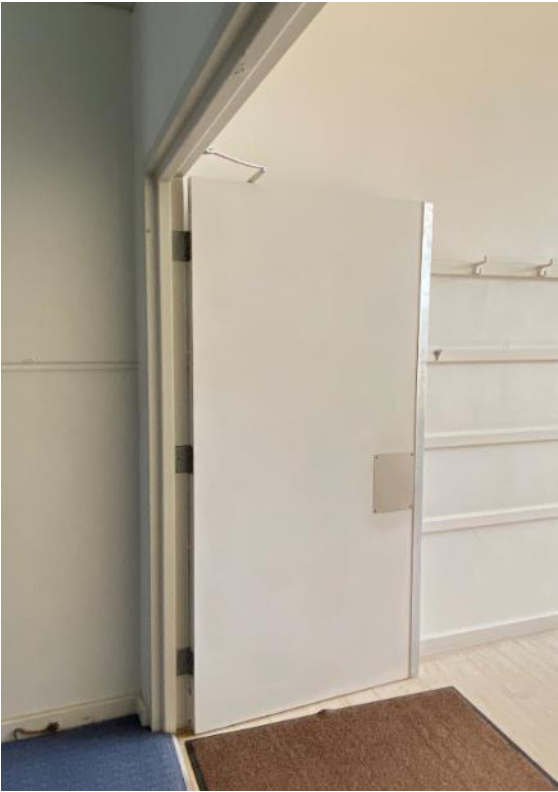
| No. | Alterations/modifications | Significance | Image |
|---|---|---|---|
| 5 | All non-original doors | Intrusive - Little | |

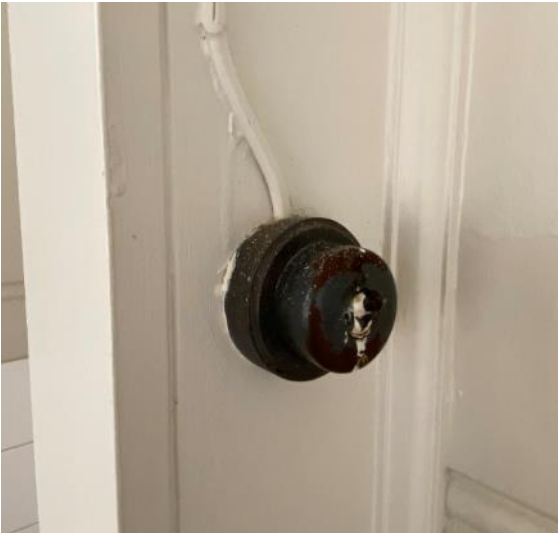
| No. | Alterations/modifications | Significance | Image |
|---|---|---|---|
| 6 | Early electrical fixtures | Moderate | |

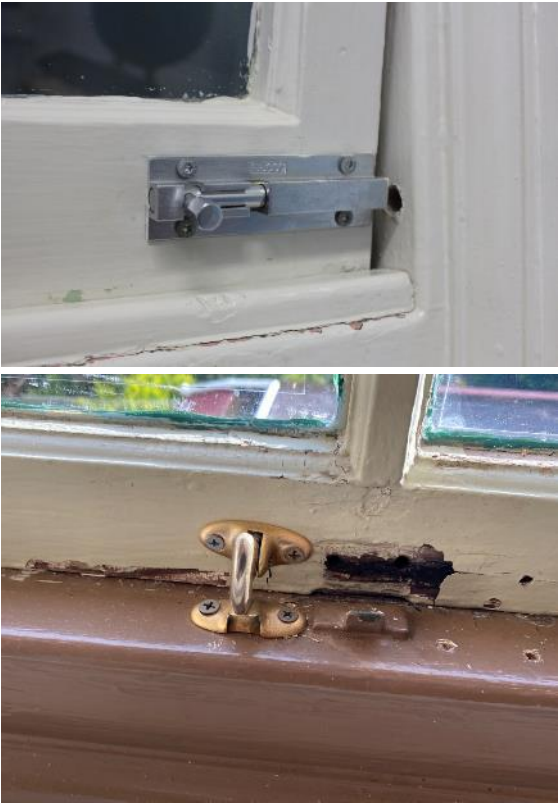
| No. | Alterations/modifications | Significance | Image |
|---|---|---|---|
| 7 | all non-original window hardware to external and internal windows | Early – Moderate<br><br>Recent – Little/Intrusive | |

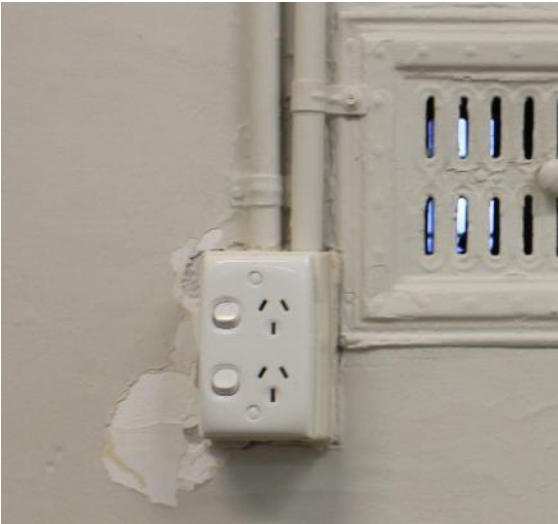
| No. | Alterations/modifications | Significance | Image |
|---|---|---|---|
| 8 | services, wiring, cable trays and other intrusive elements applied to masonry walls and ceilings. | Early – Little | |
| | | Recent - Intrusive | |

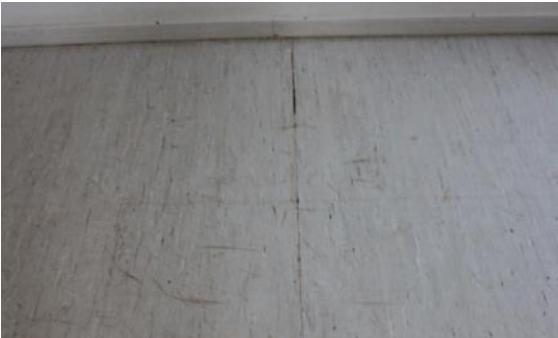
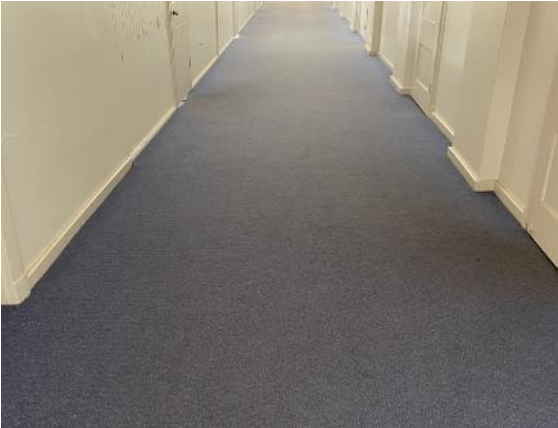
| No. | Alterations/modifications | Significance | Image |
|---|---|---|---|
| 10 | <div>all non-original flooring incl.<ul style="list-style-type: none"><li>all vinyl flooring to circulation spaces;</li><li>carpet flooring to classrooms and performance room.</li></ul></div> | | <div></div> <div></div> |

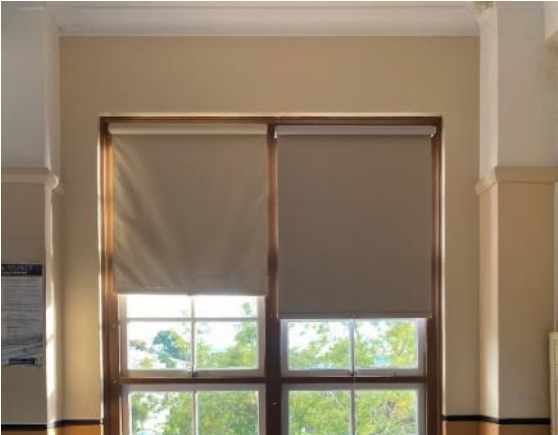
| No. | Alterations/modifications | Significance | Image |
|---|---|---|---|
| 11 | <div>all recent blinds applied to windows to all spaces</div> | Intrusive | <div></div> |

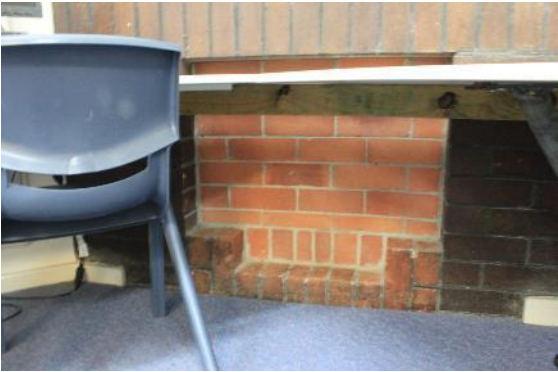
| No. | Alterations/modifications | Significance | Image |
|---|---|---|---|
| 12 | infill to fireplace cavities | Intrusive | |

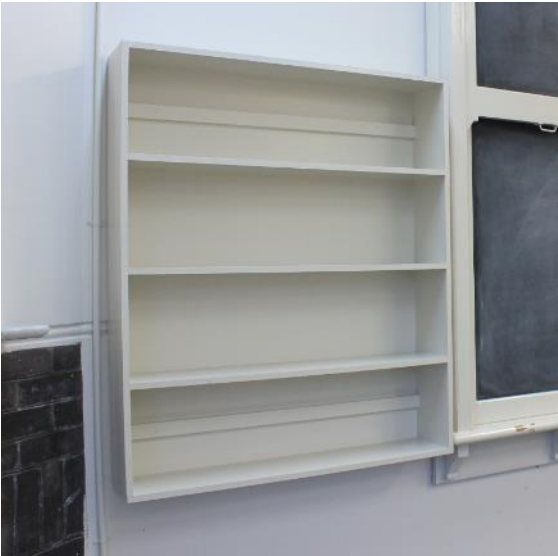
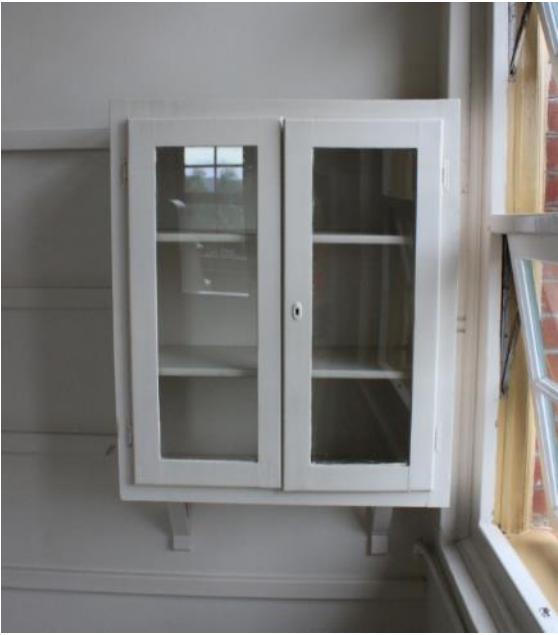
| No. | Alterations/modifications | Significance | Image |
|---|---|---|---|
| 13 | all non-original joinery and additions to classroom and staff room walls. | Early – Moderate<br>Recent - Little | <br> |

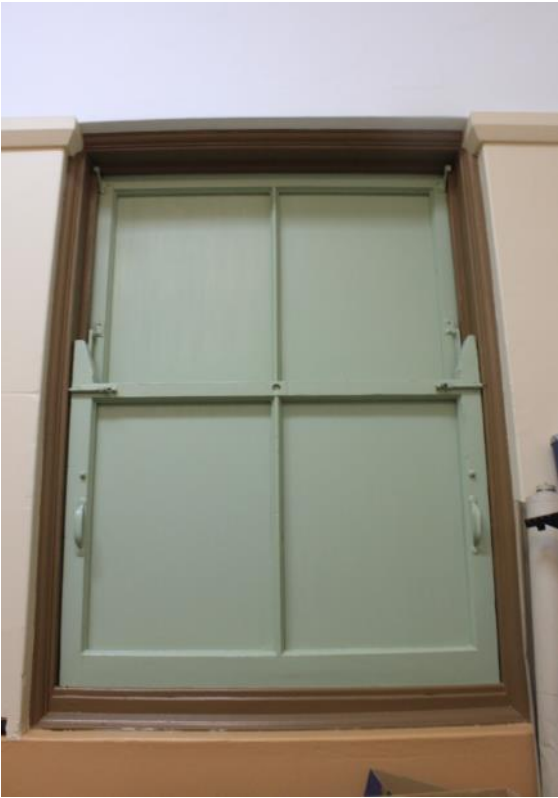
| No. | Alterations/modifications | Significance | Image |
|---|---|---|---|
| 14 | paintwork applied to window glazing and door | Intrusive | |

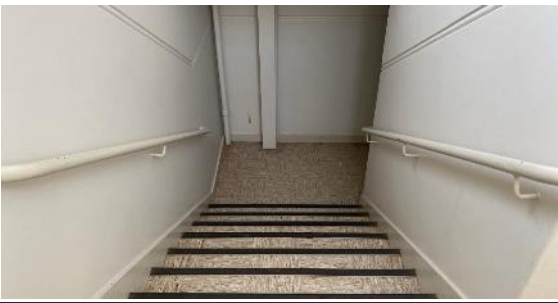
| No. | Alterations/modifications | Significance | Image |
|---|---|---|---|
| 15 | handrails to circulation spaces | Little | |

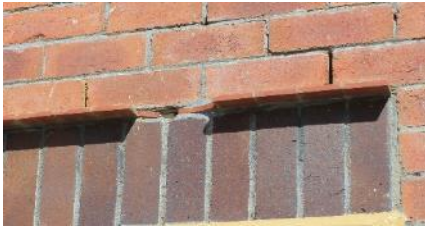
| No. | Issue | Image | Action |
|---|---|---|---|
| 1 | damaged or broken lintel trim ceramic/terracotta tiles. | | replace damaged or missing terracotta/ceramic tiles to match.<br><br><u>Hold Point: identify if any original tiles are stored on site for use in repair works.</u> |

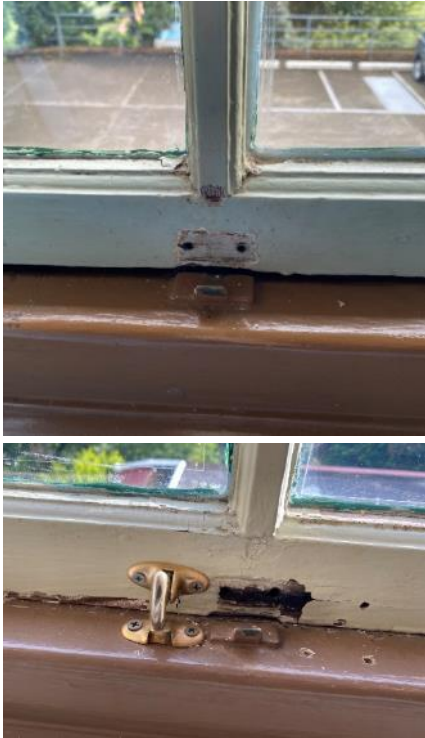
| No. | Issue | Image | Action |
|---|---|---|---|
| 2 | damage to timber elements of original windows and other timber elements | | putty or apply non-toxic and reversable resin to cavities and damaged segments. Do not repaint. |

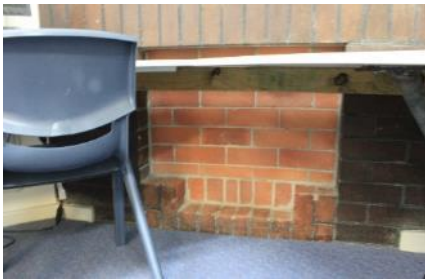
| No. | Issue | Image | Action |
|---|---|---|---|
| 3 | infilled fireplaces within classrooms. | | remove intrusive brickwork to re-open fireplace cavities. |

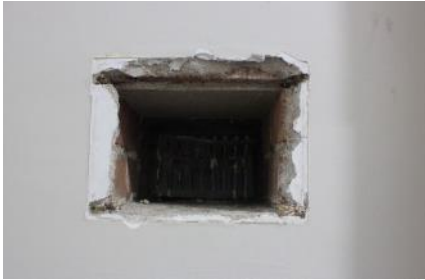
| No. | Issue | Image | Action |
|---|---|---|---|
| 4 | missing original vent plates to Level 1 and Level 2 | | provide cover/plates to cavities that does not impact undamaged fabric. |

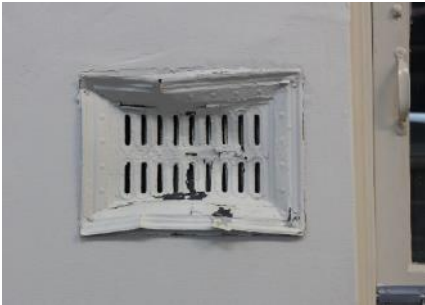
| No. | Issue | Image | Action |
|---|---|---|---|
| 5 | damaged or dilapidated original vent plate to Level 1 and Level 2 | | <p>If highly damaged, highly warped, missing screws or partially unscrewed:</p> <ul style="list-style-type: none"> <li>• document location of plate;</li> <li>• carefully remove plate;</li> <li>• store plate on site</li> <li>• provide cover/plates to cavities that does not impact undamaged fabric.</li> </ul> |

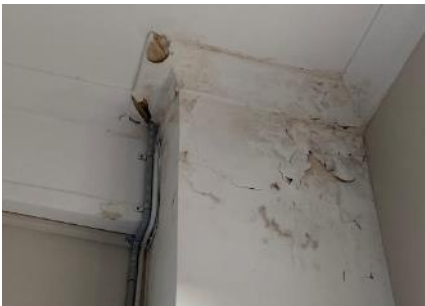
| No. | Issue | Image | Action |
|---|---|---|---|
| 6 | Peeling paintwork and potential damp issues to north-west corner of Level 2, classroom A19. | | Strip back paintwork, identify and rectify source of water ingress and assess damp levels. Do not repaint until ingress is rectified. |

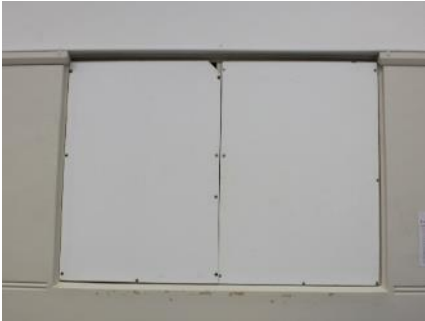
| No. | Issue | Image | Action |
|---|---|---|---|
| 7 | Intrusive boarding to internal windows to all levels. | | Carefully remove boarding and identify and document feature behind. Putty or apply non-toxic and reversable resin to cavities and damaged segments. |

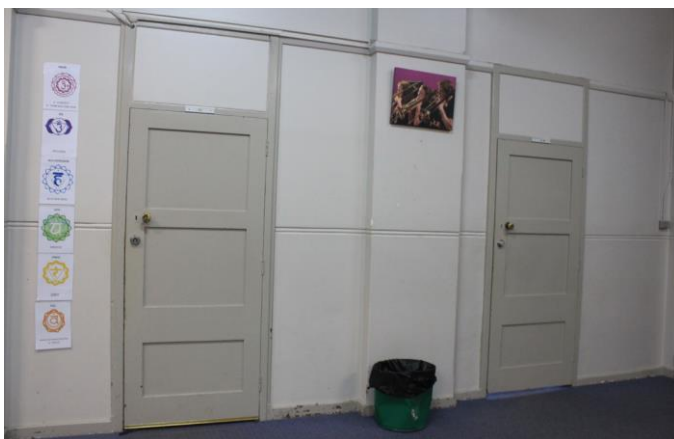
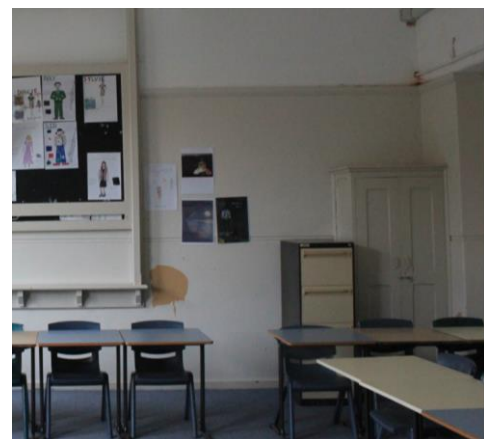
**Plate 9.3** Doors proposed for removal (left) and typical Ground Level classroom west wall (right).  
Source: EMM 2021.

The three doors proposed for demolition have been identified as original to the building. Note that the door located in the second performance room has been painted black however the door frame is in good condition and the early/original door handle is present. Their removal would constitute an unnecessary loss of original fabric and would impact the visual cohesion throughout the level and performance spaces. Impacts would be overall moderate and potentially minor if the doors were retained and were able to be reinstated in the future if required see recommendations.

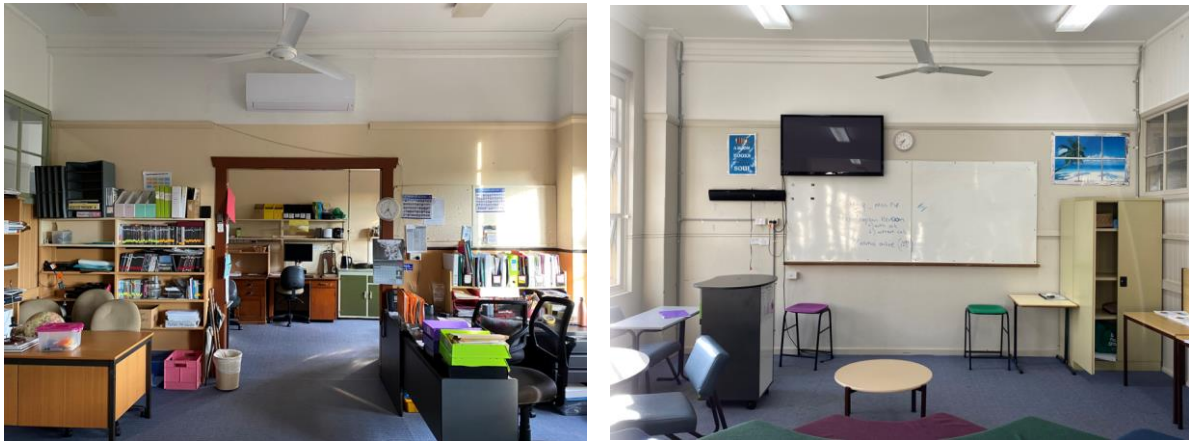
Two of the walls proposed for demolition, associated with the small A21 western staff room and A19 classroom, are original to the Block A building (Plate 9.5). Impacts would be minor through the removal of the A21 western staff room wall as the fabric has been modified in the past to include a portal, impacting its overall significance.

Removal of the wall between classrooms A18 and A19 would result in the removal of minor wall detailing such as skirting, dados and cornices and includes non-significant shelving in A18. The classrooms do not exhibit significance wall elements such as original blackboards. The removal of the full extent of the wall would constitute the irreversible loss of original fabric and moderate heritage impacts.

The partition wall between the A19 classroom and A21 staff room was likely constructed in the inter-war period to mid-twentieth century and is of little significance and would have a generally minor impact. The main wall to the hallway also constructed in the interwar period would be retained.

**Plate 9.5** Original wall fabric to staff room A21 (left) and classroom A19 proposed for demolition.  
Source: EMM 2021.

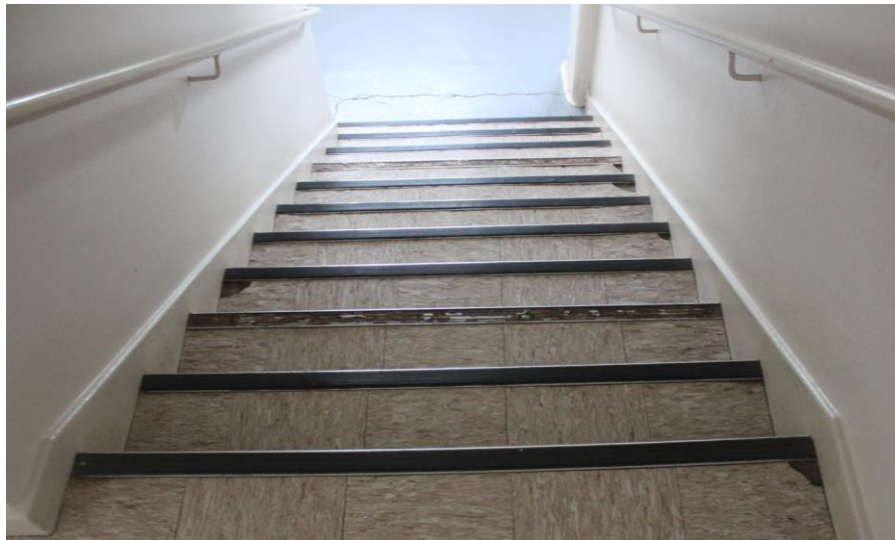
**Plate 9.6** Western Block A stairway with vinyl flooring. Source: EMM 2021.

Due to the current mid-century vinyl flooring, it is difficult to ascertain the nature and condition of both of the original concrete stairs. It is assumed that the vinyl flooring was applied directly to the original concrete surface. The heritage significance of the east and west stairs would be moderate as they are original but modified elements that were utilised exclusively for circulation and the steps do not exhibit any unique or significant architectural detailing.

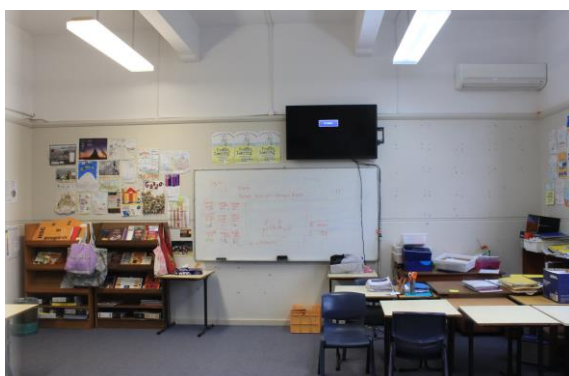
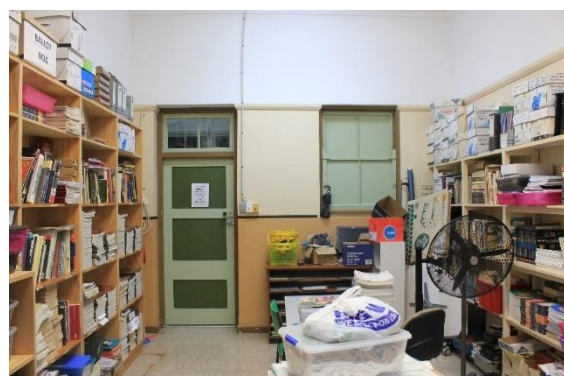
The location of the proposed Ground Level amenities would be within a current classroom space to the east and south walls. The east wall to classrooms does not generally include elements or features of particular significance (refer to photograph below) as the west wall does (blackboards, fireplaces and cabinets). The defined space of the proposed amenities to the Ground Floor would include a window to the south wall, which is to be retained as well as the majority of the east and south wall surface area. Overall impacts would be minor to moderate.

The Level 1 amenities will be introduced to the current storeroom space that is similar in level of wall detailing to the Ground Level classroom east walls however it is more intact in terms of previous penetrations and physical interventions to its fabric. The space includes non-significant shelving that would have no impact to the heritage significance of the space if removed (refer to image below). The Level 1 amenities would require greater intervention to original fabric as it would be bounded by four original walls. Impacts are likely to be moderate.

## Plate 9.8 Typical Ground Level classroom east wall (left) and Level 1 store room (right). Source: EMM 2021.

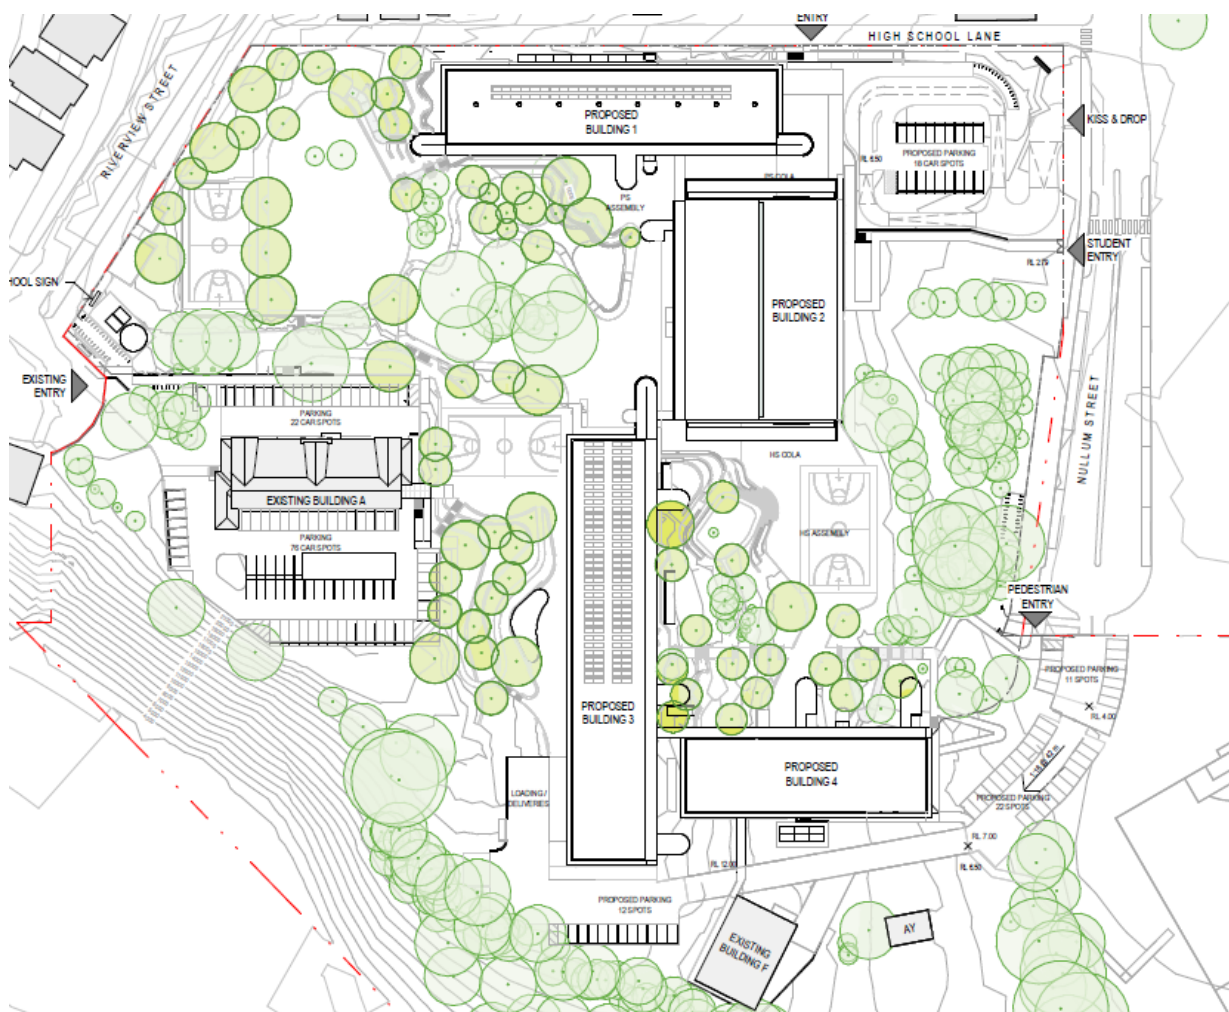
**Plate 9.11** Proposed new school buildings to be constructed at the Murwillumbah High School site.  
Source: Architectus.

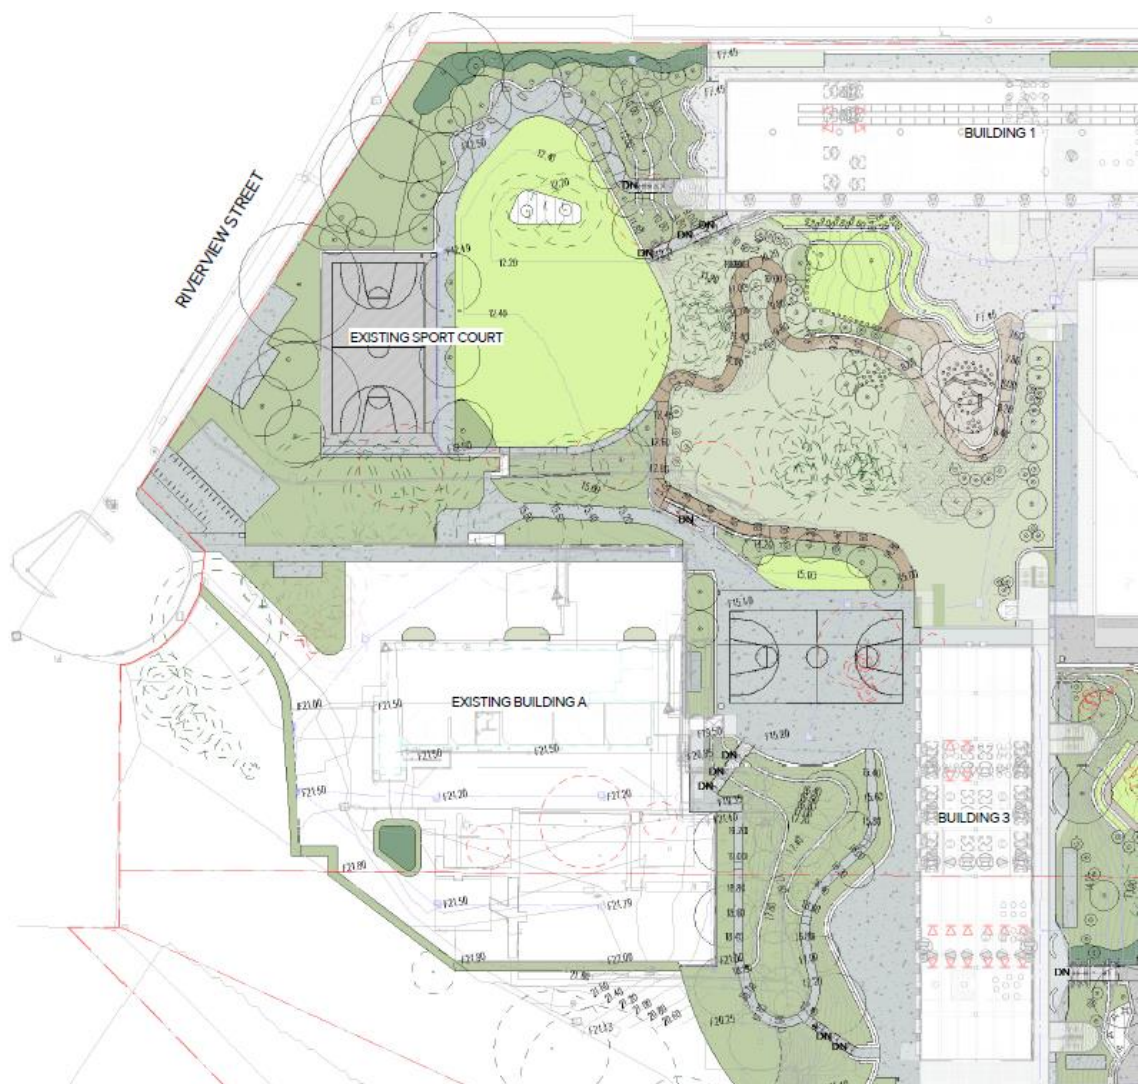
**Plate 9.13 Proposed landscape plan near to and surrounding Block A. Source: Arcadia**
