Blind Creek
Solar Farm

Tarago Road Intersection Changes to the EIS

VERSION 2

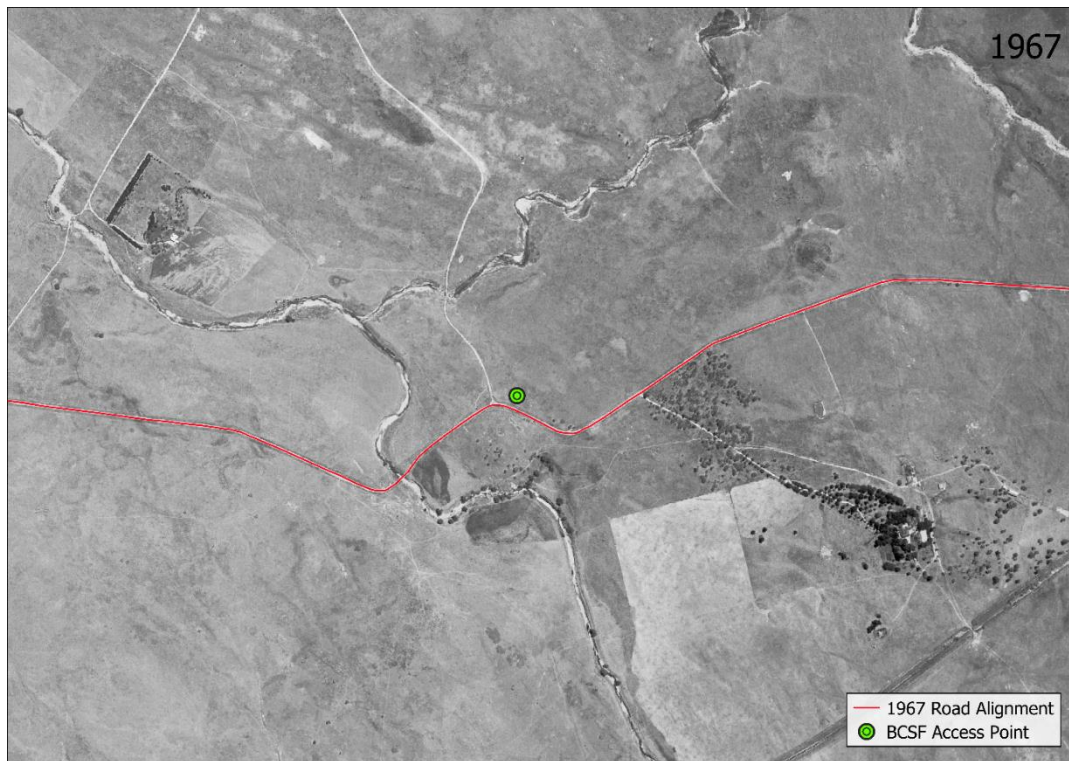
Figure 1 – Tarago Road alignment in 1967, digitised from historical arial imagery taken March 4th 1967.

According to our analysis of historical arial imagery, the intersection was built sometime between 1967 and 1976, coinciding the realignment and re-construction of the Tarago Rd. Previously, the access to the property was in a slightly different location. Please refer to Figure 1 and Figure 2 to see both the alteration of the entrance and the realignment of the Tarago Road. The most notable change was a large cutting through the hill adjacent to the entrance and the fill of a low lying area allowing the Tarago Road to be straightened.

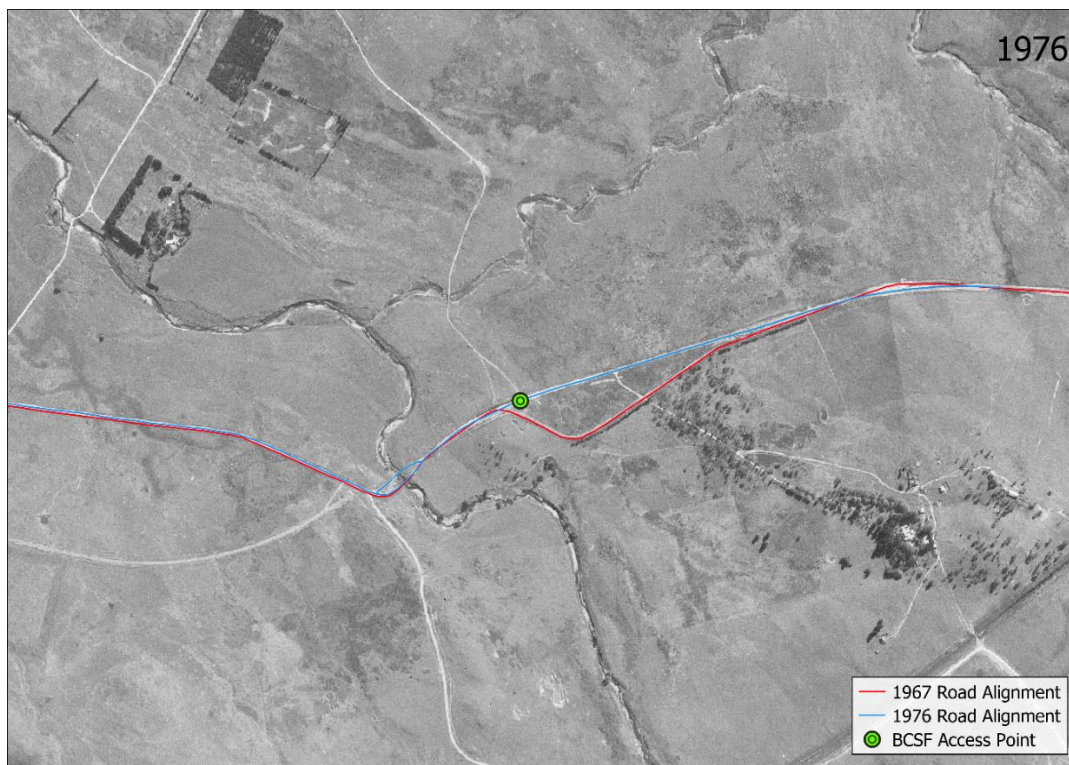
Figure 2 - Tarago Road alignment in 1976, digitised from historical arial imagery taken May 5th 1976.

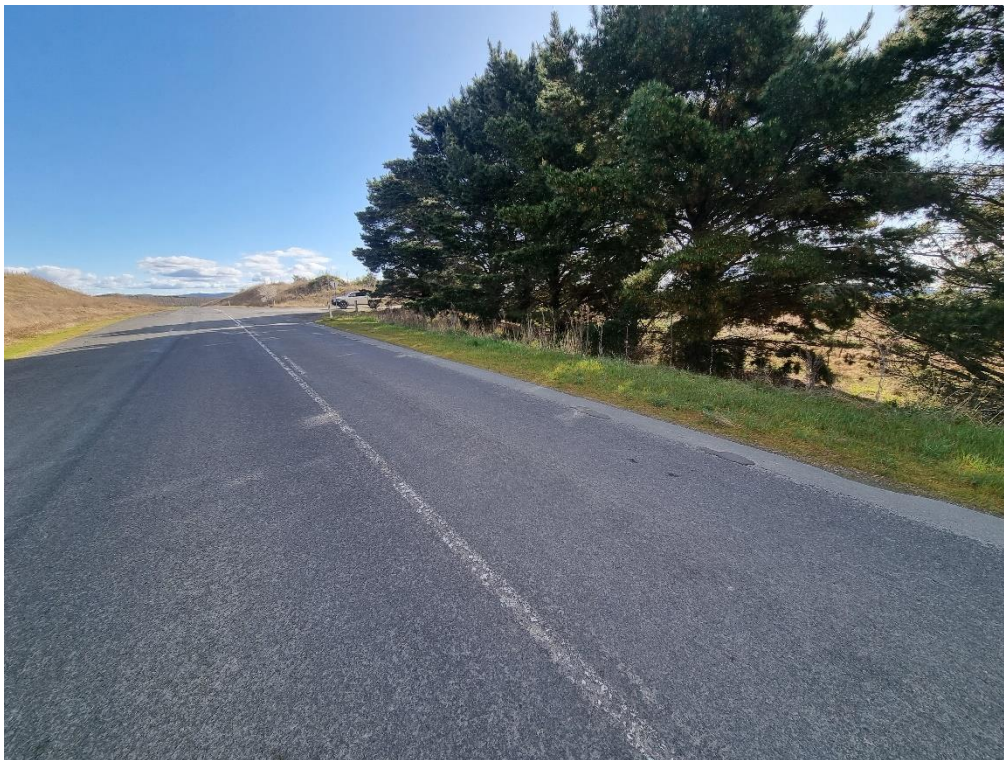
FIGURE 3 LOOKING SOUTH-WEST TO THE CUTTING

- The ‘cutting’ of the western road section from the existing north-facing slope of the knoll.
- The building of the eastern road section using a ‘fill’ over the low-lying marsh area it crosses.
- Cutting of drainage gutters on both sides of the road.
- Further cutting of the intersection area to install a culvert

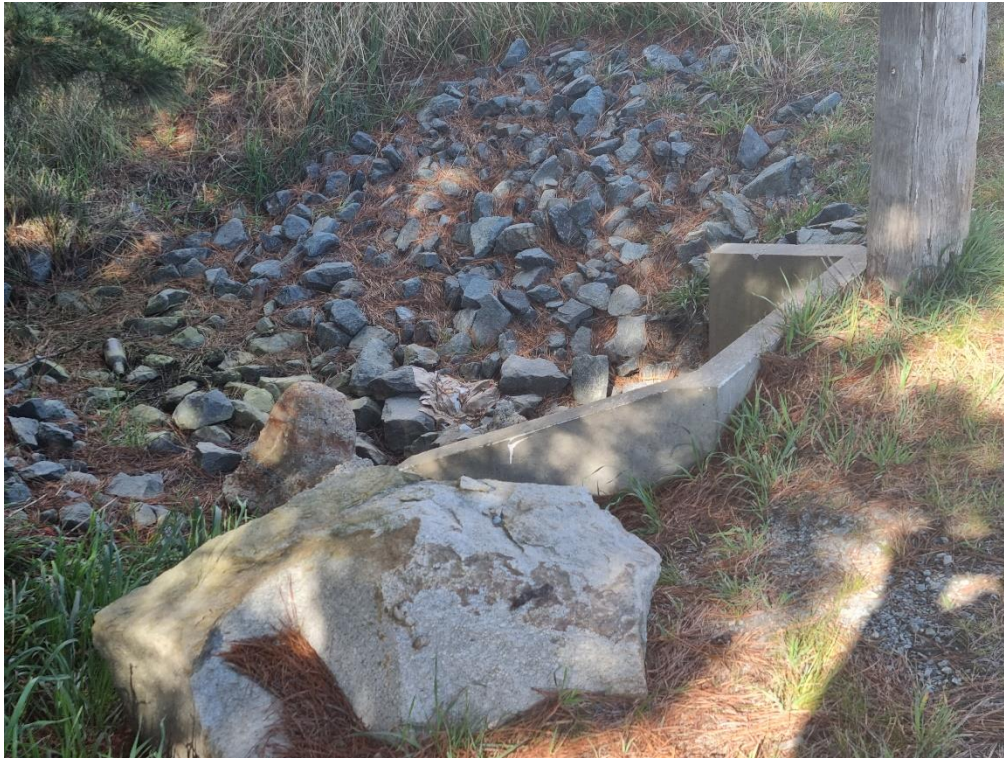
FIGURE 4 CULVERT ACROSS THE INTERSECTION (NORTH HEADWALL AND SWALE SHOWN)

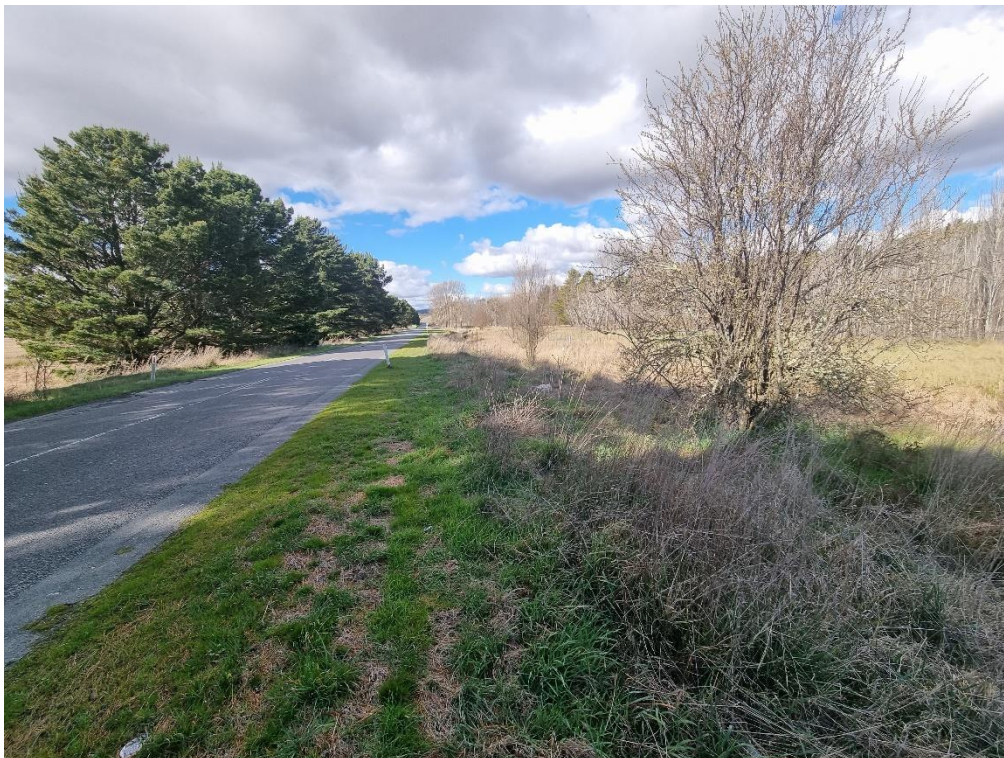
FIGURE 5 LOOKING NORTH-EAST, WITH THE EMBANKMENT ABOVE THE LOW-LYING NATURAL GROUND CLEARLY DISCERNIBLE.

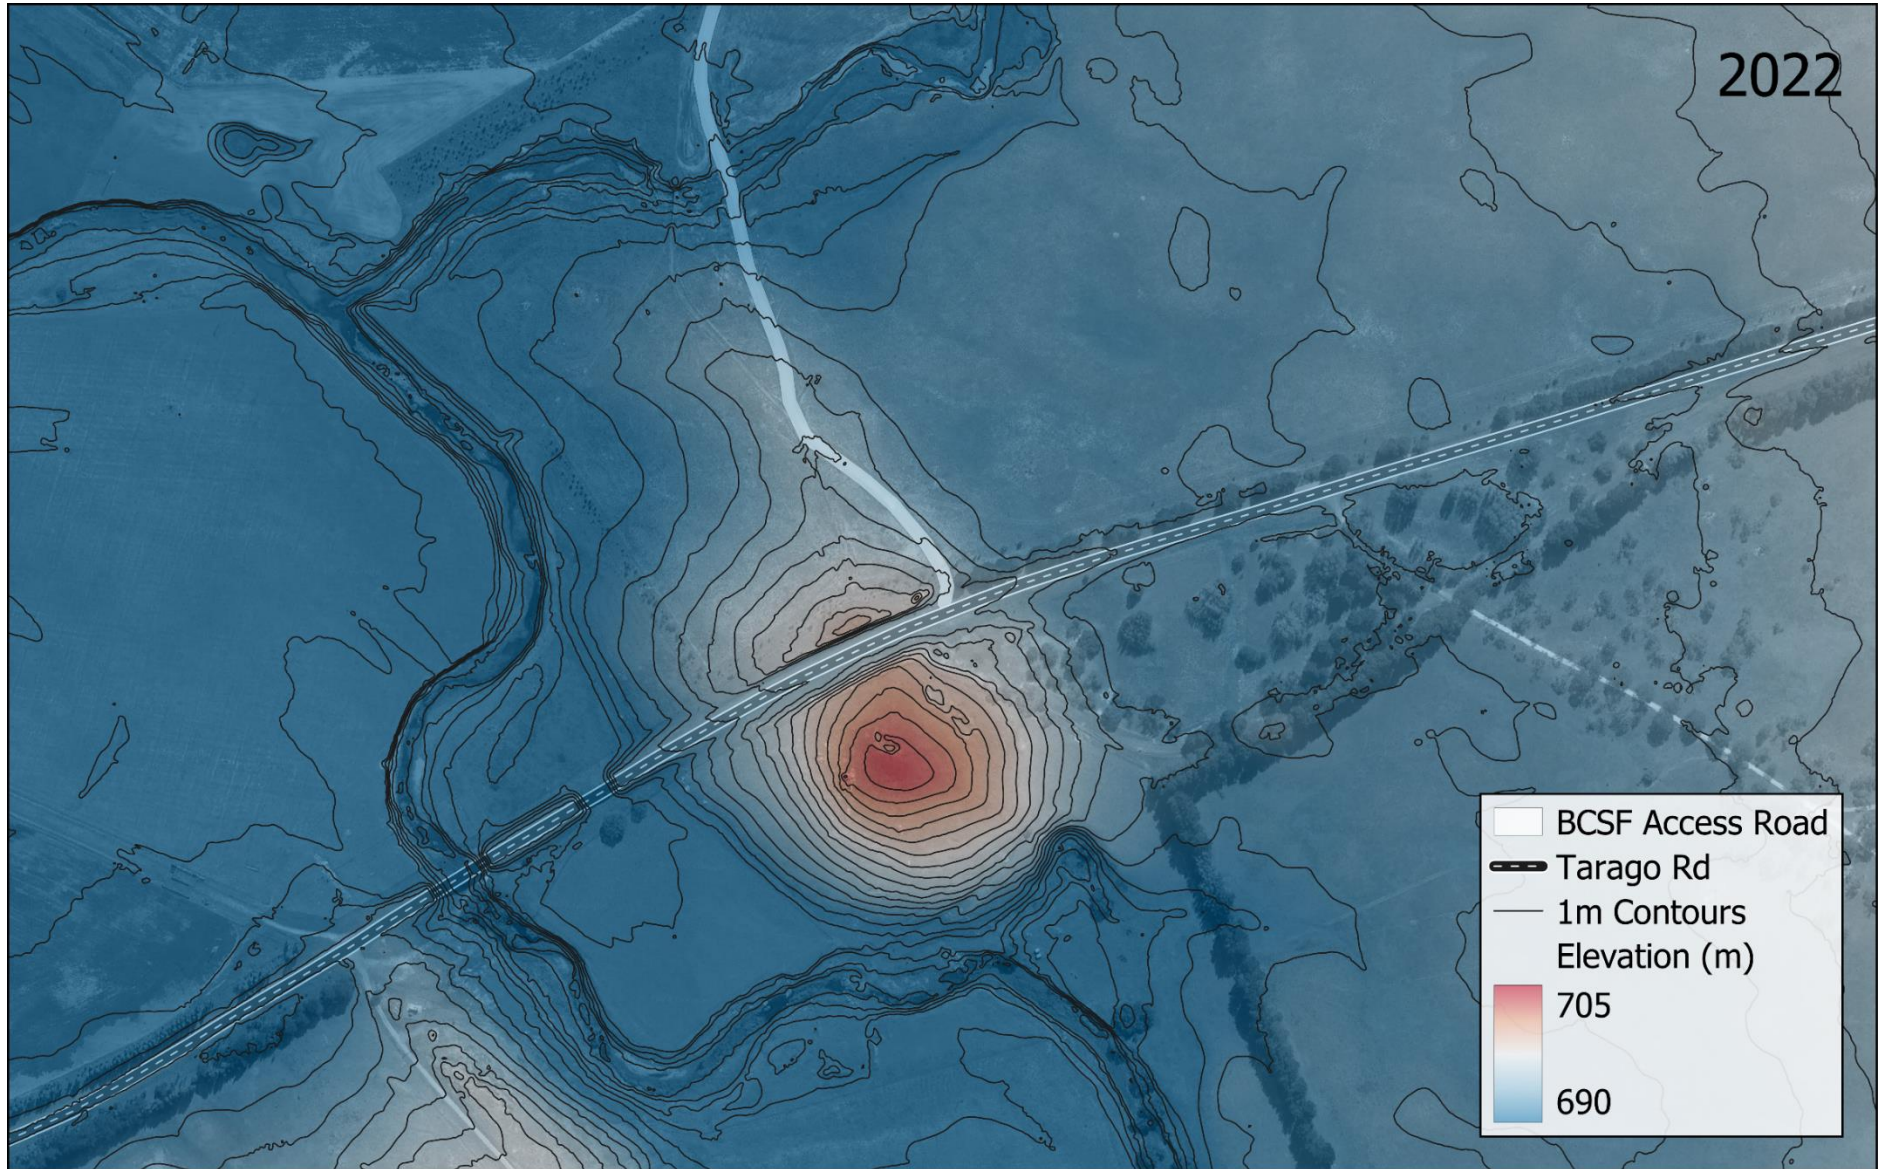
Figure 6 - Current Tarago Road alignment and surrounding topography.

Figure 6 shows the current alignment of the Tarago Rd and its signature through the elevation contours, particularly noticeable on the road section to the west of the intersection. *Figure 7* illustrates our method of determining the historically disturbed footprint, specifying the positions of the elevation profiles shown in Figures 5 – 8.

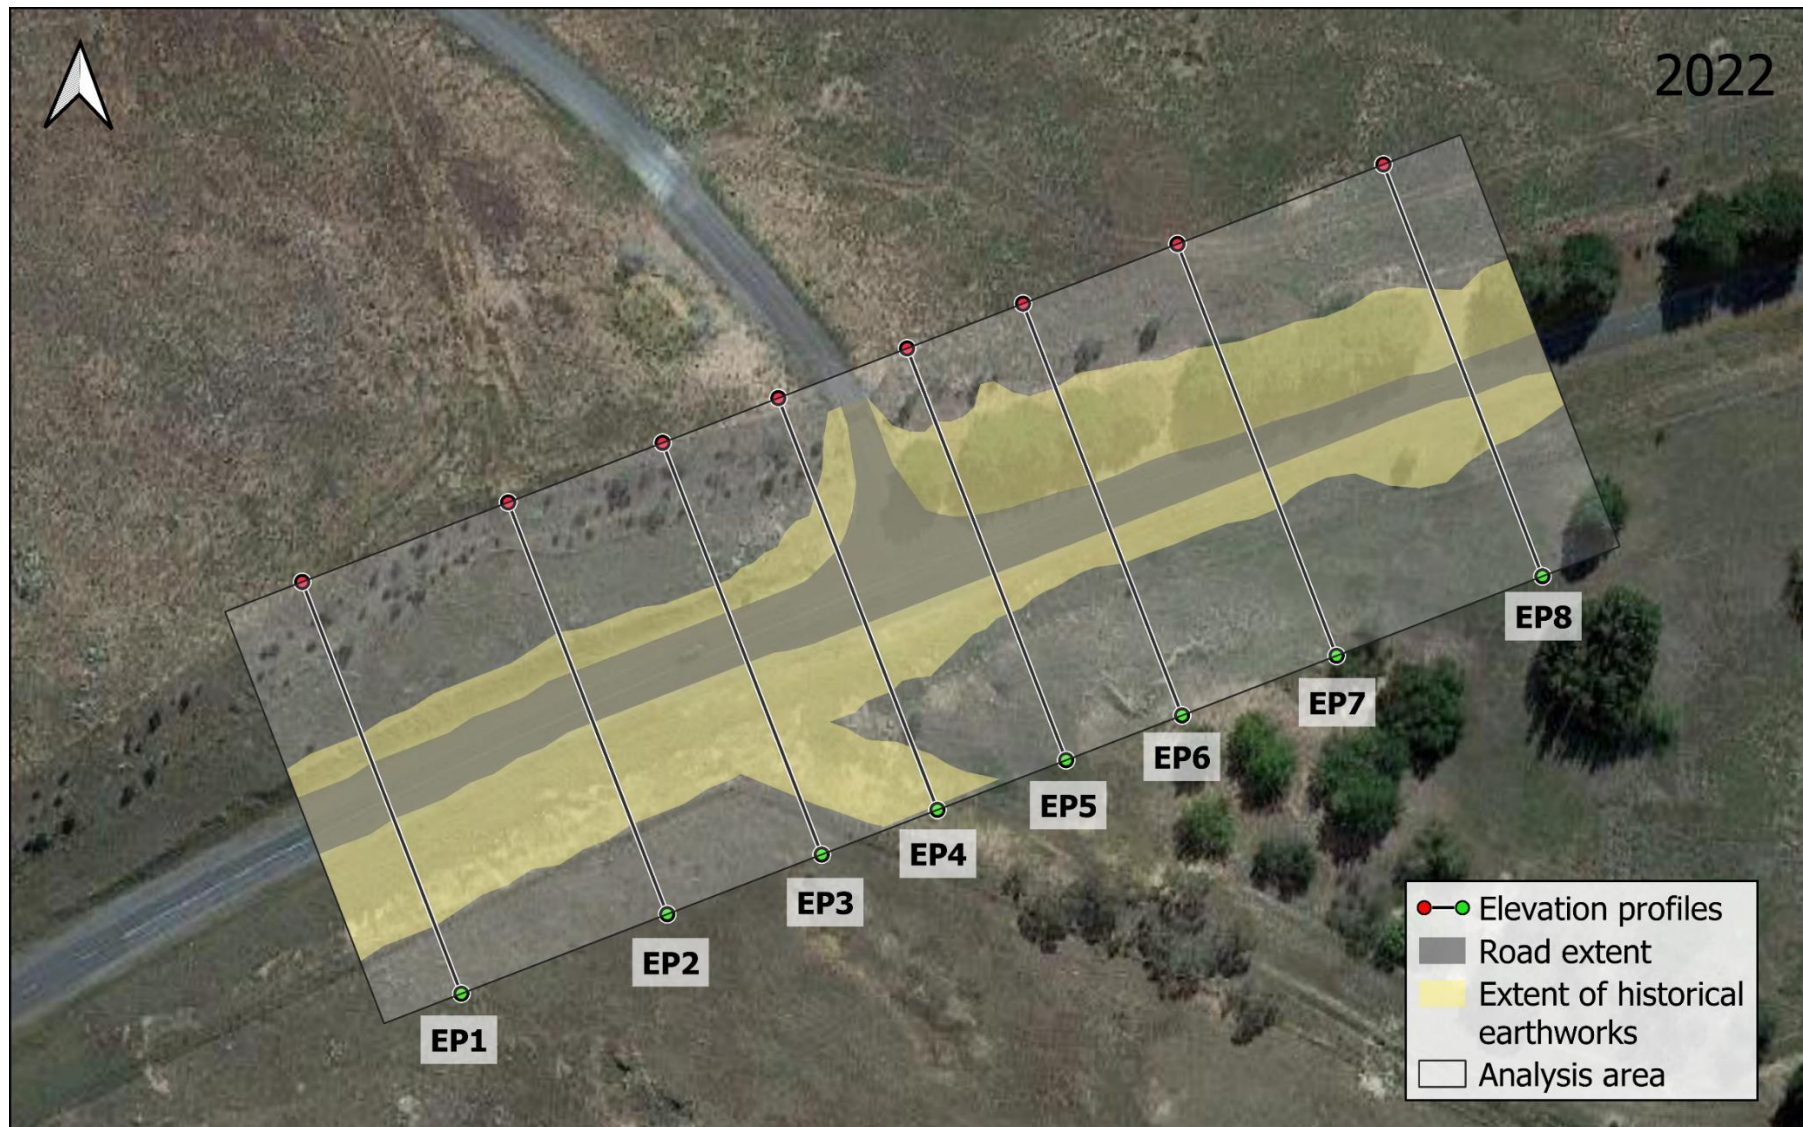
Figure 7 – Position of the analysis area and elevation profiles considered in this response. The related elevations profiles are shown on the following pages. The interpolated disturbed area footprint is shown.

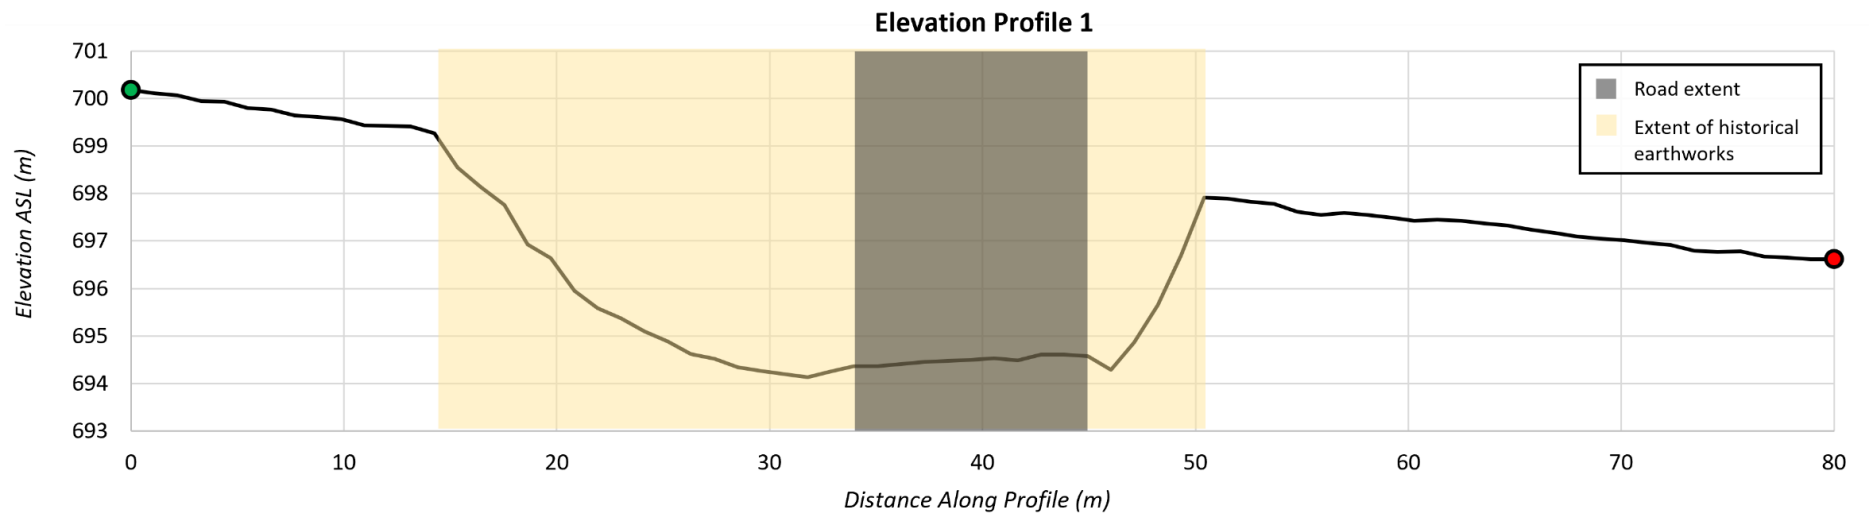
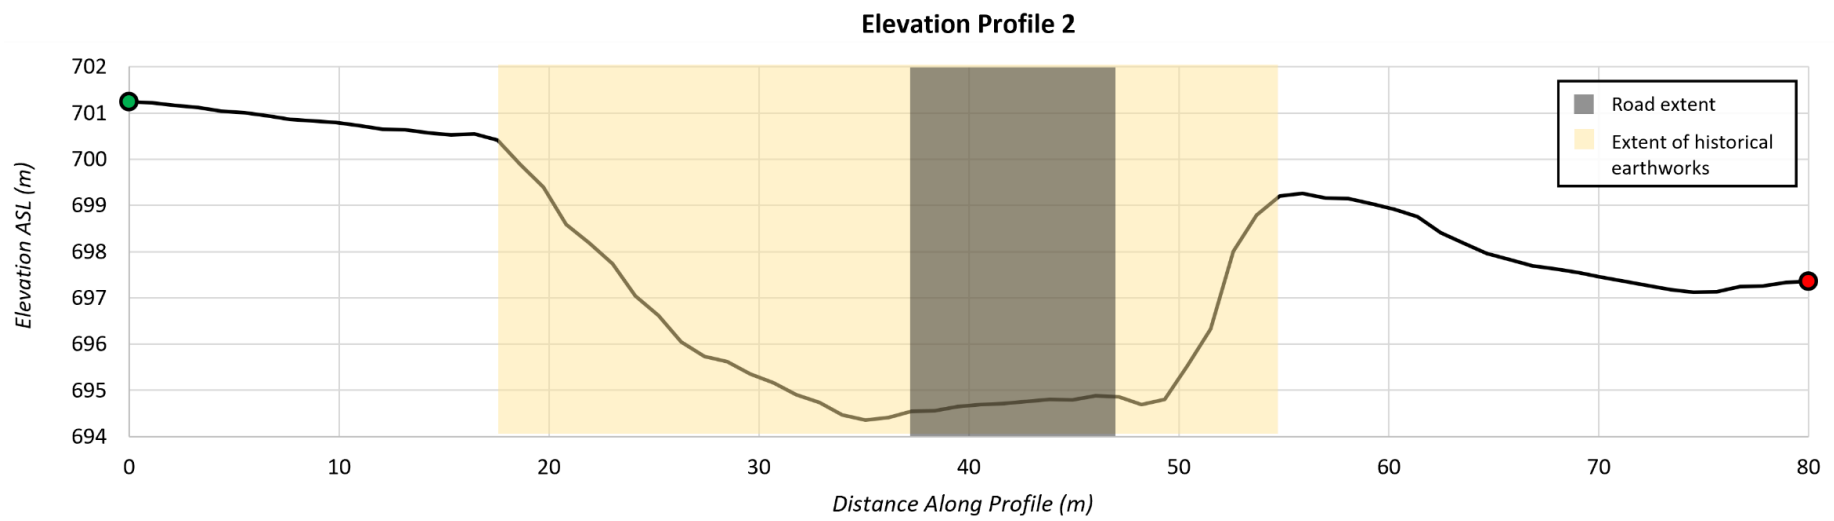
Figure 8 – Elevation profiles for cross-sections marked in Figure 7

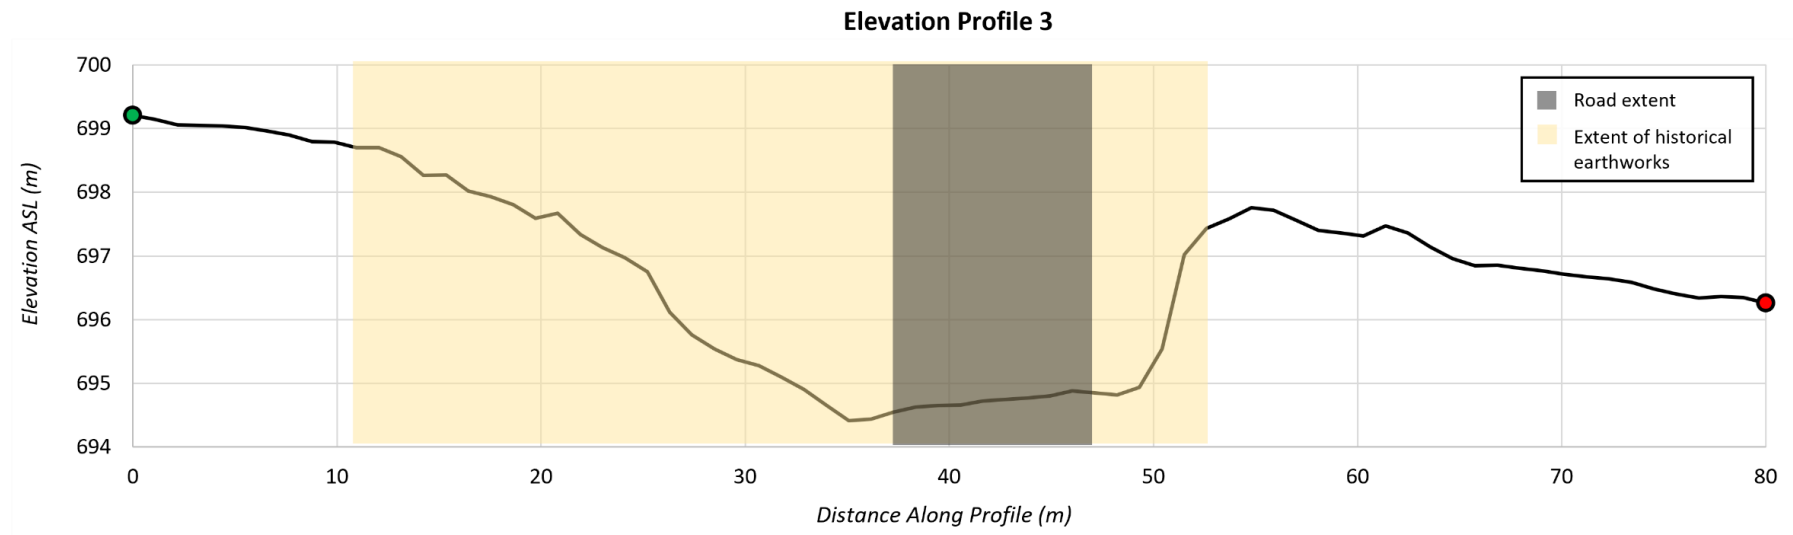
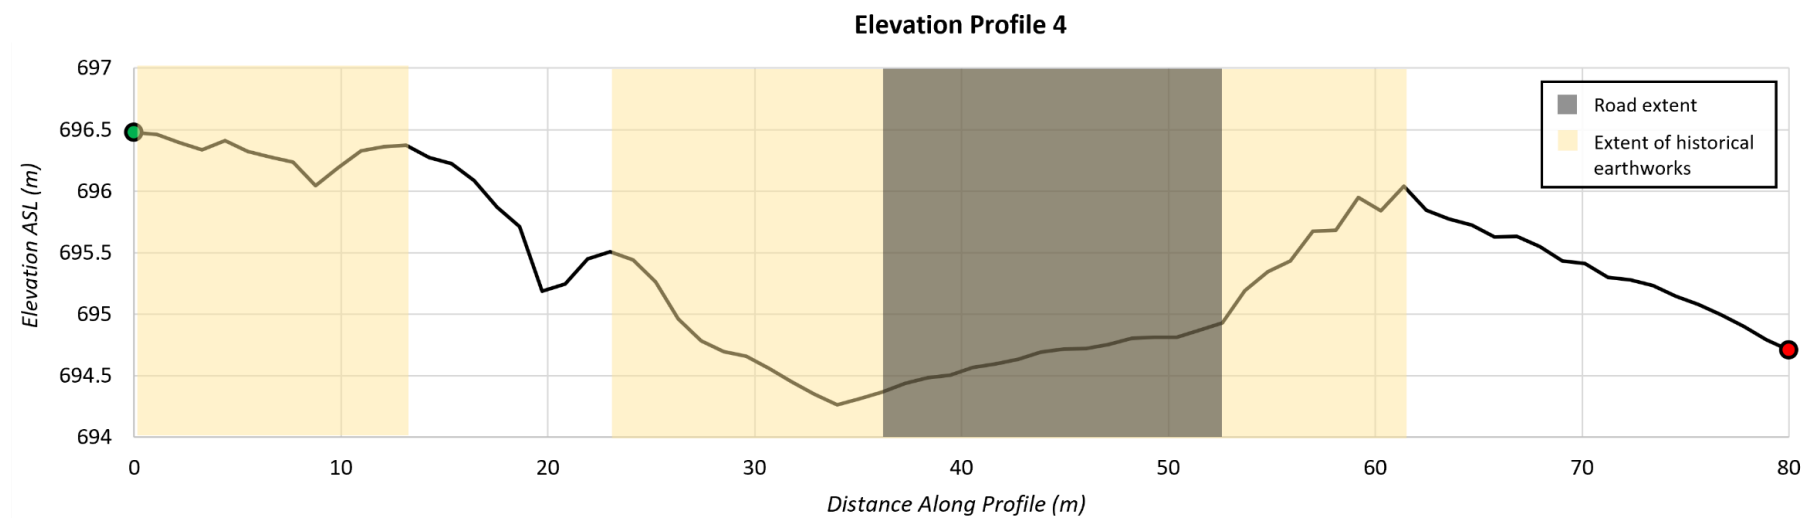
Figure 9 - Elevation profiles for cross-sections marked in Figure 7

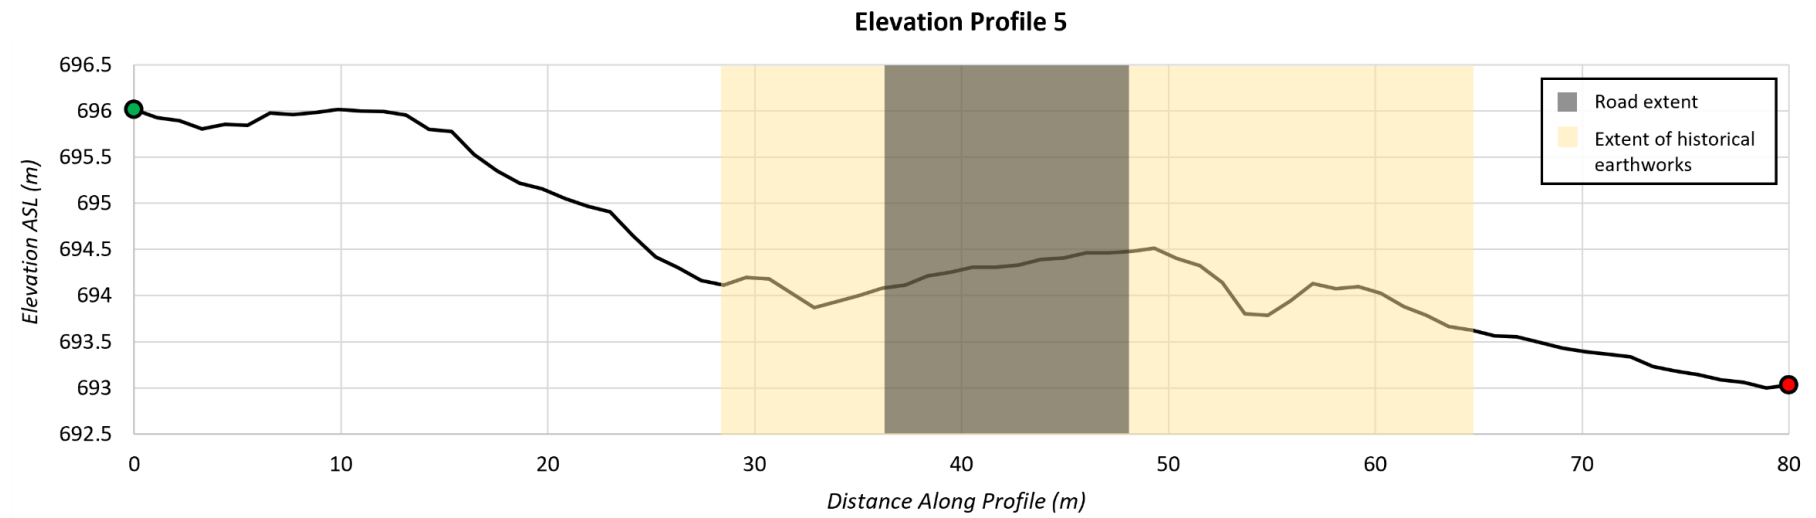
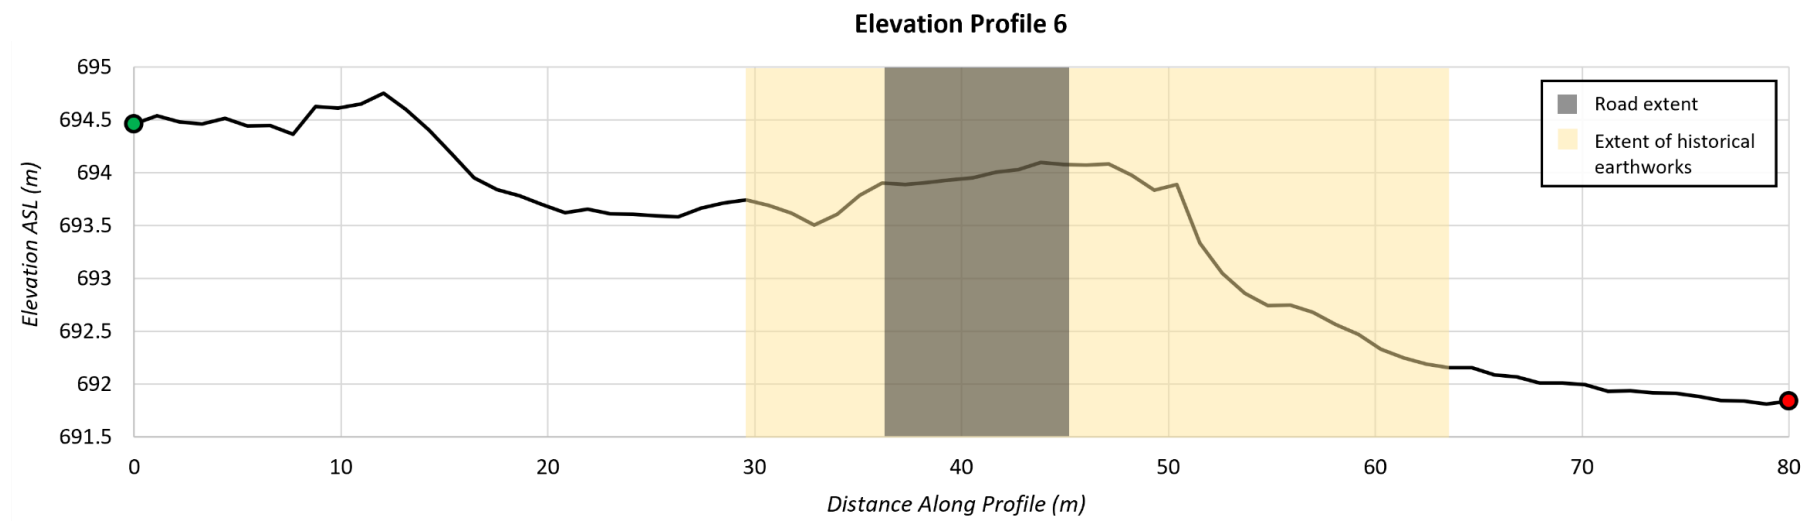
Figure 10 - Elevation profiles for cross-sections marked in Figure 7

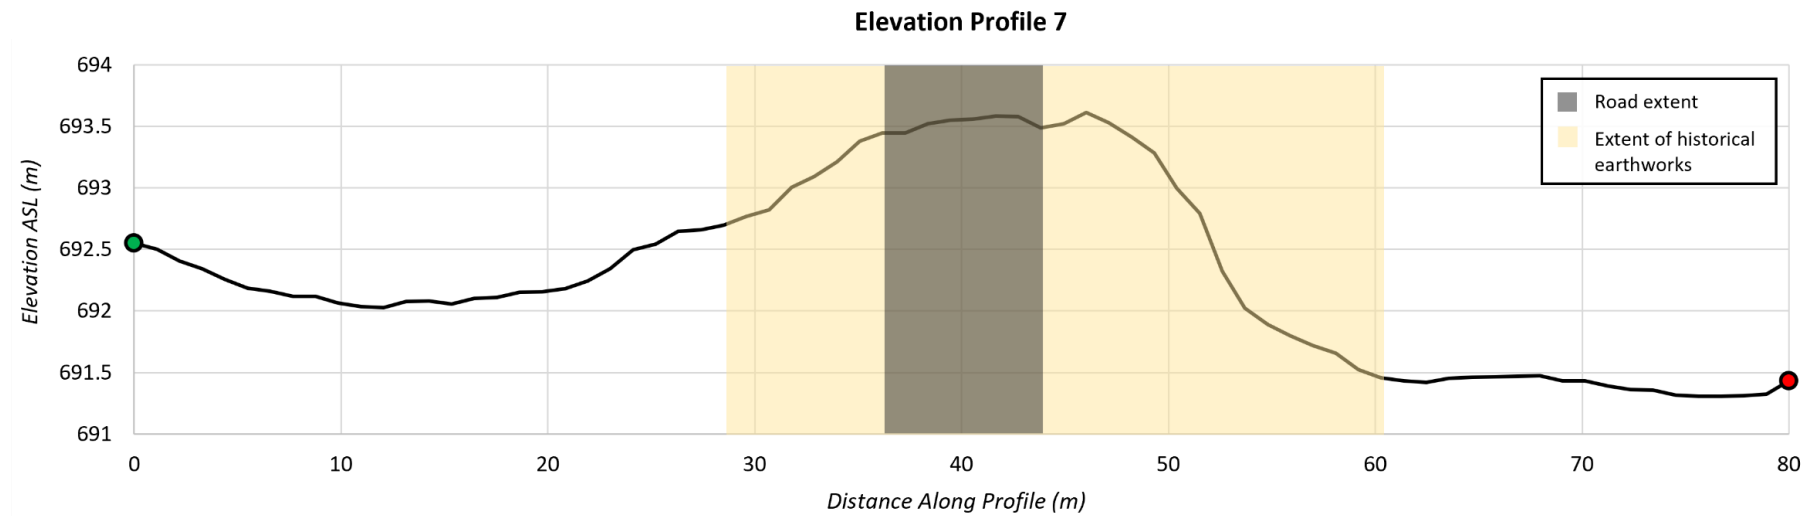
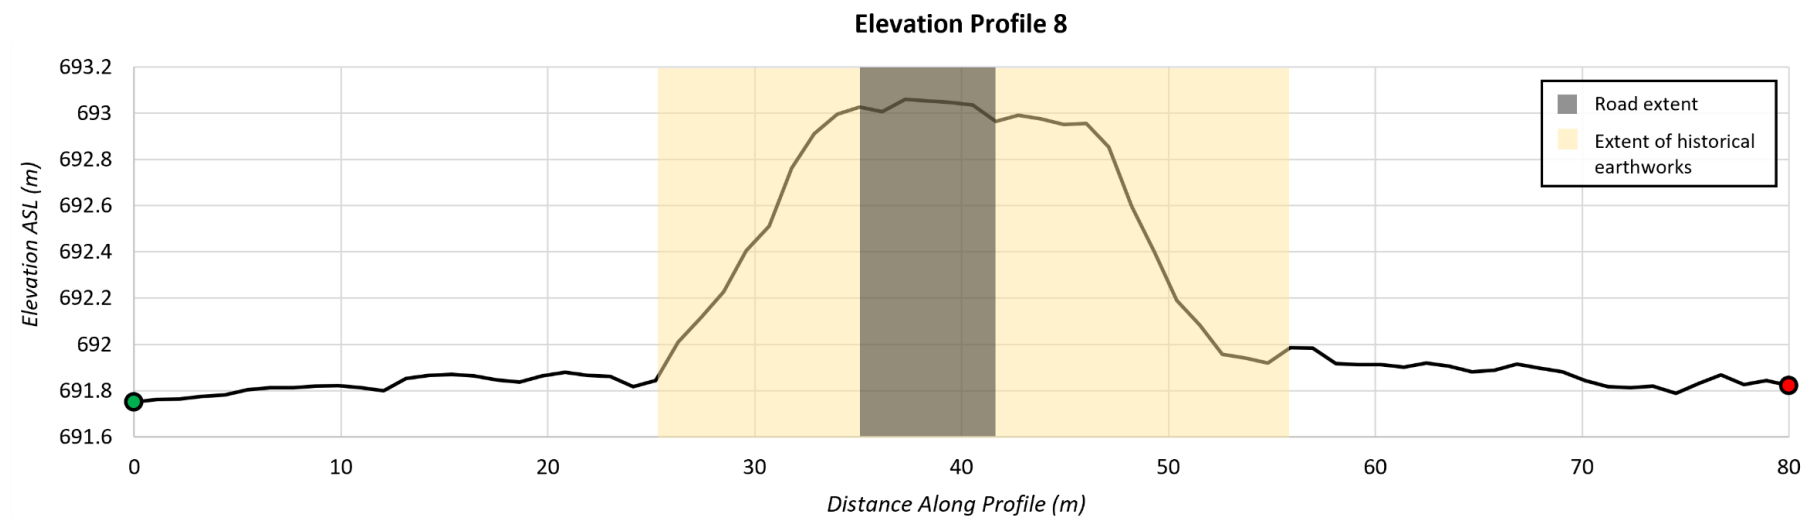
Figure 11 - Elevation profiles for cross-sections marked in Figure 7

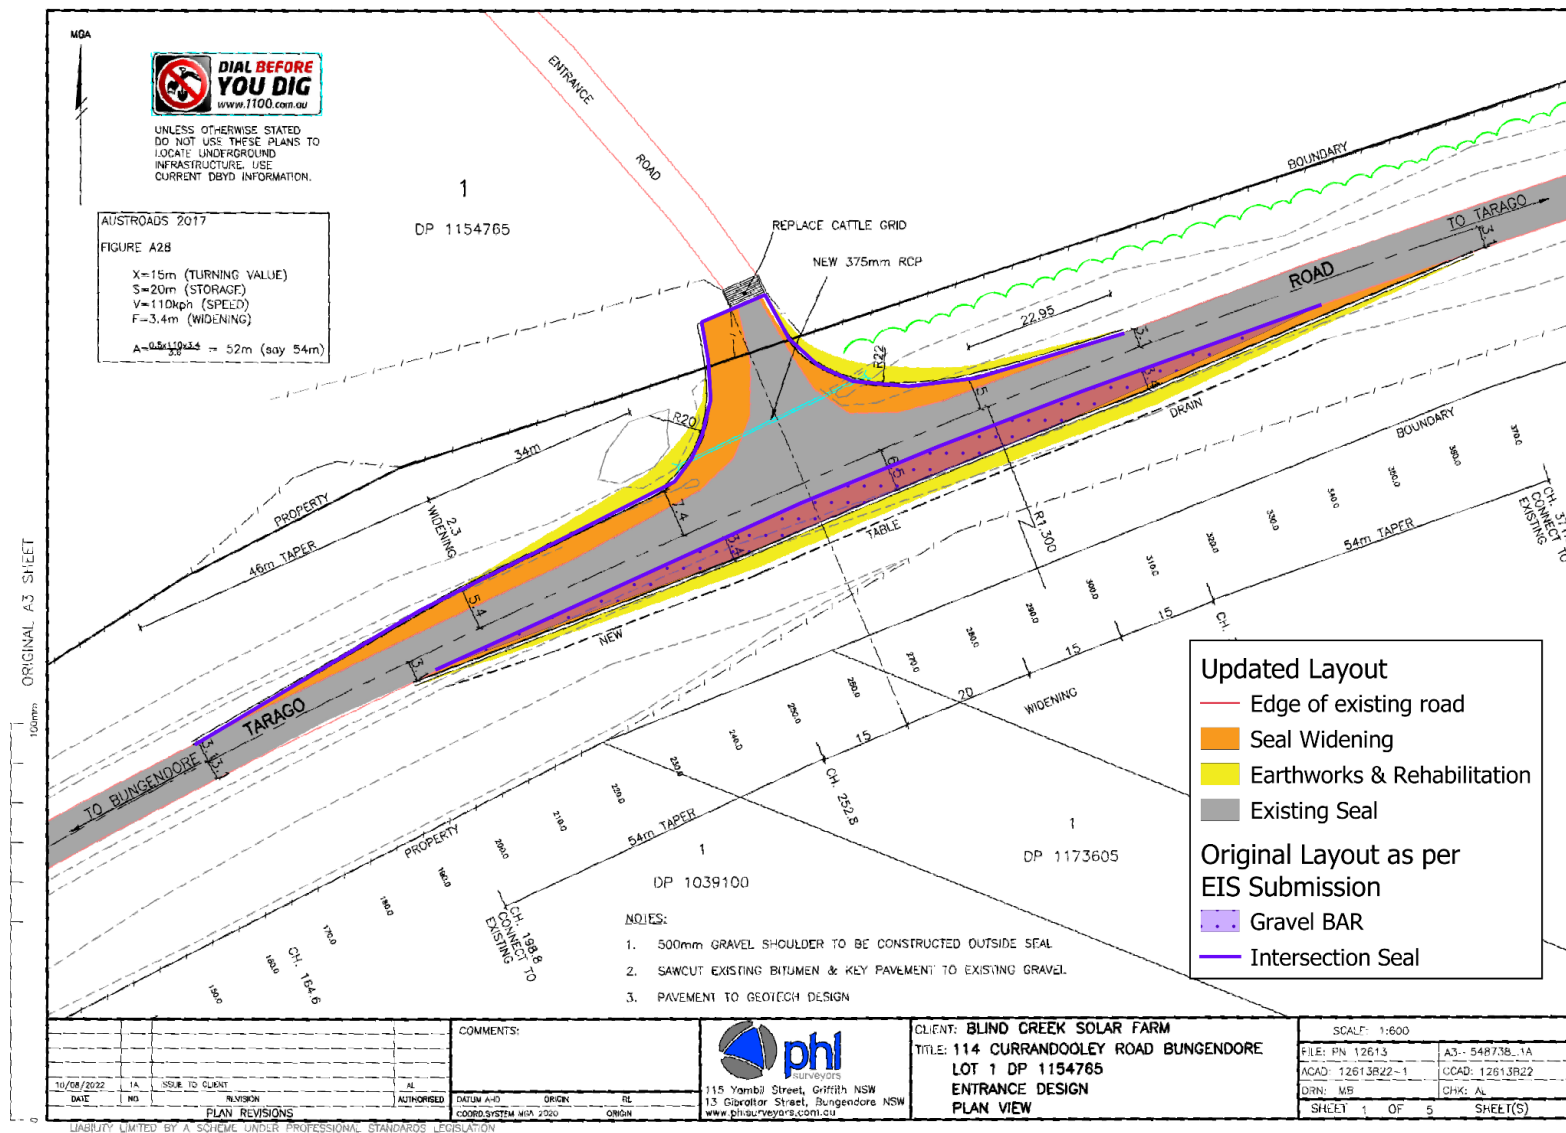
FIGURE 12 COMPARISON OF THE EIS SUBMISSION DESIGN AND THE AMENDED DESIGN.

The updated intersection layout and the original layout proposed in the EIS of March 2022 are compared in Figure 12. The differences include; one further area of seal widening on the south side of Tarago Rd which was mainly shown as gravel on the original; and three clarified areas of earthworks and rehabilitation (which were not shown on the original but were planned). We note that all additional works are within the historically disturbed area identified in our topographic analysis described below.
