CONSERVATION MANAGEMENT PLAN

Adina Hotel (Former Parcels
Post), 2 Lee Street,
Haymarket

Prepared for
TOGA PTY LTD
24 November 2022

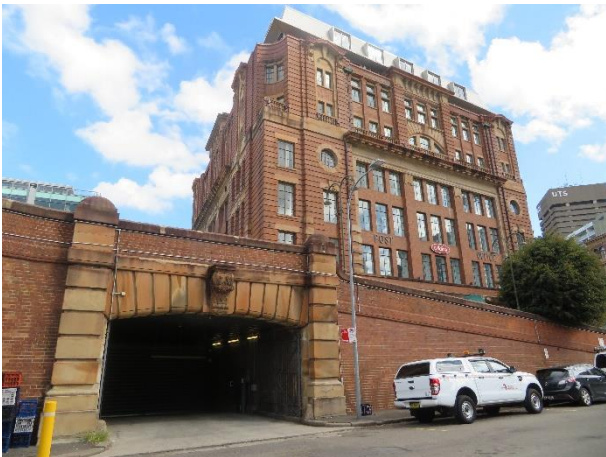
Figure 98 – Vehicle entry to the basement level. Note the ornate sandstone framing.

Vehicle access to the basement is via the former rear yard entry, through the subway below the ramp to the YHA, from Ambulance Avenue. The sandstone arch dates to the construction of the Parcels Post building in 1912. The external sandstone arch remains intact however the drive now ramps down to access the basement. The entry is flanked by heavily rusticated sandstone piers, with a segmental arch and decorative keystone bracket. The decorative wrought iron gates remain extant.

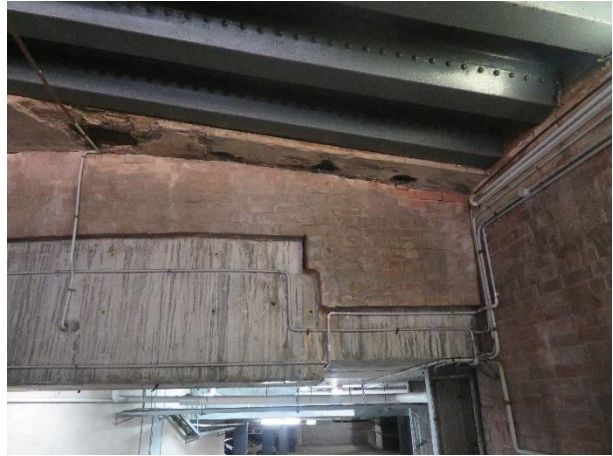
Figure 101 – Basement foundations

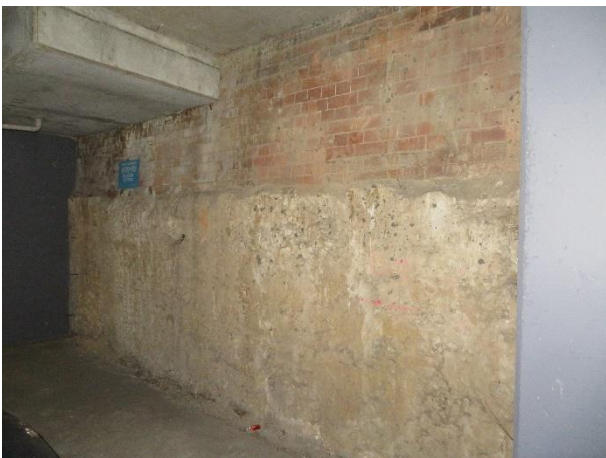
Figure 102 – Basement foundations

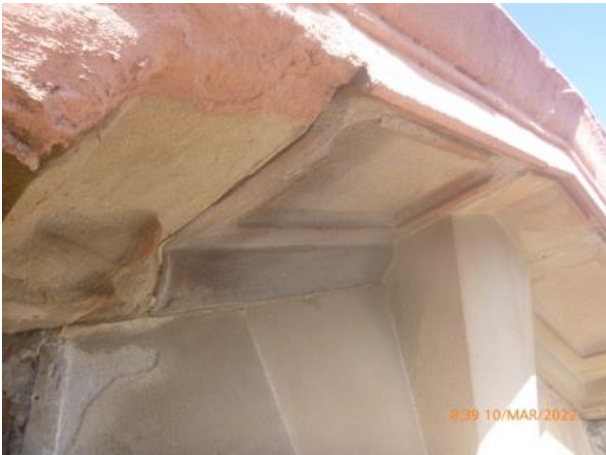
Figure 128 – Sandstone delamination

The 2022 notes that the masonry (brick) is in relatively good condition considering the age of the building. Little works was identified as being required and was limited to localised repointing, isolated brick replacements and the removal of organism growth. However, some missing brickwork at Level 6 required replacement. The sandstone was identified to be significantly deteriorated (significant delamination cracking and some structural cracking of stone) and required significant conservation work.

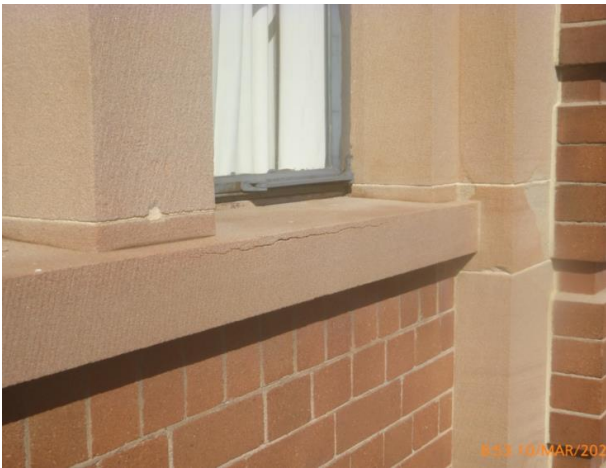
Figure 130 – Sandstone cracking
Source: Apex Diagnostics, 2022

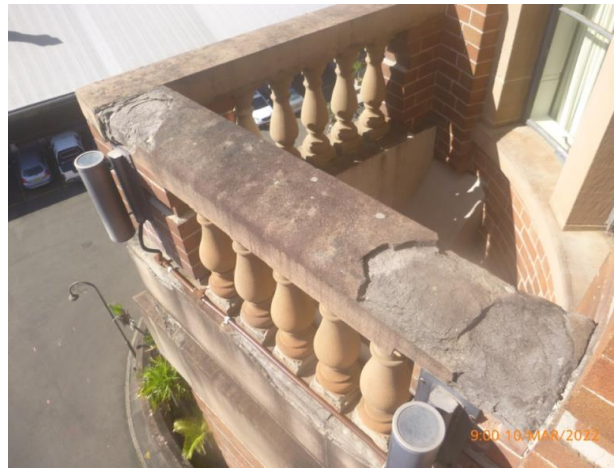
Figure 131 – Sandstone delamination
Source: Apex Diagnostics, 2022

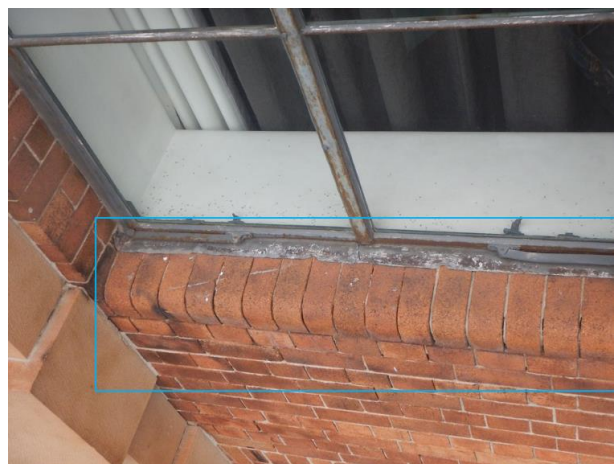
Figure 135 – Pointing erosion
Source: Apex Diagnostics, 2022
