ATTACHMENTS to EXISTING SUBMISSION POINTS

The visual impact report Appendix QQ - Supplementary Visual Impact Assessment by Ethos Urban is extraordinarily misleading. Very elevated drone photography is likely in this report and it is not at all a plausible visual impact assessment.

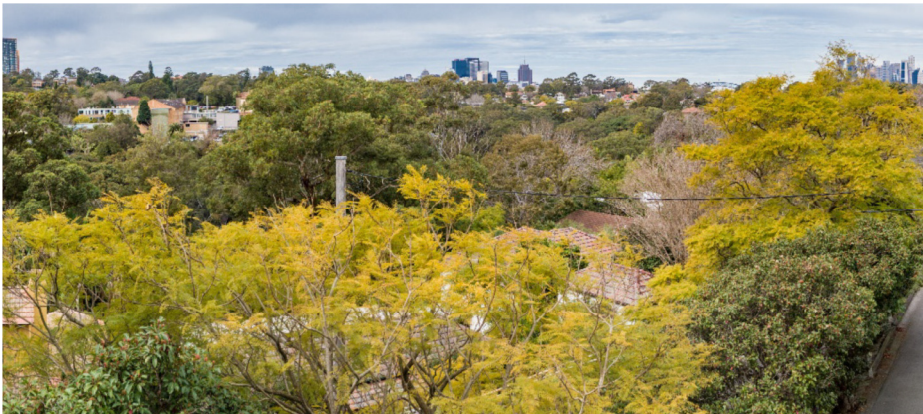
Fig 14 Appendix QQ. Far left shows towers in St Leonards, far right shows Sydney Tower Eye, Westfield, CBD.

It is completely misleading. It has an a cone of vision unlike what would be seen from this property, taking in a huge “fisheye” barrel view, from St Leonards towers about 1.3 km away, to Greenwich Hospital site, about 130 m away, to Sydney Tower Eye, Westfield (Centrepont Tower) in the CBD, about 6km or more away.

Such a highly distorted view distorts completely the size of Greenwich Hospital in the normal field of vision of humans.

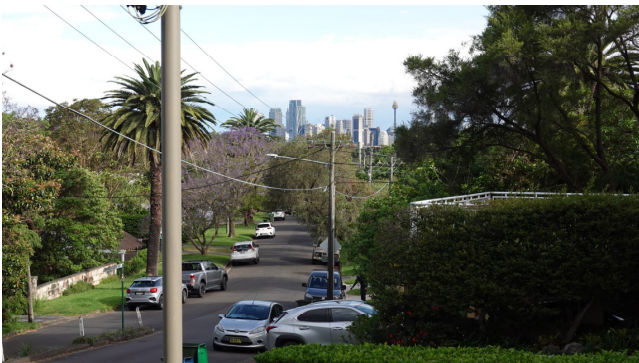
Above: Sydney Tower lies 6km + to the SSE looking along road from 17 Upper Cliff (photo: 50 mm focal length)

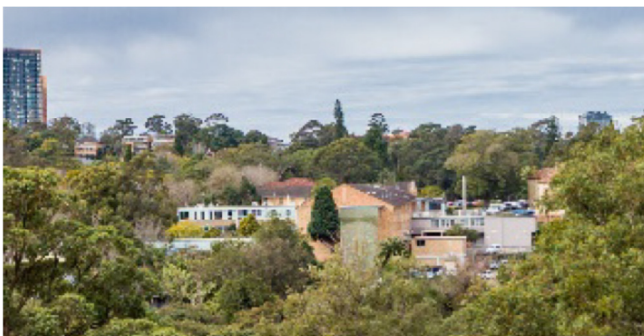
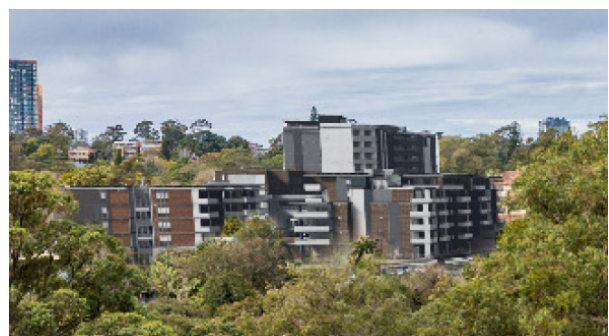
Cropping Fig 14 & Fig 16, App. QQ, although still distorted, indicates more closely the huge visual impact.

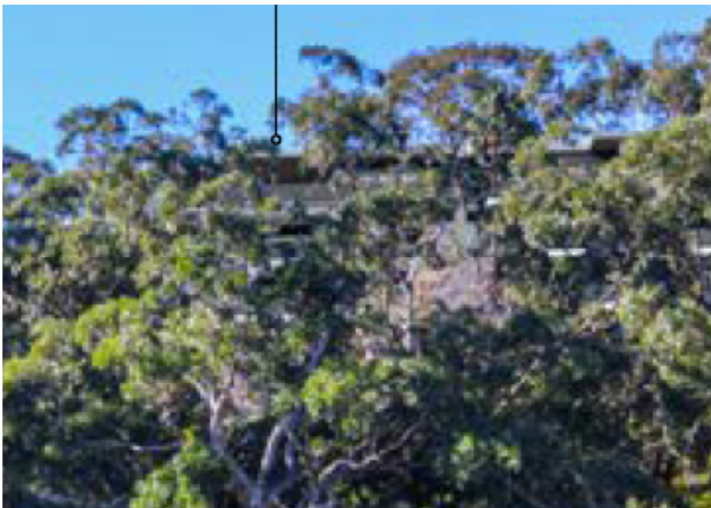
Photomontage View of Proposal.

Viewpoint 2 : Extracts from the 2022 photomontage from Bob Campbell Oval , compared with 2019 photomontage form the same location, shows the 2022 building looking smaller, despite GFA increases. REALLY?

The 2022 version – more GFA, but looks smaller ??

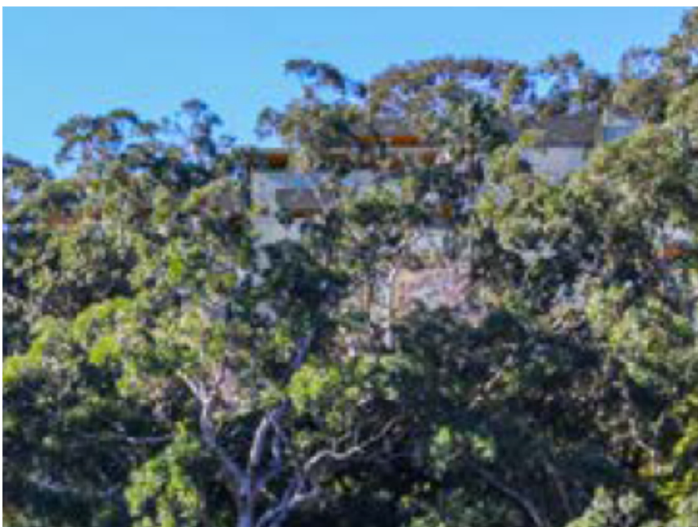
Photomontage View of Proposal.

This is the 2019 version – looks bigger , inexplicably.

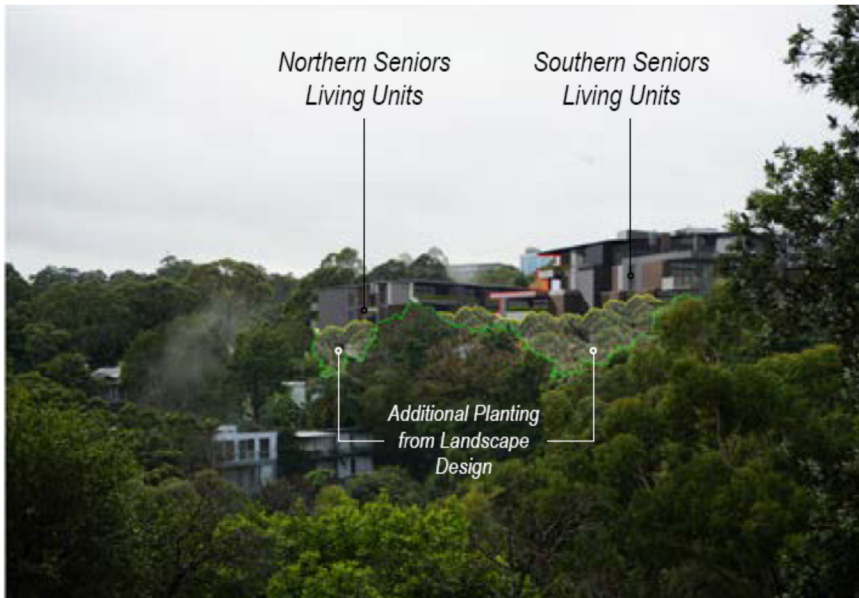
Anticipated View Upon Planting Maturity.

Viewpoint 6: This anticipated view is just as misleading as it was in the 2019 visual impact assessment because it makes the false claim that additional planting when grown to maturity (about 40 years!!) it will obscure the lower portions of the Seniors Buildings.

The Landscape Detail design is now prepared, yet no correction has been made to the text of the notation, see extract below.

Furthermore, the Landscape does not have any planting of such a type to reach this canopy at maturity.

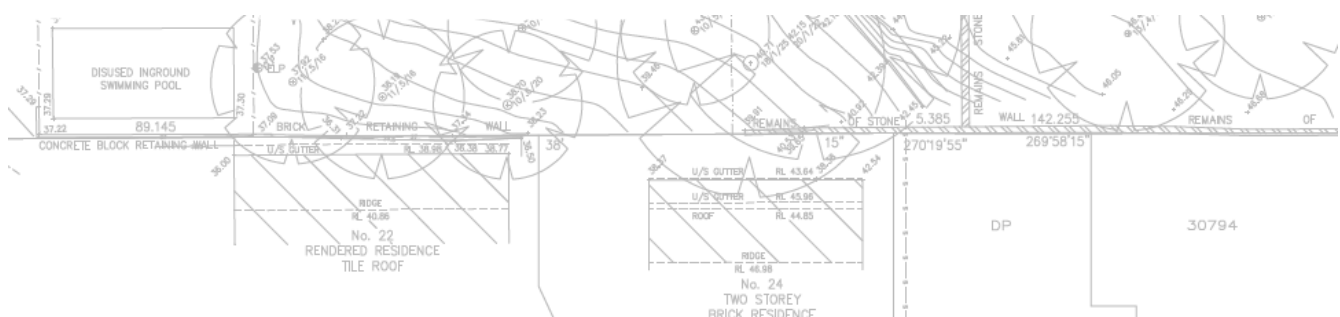
Below: Appendix I 2 Civil Eng. Plan extract at south boundary between adjoining 24 Gore St (wrongly labelled herein as 22 Gore St) and 51 Gore St, Greenwich

Clearly, the underlying Survey layer is the same in each extract above. The wrong house addresses occur in both extracts which is not a co-incidence because the LTS Survey is used as the underlayer for the Civil Engineering. (No. 22 should read 24, and what is labelled No. 24 should read No. 55). It is a common practice in computer aided drafting (CAD) to use the CAD survey in this way, which has the benefit of reducing discrepancies, The CAD survey file can enable accurate measuring and calculations such as slope or gradient, which is important for hydraulic calculations, pipe sizing and fluid dynamics.

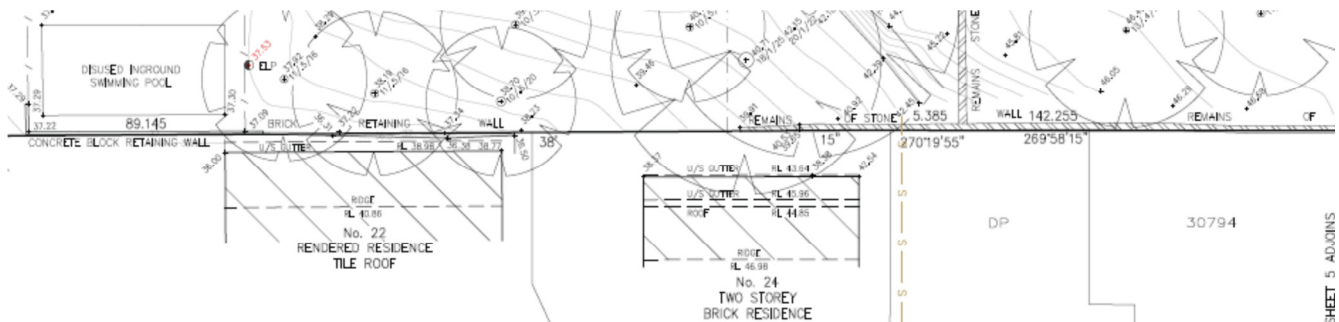
Below: Appendix E Survey—extract at south boundary between adjoining 24 Gore St (wrongly labelled herein as 22 Gore St) and 51 Gore St, Greenwich.

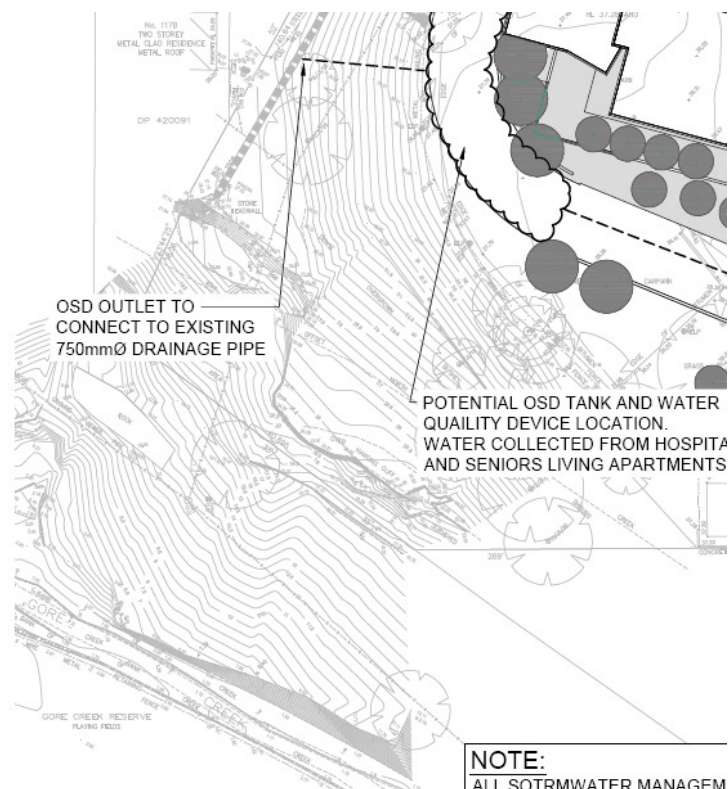
Below : Appendix I 2 Civil Eng. Plan extract at SW b'dy. Below R: Appendix E Survey p.4— extract at SW bound'y

The south-west bushland slope contours below RL 37 appear very differently on the LTS Survey, than on the Civil Eng. Plan. Starting from contour RL 37 (see it at the SW corner of the disused swimming pool) and continuing downslope to Gore Creek, the CAD layer of contour isolines below RL 37 have been altered. In fact, at the west end of the southern boundary, the survey drawing contour gives the corner elevation as being more than four (4) metres higher than on the Civil Eng. Plan does. CAD software has a “stretch” function, which can aid in the creation of an averaging of isolines between chosen field perimeters.

NOTE the underlay words appearing on each extract (such as “dense” and “40m offset north bank creek”) are the same, and in the same places. NOTE The words “this area not surveyed” appear only on the Appendix E Survey.

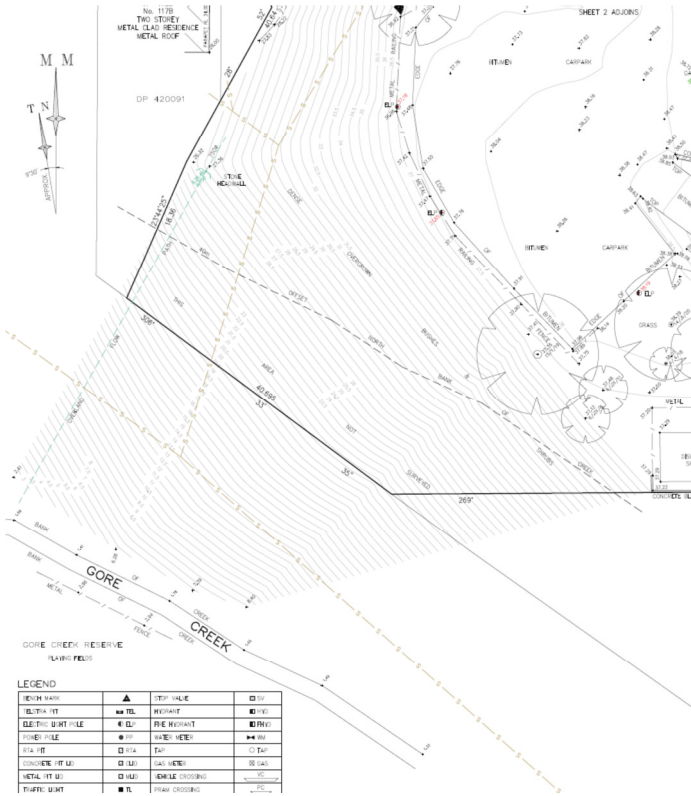
ALTERED CONTOURS are shown on App. E Survey when compared with the accurate topographical information shown on Civil Eng. App. I 2 underlay survey

Below : Appendix E Survey p.4-- extract at SW bound'y

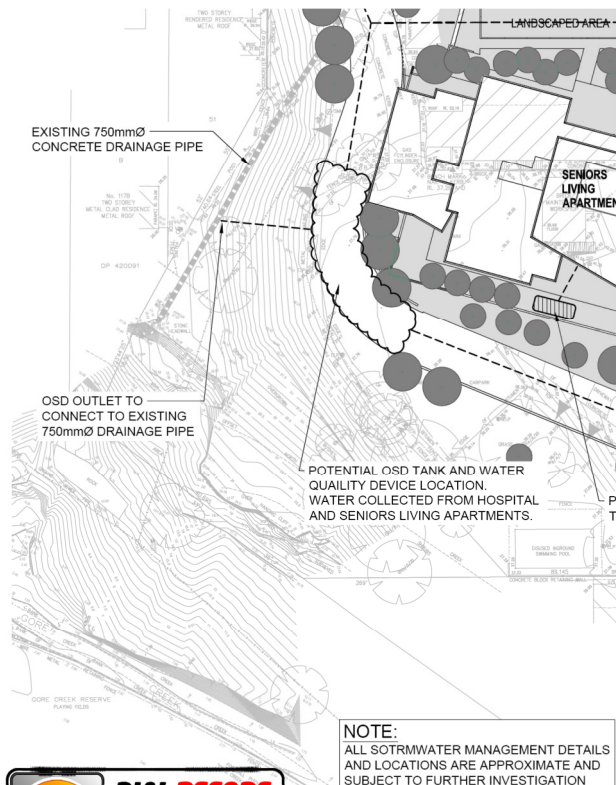
Below L: Appendix 1 2 Civil Eng. Plan extract at SW bdy.

Note in the above left, it seems beyond belief that the detail rock formations, contours, cliffs, tree clusters etc were not known in 2018 (from 2009) by the surveyors. The extract above right, from architectural drawings produced four years later, correlates so exactly and so precisely, with the Civil extract above L. available in 2018, that it is not an accident.

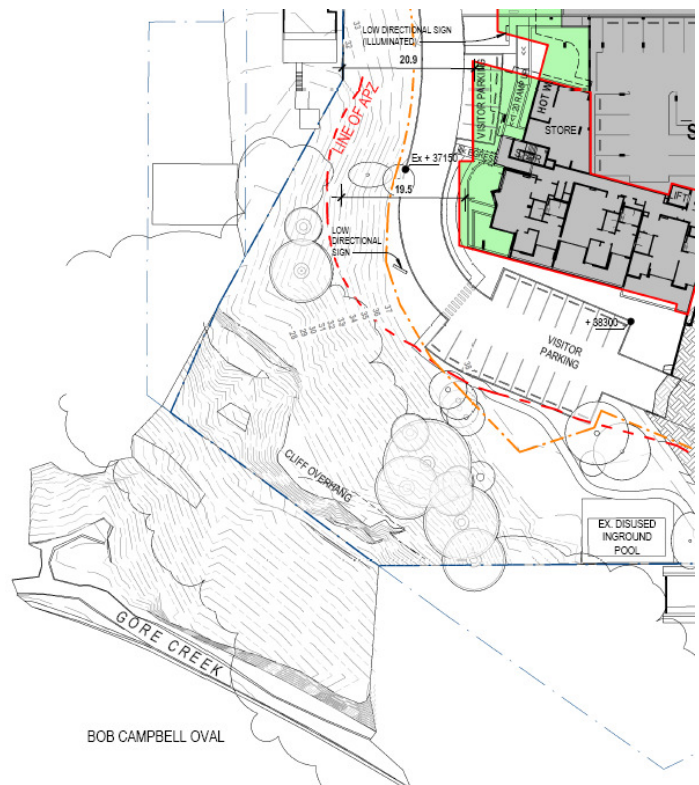
Below R: Mod. 1 Concept App. C dwg- DD – SW – 4011

Where there is a difference at top of bushland slope and to the west of disused pool, is result of where Hammondcare have been carrying out works to produce a different “start” scenario. Eg. removal of vegetation, re-contouring and filling (flattening) of the upper area with coir logs, and revegetation ahead of any Landscape plan approval or any comprehensive survey of trees on the bushland slope.

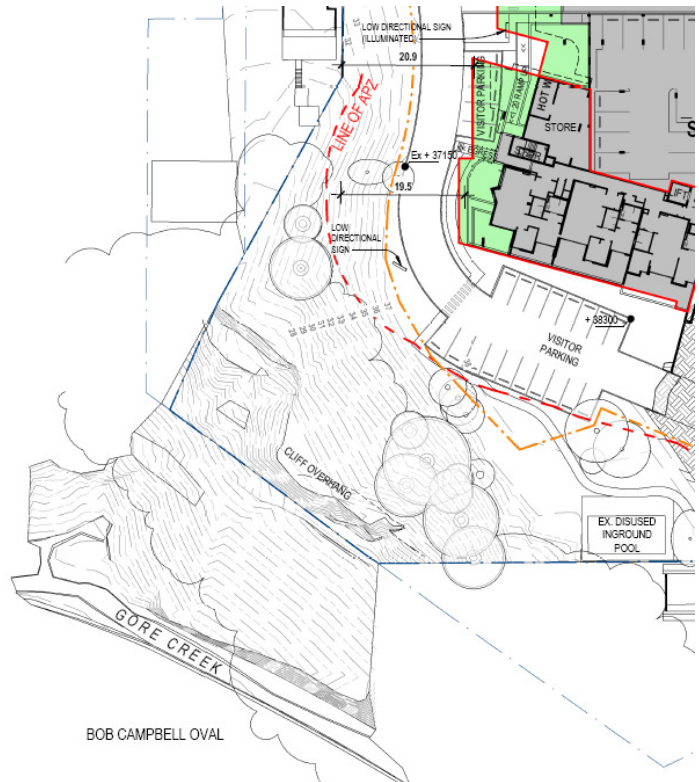
Below R: Mod. 1 Concept App. C dwg- DD – SW – 4011

Compare the below extract of 2019 version of the Survey, App. NN with the Mod. 1 Concept drawing – the surveyor clearly does not want to show something.....
