# SALT ASH SAND OPERATIONS REHABILITATION STRATEGY

Report Number: MS-036a Final  
Prepared for: Holcim Australia Pty Ltd  
Prepared by: Minesoils Pty Ltd

July 2025

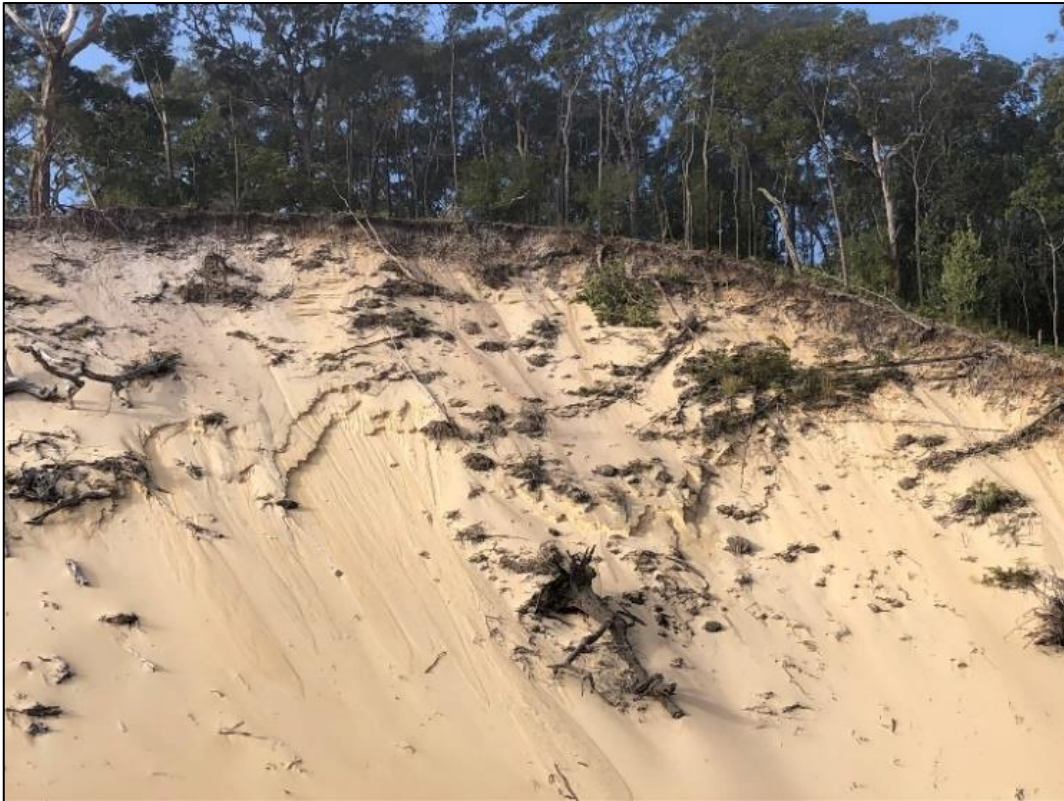
Plate 1: Example of unstable angle of repose on existing landform to be intersected with 20° batter.

The final landform involves instability risk due to the requirement to batter existing slopes. The design criteria approach for a slope stability analysis of a selected final landform will be based on the minimum required factor of safety ("FoS") for the appropriate consequence of failure. The adopted FoS will be in accordance with those typically adopted within the industry for slope stability assessments and in general accordance with NSW Health and Safety at Quarries Guidelines. Further, friction angle of sand above and below static water is the same, however, wave impact due to wind energy on the pond perimeter may not reflect conventional slope stability.

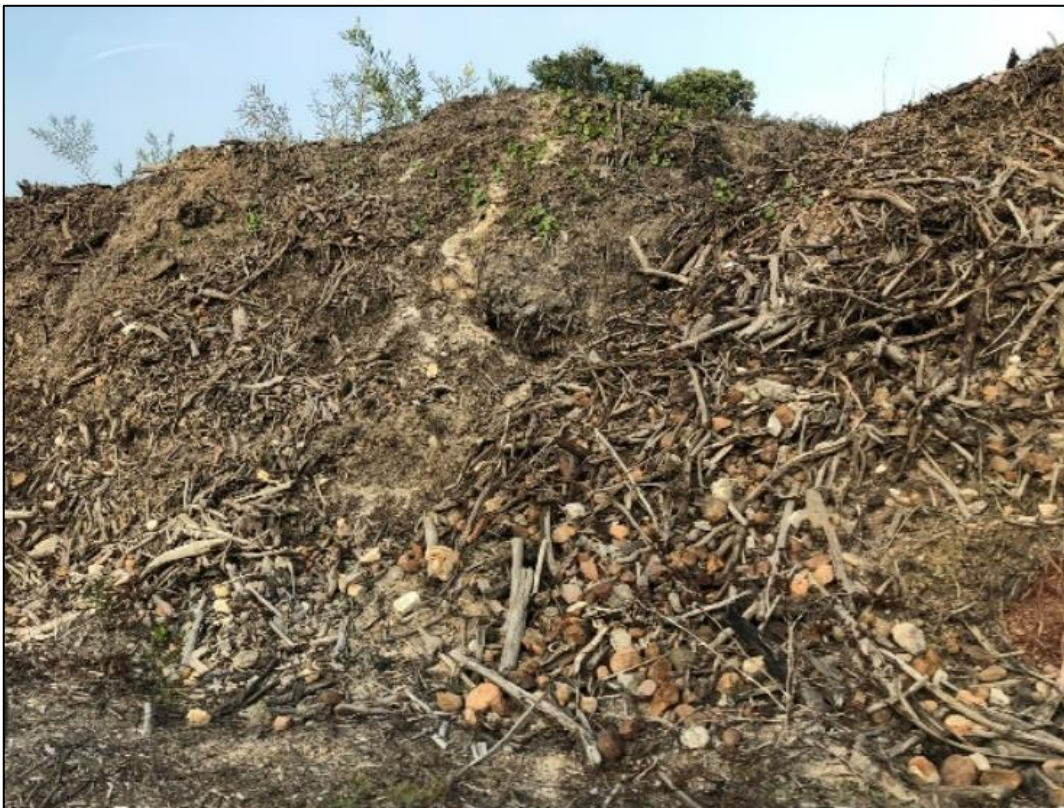
Plate 2: Example of using coarse material as protective cover to stockpile onsite.

- The surface of soil stockpiles should be left in as coarsely structured a condition as possible in order to promote infiltration and minimise erosion until vegetation is established, and to prevent anaerobic zones forming.

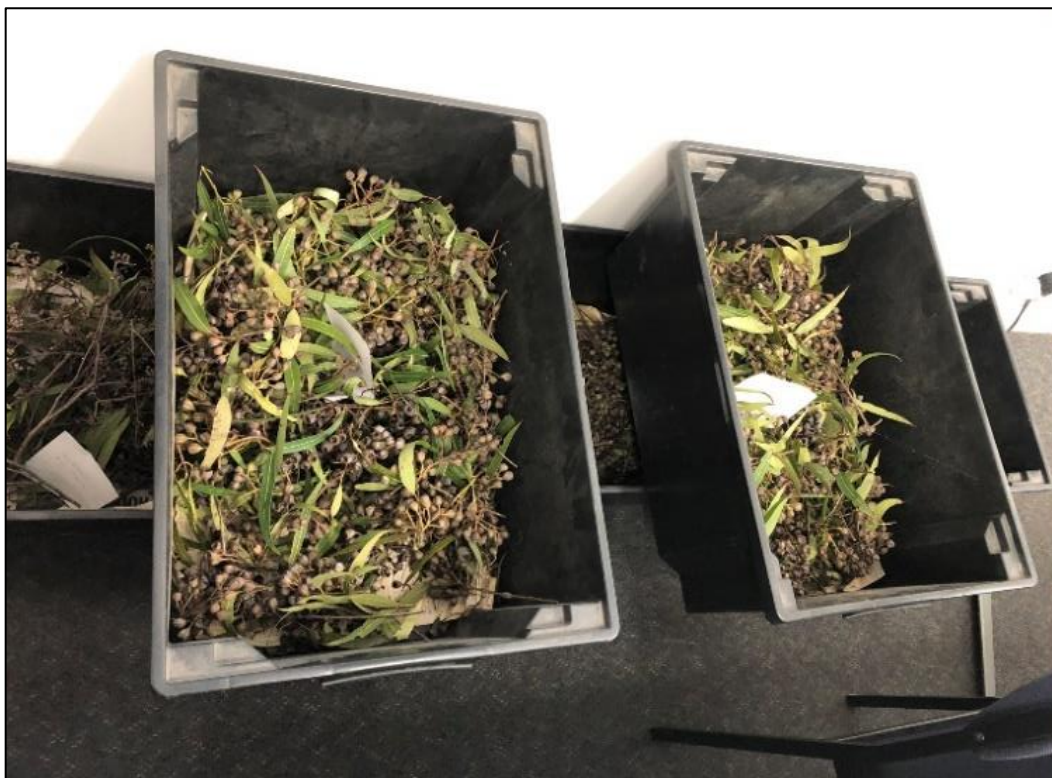
Plate 3: Seedbank store for rehabilitation purposes.

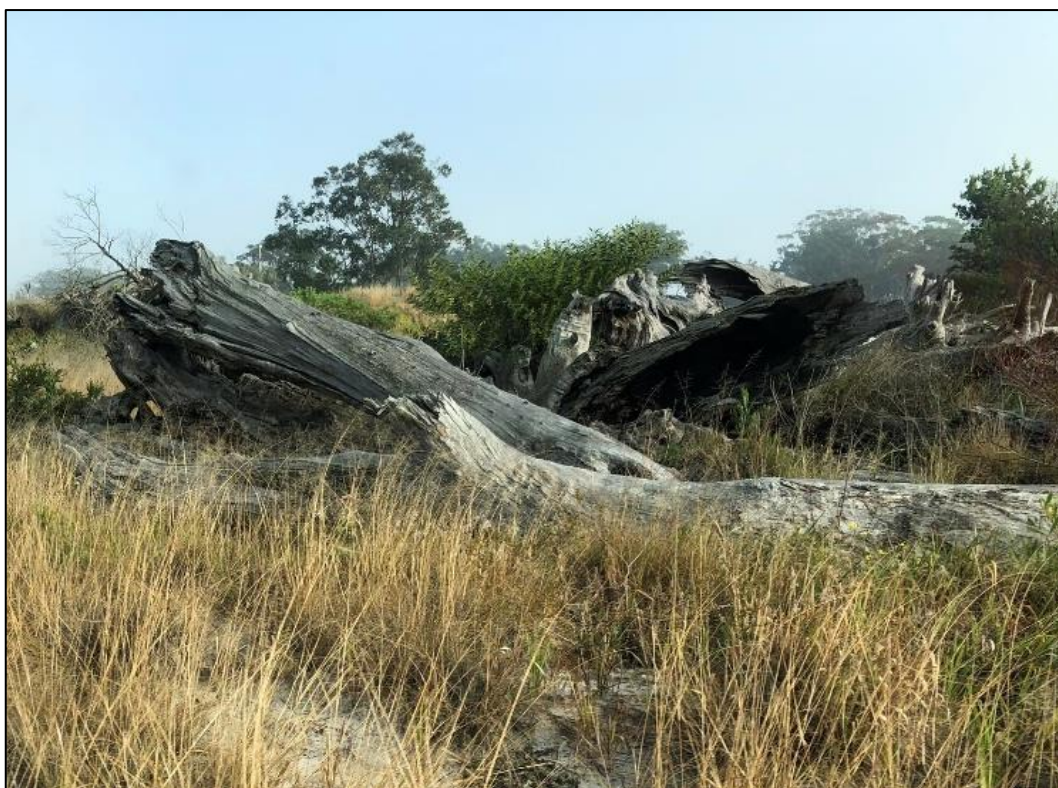
Plate 4. Felled trees stored for use in rehabilitation as fauna habitat and erosion control.

- Where necessary, silt fences or cleared vegetation should be installed around topsoil stockpiles or stripped areas as a form of erosion and sediment control. Mulch or wood chip from cleared vegetation can also be applied as a veneer over topsoil stockpiles to slow erosion, weed establishment and to maintain moisture content.

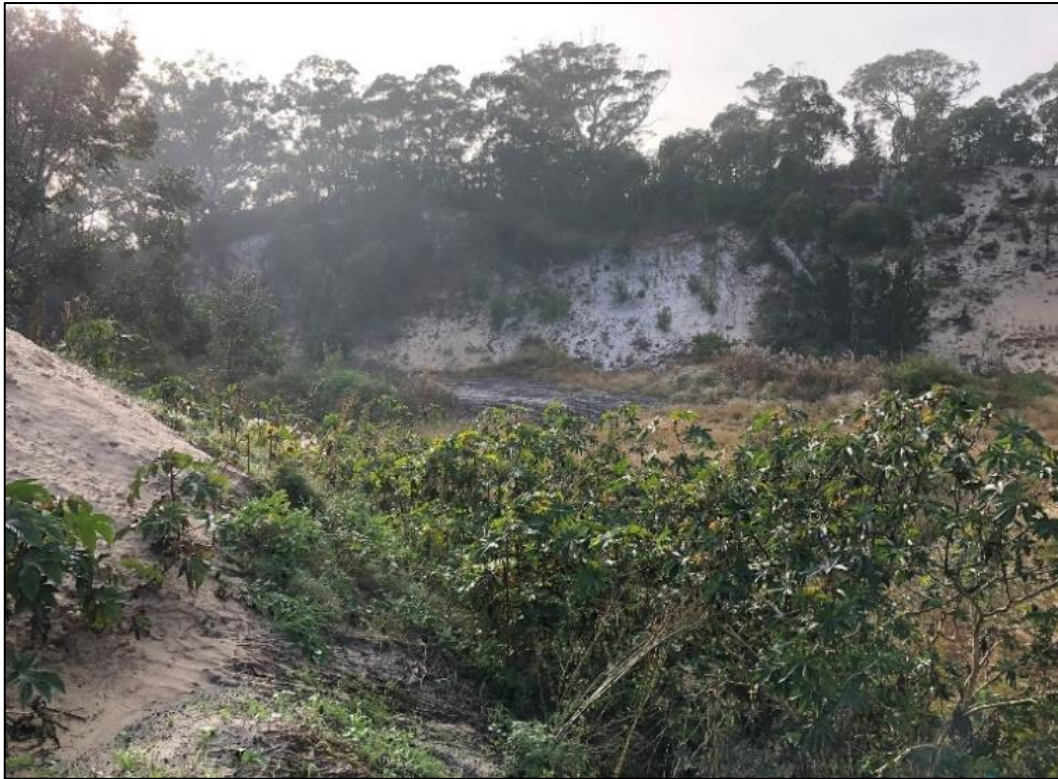
Plate 5: Identified weed species including *Ricinus communis* (foreground) to be eliminated as part of pest management measures.

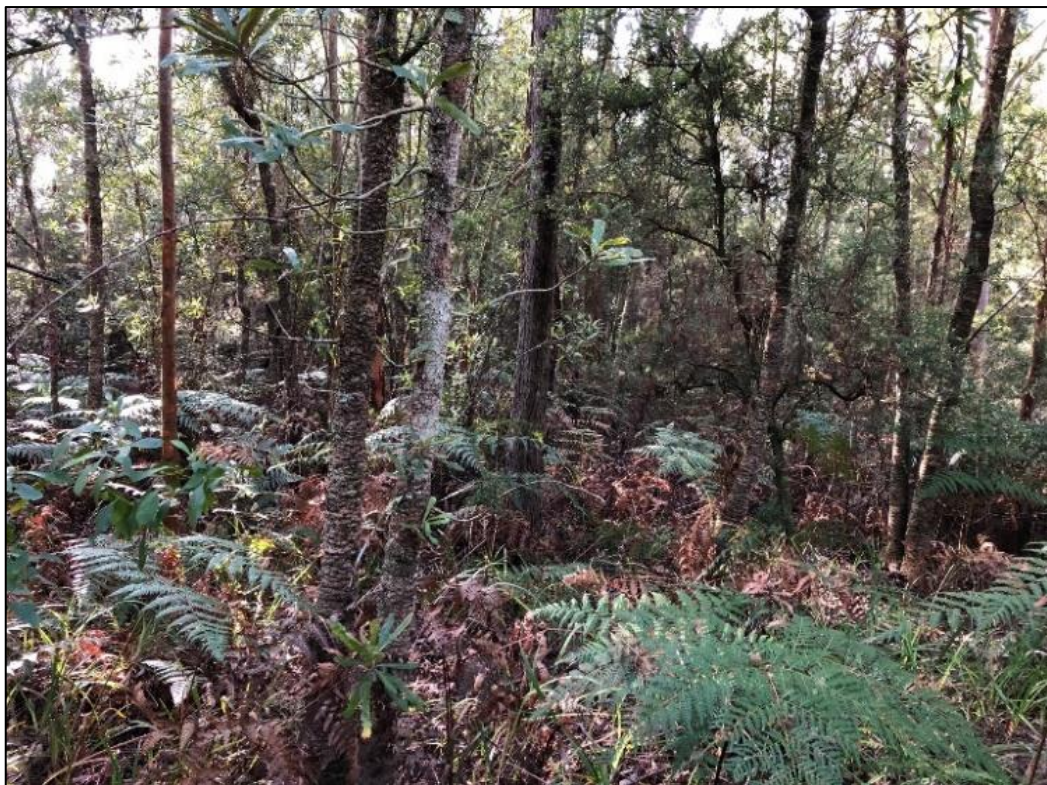
Plate 6. Coastal woodland native species including *Banksia Serrata* (foreground), target rehabilitation species; observed June 2020.
