# **SALT ASH QUARRY**

**GEOTECHNICAL DESIGN ASSESSMENT**  
Holcim Australia (Pty Ltd)

**Date:** 4<sup>th</sup> July 2025

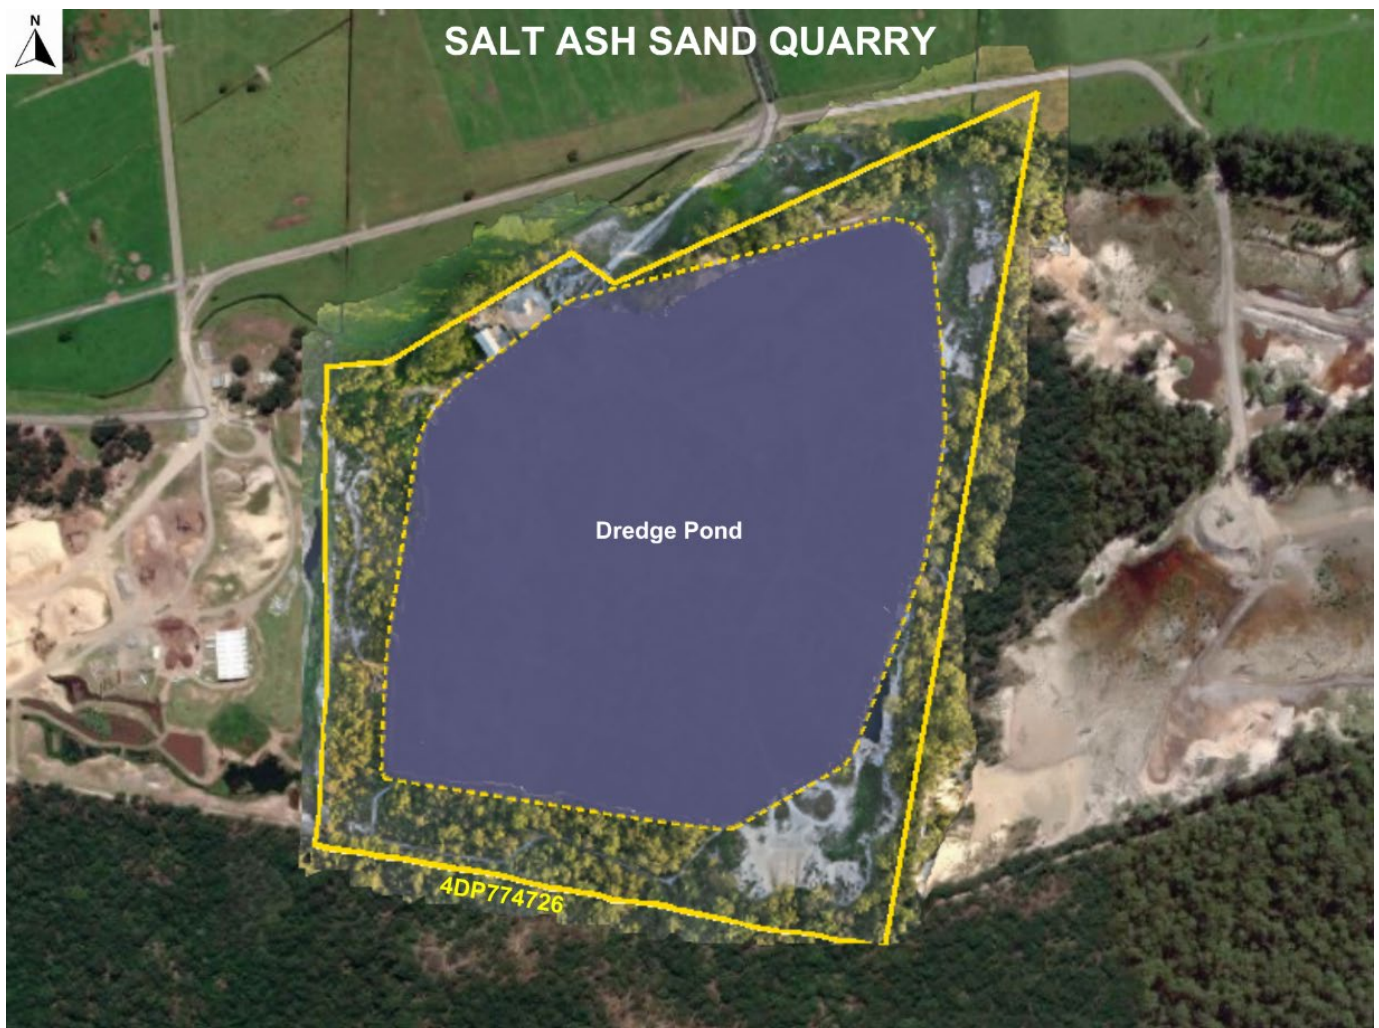
*Figure 1 Salt Ash project overview*

Extracting sand below 5m AHD will intersect the groundwater table therefore a hydraulic suction dredge method is proposed. The total depth of extraction is expected to be approximately -28m AHD below current surface level, with working and rehabilitated profiles of 1V:3H (approx. 18°) above groundwater and 1V:5H (approx. 26°) below, with a beaching bench established at the water level. A plan of the dredge pond is presented in Figure 1.

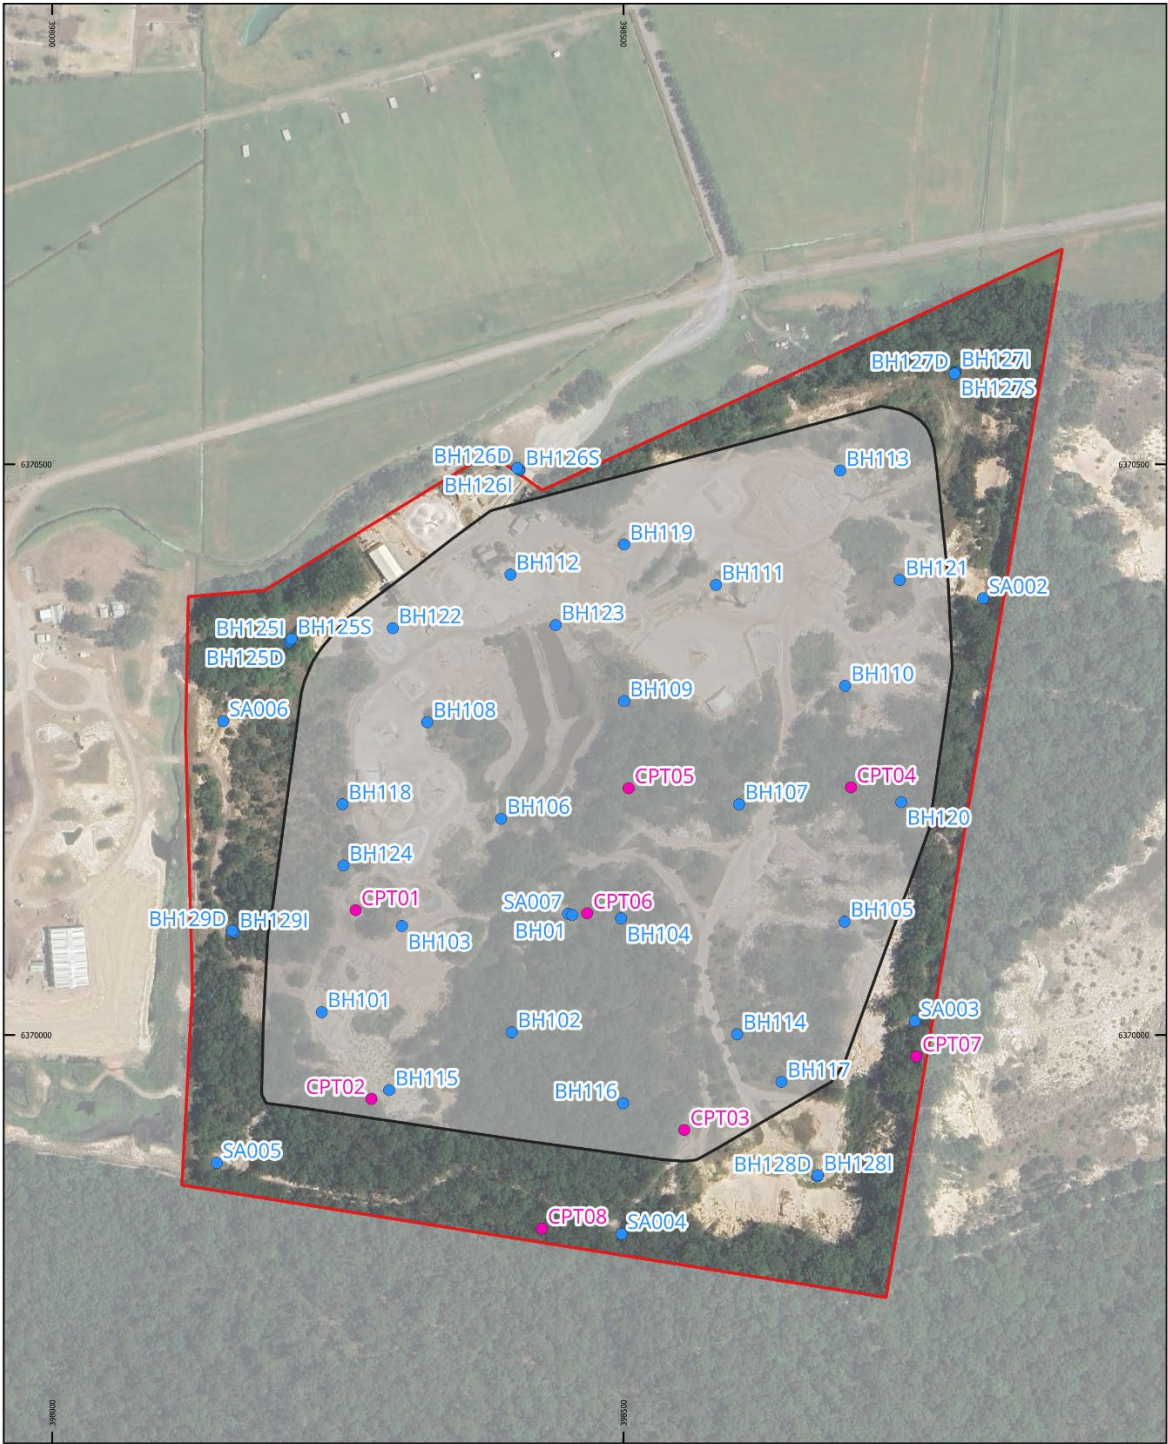
Figure 2 Salt Ash Sand Quarry historical drilling

Figure 2 illustrates presents an overview of the resource, geotechnical and ASS investigation locations across the Salt Ash Sand project area.

In 2021 Xstract (Xstract 2021) undertook a site investigation for the dredge pond extents. This investigation involved one solid flight auger / wash-bore hole and eight (8) cone penetration tests (CPT) tests. Standard penetration tests (SPT) were undertaken at regular intervals. In 2024 Geosyntec (Geosyntec 2025) also completed additional environmental field studies targeting acid sulphate soil (ASS) criteria.

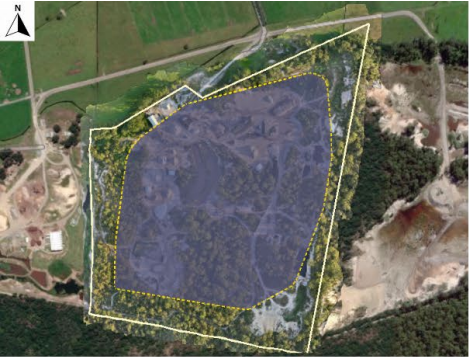
Figure 4 Salt Ash Sand Quarry -seismic LEM

### Salt Ash Sand Quarry 3DLEM seismicity

- 3D LEM design assessment returned Factors of Safety (FoS) higher than the required design acceptance criteria (DAC) for the proposed dredge pond design.
- All designs meet the required DAC when a seismic loading of 0.005 is applied.
- No further adjustment to the geotechnical slope design recommendations are required to meet DAC.
