ARBORICULTURAL DEVELOPMENT ASSESSMENT REPORT

59-67 Karne Street
Narwee NSW 2209
Lot 2 DP 518855, Lot 2 DP 16063, Lot 3 DP 16063

November 2022
Final
Updated 13th July 2023

Prepared for: Opal Healthcare
c/o CYRE Projects Pty Limited

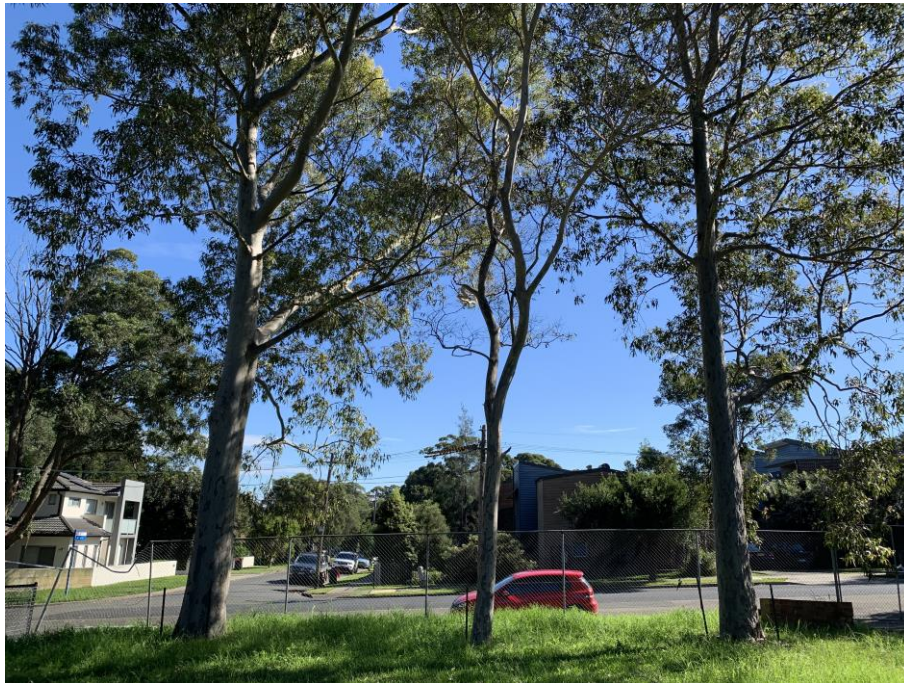
Plate 1: Image showing Trees 1-3. P. Vezgoff.

- 3.7** The more significant trees on site are Trees 1, 3, 6 and 7. Trees 1 and 3 are semi mature Spotted gum (*Corymbia maculata*). Tree 2 is a suppressed specimen between these two trees. Trees 6 and 7 are both in good health and condition (Plate 2). The main trunks, first and second order branches are free of any cracks, splits or fruiting bodies. Old pruning wounds are showing good occlusion, a sign that these trees are photosynthesizing effectively. New extension growth was noted with leaf colour showing good vitality. These trees would be considered to have 95% live canopies. The basal area and woody root zone were free of any ground heaving, or lifting. Tree 7 was noted as having a small open cavity at approximately six (6) metres from ground level.

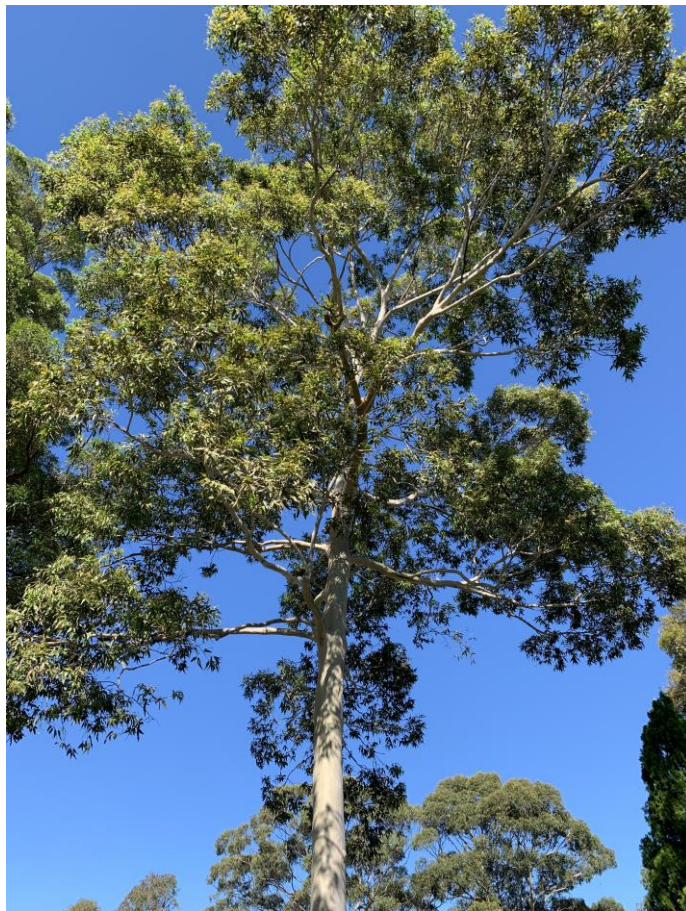
Plate 3: Image showing the canopy of Tree 6. P. Vezgoff.

- 4.4** Plans indicate the existing levels to be retained below Tree 6. The proposed suspended timber deck on the southern side of this tree is acceptable in terms of allowing moisture and oxygen exchange to continue to occur across the root zone of Tree 6. Any excavations for post holes for the deck shall be hand excavated for the top five hundred (500) millimetres of soil profile. The Project Arborist shall inspect the holes and retain a photographic record once they are exposed.

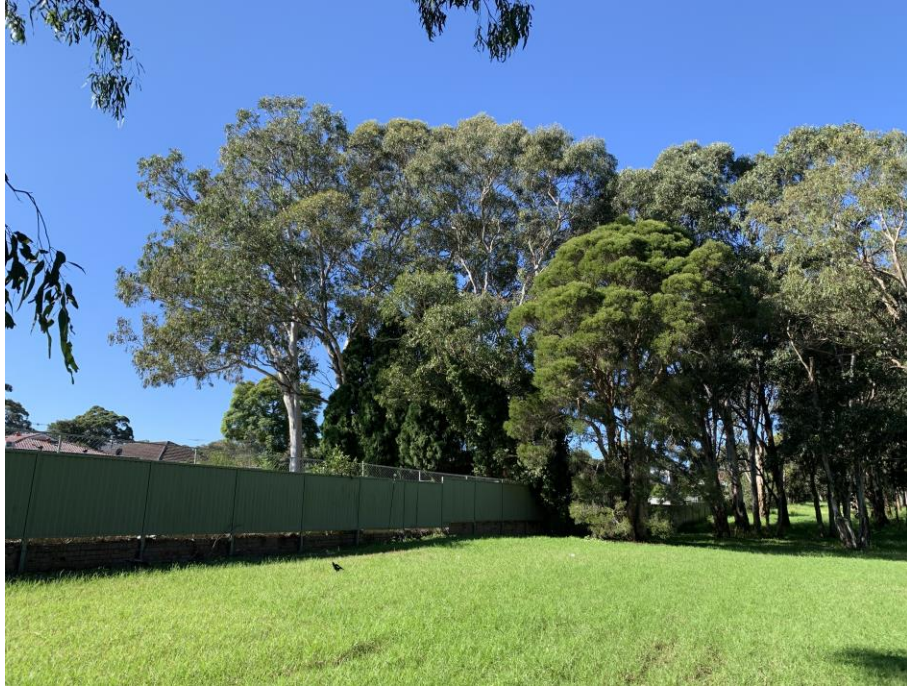
Plate 4: Image showing Trees 22-34 to the east of the site. P. Vezgoff.

3.12 Trees 24-34 are located on adjoining properties to the east. In particular, Trees 33 and 34 are large mature specimens that will require setbacks of six (6) metres from this boundary. These trees will also require protection from construction disturbance.

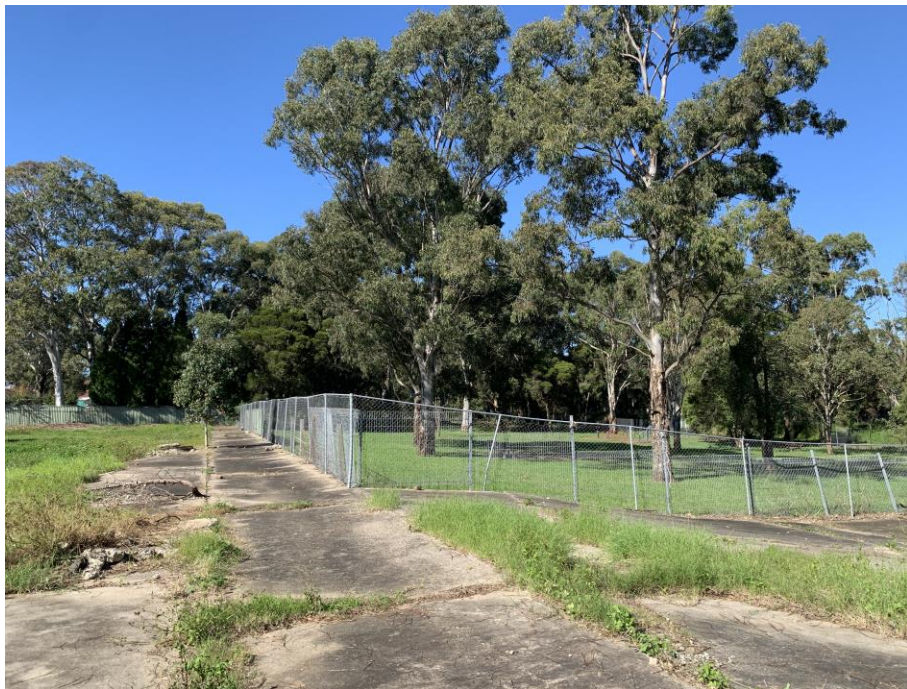
Plate 5: Image showing the Council park trees numbered as 17-20. These trees will not be impacted by any works. P. Vezgoff.

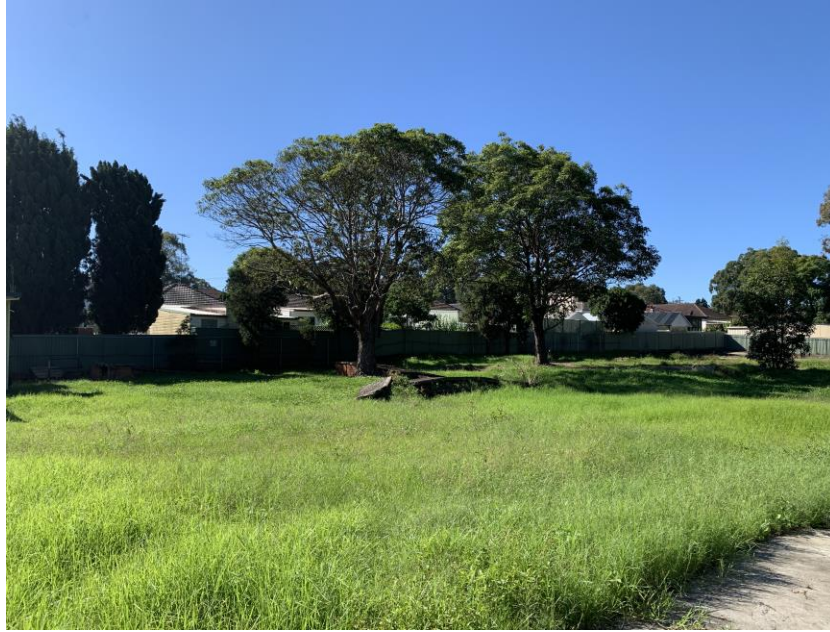
Plate 6: Image showing Trees 13 and 14. P. Vezgoff.

3.10 Impacts: Based on the plans and the bulk earthworks plans (Diagram 2) provided, Trees 4, 5, 7-16 are located within the building footprint and will require removal. Street Tree 39 is proposed to be removed due to the limitations of access to the site between the existing street trees. Trees within the site to be retained are numbered as 1, 2, 3, 6, 17-38. Street Trees 40 and 42 will be retained.

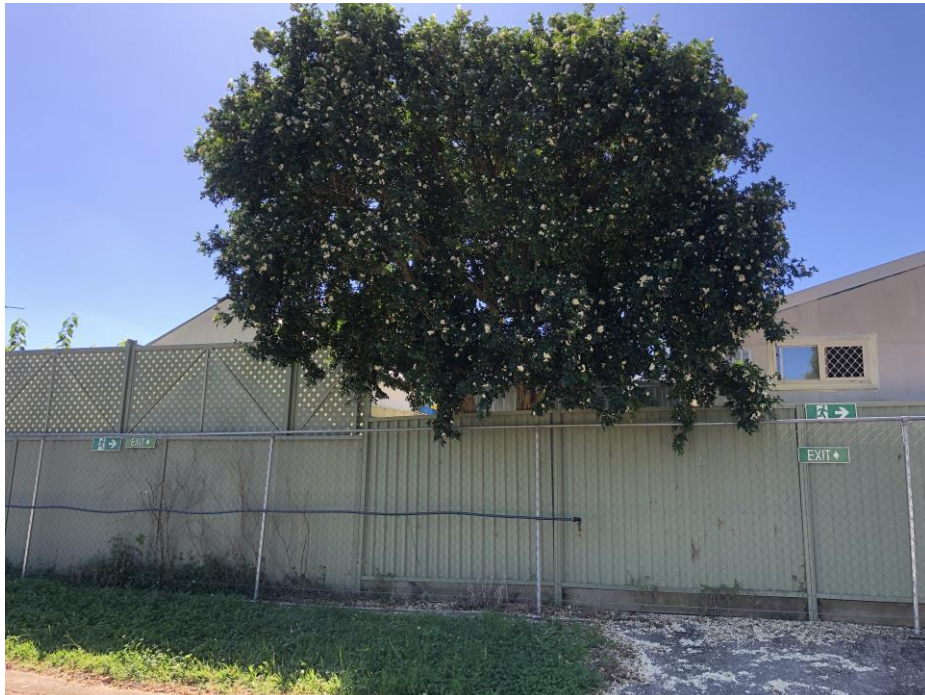
Plate 7: Image showing Tree 35. A change in level is noted by the sleeper edge. P. Vezgoff.

3.9 Trees 35, 36, 37 and 38 are growing on the adjoining property to the north. These species include *Cupresses sp.*, *Magnolia soulangiana* and *Murraya*. These trees are all growing against the boundary fence. As seen in Plates 7-9 there is a slight change in levels along this boundary to an extent where this will work in with the proposed drainage designs along this boundary.

3.11 Some smaller shrubs growing within neighbouring properties to the north will not be impacted by any works, provided there is a nine hundred (900) millimetre set back from this boundary fence. These trees are numbered as Trees 35-38. Updated plans and designs (Civil Integrated Water Management Plan by Henry and Hymas Dated May 2023, Revision 5) show that in Section Drawings A-E, the area along the northern boundary, that the existing ground level impacts will be minimal to Trees 35-38 in terms of level changes.

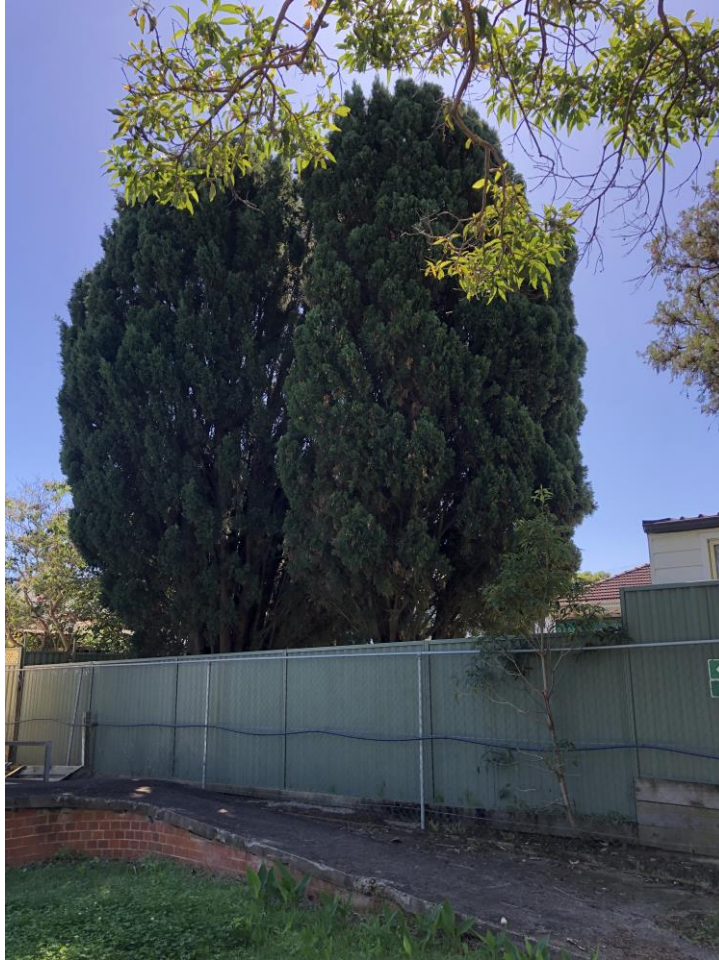
Plate 8: Image showing Trees 36 and 37. A change in level is noted by the ramp. P. Vezgoff.

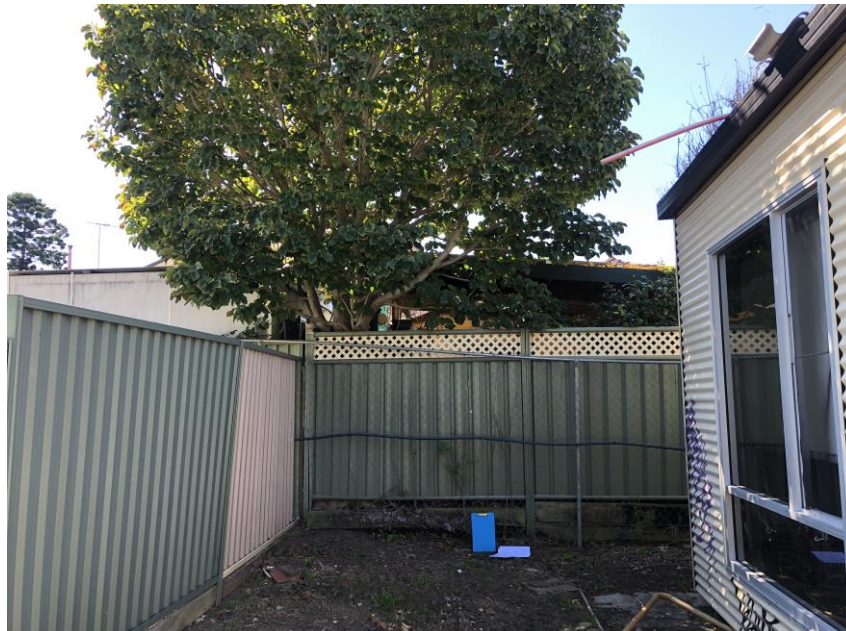
Plate 9: Image showing Tree 39. A change in level is noted by the double sleeper edge. P. Vezgoff.

3.13 The street trees numbered as Trees 39-40 and 42 are more large shrub species, however they are well established. Tree 39 is proposed to be removed to allow for the main site entry. Tree 41 has died since the initial inspection. The TPZ for Trees 39, 40 and 42 is 4.2 metres. Based on the civil plans an incursion of 15% of the TPZ for Trees 39, 40 and 42 will occur (Diagram 3). These shrubs will tolerate this incursion.

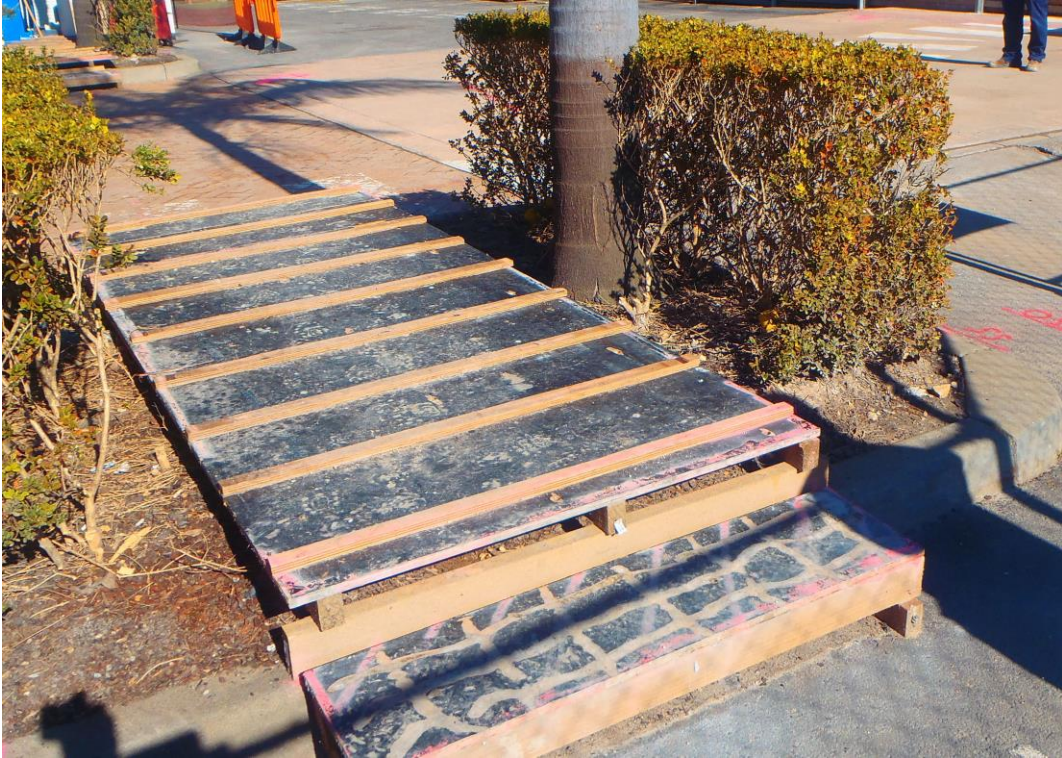
Plate A: An example of board protection to reduce compaction over the root zone. This technique should be used over the root zone of Trees 1, 2, 3 and 6. P. Vezgoff.

5.5 Root Zone Protection: Ply sheeting should be placed over the root zone of Tree 1-3 and 6 to reduce compaction over the root zone whilst works are occurring. This ground protection allows the TPZ fenced to be placed closer to a tree to allow construction access. See Plate A as an example. The area for ply sheeting can be seen in the Tree Protection Plan, Plan 2.

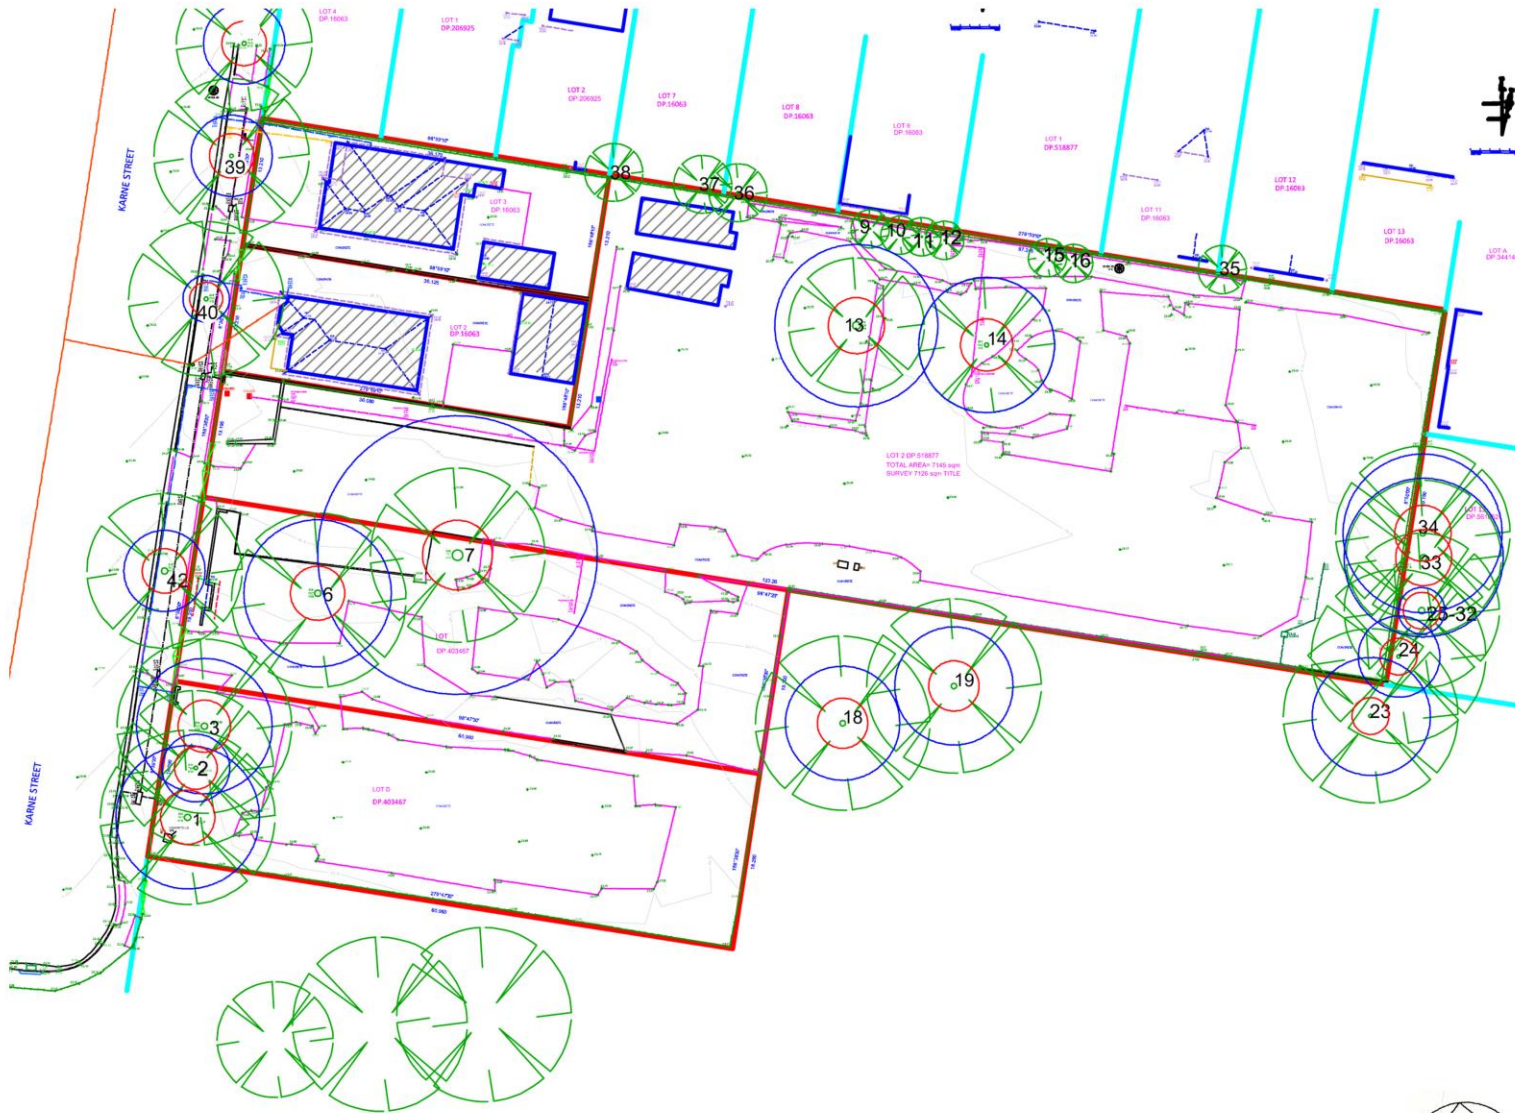
Plan 1

Structural Root Zone (SRZ). No roots over 50mm in diameter to be severed within this area. The area within this circle is also known as the Tree Protection Zone.

Tree Protection Zone (TPZ). TPZ area based on AS 4970. See *Recommendations and Tree Protection* section of Arborist Report.

- 2.4 **Tree Protection Zone (TPZ):** The TPZ is the principal means of protecting trees on development sites. The TPZ is a combination of the root area and crown area requiring protection. It is an area isolated from construction disturbance, so that the tree remains viable. TPZ’s have been calculated for each tree to determine construction impacts. The TPZ calculation is based on the Australian Standard *Protection of trees on development sites*, AS 4970, 2009. The Tree Protection Zones are shown in the Tree Protection Plan (Appendix 1, Plan 2).
