ELECTROLYSIS RISK REPORT
85-97 WATERLOO ROAD, MACQUARIE PARK NSW 2113

ELECTROLYSIS RISK REPORT

85-97 WATERLOO ROAD, MACQUARIE PARK NSW 2113

DOCUMENT NUMBER: N-000173/P100361

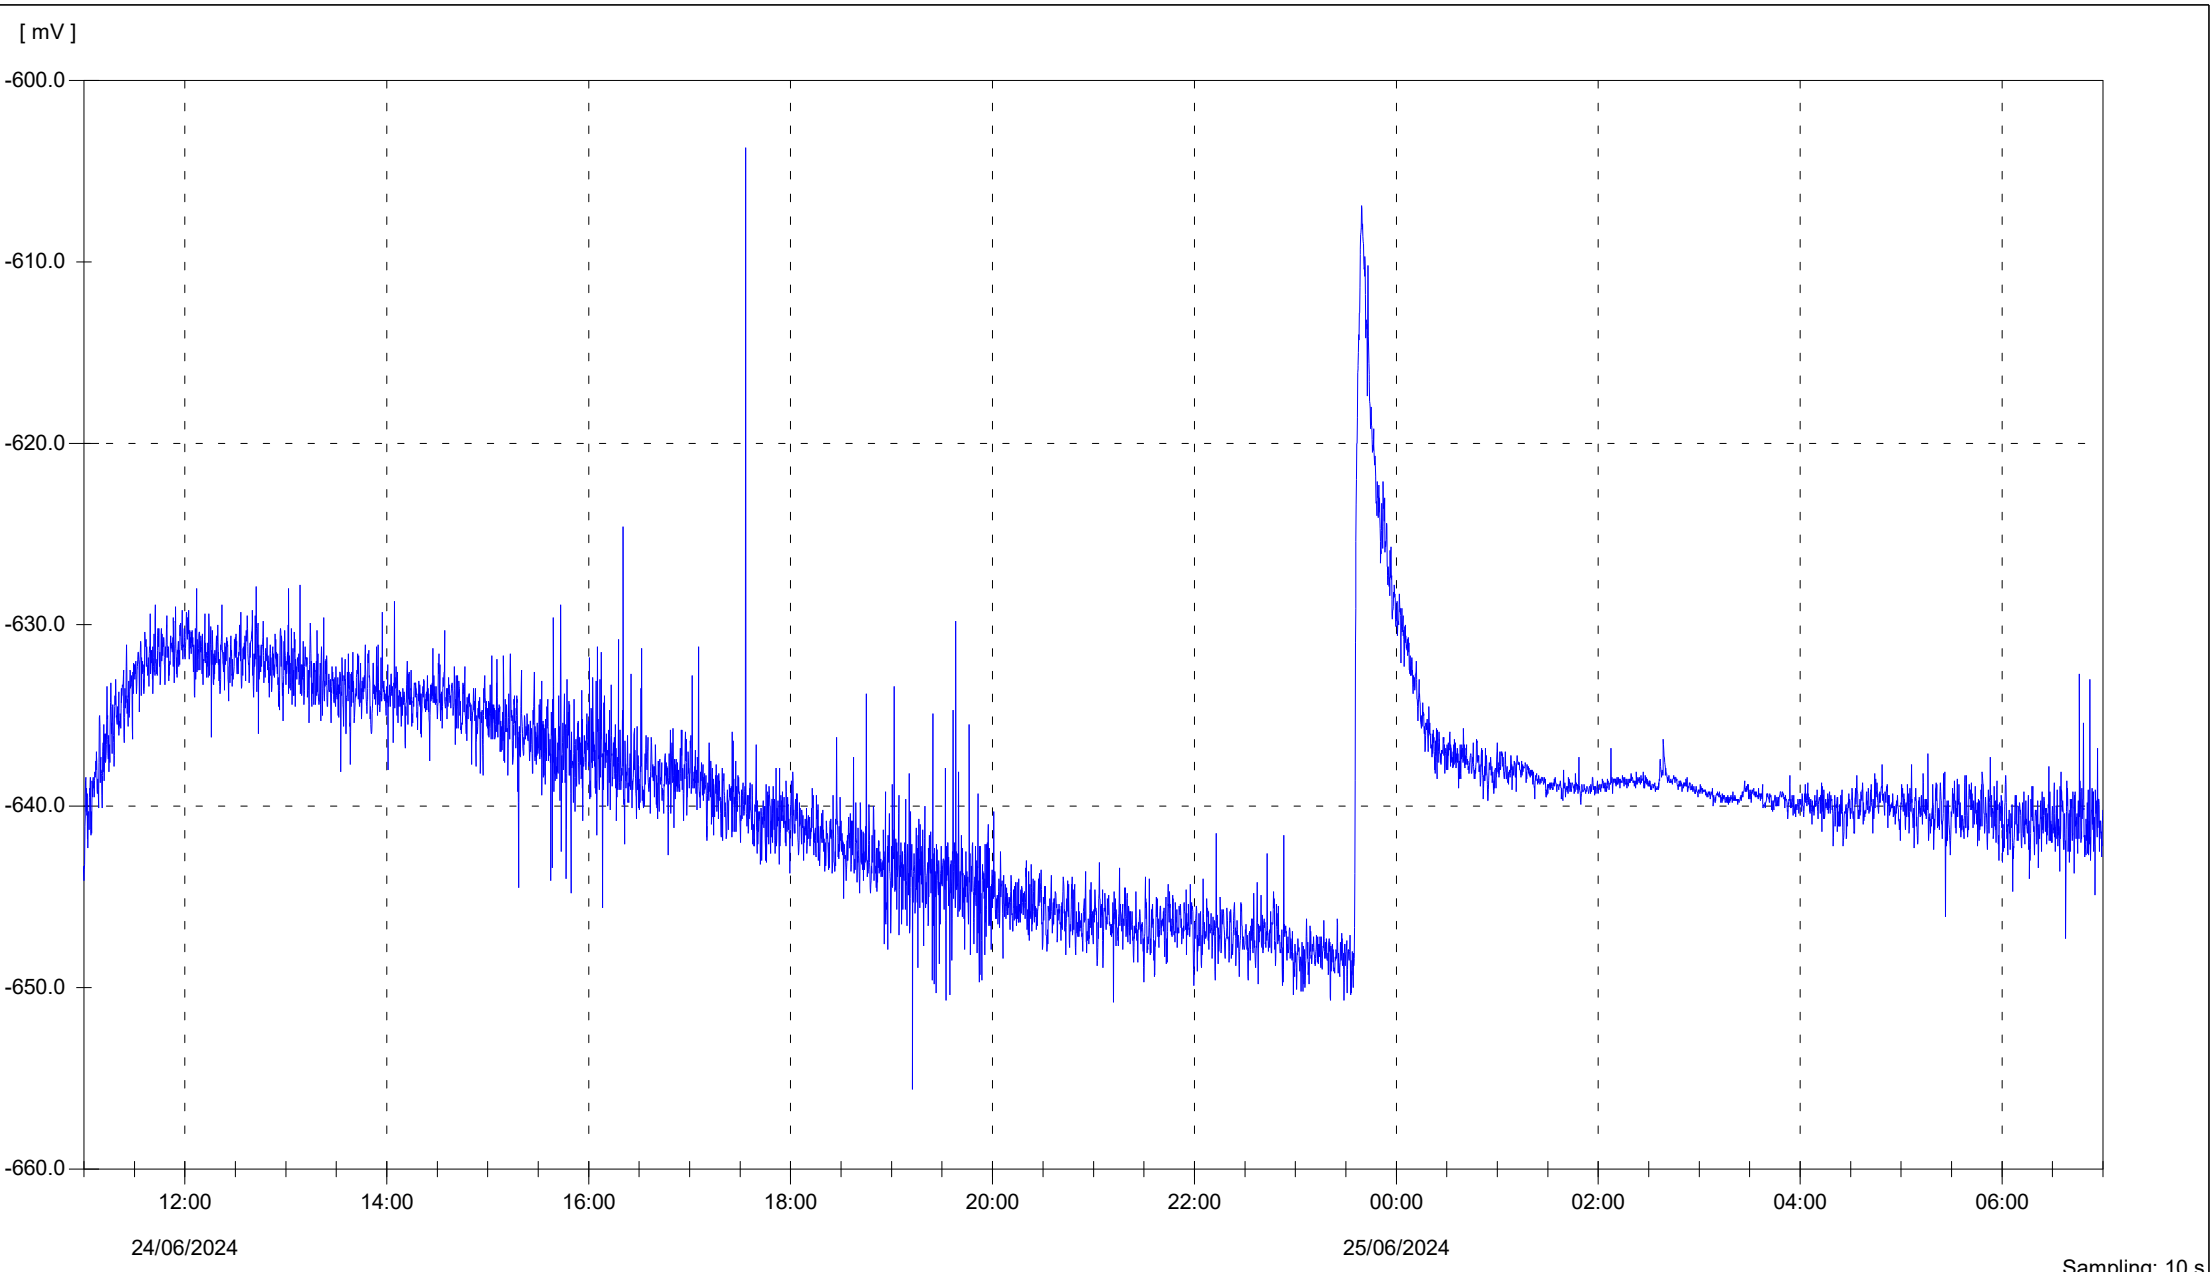
Electrolysis Risk Reporting
85-97 Waterloo Road, Macquarie Park NSW
Parallel to the rail (97 Waterloo Road)
Logger Serial Number: 2742

1. Data logging voltage gradients between steel earth stakes parallel to the rail at the southwest boundary of 97 Waterloo Road shows stray current effects that are within, but at time exceed acceptable limits.

Min	Max	Average	Std. dev.
DC 1	-0.656 V	-0.604 V	-0.639 V	0.006 V

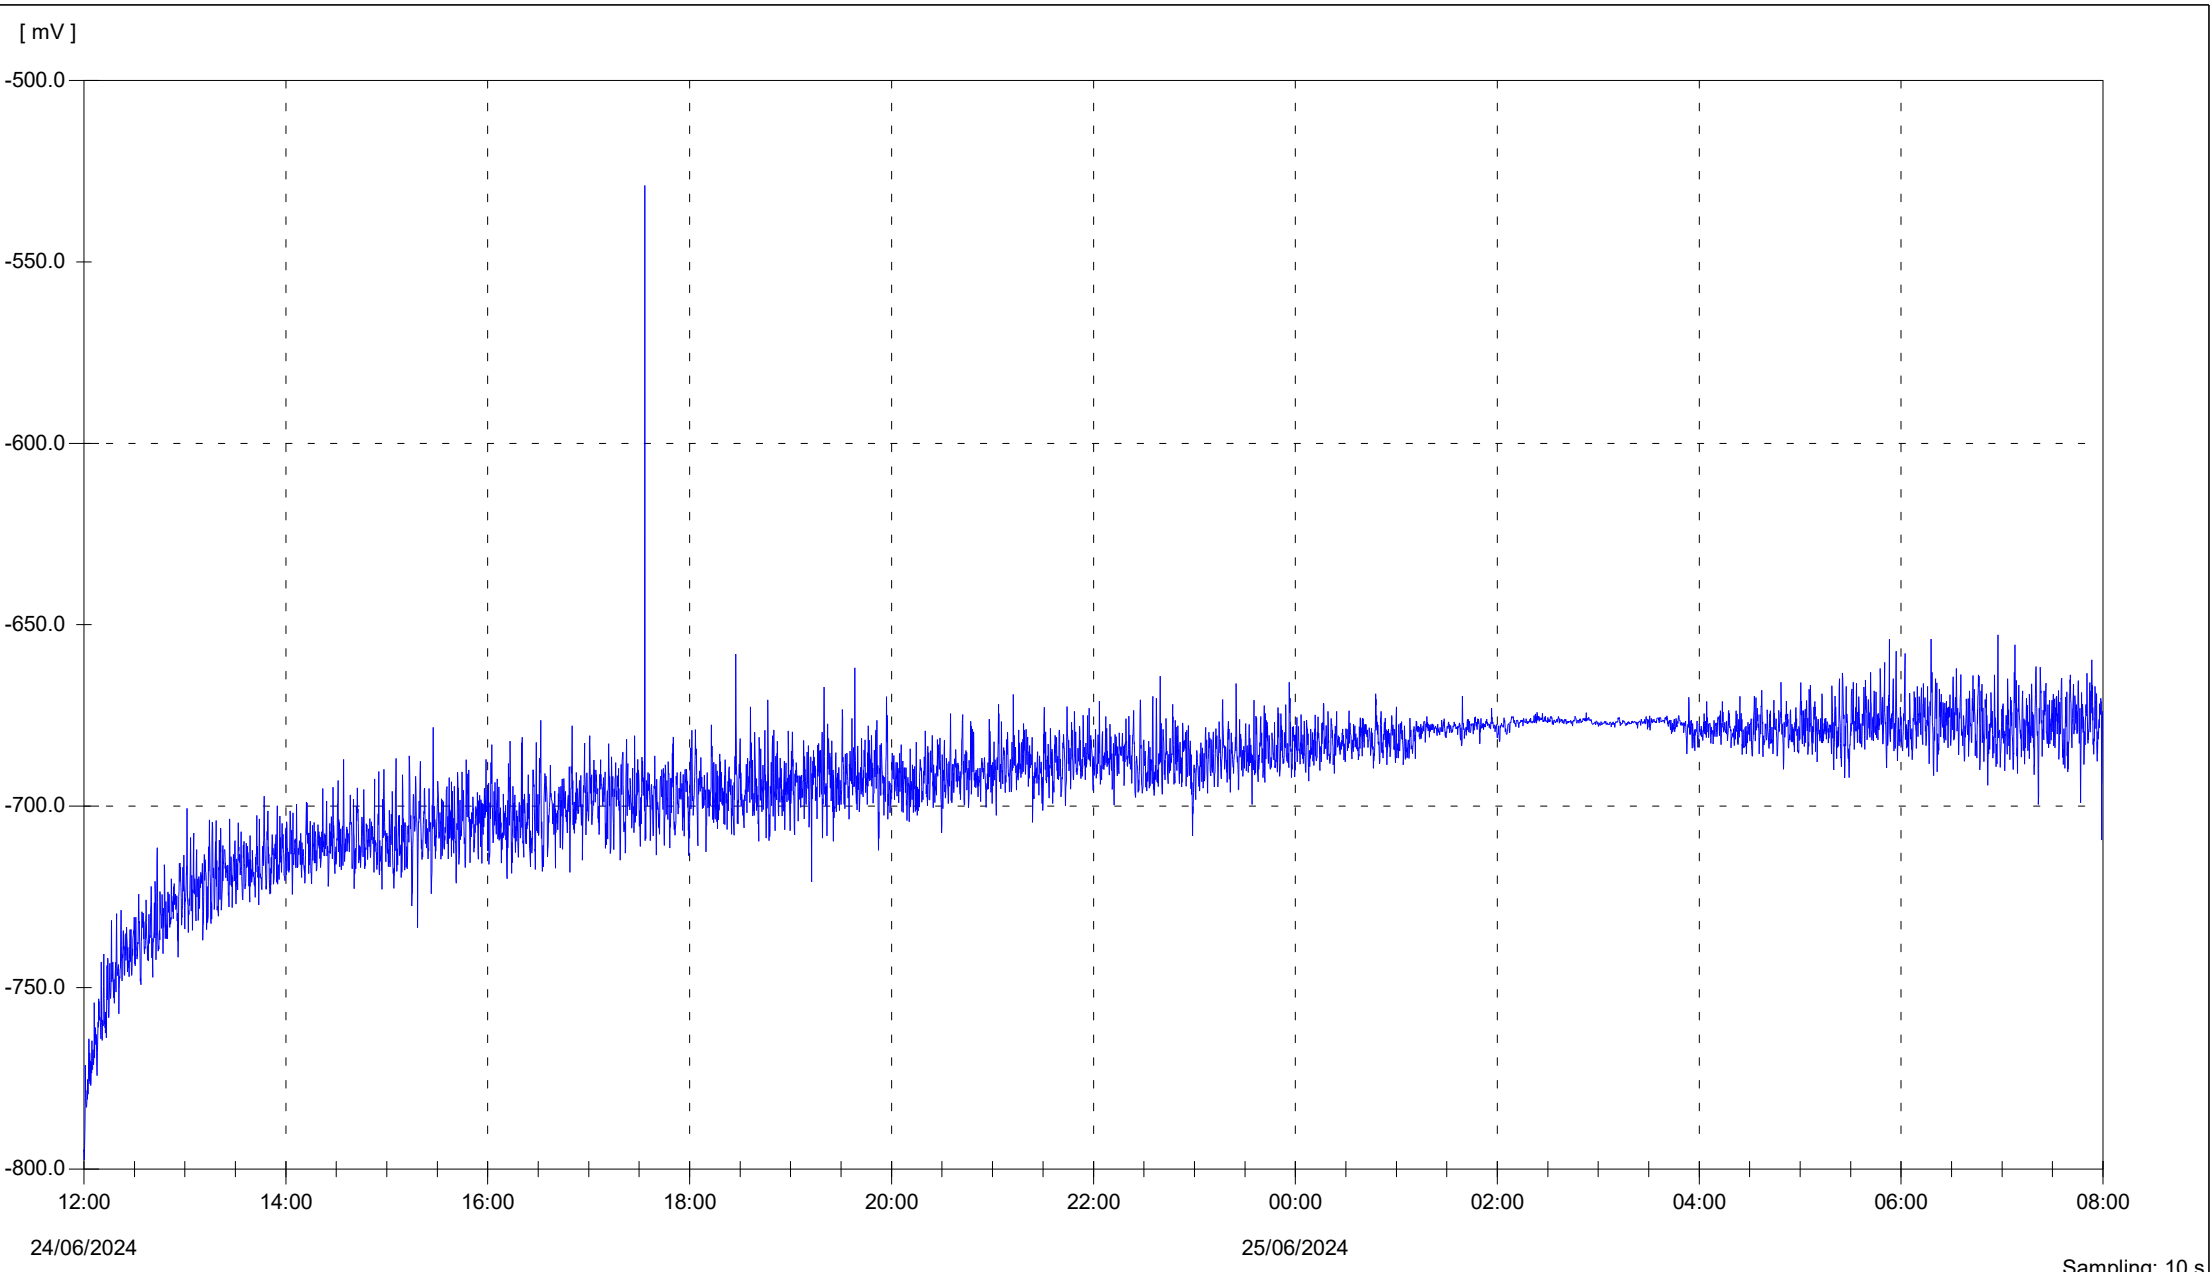
Electrolysis Risk Reporting
85-97 Waterloo Road, Macquarie Park NSW
Parallel to the rail (85 Waterloo Road)
Logger Serial Number: 2731

2. Data logging voltage gradients between steel earth stakes parallel to the rail at the southwest boundary of 85 Waterloo Road shows stray current effects that exceed acceptable limits.

Min	Max	Average	Std. dev.
DC 1	-0.798 V	-0.529 V	-0.692 V	0.018 V

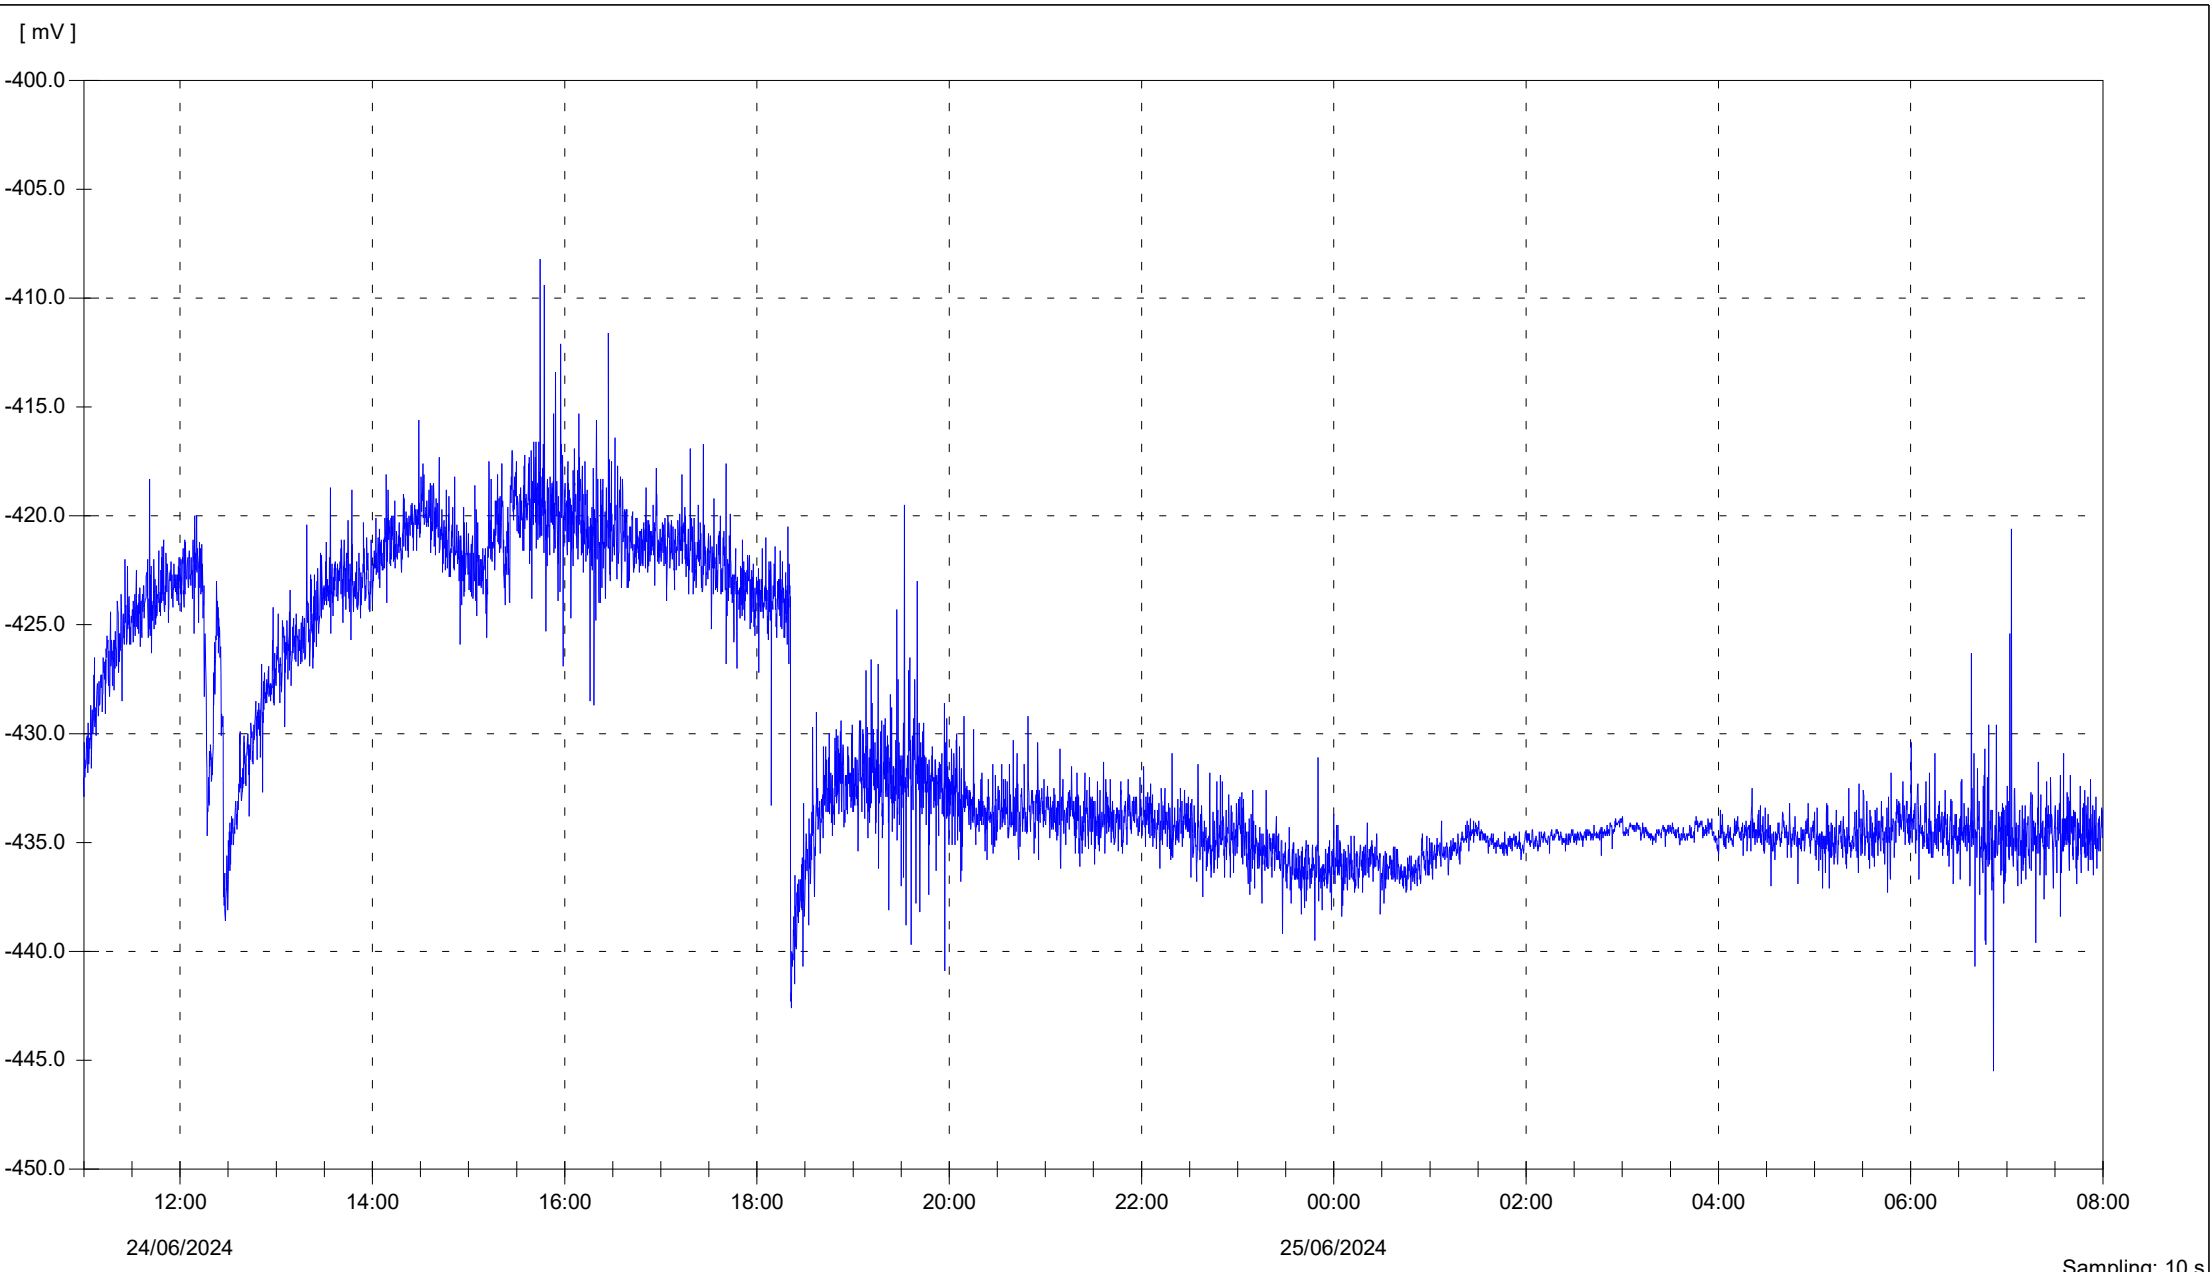
Electrolysis Risk Reporting
85-97 Waterloo Road, Macquarie Park NSW
Parallel to the rail - Fence (97 Waterloo Road)
Logger Serial Number: 3405

3. Data logging the potential of a fence at the southeast corner of 97 Waterloo Road shows stray current effects that are within acceptable limits.
4. Data logging voltage gradients between steel earth stakes perpendicular to the rail at the southeast boundary of 97 Waterloo Road shows stray current effects that are within, but at time exceed acceptable limits.

Min	Max	Average	Std. dev.
DC 1	-0.446 V	-0.408 V	-0.431 V	0.006 V

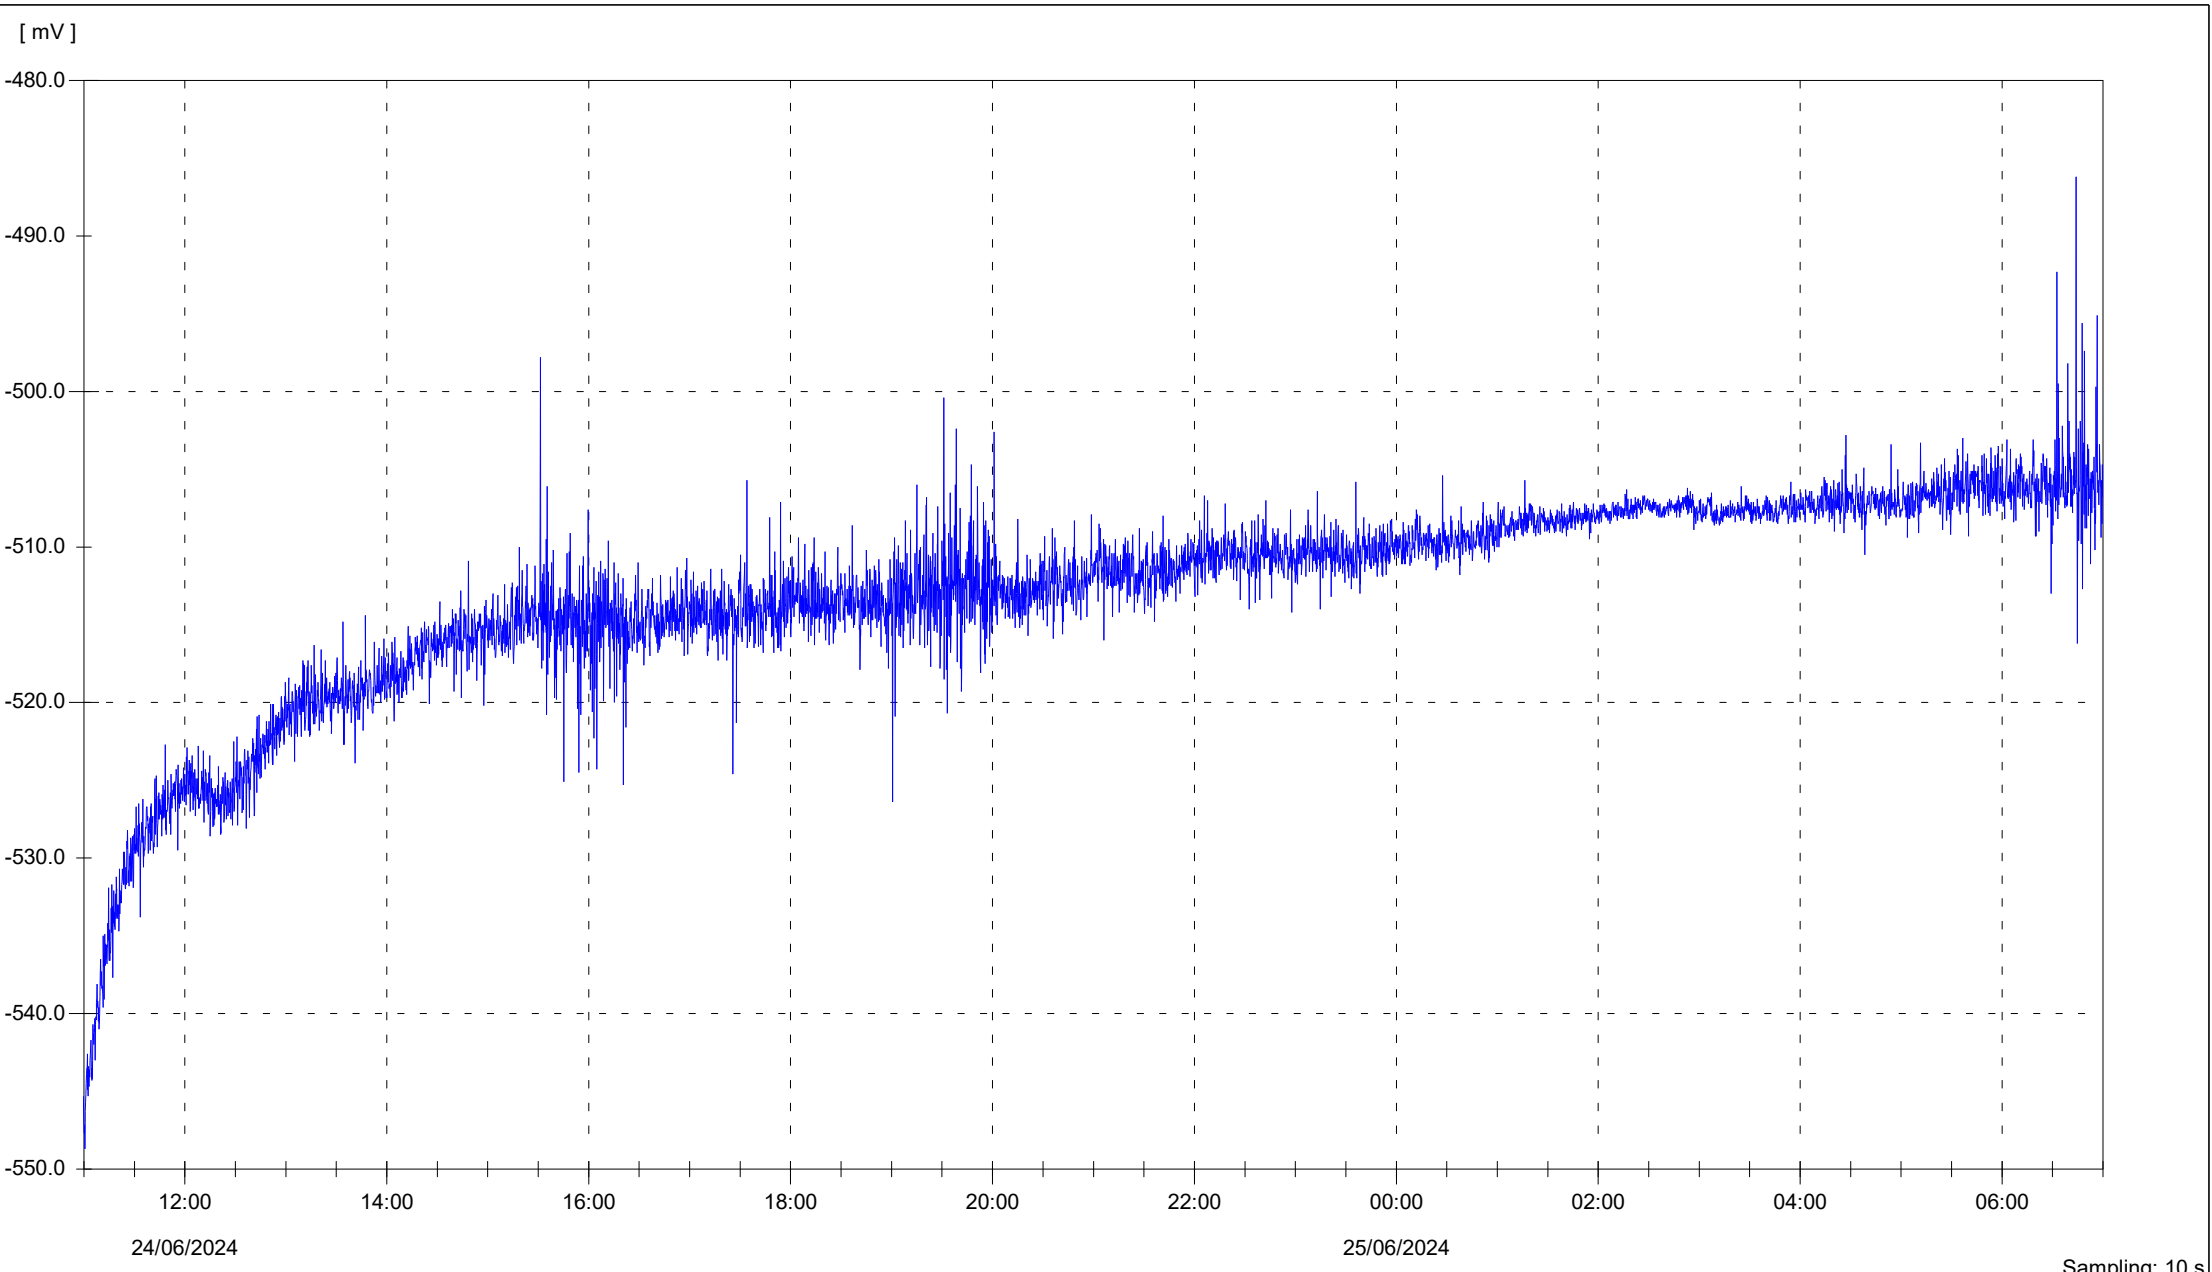
Electrolysis Risk Reporting
85-97 Waterloo Road, Macquarie Park NSW
Perpendicular to the rail (97 Waterloo Road)
Logger Serial Number: 2738

Min	Max	Average	Std. dev.
DC 1	-0.549 V	-0.486 V	-0.513 V	0.007 V

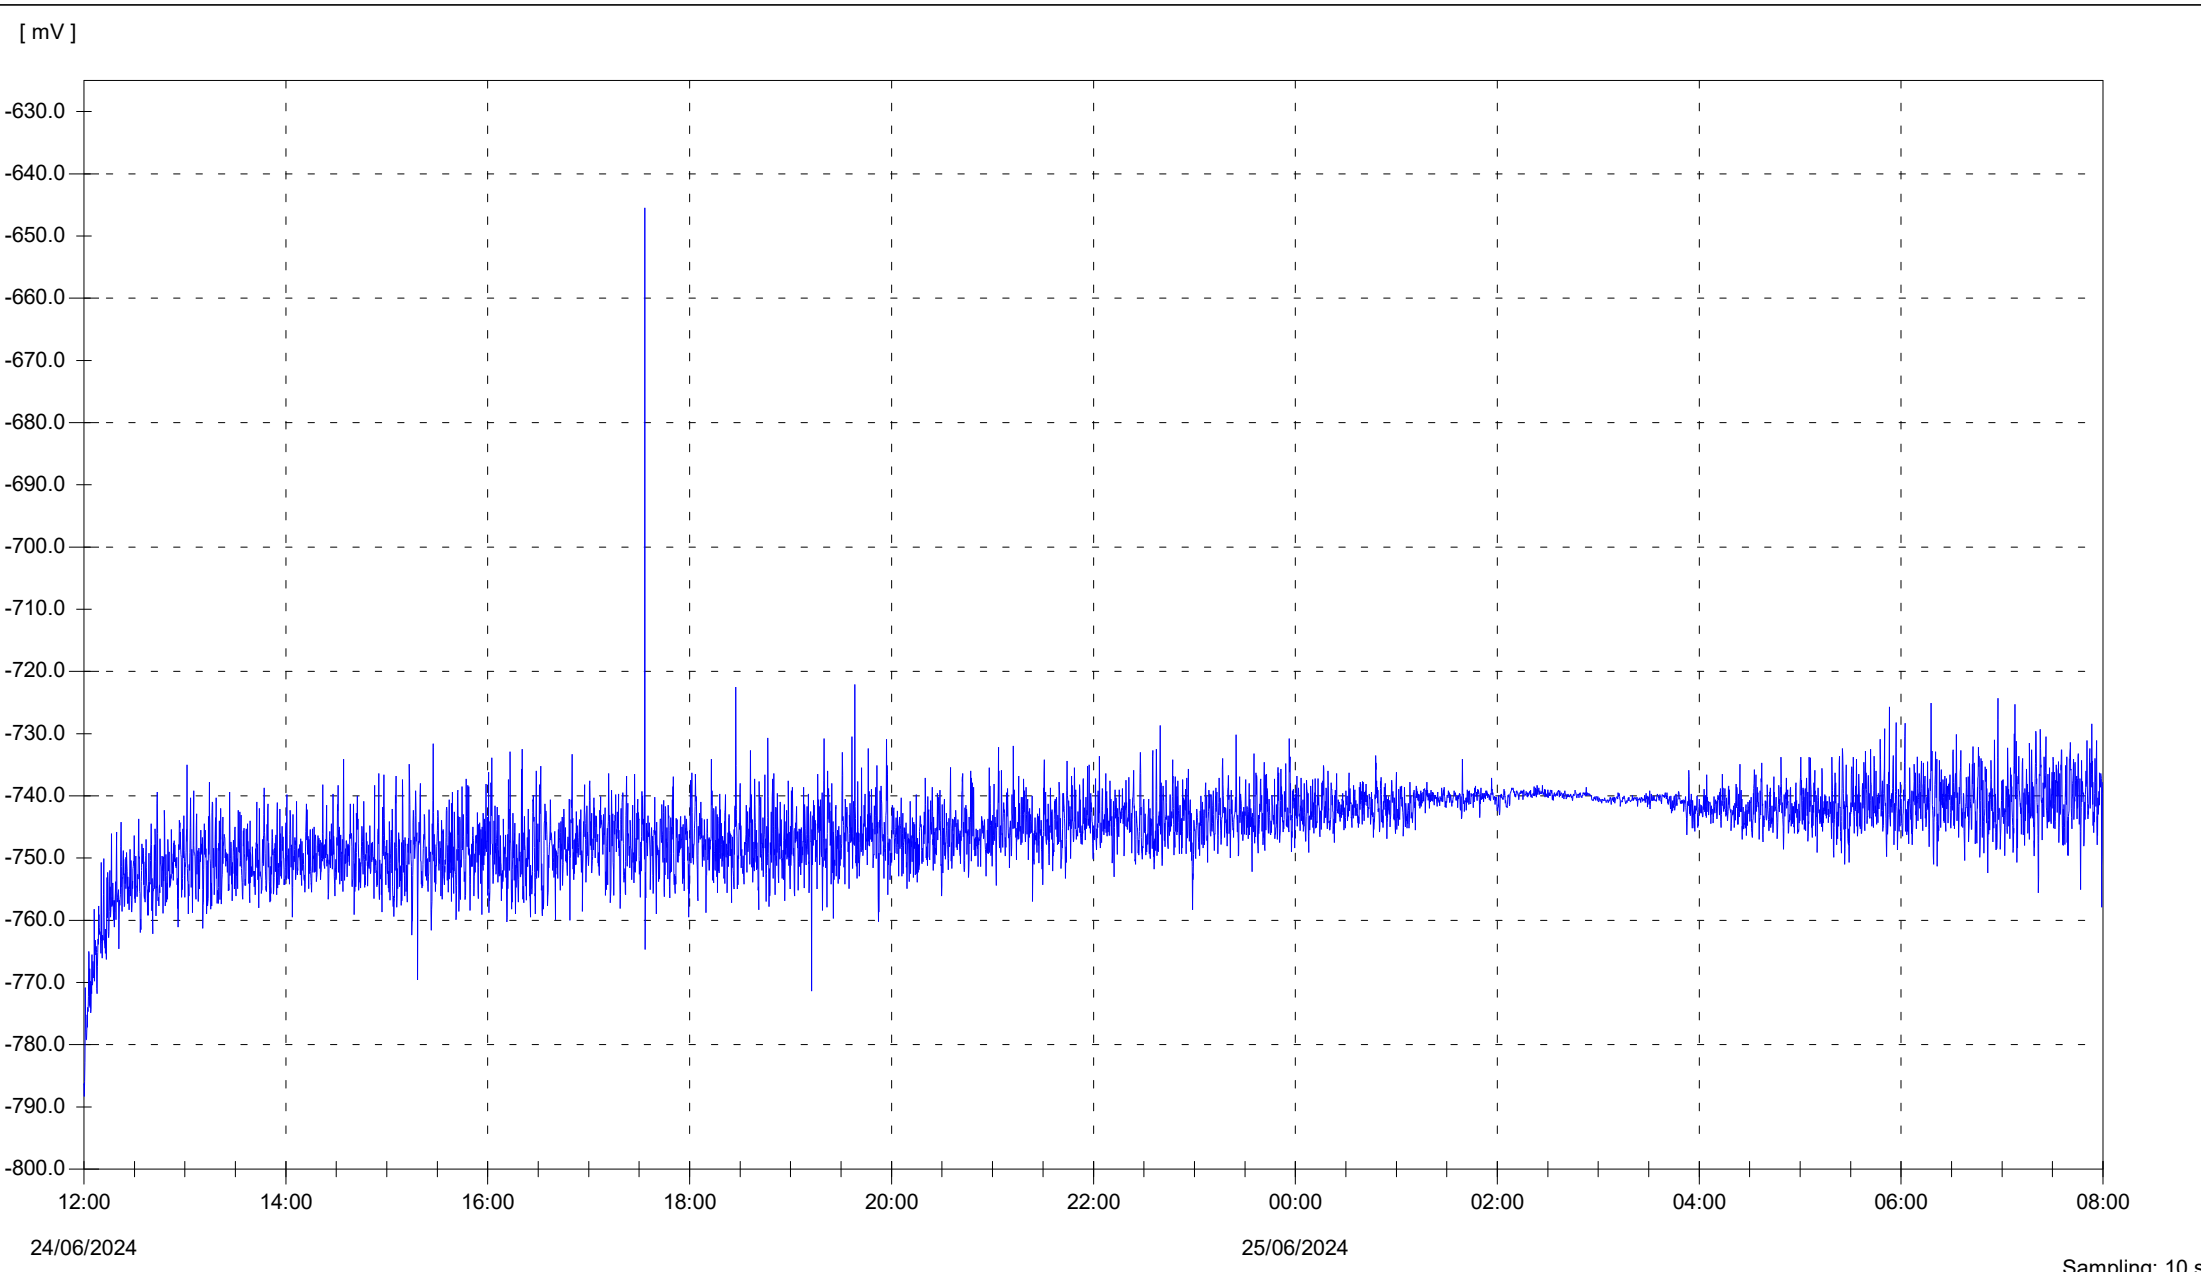
Electrolysis Risk Reporting
85-97 Waterloo Road, Macquarie Park NSW
Perpendicular to the rail (85 Waterloo Road)
Logger Serial Number: 2747

5. Data logging voltage gradients between steel earth stakes perpendicular to the rail at the southeast boundary of 85 Waterloo Road shows stray current effects that are within, but at time exceed acceptable limits.

Min	Max	Average	Std. dev.
DC 1	-0.788 V	-0.646 V	-0.745 V	0.006 V

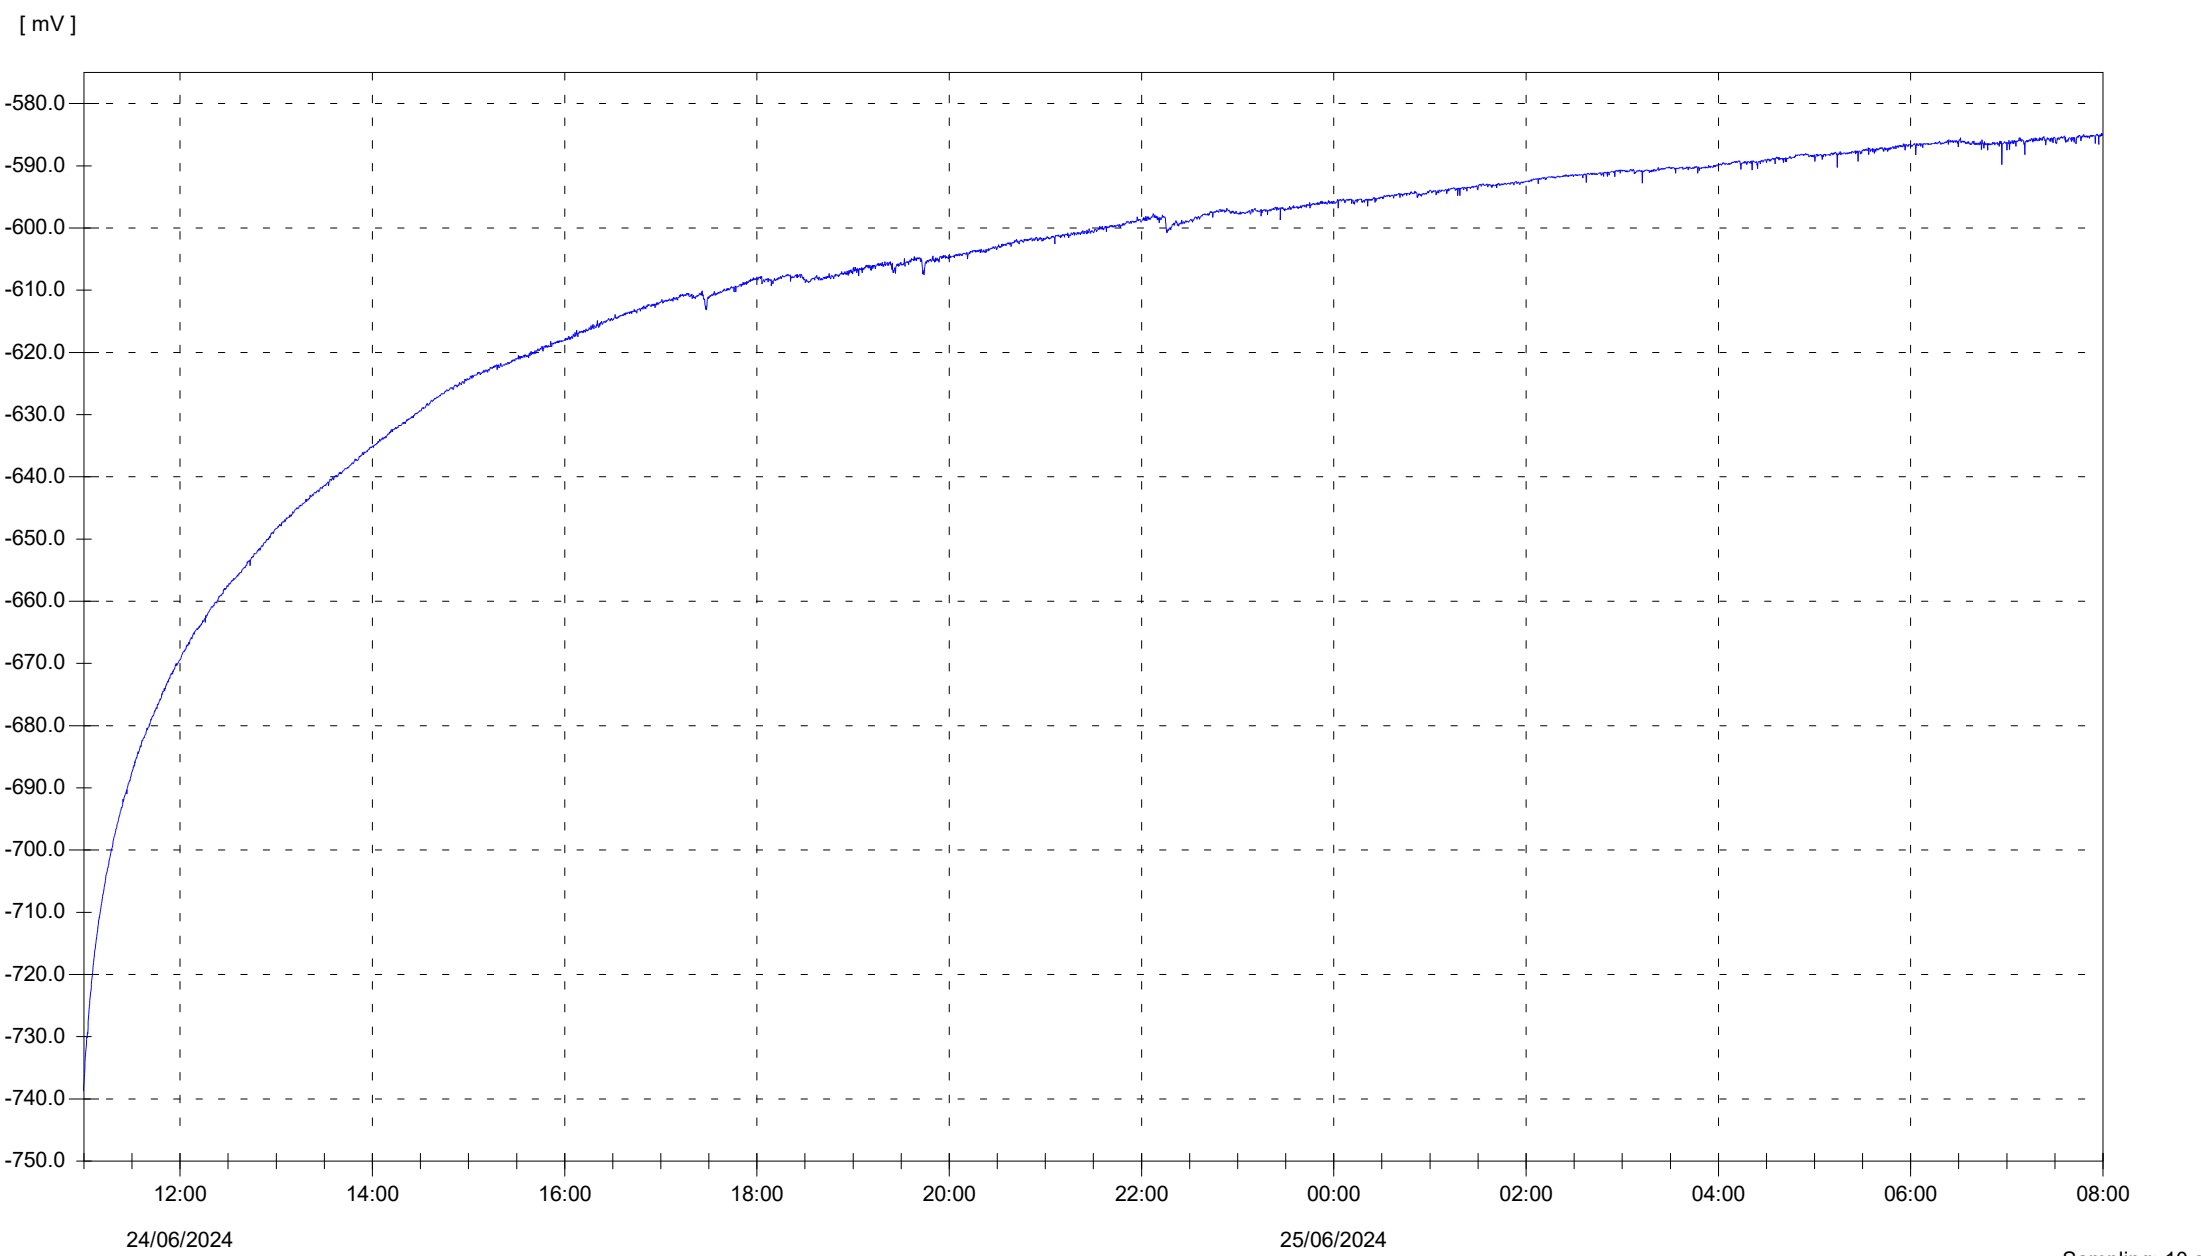
Electrolysis Risk Reporting
85-97 Waterloo Road, Macquarie Park NSW
Firewater Piping (Hydrant, 97 Waterloo Road)
Logger Serial Number: 3397

6. Data logging the potential of a Firewater piping at the northwest boundary of 97 Waterloo Road shows stray current effects that are within acceptable limits.

Min	Max	Average	Std. dev.
DC 1	-0.737 V	-0.585 V	-0.609 V	0.026 V

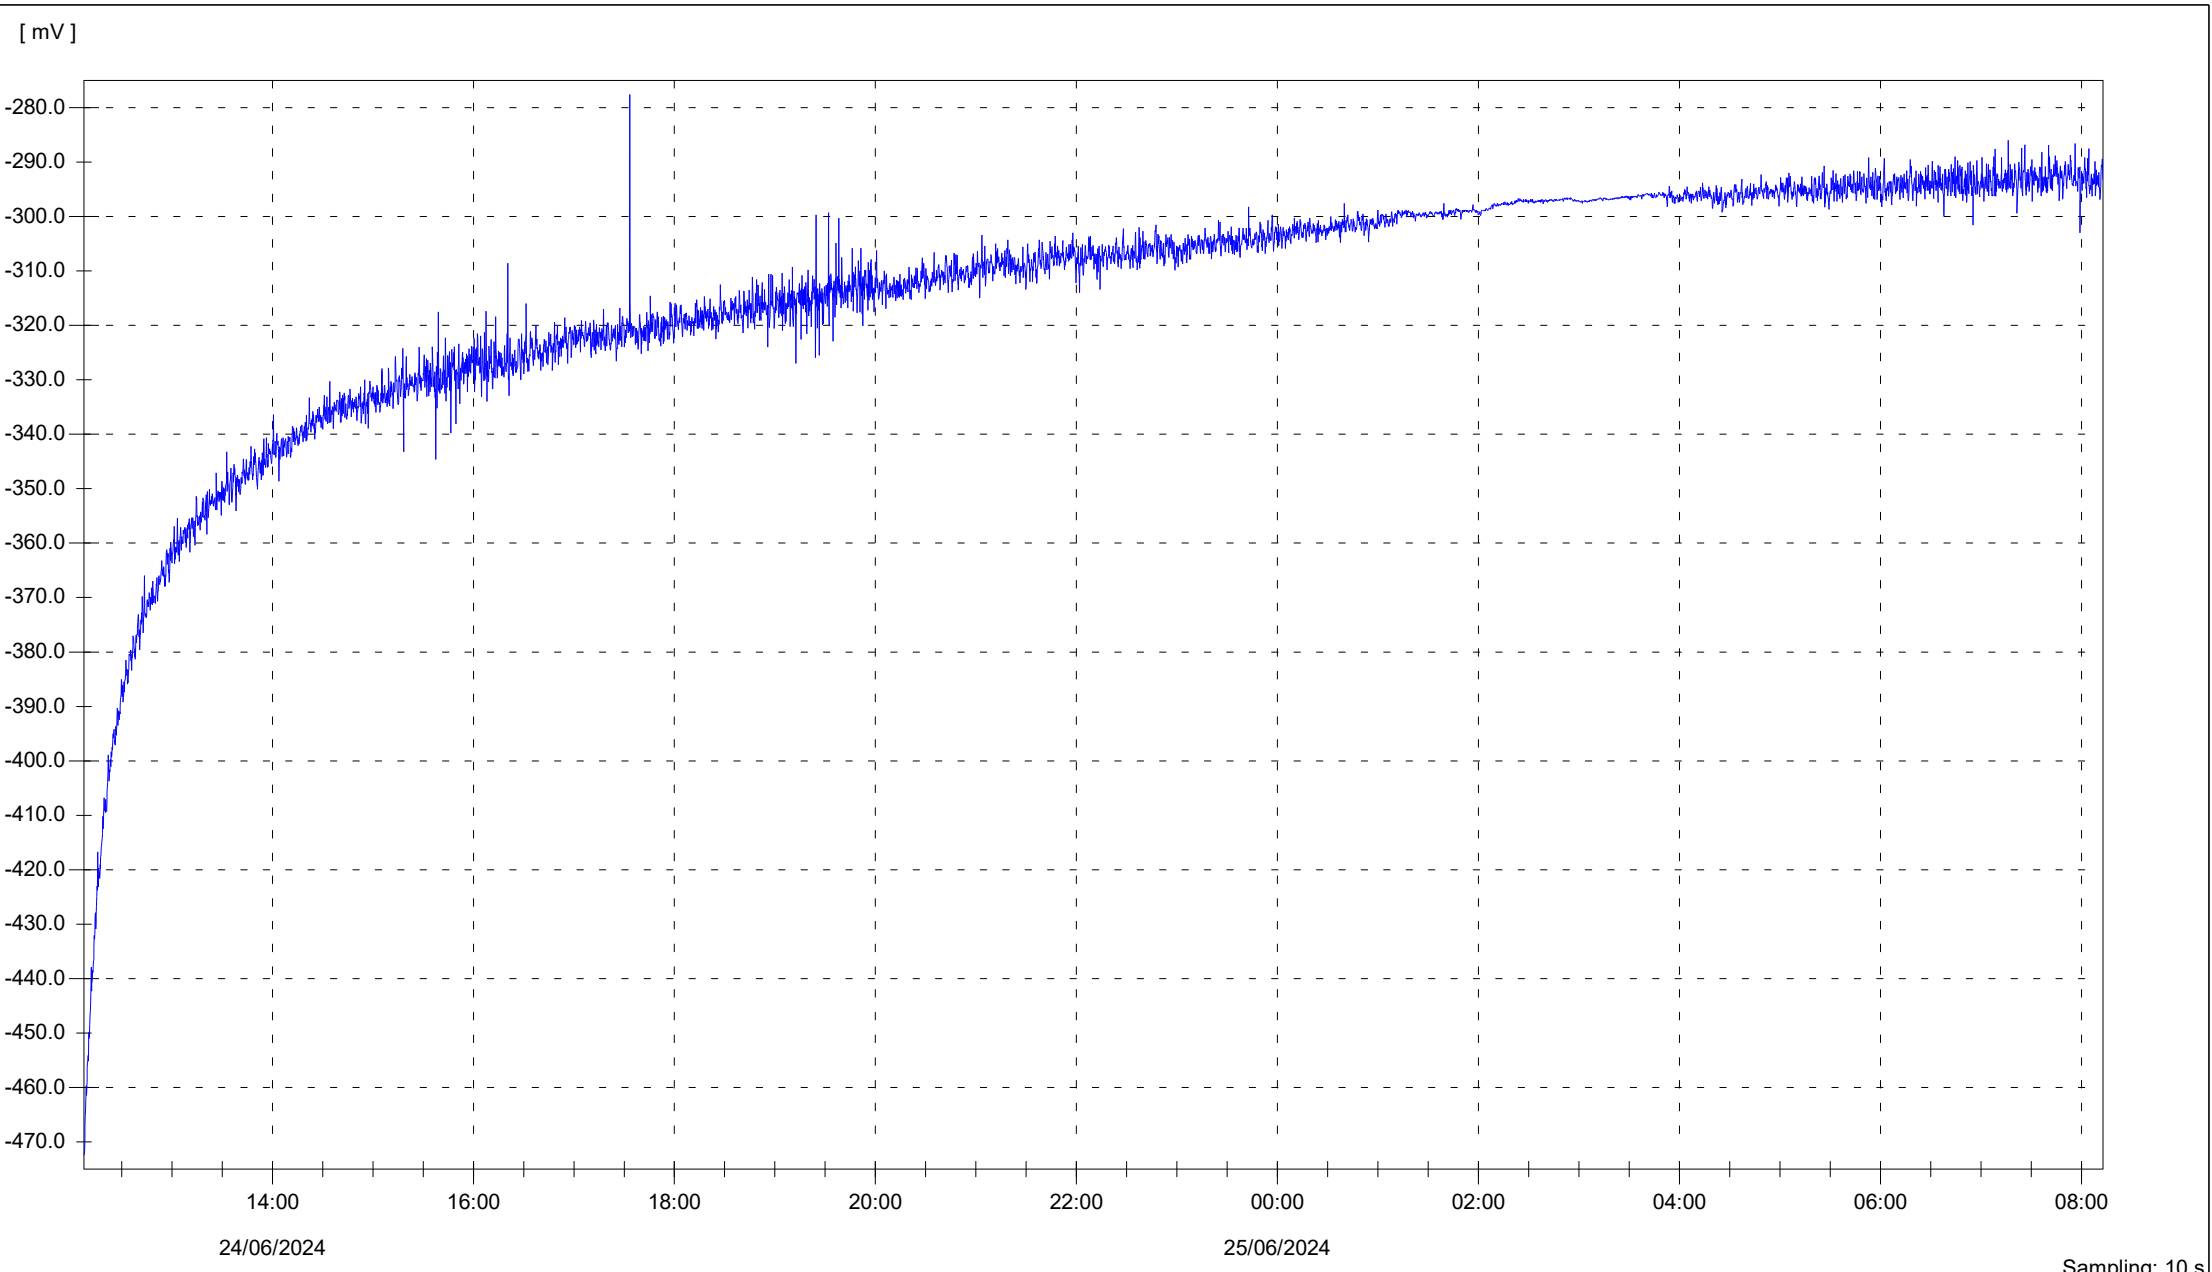
Electrolysis Risk Reporting
85-97 Waterloo Road, Macquarie Park NSW
Water Pipe (Utilities piping, 85 Waterloo Road)
Logger Serial Number: 2731

7. Data logging the potential of a water pipe at the northeast corner of 85 Waterloo Road shows stray current effects that are within, but at time exceed acceptable limits.

Min	Max	Average	Std. dev.
DC 1	-0.473 V	-0.278 V	-0.314 V	0.024 V
