ELECTROLYSIS RISK REPORT
85-97 WATERLOO ROAD, MACQUARIE PARK NSW 2113

ELECTROLYSIS RISK REPORT

85-97 WATERLOO ROAD, MACQUARIE PARK NSW 2113

DOCUMENT NUMBER: N-000173/P100361

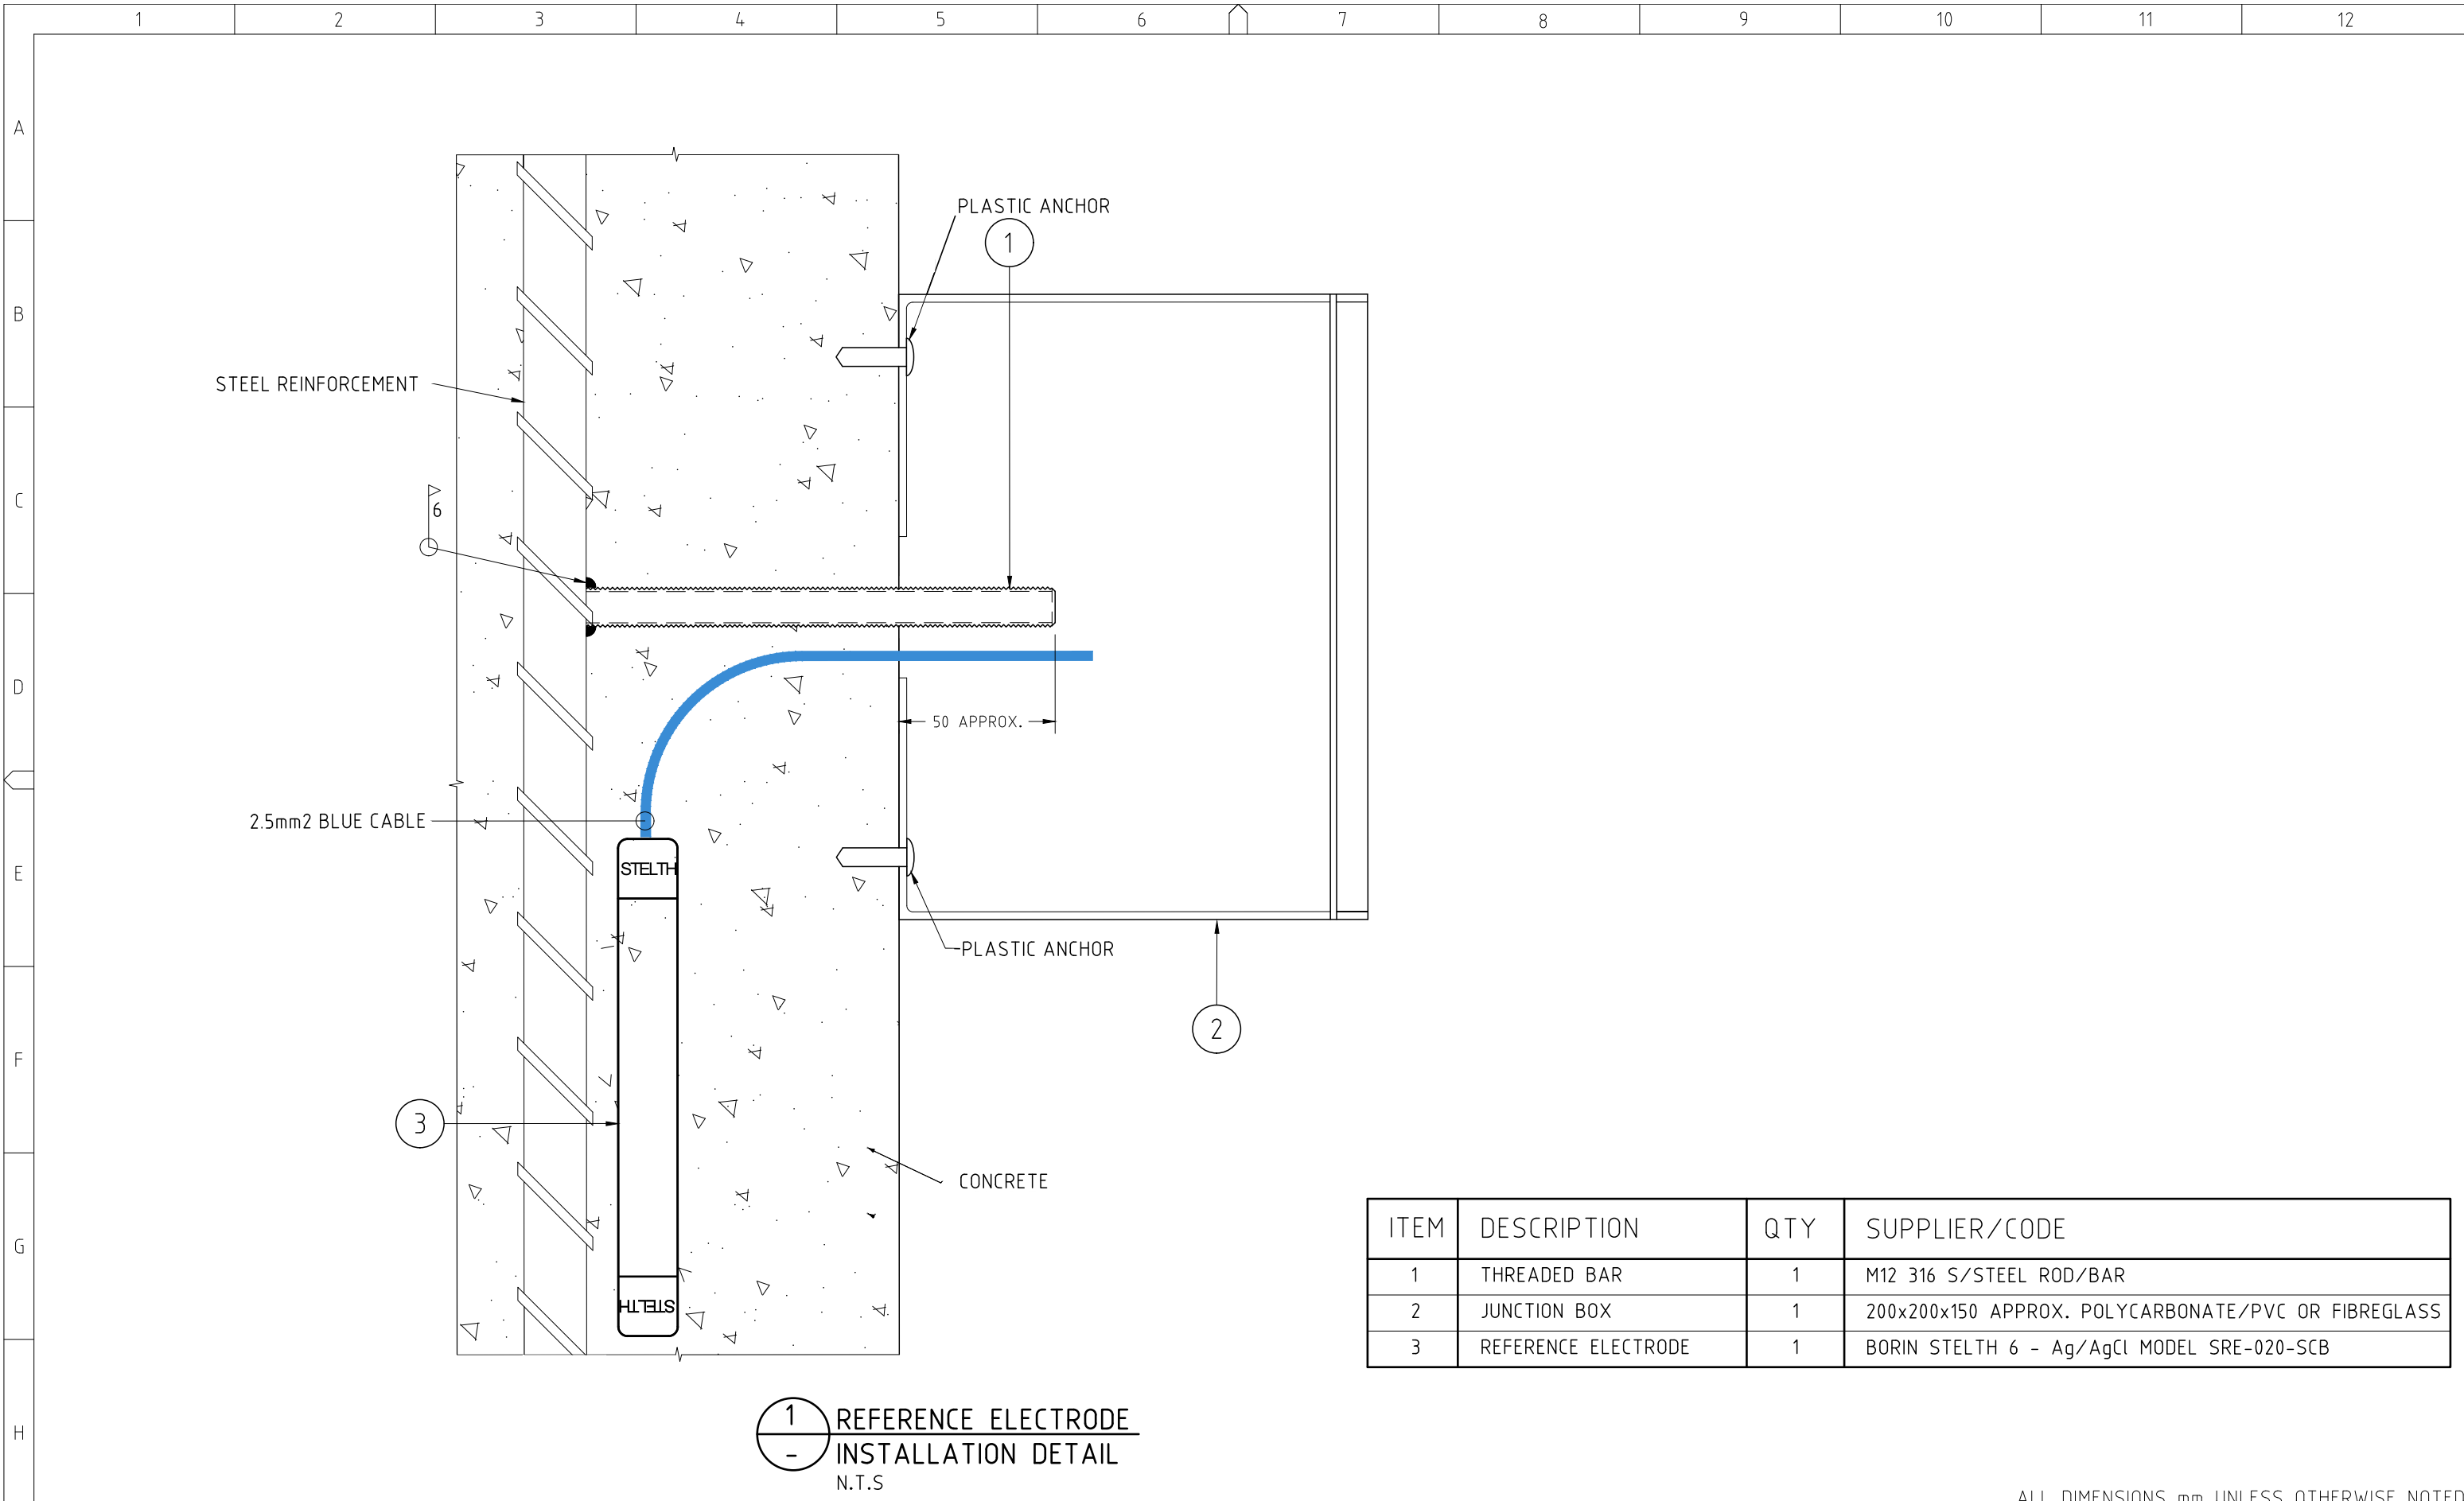
1 REFERENCE ELECTRODE
- INSTALLATION DETAIL
N.T.S

ITEM	DESCRIPTION	QTY	SUPPLIER/CODE
1	THREADED BAR	1	M12 316 S/STEEL ROD/BAR
2	JUNCTION BOX	1	200x200x150 APPROX. POLYCARBONATE/PVC OR FIBREGLASS
3	REFERENCE ELECTRODE	1	BORIN STELTH 6 - Ag/AgCl MODEL SRE-020-SCB

4. A minimum of two (2-off) electrolysis test points such as an Erico Earthbridge DB12CS701, in conjunction with an Ag/AgCl permanent reference electrode installed close to the reinforcing steel, shall be provided at every at/below ground level. This is to assist with potential (stray current) monitoring (See Appendix B for details).
