2-4 Hale Street, Botany NSW

Coombes Property Group Pty Ltd

Remedial Action Plan

18 September 2024

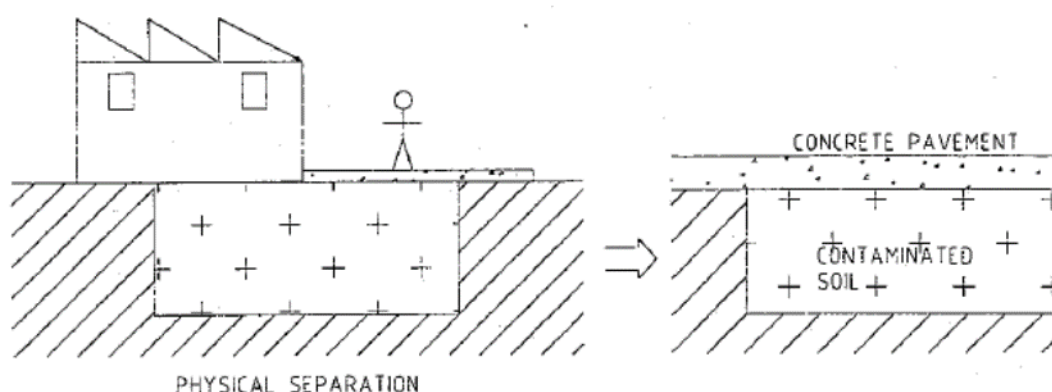
- A minimum soil cover thickness of 0.5 m¹⁰ in landscaped or mass planting/shallow landscaped areas and 1.5 m in tree pit zones which is underlain by a visual “marker layer” in unpaved areas, i.e., planter boxes in landscaped areas etc.; or
- Permanent concrete floor/ground slabs as underlain by visual “marker layer”, i.e., underlying buildings, roads, pathways; or
- Top (concrete) of pile foundations (no marker layer required for below pile foundations).

A conceptual sketch, sourced from ANZECC 1999¹¹, is shown following:

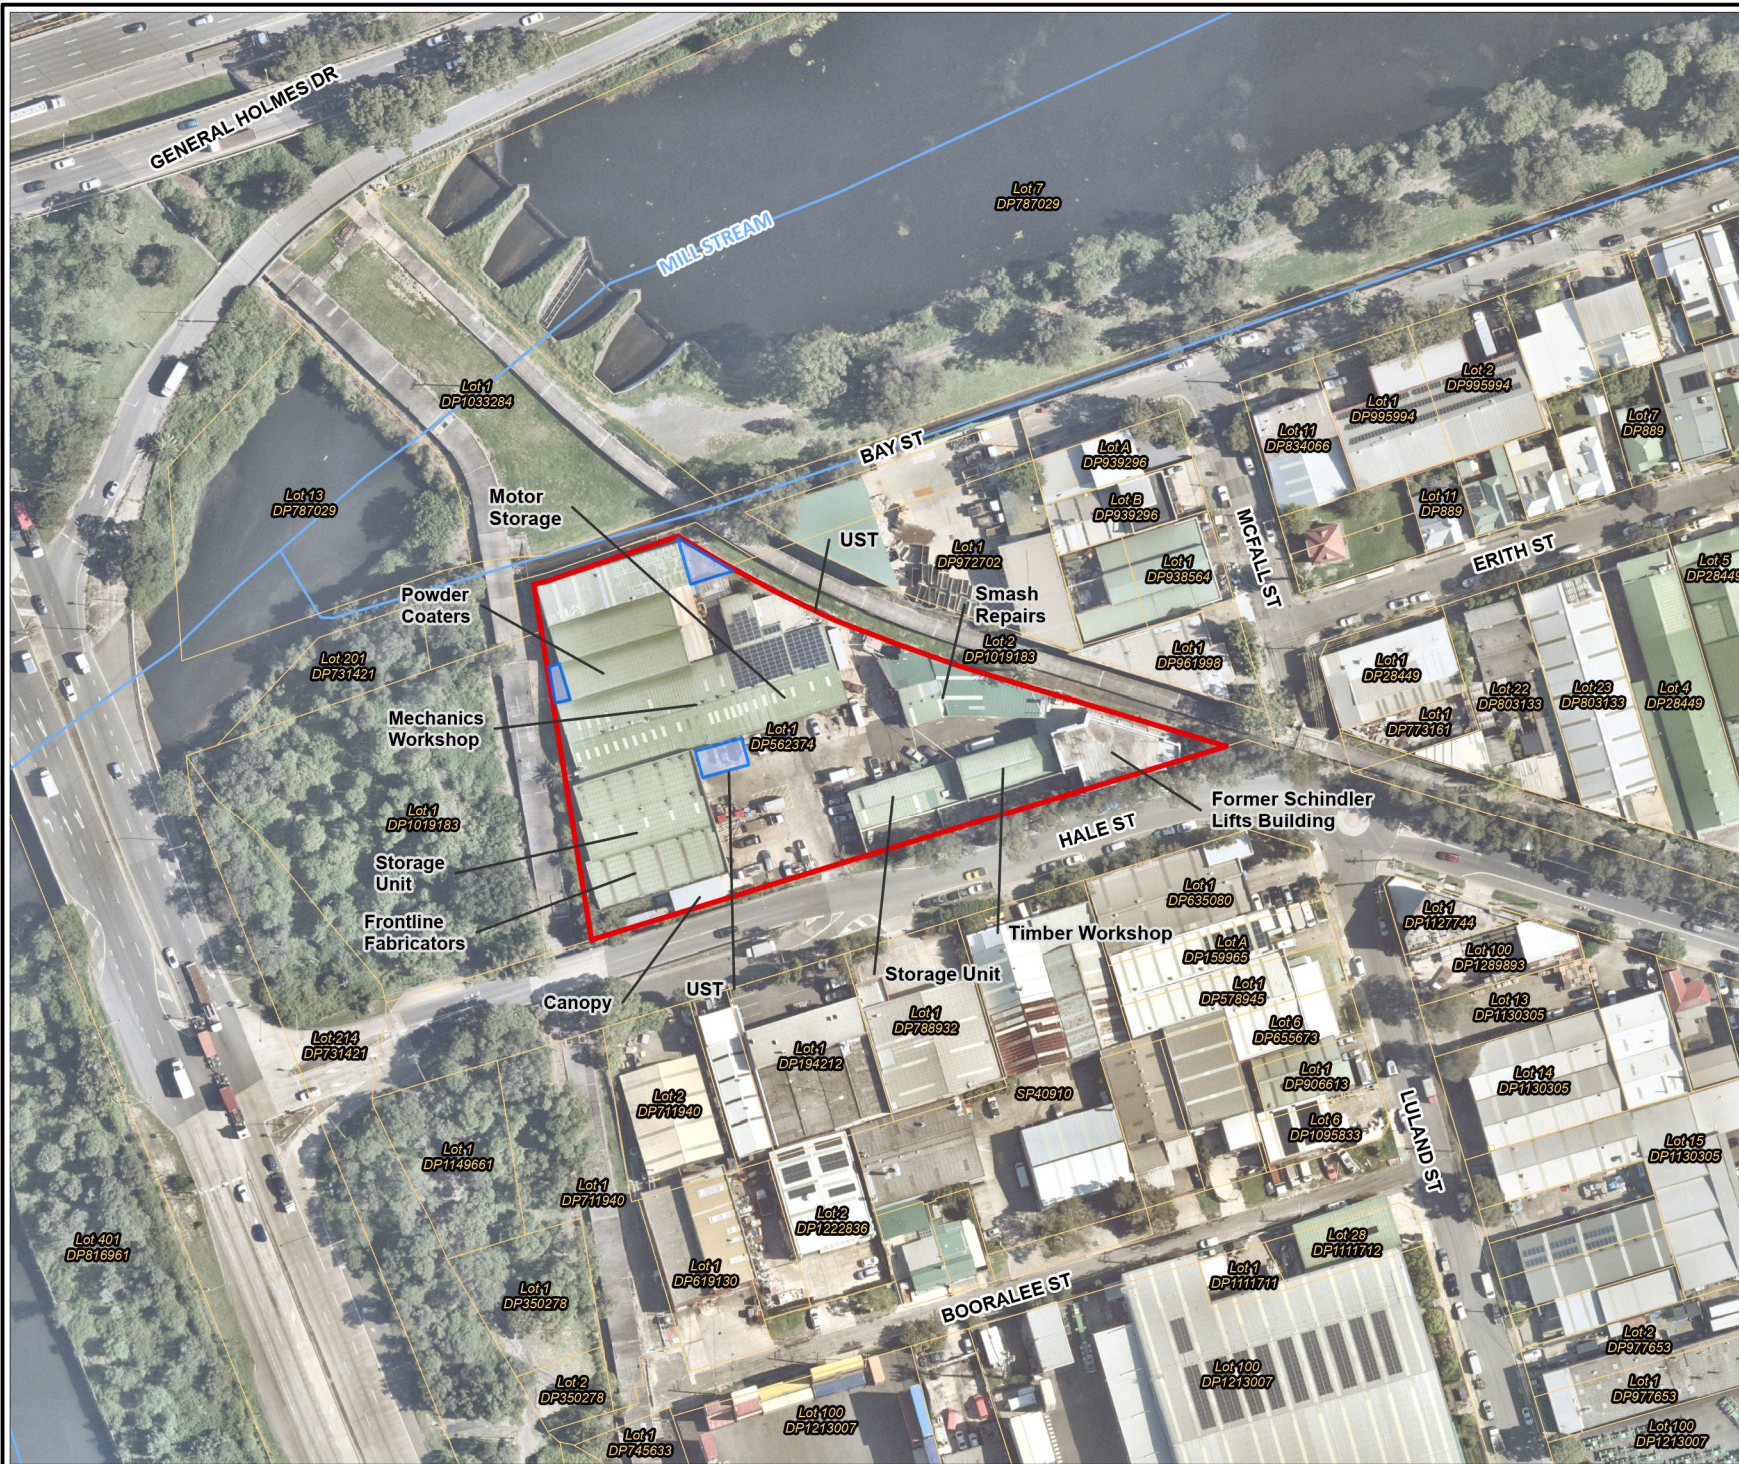
FIGURE 2

- Legend
- ▬ Approximate Site Boundary
 - NSW Cadastre
 - Stream
 - ACM on ground Surface

SITE LAYOUT

The site is currently comprised of industrial / commercial premises spread across several buildings. The current infrastructure at the site includes three large warehouse buildings with multiple units, a canopy in the southeast, carparking in the central portion, and a transmission box on the eastern boundary. Industrial sized refrigeration and meat storage units, associated with Ripe Providores, were identified in unit 12 at the site. Spray painting booths were found within the buildings leased by Botany Powder Coaters and Smash Repairs.

Two underground Storage Tanks (USTs) were identified at the site, one located on the eastern boundary and one located in the central area. During underground service location, a ground penetrating radar (GPR) was used to confirm the area and size of the USTs. It was unclear if the USTs have previously been decommissioned. A former bowser and vent was observed adjacent to the UST in the central portion of the site. Multiple intermediate bulk containers (IBCs) and storage drums were found in the northern portion of the site. Fragments of asbestos were also encountered across the site and it was reported that asbestos products are present on the site, including wall sheeting, tiles, and eaves. Dangerous goods including gas bottles, paints, lubricants, lacquers, and oils were stored in various locations across the site.

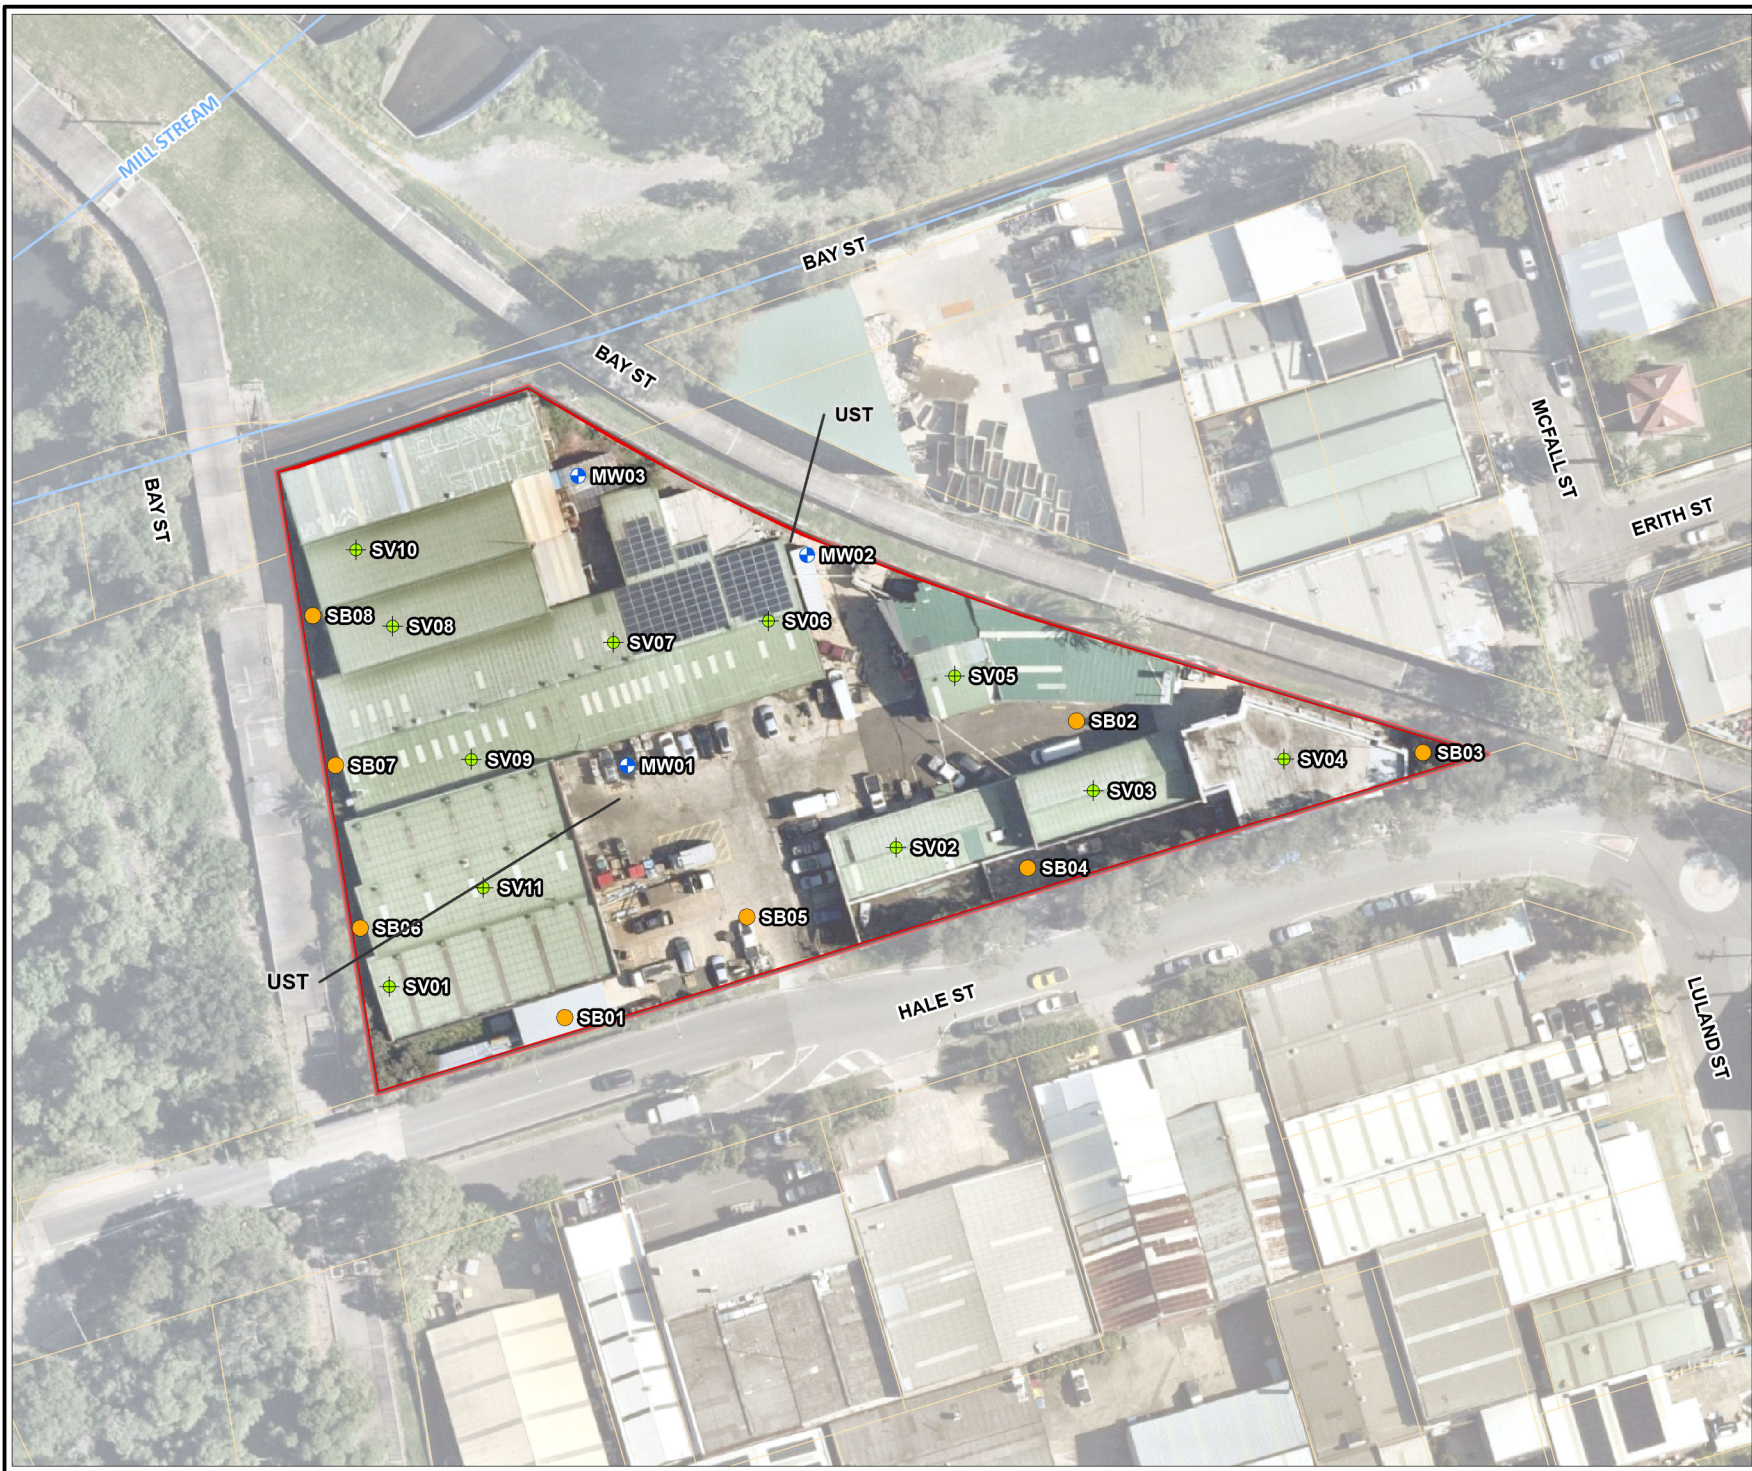
FIGURE 3

- Legend
- Approximate Site Boundary
 - NSW Cadastre
 - Proposed Sample Location
 - Soil Bores, JBS&G 2022
 - Monitoring Well (JBS&G 2022)
 - Soil Vapour (JBS&G 2022)

SAMPLE LOCATIONS

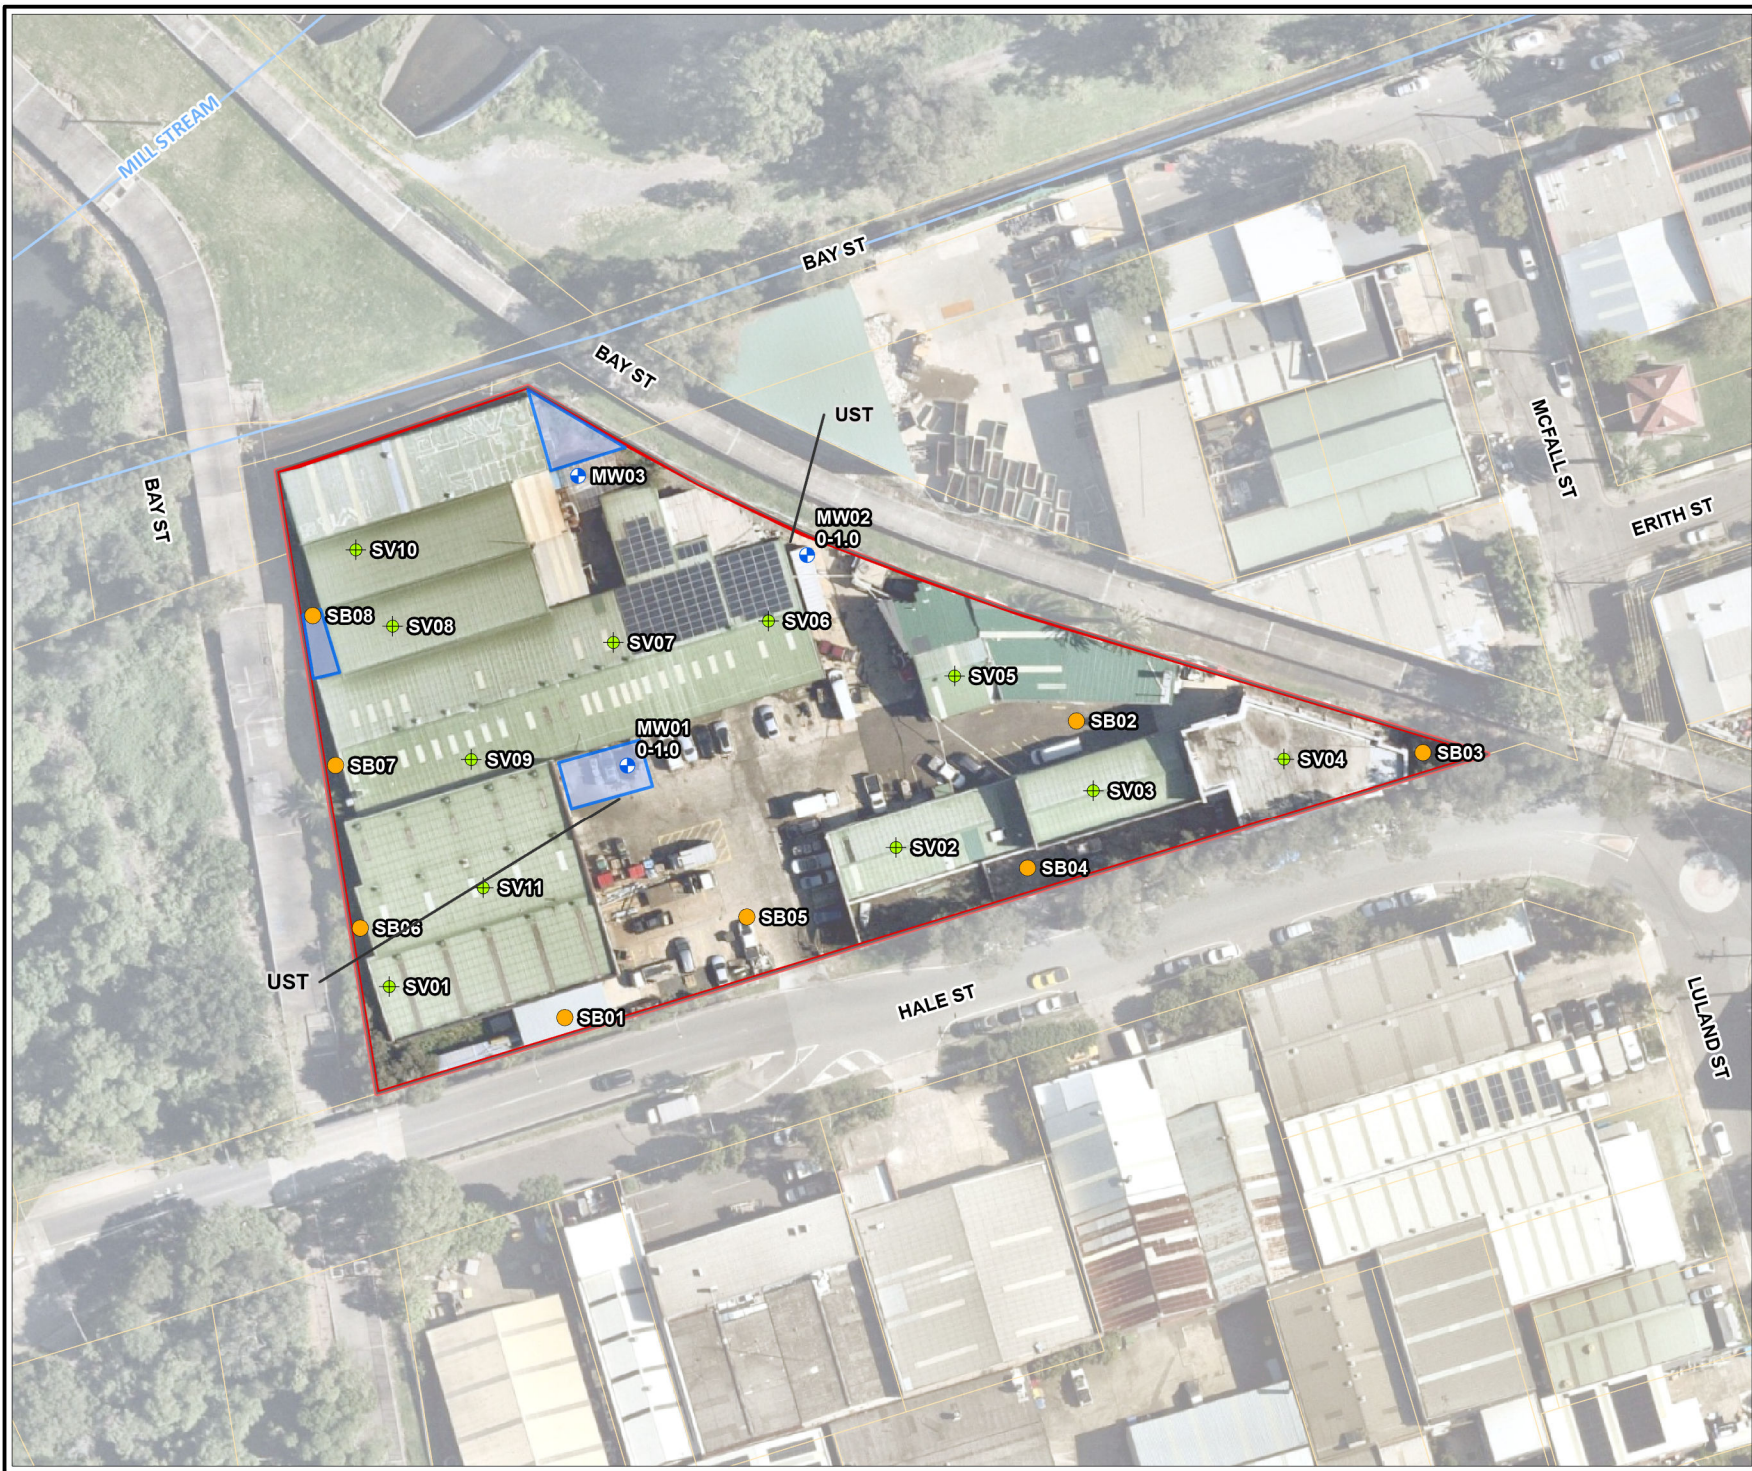
FIGURE 4

- Legend
- ▭ Approximate Site Boundary
 - ▭ NSW Cadastre
 - ▭ ACM on ground Surface
- Proposed Sample Location
- Soil Bores, JBS&G 2022
 - + Soil Vapour (JBS&G 2022)
 - ⊕ Monitoring Well (JBS&G 2022)
- 0-1.0 Bonded Asbestos Detected

ASBESTOS DETECTIONS IN SOIL

- Bonded ACM was observed in two samples with a maximum concentration of 0.0368% w/w during field asbestos quantification, with asbestos concentrations in both samples below the adopted HSL-D of 0.05% w/w. Several ACM fragments were observed on unsealed ground surface along the western boundary and central portion garden bed, which exceeds the 'no visible surface ACM' criterion.

Bonded asbestos impacts have been identified on the ground surface within the along the western boundary and the central portion of the site, which will require remediation in order to address potential unacceptable health risks to future site users as well as address aesthetic issues associated with the impact. Bonded ACM was further reported in fill at two locations, albeit at concentrations below the adopted criteria applicable to commercial / industrial land-use. However, it is noted that the soil sampling density completed as part of JBS&G (2024a) did not meet the requirements of EPA (2022) or DOH (2021⁷) – noting the observation of building and demolition wastes within site fill materials across the extent of the site, there is the potential for additional asbestos impacts in soils then previously reported. As such, for the purposes of informing required remedial extent (**Section 5.4**), it should be assumed that all fill-based soils at the site are potentially impacted with asbestos until further assessment completed as part of pre-remediation activities (**Section 5.3**) proves otherwise.

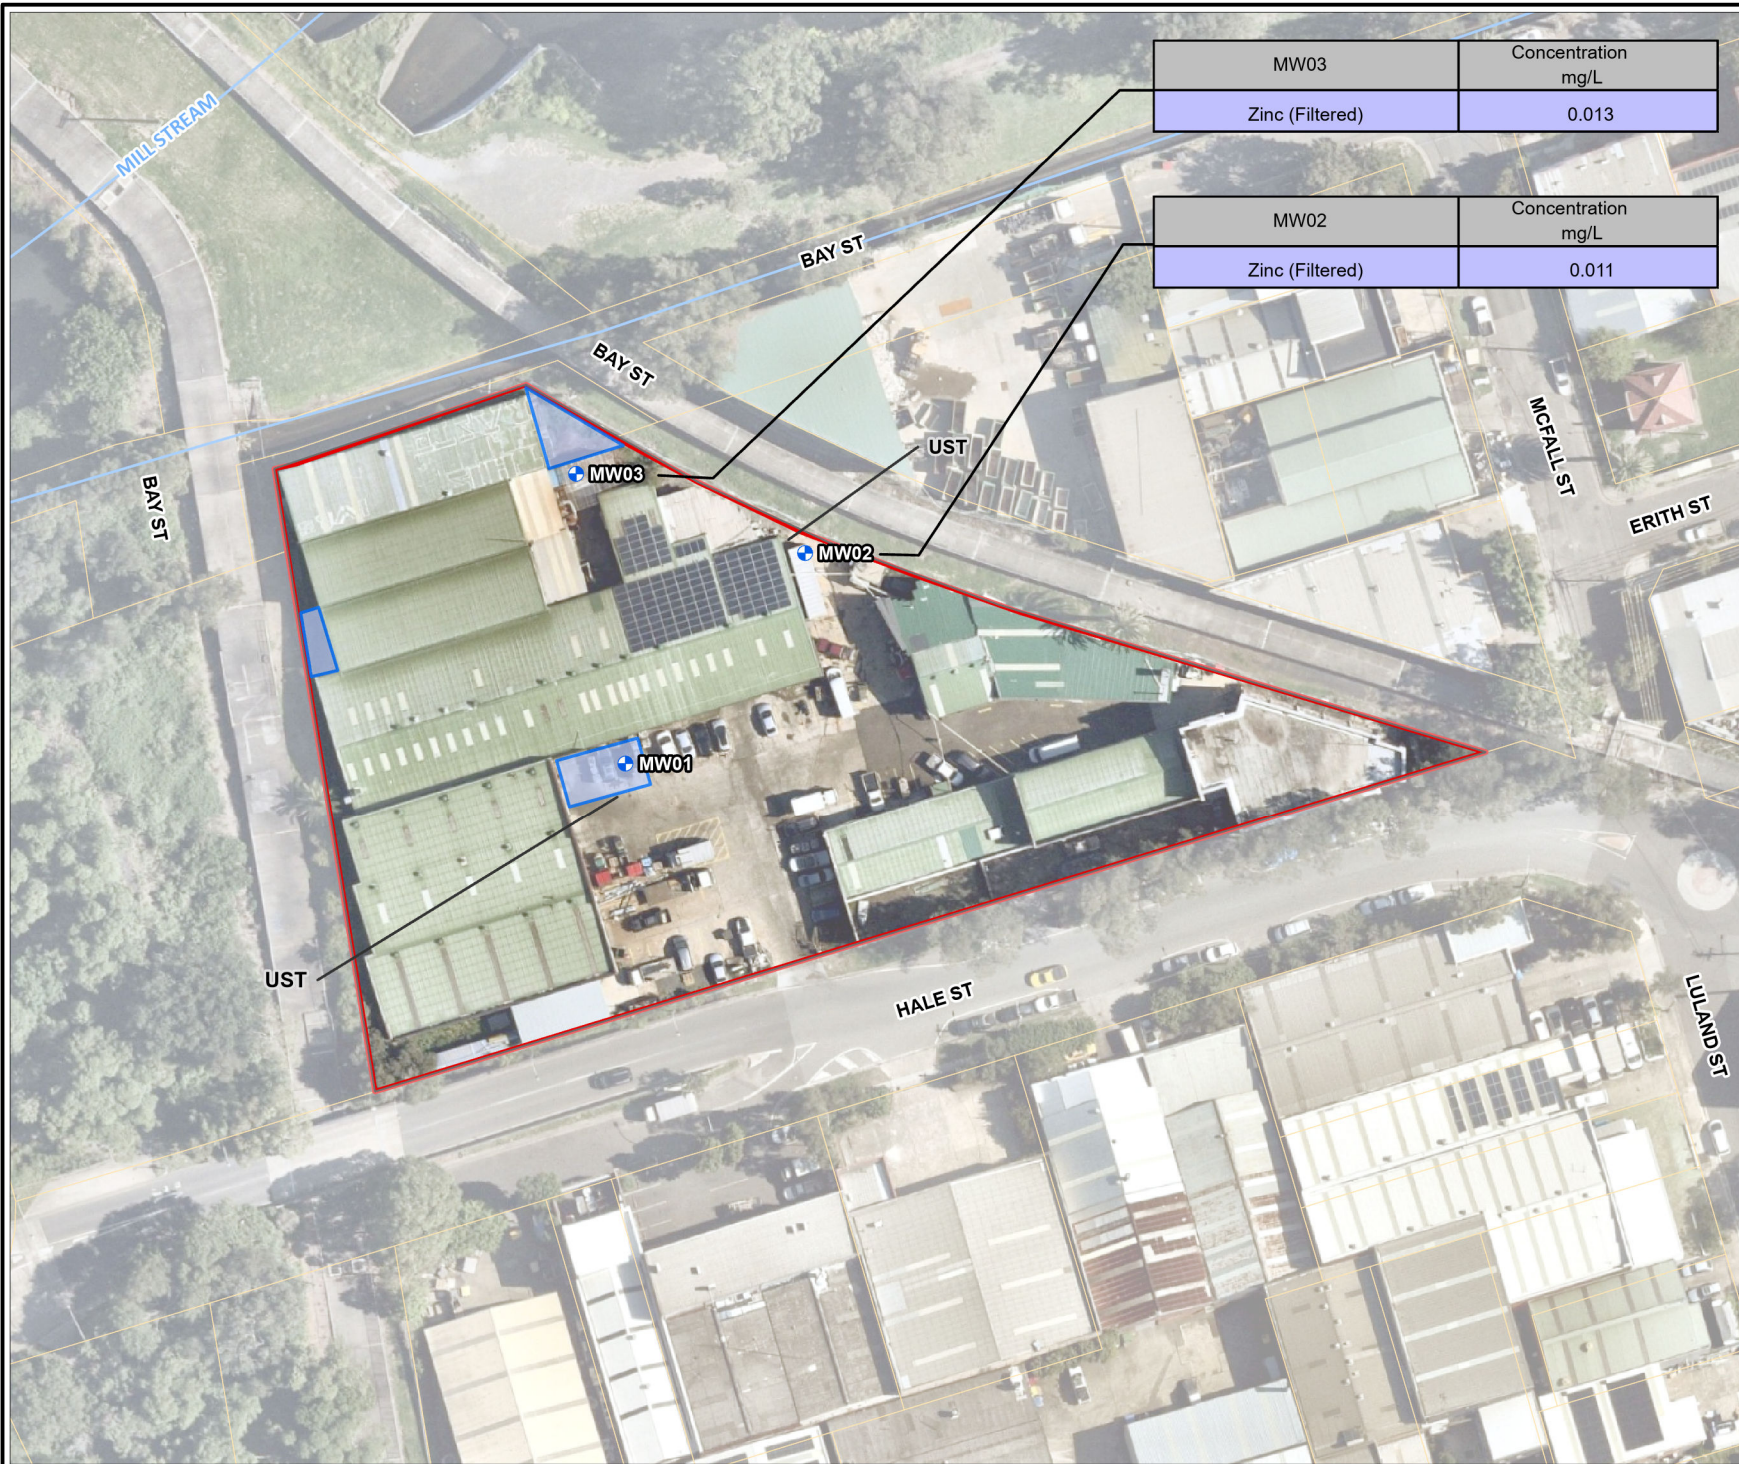
FIGURE 5

MW03	Concentration mg/L
Zinc (Filtered)	0.013

MW02	Concentration mg/L
Zinc (Filtered)	0.011

- Groundwater with slightly elevated levels of zinc were recorded in two monitoring wells (MW02 and MW03). The reported concentrations are considered to reflect urban background conditions given that there was no significant change of these constituents between up and down gradient monitoring wells and no significant source material identified within site soils. On this basis, the elevated levels of heavy metals in site groundwater are not considered to require management.

Site groundwater has been reported to have elevated levels of heavy metals. The elevated levels of heavy metals are not considered to be sourced from historical activities at the site and indicative of background conditions within the surrounding environment and as such, do not require remediation or management in order to make the site suitable for the proposed use.

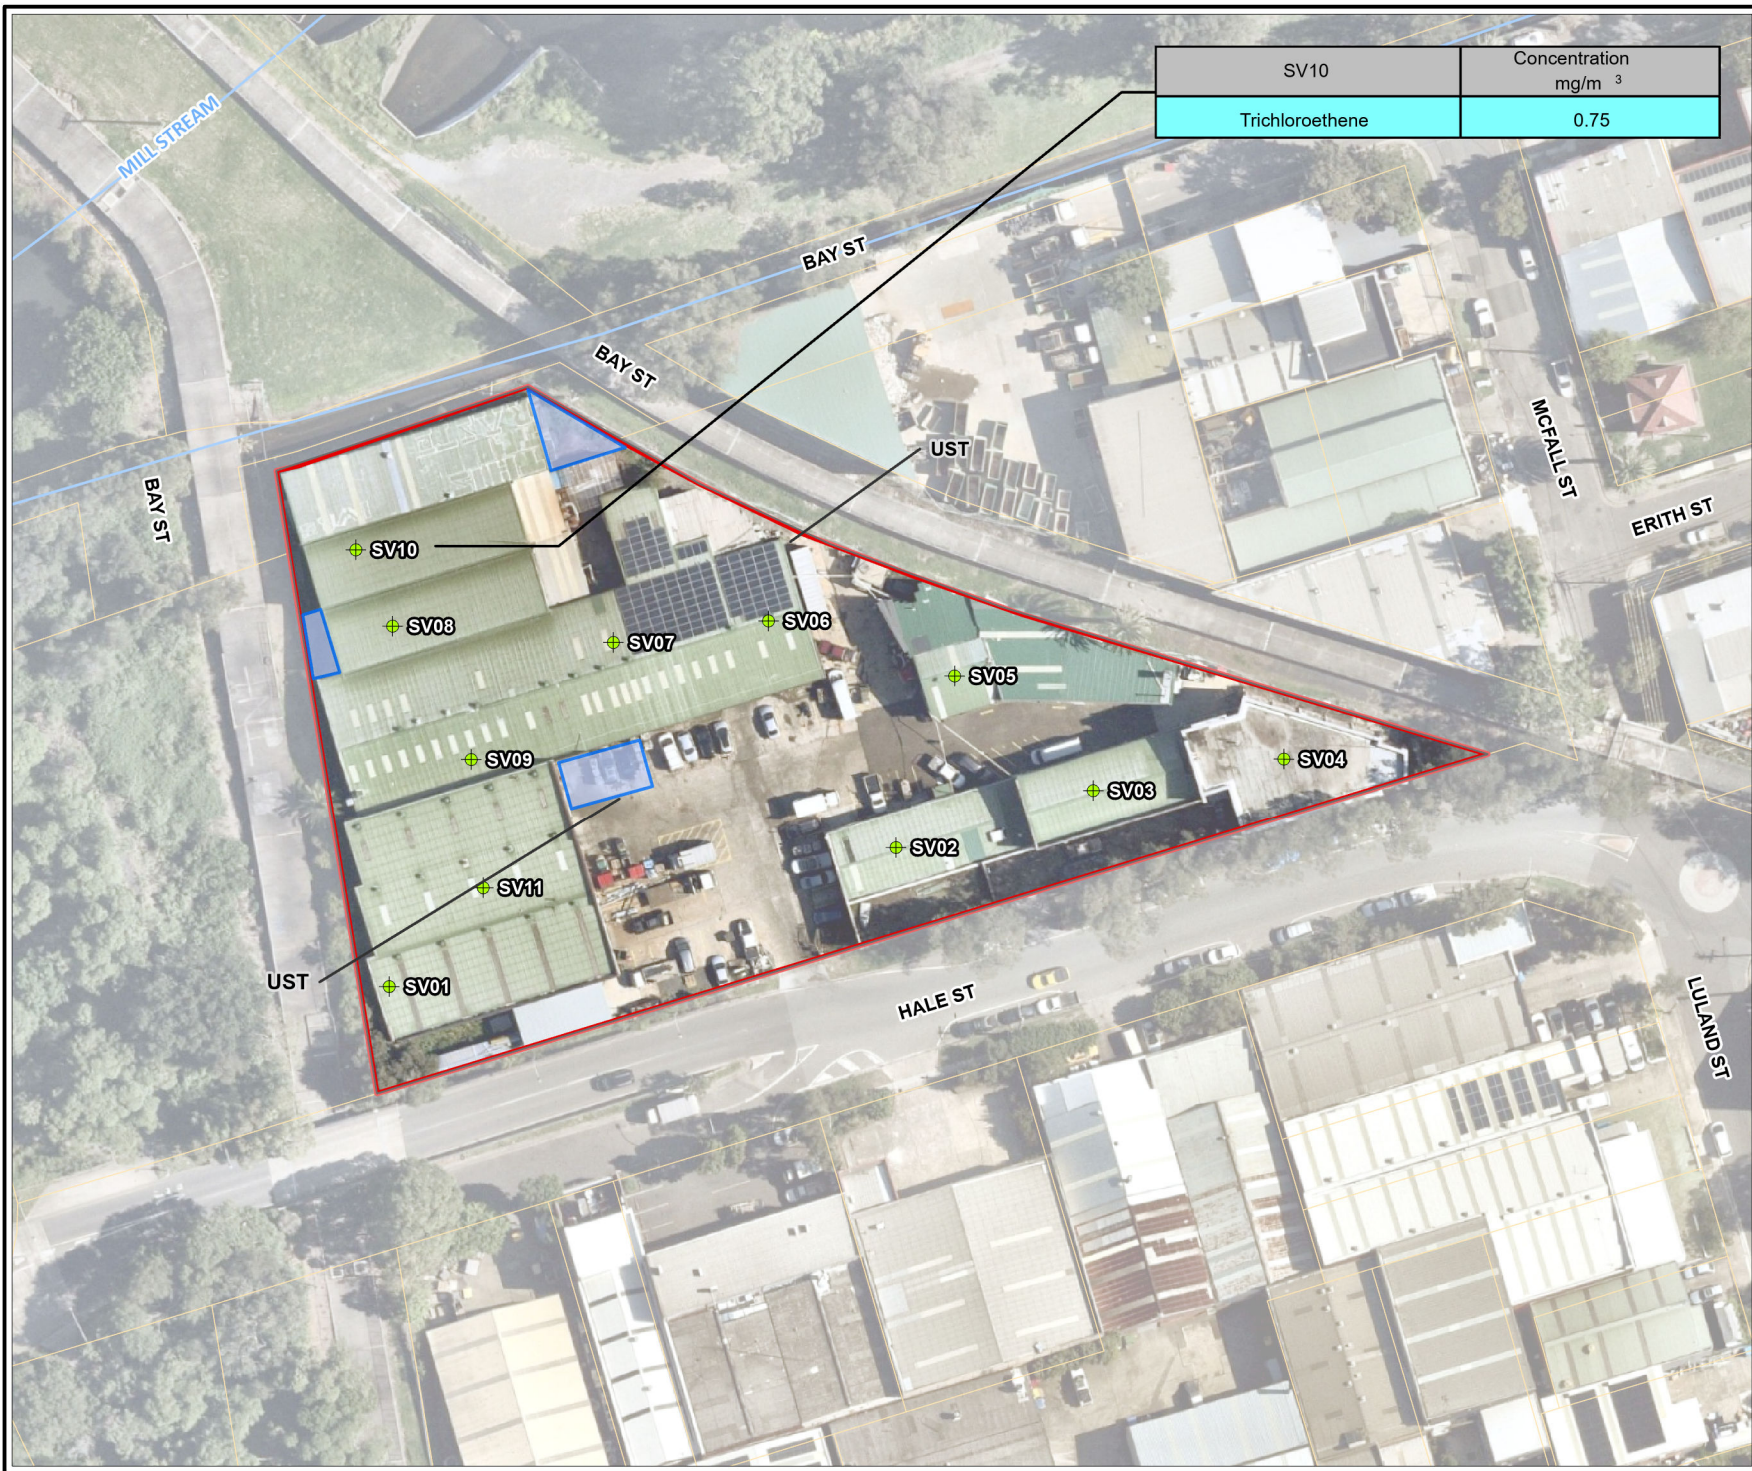
FIGURE 6

SV10	Concentration mg/m ³
Trichloroethene	0.75

- Legend
- ▬ Approximate Site Boundary
 - NSW Cadastre
 - ACM on ground Surface
- Proposed Sample Location
- ⊕ Soil Vapour (JBS&G 2022)
- Criteria Key
- NEPM 2013 Table 1A(2) Comm/Ind D Soil Vap VOCC HILs

SOIL VAPOUR EXCEEDANCES

- The lateral extent of TCE impacts in soil vapour in the north-western portion of the site which may pose an unacceptable health risk to future site users (via vapour intrusion) requires additional assessment. It is recommended that additional sub-slab vapour sample locations are placed around SV10 in order to provide further delineation at the location in which TCE impacts have been identified. The results should be assessed as part of a site-specific human health risk assessment that incorporates future building design to evaluate the potential risks via vapour intrusion in order to define the final requirements for remediation.

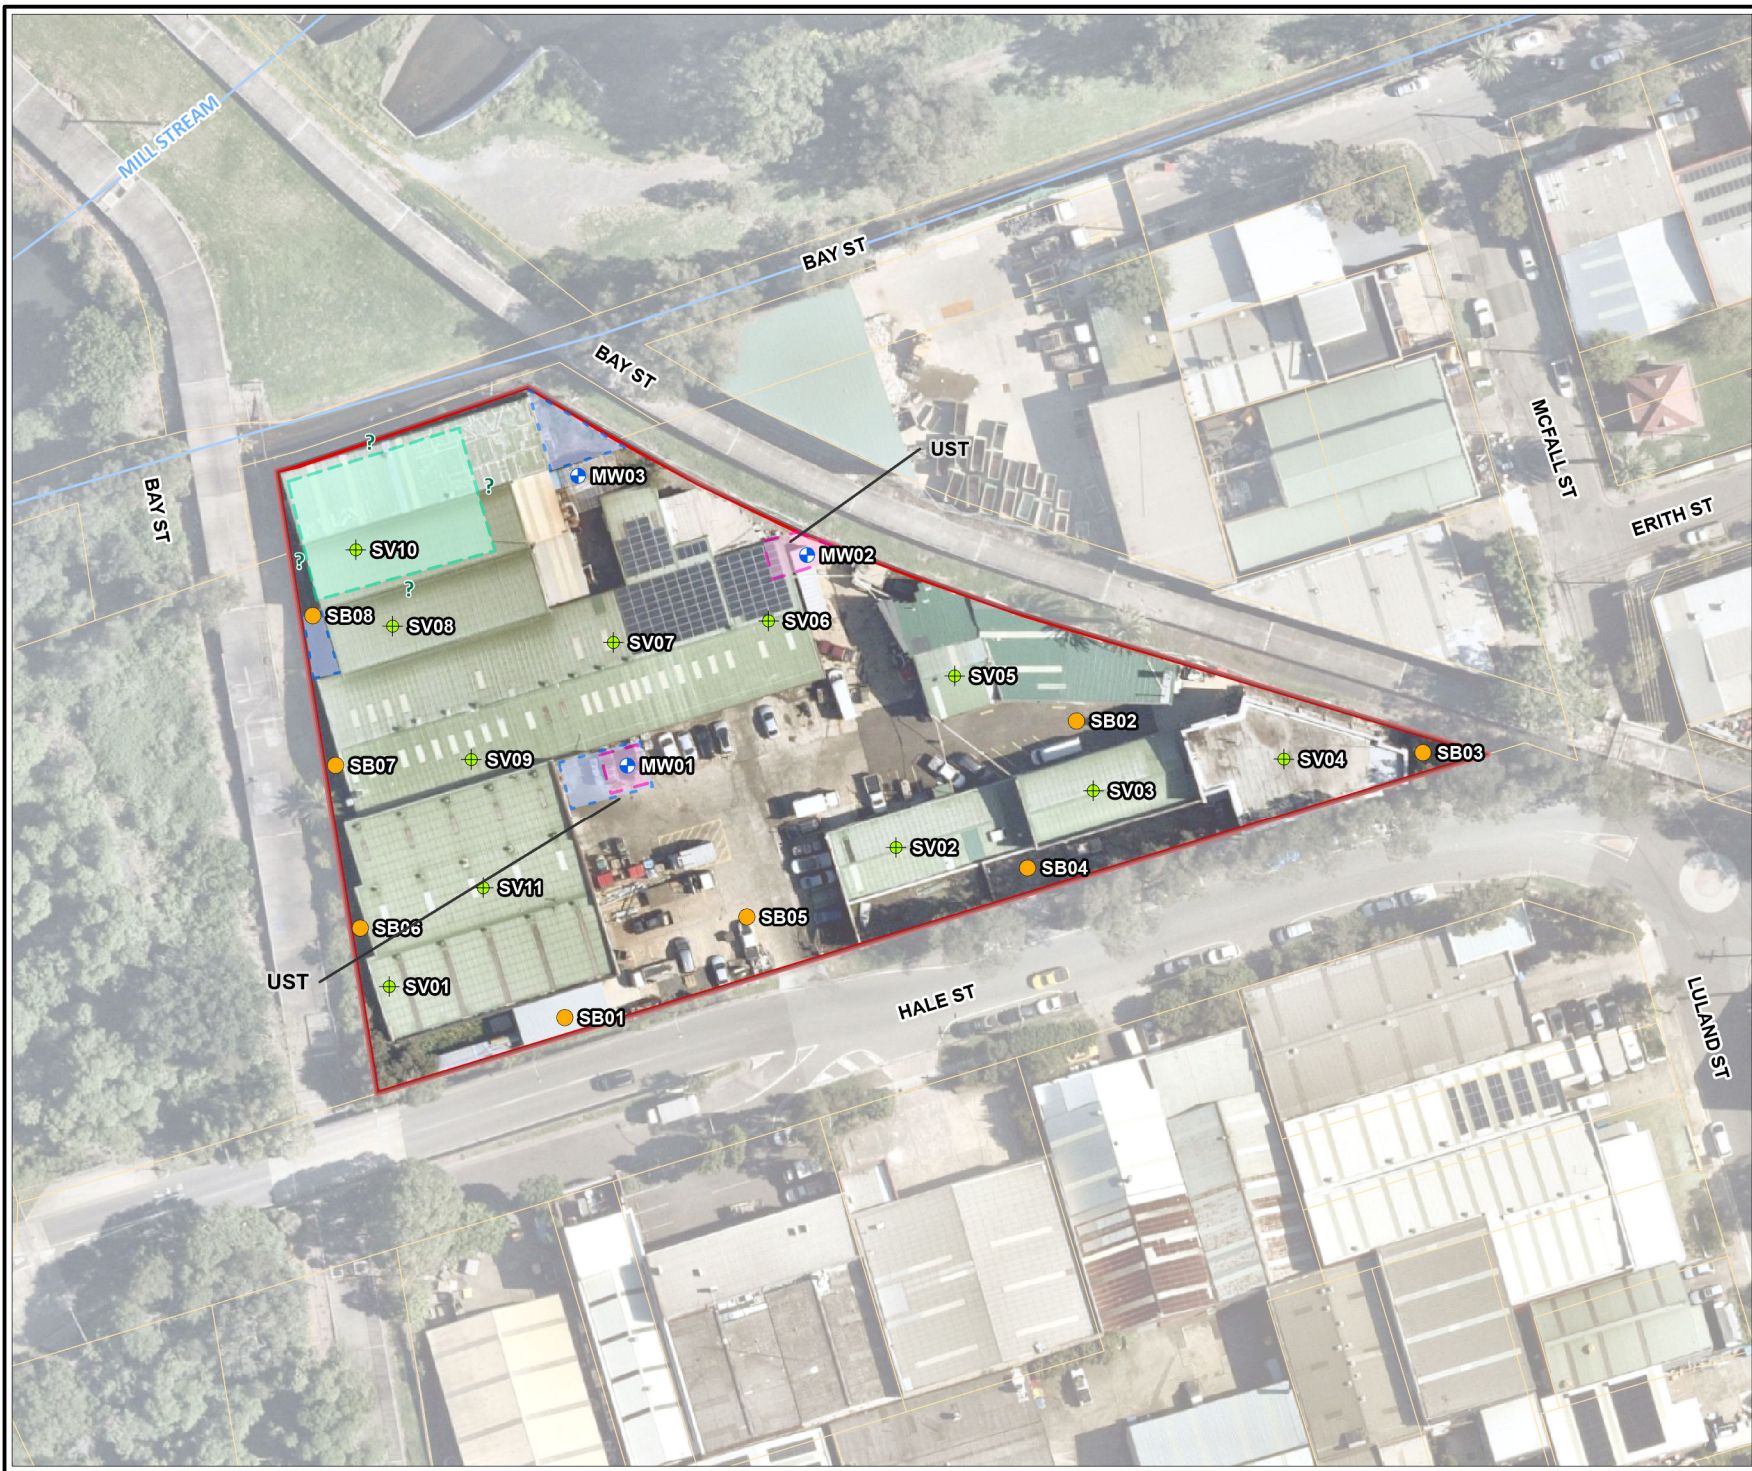
- Legend**
- Approximate Site Boundary
 - NSW Cadastre
 - Sample Locations**
 - Soil Bores, JBS&G 2022
 - + Monitoring Well (JBS&G 2022)
 - + Soil Vapour (JBS&G 2022)
 - Remedial Extents**
 - ACM Remedial Extent
 - UST Remedial Extent
 - TCE Remedial Extent

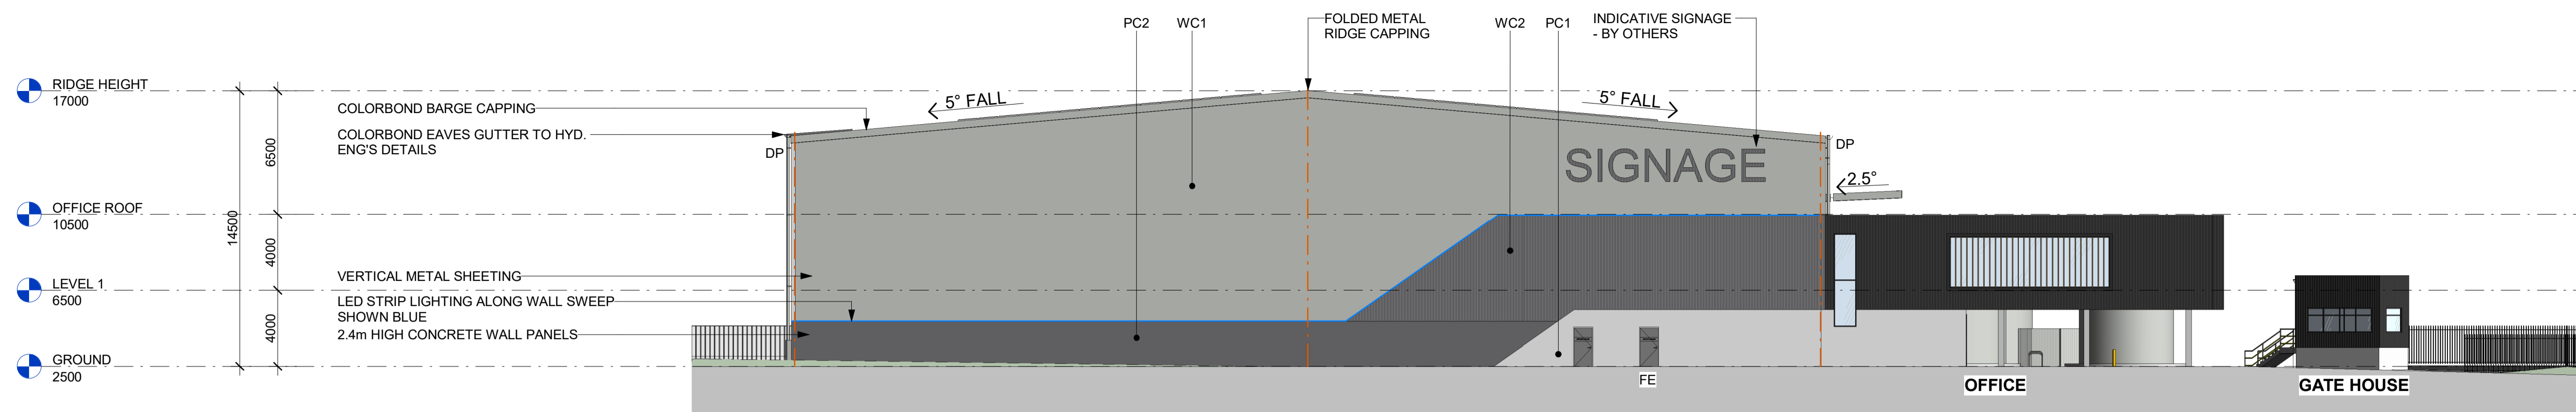
1 SOUTH ELEVATION
1: 200

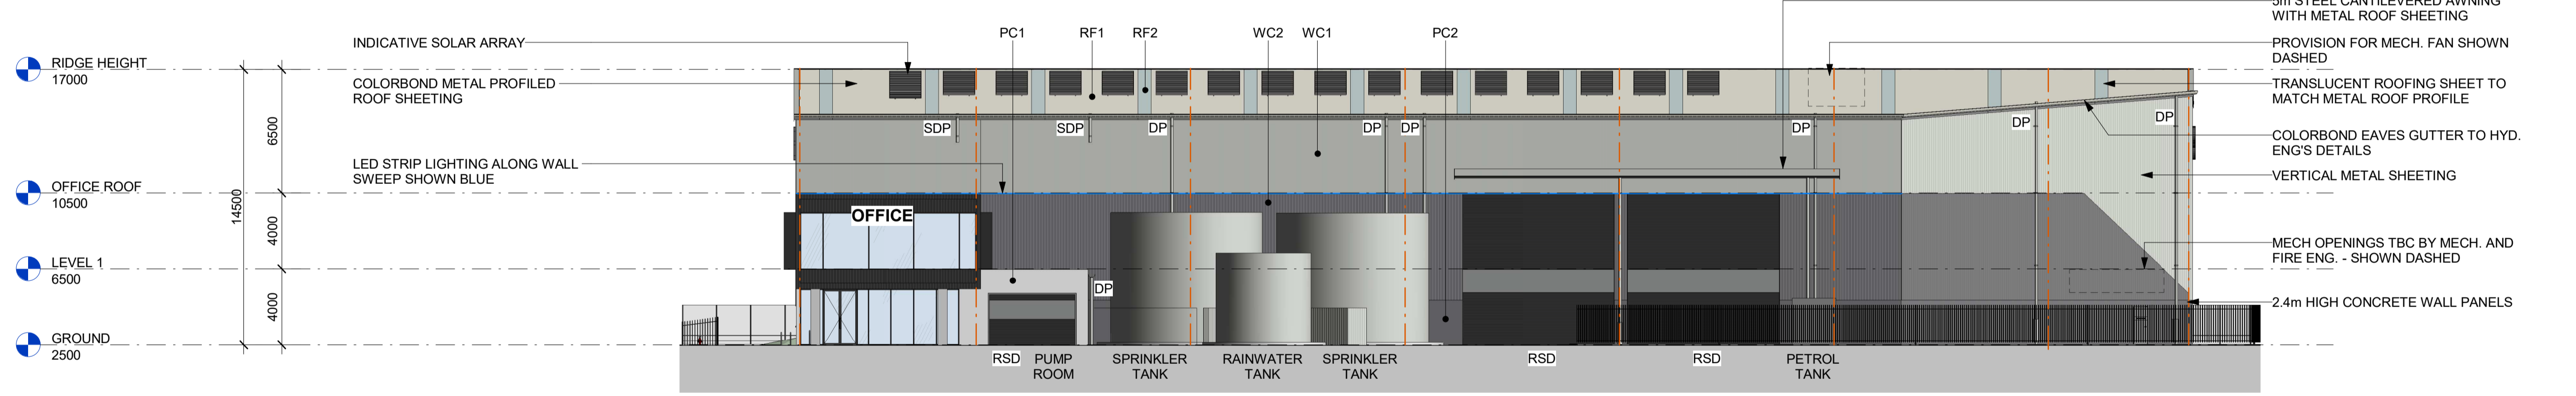
3 EAST ELEVATION
1: 200

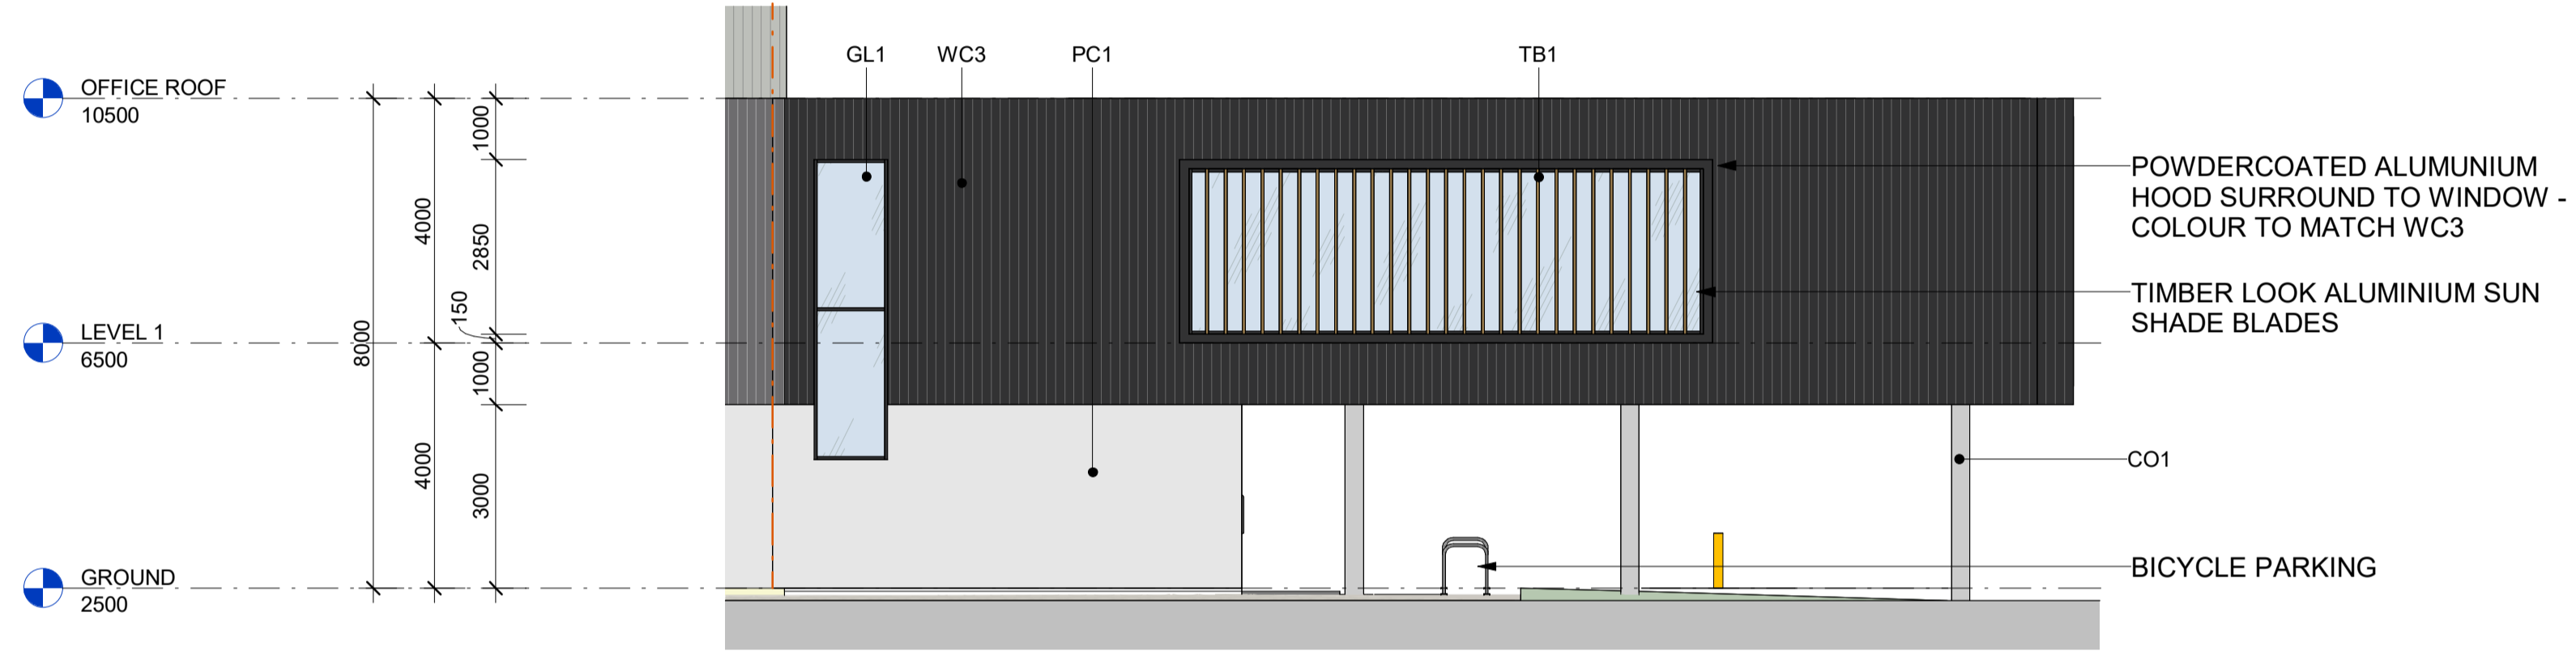
2 OFFICE SOUTH ELEVATION
1 : 100
