ACID SULFATE SOIL MANAGEMENT PLAN

**262 Hakone Road
Warnervale NSW 2259**

Environmental Consulting Services Pty Ltd (ECS) has prepared this Acid Sulfate Soil Management Plan (ASSMP) for the property known as 262 Hakone Road, Warnervale NSW (the Site). The purpose of this ASSMP is to address the approach and methodology of Acid Sulfate Soil (ASS) management at the Site during future development works.

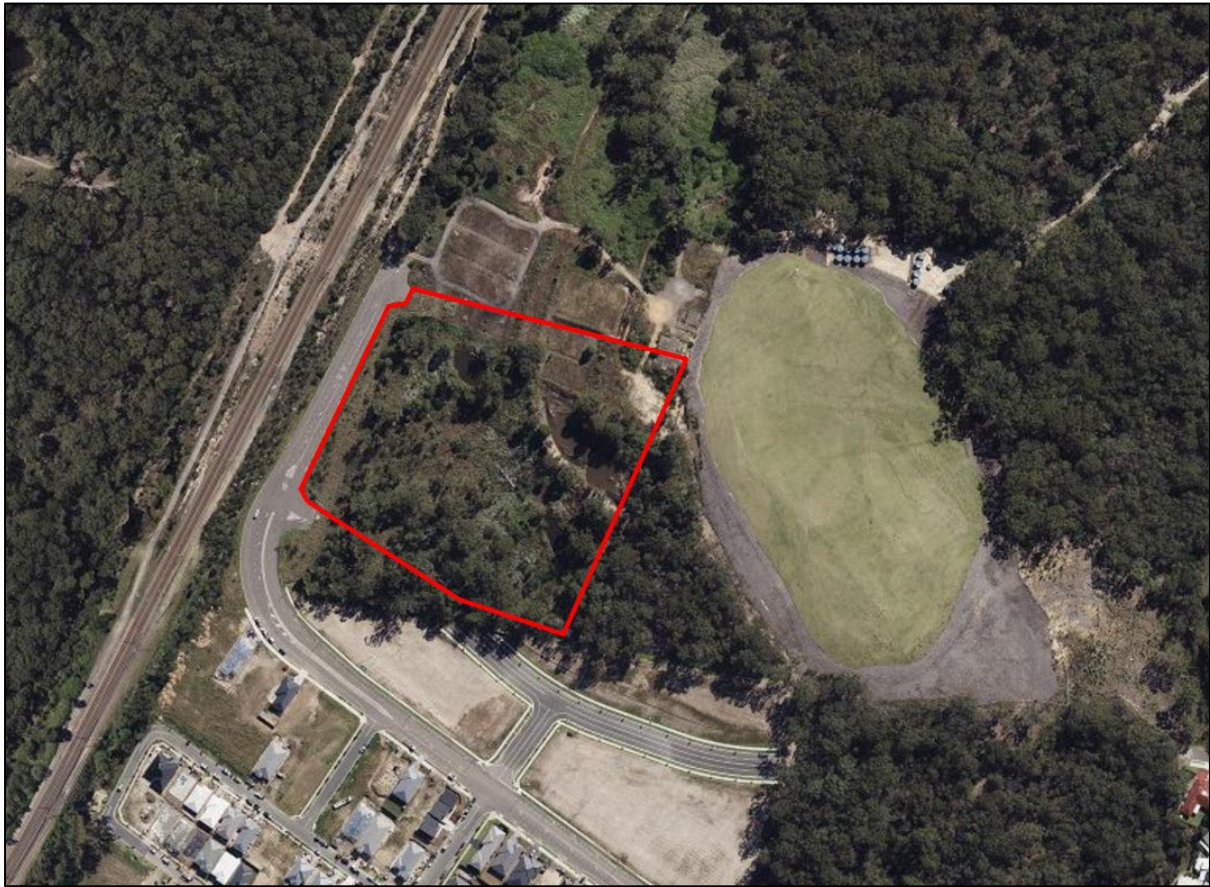
Figure 2.2 – Site Layout

The Site is outlined in red and surrounding properties are shown on Figure 2.2 – Site Layout.

The natural gradient of the surrounding landscape around the Site slope downwards towards south west. The approximate ground level at the corners of the Site are:

- RL 42m Australian Height Datum (AHD) at the north west corner;
- RL 55m AHD at the north east corner;
- RL 37m AHD at the south east corner; and
- RL 31m AHD at the south west corner.

The finished ground level across the Site has previously been modified through the construction of a level area that encompasses the northern section of the Site and extended beyond the northern boundary. The construction of this level platform has required placement of up to approximately 4m of fill at this area on the Site. There has also been the construction of two dams on the Site.

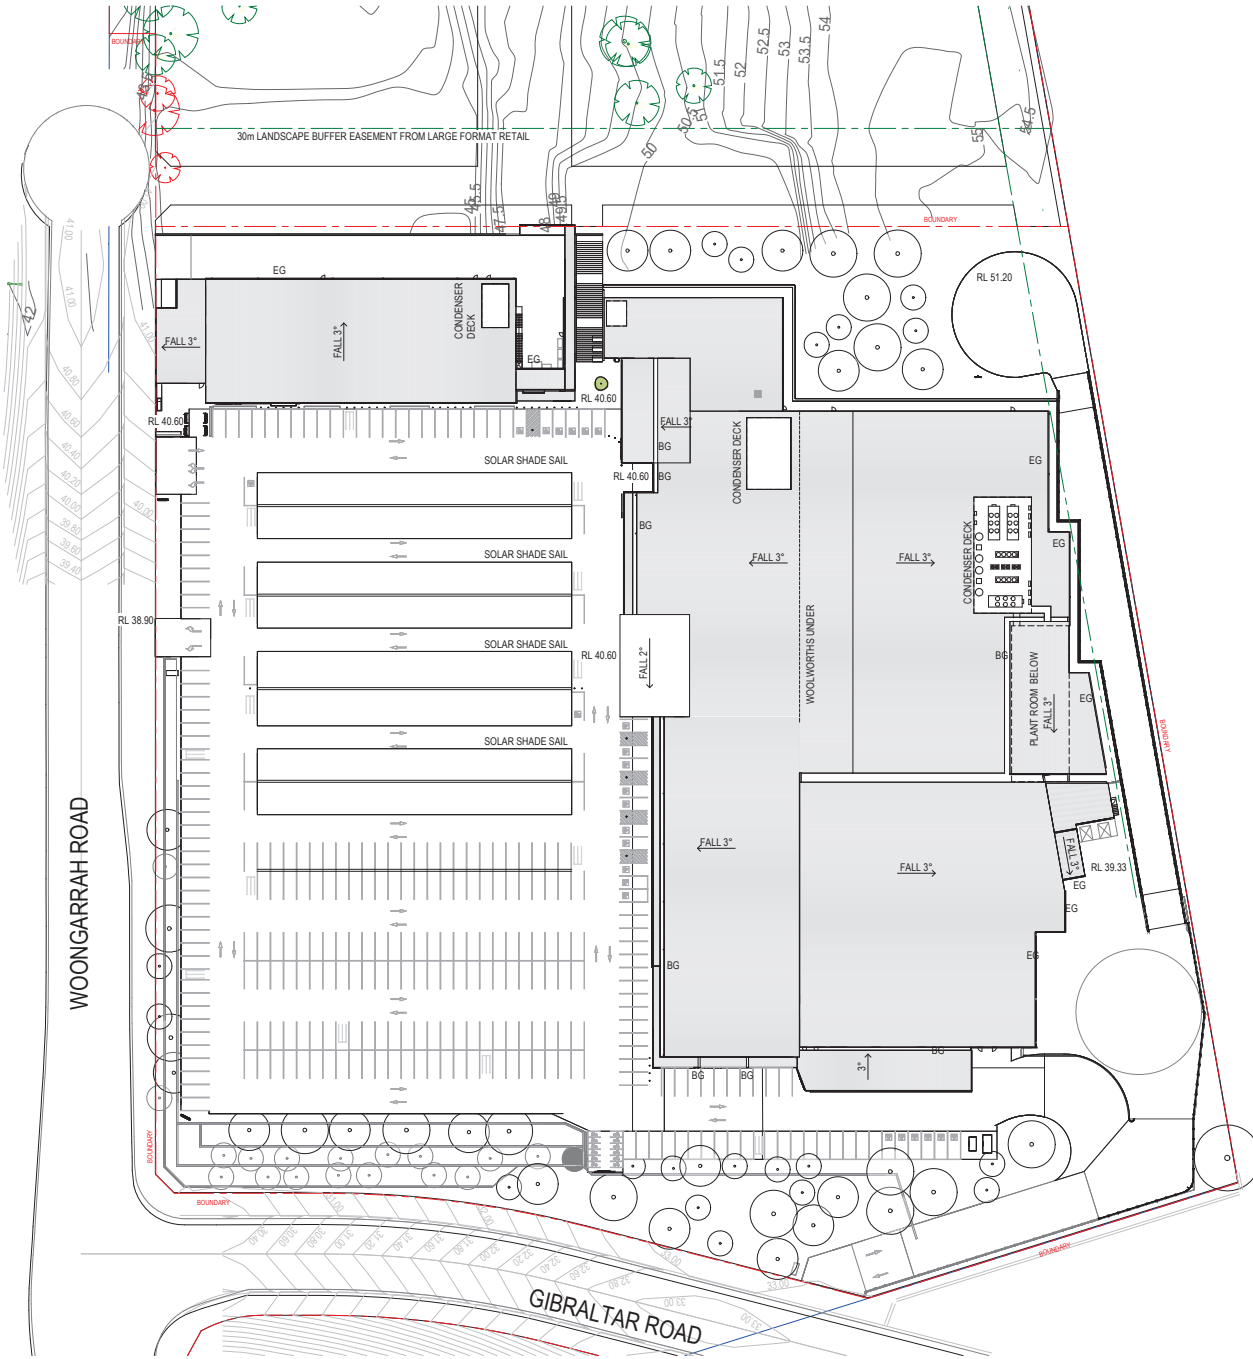
1 SITE PLAN
Scale 1:500

S4.55
SITE PLAN

ECS understands that it is proposed to develop the Site as a shopping centre with associated car parking. A development concept for the shopping centre is included in *Appendix 1*.

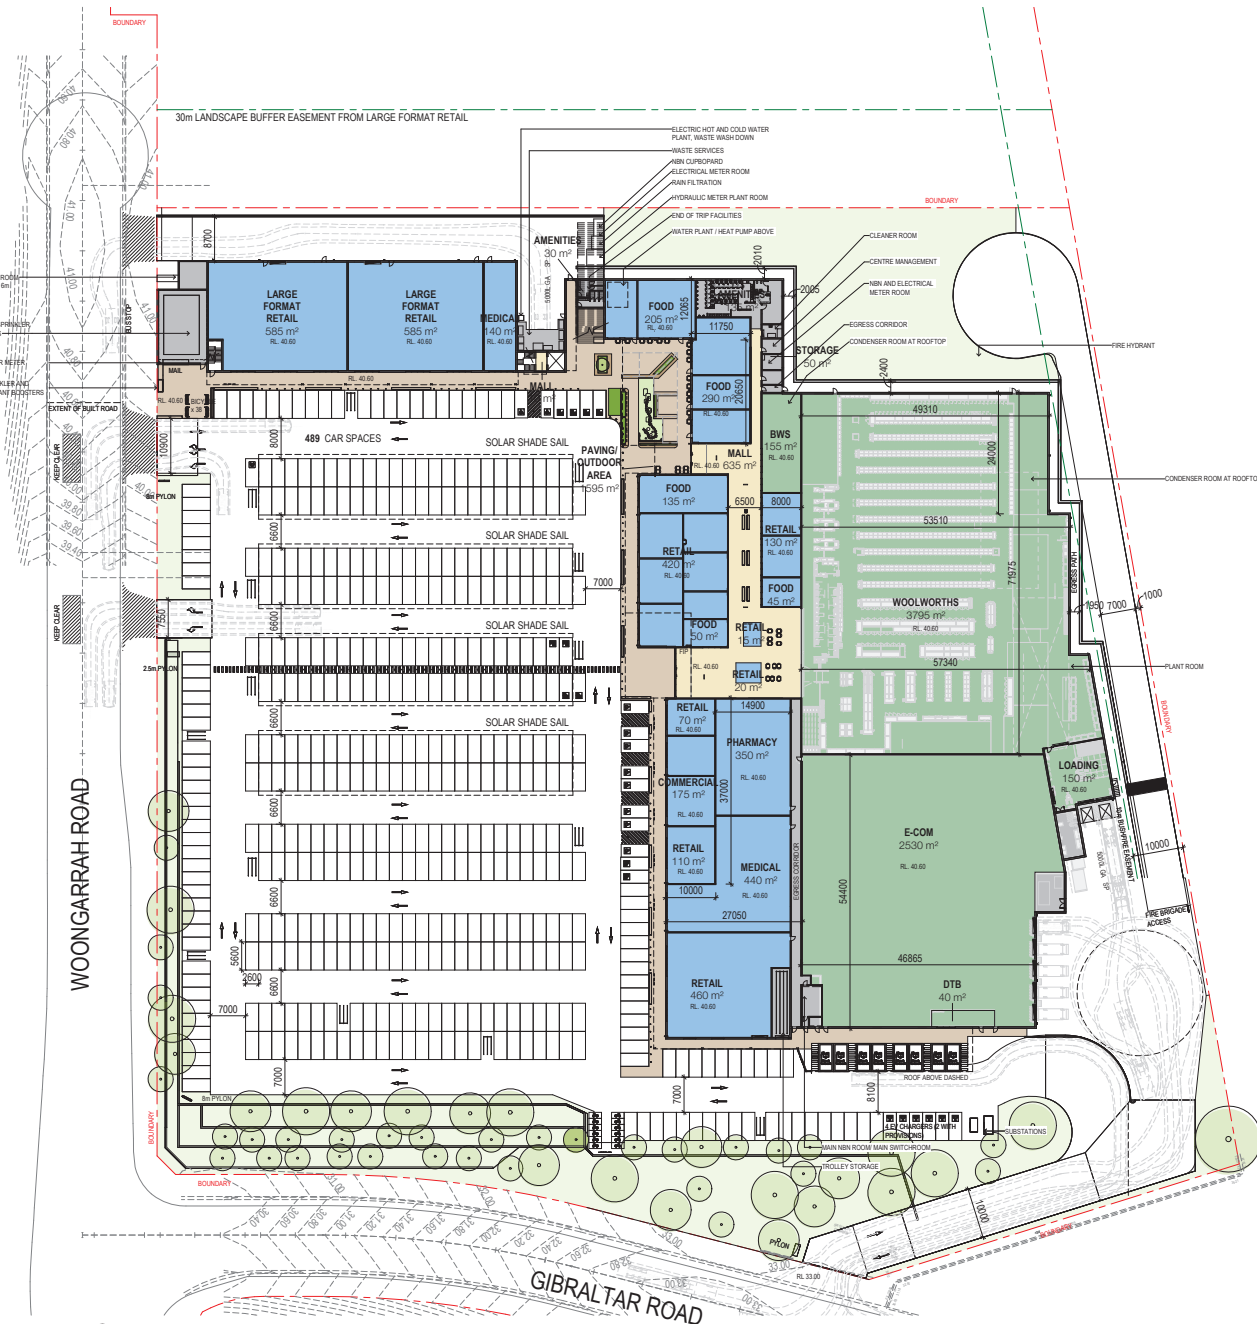
1 Ground Floor
Scale 1:500

GFA	
RETAIL	
BWS	155 m²
DTB	40 m²
FOOD	725 m²
LARGE FORMAT RETAIL	1170 m²
PHARMACY	350 m²
RETAIL	2525 m²
WOOLWORTHS	3795 m²
	8760 m²
AMENITIES	165 m²
COMMERCIAL	175 m²
E-COM	2530 m²
MALL	645 m²
MEDICAL	580 m²
	4090 m²
Grand total	12850 m²
PAVING/ OUTDOOR AREA	1595 m²
