# GEOTECHNICAL REPORT

Hakone Road and Woongarra Road, Woongarra NSW 2259

Woolworths Pty Ltd – June 2024

**Report reference:** 2301027GTRpt01FinalV03\_14Jun24

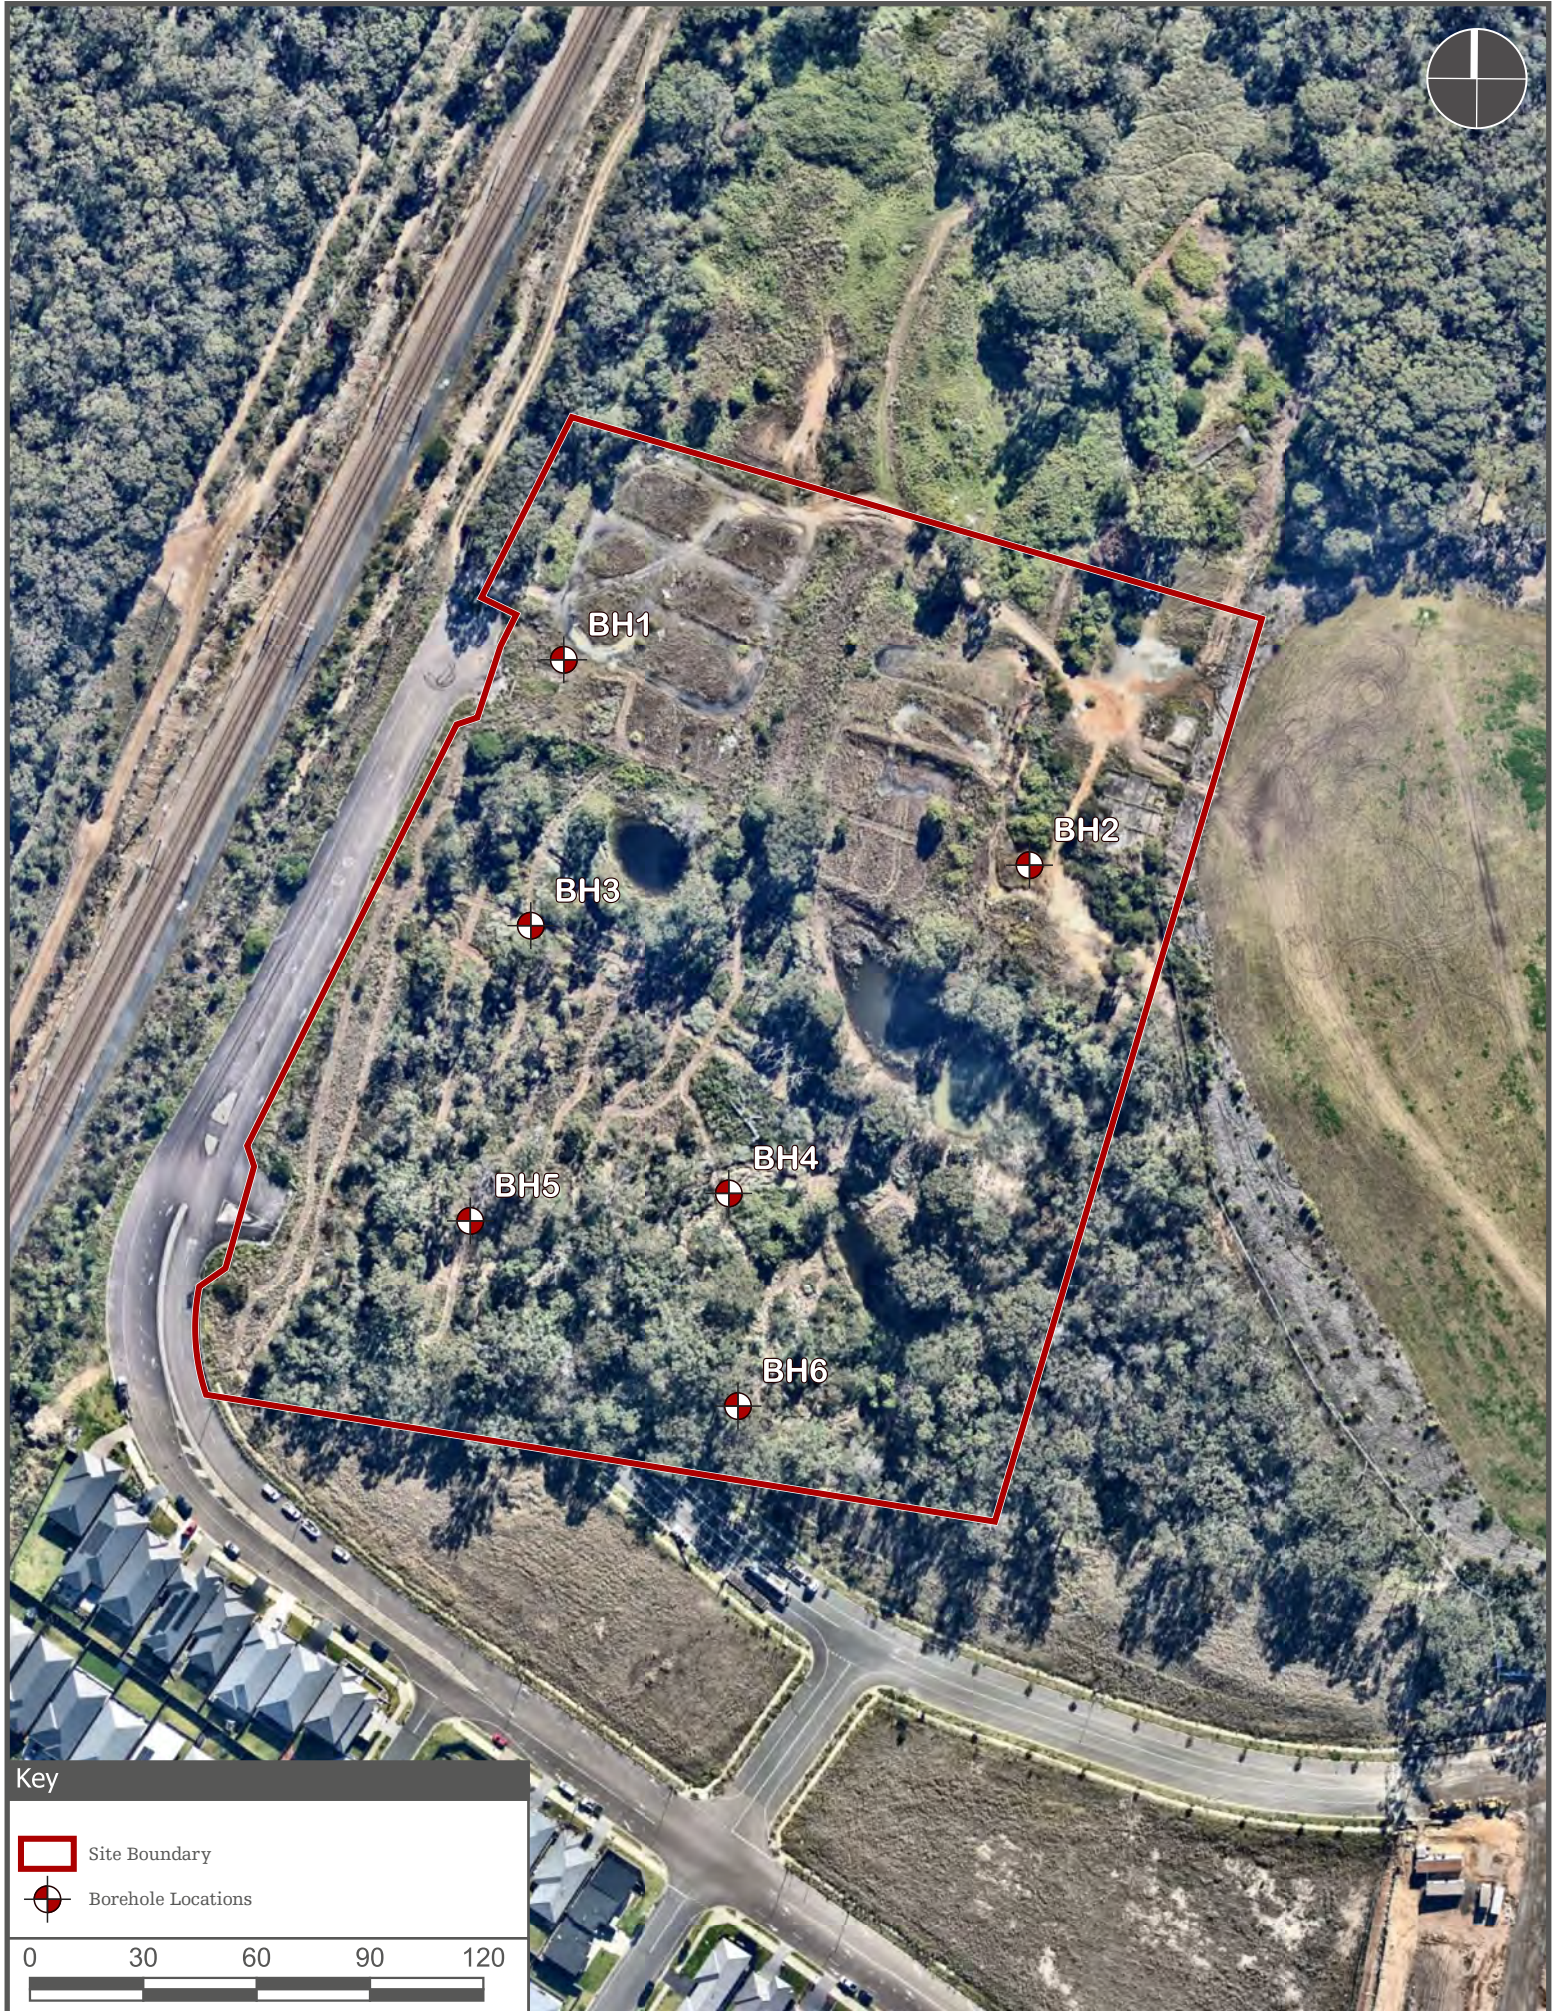
**Figure 2:** Site Map

Key

Site Boundary
