# GEOTECHNICAL SITE INVESTIGATION

**Project:** 1-3 Reid Street & 2-4 Woodside Avenue Lindfield NSW 2070

**Report no.:** NE2140

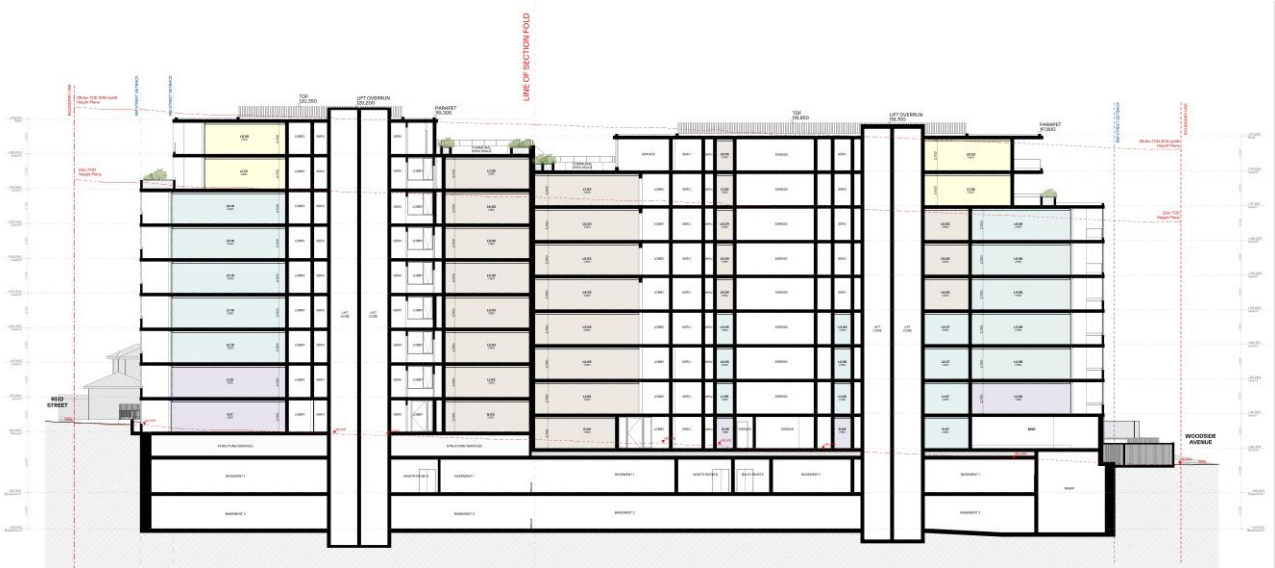
The proposed development comprises the construction of a residential flat building (RFB) containing 89 apartments, including 23 affordable units, within a 9-storey structure over two levels of basement car parking. A sectional view of the proposed building is presented in Figure 1.

Figure 1. A Section of the Residential Flat Building Development

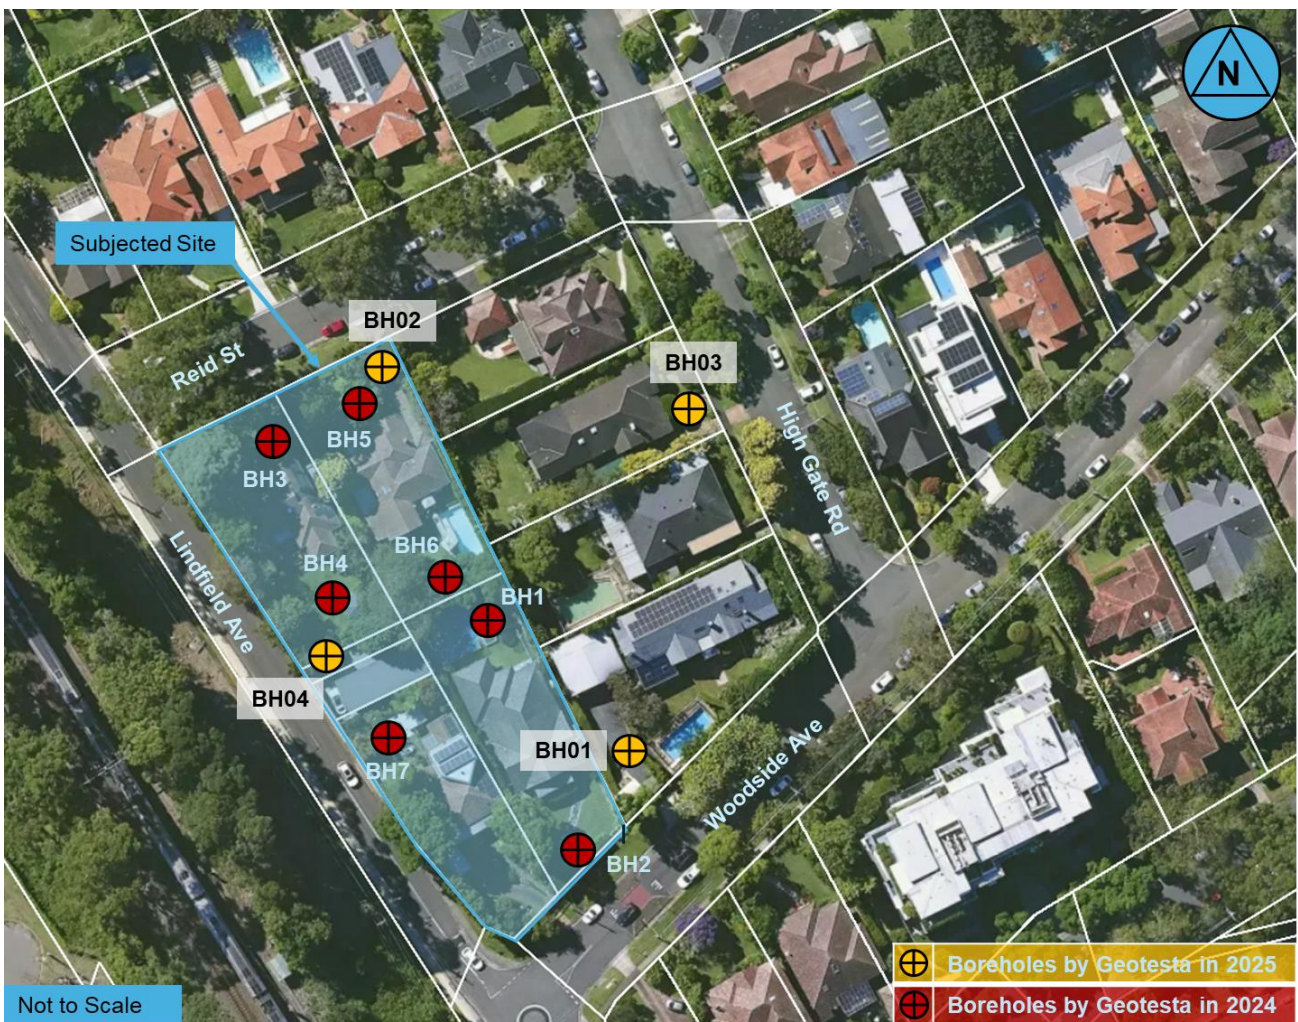
Figure 2. Site Aerial View and Drilled Boreholes

The borehole locations are presented in Figure 2, and the subsurface conditions encountered are summarised in Table 1.

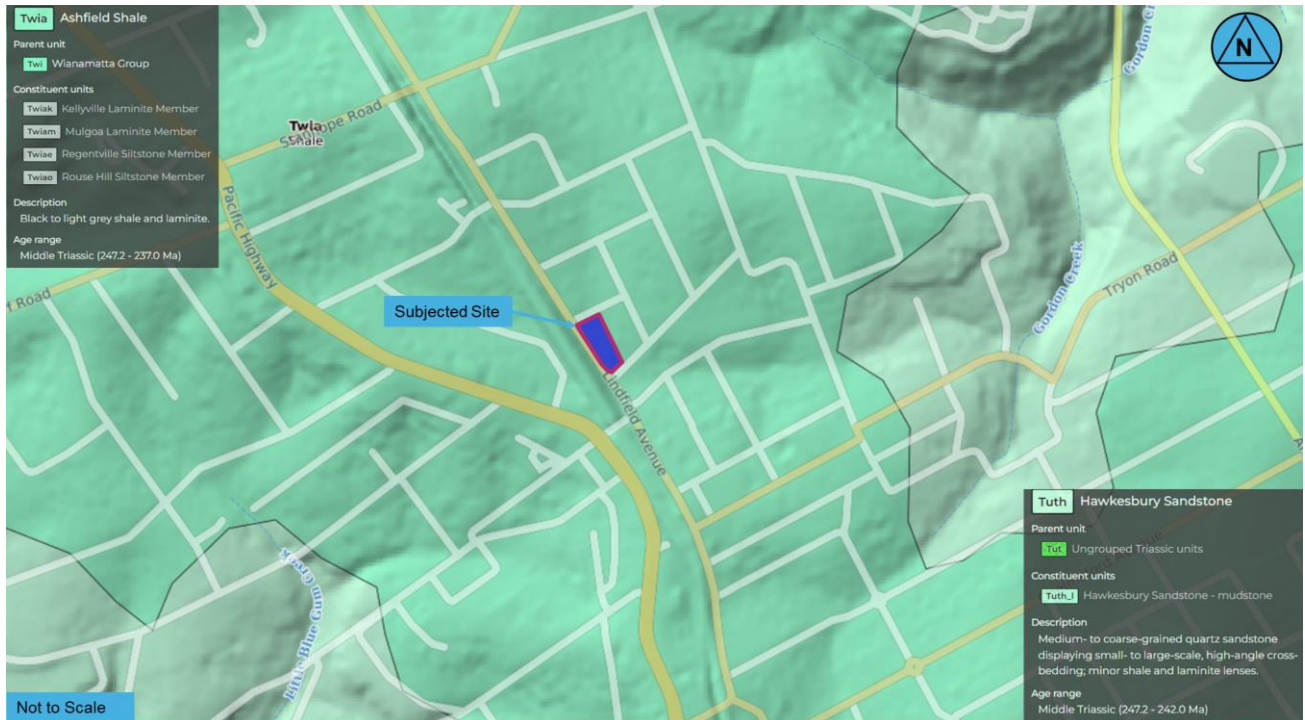
The NSW Seamless Geology database ([minview.geoscience.nsw.gov.au](http://minview.geoscience.nsw.gov.au)), developed by the Geological Survey of NSW (GSNSW), indicates that the site is underlain by the Ashfield Shale (Twia) formation. This unit comprises black to light grey shale and laminite of Middle Triassic age. In the surrounding area, the Hawkesbury Sandstone (Tuth) formation is also mapped (Figure 3), consisting

of medium- to coarse-grained sandstone with small- to large-scale high-angle cross-bedding, and minor shale and laminite lenses.

Figure 3. Geology Map of Site and Surrounding Area

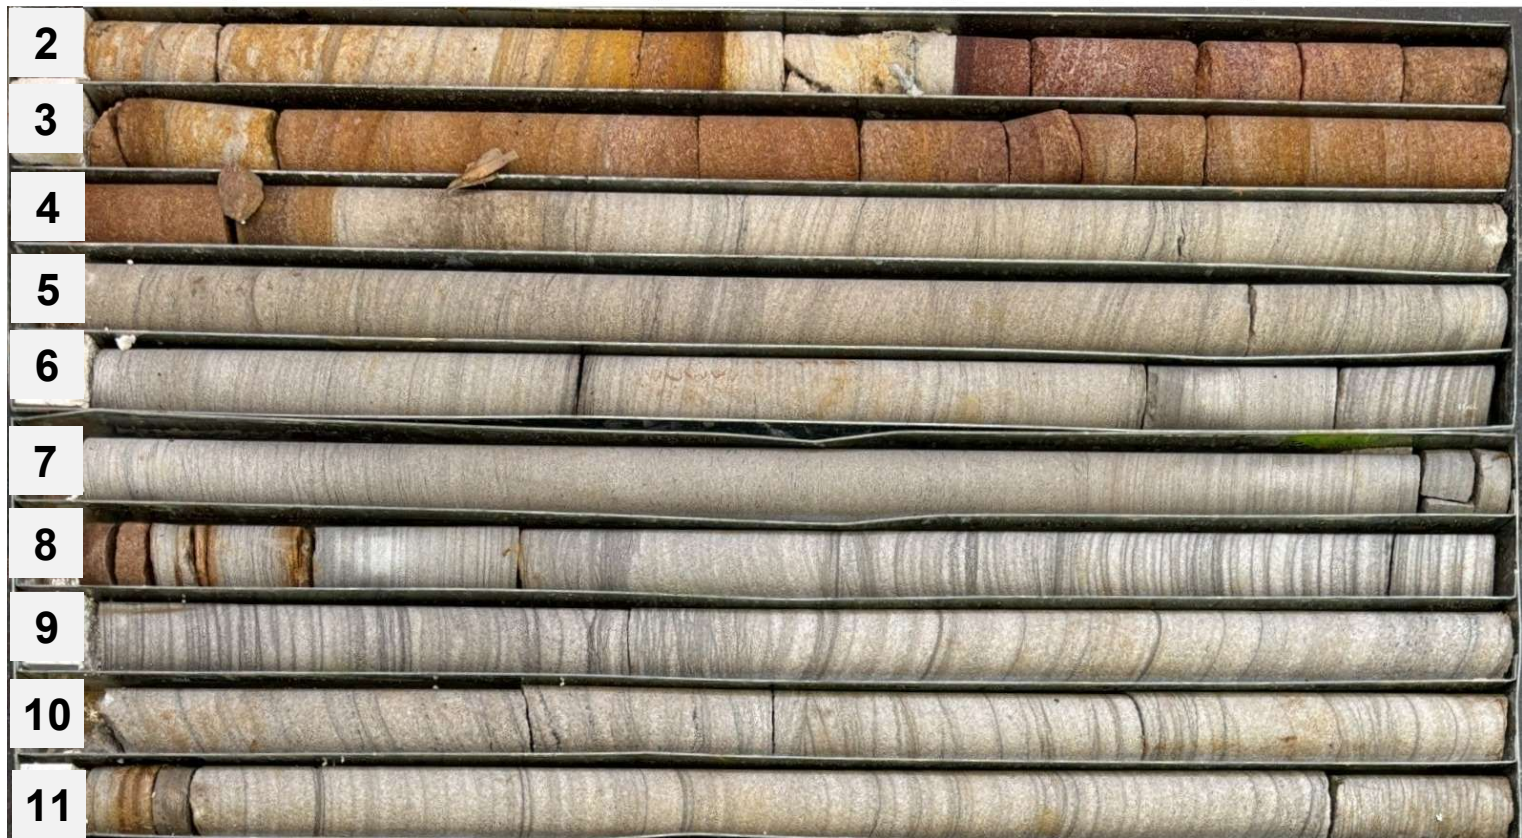
**BOREHOLE NO:** BH01

**DEPTH:** 2.0-12.0m

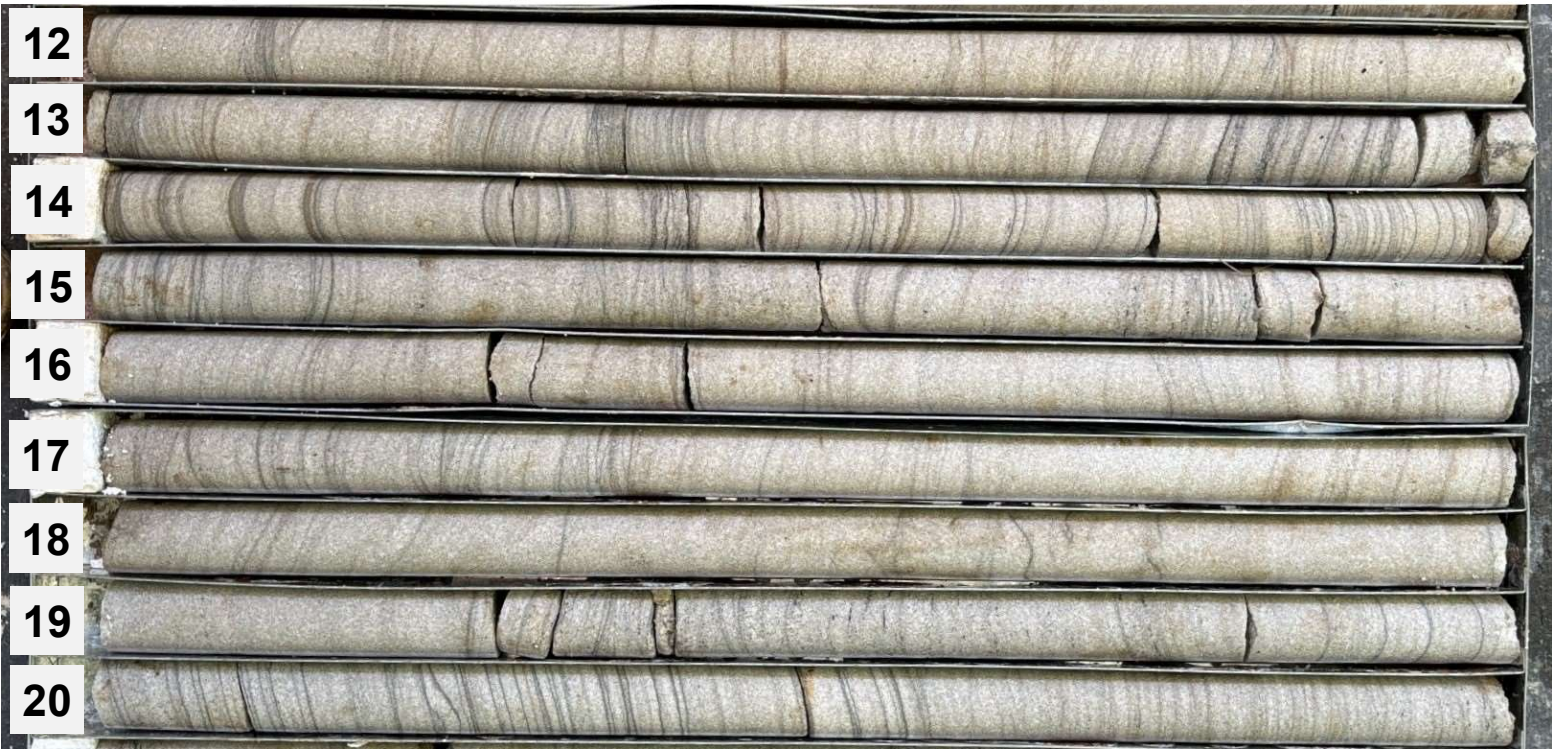
**BOREHOLE NO:** BH01

**DEPTH:** 12.0-21.0m

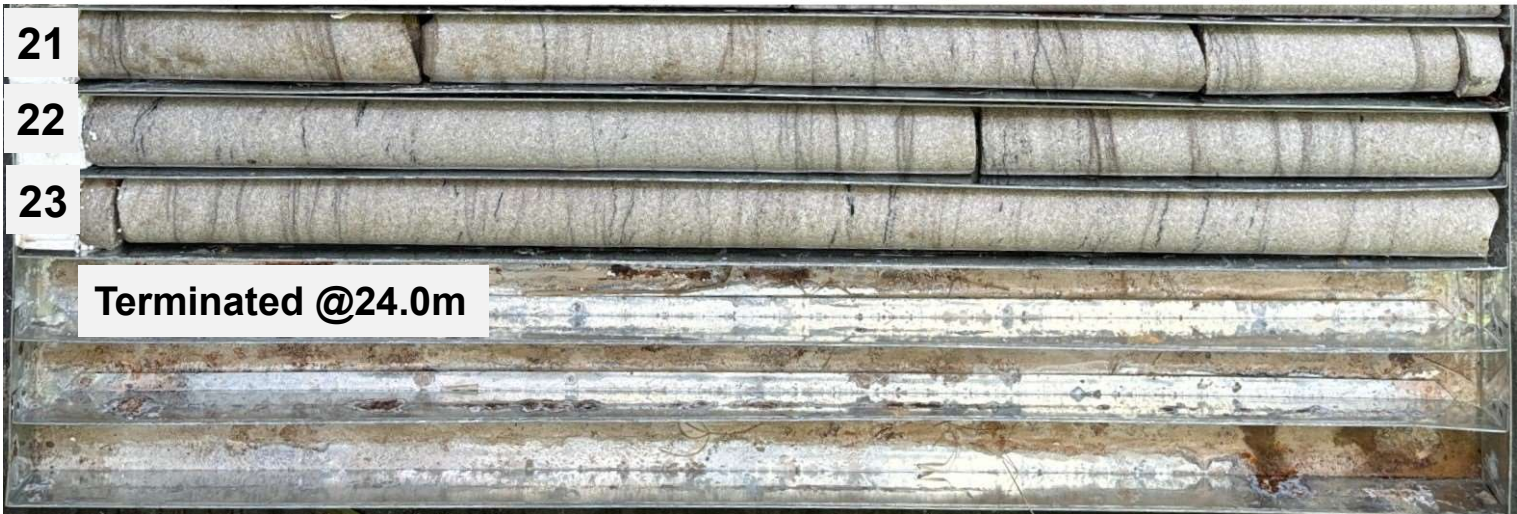
**BOREHOLE NO:** BH01

**DEPTH:** 21.0-24.0m

**Terminated @24.0m**

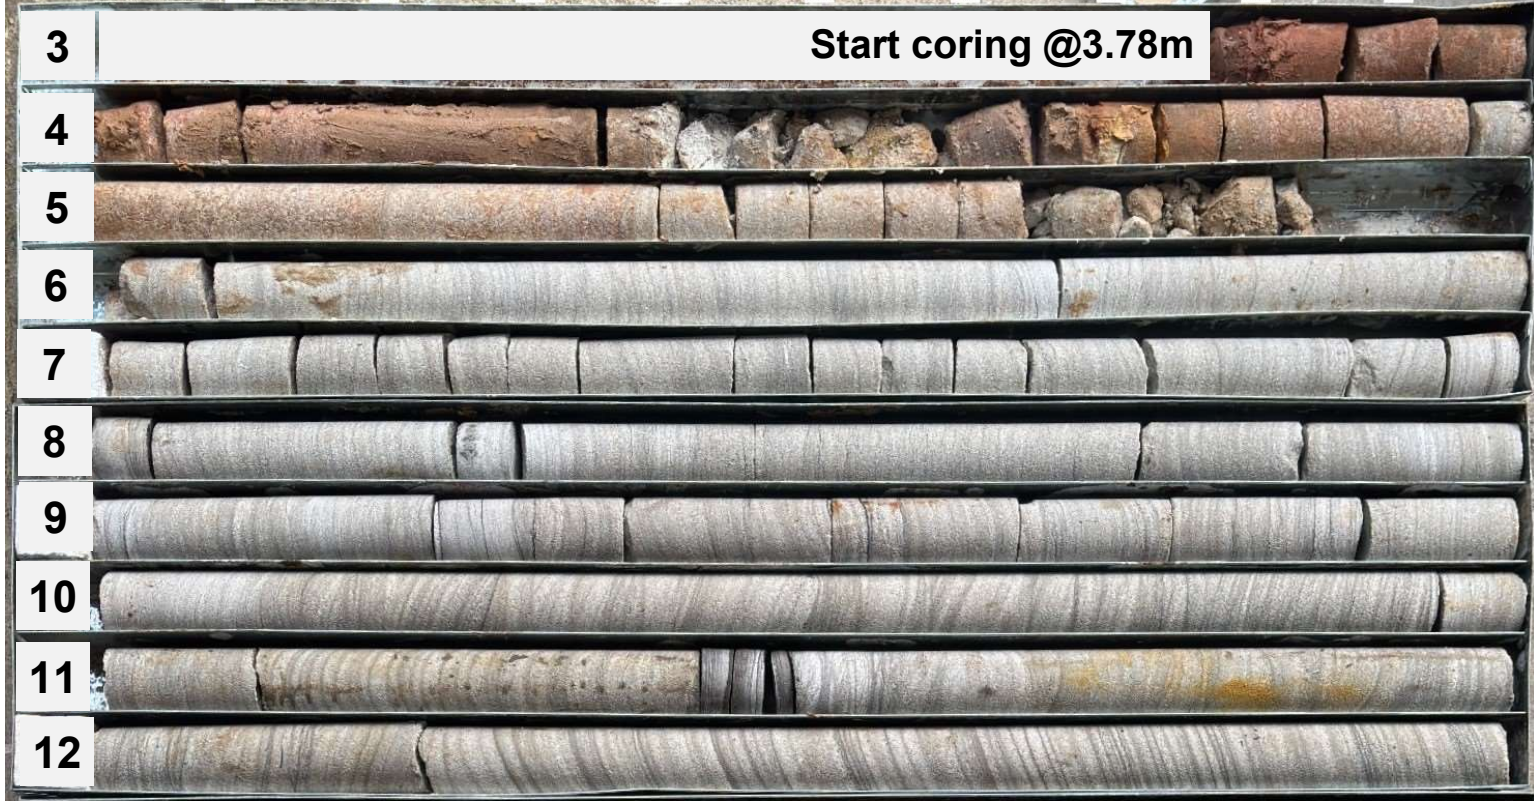
**BOREHOLE NO:** BH02

**DEPTH:** 3.78-13.0m

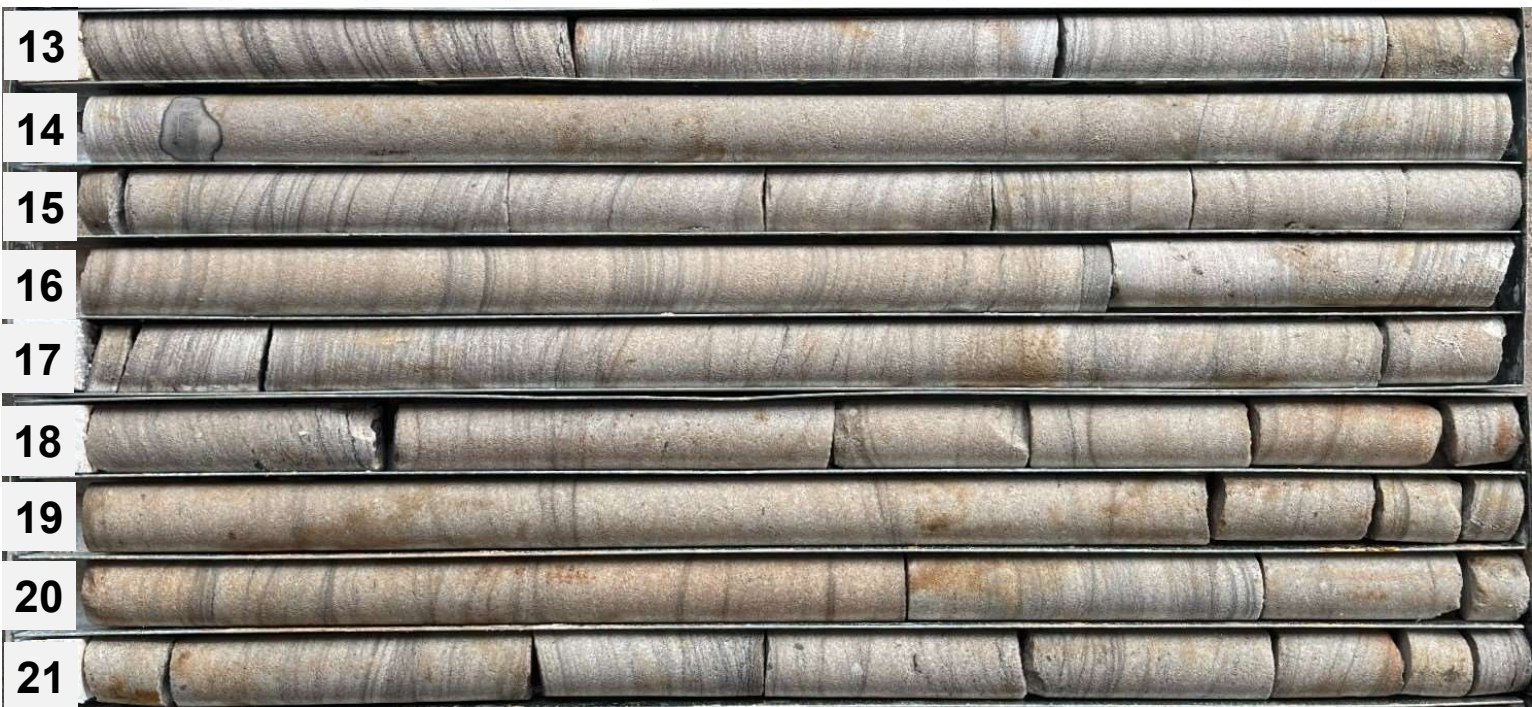
**BOREHOLE NO:** BH02

**DEPTH:** 13.0-22.0m

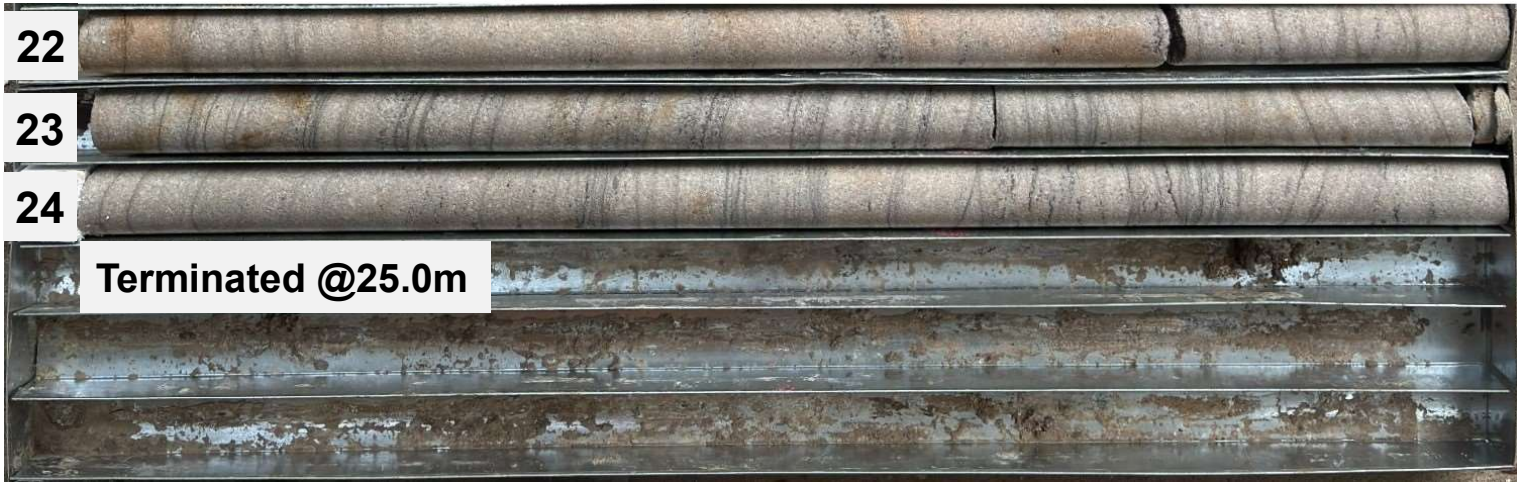
**BOREHOLE NO:** BH02

**DEPTH:** 22.0-25.0m

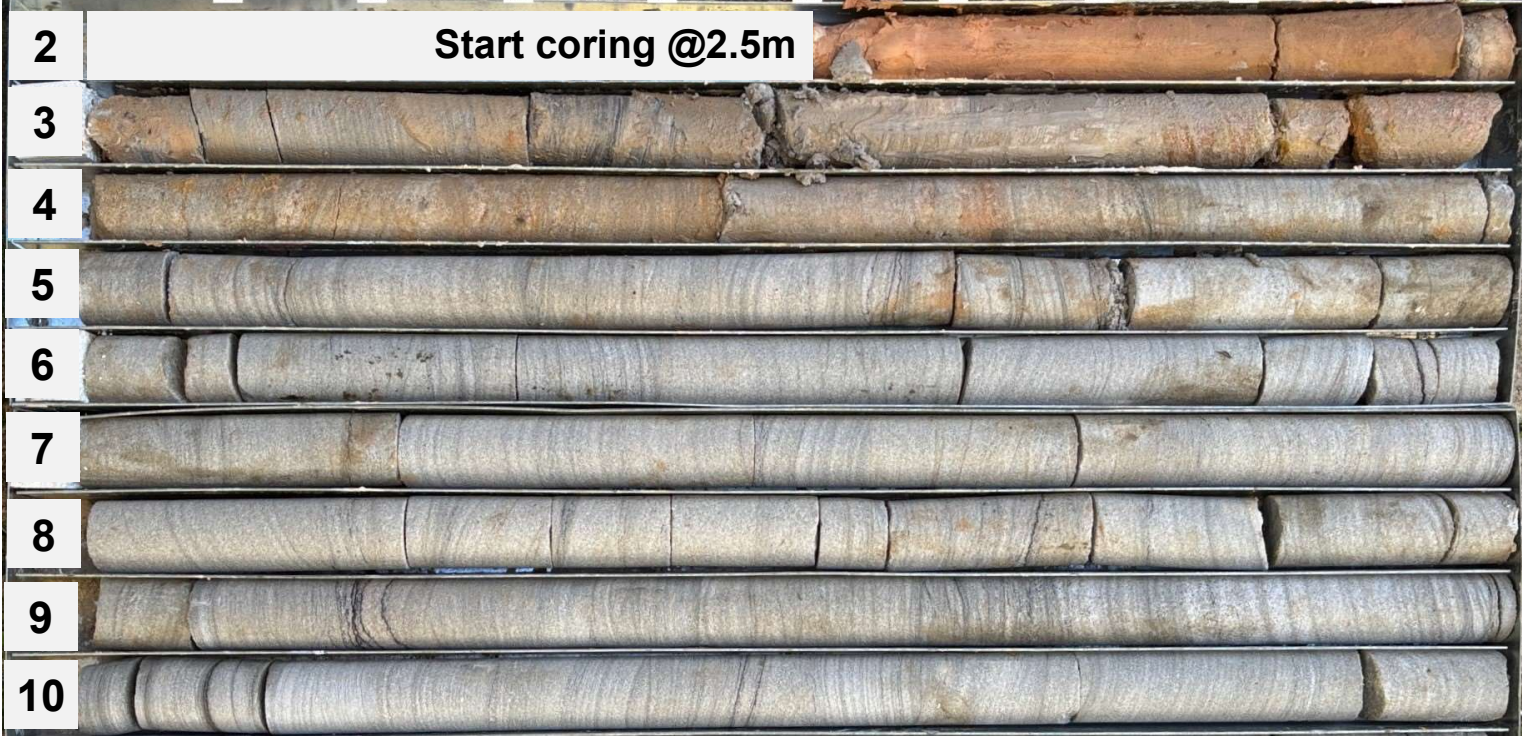
**BOREHOLE NO:** BH03

**DEPTH:** 2.5-11.0m

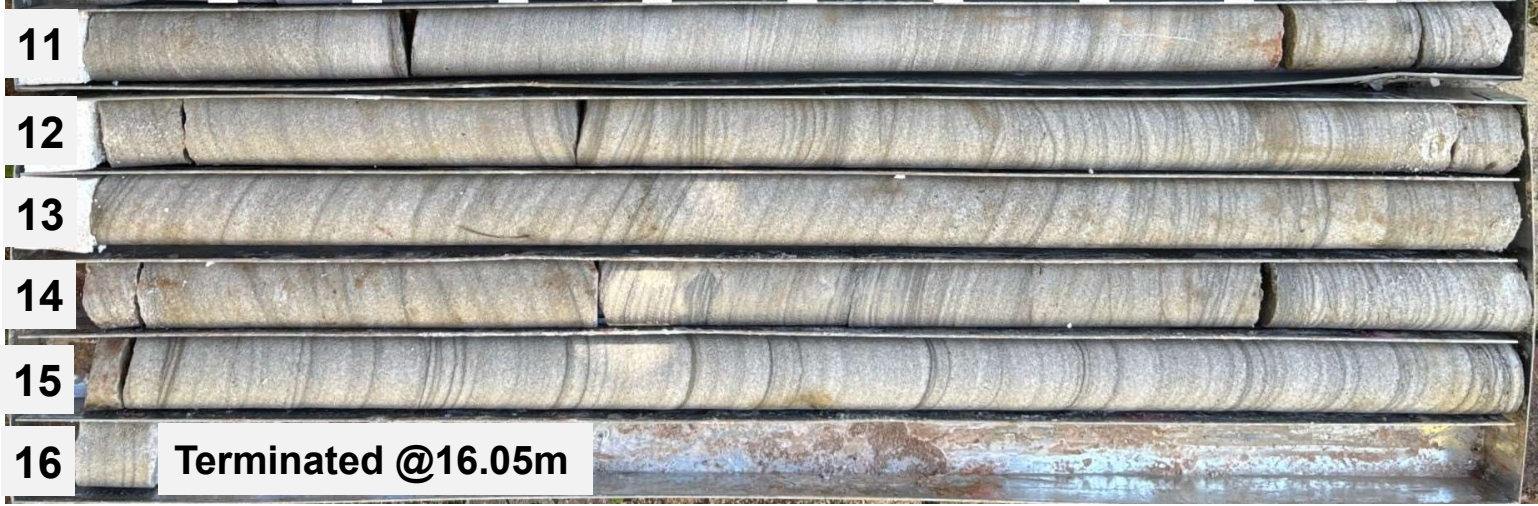
**BOREHOLE NO:** BH03

**DEPTH:** 11.0-16.05m

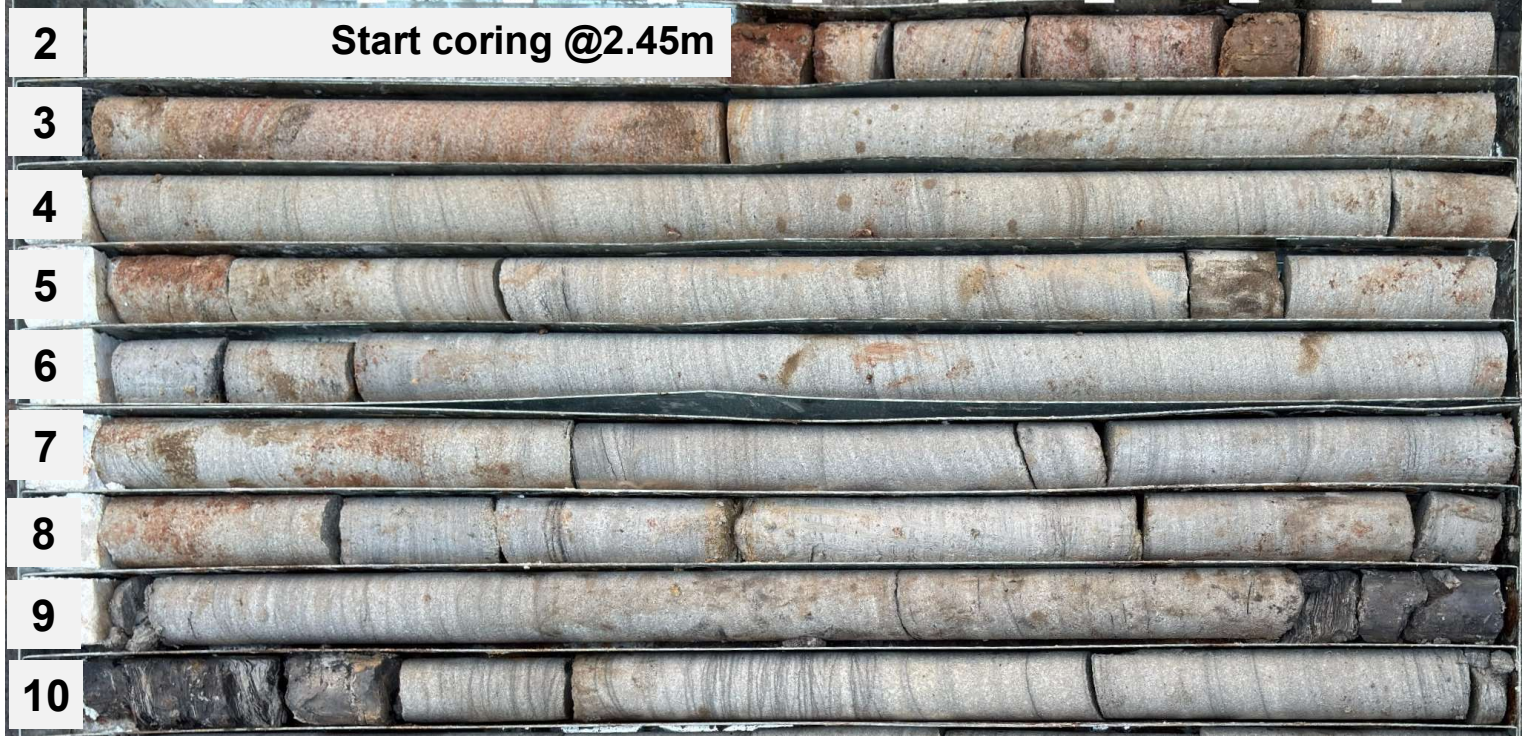
**BOREHOLE NO:** BH04

**DEPTH:** 2.45-11.0m

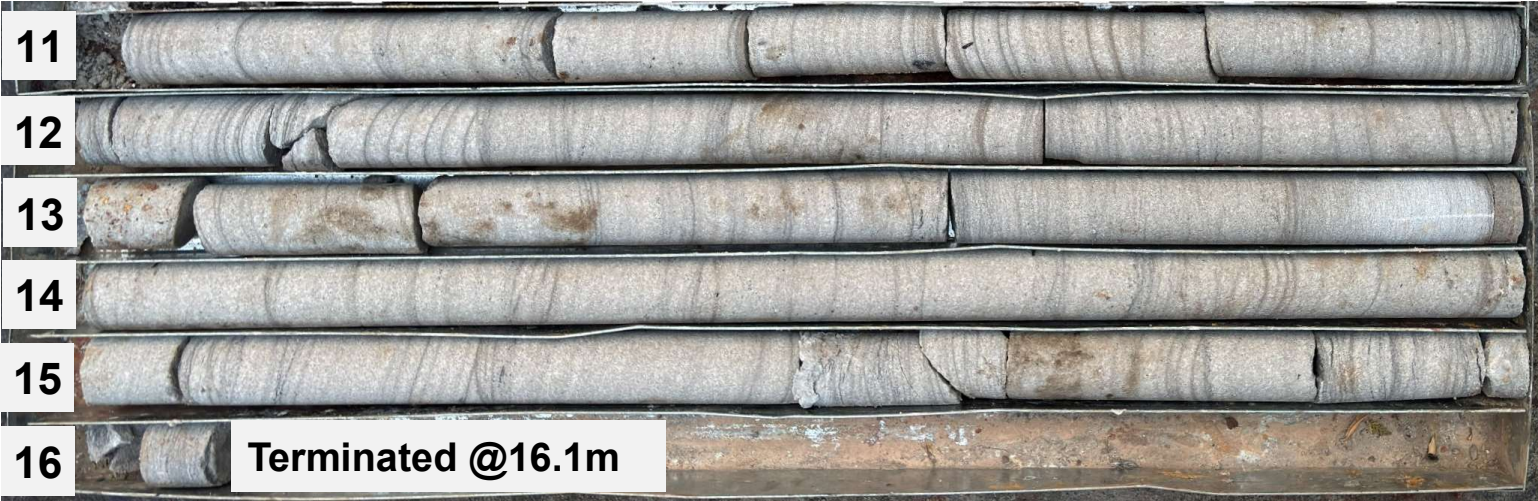
**BOREHOLE NO:** BH04

**DEPTH:** 11.0-16.1m
