APPENDIX 4

Formal Objection to SSD-79276958 Proposed Residential Development at 59–63 Trafalgar Avenue and 1A & 1B Valley Road, Lindfield

Native Vegetation and Ecological Significance

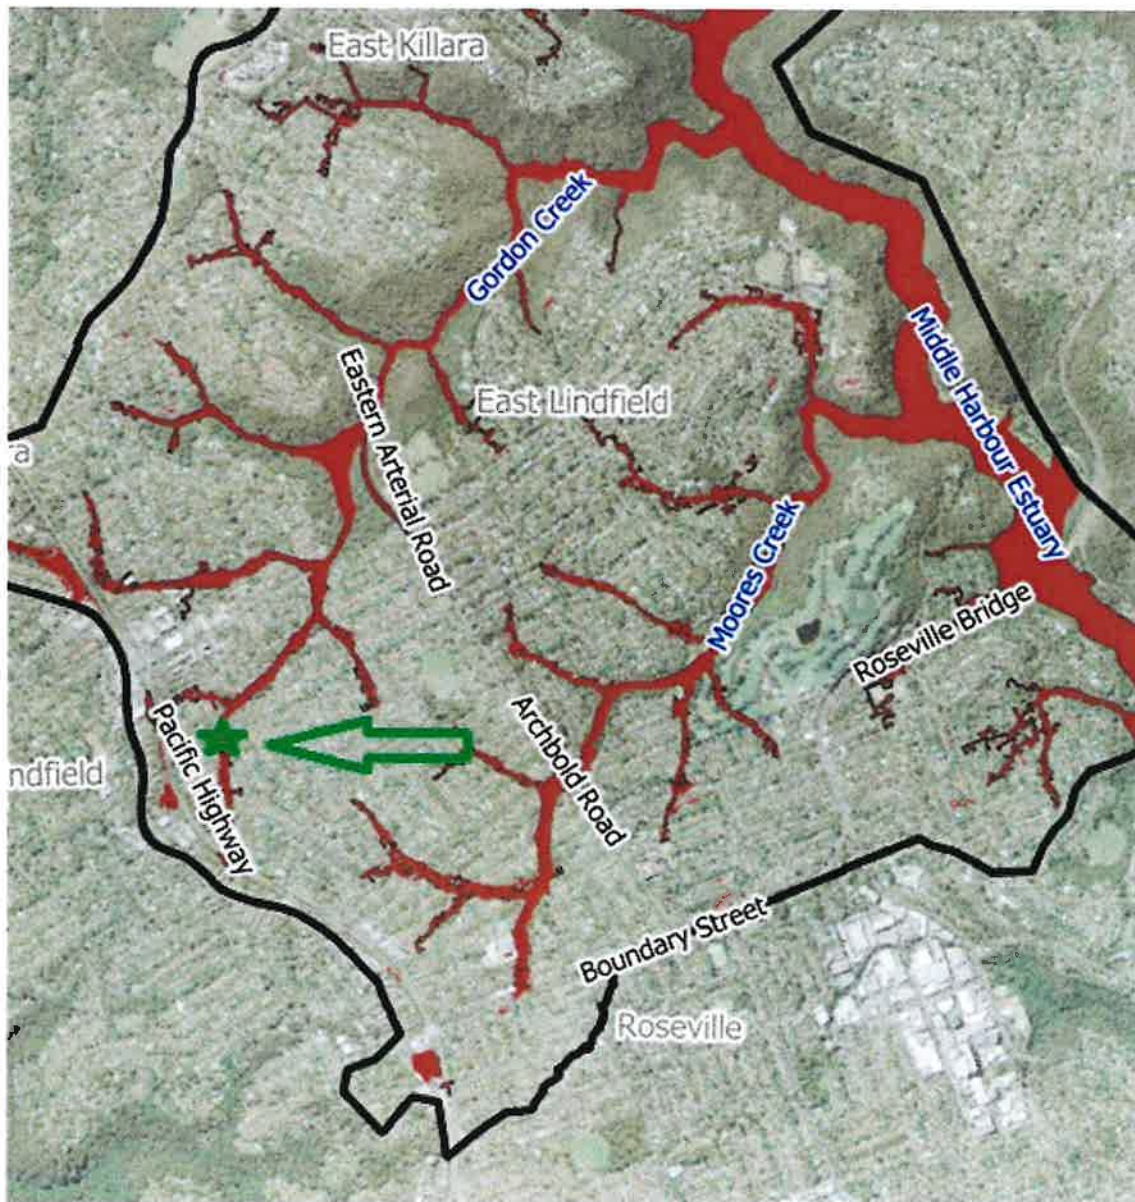
The SSD-79276958 Proposed Residential Development at 59–63 Trafalgar Avenue & 1A & 1B Valley Road, Lindfield development site showing its proximity to Gordon Creek and Riparian Corridors shown in **red**.

The site adjoins the headwaters of Gordon Creek, one of seven creeks flowing east to Middle Harbour.

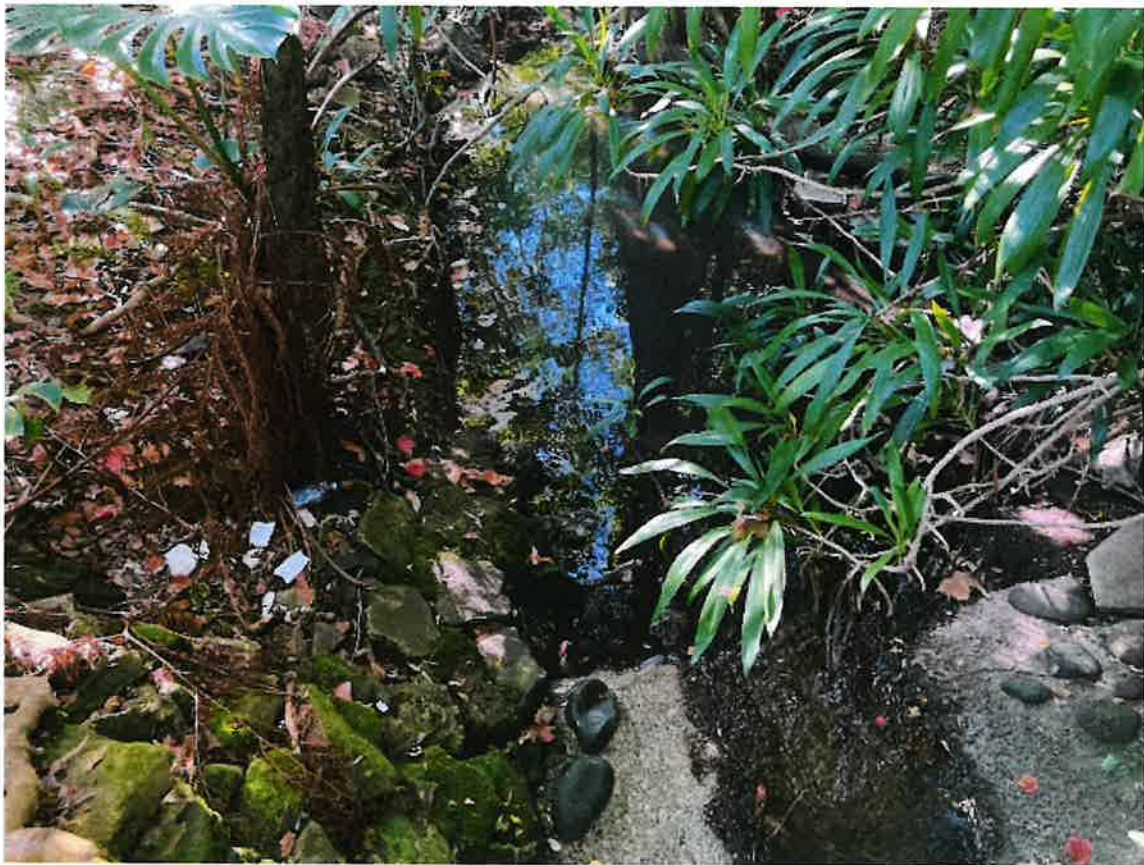
Photos taken from 32 Middle Harbour Rd and flowing East towards 32A Middle Harbour Road, Lindfield and onwards.

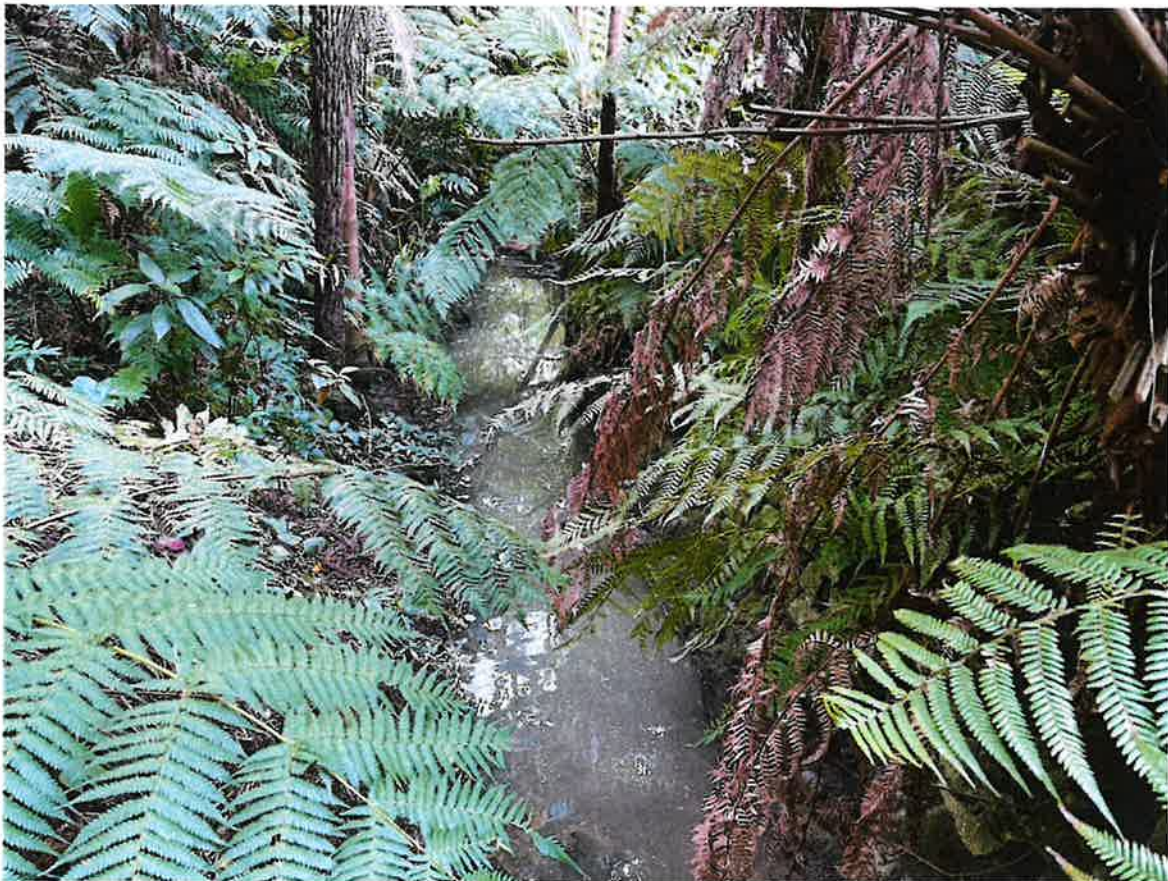
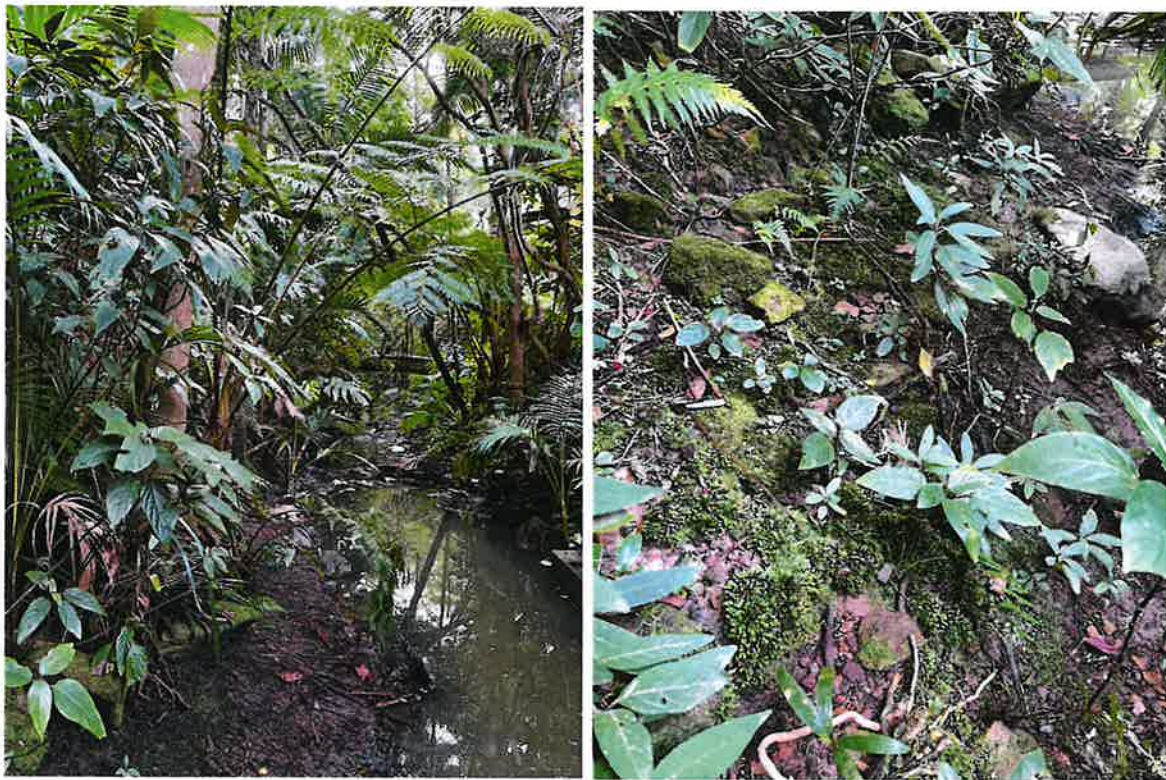
Photos taken from water flowing East from 36A through 38 Middle Harbour Road, Lindfield

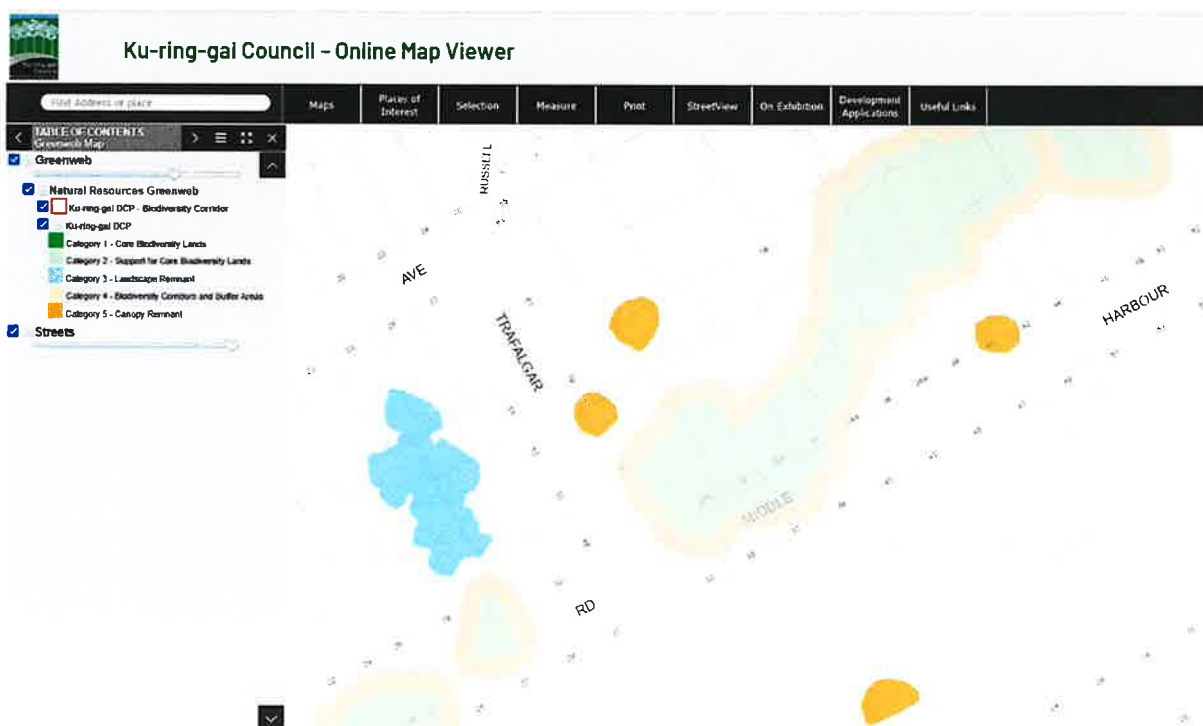
Image Greenweb Map

The **Ku-ring-gai DCP Greenweb Map** identifies this area as part of a **core biodiversity support and buffer zone**, which includes remnant bushland and a mapped **20m riparian zone**.

It extends further along Middle Harbour Road than was identified by Landmark and their Consultants

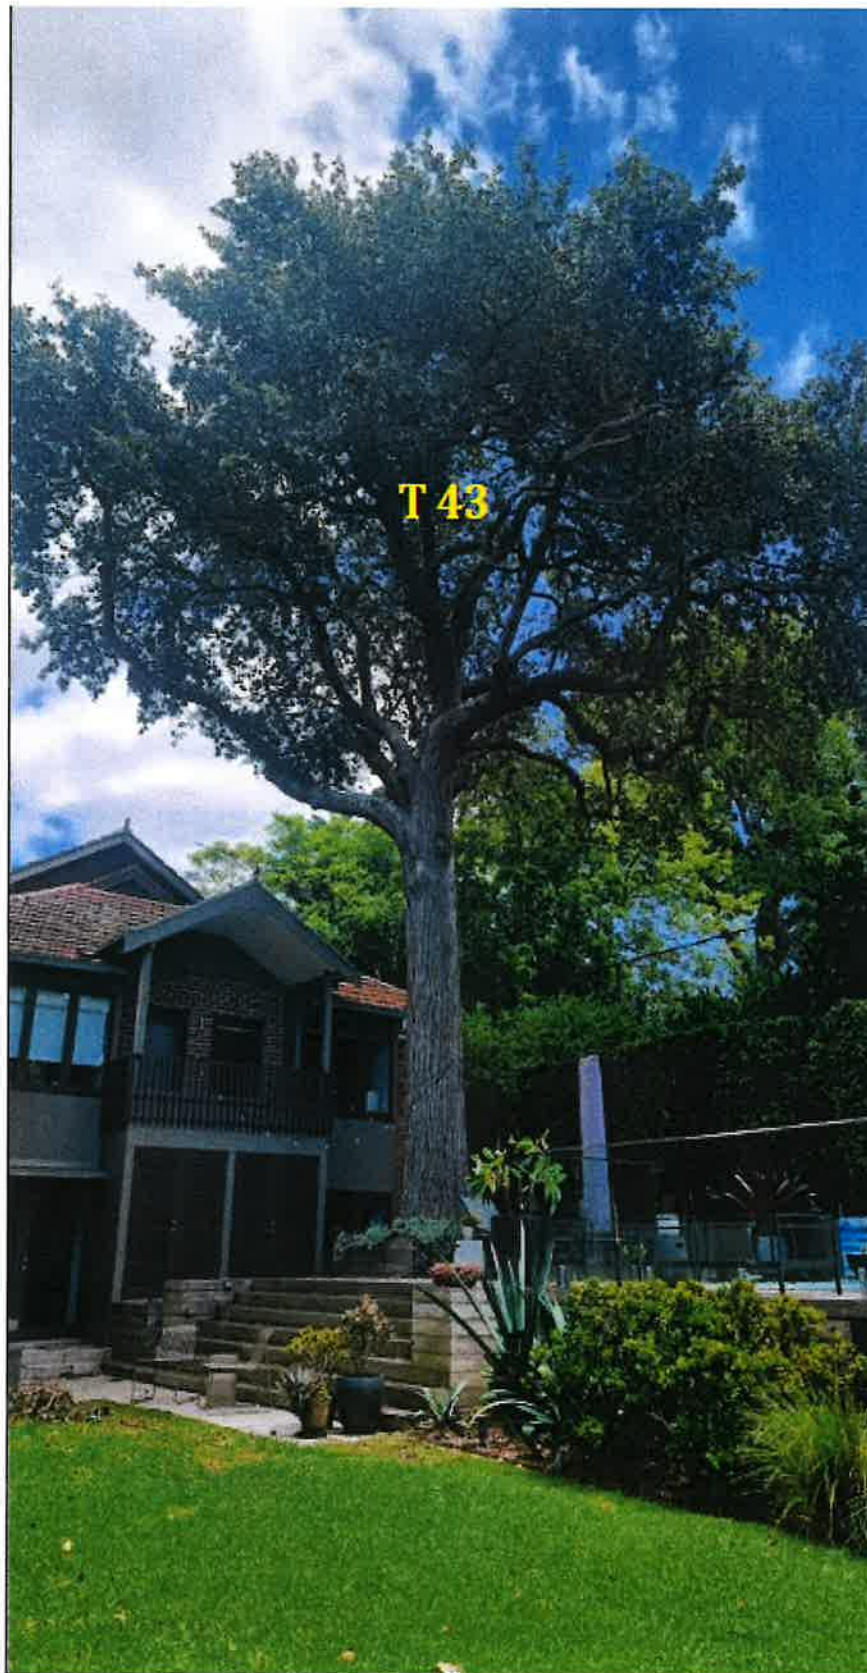
Figure 7: Remnant Turpentine (tree 43) in the rear of number 59 Trafalgar Avenue. Note the built form surrounding the tree.

Of critical importance are **two remnant specimens of the Sydney Turpentine (*Syncarpia glomulifera*)**—designated as **T43 and T17**—located near the centre of the site. These trees are representative of the **Sydney Turpentine-Ironbark Forest (STIF)**, a now-fragmented native forest community historically found in this part of the Sydney Basin.

The proposal, as currently designed, seeks to remove both STIF remnant trees (T43 and T17) due to their central location on the site, which is earmarked for built form and does **not contain deep soil planting zones**. The BDAR notes that opportunities for the **retention of native trees are minimal**, due to their spatial distribution across the site. It also states:

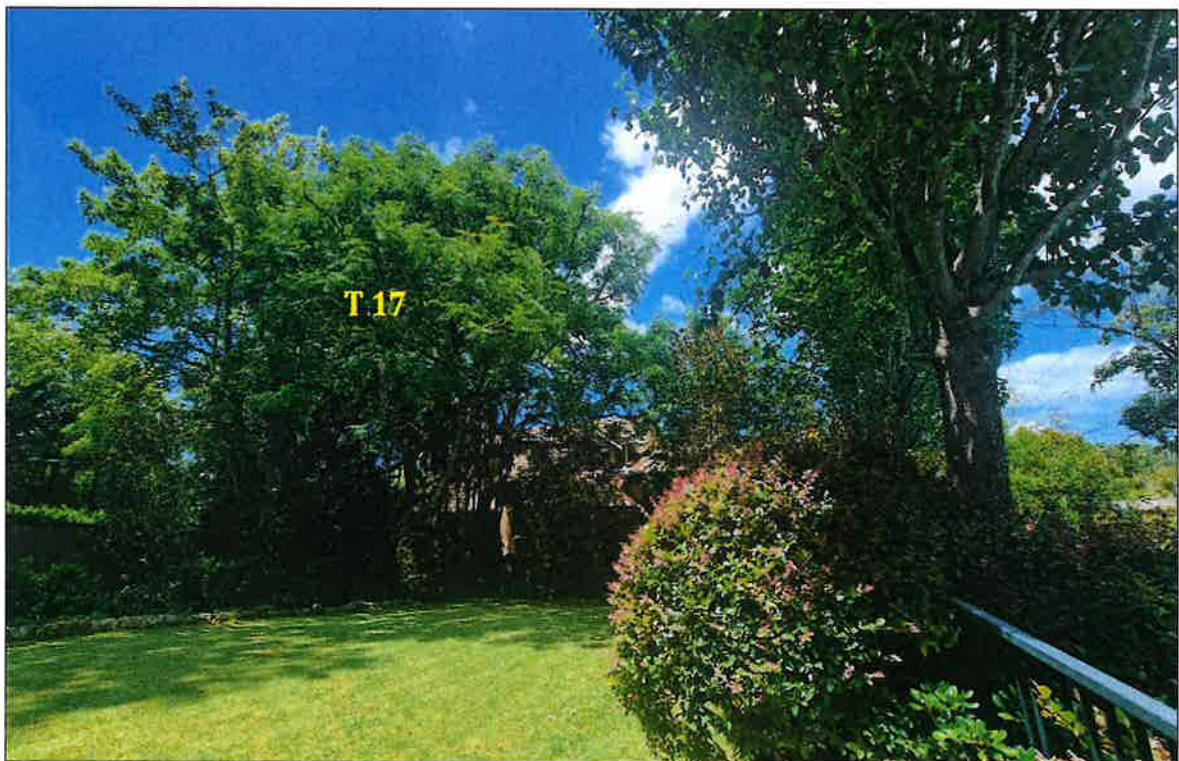
Figure 8: Looking to the south eastern corner of the rear garden of number 61 Trafalgar Avenue where the BAM plot was located. The remnant White Cedar (tree 17) is located in the perimeter garden bed.

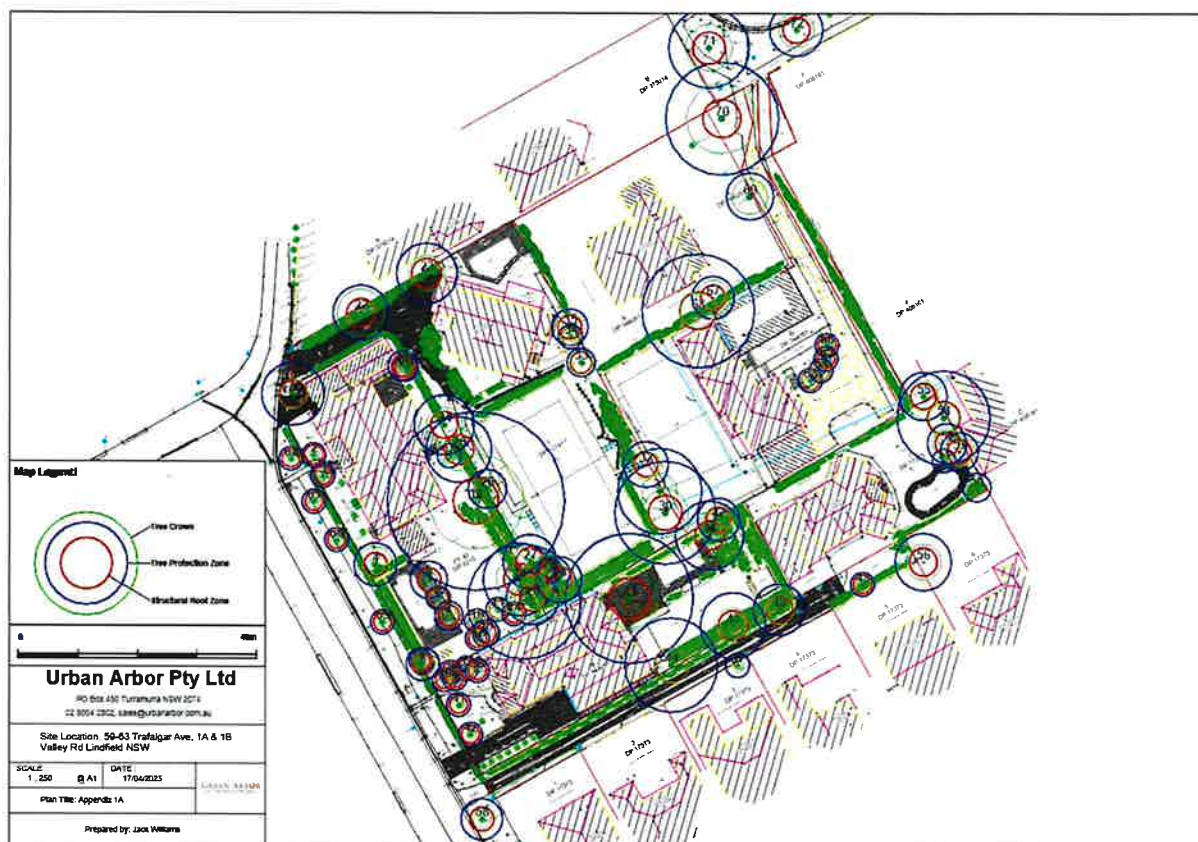
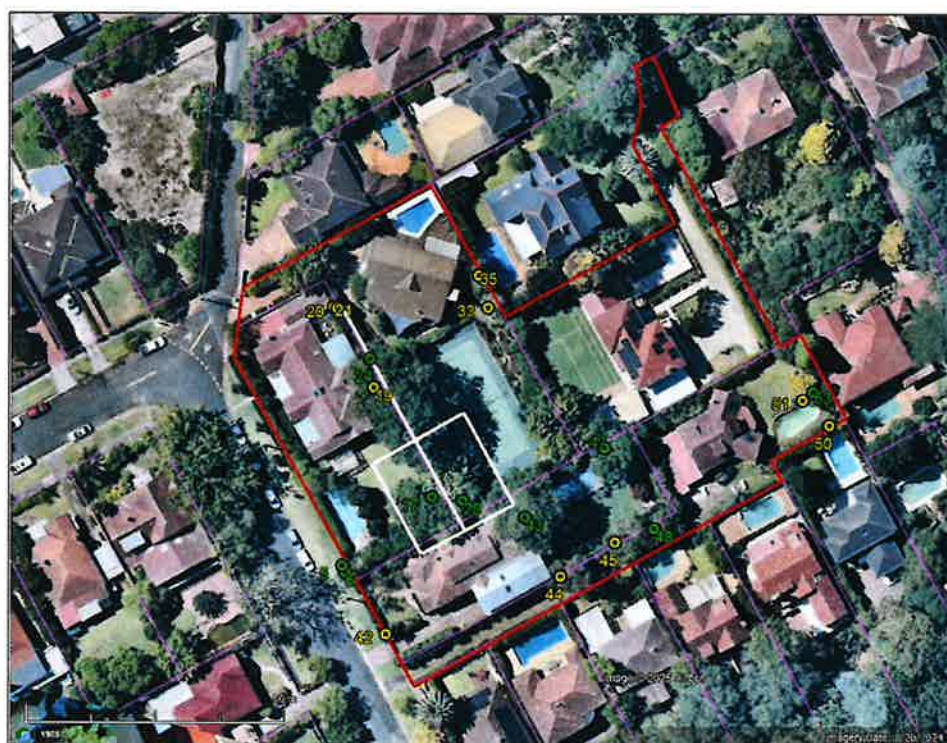
Figure 5: BAM plot location. Shown also are the locations and numbers assigned to the locally native tree species that are likely to be naturally occurring (green) and those native to NSW that have been planted (yellow).

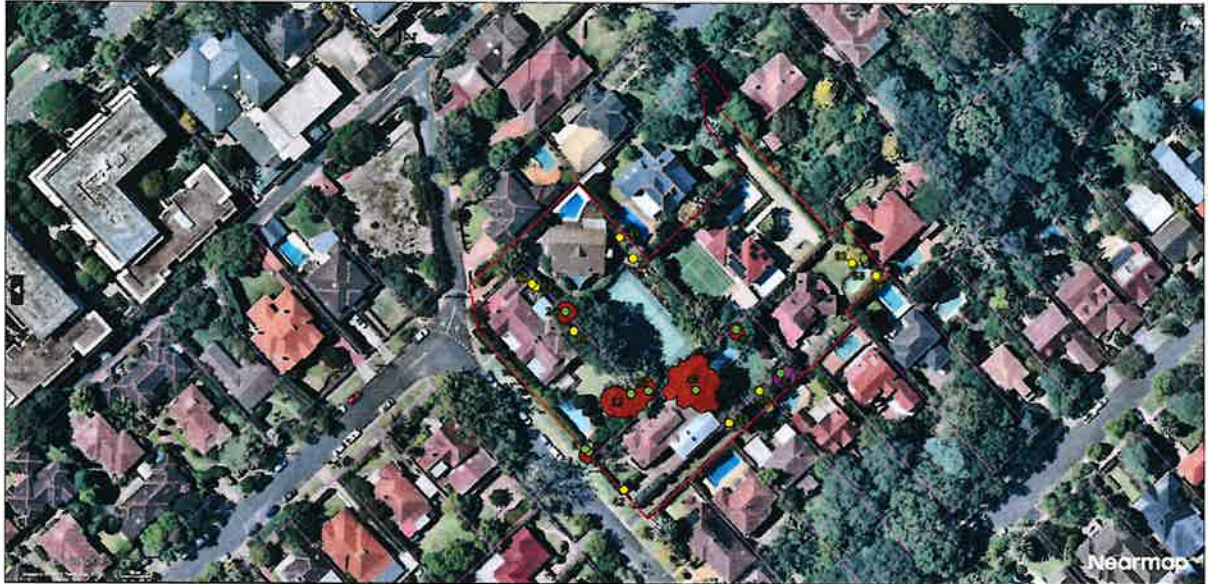
Figure 10: The extent of PCT 3262 (VZ1, red and purple polygons), and its relationship with the native trees on site (green = naturally occurring, yellow = planted). The impact of the footprint is demonstrated in the colour of the VZ1 polygons (red = direct loss, 7 trees, 0.04 hectares; purple = retained, 2 trees, 0.004 hectares).

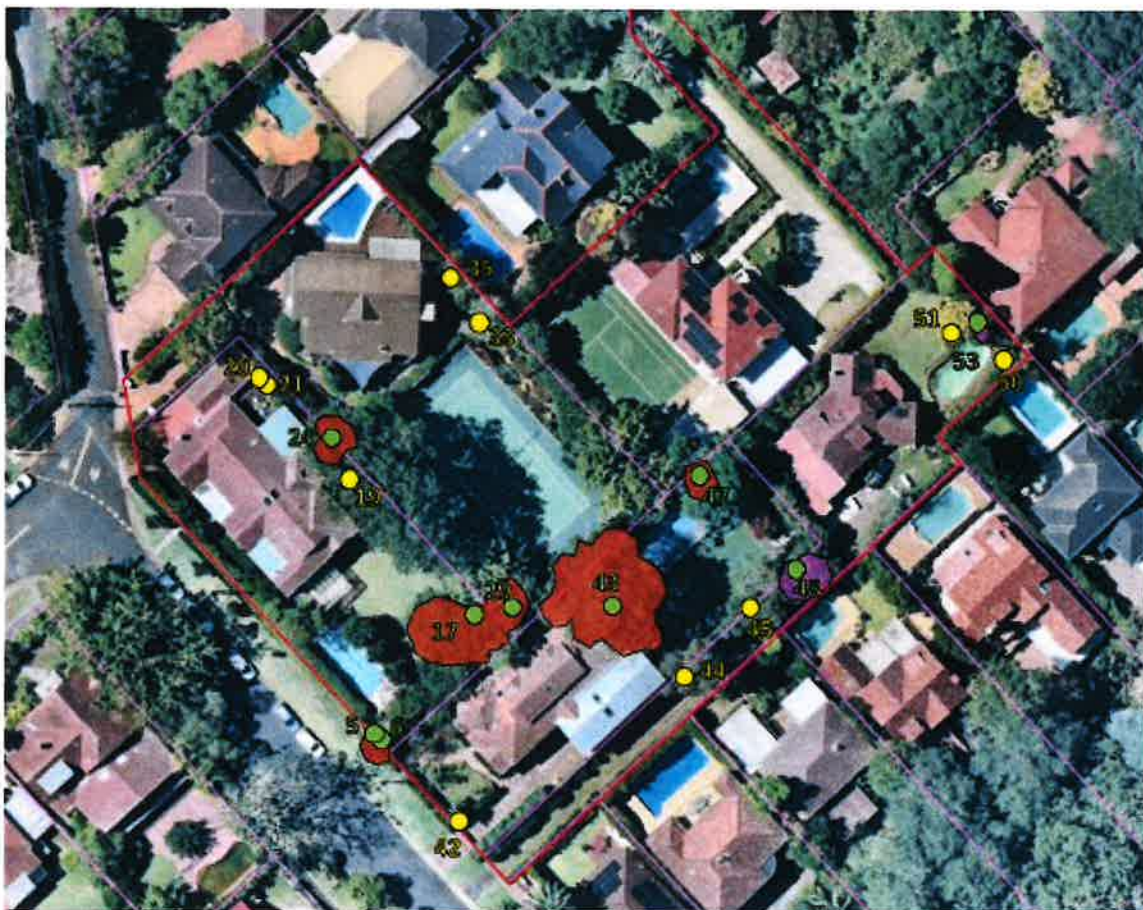
Yellow dot = native

green dot = planted
