## **Dewatering Management Plan 59-63 Trafalgar Avenue & 1A/B Valley Road, Lindfield NSW**

**Reference: P3444\_03 Rev2**

**Date: 12 June 2025**

### **Morrow Geotechnics Pty Ltd**

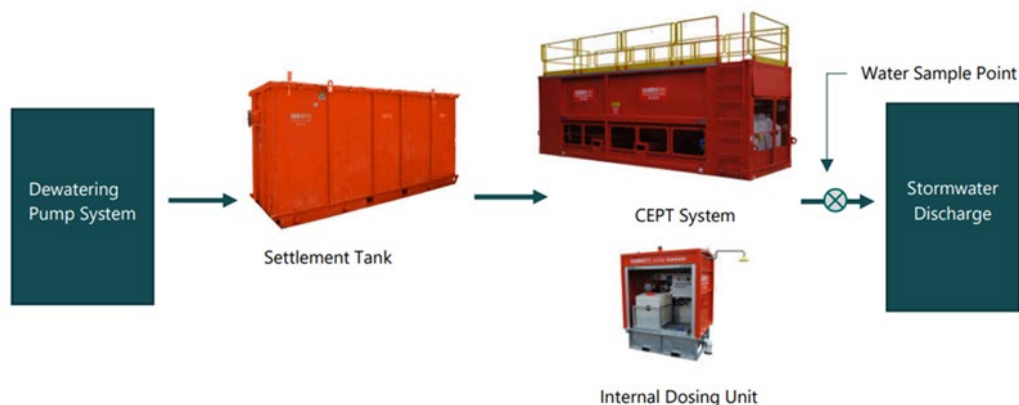
**Figure 6:** Indicative possible treatment system where analyte values exceed Council, ANZG or NEPM threshold values
