CSR Limited

## Remediation Action Plan

327 – 335 Burley Road, Horsley Park,  
NSW 2175

20 December 2019

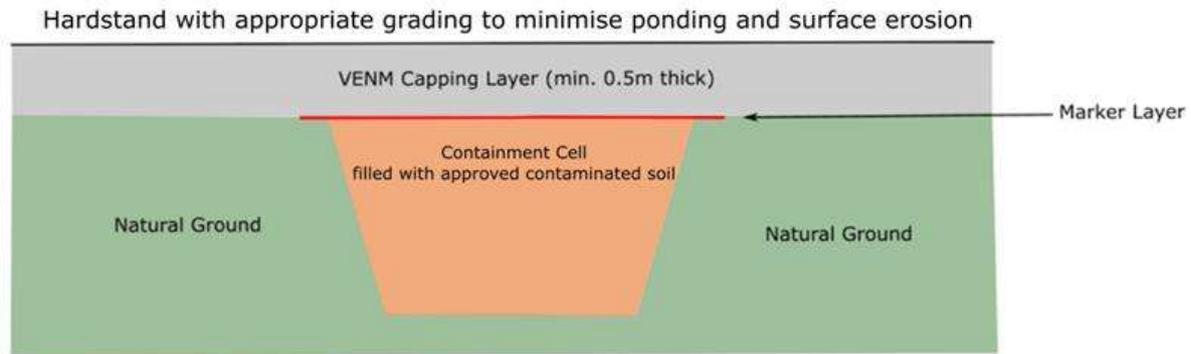
Concept Design Only

Following filling and compaction of the containment cell with asbestos containing soils, a high visibility non-woven geotextile marker layer will be installed over the footprint of the cell such that it covers all approved ACM contaminated fill. The marker layer will extend at least 1 m beyond the perimeter of the cell. Where joins in the marker layer occur, an overlap of at least 200 mm is required.

Following installation of the marker layer, a minimum 0.5m thick capping layer, consisting of Virgin Excavated Natural Material (VENM), will be placed over the top of the marker layer. To reduce the potential for erosion or penetration of the capping layer, loose or unconsolidated sediments should not be used to create the cap.

The concept excavation and capping strategy subject to Council and regulatory authority approval is shown below.
