BIODIVERSITY DEVELOPMENT ASSESSMENT
REPORT (BDAR)
FOR
PROPOSED TRANSIT-ORIENTATED
DEVELOPMENT AT 19 - 25 BALFOUR STREET,
LINDFIELD, NSW, 2107

PREPARED FOR:

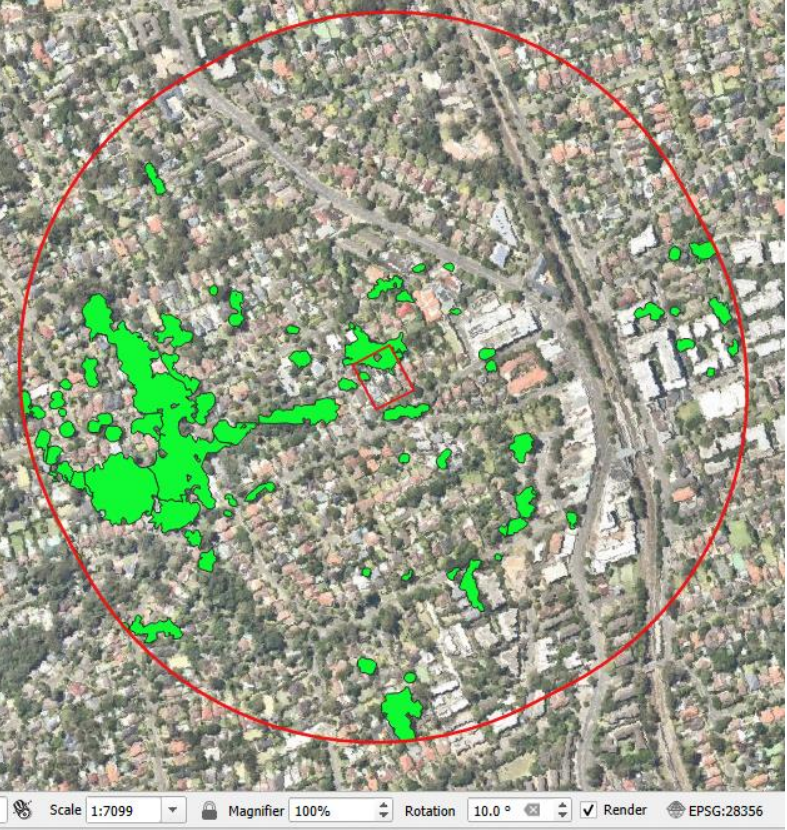
<p>Figure 19: Estimated remaining Sydney Turpentine Ironbark Forest (green) within 500m of the subject site (red outline)</p> <ul style="list-style-type: none"> ii. the small area of the proposed development occurs in an extensively landscaped and urbanised form of the ecological community, with similar urbanised areas
