# Appendices

| Appendix F | Blasting Fly-Rock Control Assessment (20 pages) |

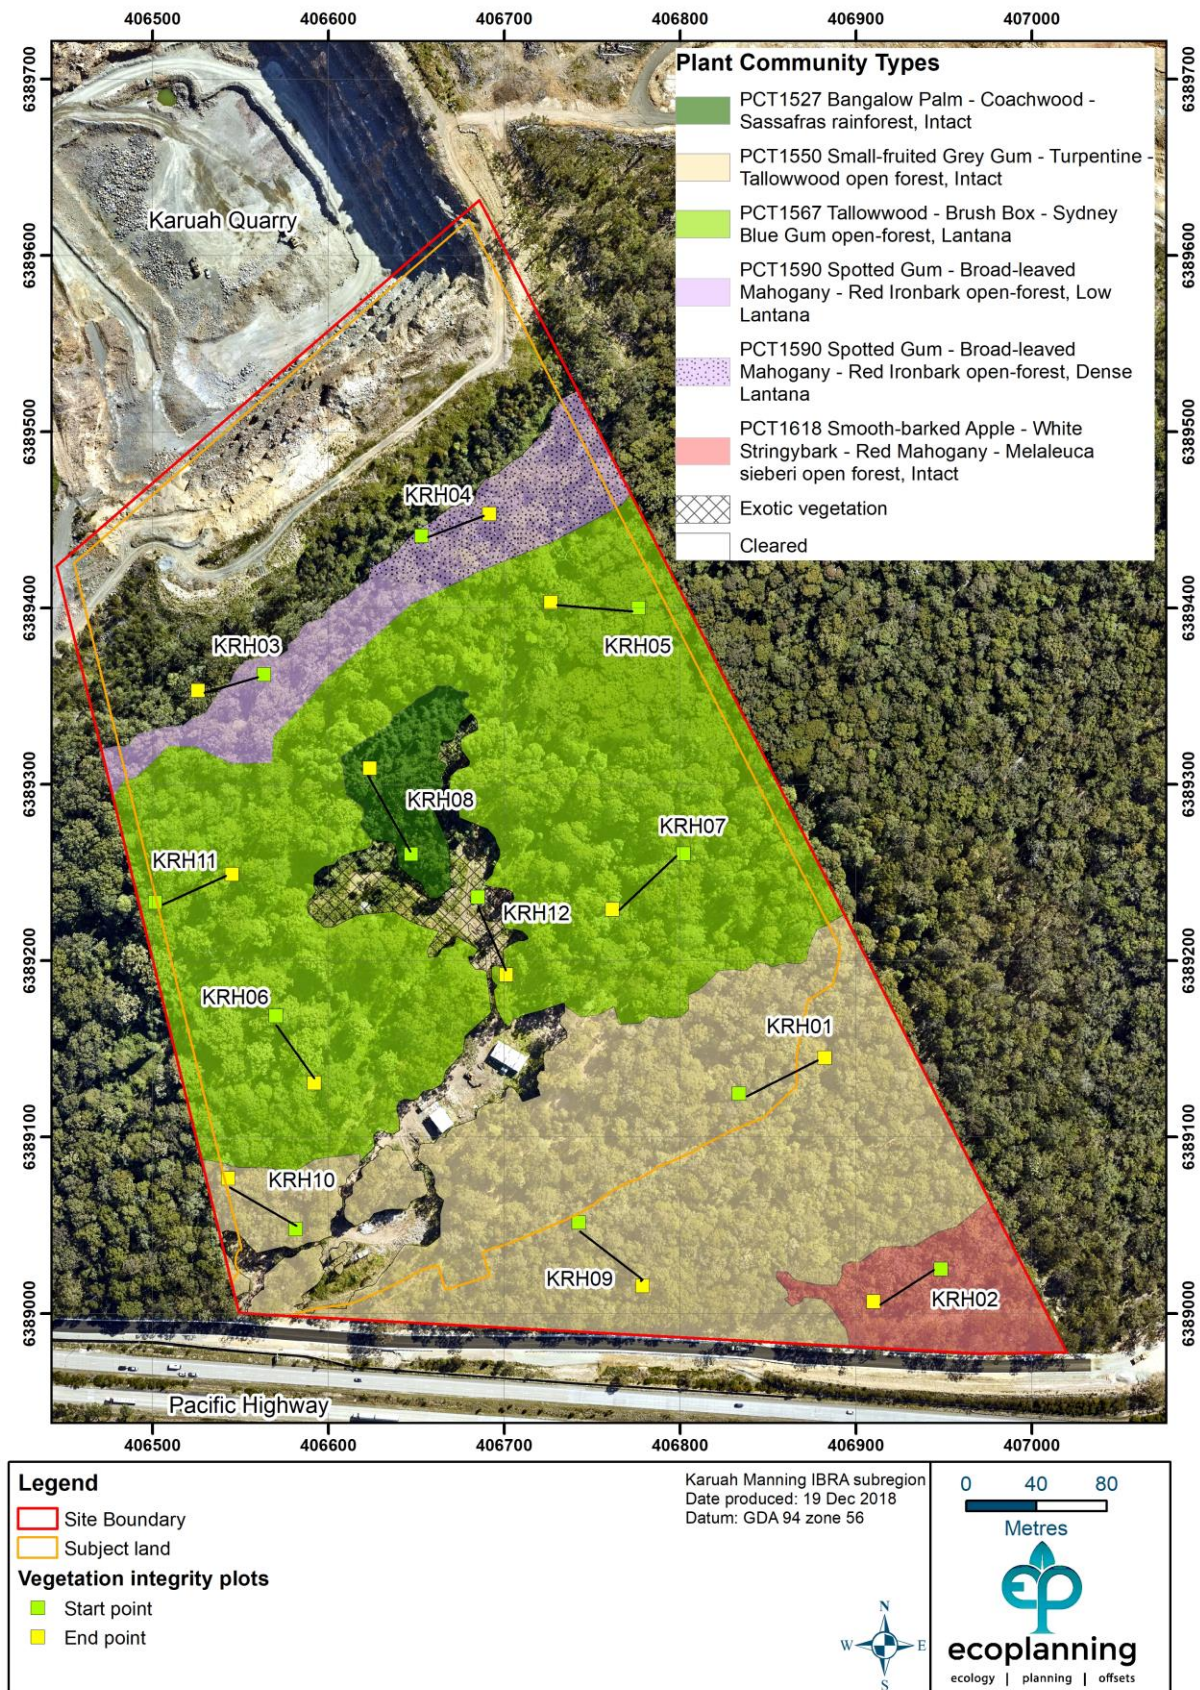
**Figure 6 Plant Community Types (PCTs) and Vegetation Integrity Plot Locations**

This vegetation community is located in the northern part of the subject land (**Figure 6**) on the gentle upper slopes of the hill and is an open-forest dominated by *C. maculata*, *E. acmenoides* and *E. paniculata* (**Plate 1**). *Eucalyptus fibrosa* was also identified as being present within this PCT. This PCT supported an open midstorey which included a number of mesic shrub species including *Cryptocarya rigida* (Forest Maple) and *Clerodendrum tomentosum* (Hairy Clerodendrum) over a diverse grassy understorey. The condition of this vegetation community was variable with some areas being in a relatively undisturbed condition with low levels of *Lantana camara*\* (Lantana) infestation, while other areas have been disturbed as part of the approved activities within the adjacent Karuah Quarry and supported a sparse canopy layer and very dense infestations of *L. camara*\*. Two vegetation zones (based upon areas in a broadly similar condition state, consistent with section 5.3.1.1 of the BAM) were identified for this PCT, which separated areas with low *L. camara*\* cover and a higher density of native shrub and understorey species (termed 'Low lantana') from those areas with a dense cover of *L. camara*\* and lower cover of native shrub and understorey species (termed 'Dense lantana').
